MINUTES  
Regular City Council Meeting  
September 9, 2019  
Page 1

Re: **Status of Recreation Building, 213-215 East 2<sup>nd</sup> Street**

**Structural Inspection at 213 East Second Street, The Dalles, Oregon (Recreation Building)**

## Structure Damage Assessment

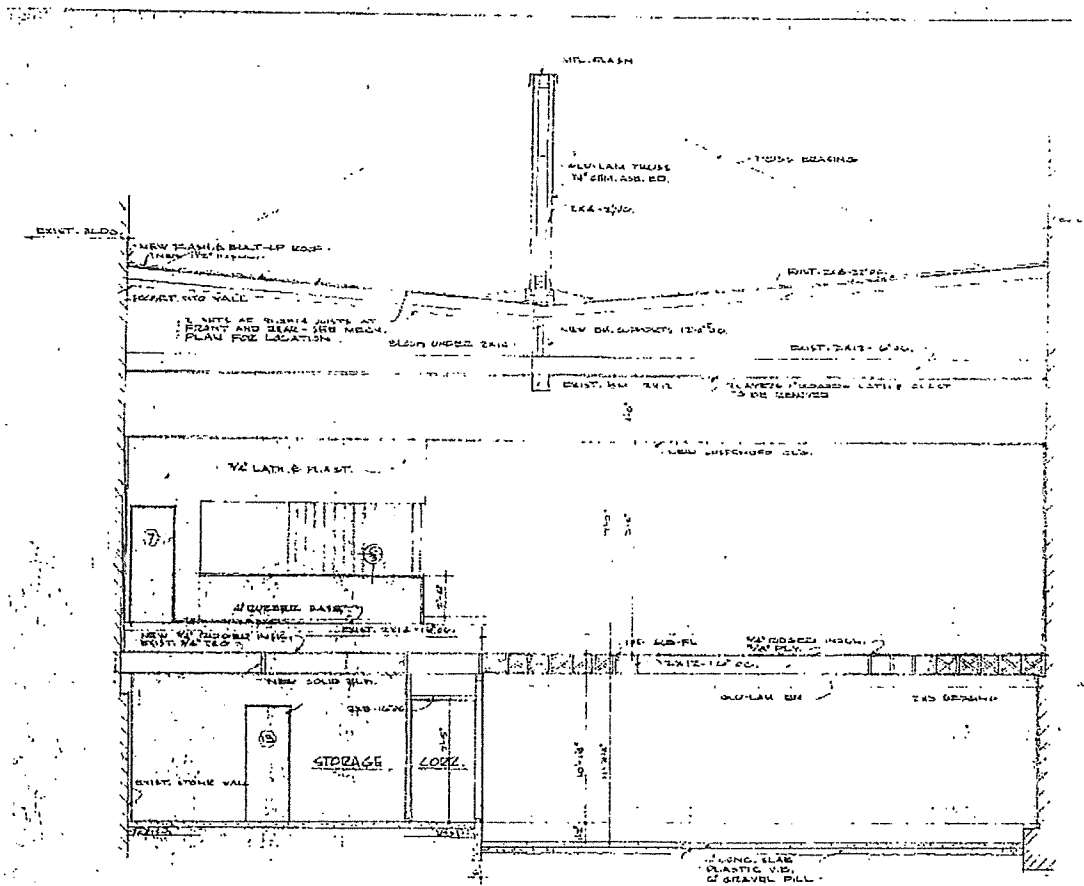
Figure 1 - Rehabilitation Drawings - Roof Assembly and Truss Lateral Bracing

The rehabilitation drawings converting the subject structure to a bowling alley were reviewed. These drawings were dated June 1958. These drawings included the installation of a truss spanning from the front to the back of the structure which supported the existing beam. This was done in order to eliminate the columns supporting the beam. Hangers were installed approximately every 15 feet per these drawings to support the beam using the newly installed truss. The cables which were noted to be loose during the inspection were lateral bracing for the truss. Selected details from these drawings are included below as Figures 1 and 2.

The subject structure experienced a partial roof structural failure which resulted in the apparent failure of a beam running the length of the structure. The structure had been previously modified to replace the intermediate column supports for the subject beam with a full-length truss spanning the length of the structure supporting the subject beam. Given the condition of the structure, the exact cause of the failure could not be determined as the truss system could not be safely accessed to assess the nature of the failure.

The failure was consistent with the failure of the main truss supporting the subject beam. This failure subsequently resulted in the beam being over-spanned and failing as well. The estimated load experienced on the subject roof on the date of loss, even if the roof drainage system was fully clogged and all water from the rainstorm was retained on the structure, was approximately 4 psf. This load would be insufficient to cause the failure of a properly designed and maintained roof in otherwise good condition. Common building codes used during the time of the rehabilitation of the structure specified minimum design roof live loads of 12 psf. The failure is thus attributed to long-term deterioration of truss components due to lack of maintenance.
