COLUMBIA GATEWAY URBAN RENEWAL AGENCY

AGENDA STAFF REPORT

ISSUE: Declaration of emergency circumstances requiring partial demolition of Recreation Building, exempting the contract for demolition from competitive bidding requirements, and authorization of award of contract for partial demolition of Recreation Building and waiver of performance and payment bonds

Structure Damage Assessment

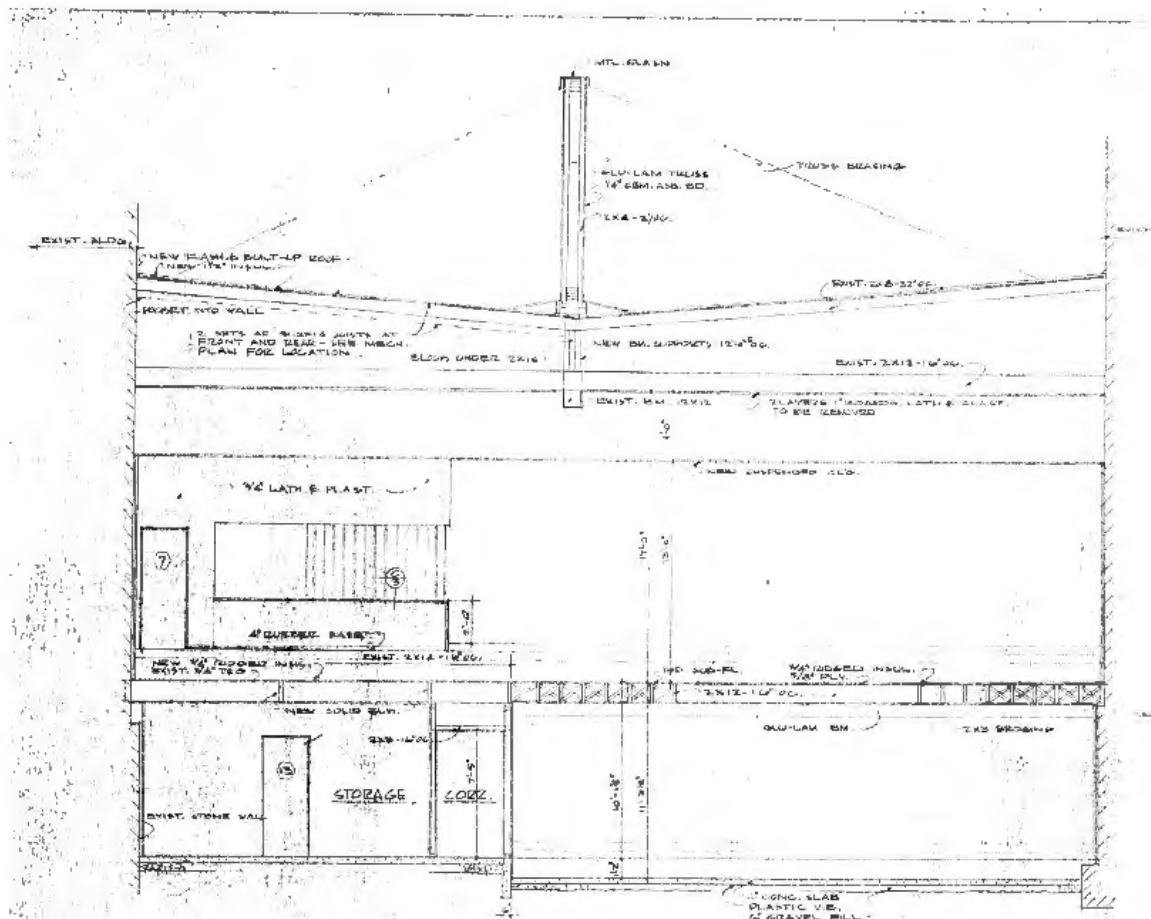
The rehabilitation drawings converting the subject structure to a bowling alley were reviewed. These drawings were dated June 1958. These drawings included the installation of a truss spanning from the front to the back of the structure which supported the existing beam. This was done in order to eliminate the columns supporting the beam. Hangers were installed approximately every 15 feet per these drawings to support the beam using the newly installed truss. The cables which were noted to be loose during the inspection were lateral bracing for the truss. Selected details from these drawings are included below as Figures 1 and 2.

Figure 1 - Rehabilitation Drawings - Roof Assembly and Truss Lateral Bracing

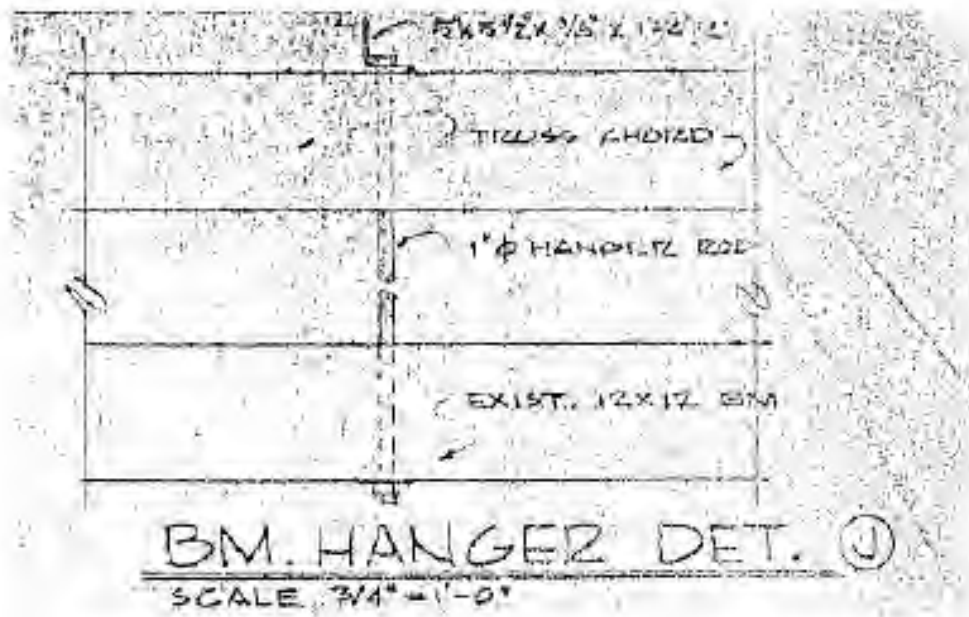
Figure 2 - Rehabilitation Drawings - Beam Hanger Detail

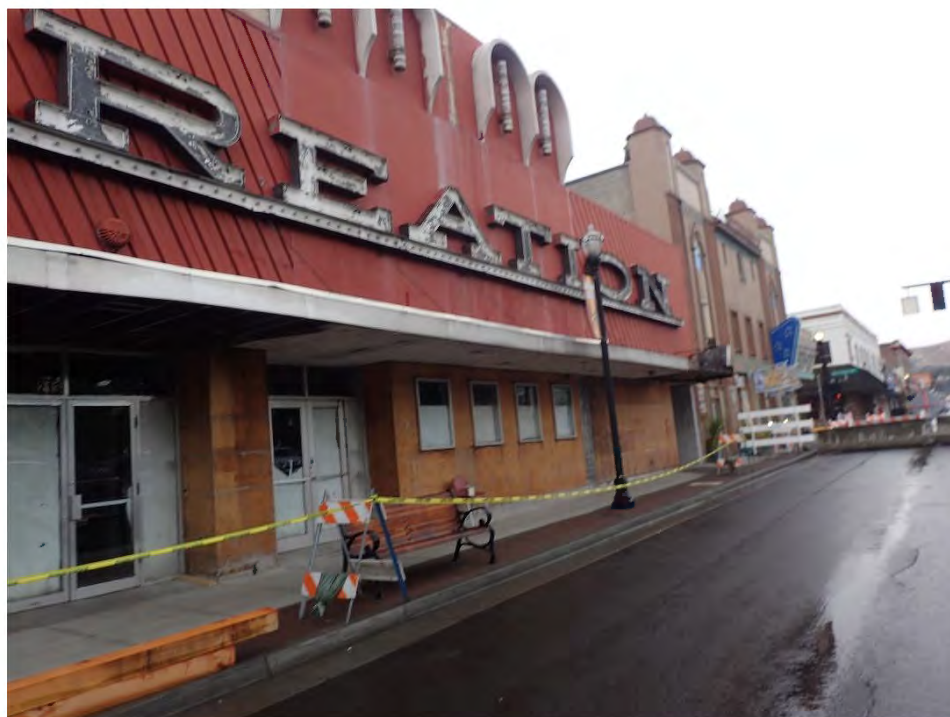
The out-of-plumb condition of the front façade resulted from the beam and truss failure which pushed the top of the wall outward.

Photo No. 2: Front, south face, of subject structure

EFI advised Mr. Harris during the inspection that the structure in its current condition is unsafe and should be demolished or properly shored immediately. The condition of the front façade poses an immediate safety risk to pedestrians and vehicles on 2nd Street. The shoring that has been installed to support the failed beam and truss is inadequate. The subject structure should be demolished or properly shored immediately.

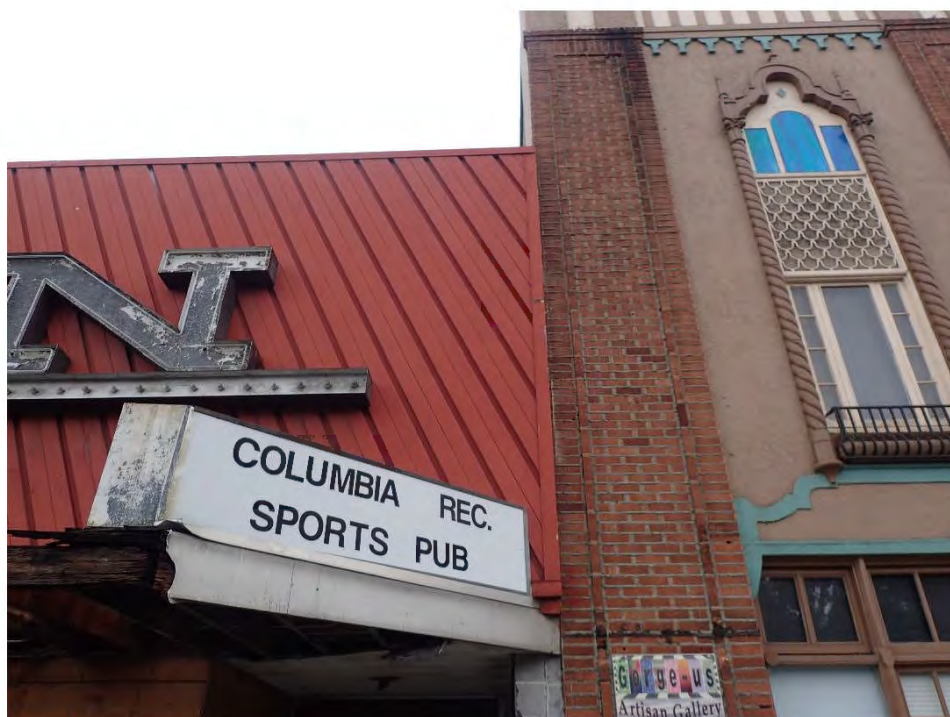
Photo No. 3: Alternate view

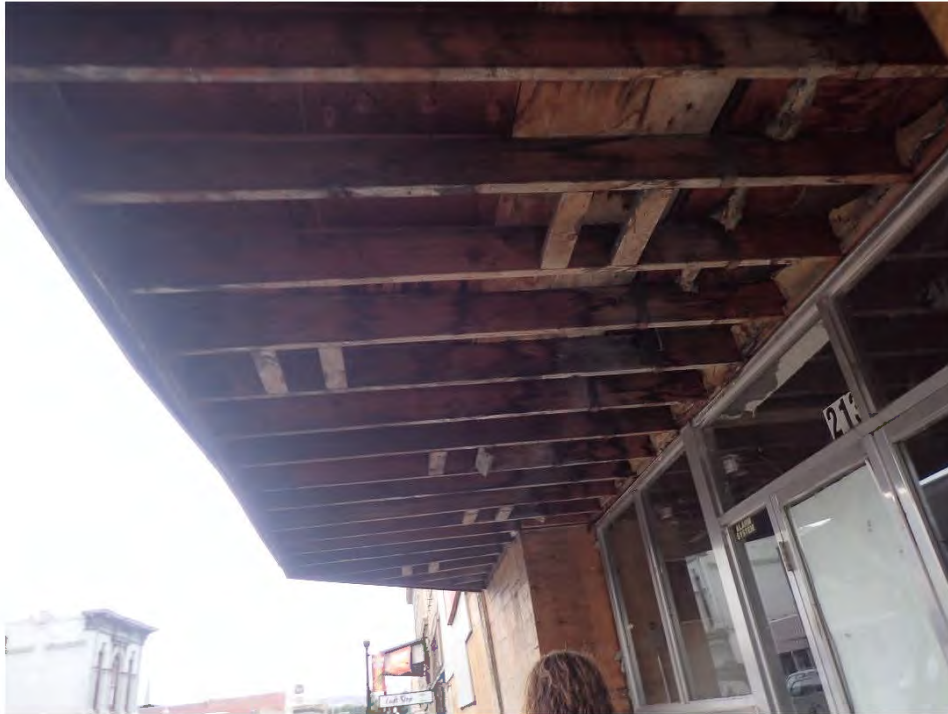
Photo No. 4: Condition of framing beneath front awning

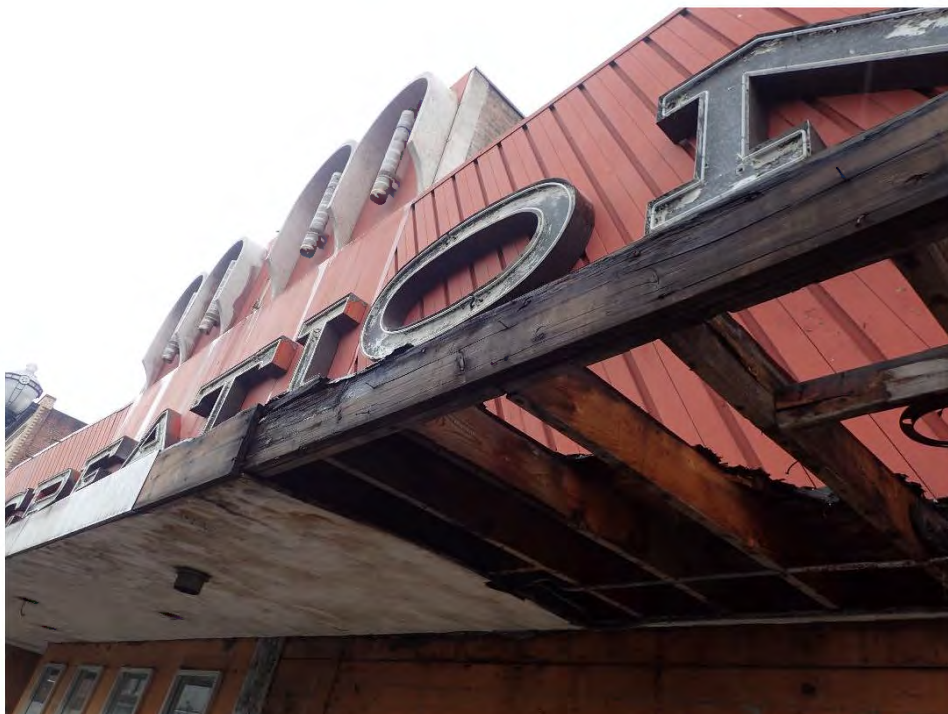
Photo No. 5: Alternate view

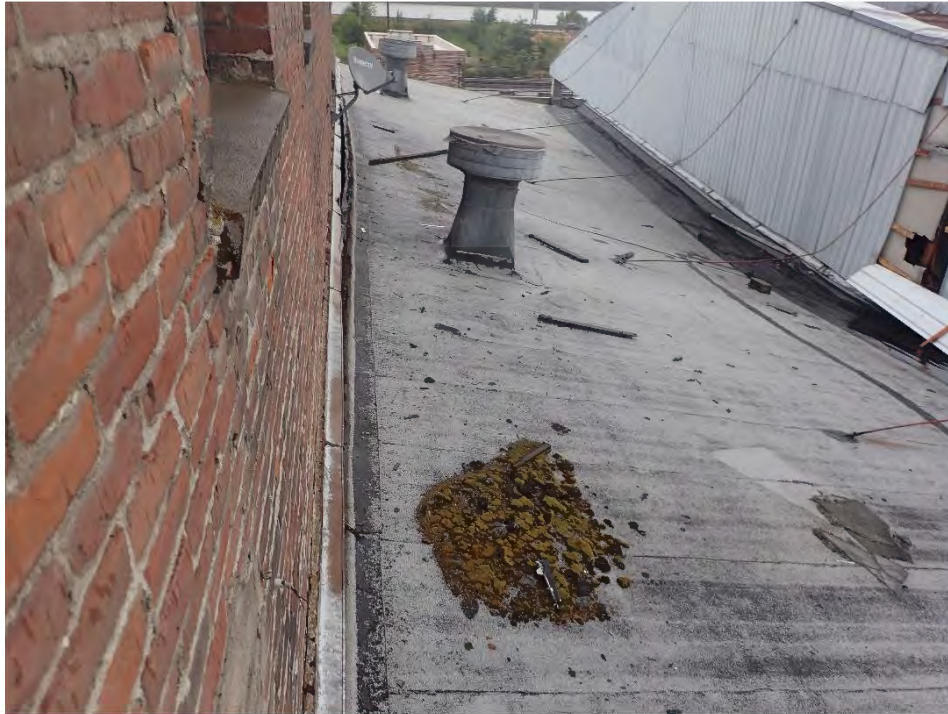
3. The roof of the subject structure was observed from the third floor of the adjacent building to the west. The roof examination was limited to what was visible from this location.
4. The roofing material appeared to have been patched in some areas somewhat recently.
5. The roofing material had been pulled away from the masonry wall to the west. A visible gap was present.
6. The lateral braces supporting the superstructure were visibly sagging.
7. The roof was visibly sagging.
8. The area of roof that was visible generally appeared to be in poor condition.

Photo No. 6: View of roof collapse from structure to the west

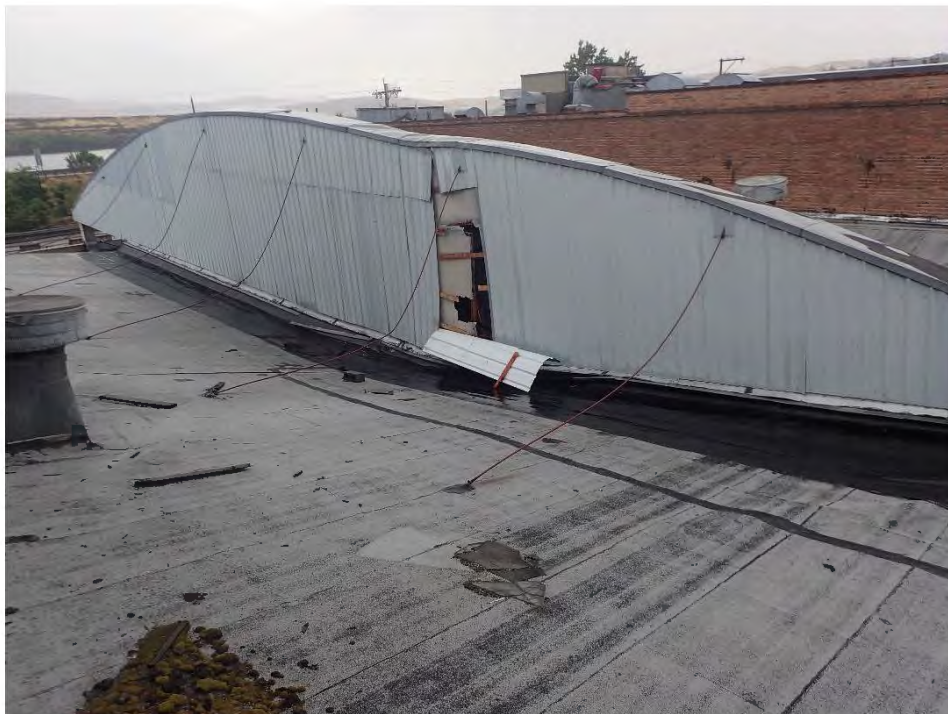
Photo No. 7: Alternate view

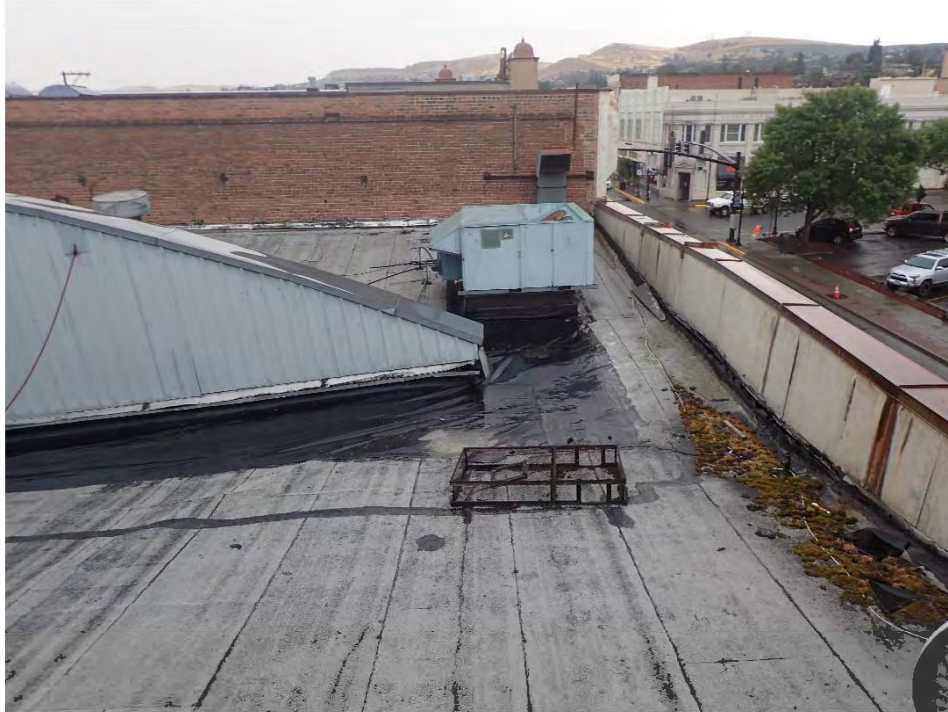
Photo No. 8: Alternate view

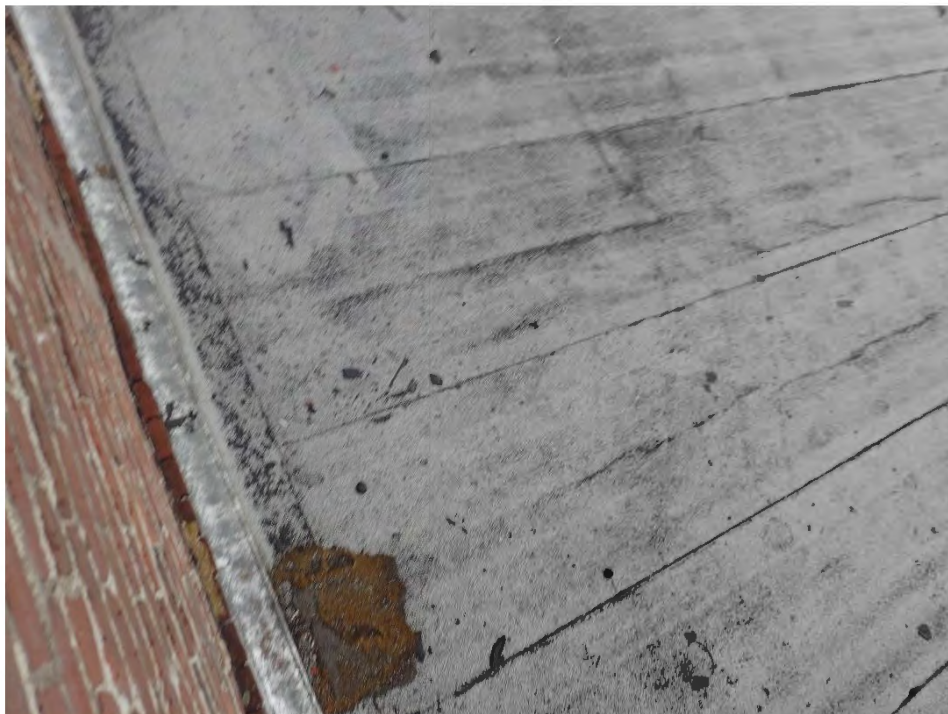
Photo No. 9: Condition of roofing material, visible gap

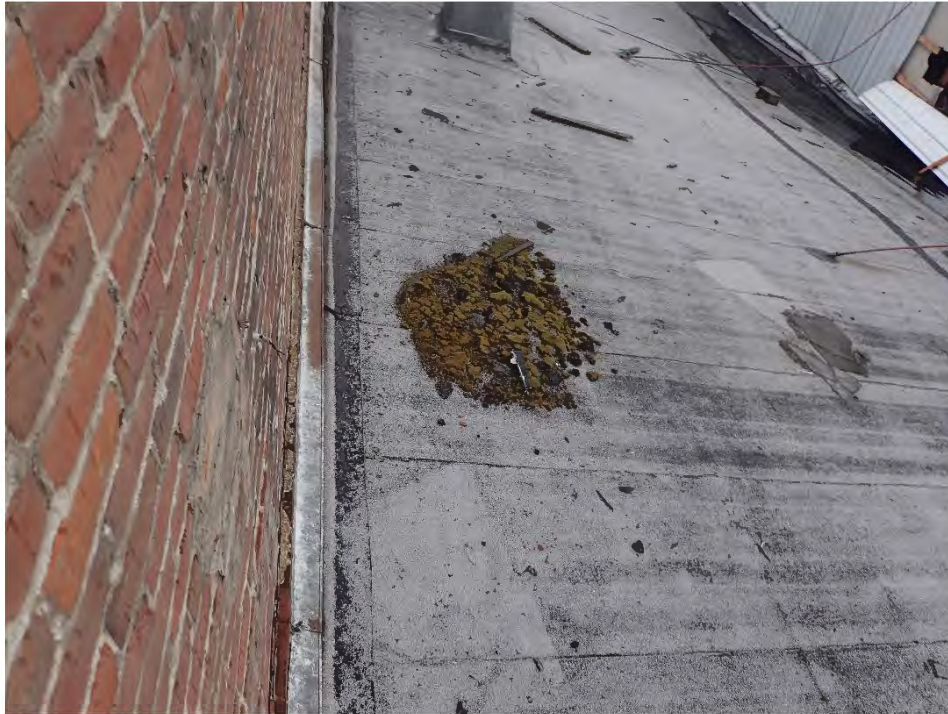
Photo No. 10: Alternate view

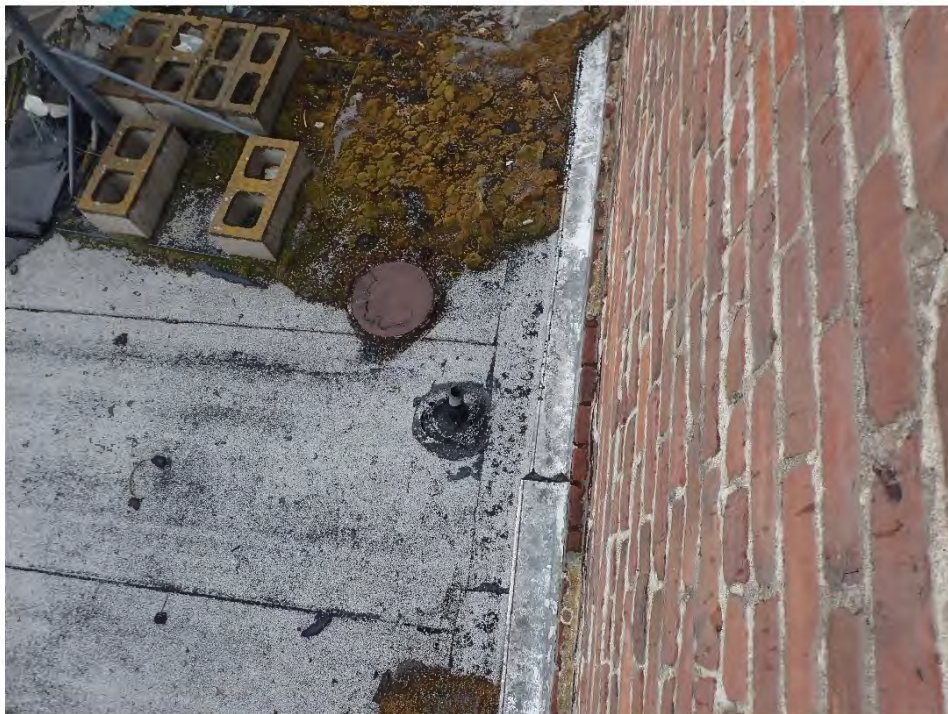
Photo No. 11: Alternate view

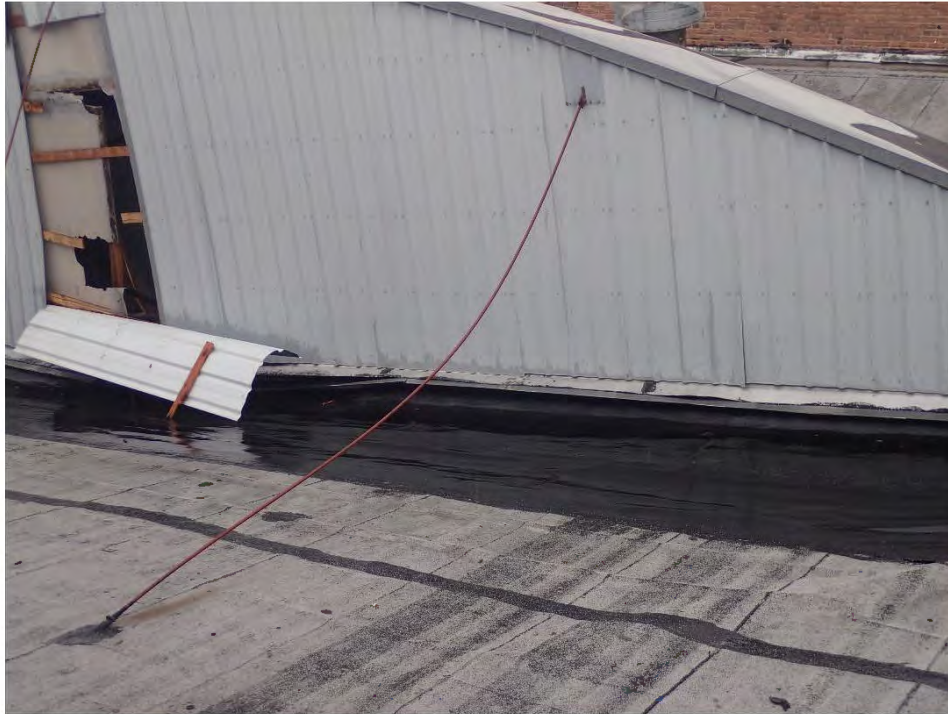
The failure was consistent with the failure of the main truss supporting the subject beam. This failure subsequently resulted in the beam being over-spanned and failing as well. The estimated load experienced on the subject roof on the date of loss, even if the roof drainage system was fully clogged and all water from the rainstorm was retained on the structure, was approximately 4 psf. This load would be insufficient to cause the failure of a properly designed and maintained roof in otherwise good condition. Common building codes used during the time of the rehabilitation of the structure specified minimum design roof live loads of 12 psf. The failure is thus attributed to long-term deterioration of truss components due to lack of maintenance.

Photo No. 12: Closer view of superstructure containing truss

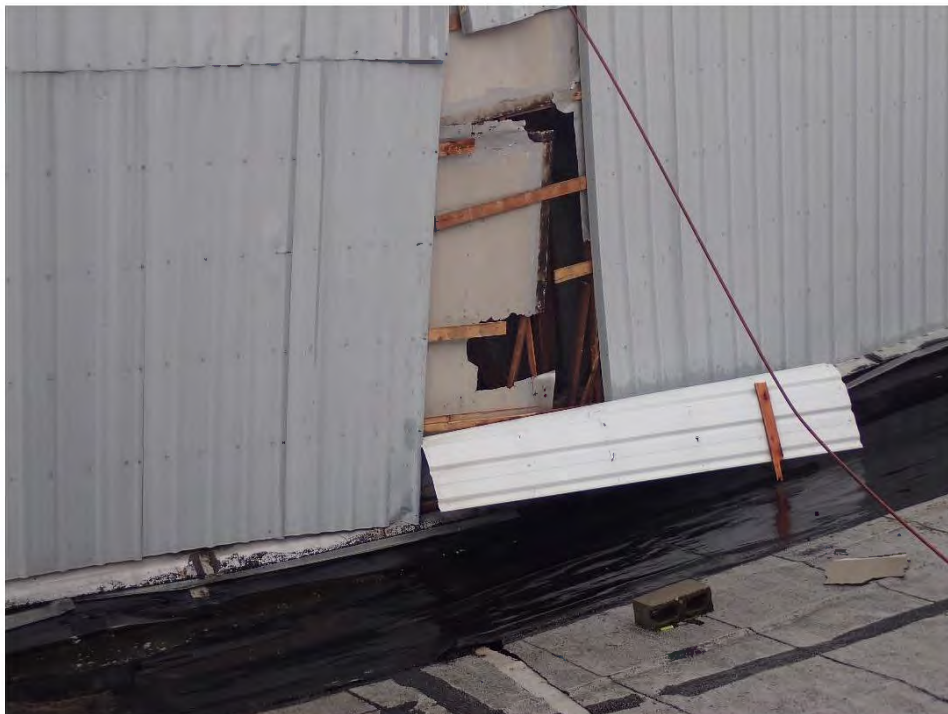
Photo No. 13: Alternate view

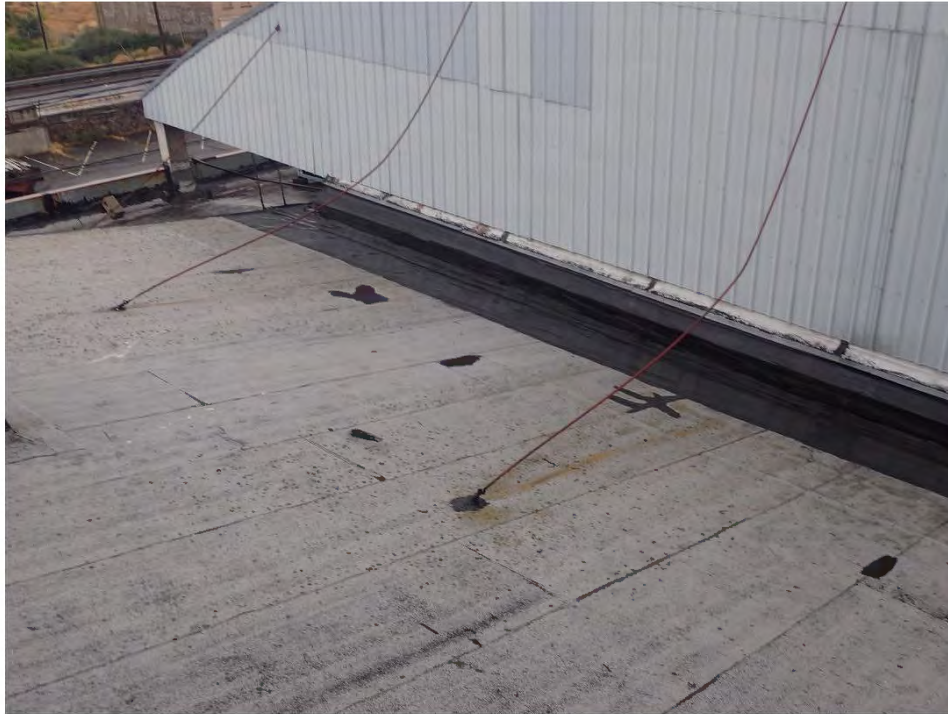
Photo No. 14: Alternate view

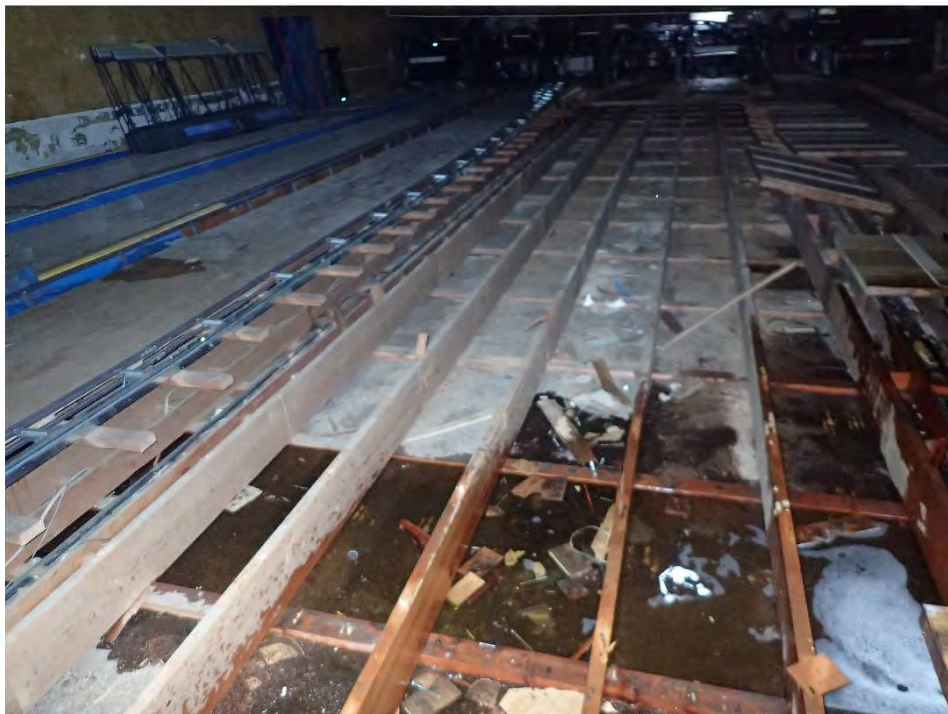
9. The interior was inspected in the area of the roof collapse.
10. A beam oriented in the north-south direction which spanned from the north wall to the south wall was fractured.
11. The beam had intermediate support brackets spaced approximately every 15 feet.
12. The supports roughly corresponded to locations where it appeared intermediate columns had been removed.
13. Temporary shoring had been installed to support the failed beam; however, it was bearing directly on the existing bowling alley and was not braced laterally.
14. The roof joists appeared to be weathered and there were indications of long-term water intrusion and deterioration in some locations.

Photo No. 15: View of interior

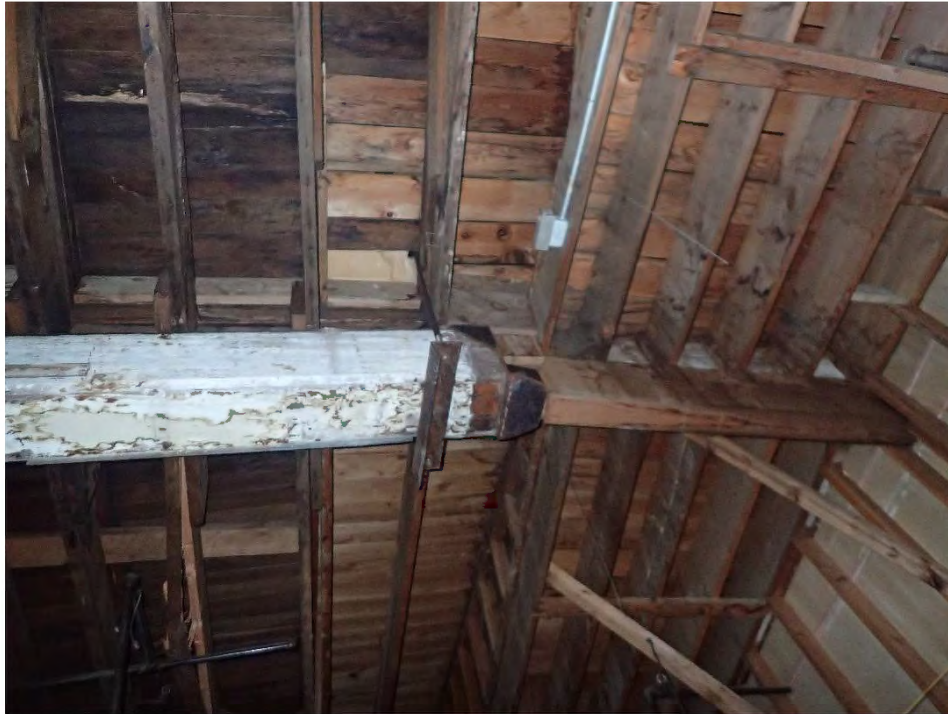
Photo No. 16: View of beam, beam support bracket

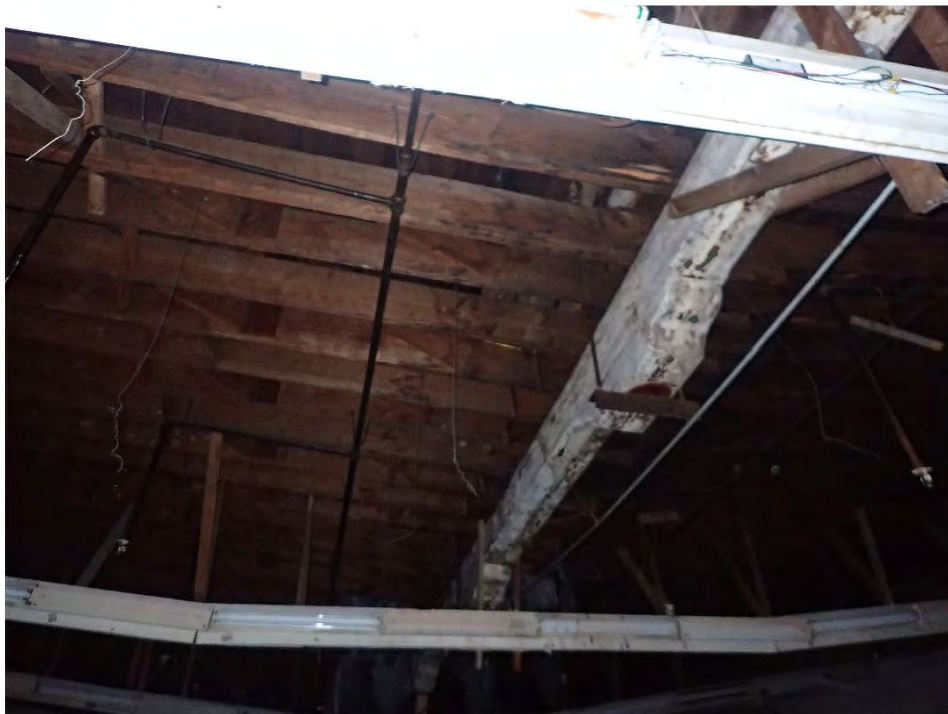
The subject structure experienced a partial roof structural failure which resulted in the apparent failure of a beam running the length of the structure. The structure had been previously modified to replace the intermediate column supports for the subject beam with a full-length truss spanning the length of the structure supporting the subject beam. Given the condition of the structure, the exact cause of the failure could not be determined as the truss system could not be safely accessed to assess the nature of the failure.

Photo No. 17: View of beam support bracket at previous column locations

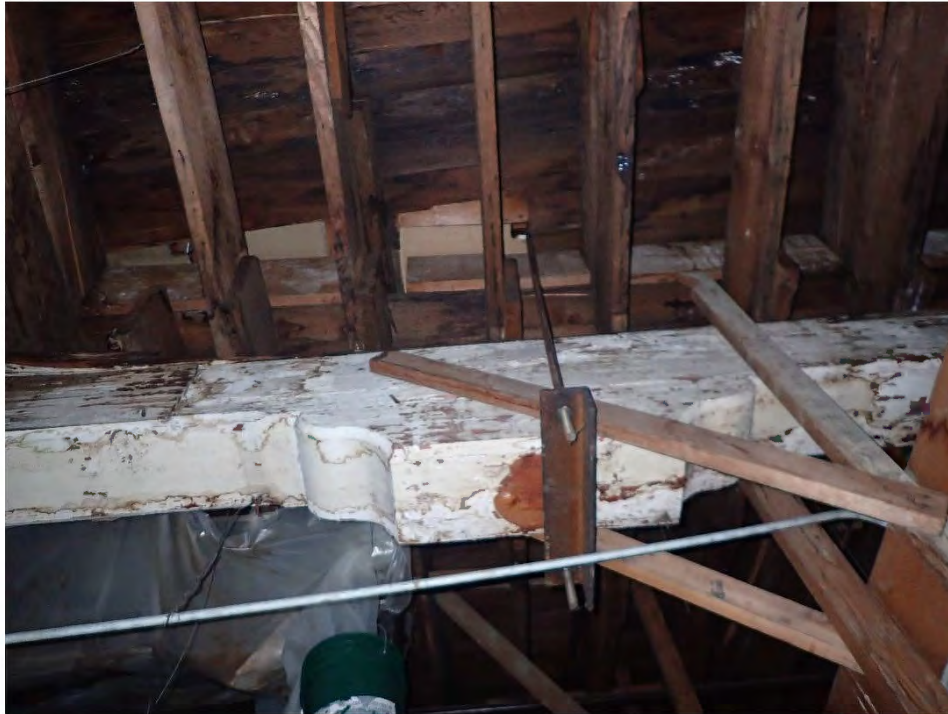
Photo No. 18: Alternate view

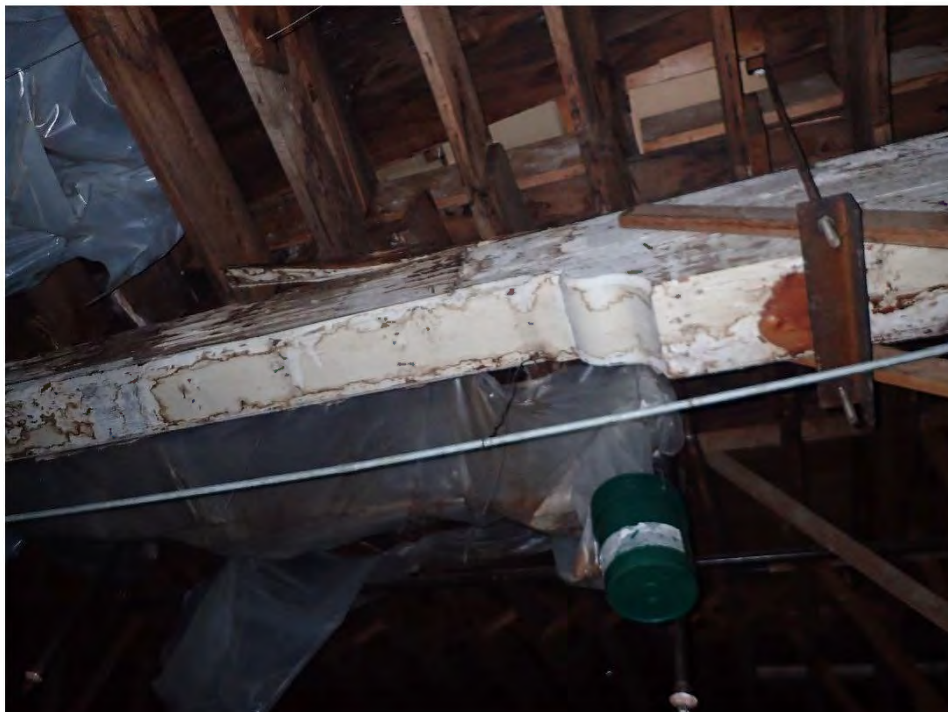
Photo No. 19: Alternate view

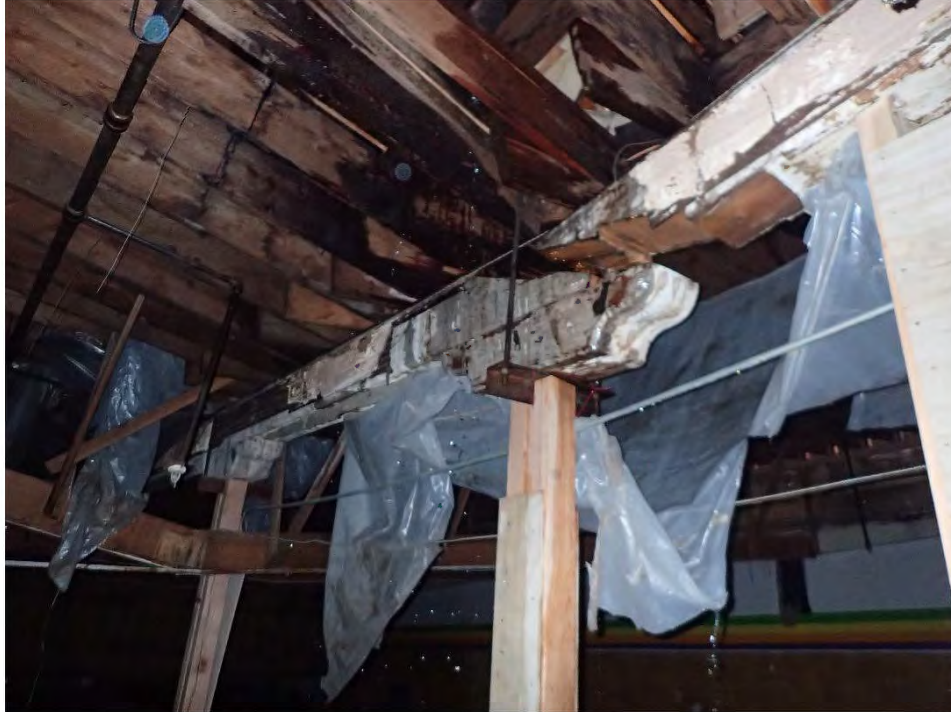
Photo No. 20: Fractured beam and shoring

3. The structure in its current condition poses an immediate safety risk to the public. It should be demolished or properly shored immediately.
4. These construction activities should be executed by a licensed and experienced contractor who is familiar with these types of activities. Note that the means and methods of these repairs, and obtaining a building permit, are the responsibility of the chosen contractor. Additional required code related upgrades including energy efficiency, mechanical, plumbing and electrical should be reviewed with the local Building Code Official.

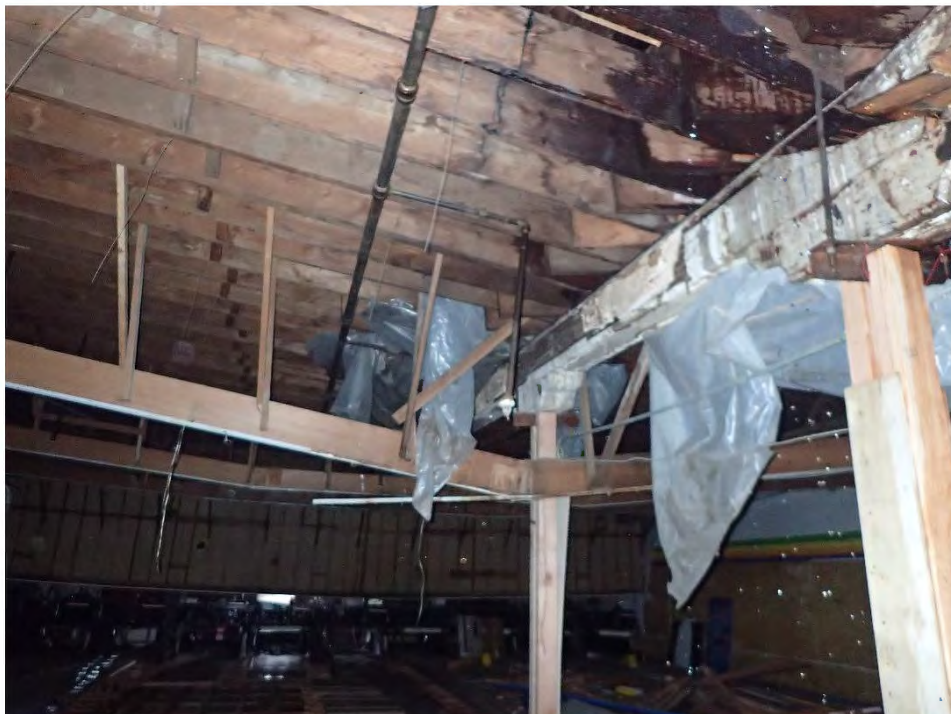
Photo No. 21: Alternate view

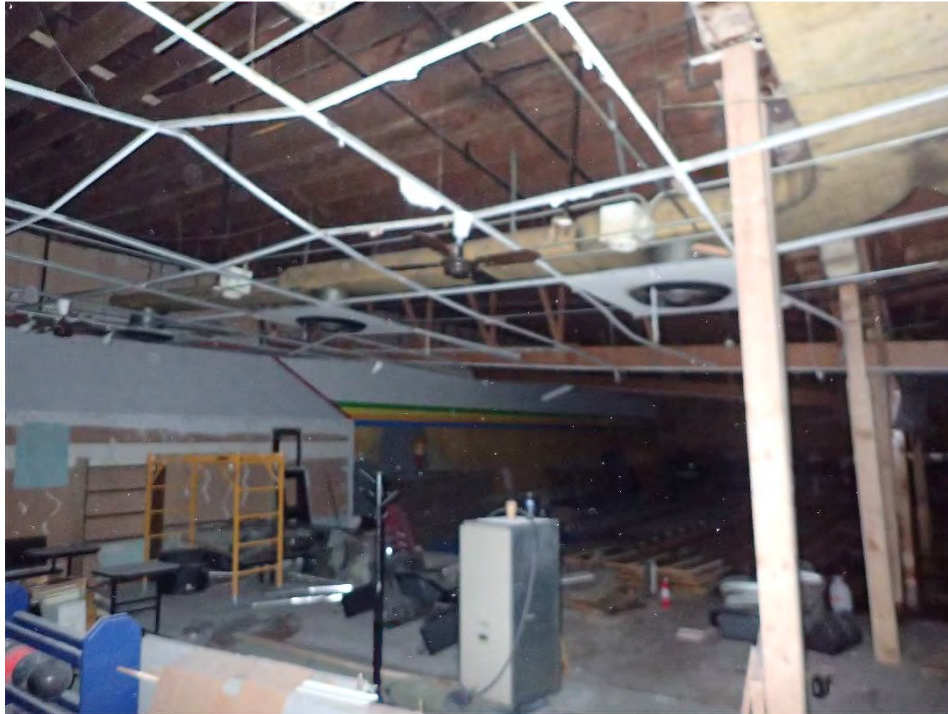
Photo No. 22: View of shoring

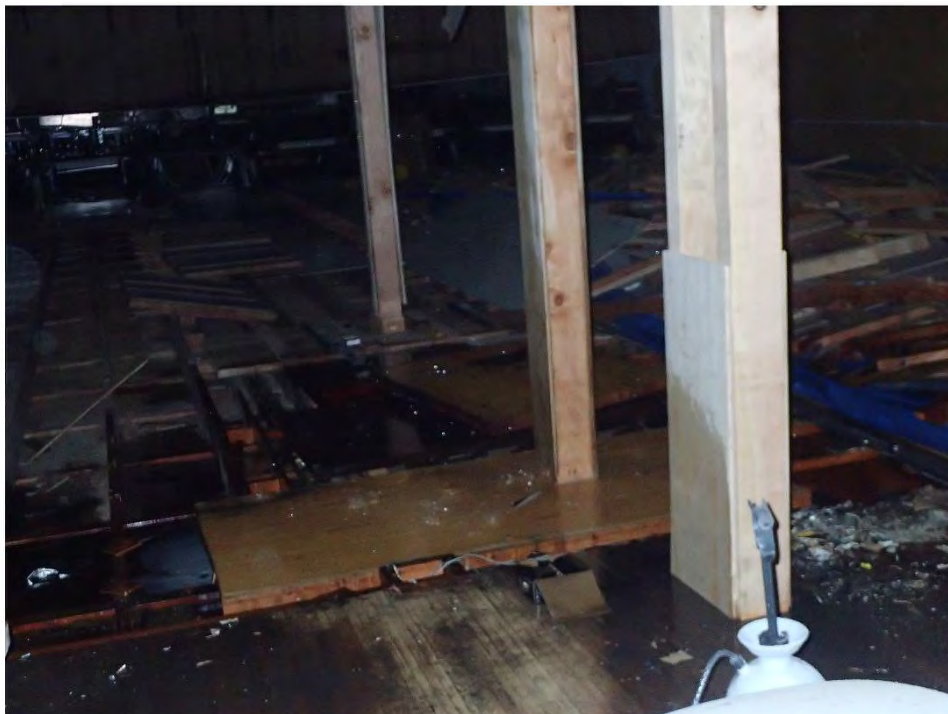
Photo No. 23: View of shoring

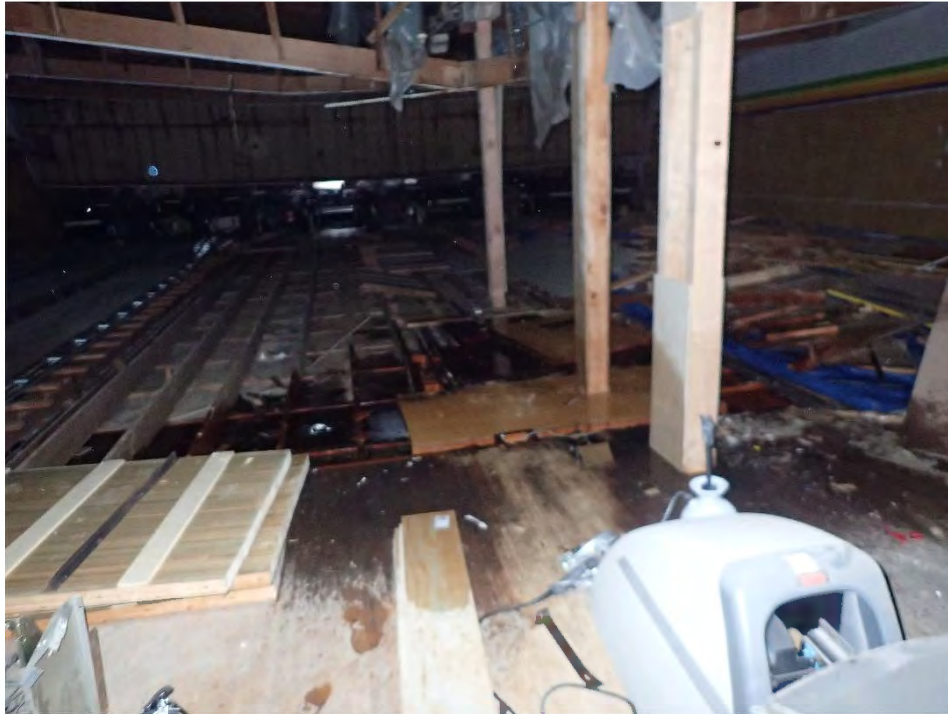
Photo No. 24: Alternate view

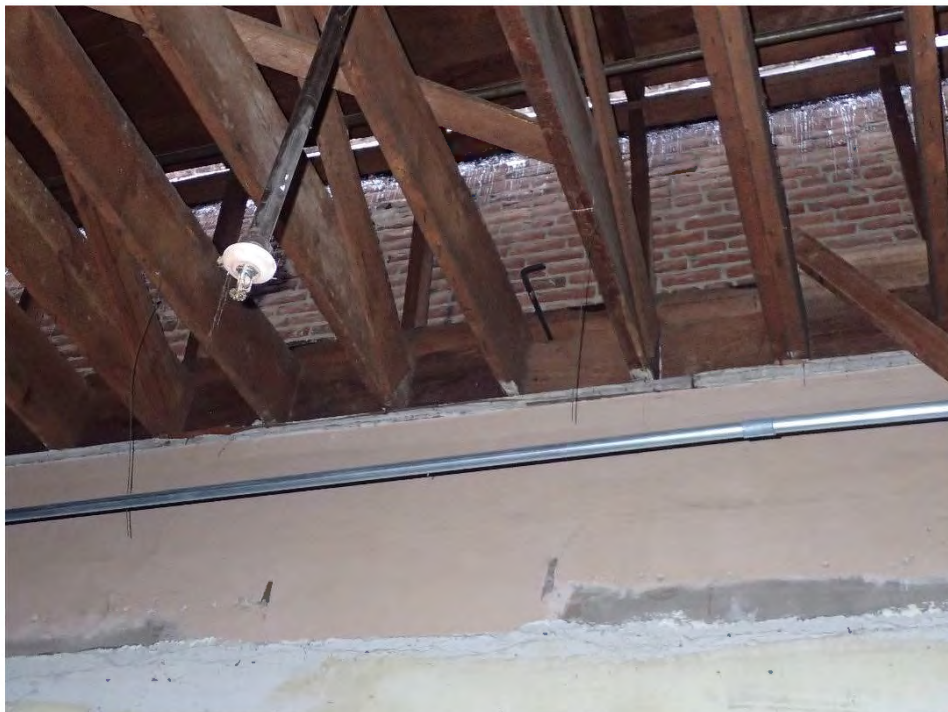
Photo No. 25: View of ceiling joists

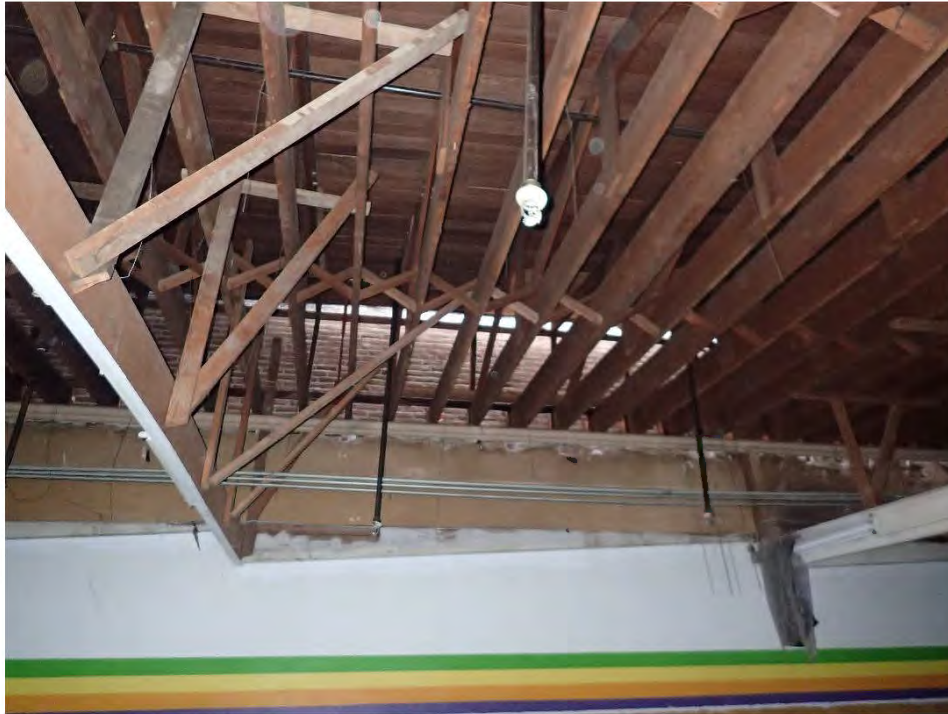
Photo No. 26: Alternate view

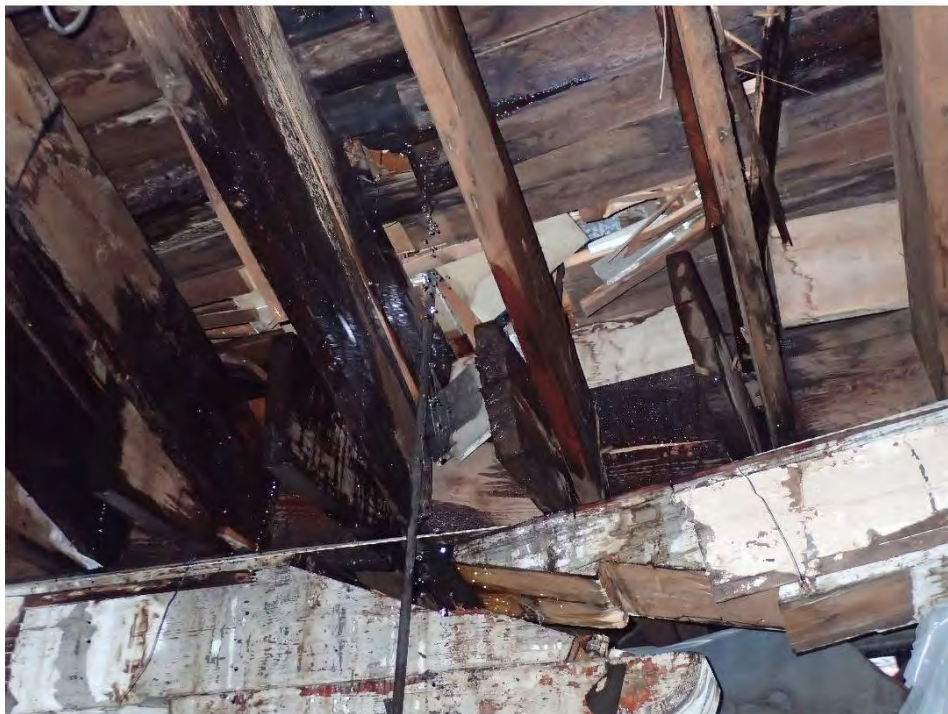
1. The roof structure failure was the result of long-term deterioration of the truss supporting the beam which spanned the length of the structure.
2. The estimated applied loading due to the rain event on the listed date of loss was insufficient to cause a structural failure to a properly designed and maintained structure.

Photo No. 27: Roof structure, water intrusion
