### **CITY OF THE DALLES HISTORIC LANDMARKS COMMISSION**

HLC #57-01, 6<sup>th</sup> Street Bridge
- VII. Presentation by The Dalles Mural Society on possible new murals.**
- VIII. Next meeting date: March 28, 2001 – 4:00 p.m.**
- IX. Adjournment**

# Technical Evaluation Report

## West 6th Street Bridge Over Mill Creek

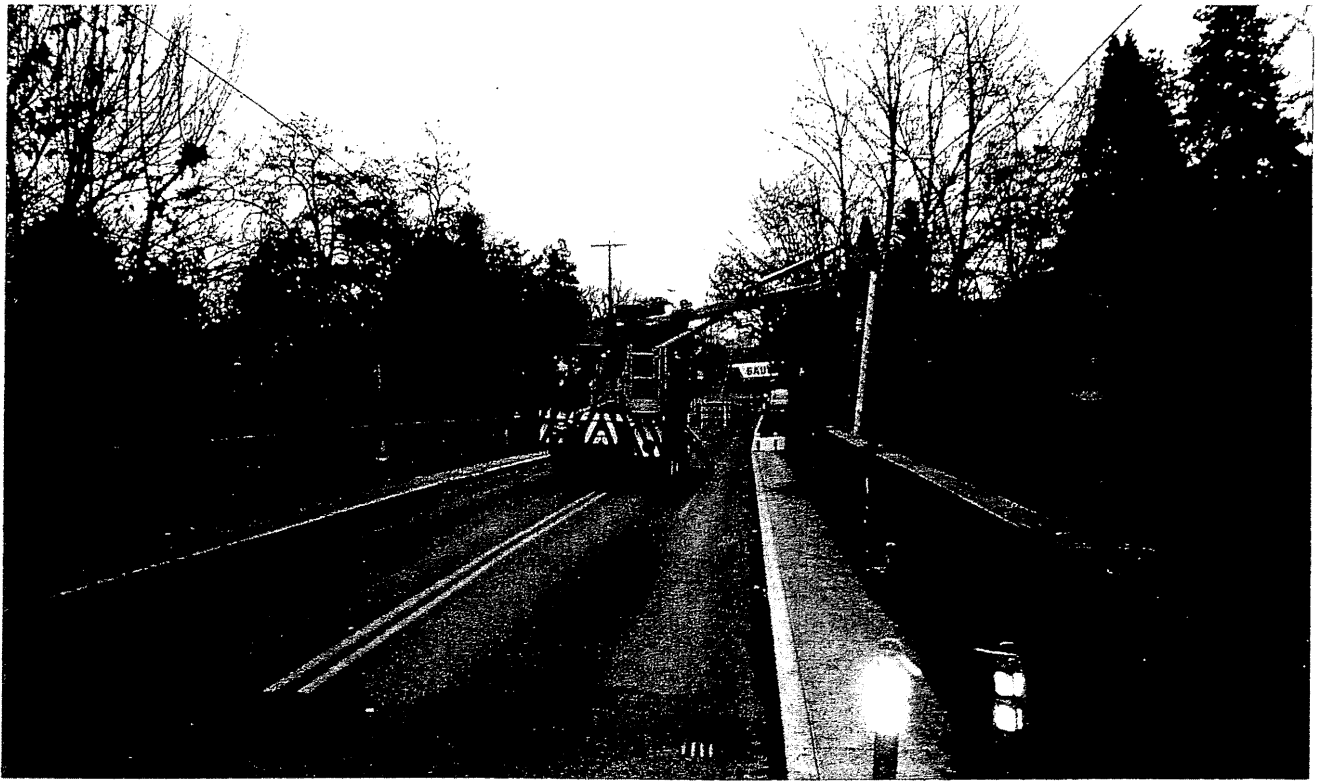
Photo 1 - A truck-mounted hydraulic overhang scaffold was used to access the underside of the bridge. The truck was used for two days.

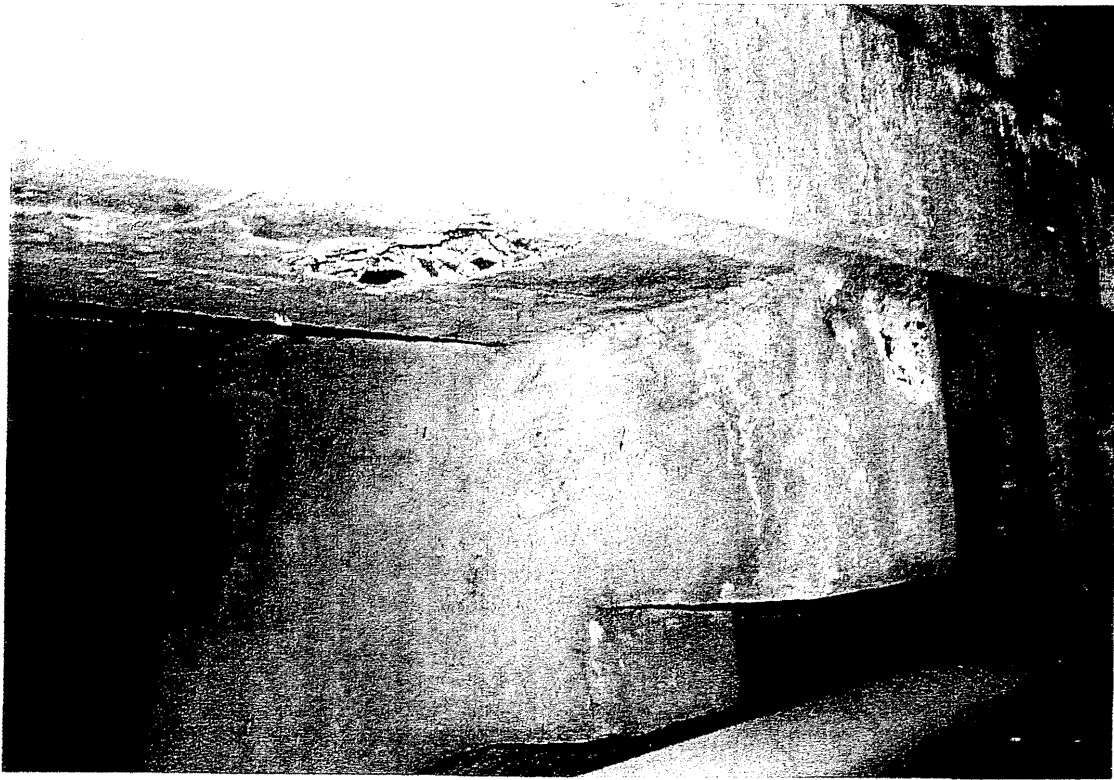
We noted that the entire length of the sidewalks show significant map cracking or surface crazing. In some instances this cracking has progressed to the further stage of complete sidewalk surface crumbling. Additionally, at some locations, the curb faces have undergone some traffic impact damage, and in a few areas are crumbled by rusting of embedded reinforcing steel located too near the surface. Nearly half of the underside of the sidewalk girder shows spalling at the reinforcing bar locations. (Photos 3 & 12) Similar reinforcing steel exposure was noted on the underside of the sidewalk itself.

Photo 3 - This photo shows typical problems with corrosion spalling under the sidewalk girder. Also shown is typical spalling at the sidewalk bracket.

We recommend that at least three of the concrete sidewalk brackets be replaced in entirety. To accomplish this, the irretrievably damaged brackets will be demolished back to the exterior girder faces, leaving the main reinforcing steel in place to effect monolithic cantilever effect in the replacement bracket. The replacement bracket will be replaced in similar configuration to the removed original. On the salvageable brackets, the areas of exposed reinforcing steel will

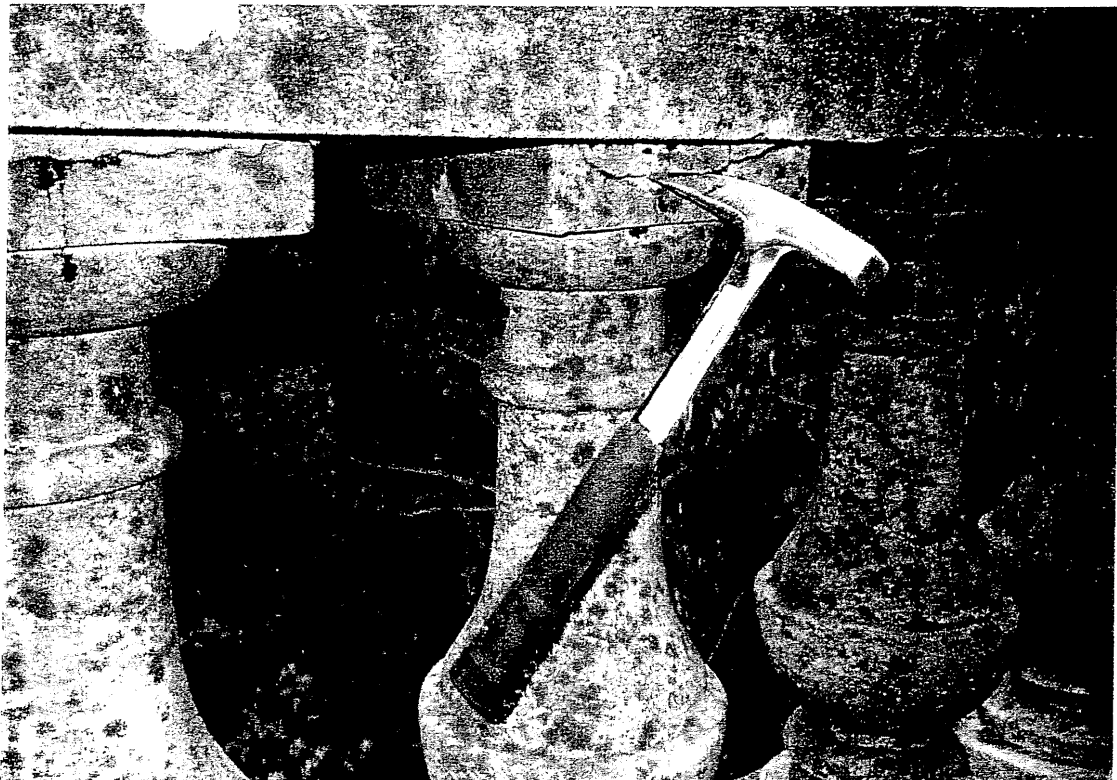
On the south side of the bridge, 40' of the bridge rail is missing (with part of the missing pieces evidenced in the stream below). Throughout the bridge rail length, many of the concrete balusters are cracked (Photo 4 ). At all lamp post locations (corresponding to all bent locations) the embedded conduit is located too near the concrete lower rail face. This occurs because, during construction, it was necessary to bend the conduit outside the vertical sidewalk bars to allow the conduit to mate up to the junction boxes. This lightly protected conduit has corroded, and the ensuing rust has spalled the concrete faces at these locations (Photo 5). As a result, at nearly every lamp post location, the lower bridge rail is badly spalled. The remaining top bridge rail is in good condition. The urn-style balusters remaining are mostly cracked and weathered.

Photo 4 This photo show lthe cracking on the urn-style balusters. For lack of better analogy, we refer to it as "puzzle cracking" because in a majority of cases, the balusters are cracked into pieces yet retain shape by adhering (like puzzle pieces) to a single reinforcing bar which runs up the center of the baluster. Any structural strength the baluster may have ever had is entirely gone when this type of deterioration exists.

We recommend replacing the existing bridge rail with a crashworthy rail system meeting crash Test Level 1 (NCHRP). This test criteria is appropriate for a low speed local street (AASHTO 13.7.2). However to comply with the contract and your desire to have an historic replication, you may wish to consider replacement in-kind with replication of the urn style balusters (a non-tested system). To clarify the bridge rail issues and assist you in further understanding the various features of the available historic bridge rail, we will assess historic and functional features of three types of bridge rail in the following discussion. See also Sheet 1 and Sheet 2 in the Exhibit

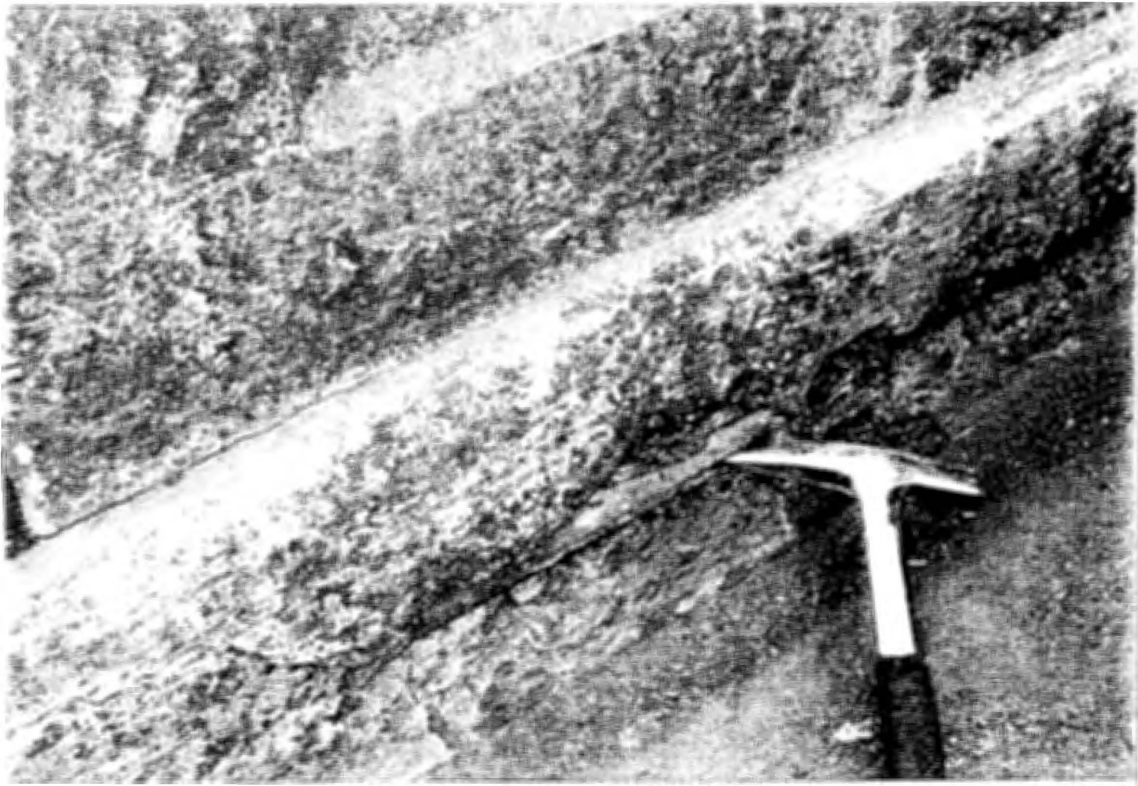
The bridge rail end and interior post are only minimally damaged by collision and age-related deterioration and collision. Testing the concrete with the Schmidt hammer indicated that the concrete strength remains high. However, the embedded electrical conduit system, which feeds the lamps atop the lamp posts, is severely deteriorated.

Photo 5 - This photo shows deterioration of the existing conduit that occurs in each rail post area. This damage essentially eliminates any possibility of reuse of the conduit.

We initially examined the possibility of saving the bridge rail flared end posts (located at the four corners of the bridge). Further examination of the problems involved with providing electrical power to the new lamps indicated that it was not practical to save the end post assemblies. The existing conduits and junction boxes were rendered unusable by corrosion and it was deemed impractical to incorporate new concealed electrical conduit in the old end posts, thus necessitating their replacement.

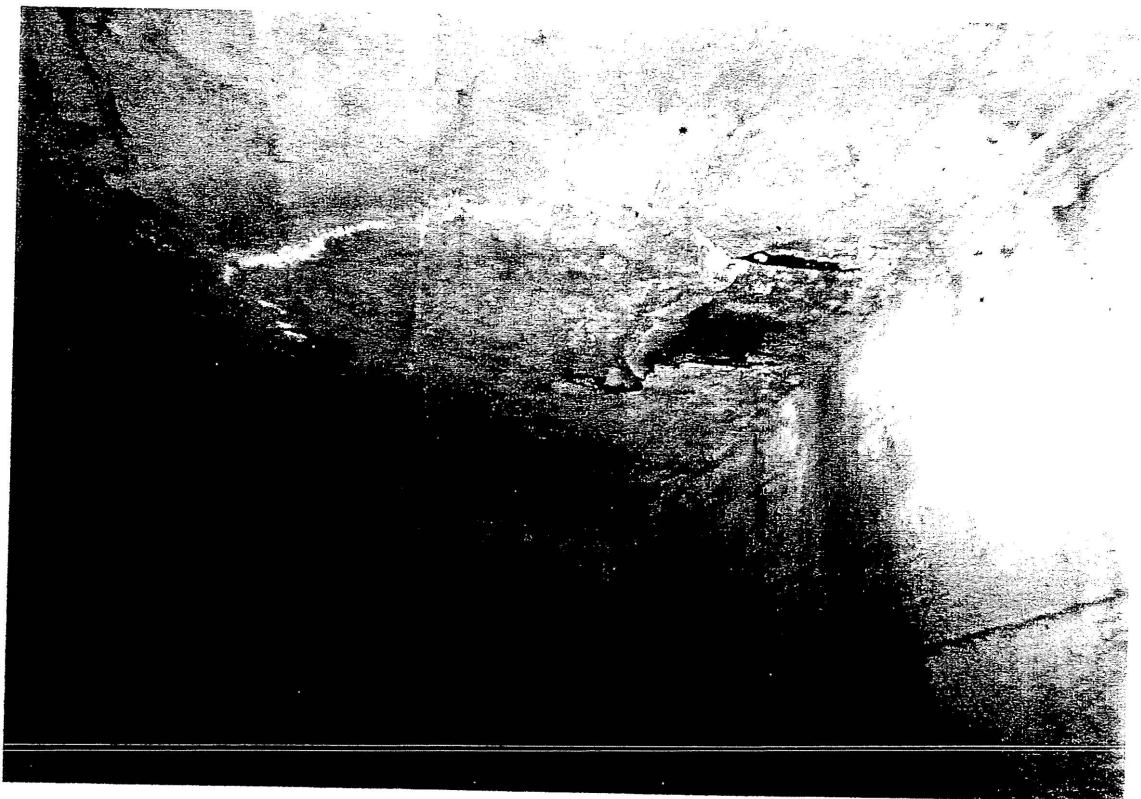
Photo 6 - This photo shows typical damage to the underside of the deck at the deck drain locations. Notice also (the discoloration) how the water has run on the lower bridge surfaces.

In all cases above, the areas immediately around the deck drains will be completely removed, with the deck reinforcing steel left intact and cleaned. These drain areas shall be formed and new concrete placed to reestablish the existing drain assemblies. We would recommend that, as extra work, a diverting pipe be added to direct the water away from the substructure below to avoid recreating the existing corrosion conditions caused by the deck drainage water.

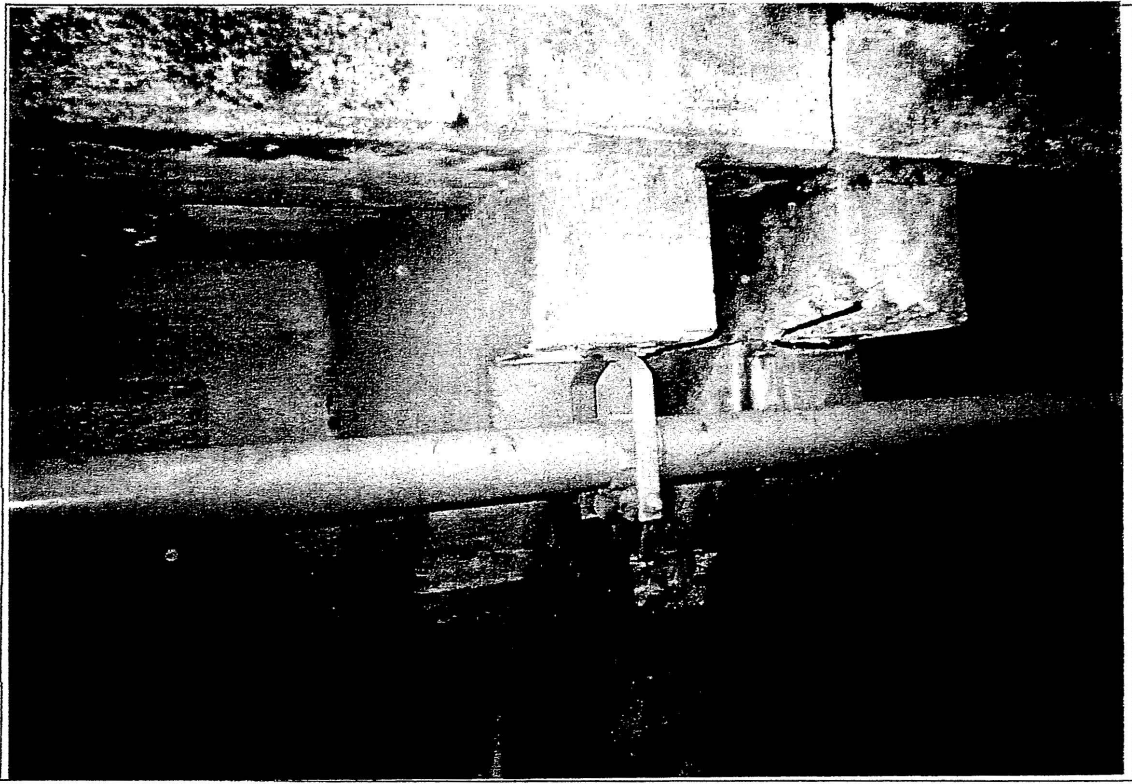
The sidewalk brackets extend about 4 feet out from the exterior face of the exterior girders (Photo 7). There are 11 brackets on each side of the bridge. It was estimated that three of the brackets were damaged beyond repair. The most prevalent spalling damage occurred due to inadequate concrete cover over the reinforcing steel. On the north side of the bridge, the brackets carried a steel gas main suspended by hangers anchored into the underside of the brackets. These

Photo 7 - This photo shows typical sidewalk bracket detail, this specific photo being taken at a bent location on the north side of the bridge, where a pair of brackets exists. Note the spalling of the bracket at areas of reinforcing steel corrosion. Notice, also, the gas main support required at all bracket locations along the north side.

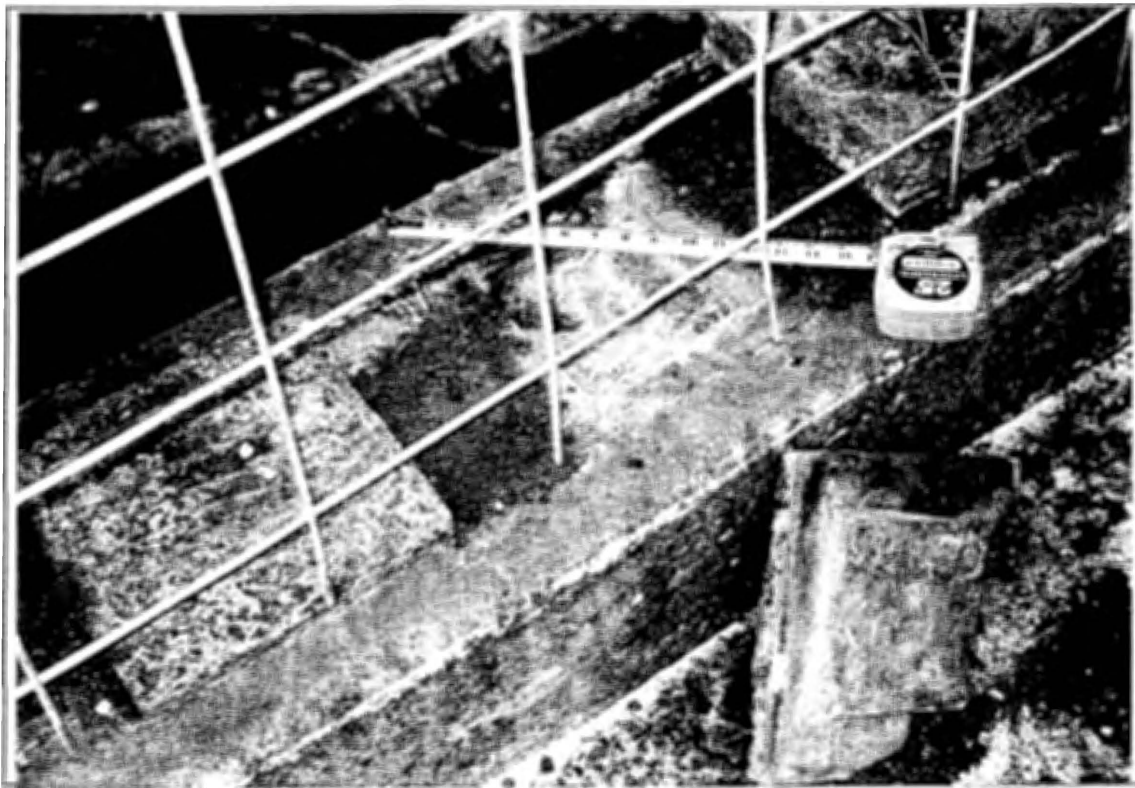
Photo 9 - This photo shows the bottom recess formed at the base of each existing urn-style baluster. The structural aspects of the baluster are developed entirely by keying action in these recesses. It was probably done to allow simpler replacement of damaged balusters without affecting the upper or lower rail. This detail does not structurally develop enough restraint action to meet today's modern bridge rail standards.

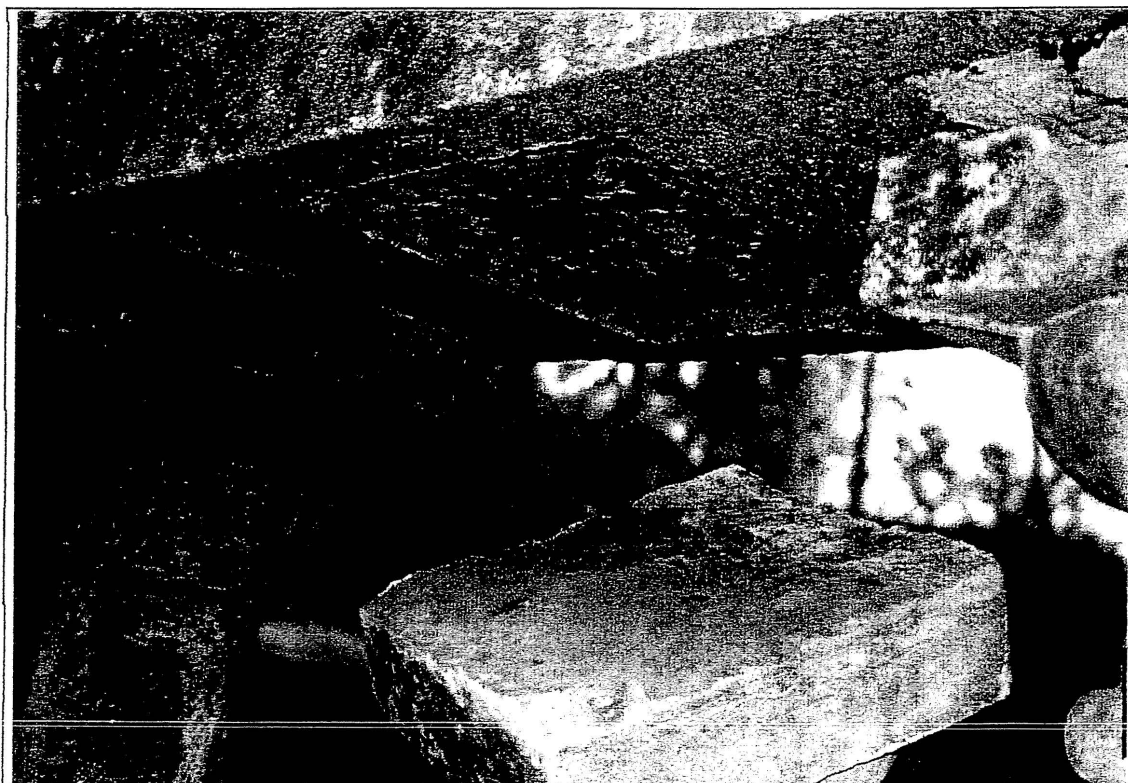
Photo 10 - This photo shows the recess left on the underside of the top rail element (on a removed existing baluster). Notice the dry pack concrete left on top of the baluster. The recess apparently was formed in the top precast rail element, and the baluster top was dry-packed into position into square key in the top rail element. Again this does not develop enough restraint for modern code.

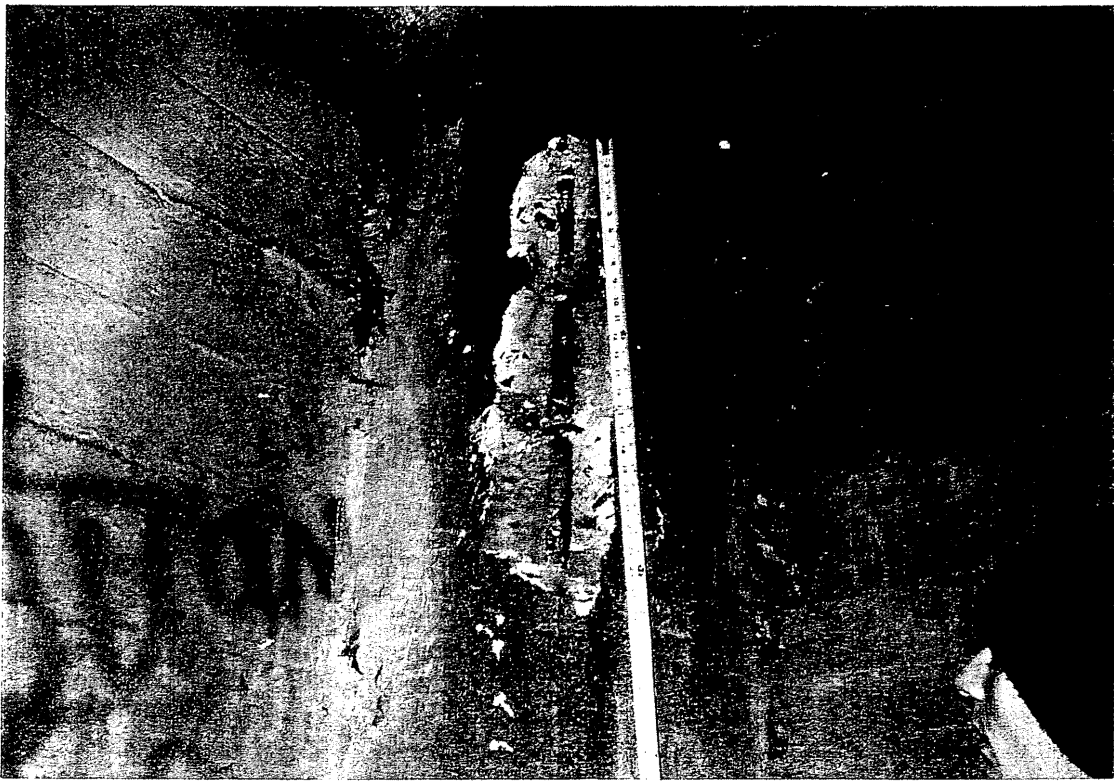
Areas of spalling and reinforcing steel were observed on vertical surfaces of substructure elements (Photo \_\_\_\_). These areas occur predominantly where drainage water from the deck drains flowed onto the substructure concrete surfaces. We preliminarily excavated the loosened concrete from some of the areas of reinforcing area corrosion (for photography purposes), and sounded out the limits of the damage in other areas without excavating the concrete. The major damage occurs at the south end of the west abutment near the drainage from the local deck drain, and at Bent 3, where the deck joint occurs and allows water to spill through onto substructure surfaces. It is estimated that about 250 s.f. of substructure surface should be air-chisel excavated to expose the reinforcing steel, the exposed reinforcing steel should be cleaned and coated, and new concrete patching material should be applied at the excavated areas. The average depth of this concrete excavation is about 3 ½ inches.

Photo 11 - This photo looks at the upper portions of the column at the south end of the west abutment, near a deck drain. This photo shows typical concrete deterioration which has occurred when deck water has, for decades, been allowed to flow on the face of the substructure. This happens at drain locations and at deck joint locations.

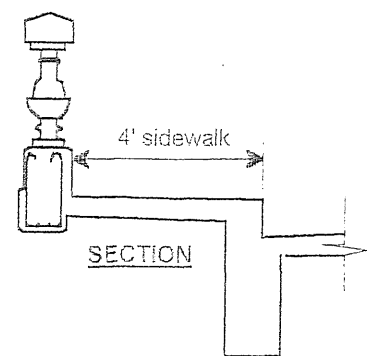
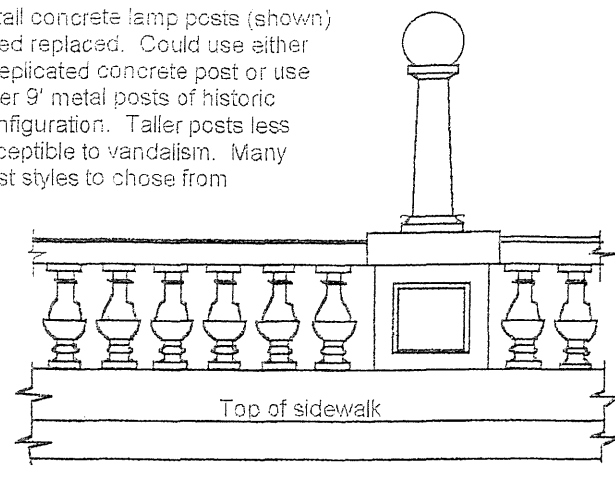
**ELEVATION VIEW OF EXISTING BRIDGE RAIL**

4' tall concrete lamp posts (shown) need replaced. Could use either a replicated concrete post or use taller 9' metal posts of historic configuration. Taller posts less susceptible to vandalism. Many post styles to chose from

This bridge rail not crash tested, meets no traffic rail standard, meets handrail structural standards only if more rail posts are added when rebuilt, balaster spacing provides too large openings to meet code. (in excess of 6")

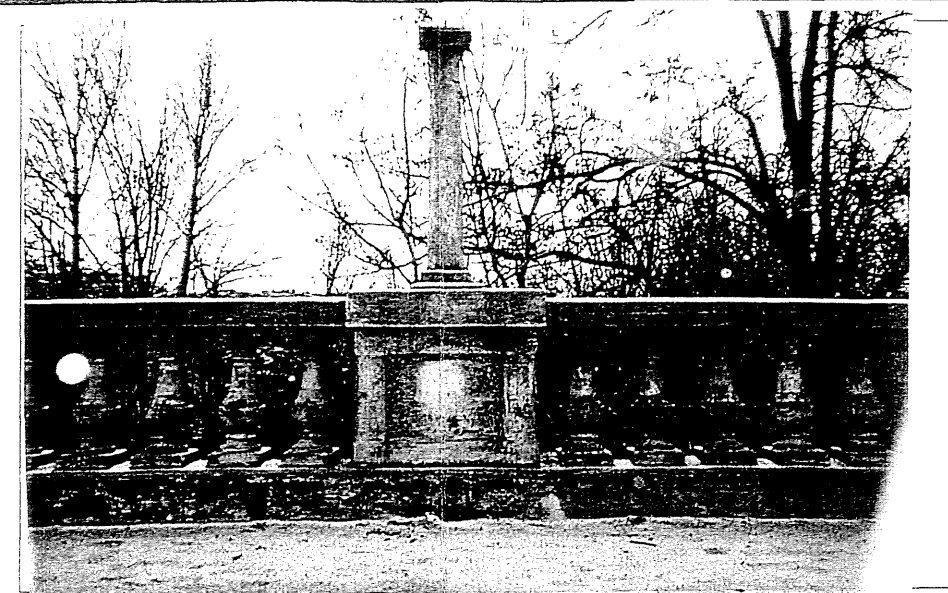
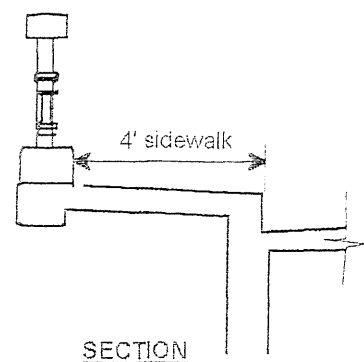
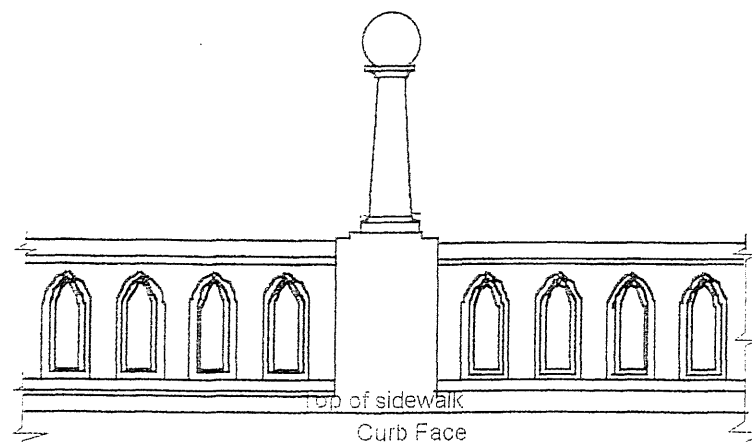
**ELEVATION VIEW OF CIP ARCH BRIDGERAIL**

This rail is cast monolithically with the sidewalk curb. Meet traffic rail standards and is crash-tested for 25 mph curb-protected use (Level T1 crash test). 6" opening widths.

Notice the steel posts (about 9' tall) They are capped with high pressure sodium lamps (50 watt) in plastic globes. These could be used instead of the 4' high concrete lamp posts.

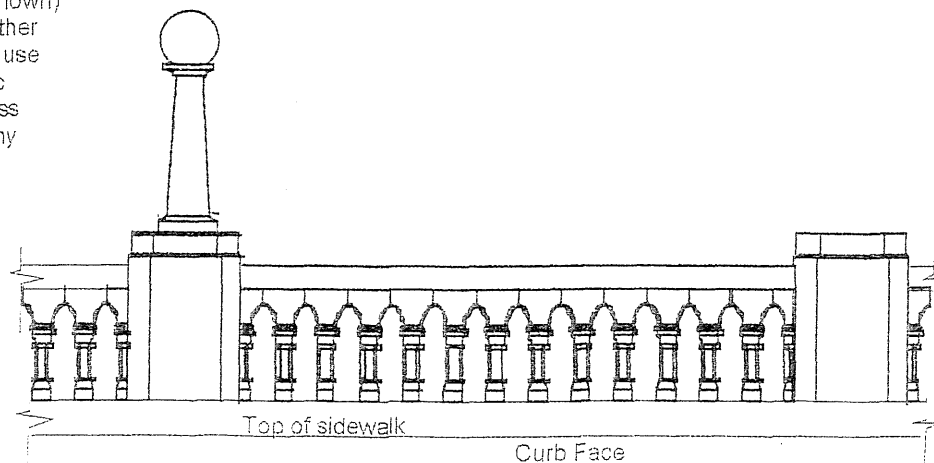
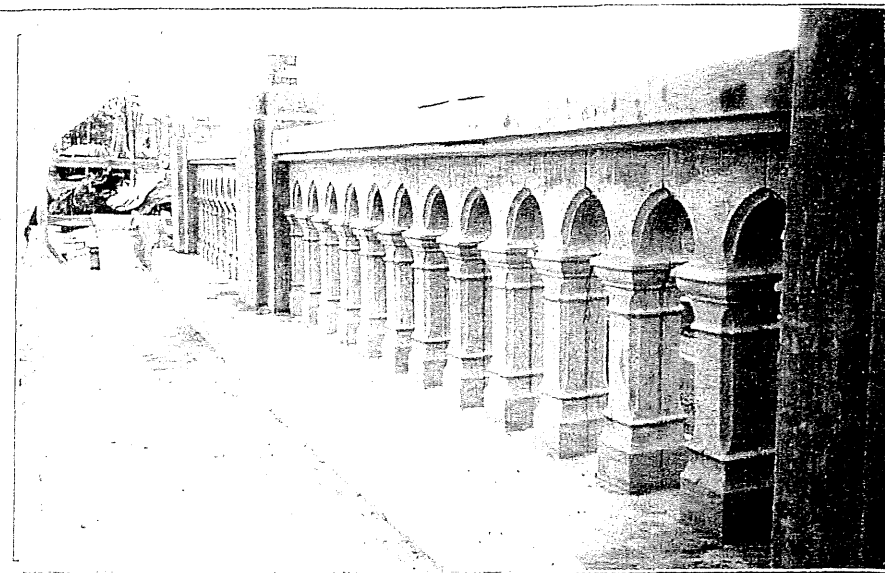
**ELEVATION VIEW OF PRECAST TEE ARCH BRIDGE RAIL**

Used as photographed in reconstruction of the Ross Island Bridge

This bridge rail is meets traffic standard if curb-protected, 25 mph traffic. The balusters are precast in ornate "tee shape segments" that are field cast into the upper and lower rail members. Meets pedestrian rail structural and literal stands
