**FIFTH FIVE-YEAR REVIEW REPORT FOR
MCCORMICK & BAXTER CREOSOTING COMPANY SUPERFUND SITE
MULTMOMAH COUNTY, OREGON**

**Oregon Department of Environmental Quality
Northwest Region
Portland, Oregon**

**U.S. Environmental Protection Agency
Region 10
Seattle, Washington**

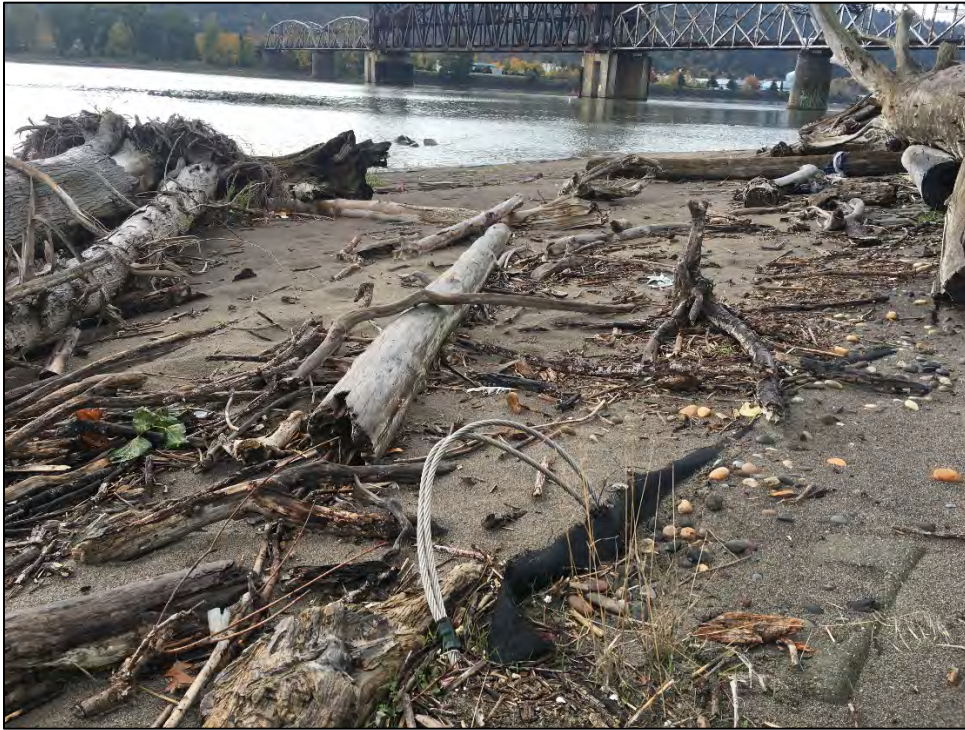
Photograph 1: Cable loops from ACB mats that were cut during maintenance activities to remove trip hazard, October 2016.

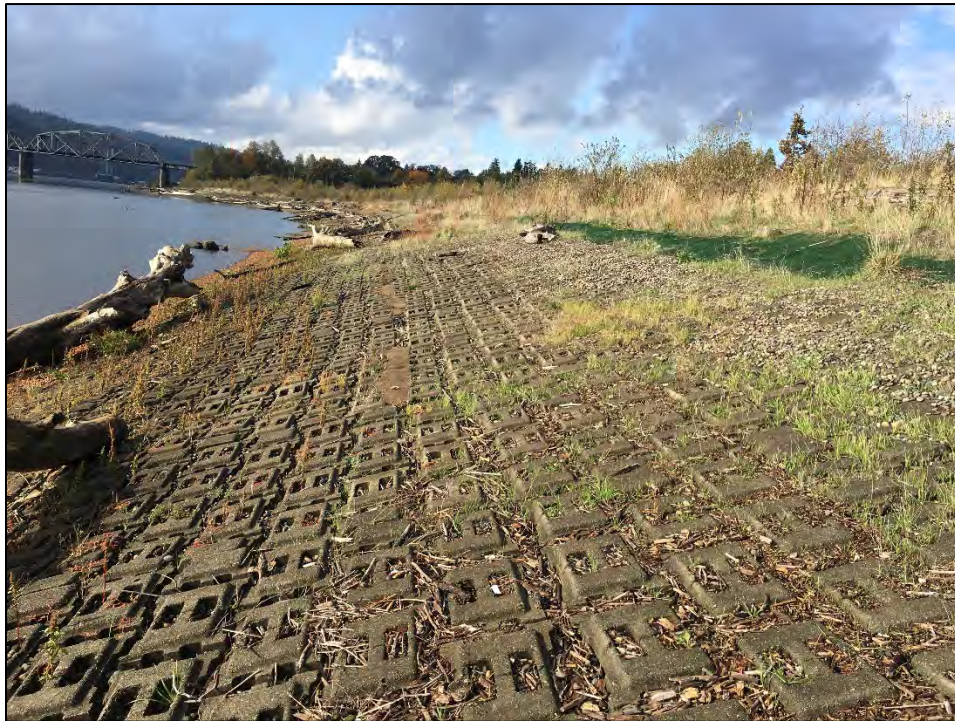
Photograph 2: Shoreline conditions along Willamette River, October 2016.

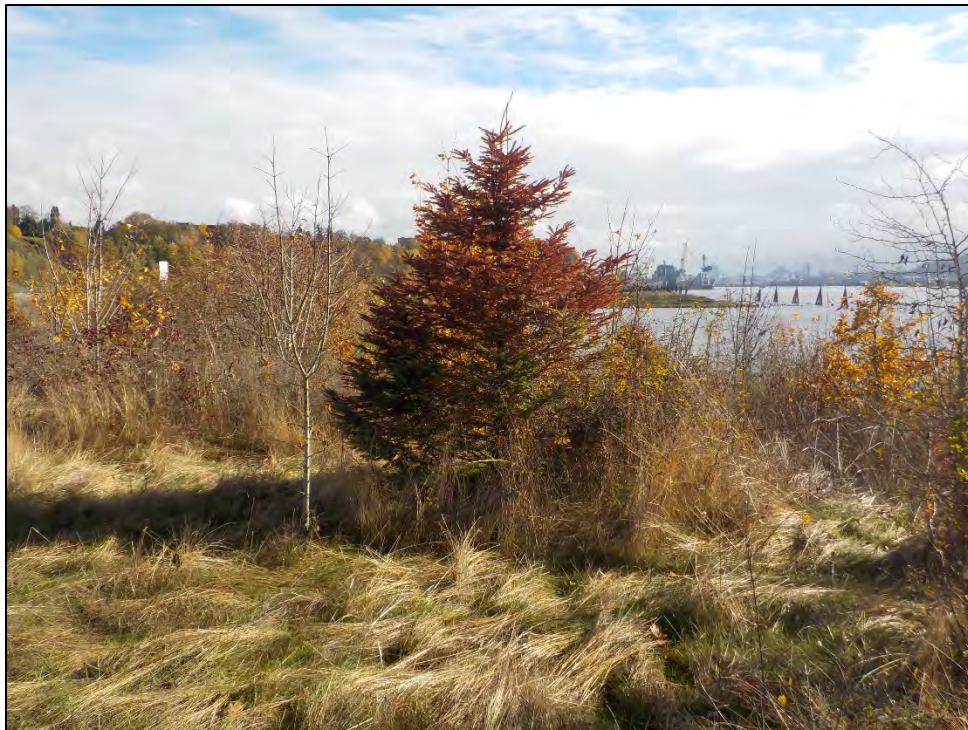
Photograph 7: Fir tree in riparian area experiencing stress from drought conditions, Nov 2017.

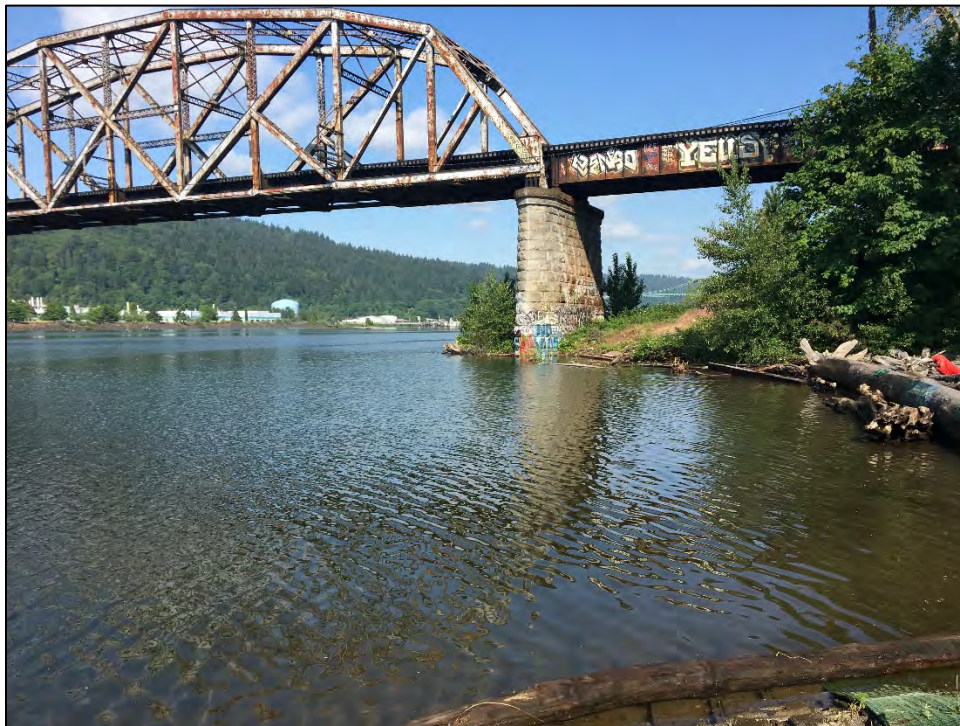
Photograph 8: High-river stage conditions along Willamette River shoreline at BNSF railroad, May 2018.

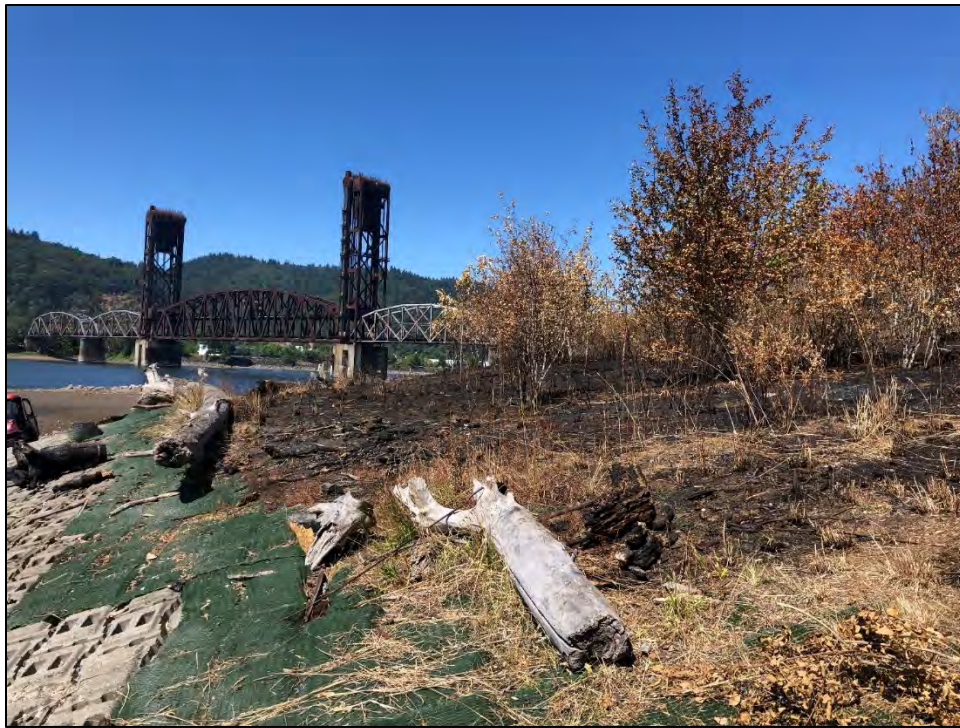
Photograph 8: Condition of the northern end of the Willamette River shoreline after the July 2018 riparian area fire, July 2018.

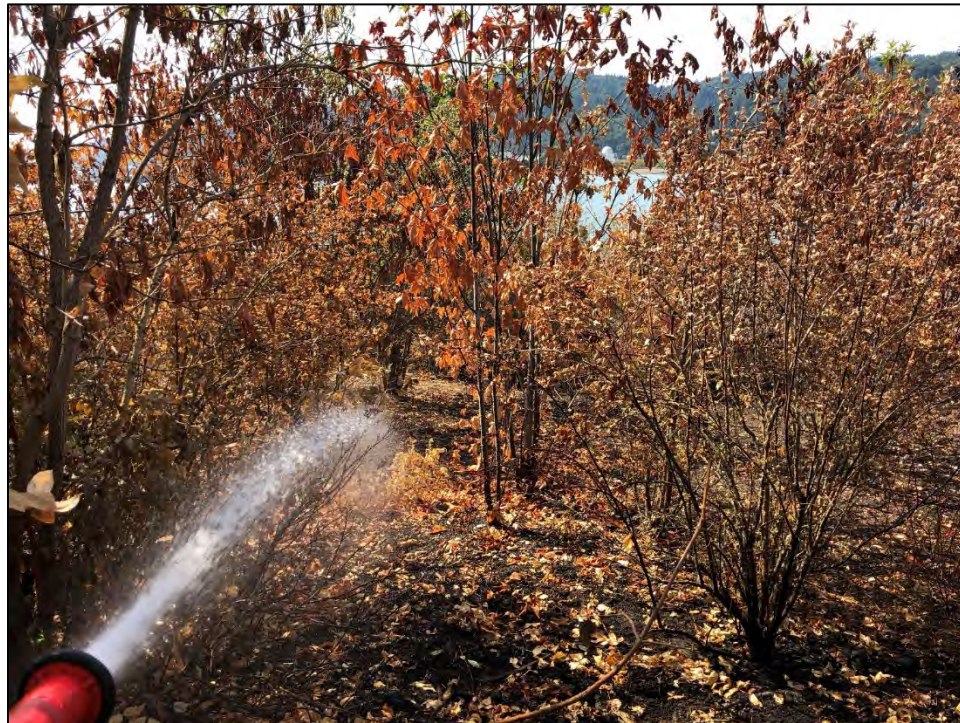
Photograph 9: Watering vegetation stressed by the July 2018 riparian fire area, August 2018.

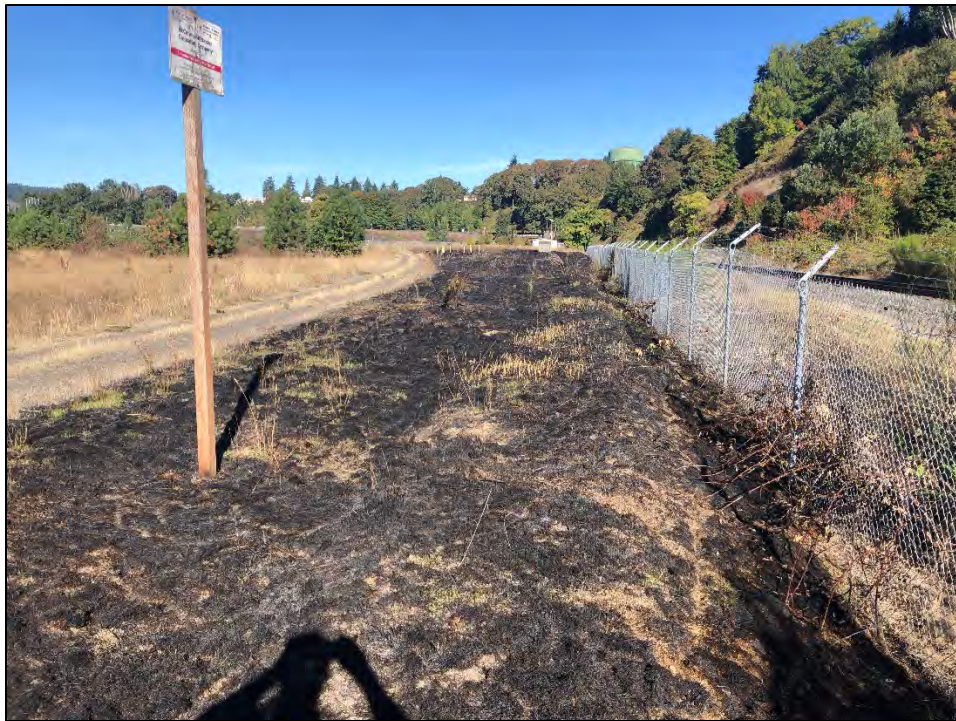
Photograph 10: Burned grass area from September fire along the northwestern perimeter fence adjacent to the Union Pacific railroad.

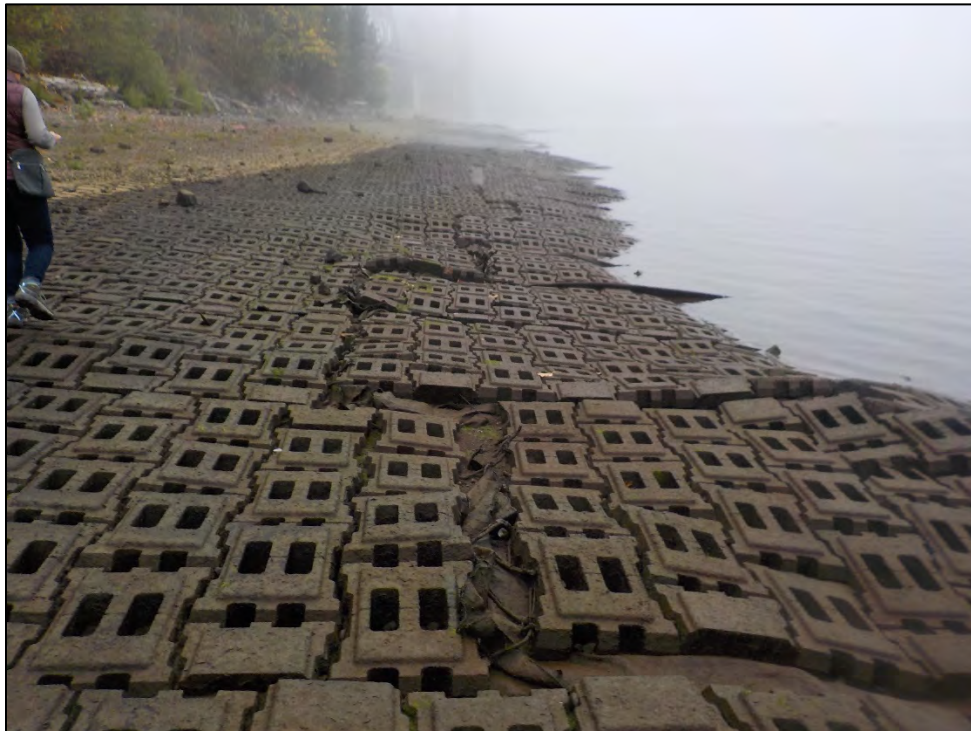
Photograph 11: Separation of ACB mats results in voids, October 2018.

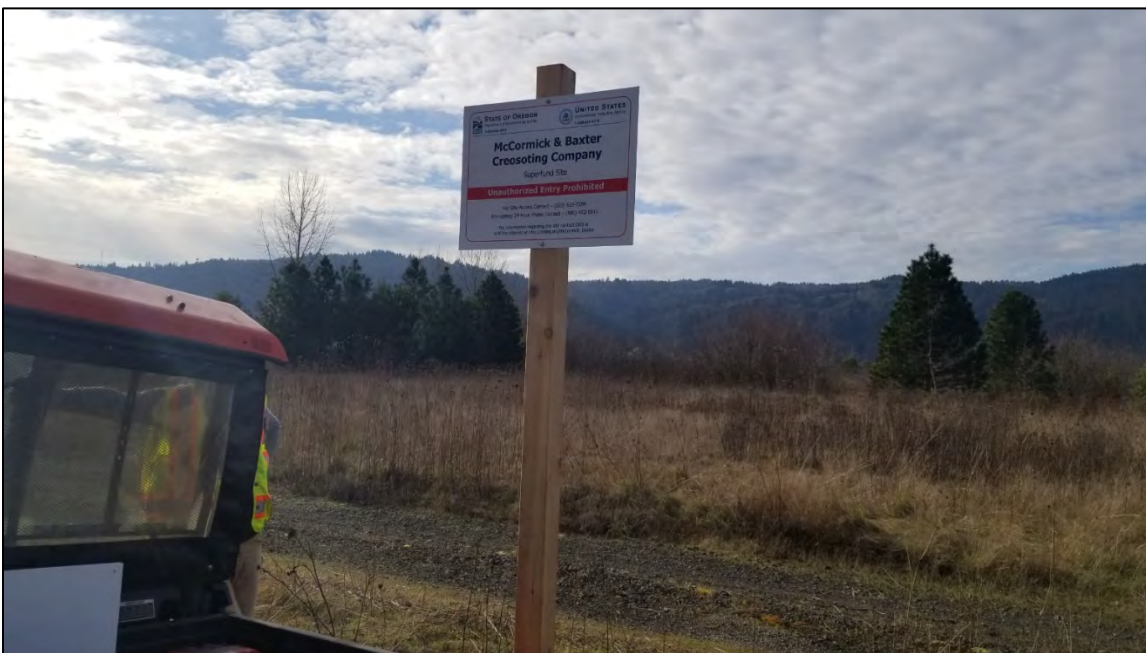
Photograph 19: Replacement signpost with warning sign, January 2021.

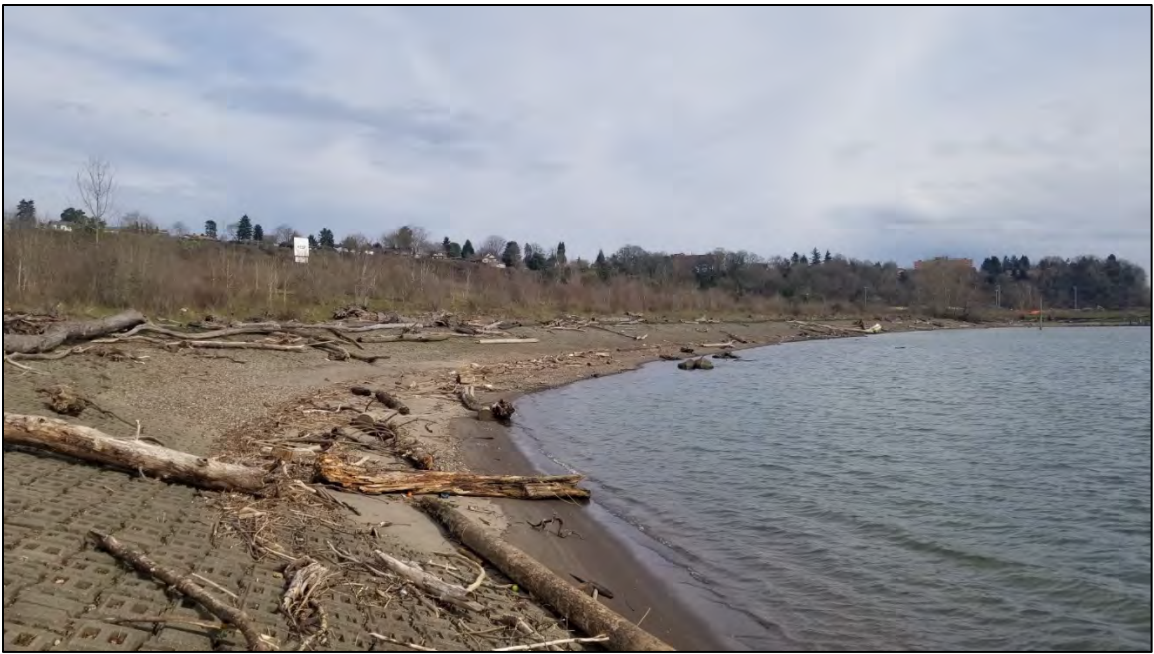
Photograph 20: Willamette River Shoreline conditions with abundant driftwood, March 2021.

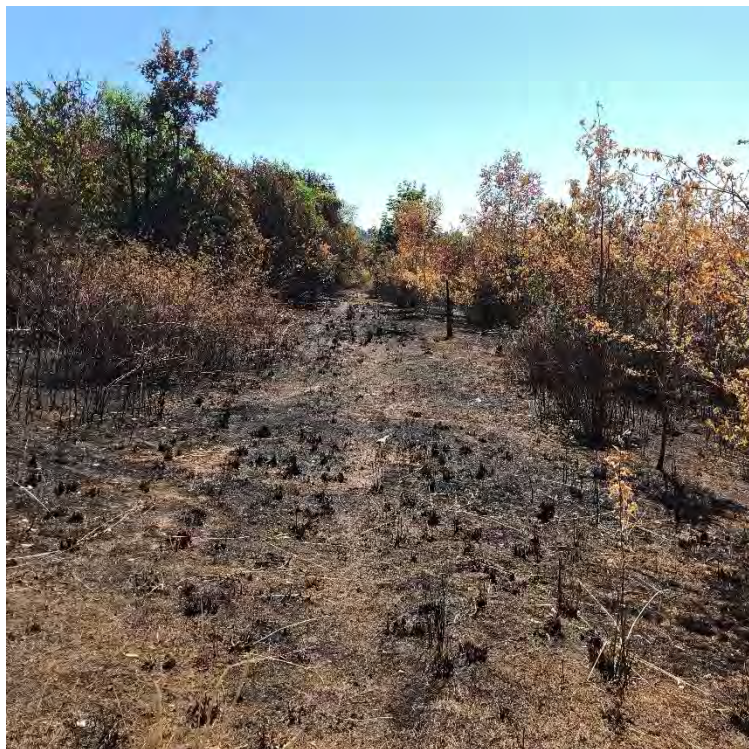
Photo 1 –View of fire damage along the service road in the riparian area.

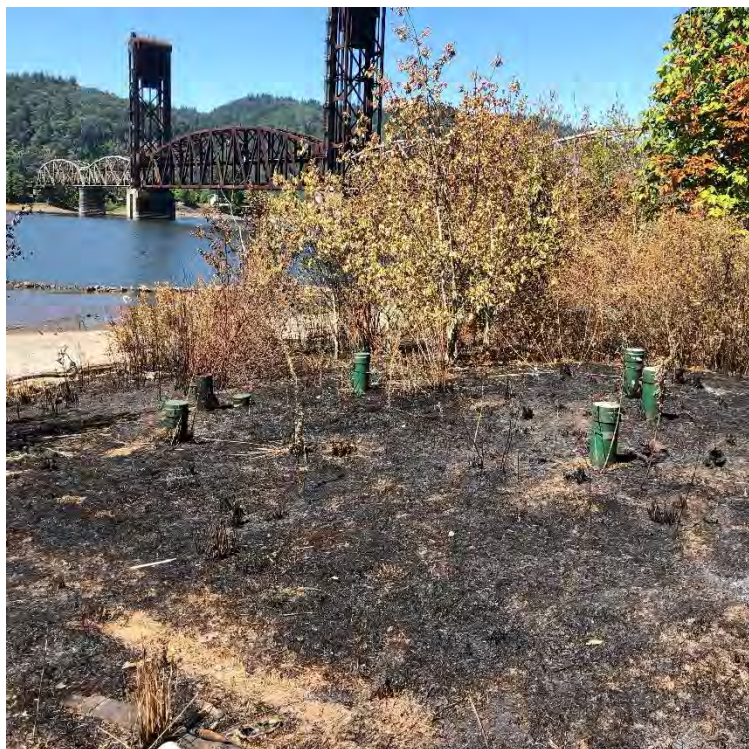
Photo 2 – Northwest view of fire damage surrounding monitoring wells (MW-40i, MW-40s, MW-40d, MW-41i, MW-41s, and MW-41d).

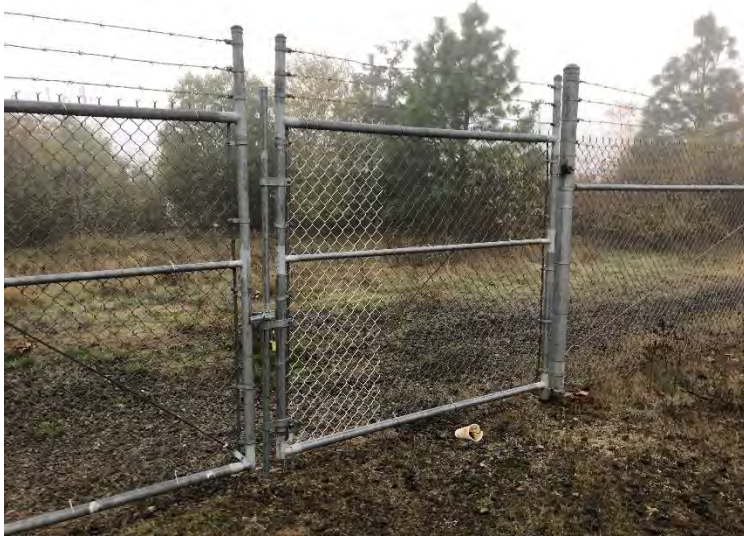
Photo 3 – View of repaired gate fence that was damaged from a 2-foot by 2-foot cut in the chain link fence.

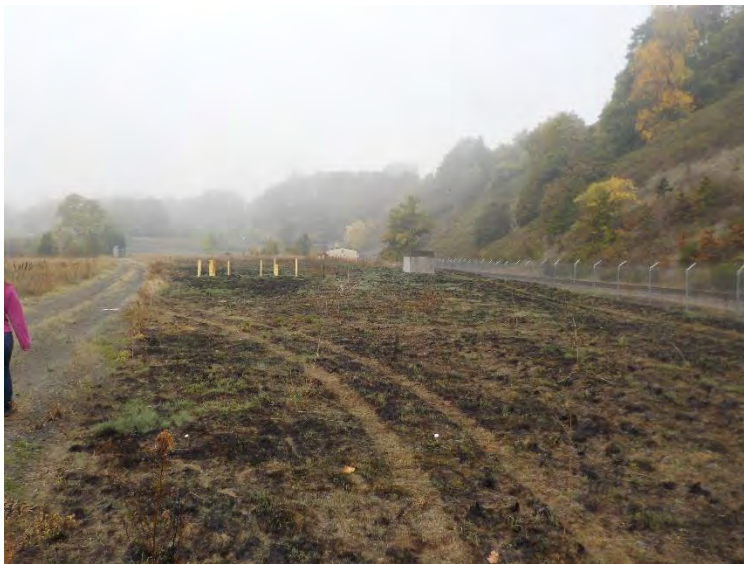
Photo 4 – View of the fire damage at the northeastern end of the site along the railroad.

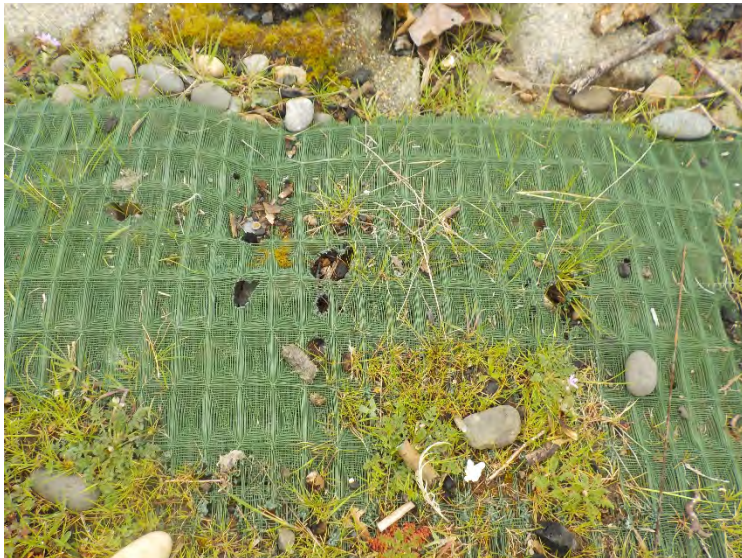
Photo 2 –View of one to three-inch diameter holes in the TRM caused by the 2018 fire in the riparian area.

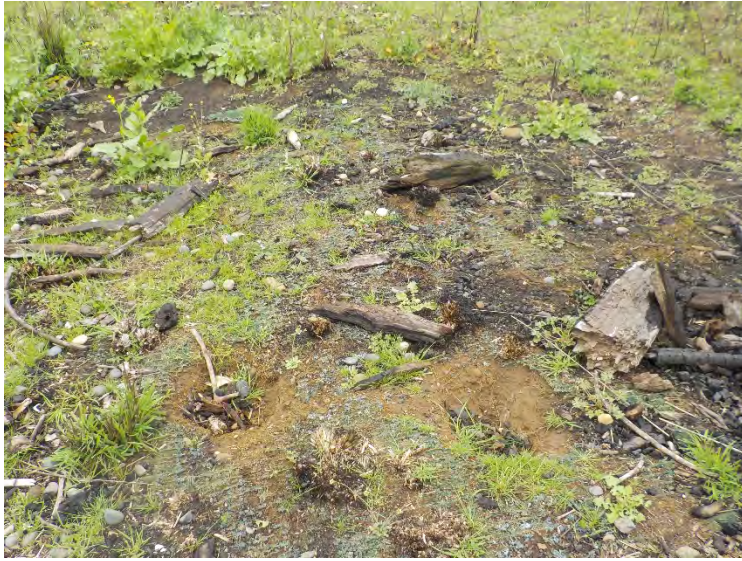
Photo 3 –View of six-inch diameter patches in the TRM as a result of the 2018 fire in the riparian area.

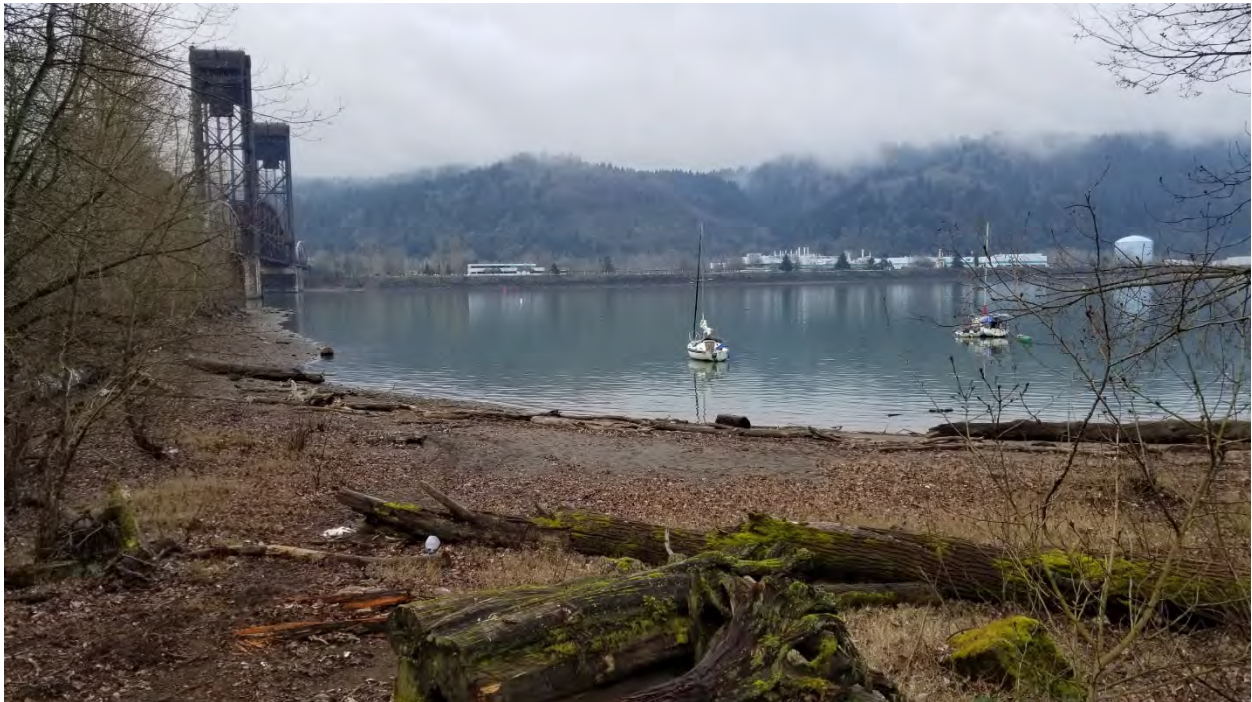
Photograph 1: Derelict boats anchored in Willamette Cove.

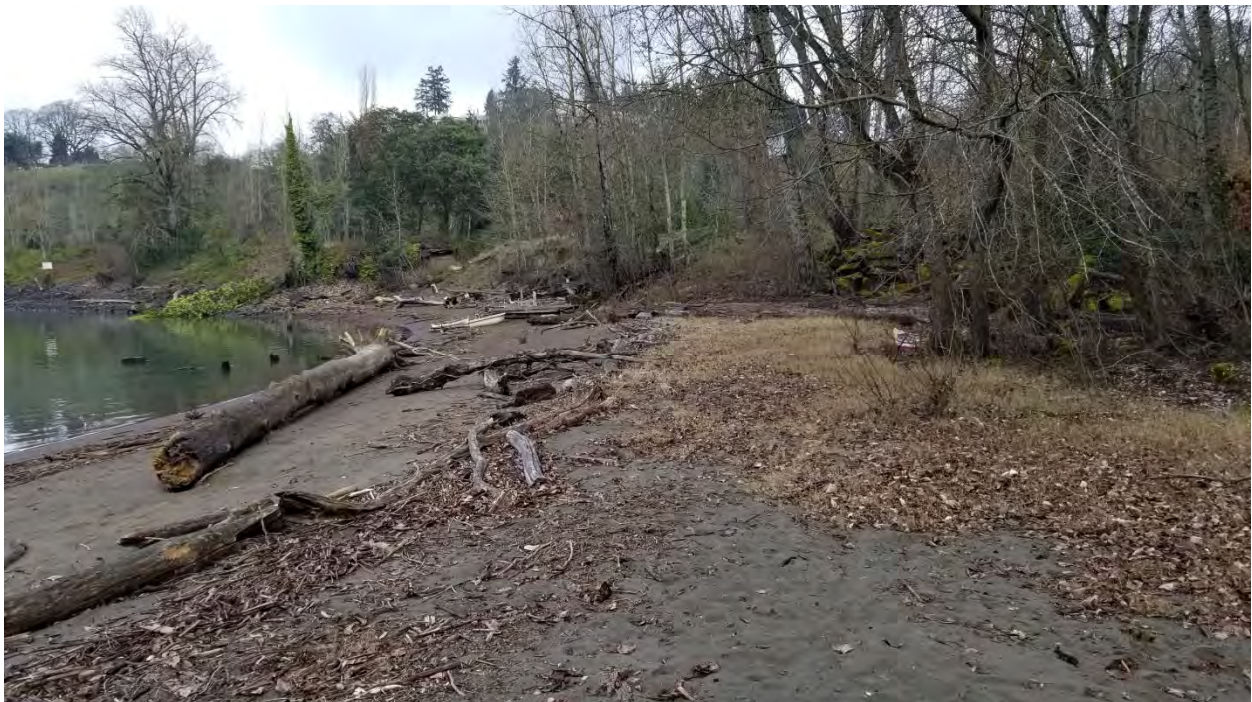
Photograph 2: Trash and debris items observed along the shoreline in Willamette Cove.

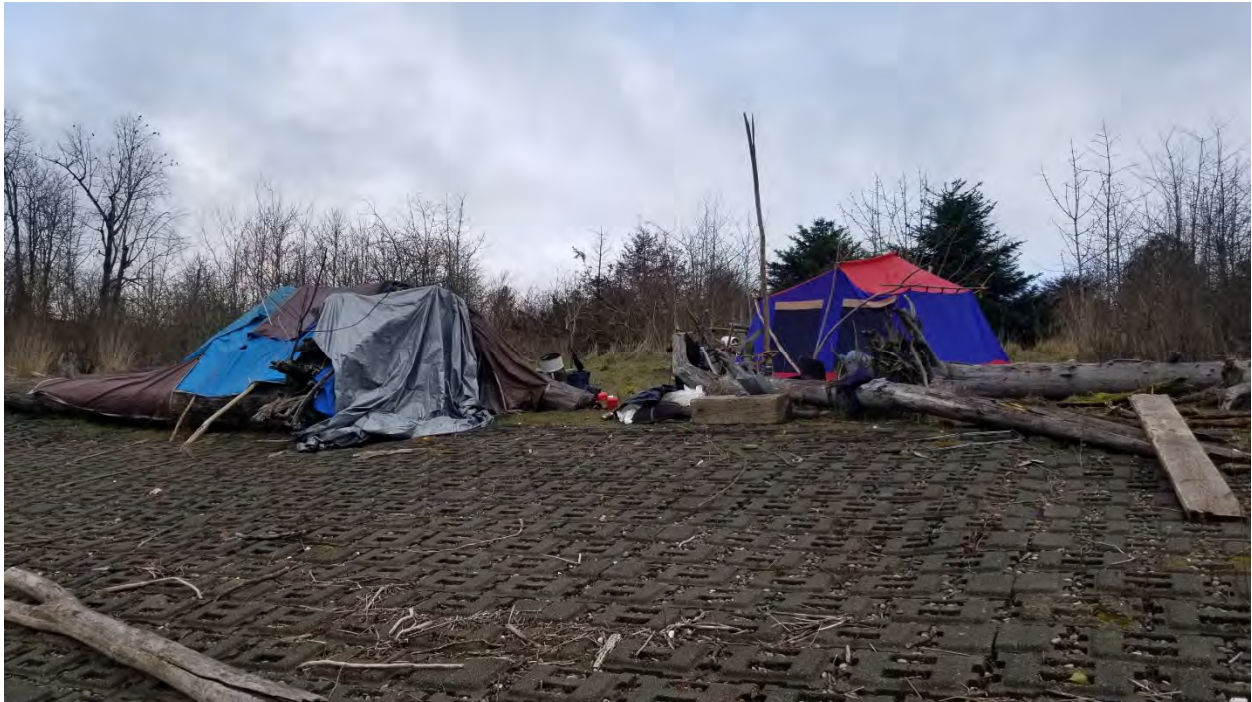
Photograph 3: Homeless encampment along the riparian area shoreline at the upper edge of the ACB.

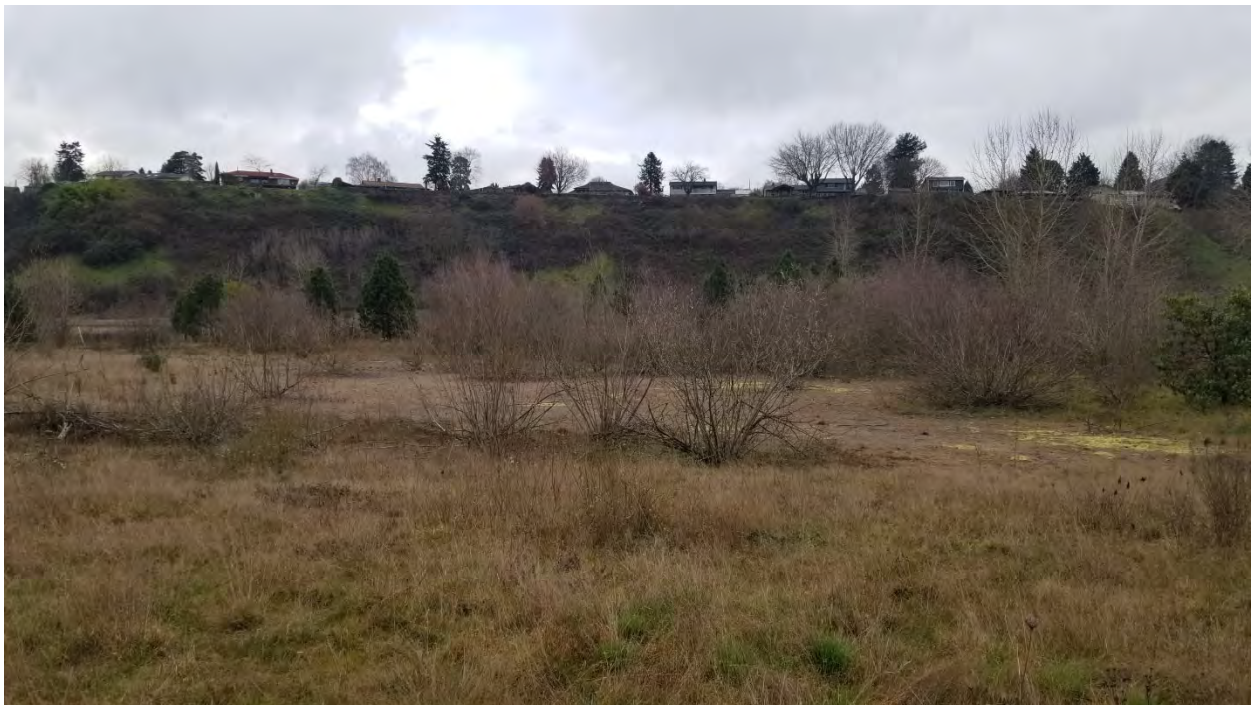
Photograph 6: View of the infiltration pond and drainage swale. No standing water present.

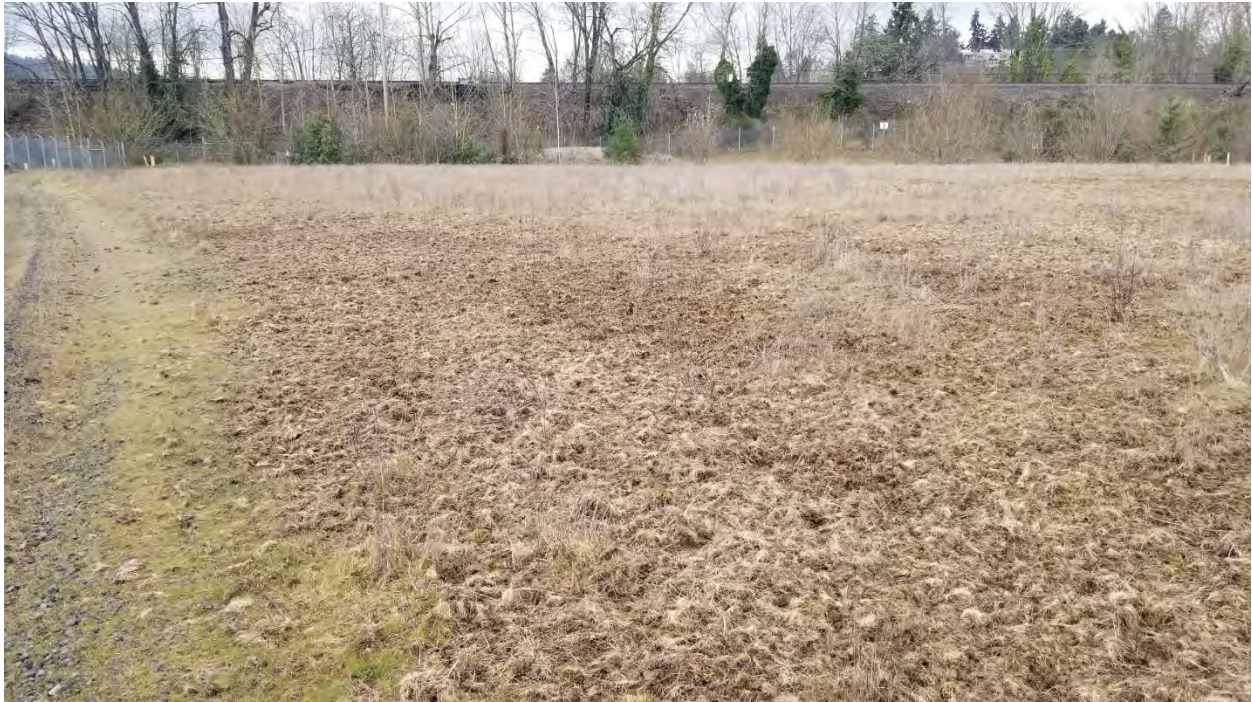
Photograph 7: Impermeable cap surface vegetation following crow foraging activities.

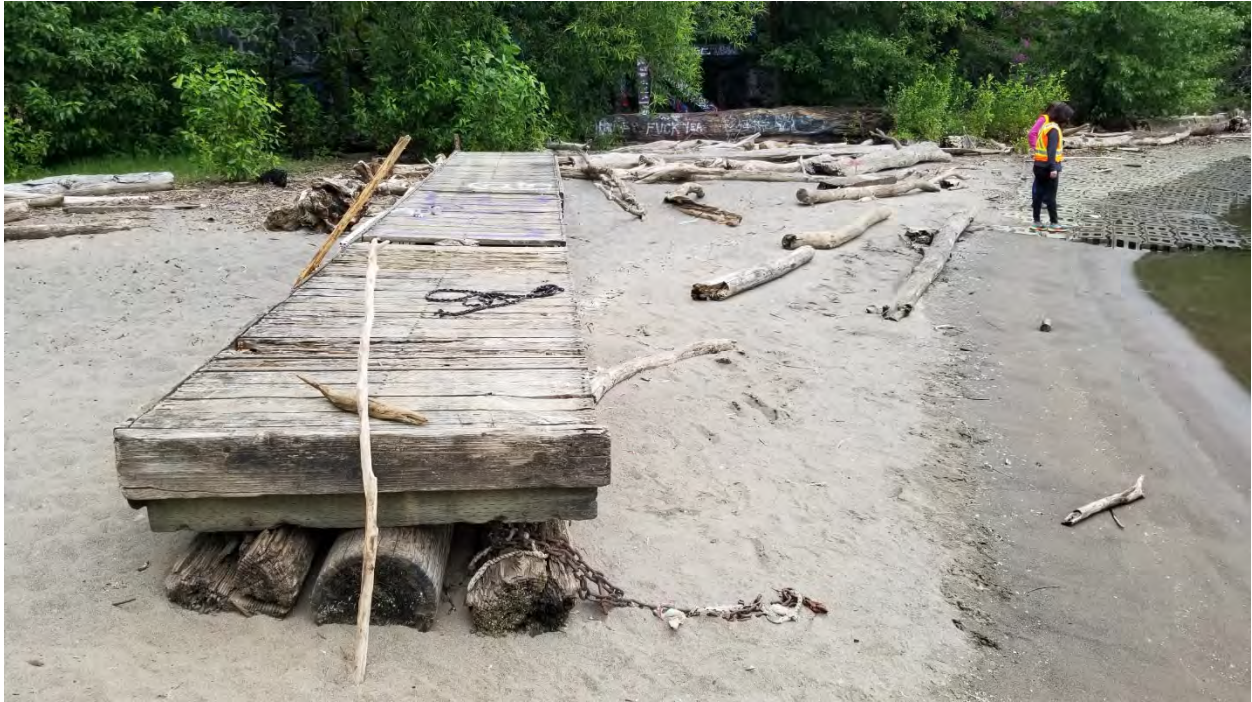
Photograph 1: Section of floating dock washed up along Willamette Cove shoreline.

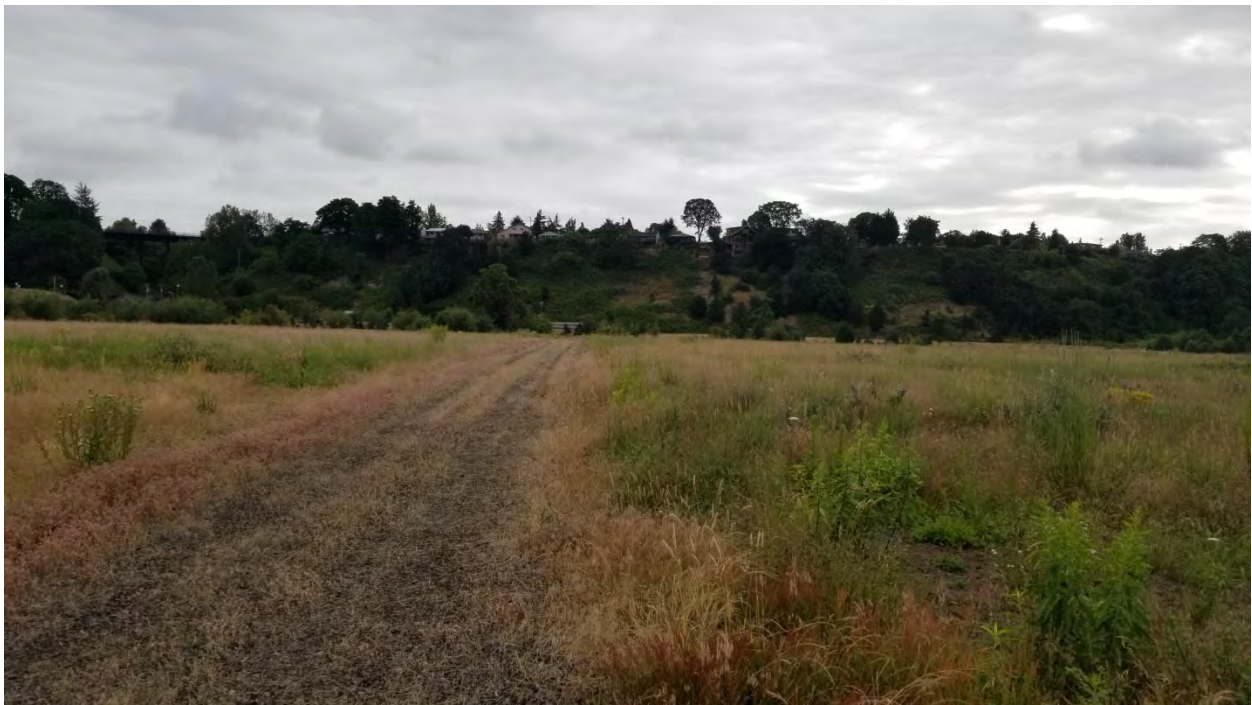
Photograph 4: Soil cap conditions and current vegetation state.

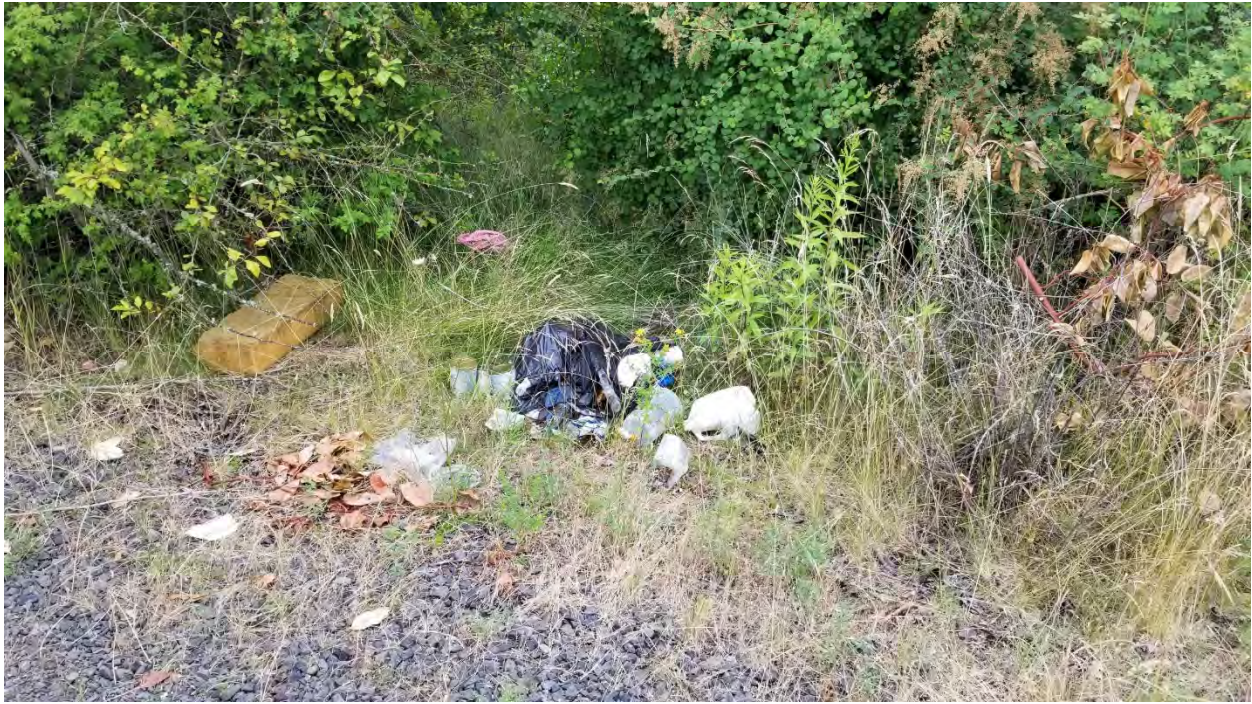
Photograph 5: Trash dumped along exterior of perimeter fence.

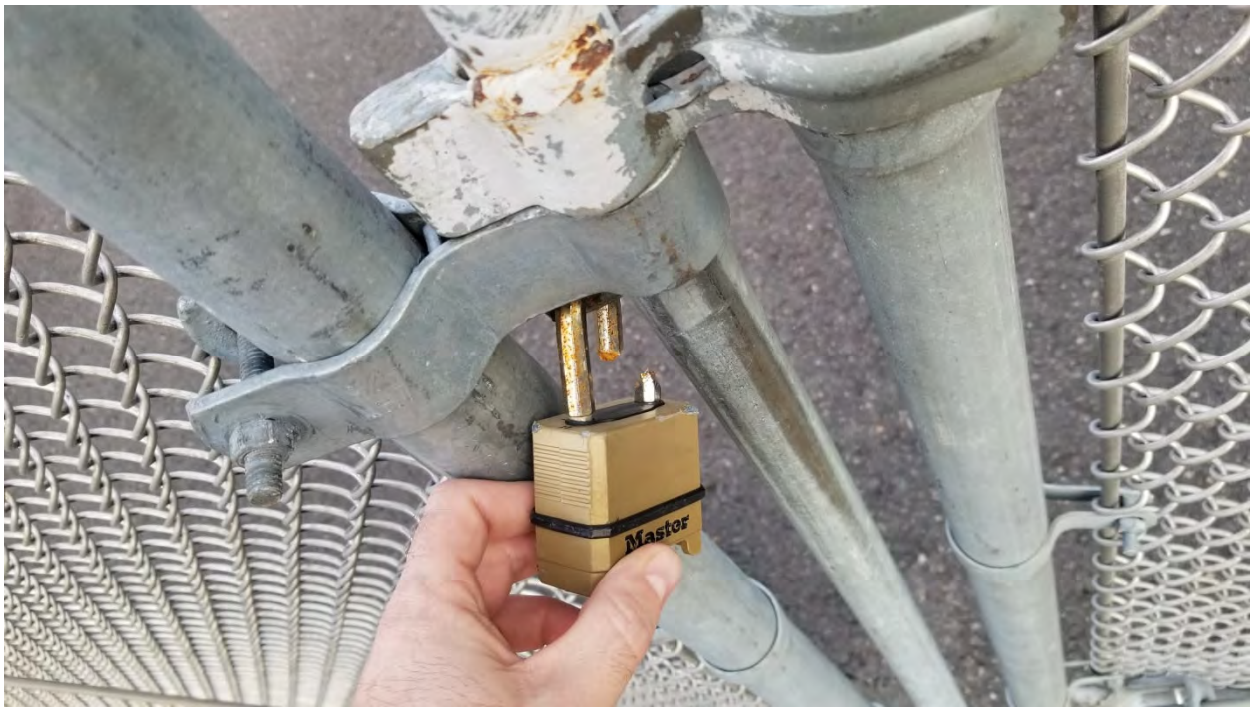
Photograph 4: Lock on main gate entrance found cut and metal tab bent so that gate can't open.

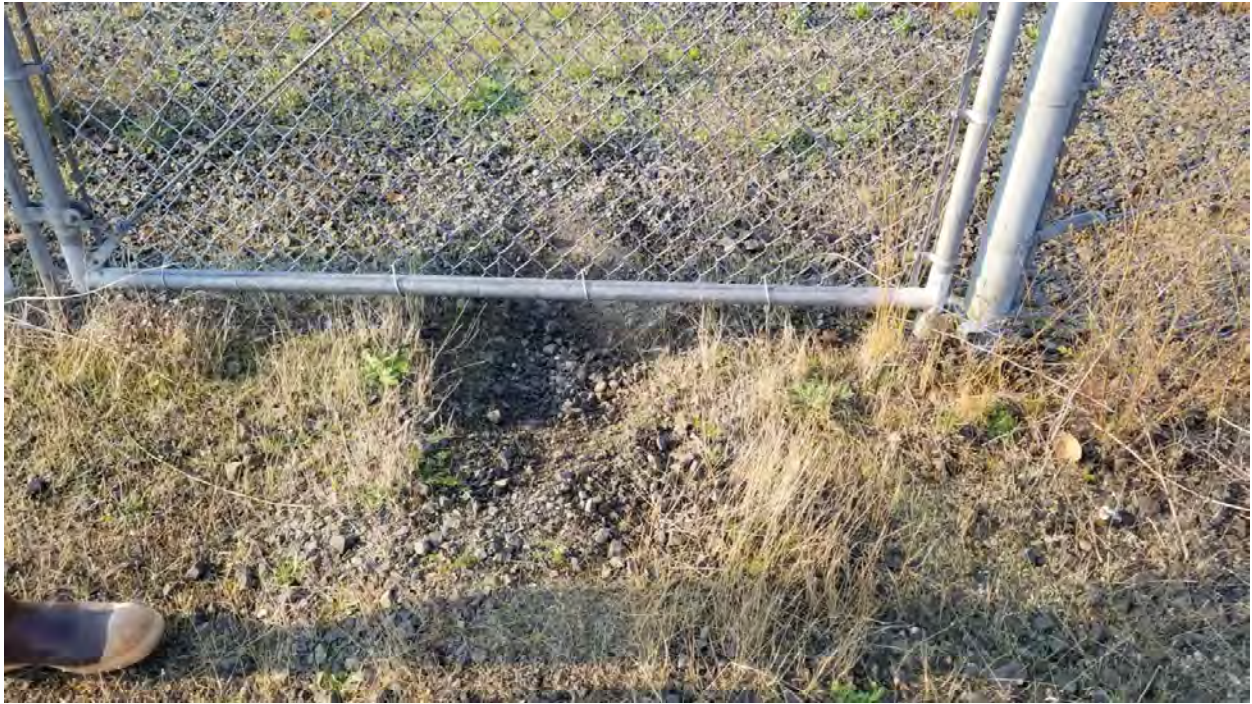
Photograph 5: Burrow underneath fence gate along southwest perimeter of site.

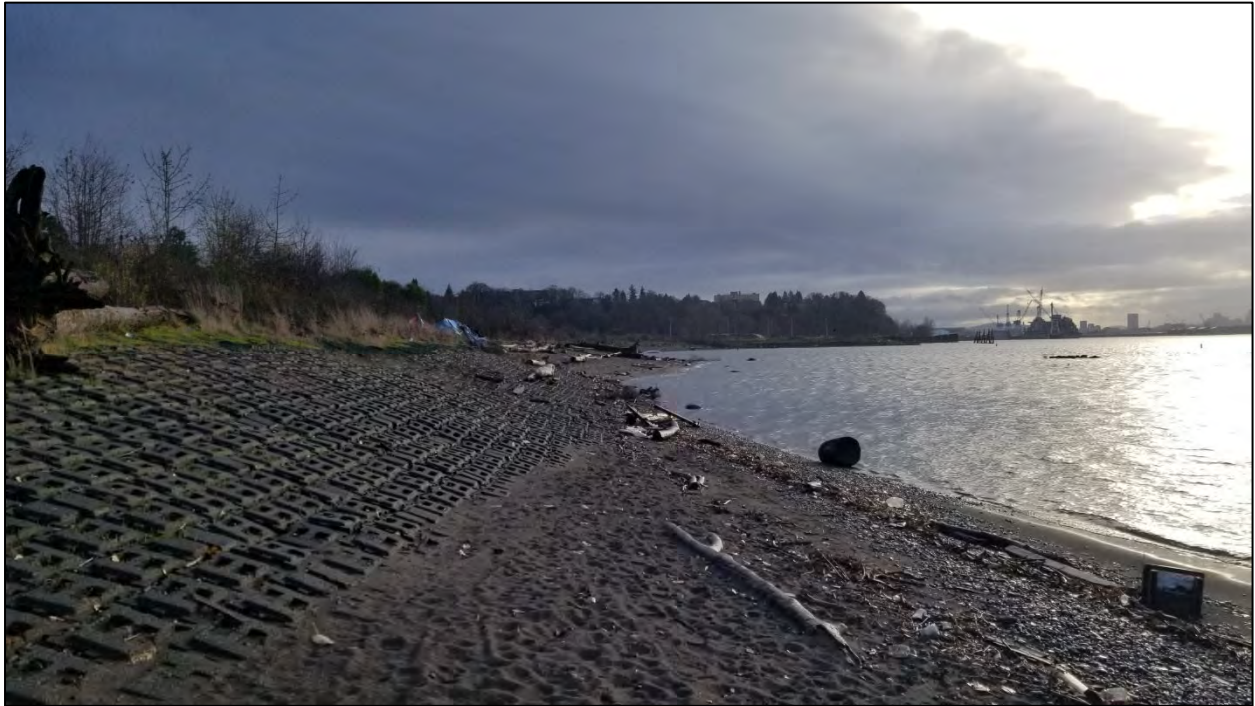
Photograph 1: Shoreline conditions with abandoned transient camp still present (visible in background).

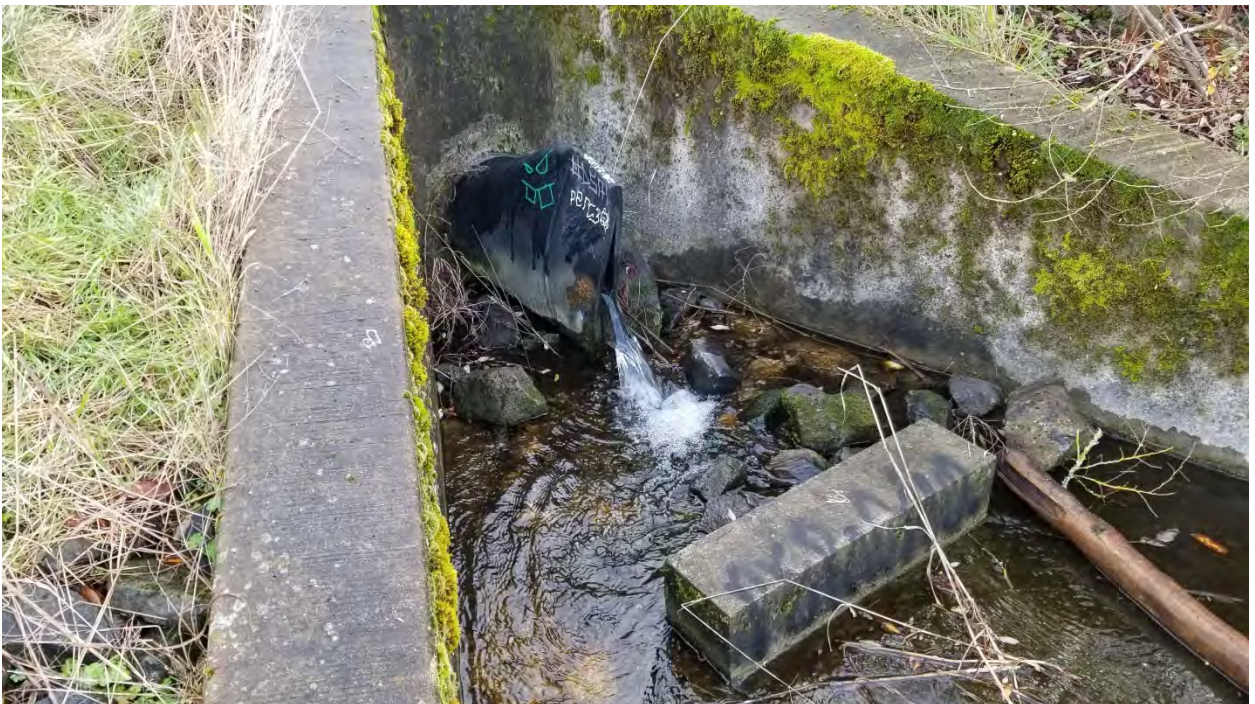
Photograph 2: Stormwater outfall discharge at an estimated 5-10 gallons per minute.

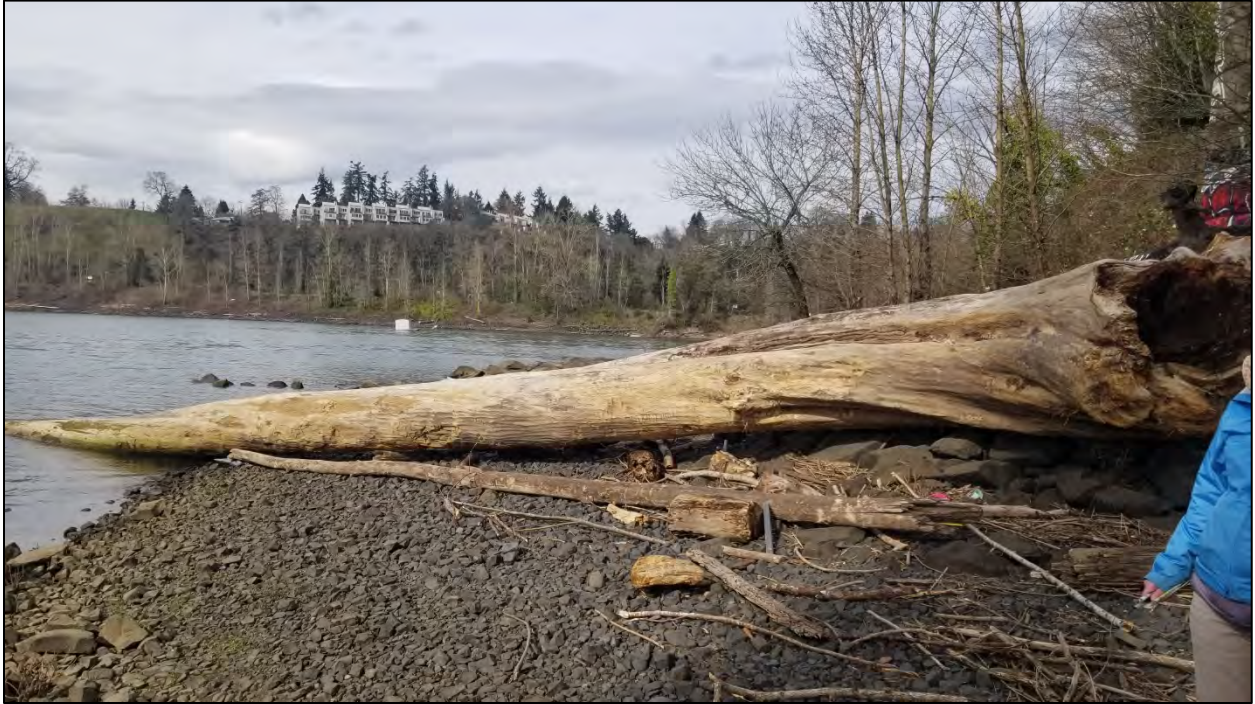
Photograph 1: Large tree trunk that washed up on shore at Willamette Cove and Willamette River shoreline junction beneath Burlington Northern Railroad lines. View facing northeast.

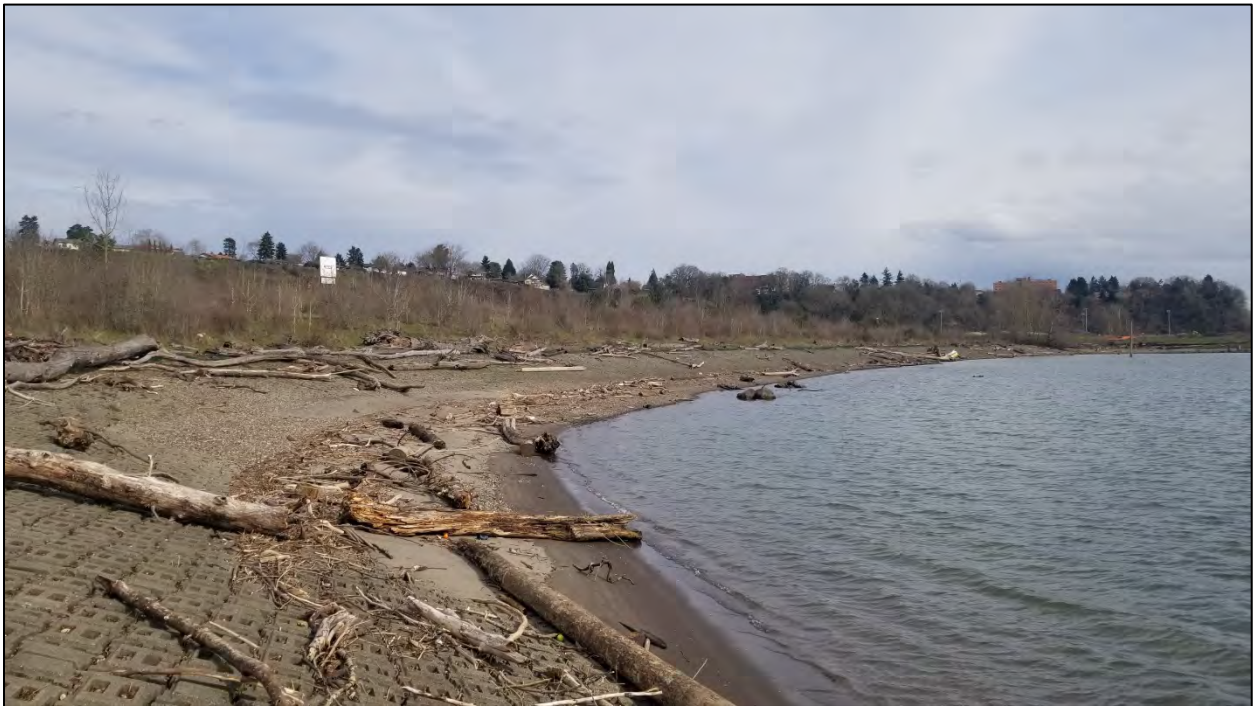
Photograph 2: Willamette River shoreline with lots of wood debris deposited on it. View facing southeast.
