**FIFTH FIVE-YEAR REVIEW REPORT FOR
MCCORMICK & BAXTER CREOSOTING COMPANY SUPERFUND SITE
MULTMOMAH COUNTY, OREGON**

**Oregon Department of Environmental Quality
Northwest Region
Portland, Oregon**

**U.S. Environmental Protection Agency
Region 10
Seattle, Washington**

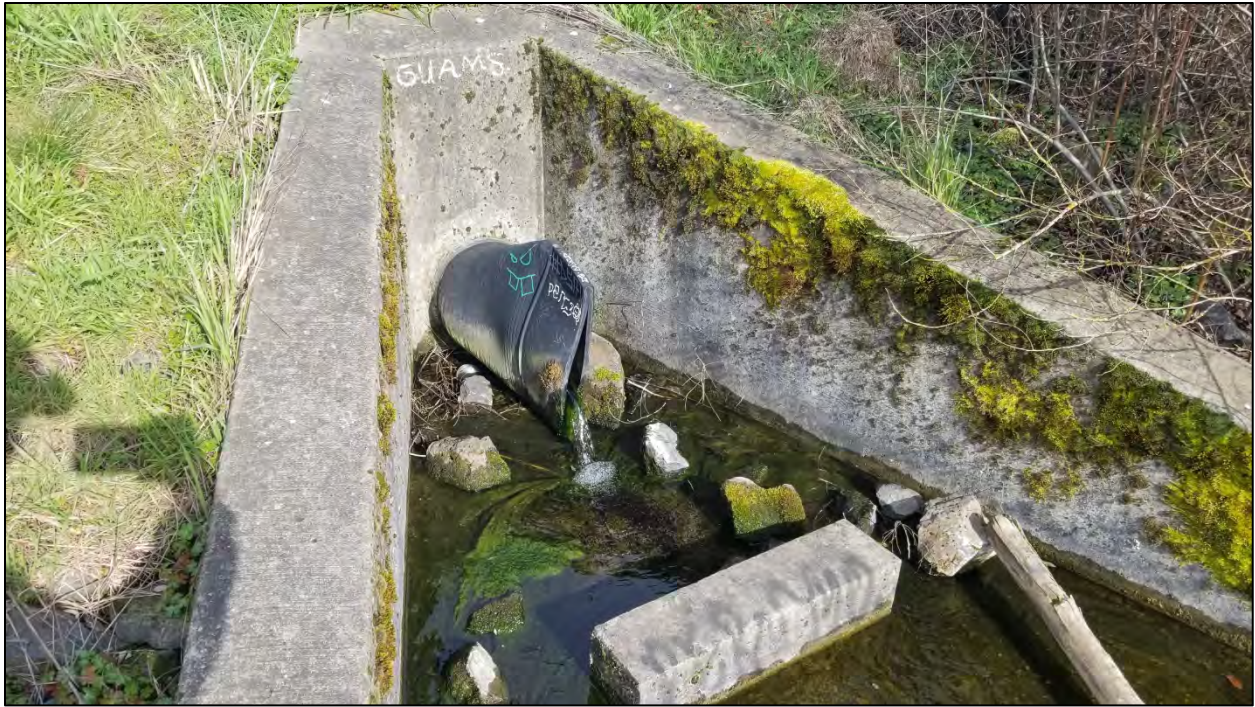
Photograph 3: Stormwater outfall with approximately 5-8 gpm of flow. View facing southeast.

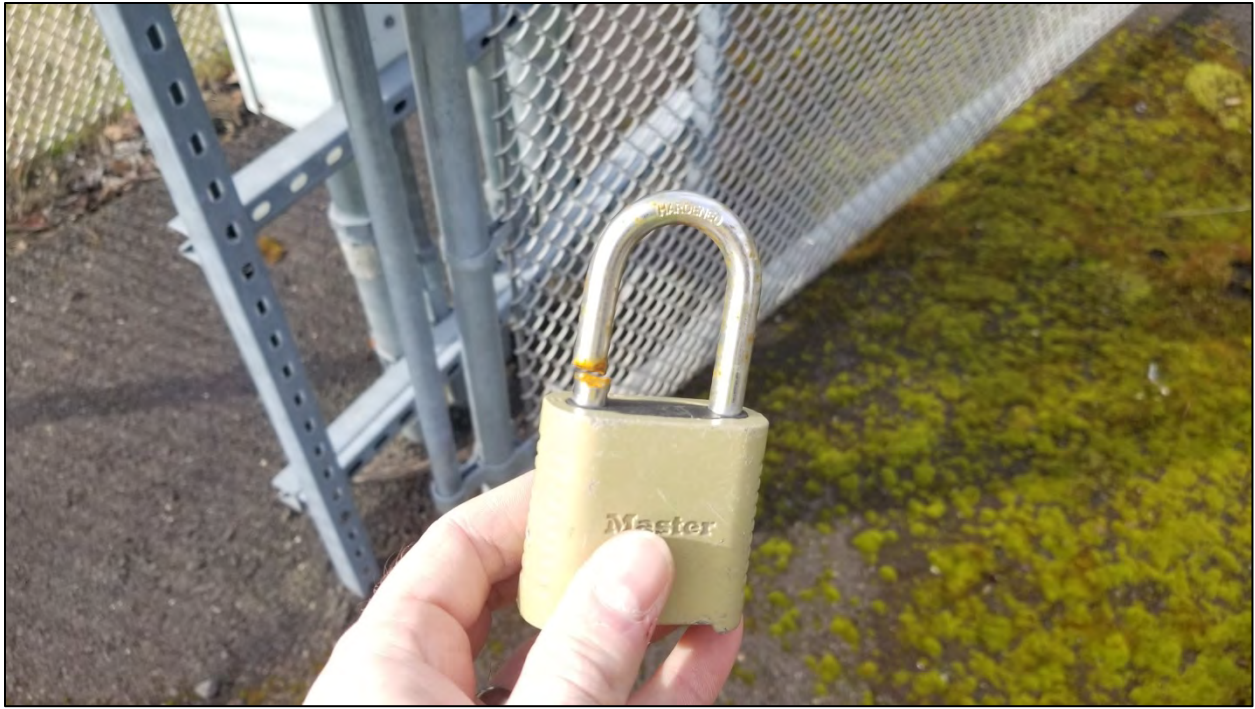
Photograph 5: Lock cut on the main gated entrance from N. Edgewater Avenue.

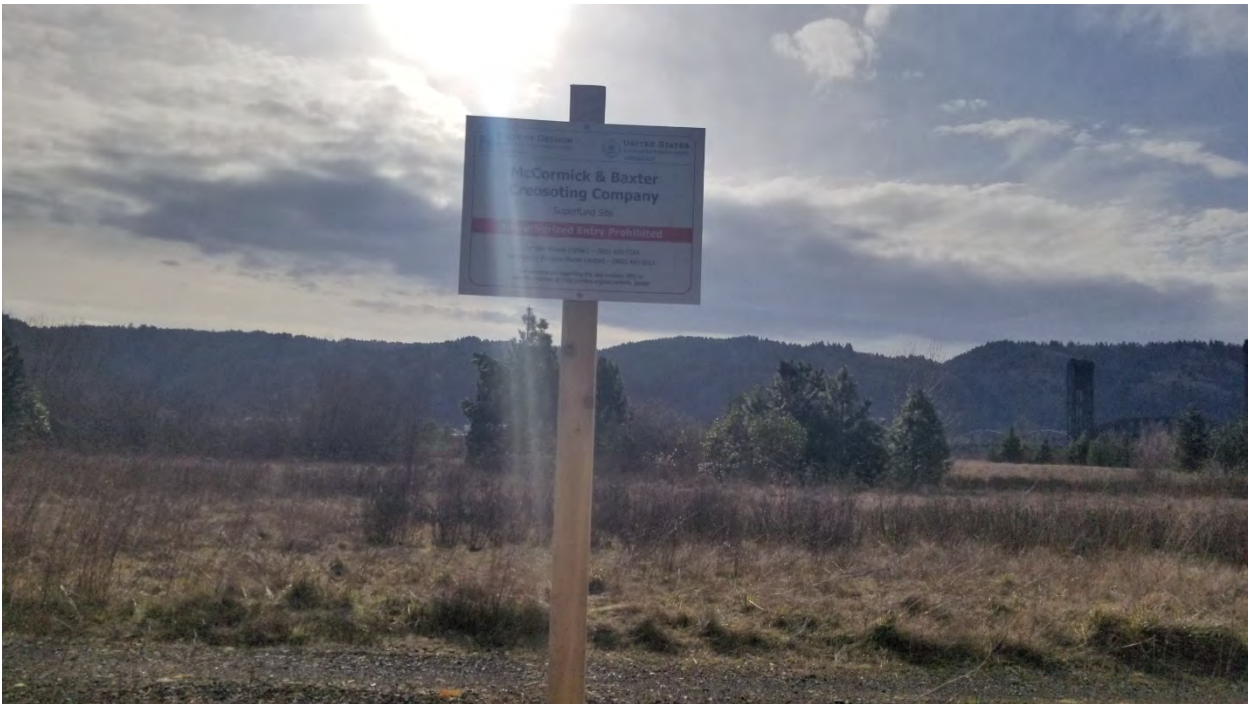
Photograph 6: Replaced sign and sign post by eastern perimeter fence. View facing west.

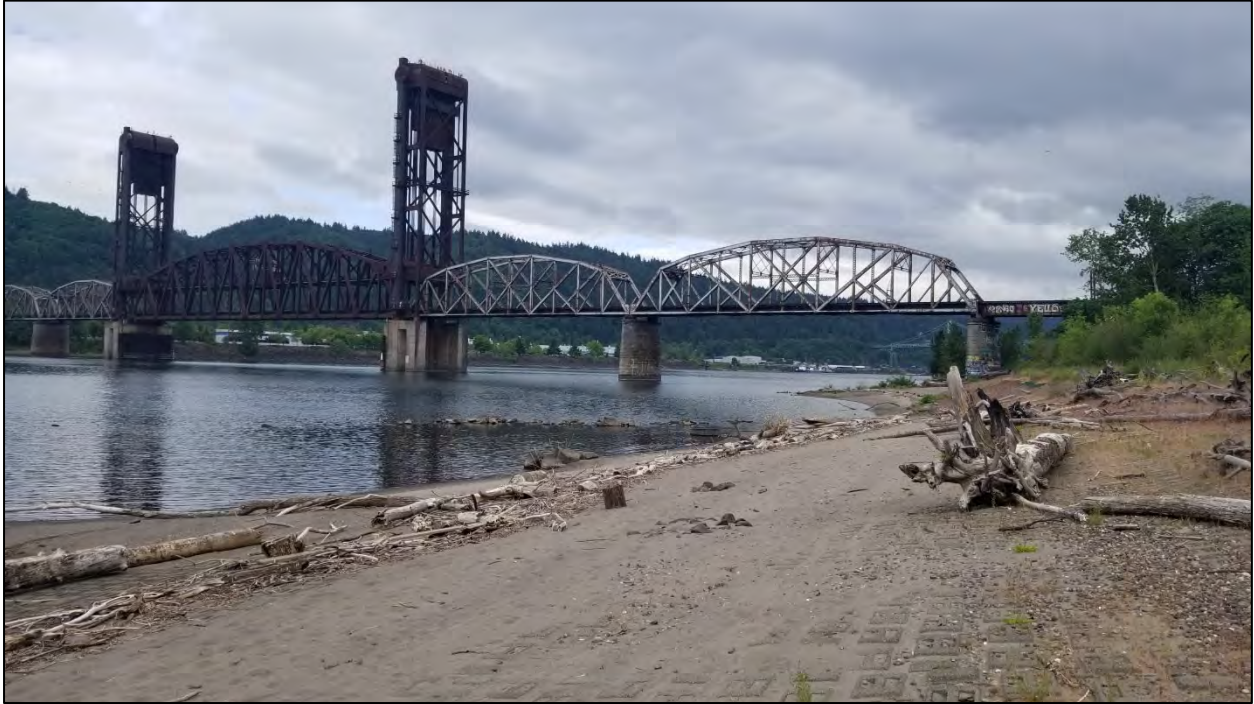
Photograph 1: Willamette River shoreline conditions south of the Burlington Northern Santa Fe Railroad lines. View facing northeast.

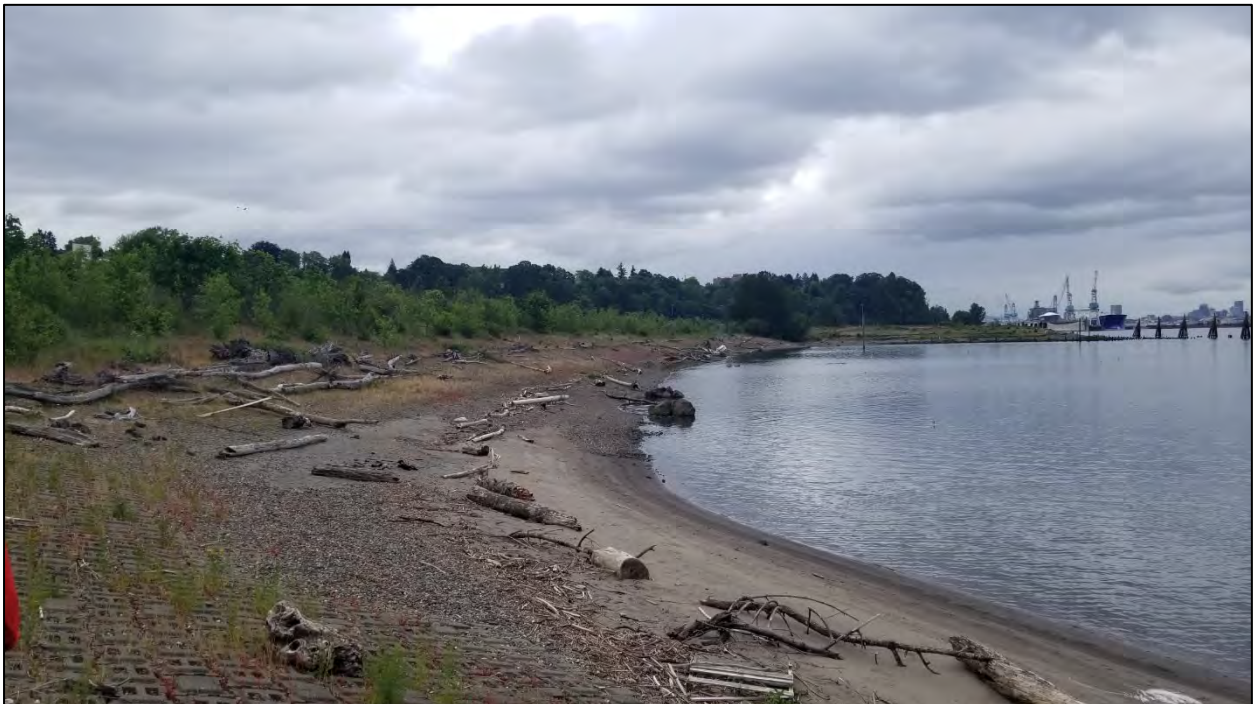
Photograph 2: Willamette River shoreline with lots of wood debris deposited on it. View facing southeast.

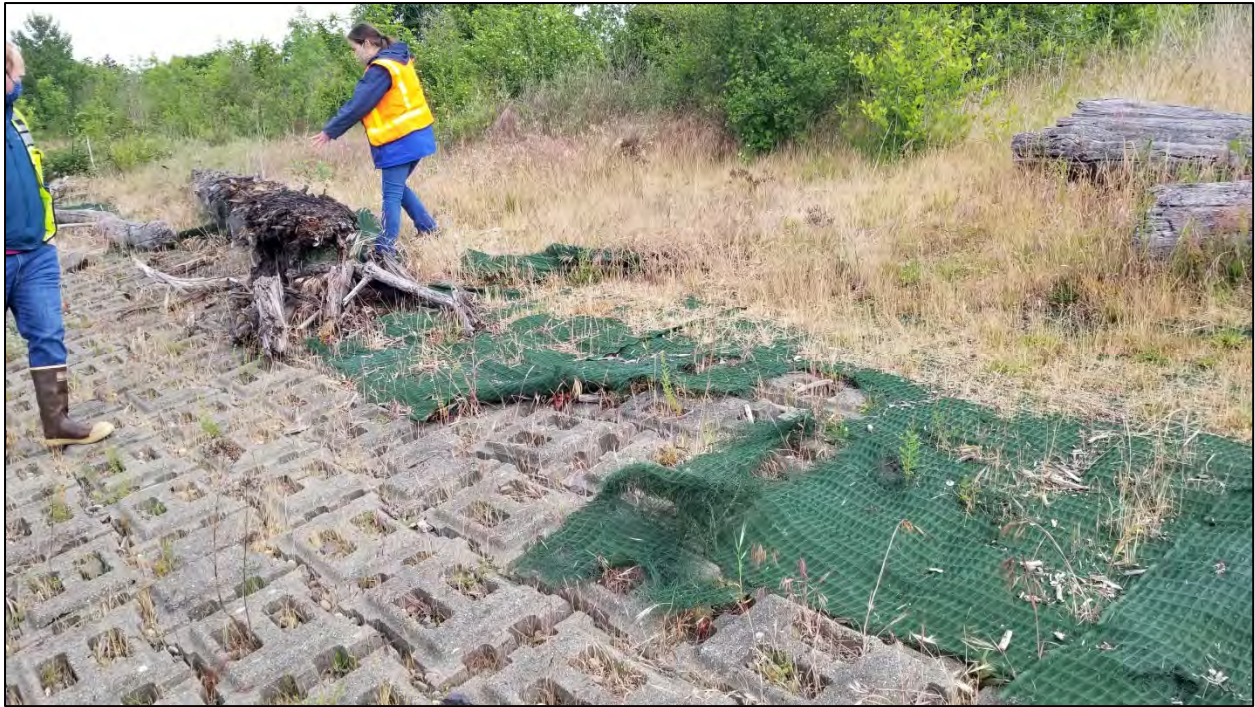
Photograph 3: Loose or torn section of TRM that requires repairs. View facing north.

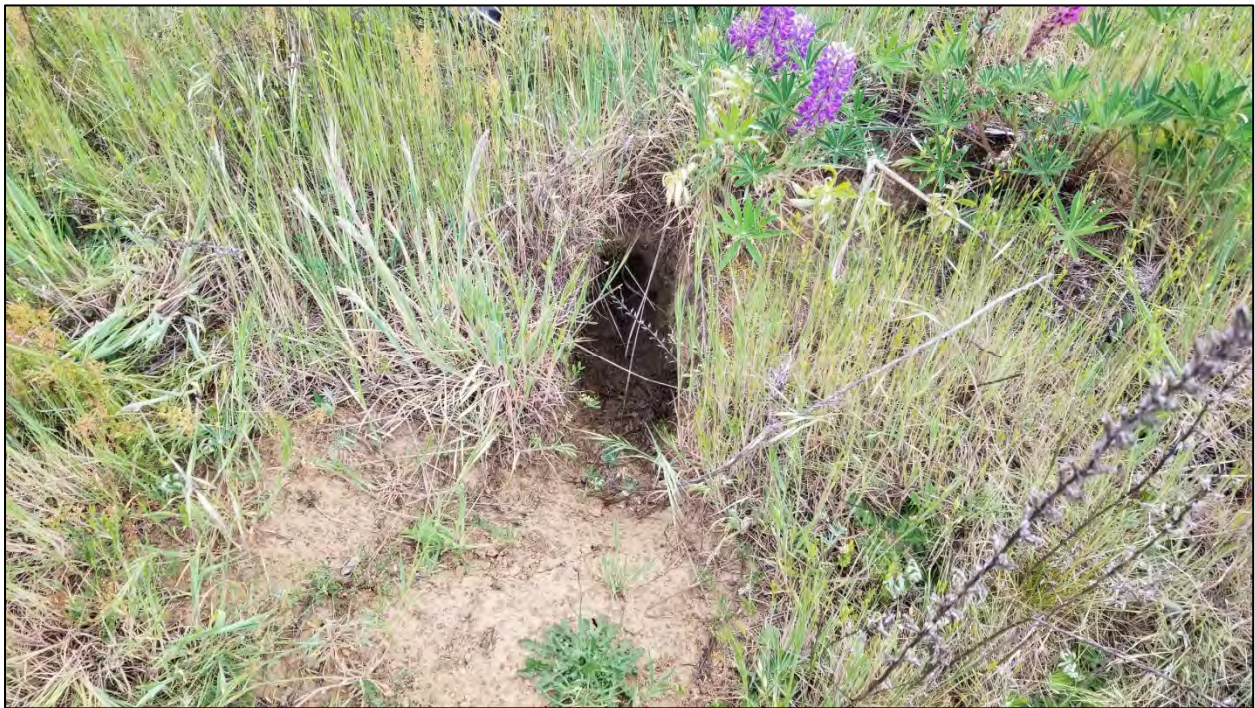
Photograph 4: Animal burrow in the vicinity of MW-48s.

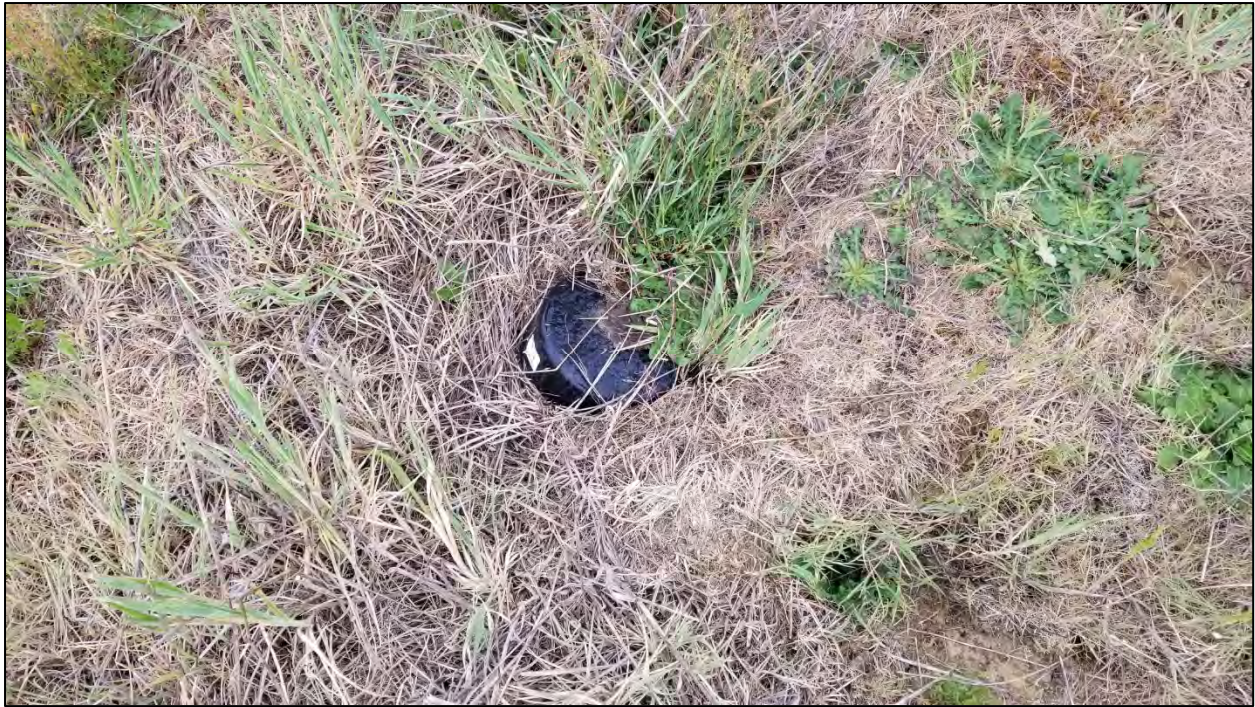
Photograph 5: PVC riser and cap protruding through the soil cap and presumed to be a storm sewer cleanout.
