2014 ANNUAL MONITORING AND MAINTENANCE REPORT

Ross Island Sand & Gravel Company
Portland, Oregon

Annual Monitoring and Maintenance Report

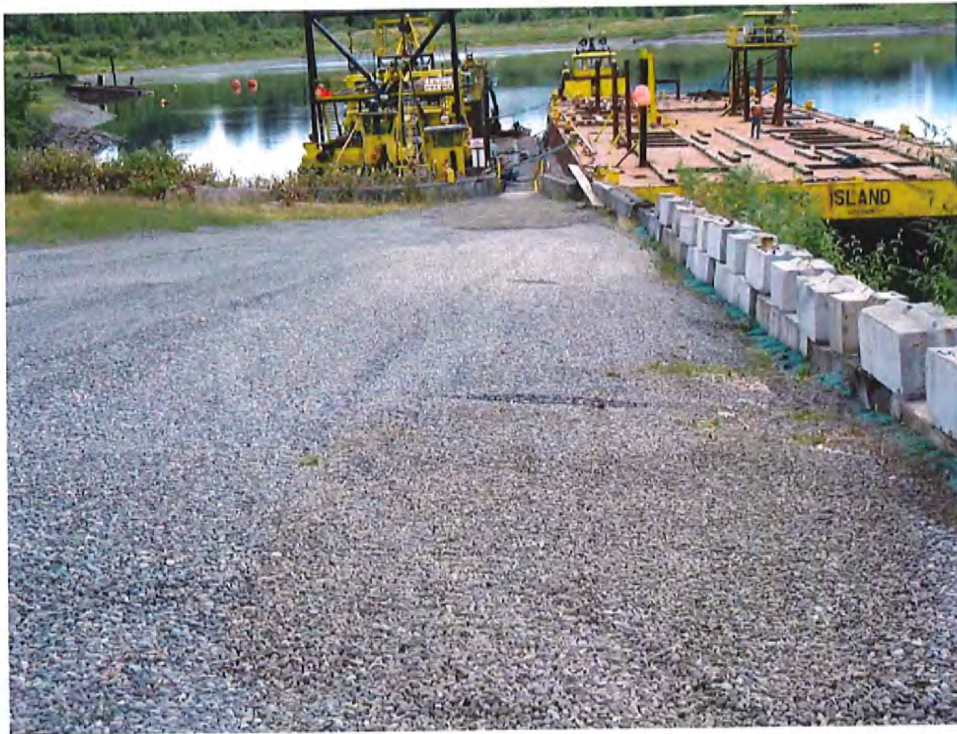
REMEDIAL ACTION SUB-AREA A2-1.ECOLOGY BLOCKS AND BIOFILTER BAGS FACING SOUTH

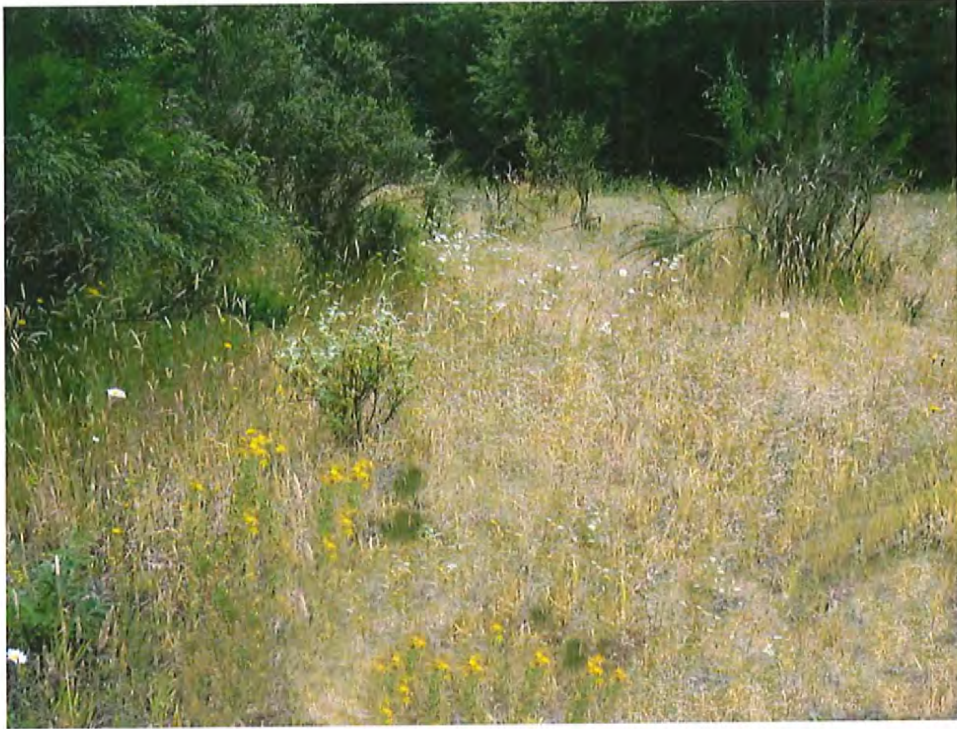
REMEDIAL ACTION SUB-AREA B. FACING SOUTHWEST

Remedial Action Area B is the site of a former settling pond that is now capped with clean fill material. RISG performed the annual monitoring event on June 24, 2014. The soil cap was inspected for displacement of cap material. The soil cap was in great condition with no signs of settling, holes, animal intrusions, or ponding. The vegetation on the soil cap was inspected for signs of dead spots and stress. Vegetation appeared to be in good shape with one slight exception during the annual monitoring event. There are signs of animal (deer) activity that has created a pathway across the top of this area. Based on the inspection, the soil cap did not require any maintenance or contingency measures at this time.

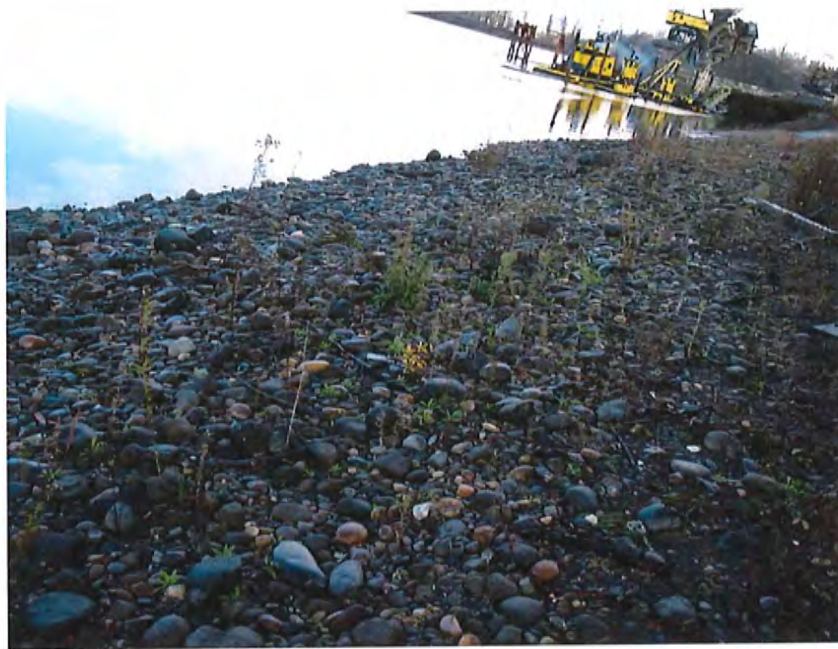
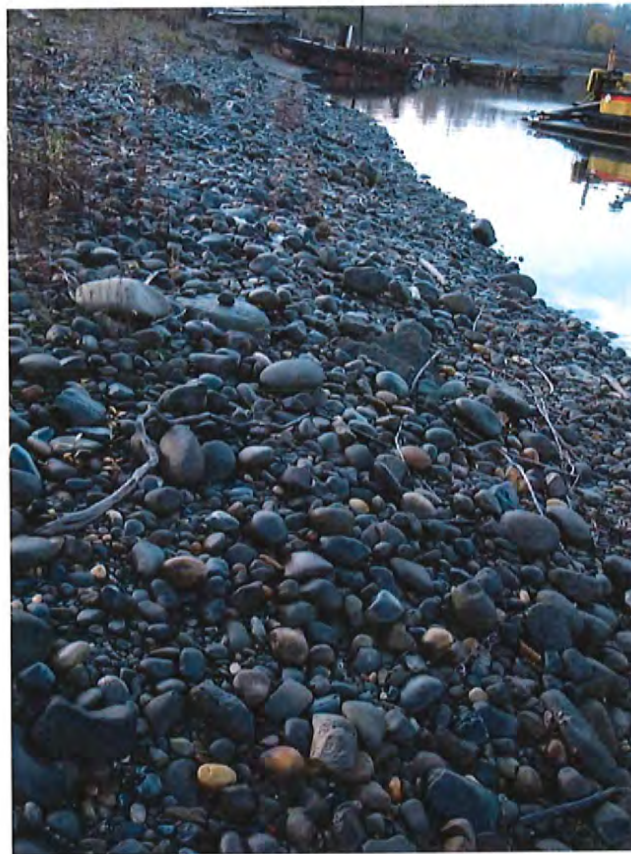
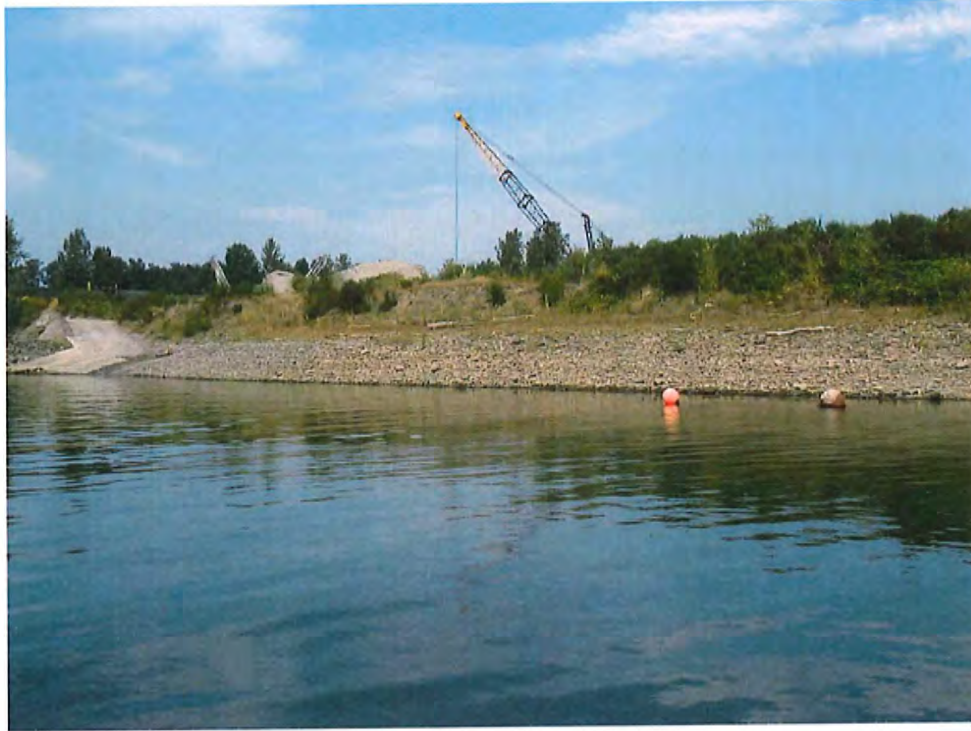
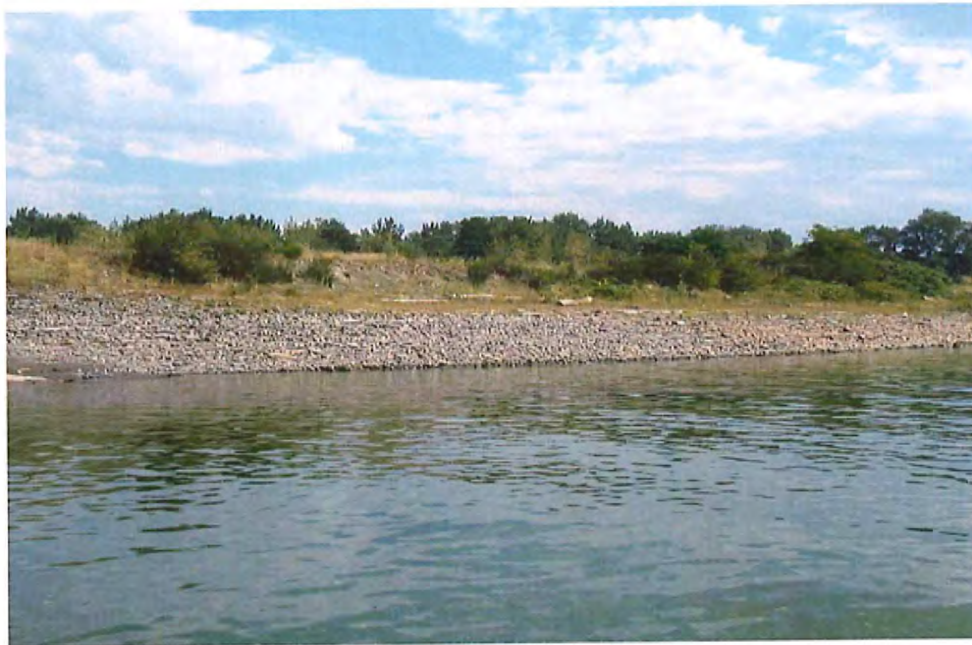
REMEDIAL ACTION SUB-AREA A2-2. DURING LOW WATER, FACING NORTH

REMEDIAL ACTION SUB-AREA A2-2. DURING LOW WATER. FACING SOUTH

REMEDIAL ACTION SUB-AREA A2-2. DURING LOW WATER, FACING EAST

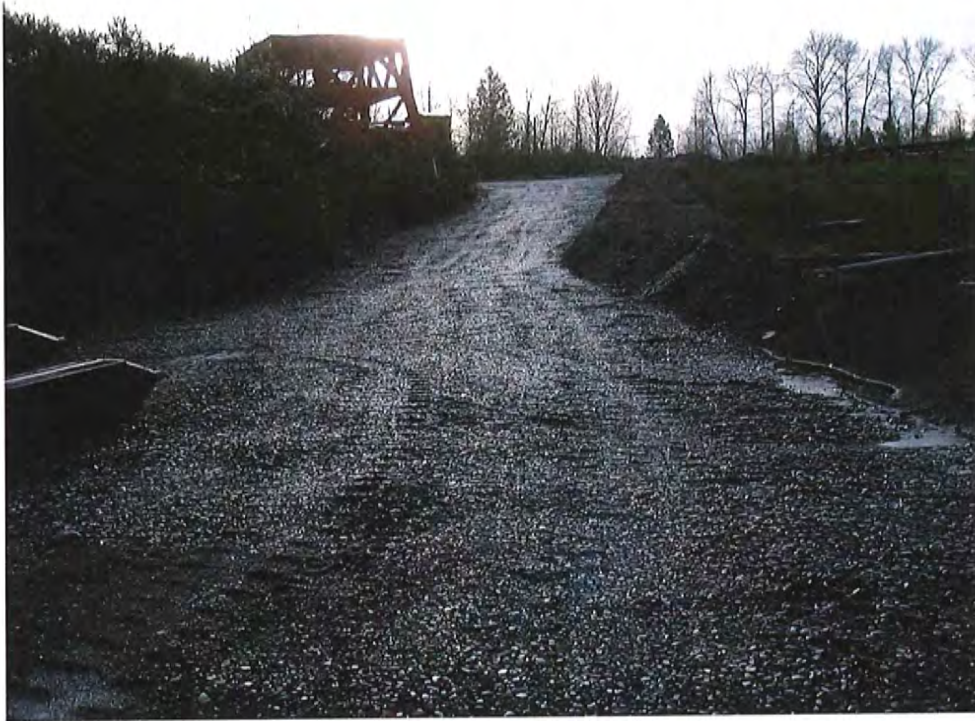
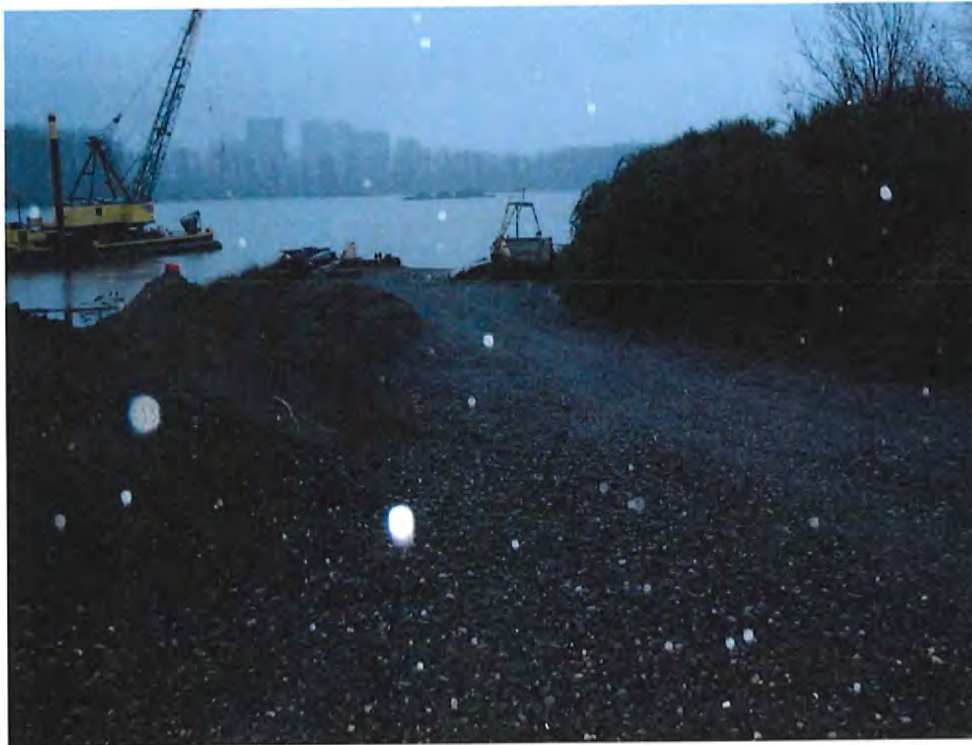
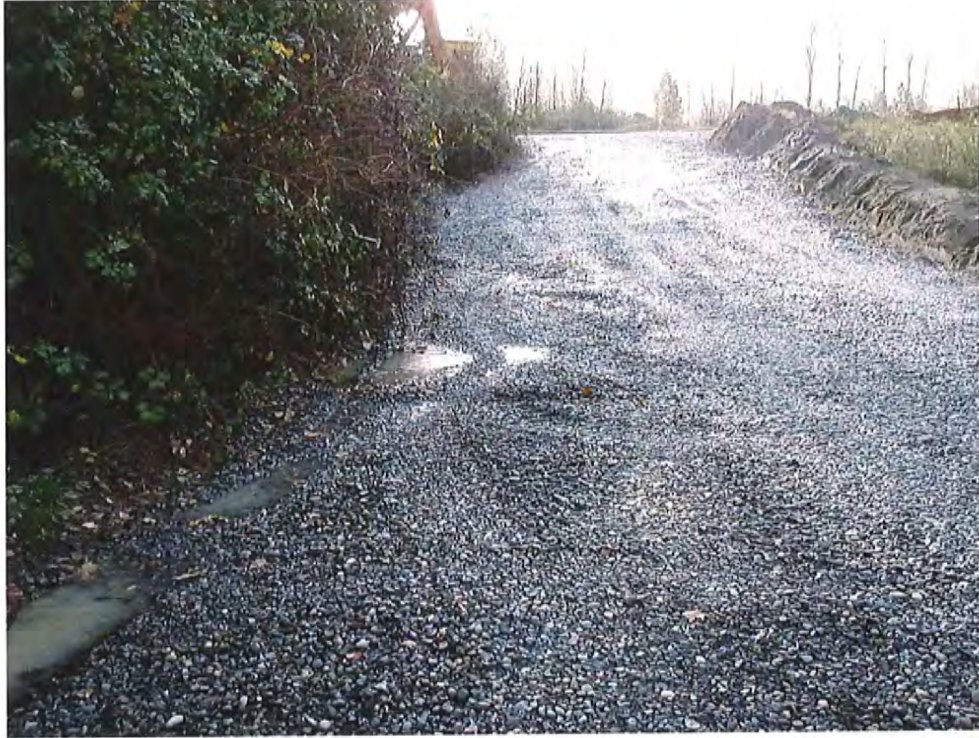
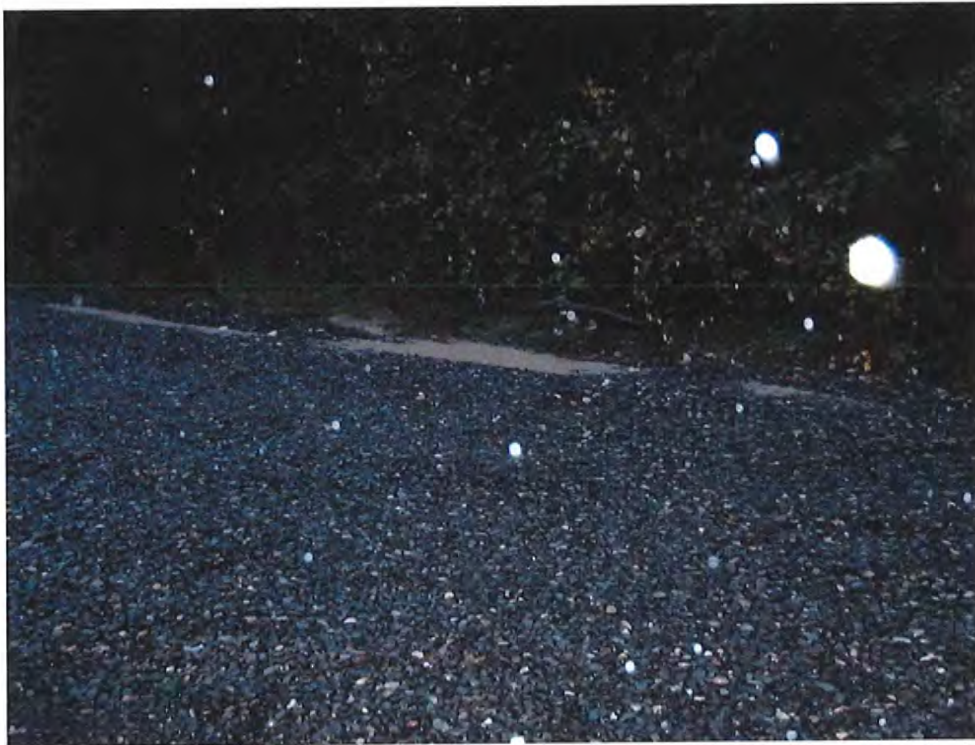
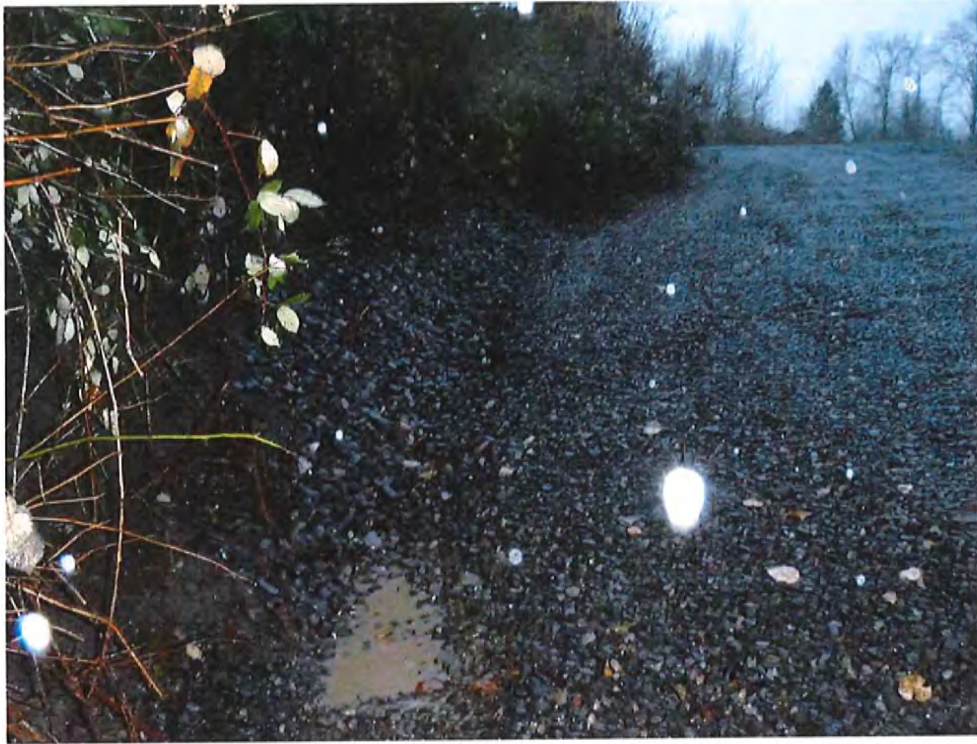
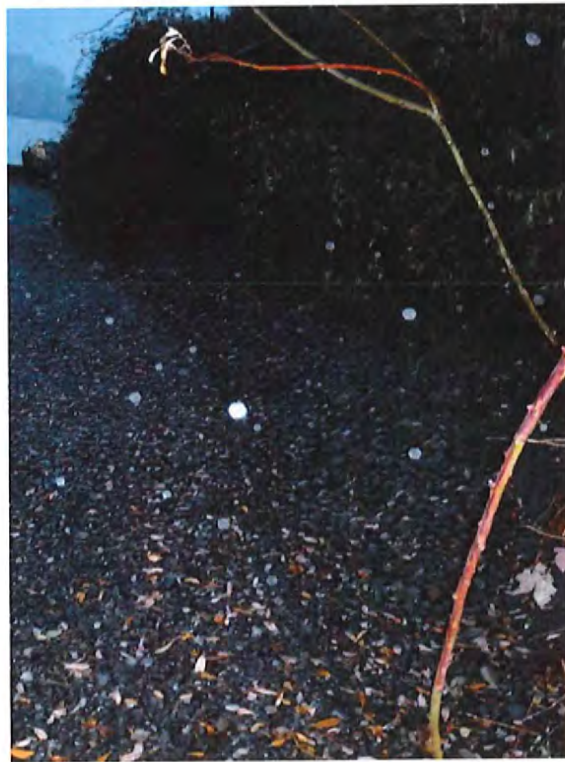
On March 28, 2014, a rainfall event of 1.79 inches occurred. Because the end of this event occurred late Friday, RISG staff was not present to complete monitoring over the weekend. Monitoring was conducted on Monday, March 31, and no signs of erosion or sediment runoff were observed.

REMEDIAL ACTION SUB-AREA A2-3. DURING RAIN EVENT
