# CITY OF PORTLAND ENVIRONMENTAL SERVICES

December 13, 2011

Subject: Request for DEQ Site Assessment of Peninsula Iron Works Property at 6618 N. Alta Avenue

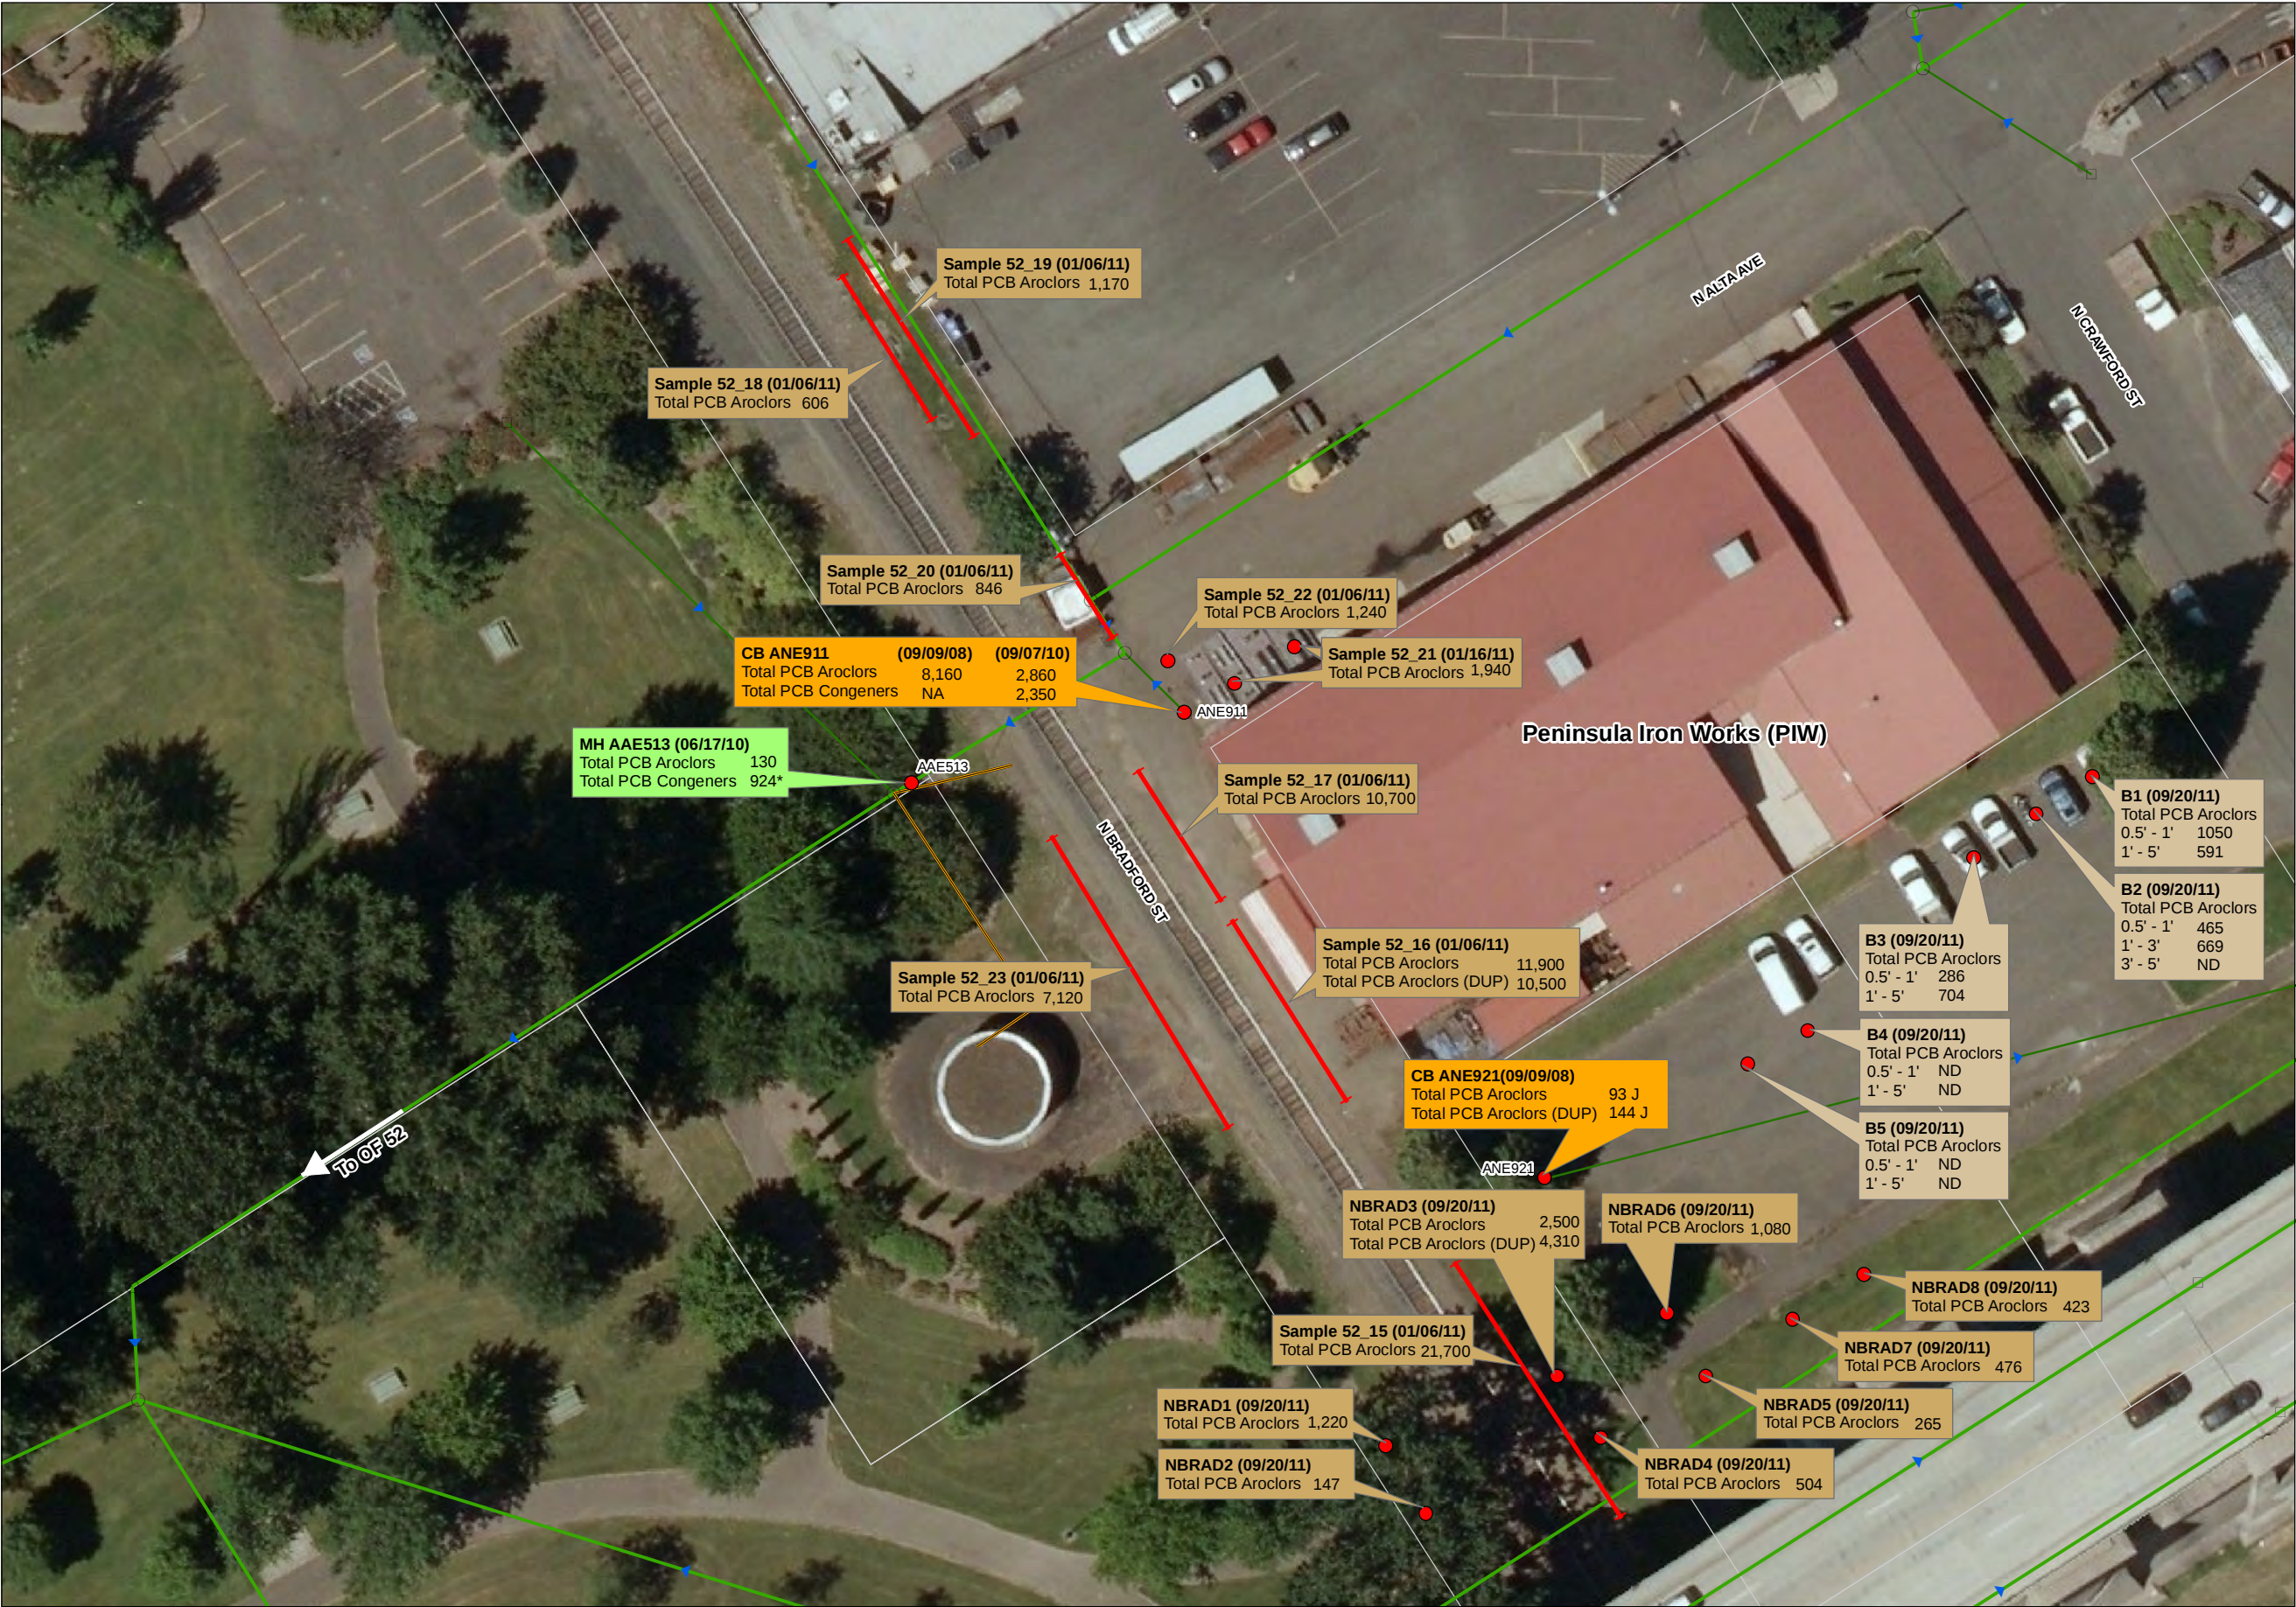
**FIGURE 1**  
Total PCBs Concentrations in Vicinity of Peninsula Iron Works

Attachment 1 includes a figure depicting sample locations and total PCBs concentrations for these investigations and a table summarizing analytical results. Data indicate that the PIW site is a likely current and/or historical source of PCBs detected in the Basin 52 conveyance system, in the N. Bradford St. right-of-way, and on adjacent City property.

In September 2008, total PCB Aroclors were detected in CB ANE911 at a concentration of 8,160 µg/Kg. Following the January 2010 line cleaning activities in Basin 52, total PCB congeners were detected at a concentration of 924 µg/Kg in the downstream manhole AAE513 sediment trap sample (June 2010), indicating a PCBs source (see Attachment 1)<sup>3</sup>. Because this sampling location represents discharge from the majority of the northern Basin 52 drainage area, the City also resampled sediments that had accumulated in CB ANE911 since the January 2010 cleanout. The catch basin data (September 2010) were used to evaluate whether contaminant concentrations in sediments indicates a current source, and if so, whether that source likely represents the most significant source to the manhole AAE513 sediment trap location. Total PCB congeners in the follow up sample from CB ANE911 were 2,350 µg/Kg. These data indicate the presence of a PCBs source within the CB ANE911 drainage area.

There are no piped connections to CB ANE911. Runoff from the PIW site and other areas, such as N. Alta and N. Bradford Streets, discharges to this inlet. To determine the source of contaminated sediment to CB ANE911, the City sampled erodible soils in the vicinity of the catch basin in January 2011 (see Attachment 1). Total PCBs concentrations were highest along the N. Bradford St. right-of-way closest to the site (~7,000 to 21,000 µg/Kg). These concentrations also exceeded the concentration detected in CB ANE911. PCB Aroclor 1260 was the only Aroclor detected in CB ANE911 and all erodible soils samples. Results indicate that contaminated erodible soils in the vicinity of PIW and N. Bradford St. are a significant source to CB ANE911.

PCBs also were detected at elevated concentrations in erodible soils samples collected from Cathedral Park pedestrian areas near this parking lot. Highest concentrations (1,080 -4,310 µg/Kg) were observed in the three samples collected north of the sidewalk that parallels the south side of the parking lot, suggesting that PCBs in erodible soils in this area decrease with distance from the PIW site. If the PIW site is a historical and/or current source of PCBs in this area, offsite migration via vehicle and equipment dragout, overland runoff, fugitive dusts, and direct releases may all have contributed to PCBs concentrations observed in the vicinity of the site.
