# BASIN K1 BIOINFILTRATION BASIN ANNUAL REPORT

KINDER MORGAN PORT OF PORTLAND TERMINAL 4, SLIP 3

*December 23, 2022*  
*Project No. M1017.01.016*

BASIN K1 BIOINFILTRATION BASIN ANNUAL REPORT  
KINDER MORGAN PORT OF PORTLAND TERMINAL 4, SLIP 3

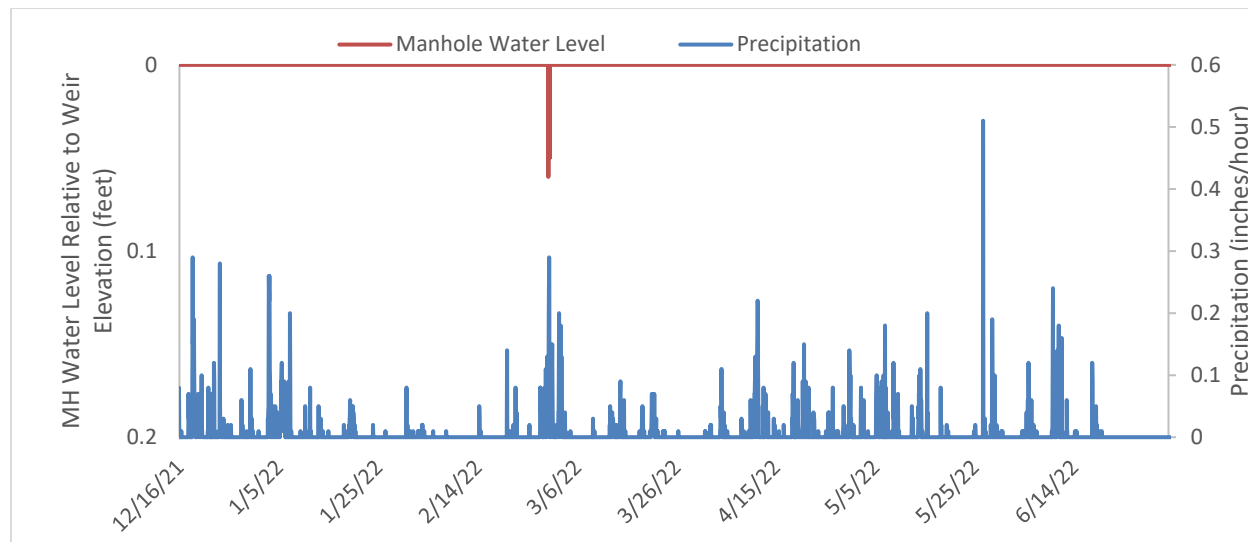
**Chart 1 – Manhole Water Level Above the Overflow Weir Elevation**

Chart 1 indicates a bypass from the flow- and spill-control manhole occurred once between December 16, 2022 and June 30, 2022 when a large storm event occurred when the pumps were conveying less than the design flowrate.

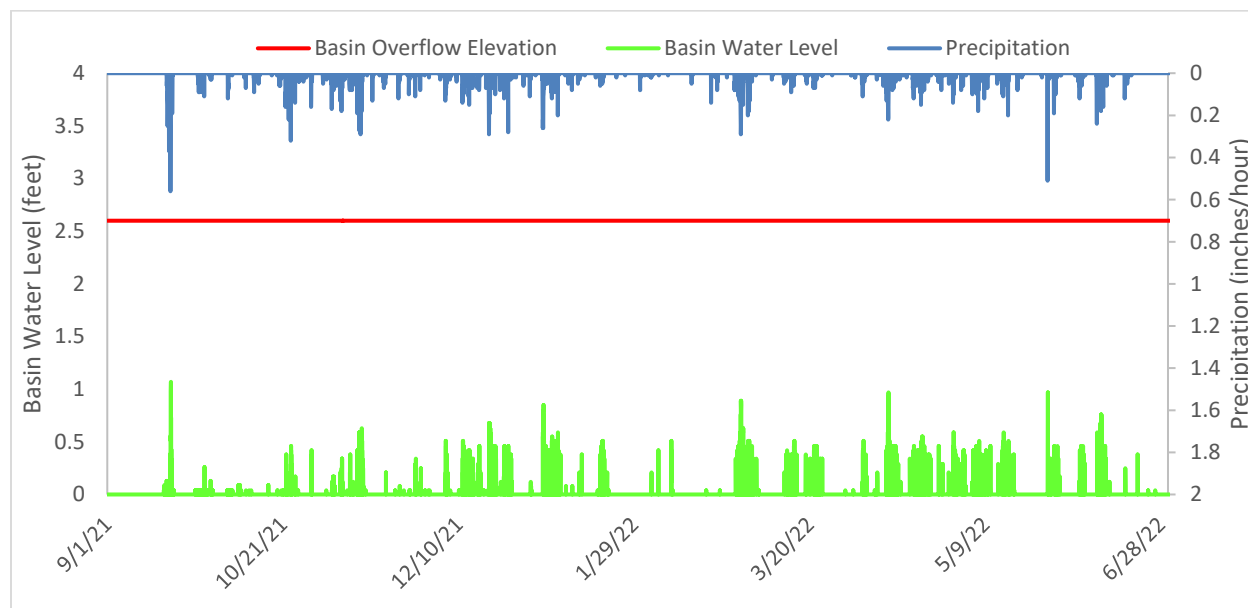
**Chart 2 – Basin Water Level Relative to the Basin Overflow Elevation**

Chart 2 shows that no overflow from the bioinfiltration basin occurred from the time of commissioning to the end of June 2022. The maximum ponding depth over the basin media bed was 1.03 feet. However, the water depth when pumping ceased was less than 12 inches; therefore the minimum and maximum infiltration rate when the depth above the media is at least 12 inches cannot be calculated.

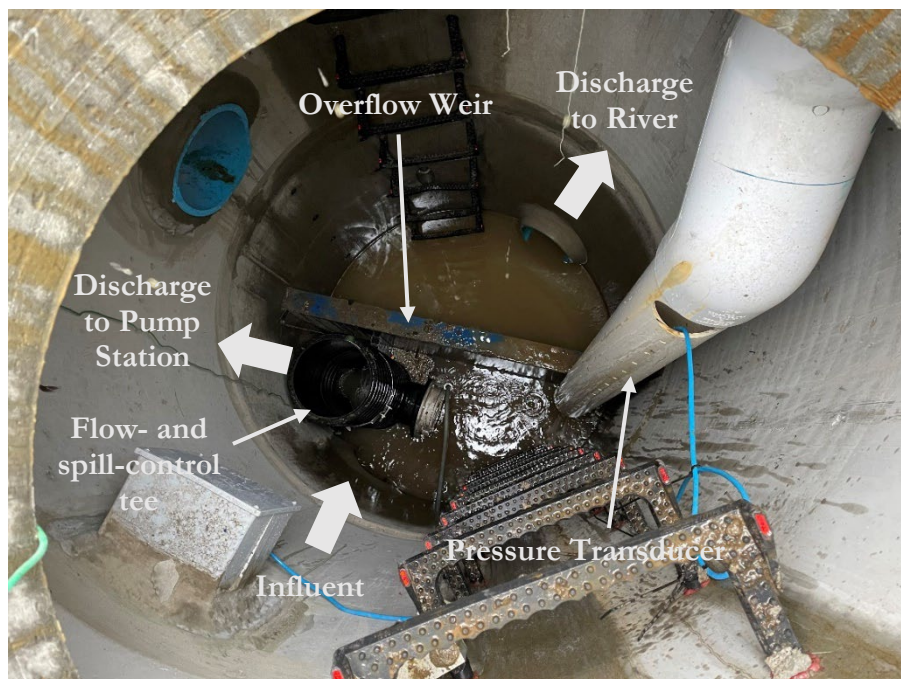
Flow- and spill-control  
manhole

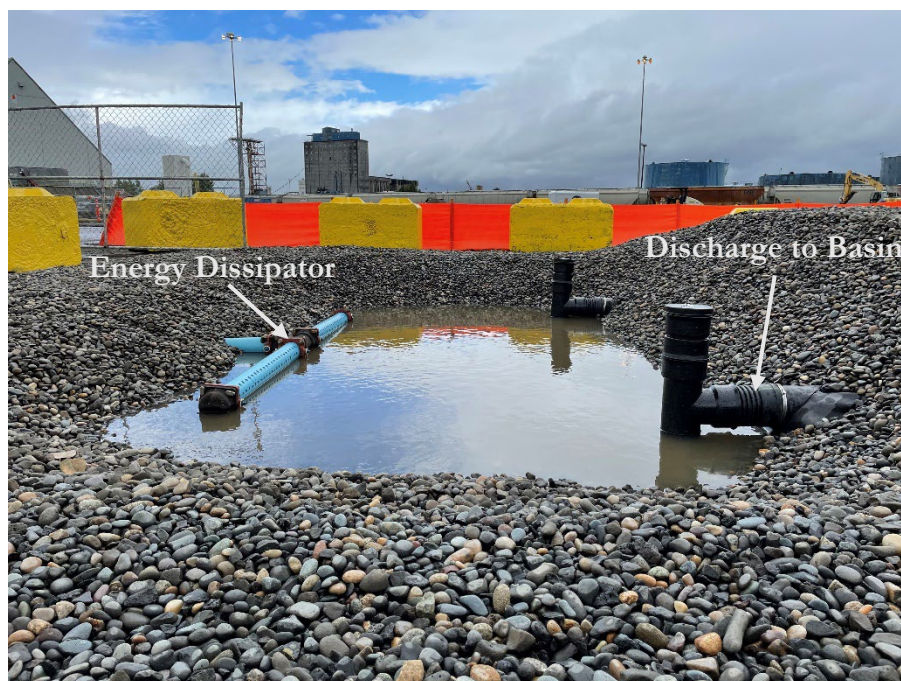
### Photo No. 2.

Sedimentation forebay

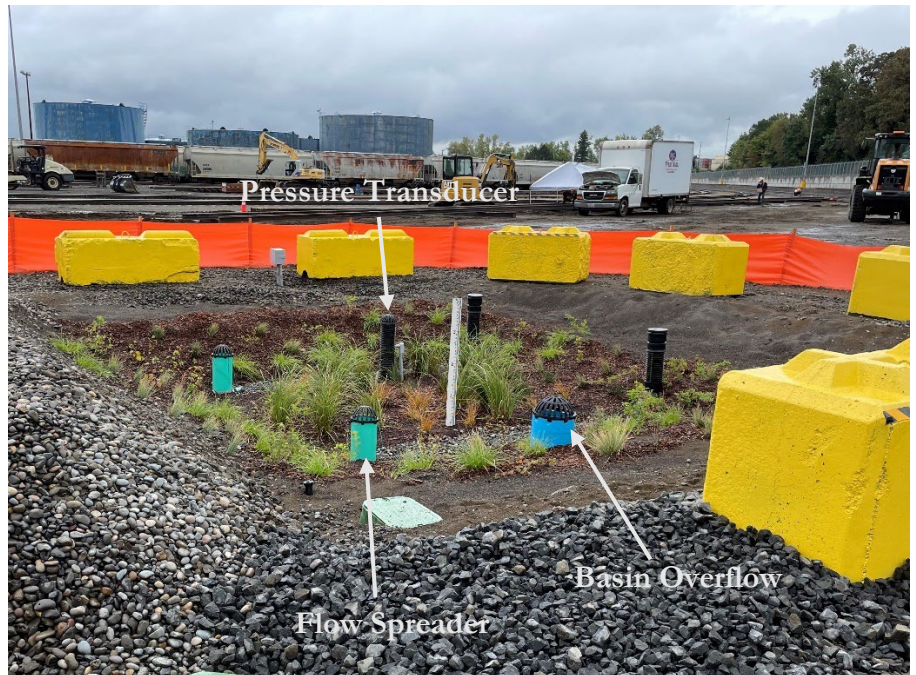
Bioinfiltration basin

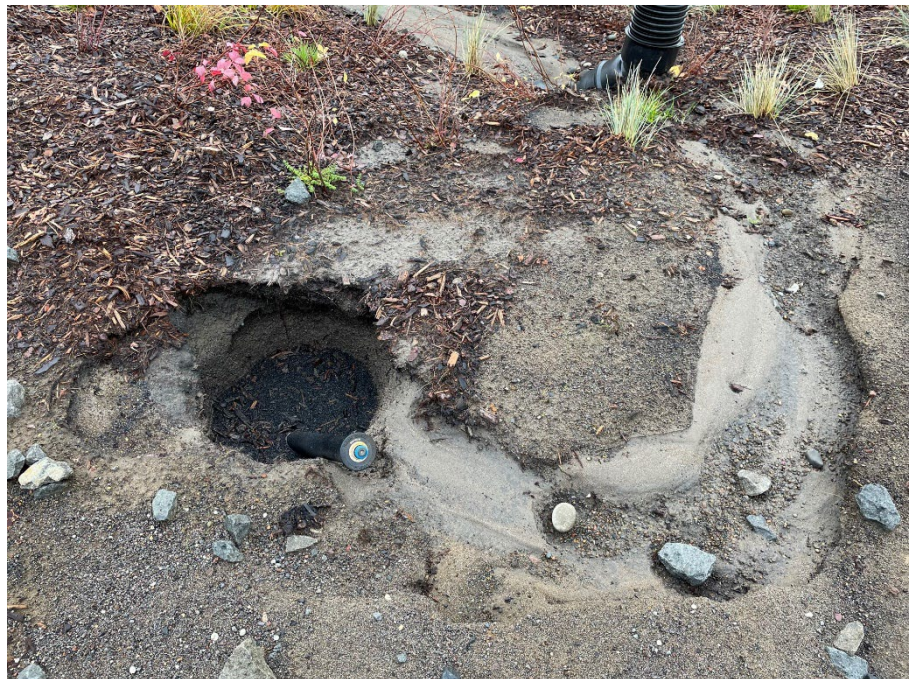
### Photo No. 4.

- December 16, 2021: The basin irrigation sprinkler was observed to have fallen over and created a small (approximately 12-inch by 12-inch by 12-inch) scour hole in the basin. The contractor repaired the damage and added rock around the basin to prevent erosion. The transducer was removed from the stilling well in the flow-control manhole and determined to be installed at the incorrect elevation. Since the transducer could not be replaced without a confined space permit, the transducer was placed back in the manhole, but outside of the stilling well.

Erosion at the edge of the basin from sprinkler

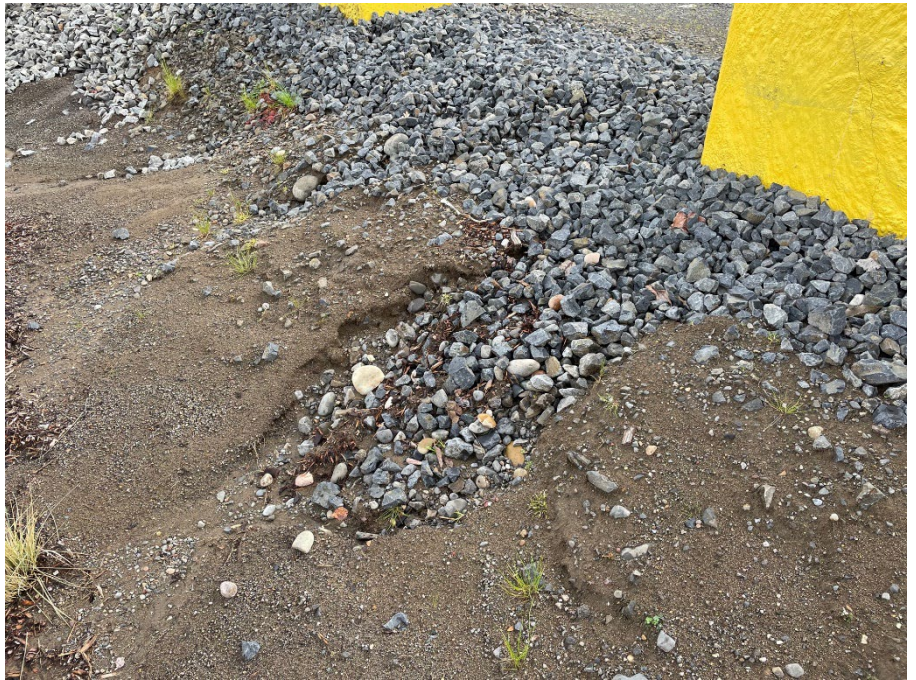
- January 25, 2022: Erosion was observed on the bioinfiltration basin slopes and the contractor added additional rock to armor the slopes.
- February 8, 2022: An additional ladder rung was added to the manhole.

Erosion observed on the slopes above the basin

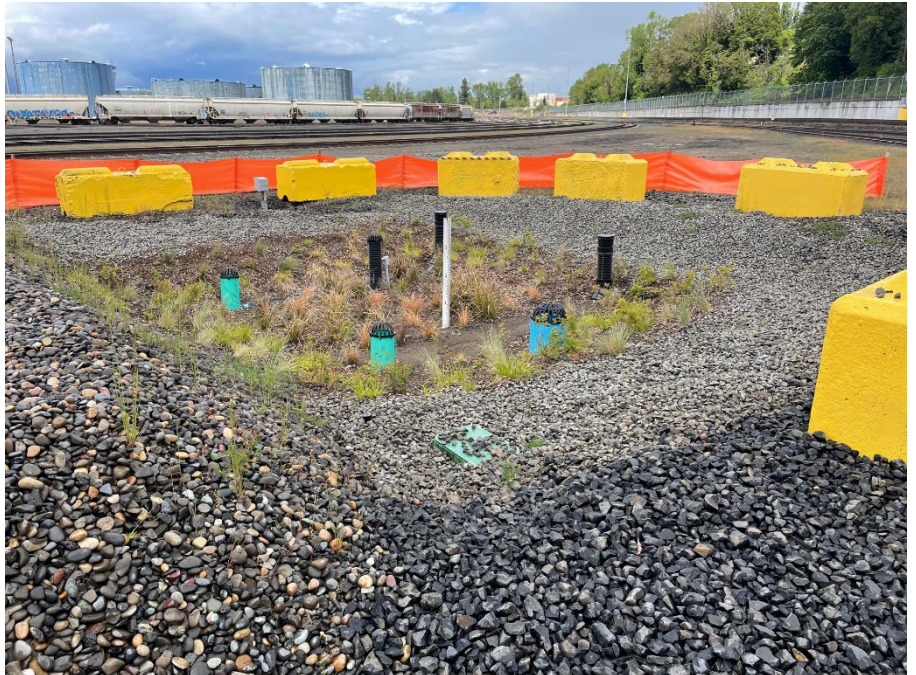
### **Photo No. 6.**

No erosion has been observed since the contractor armored the slopes above the basin in late January. Vegetation appeared healthy from when it was planted in August 2021 through June 2022.

Additional rock added to armor slopes around the basin
