Memorandum

Date: December 16, 2016

SUBJECT: Preliminary Evaluation of Bank Erosion
Potential – Sulzer Pumps, Portland, Oregon

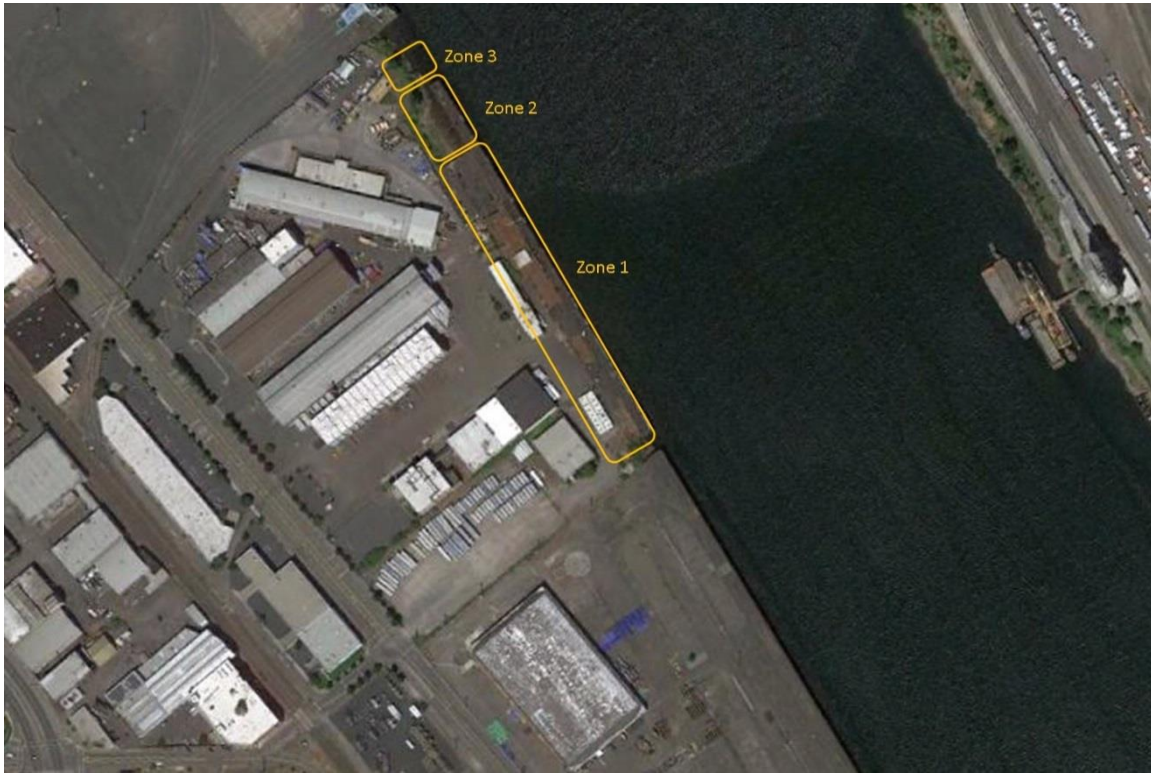
Figure 1. Zones used in Sulzer bank evaluation.

- Zone 1 - Under the dock where the dock extends completely back to the streambank.
- Zone 2 - The section with a dock that does not extend all the way back to the bank.
- Zone 3 - The most downstream section, outside of the dock area.

The streambank in Zone 1 is well protected by sheet pile and concrete riprap. The BEHI risk rating for this area is LOW. The streambank in Zone 2 does not have sheet pile or complete riprap coverage, but it does have some concrete riprap and some vegetated cover. The bank angle is lower in this area than elsewhere along the bank, reducing the erosion potential. The BEHI risk for this area is also LOW. The streambank in Zone 3 is covered with riprap and vegetation and has a lower bank to bankfull height ratio than the rest of the bank. The BEHI risk for this area is LOW, bordering on VERY LOW.

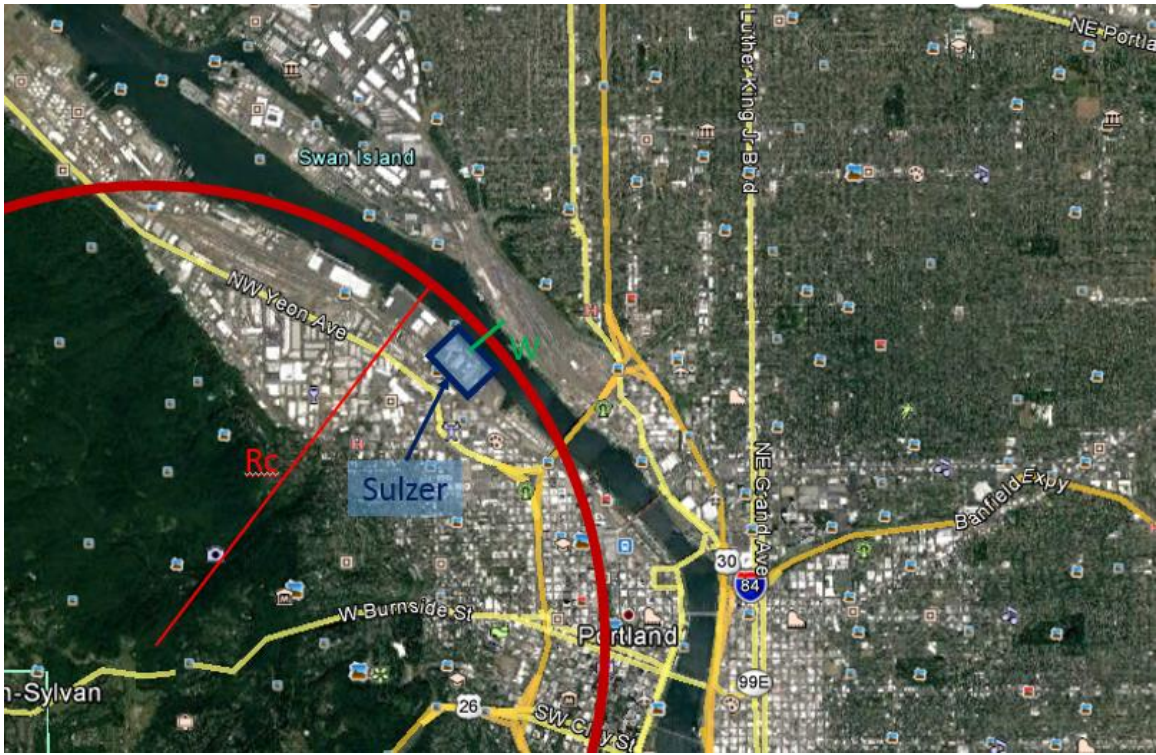
Figure 2. Channel pattern near Sulzer bank.

Method 2 takes into consideration more detailed measurements of the channel pattern, evaluating the radius of curvature (Rc) relative to the bankfull width (W). Figure 2 shows the position of Sulzer in the context of the broader channel pattern. Ratios of Rc/W greater than 3 result in a NBS rating of VERY LOW, and it is clear from Figure 2 that Rc/W near Sulzer is much greater than 3.

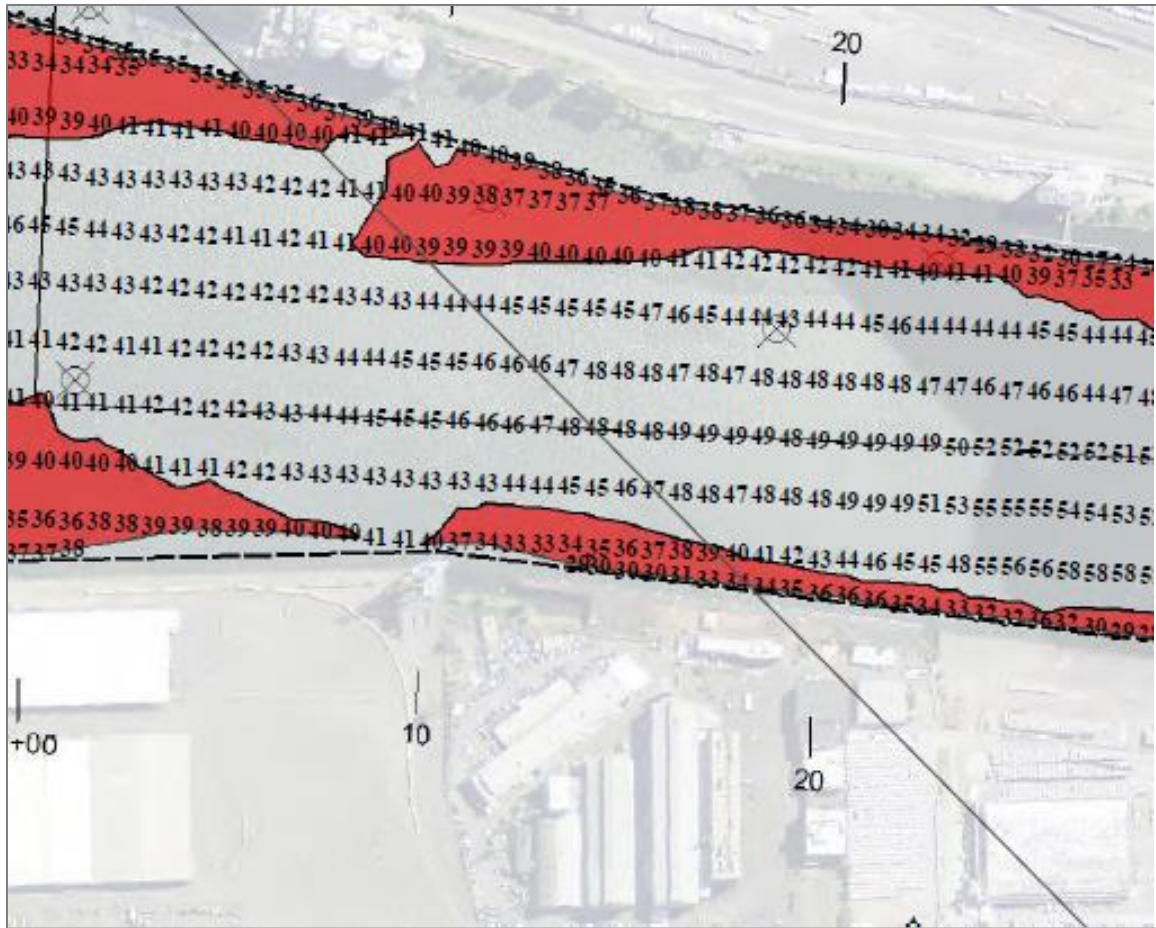
Figure 3. Bathymetry in the vicinity of Sulzer from 2014 USACE condition survey (USACE, 2014).

A third method (BANCS Method 5) evaluates the ratio of near-bank maximum depth to mean depth of the river cross-section at bankfull. Higher ratios are indicative of conditions where flow is concentrated near the bank, while lower ratios indicate flow is concentrated through the center channel. Figure 3 shows water depths in the vicinity of Sulzer. The decrease in water depth moving from the center channel to near the Sulzer bank is evident. With a near-bank to mean depth ratio less than 1, the Sulzer bank receives a VERY LOW NBS rating.

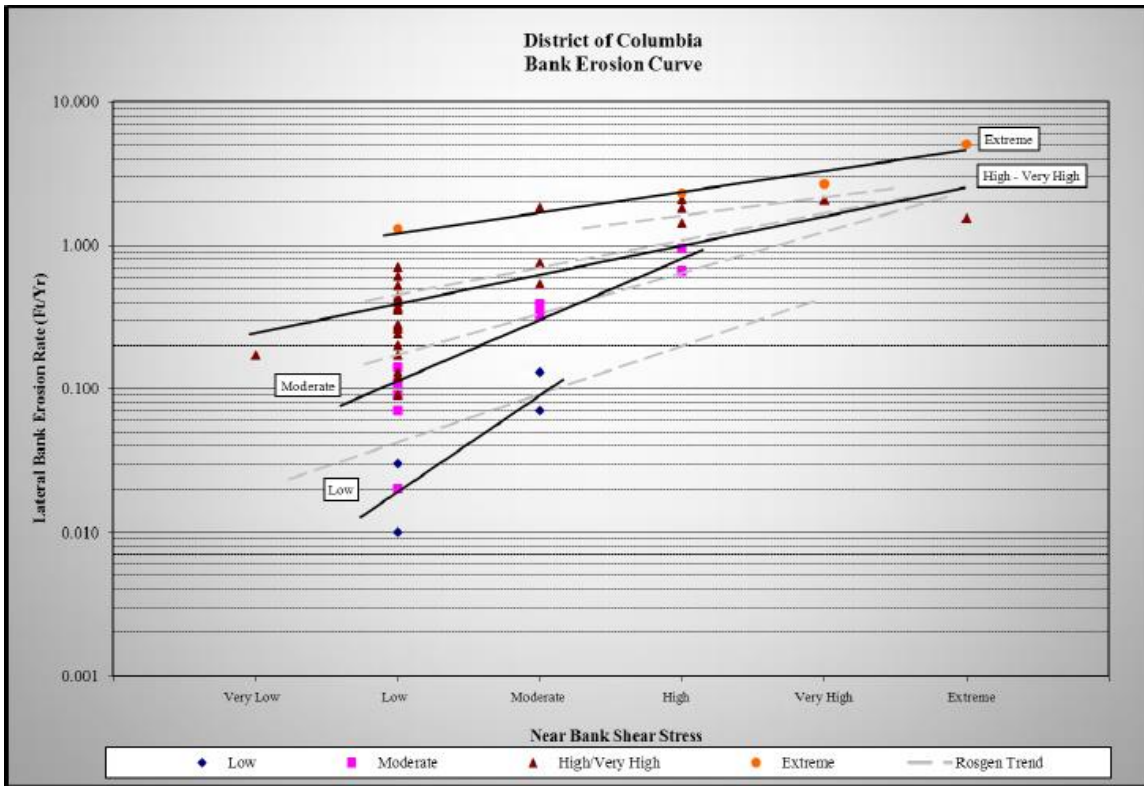
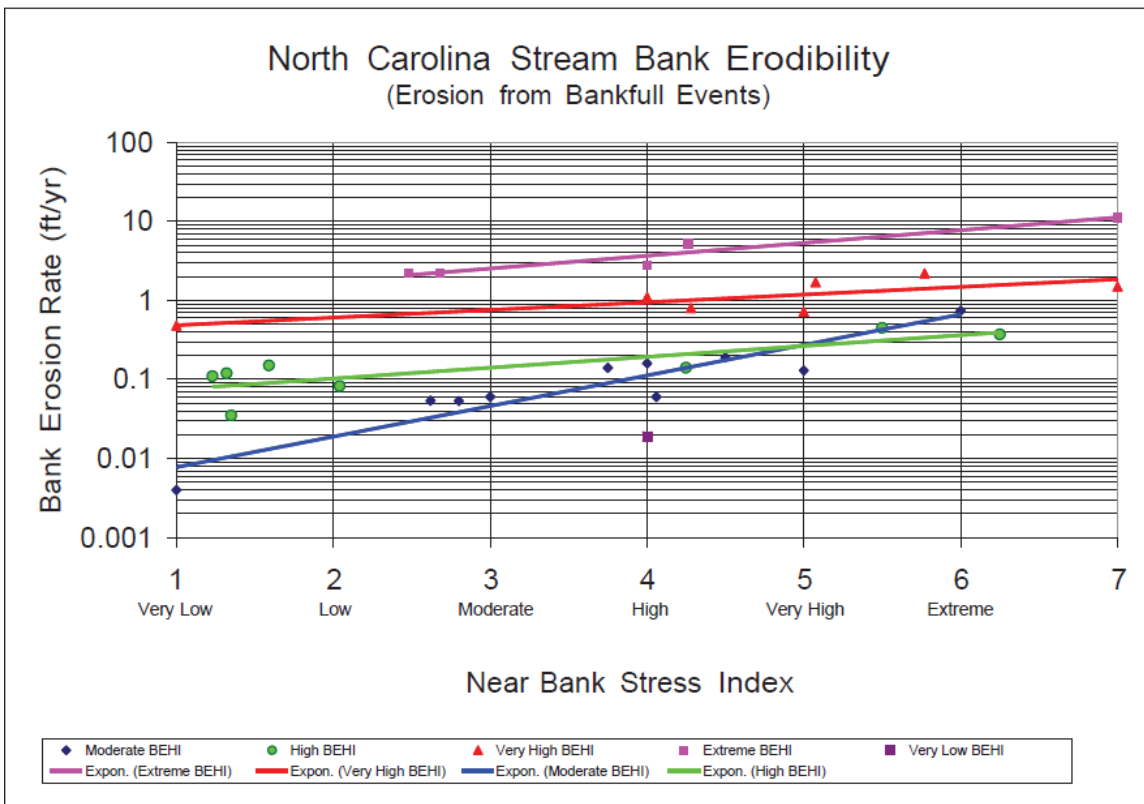
Figure 4. Streambank erodibility curves for the District of Columbia (Starr, 2013) and North Carolina (McQueen, 2011).

The BANCS model estimates a Bank Erosion Rate (BER) as a function of both the BEHI and the NBS assessments. Figure 4 shows BER curves developed for the District of Columbia and North Carolina. The bank in the vicinity of the Sulzer facility has a LOW BEHI and VERY LOW NBS. This combination indicates a lower erosion potential than the lowest values of either the District of Columbia or the North Carolina curves, suggesting an erosion rate less than 0.01 ft/year (0.3 cm/year). The LOW BEHI curve for the District of Columbia does not extend to the VERY LOW NBS value and North Carolina does not include a LOW BEHI curve. Because the combination of LOW BEHI and VERY LOW NBS is lower than the range of BER curves, zero erosion is the most likely scenario.

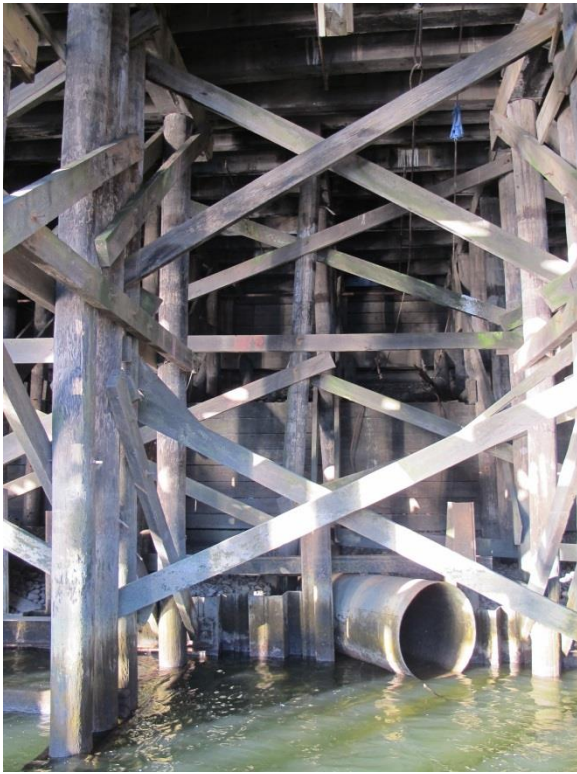
6. OF-E area

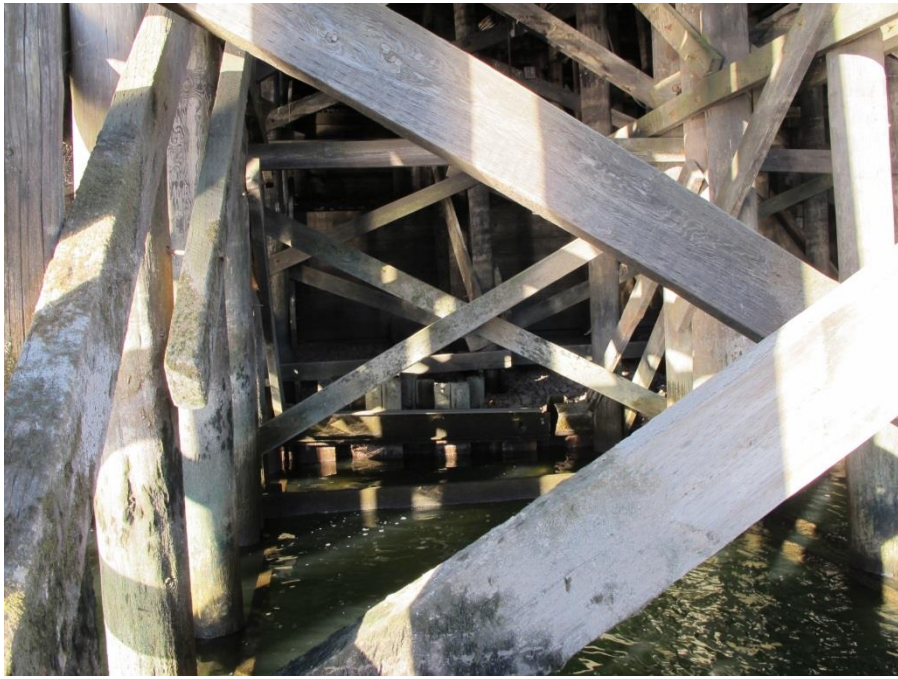
PIER 10

10. Gap in first wood wall back at piers 21-23

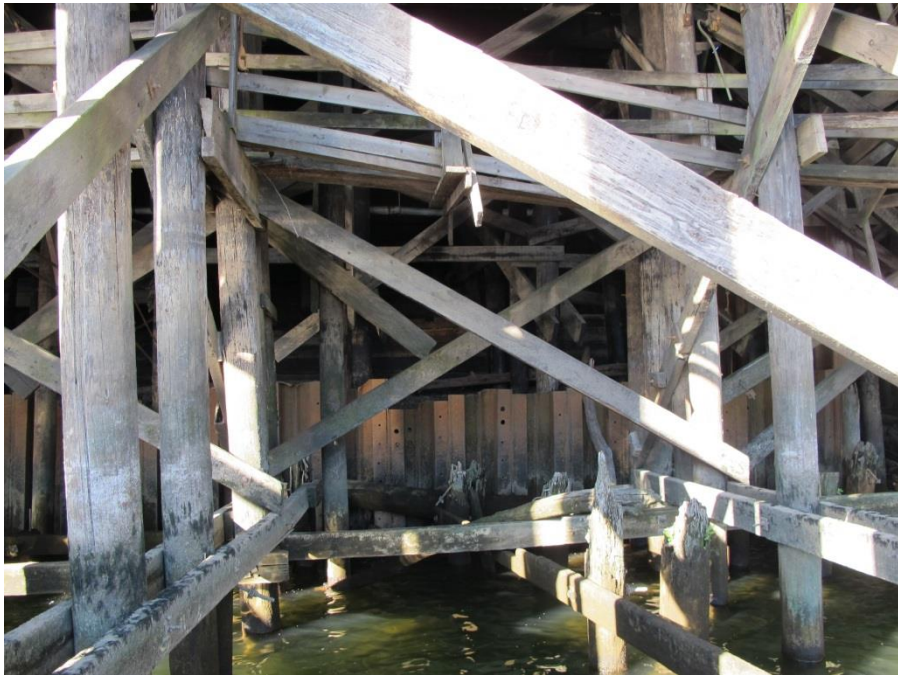
PIER 33

33. 13 feet from sheet pile to first wood wall at pier 33

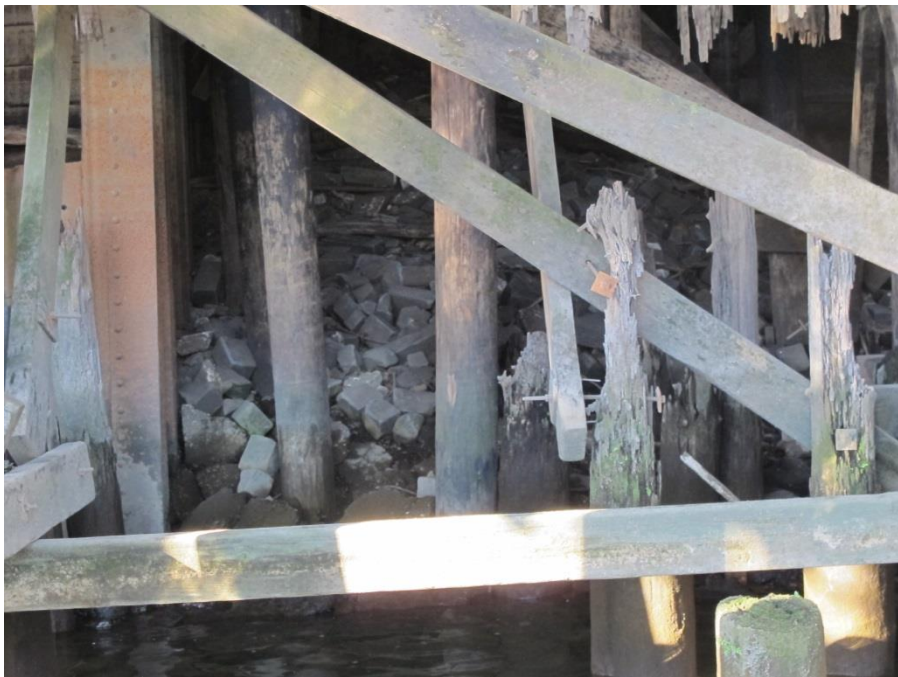
PIER 35

35. >1' concrete below water surface

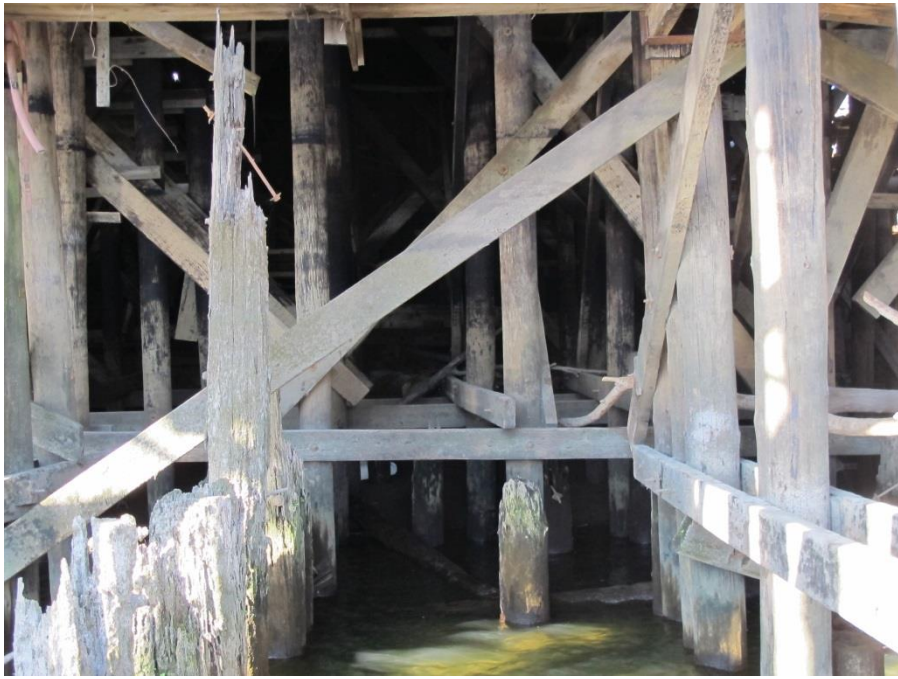
PIER 44

44. OF-C area, large rip rap and exposed bank, very large metal piles riverside

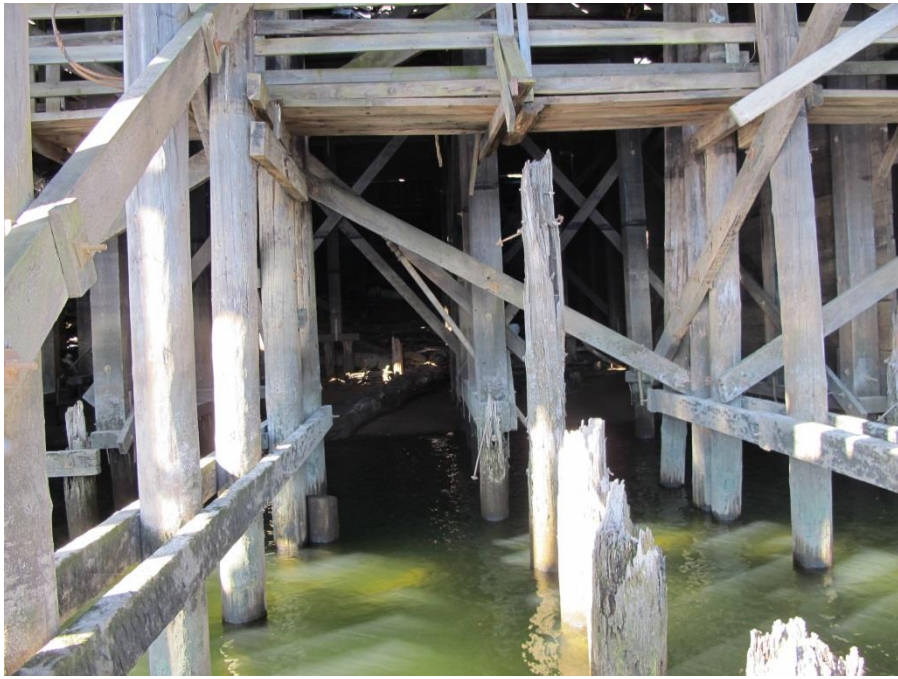
PIER 51

51. Wall behind concrete rip rap

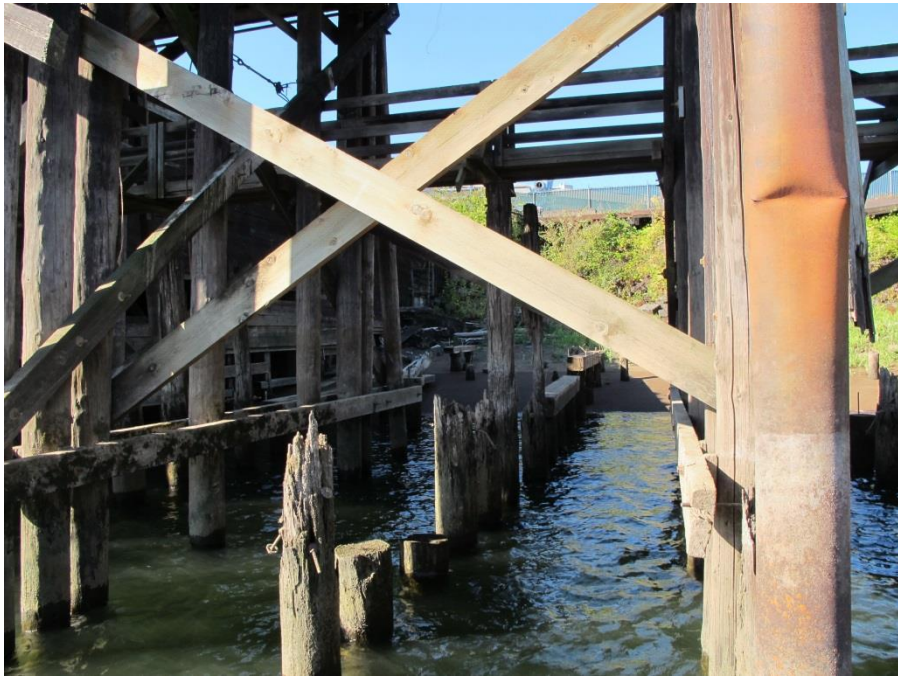
END OF DOCK

57. End of covered dock. Measurements applied to area downstream and right of pier 57 (not covered by dock)

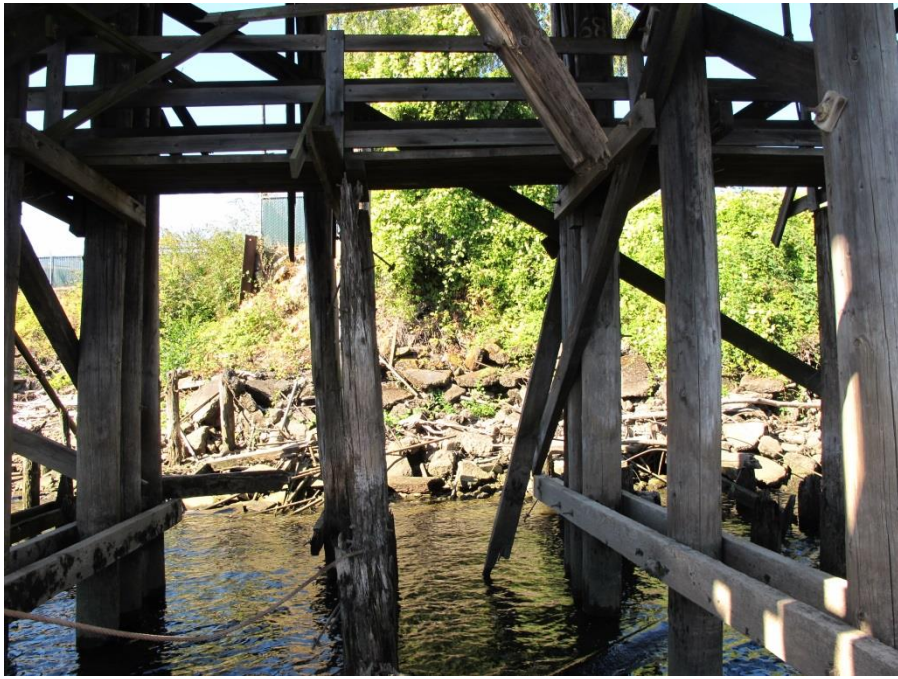
PIER 68 AREA

68. Rip rap from water line
