OPERATIONS AND MAINTENANCE REPORT  
JANUARY 2022 TO DECEMBER 2022  
MCCORMICK & BAXTER SUPERFUND SITE  
PORTLAND, OREGON

by  
Haley & Aldrich, Inc.  
Portland, Oregon

for  
Oregon Department of Environmental Quality  
Portland, Oregon

File No. 0202315-000  
August 2023

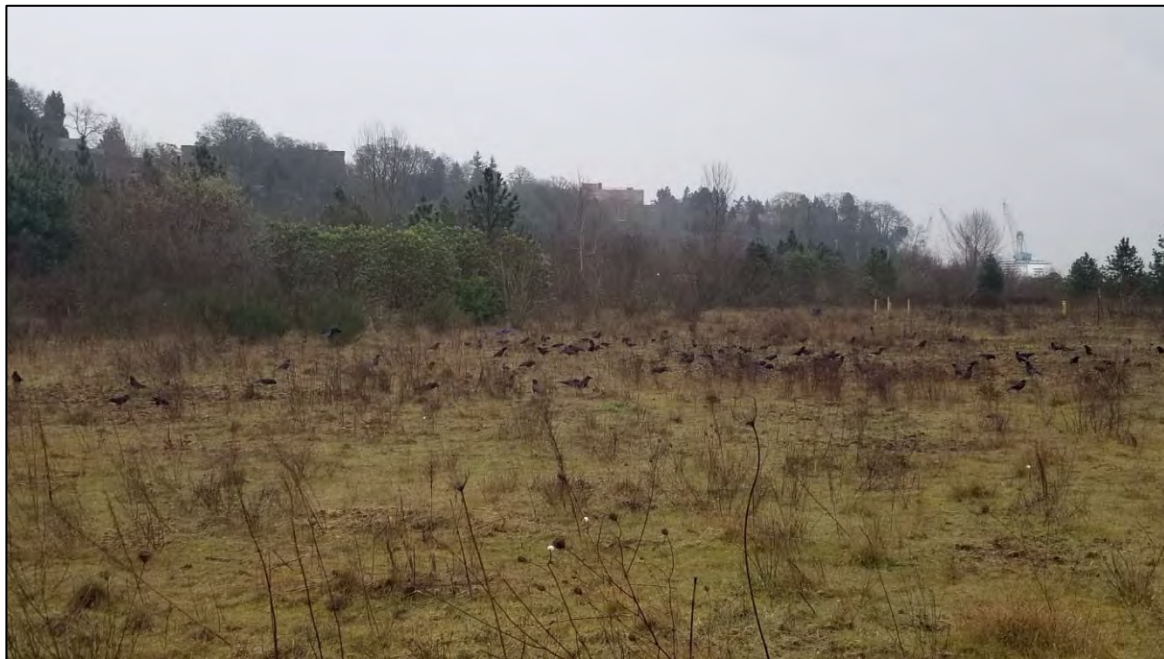
Avian wildlife was observed on the soil cap infrequently and mostly from a distance during site inspections in 2022, with the exception of a murder of crows that was observed during the March inspection (Appendix A, Photograph A1). Additionally, signs of bird foraging on the surface of the soil cap were observed in the spring and goose scat was observed throughout the soil cap over the course of the year indicating that substantial geese flocks periodically visit the Site. A coyote was observed along the eastern perimeter fence during the December inspection and immediately left the site as personnel were driving to the paved storage area. Coyote scat was also observed on the soil cap throughout the year, indicating frequent coyote visits.

**Photograph A1:** A murder of crows foraging on the soil cap. View from center of soil cap facing south. March 2022.

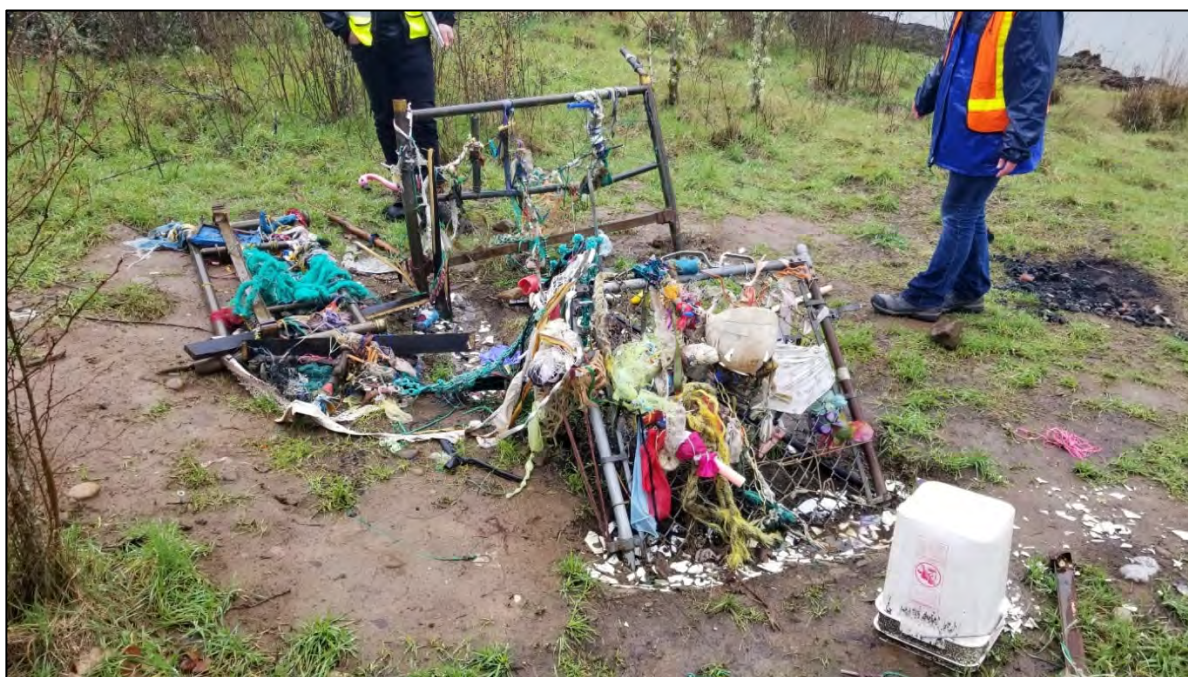
During the March 2022 inspection, field personnel observed what appeared to be a form of “art installation” by an unknown individual(s) in the riparian area of the soil cap (Appendix A, Photographs A2 and A3). The installation consisted of a fence gate cemented into the ground and covered with various bits of fabric and assorted decorations. The installation was removed during a subsequent O&M visit and is discussed in further detail in Section 2.3. The stormwater conveyance lines were functioning during the inspection and flow through the outfall occurred at an estimated 45 gallons per minute (gpm).

**Photograph A2:** An apparent “art installation” installed in the riparian zone. March 2022.

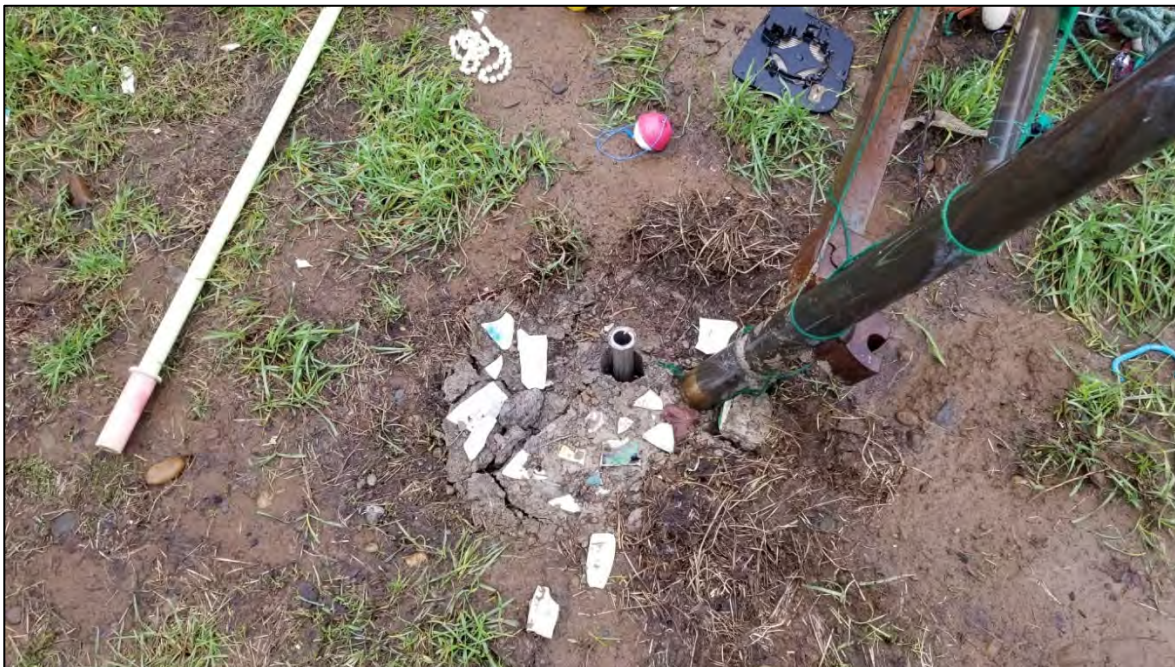
**Photograph A3:** A portion of the “art installation” that was cemented into the soil cap. March 2022.

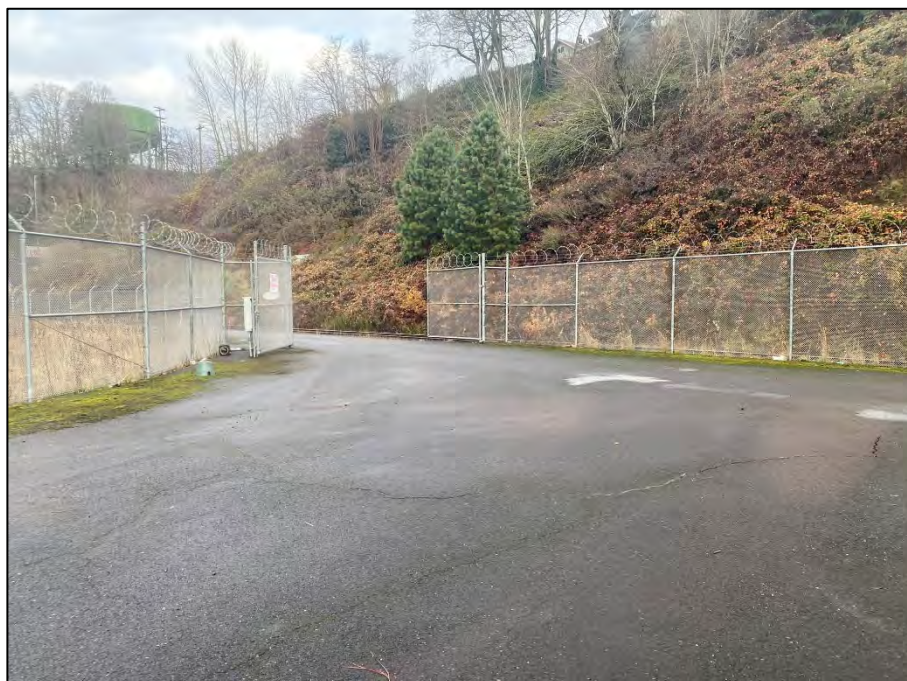
On December 12, 2022, Haley & Aldrich had Waste Management empty the trash dumpster in the storage area. Upon arrival at the site, Haley & Aldrich found the main entrance gate to North Edgewater Street, a gate from the paved storage area to the soil cap, and the secondary entrance gate to North Van Houten Place to be open with cut locks (Appendix A, Photograph 4). It appeared as if locks were cut to traverse the site, possibly due to train stoppages that occasionally occur at the railroad tracks crossing N. Van Houten Road or N. Edgewater Road. The locks and chains were replaced prior to departure.

**Photograph A4:** Main entrance gate found unlocked and open upon arrival to the site for trash dumpster emptying. December 2022.

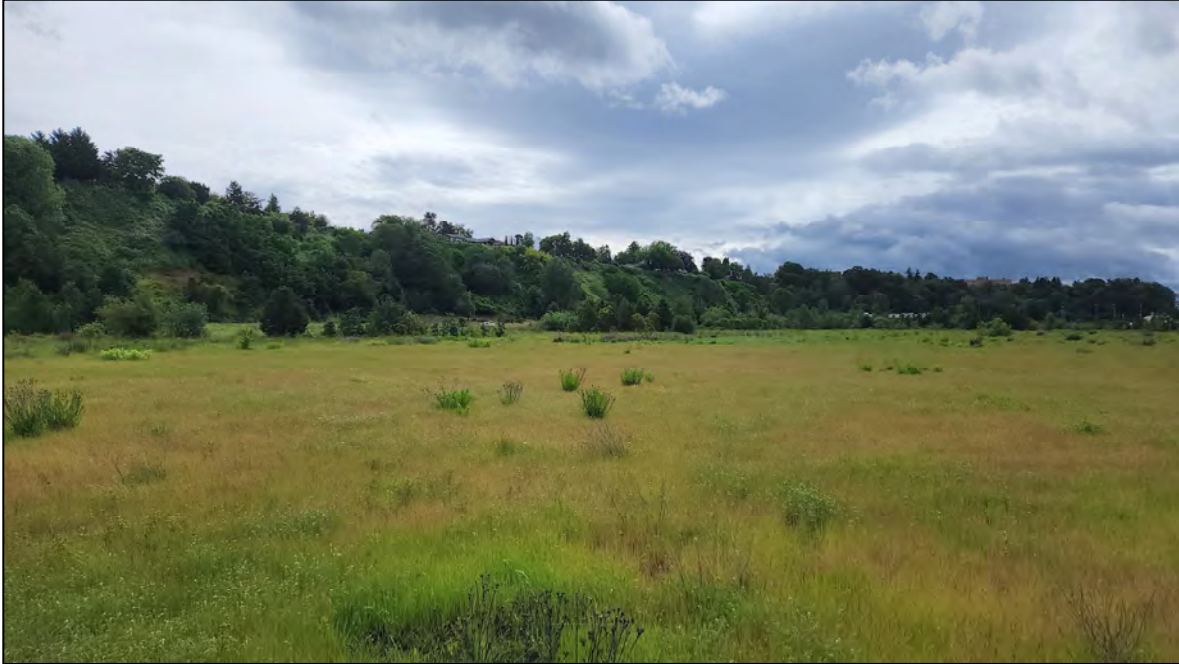
Overall, upland soil cap observations and inspections revealed no significant change in remedy performance or areas of concern. The soil cap continues to have a consistent layer of vegetative cover across the Site (Appendix A, Photograph A5). Future O&M activities will consist primarily of quarterly inspections and routine maintenance. Although gate locks are periodically cut and require replacement, there is no evidence that trespassers damage the integrity of the soil cap.

**Photograph A5:** Vegetative cover across the upland cap area. June 2022.

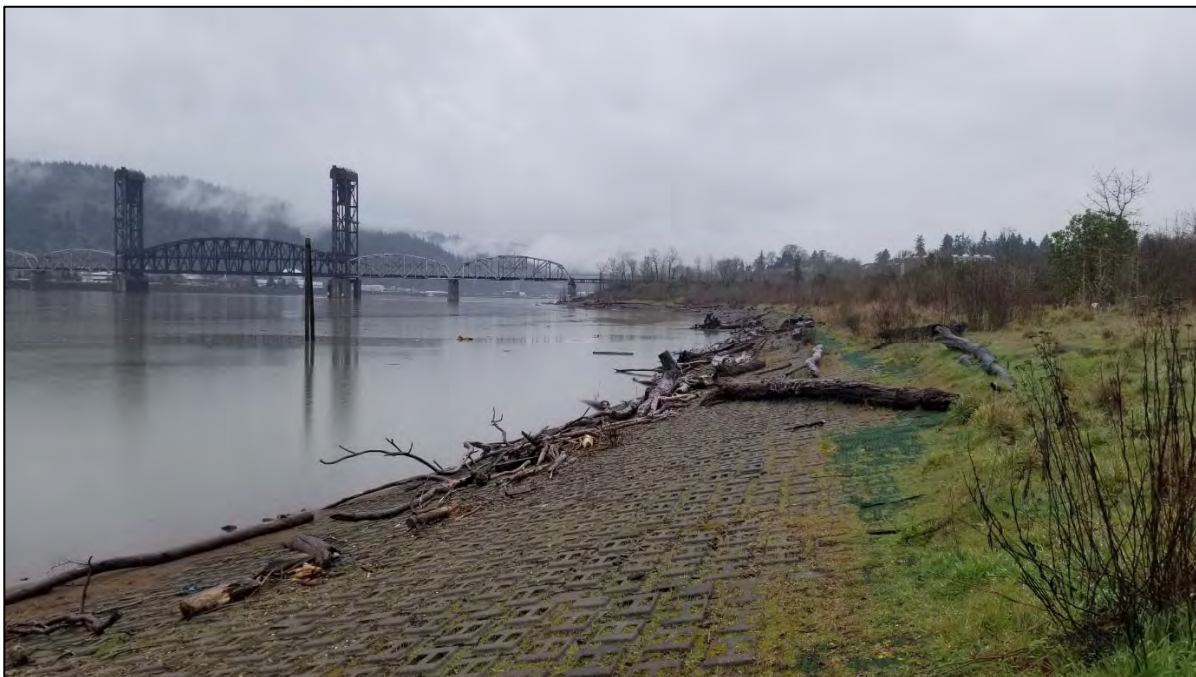
During the March 2022 inspection, large amounts of woody debris ranging from small branches to large tree trunks were observed along the Willamette River shoreline due to the high river stage (Appendix A, Photograph A6). The woody debris exacerbated existing tears in the turf reinforcement matting (TRM) planned for repairs in summer 2022. Buoys 1, 3, and 5 were first observed missing in 2021. Replacement of the buoys was initiated in 2021 however, the buoy replacement was not performed until May 2022.

**Photograph A6:** Woody debris along Willamette River shoreline. March 2022.

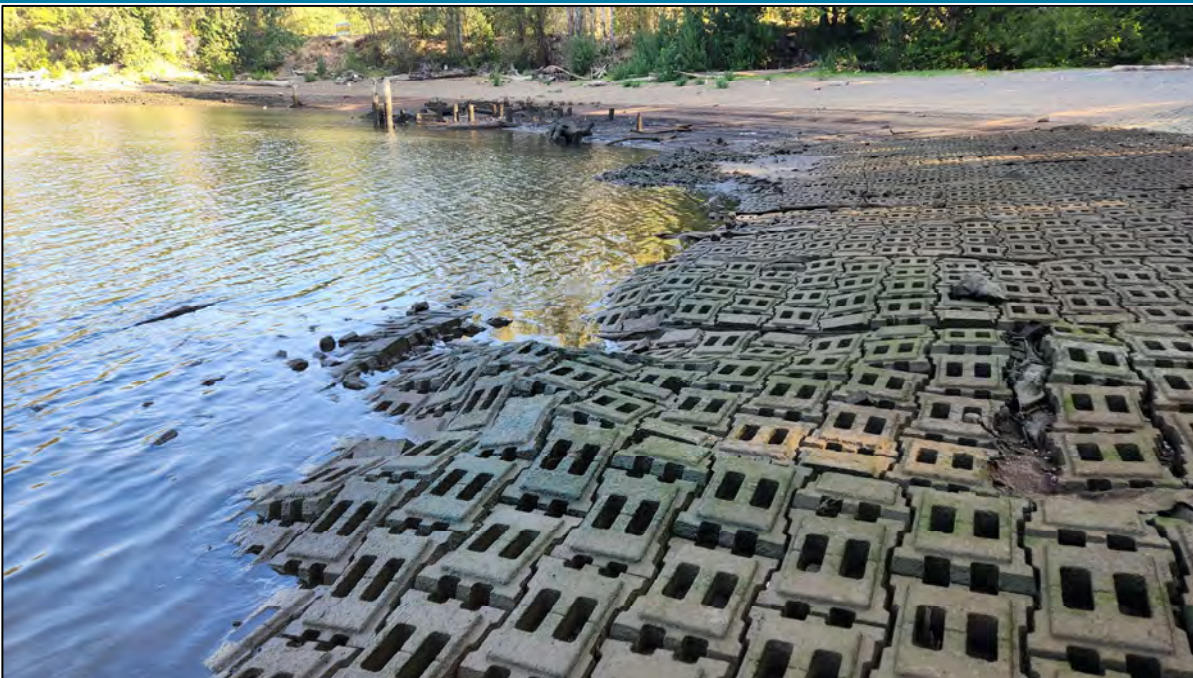
During the October 2018 site inspection, multiple 2- to 6-inch-wide voids and unconformities were observed in the ACB along the shoreline in the Willamette Cove during seasonal and tidal low water levels. The gaps were visible during the September 2021 and September 2022 inspections during low tide periods. In September 2022, minor undulations and unconformities were observed with gaps of approximately 6 inches between ACB mat sections present (Appendix A, Photograph A7). The source of the undulations and unconformities is unknown. As only qualitative observations have been made during the 2018, 2021, and 2022 inspections regarding displacement, height and spacing of undulations, etc., no determination regarding the rate of separation or displacement occurring could be made and will be evaluated using a more rigorous and quantitative approach.

**Photograph A7:** Undulations and unconformities in ACB in Willamette Cove. September 2022

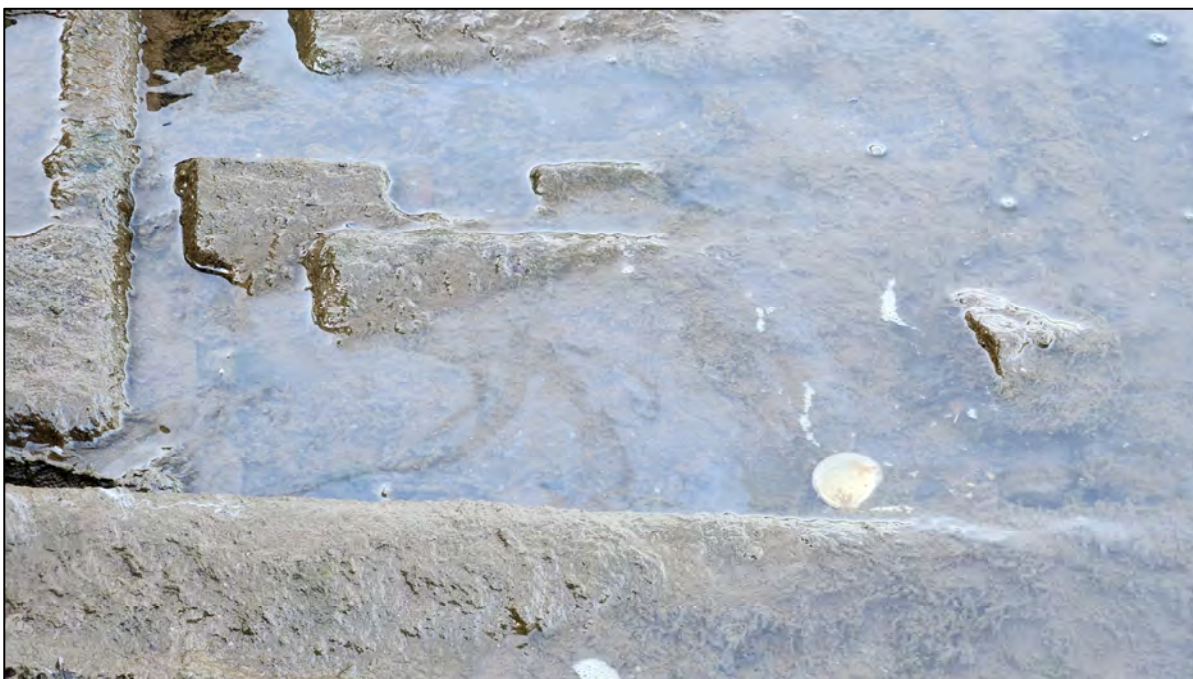
Shoreline sheen and ebullition are monitored to determine if the sediment cap is performing as intended and if NAPL from creosote seeps is reaching the Willamette River. NAPL sheen was not observed during any site inspection in 2022. Ebullition was observed from the Willamette Cove and Willamette River shorelines during the September 2022 inspection and consisted of a single bubble approximately once every 10 to 20 seconds. Organic sheen was also observed in ACB depressions in Willamette Cove during the September 2022 inspection (Appendix A, Photograph A8). Ebullition is also monitored as a measure of granular organophilic clay integrity. Sediment cap evaluations performed 2008 through 2010 determined that total organic carbon decay resulted in methane gas production and ebullition in those areas. Ebullition observed in 2022 did not contain petroleum sheen.

**Photograph A8:** Organic sheen observed in ACB depressions along Willamette Cove shoreline. September 2022.

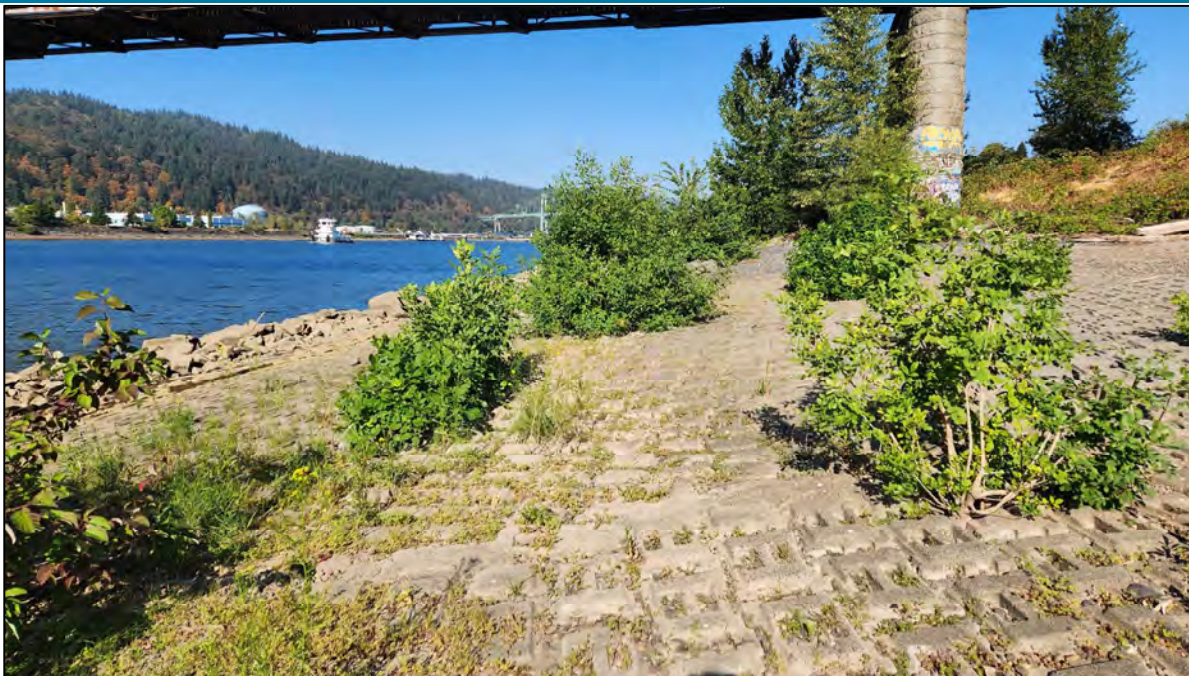
During the September 2022 inspection, several small trees were observed growing in the ACB on the north end of the Willamette River shoreline next to the railroad bridge (Appendix A, Photograph A9). Roots and trunks can grow over time and removal of the tree saplings was warranted to prevent future damage to the ACB. The trees were removed in September during the next O&M visit and is discussed in further detail in Section 3.3.

**Photograph A9:** Trees growing in the ACB on the northern end of the Willamette River Shoreline. September 2022.

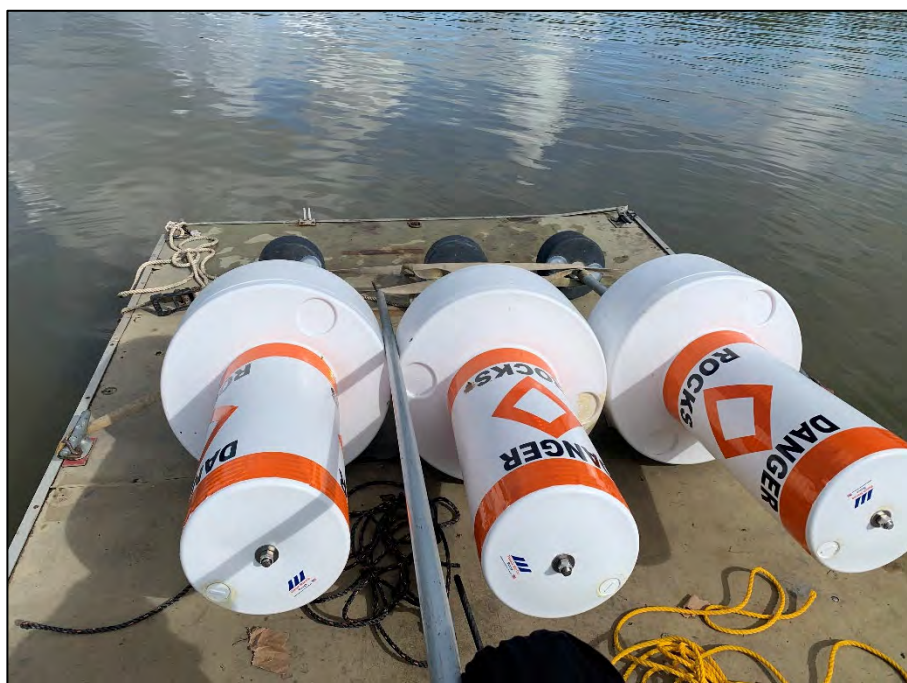
**Photograph A10:** Replacement buoys on the work barge. May 2022.

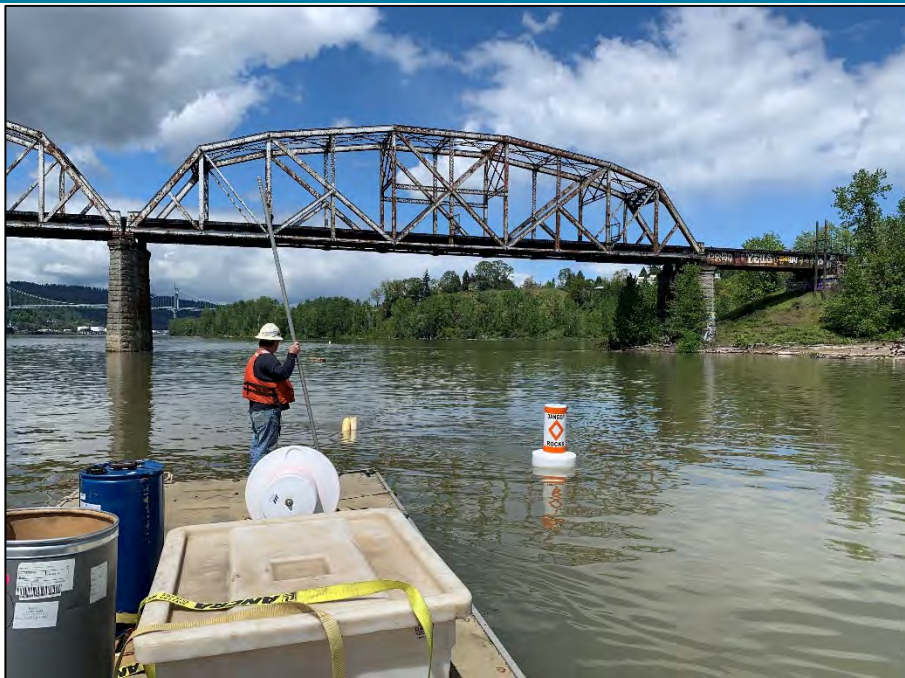
**Photograph A11:** Replacement buoy for station 3. May 2022.

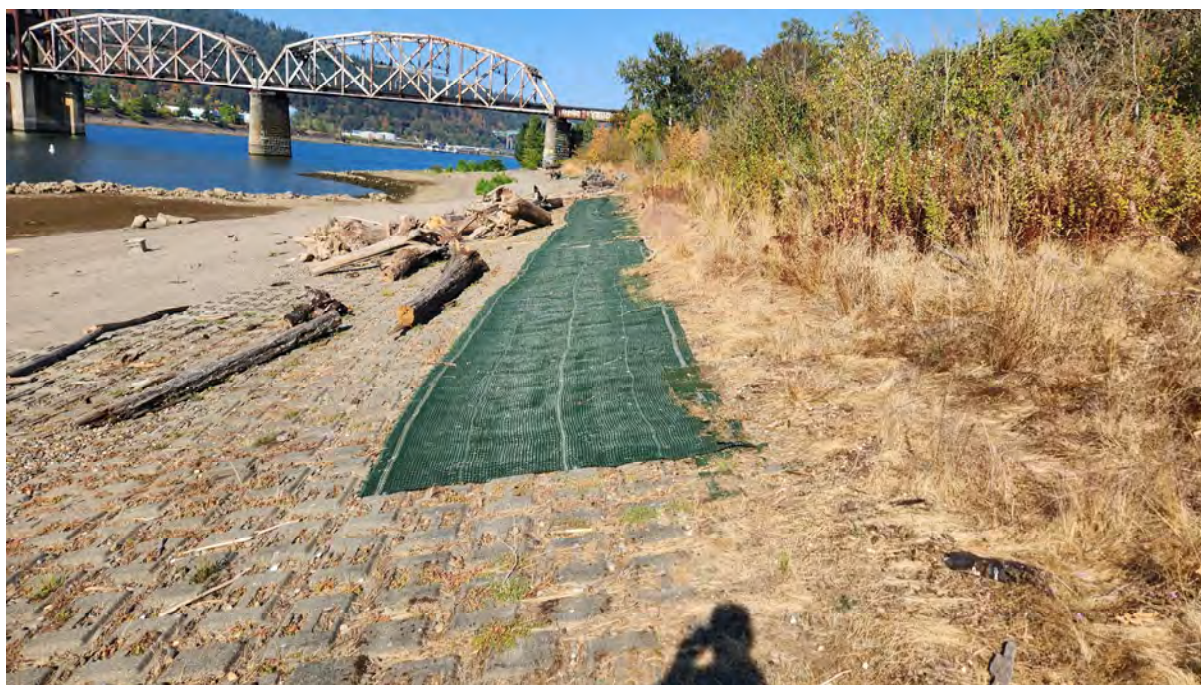
**Photograph A12:** TRM replacement repair area along Willamette River Shoreline. September 2022.

due to delays in equipment delivery. TRM repairs were performed in June 2022. Both activities are discussed in further detail in Section 3.3.

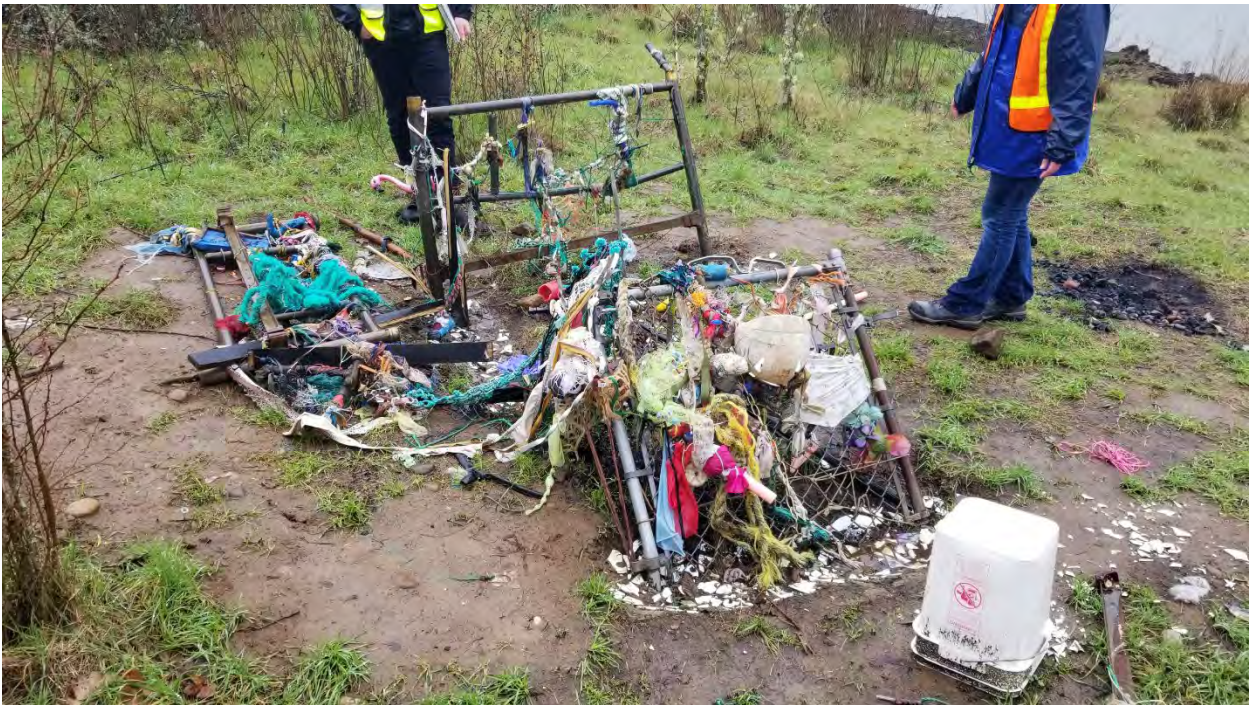
Photograph 4: A presumed art installation piece installed at the southern end of the shoreline in the riparian zone.

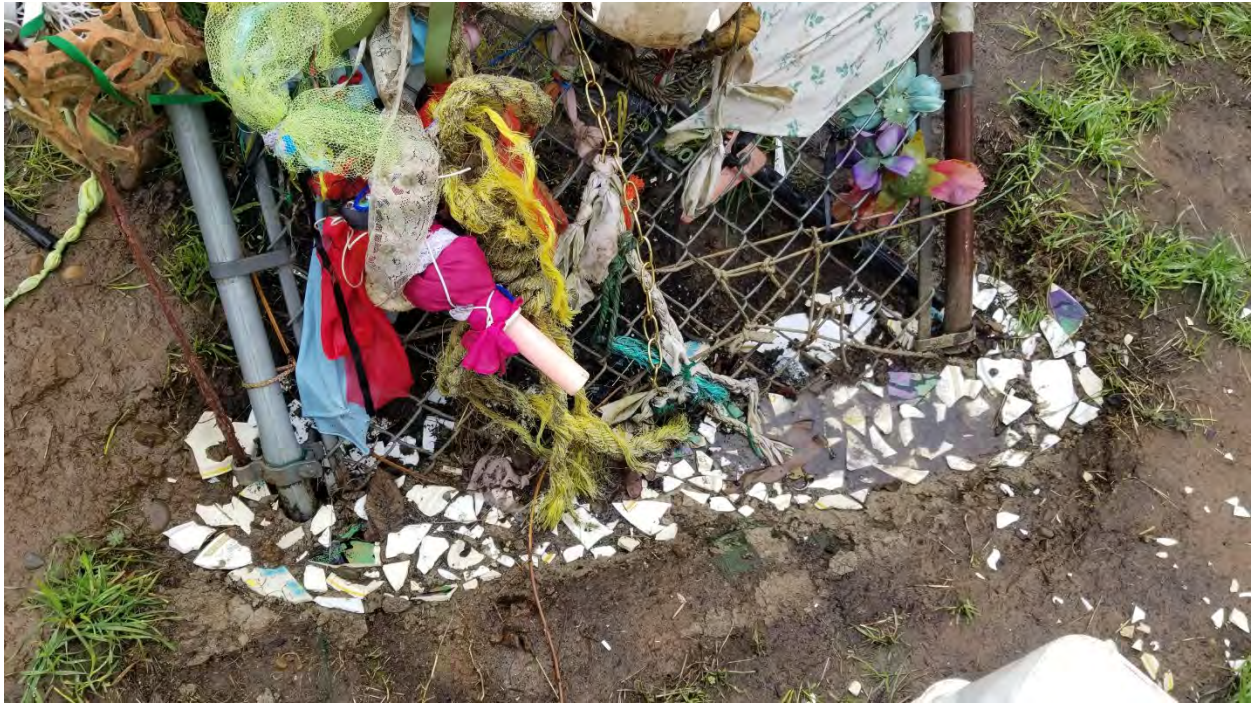
Photograph 5: The presumed art installation base with poles concreted into the soil cap.

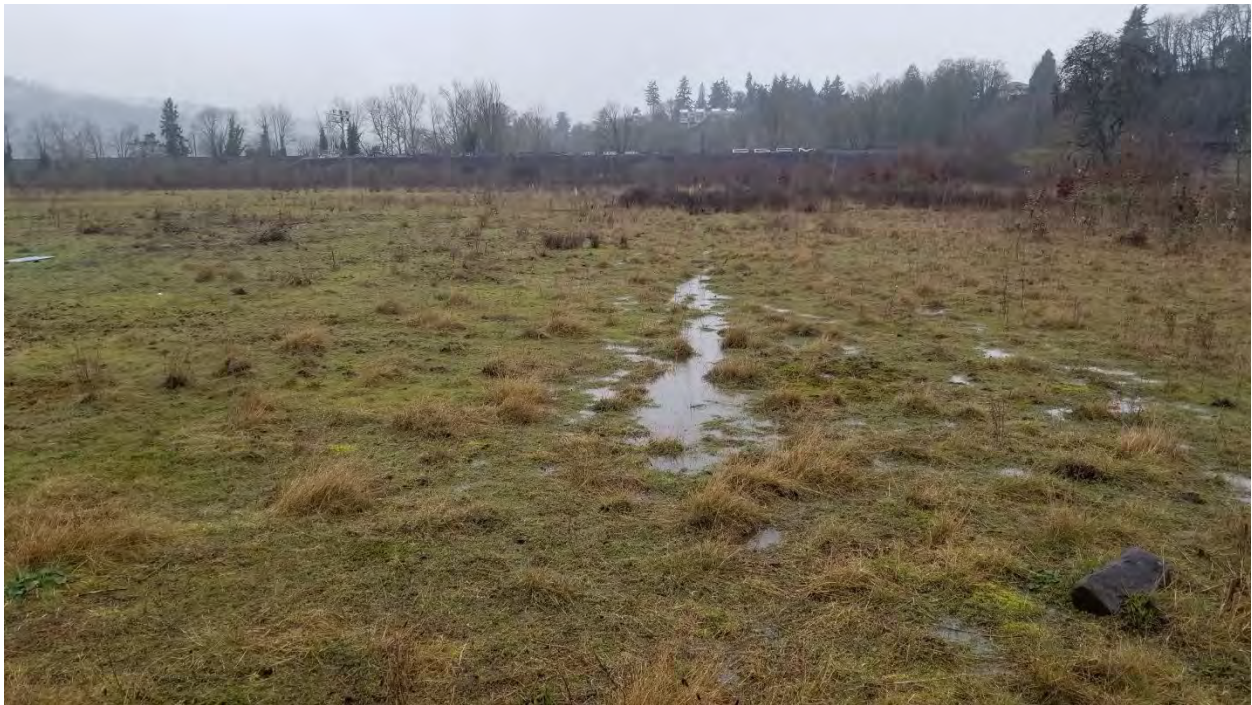
Photograph 8: Standing water on the soil cap just to the east of the surface trace of the barrier wall between MW-51s and MW-53s.

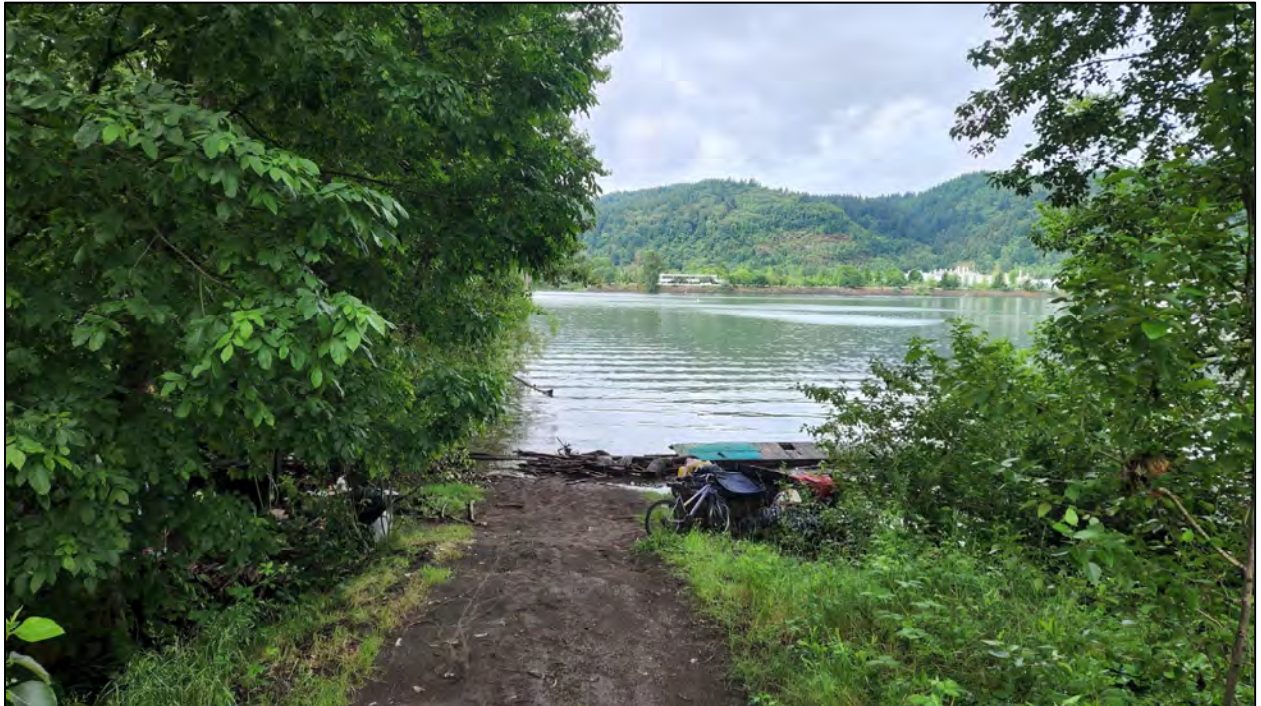
Photograph 1: High-river level conditions along Willamette Cove shoreline. Homeless encampment present along shoreline. View facing southwest.

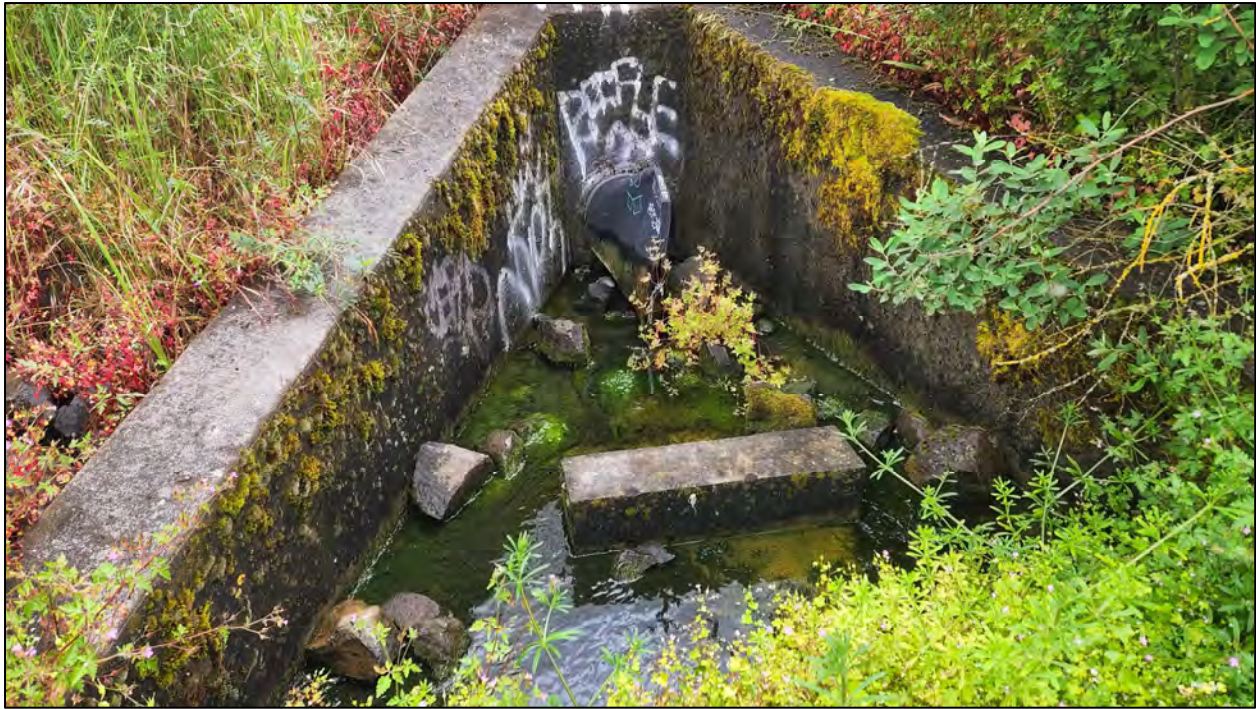
Photograph 3: Stormwater outfall flow at approximately 6 to 9 gallons per minute. View facing northeast.

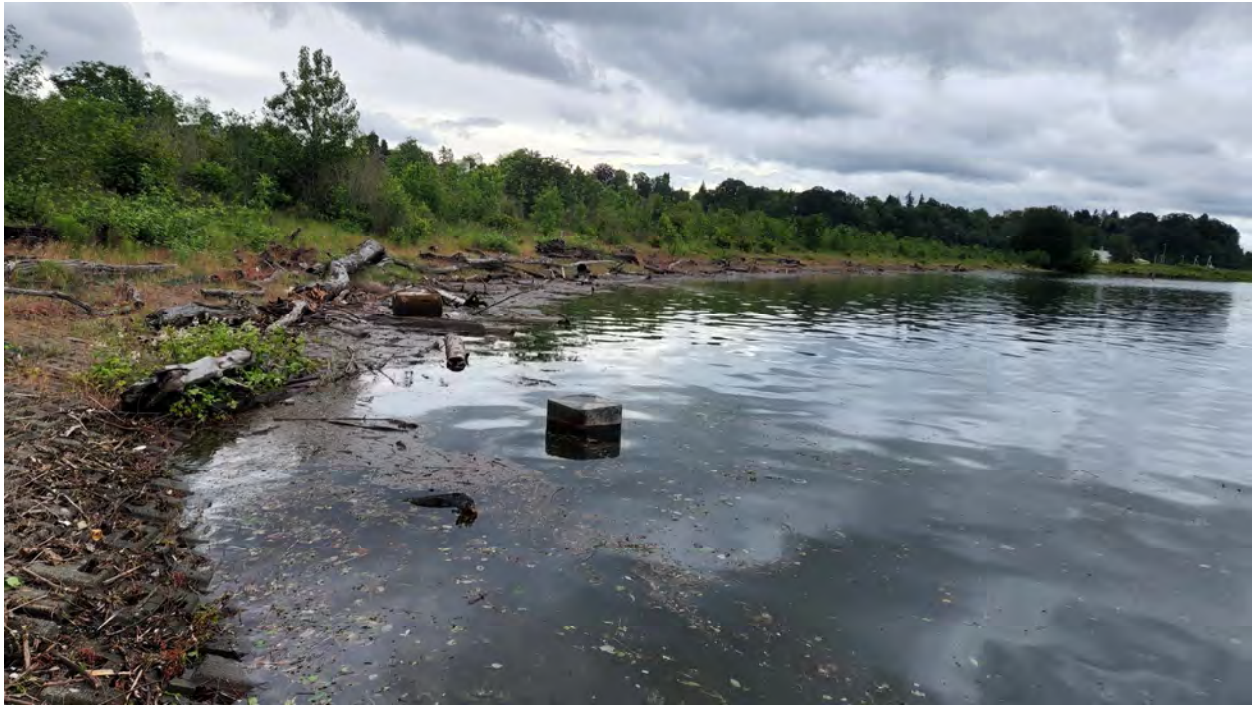
Photograph 5: Trash washed up on Willamette River shoreline. View facing southeast.

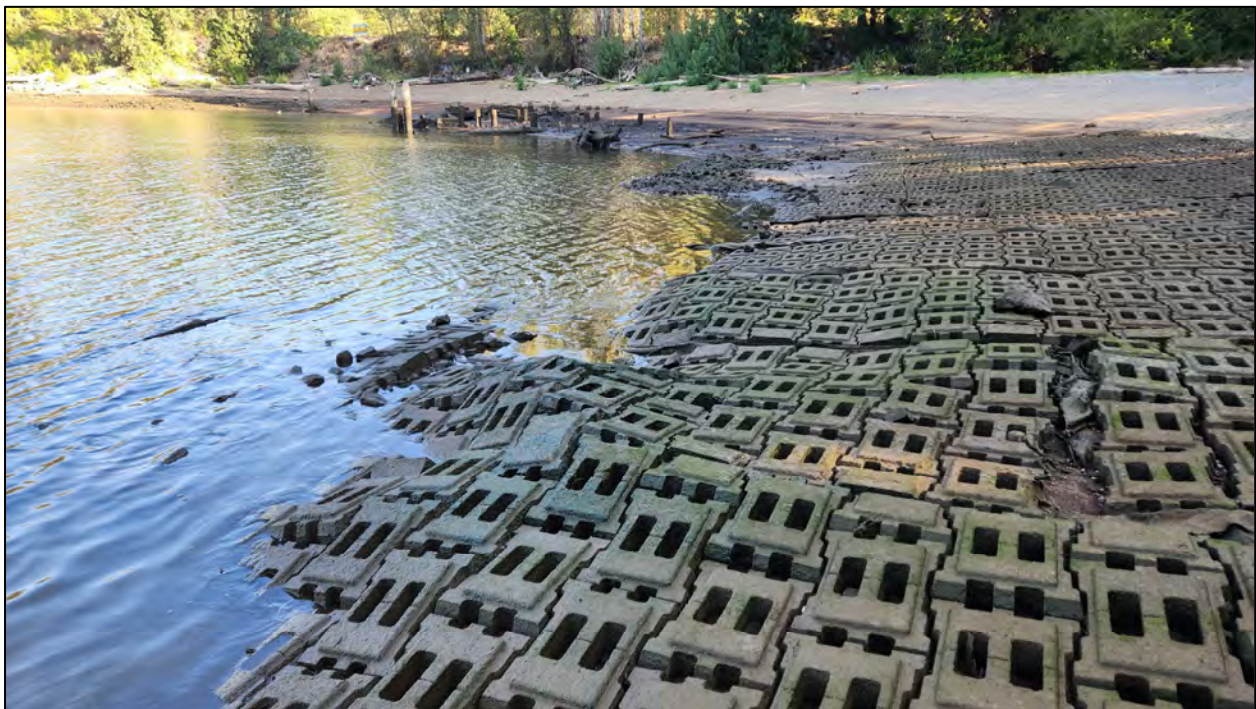
Photograph 2: ACB unconformity with largest amount of observed deflection on eastern end of ACB in Willamette Cove. View facing northeast.

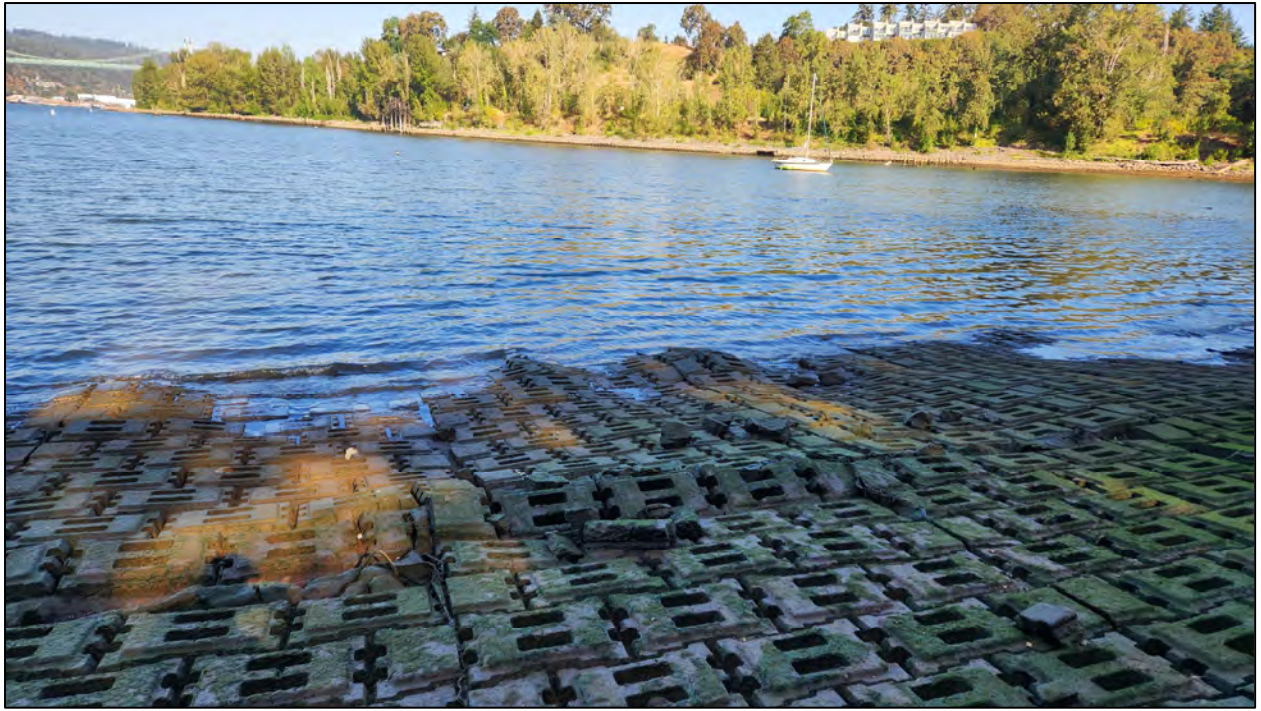
Photograph 3: ACB armoring with unconformities shown along Willamette Cover Shoreline. View facing north.

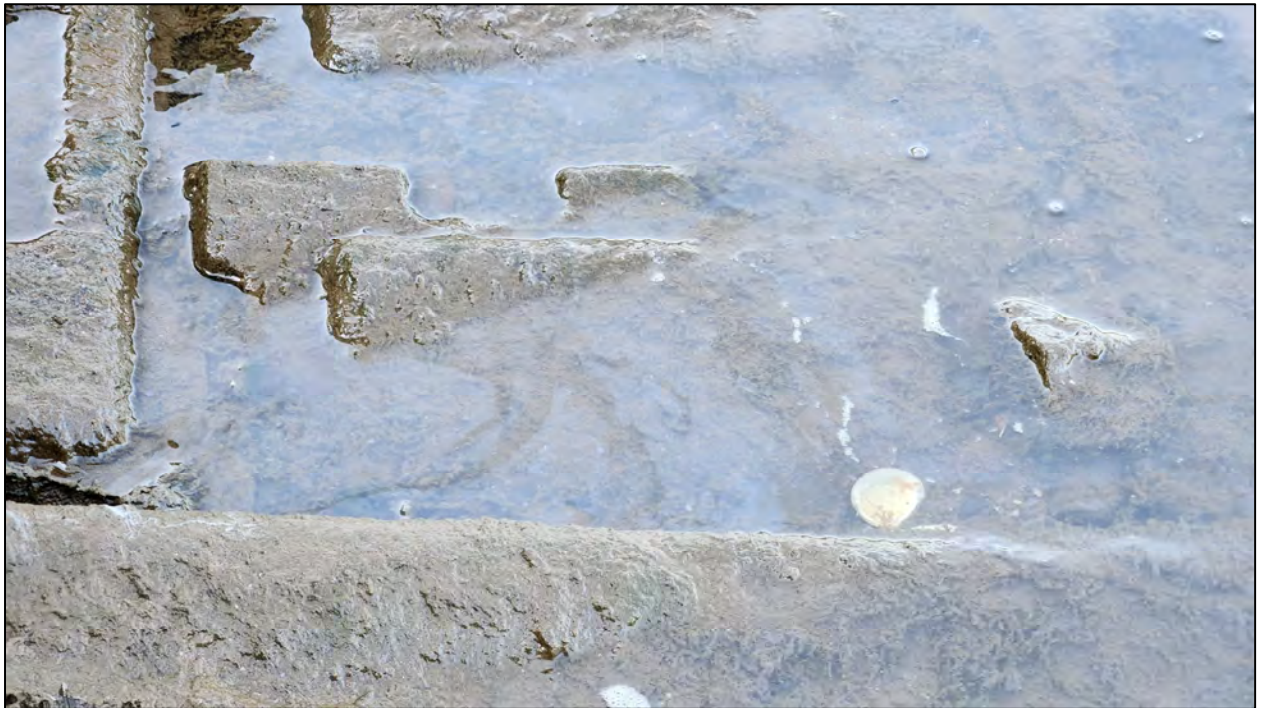
Photograph 4: Organic sheen observed in small depressions of the ACB in Willamette Cove.

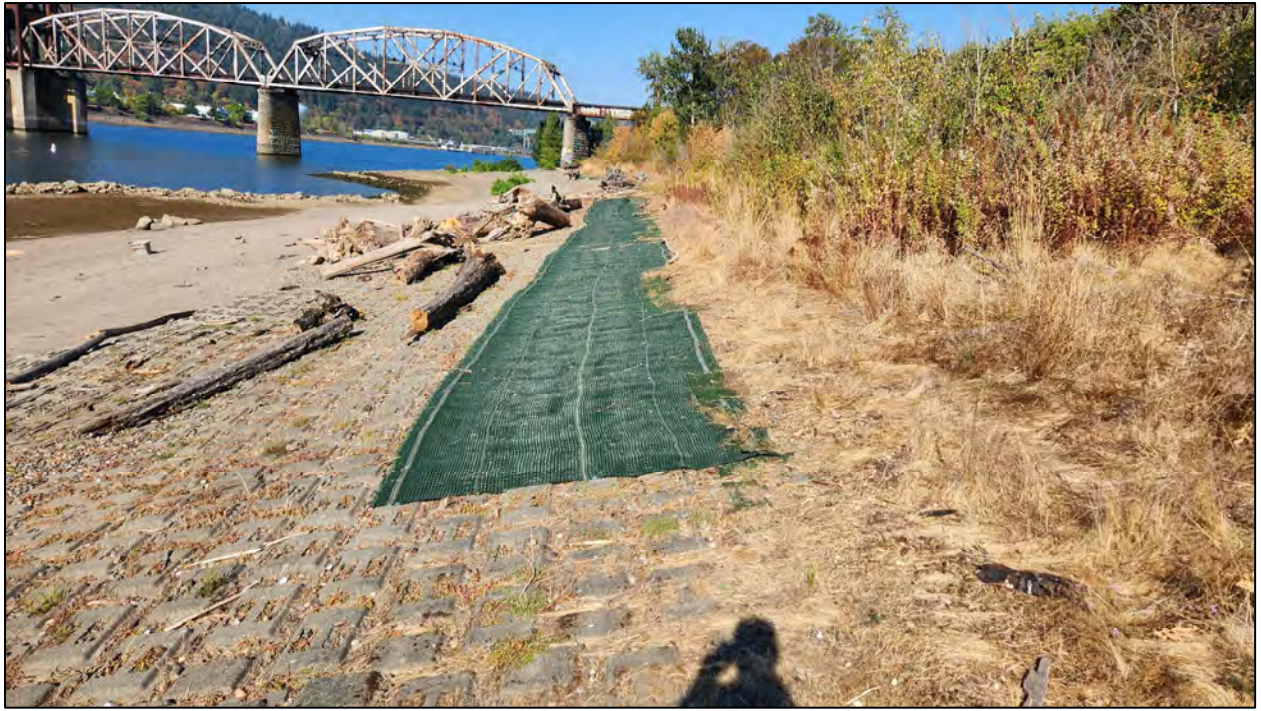
Photograph 5: TRM repair area in on northern end of Willamette River shoreline at the site. View facing north.

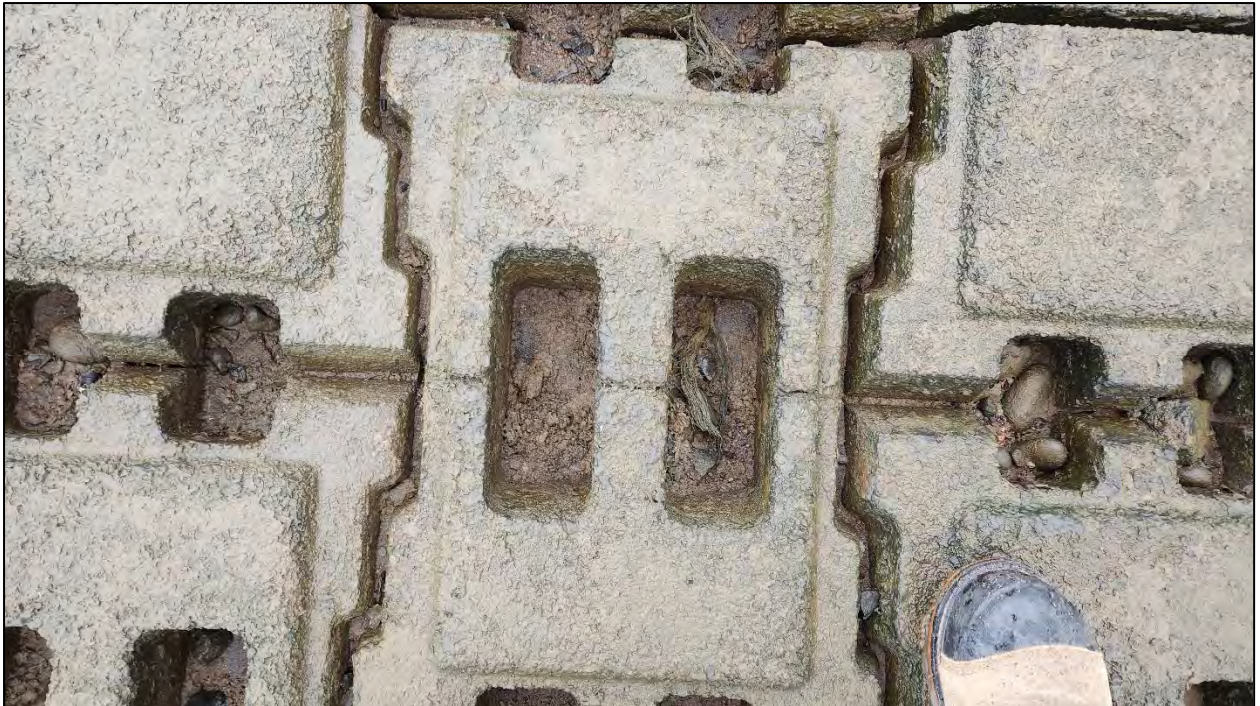
Photograph 2: ACB in Willamette Cove with no sand or river rock occupying the void space.

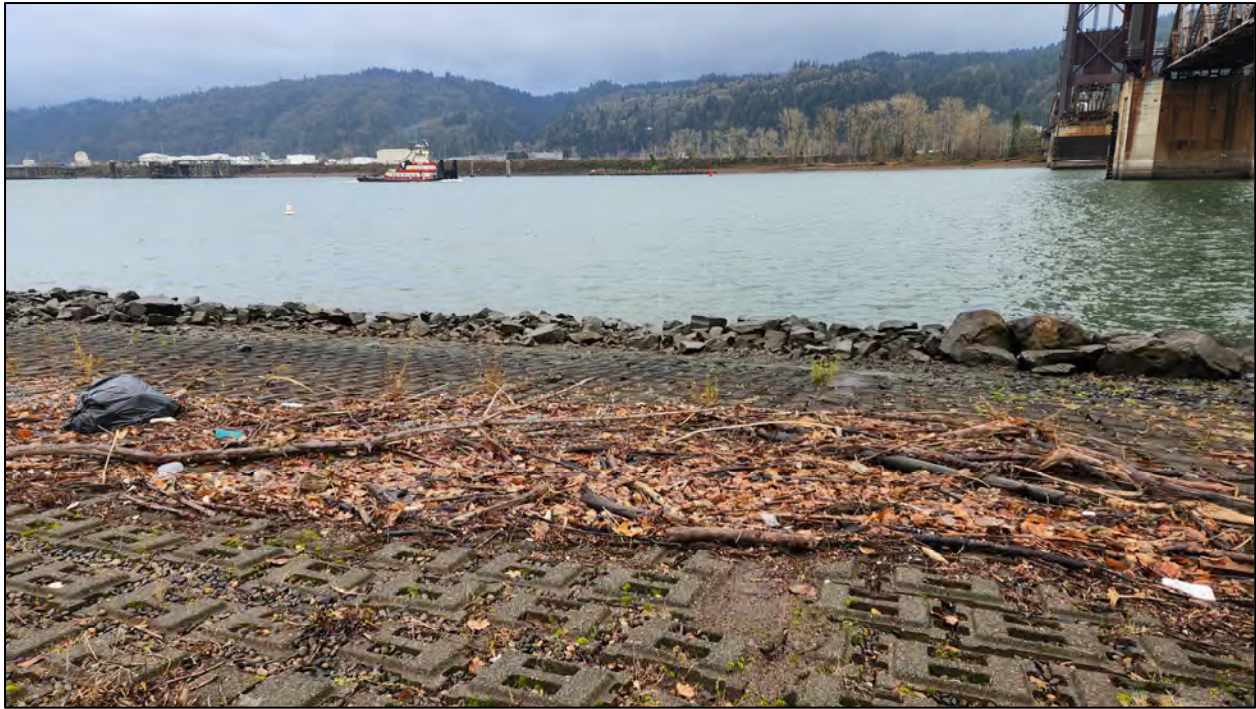
Photograph 3: ACB matting where shrub trees were removed during O&M visit. View facing west southwest.

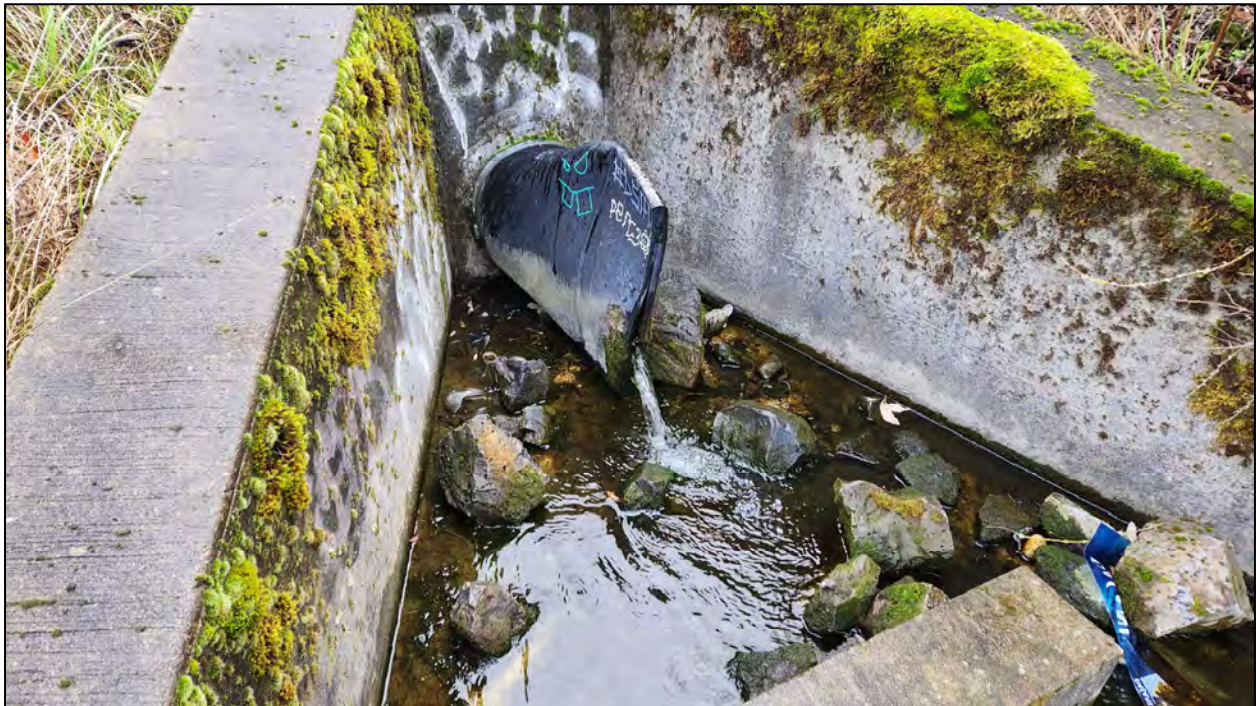
Photograph 4: Water flow (estimated at 20-30 gpm) from the stormwater outfall.
