**To: NWR Files.**

**Subject: Molalla field inspection report.**

State of Oregon  
Department of  
Environmental  
Quality

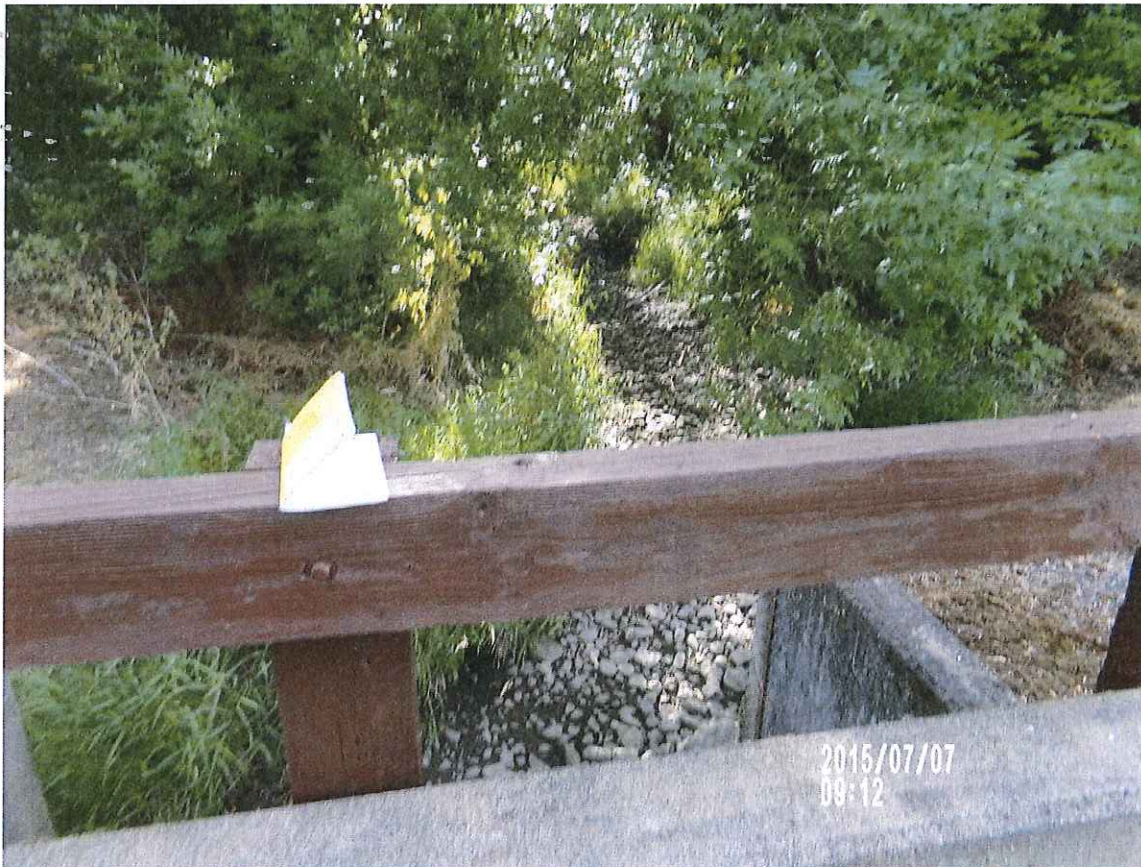
Our first stop was the bridge over Bear Creek at the facility entrance. Upstream from the bridge, no water was flowing in Bear Creek (see photo 1). Downstream of the bridge was a pool of water, with no apparent flow (see photo 2). While we were observing the condition of Bear Creek at this location, the plant operator, Jason Clifford, came out to talk with us. We explained we were out to observe the recycled water land application activities. He told us that some city personnel were out tending to the lines, and that we were likely to encounter them. He said for us to feel free and ask him any questions we might have, at any time. We thanked him and proceeded to the Coleman Ranch North property for more observations.

Photo 1. Bear Creek, upstream of the bridge at the facility entrance.

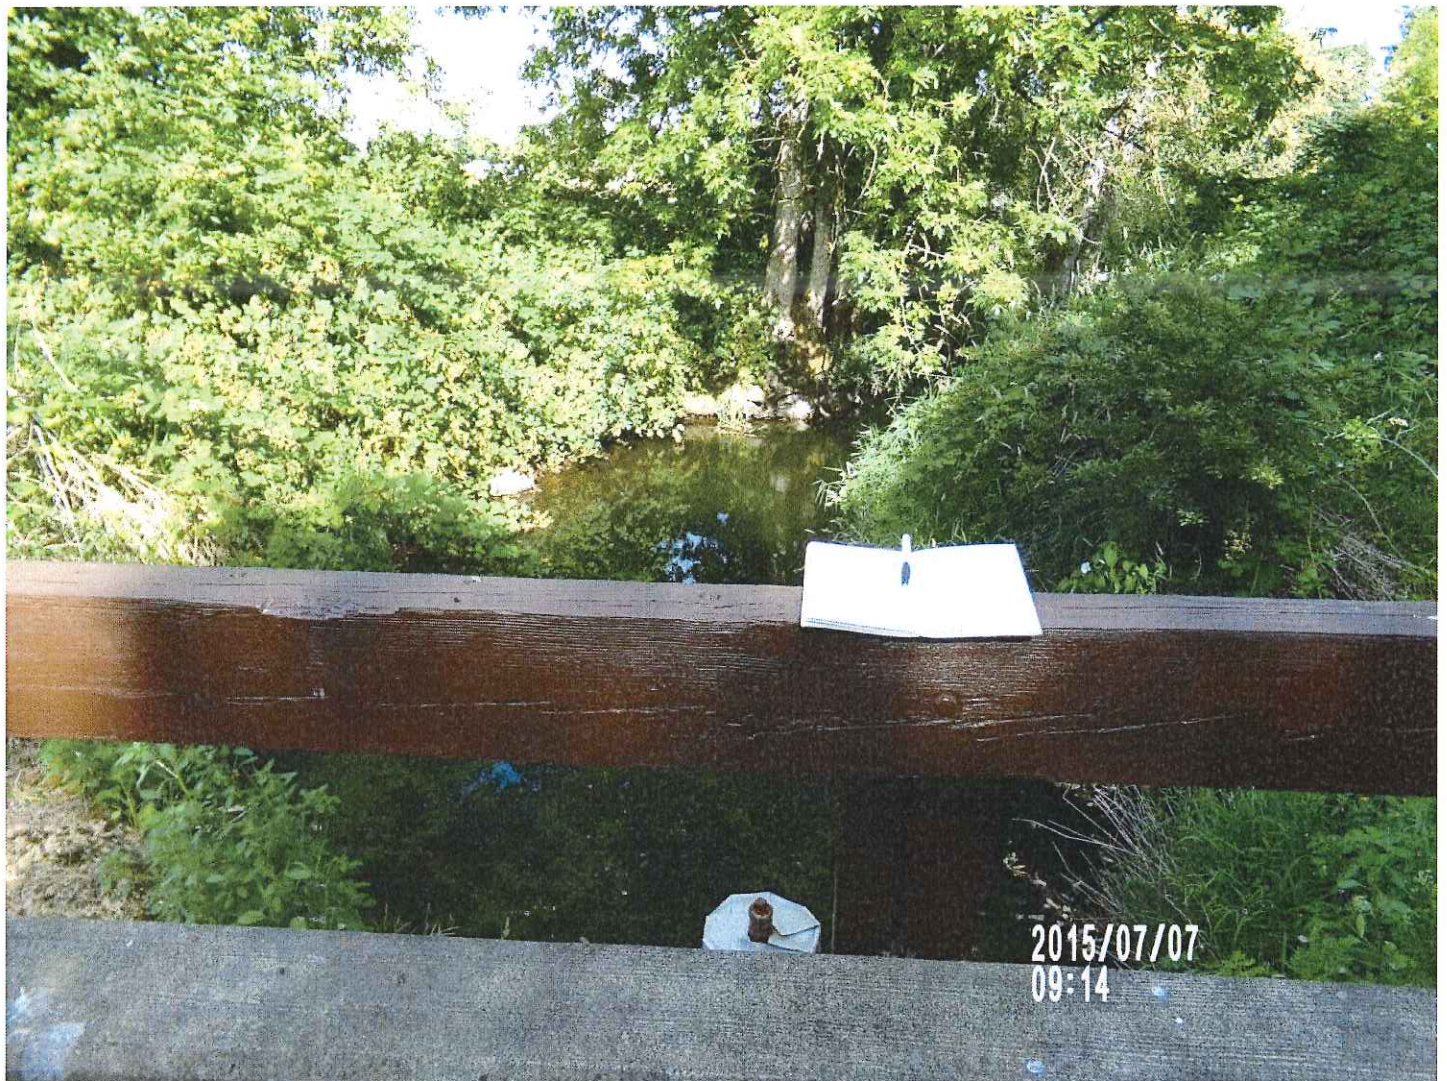
Photo 2. Bear Creek, downstream of the bridge at the facility entrance. The pool of water had no apparent flow.

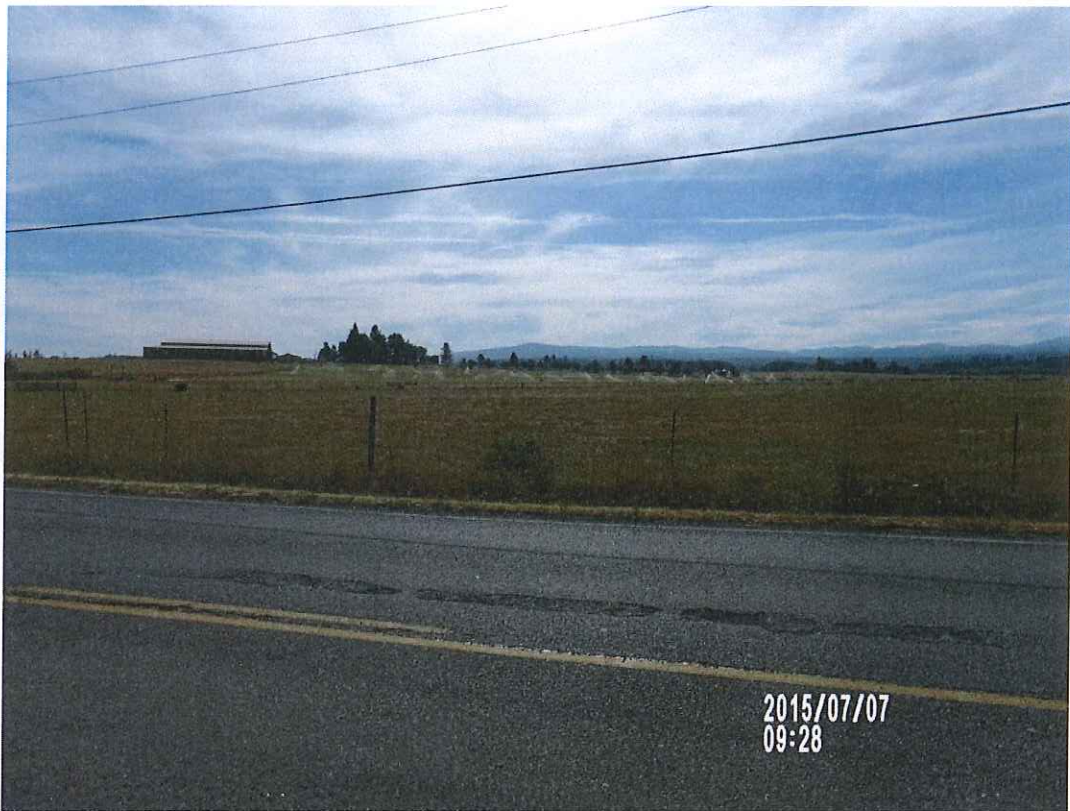
We parked on 4<sup>th</sup> Street at Mathias Road, and walked the ditch line on the western edge of the Coleman Ranch North property. Here we observed hand line irrigation taking place in the field (see photos 3 and 4). The drainage ditch along this side of the property was dry (see photo 5).

Photo 3. Coleman Ranch North, view to the east.

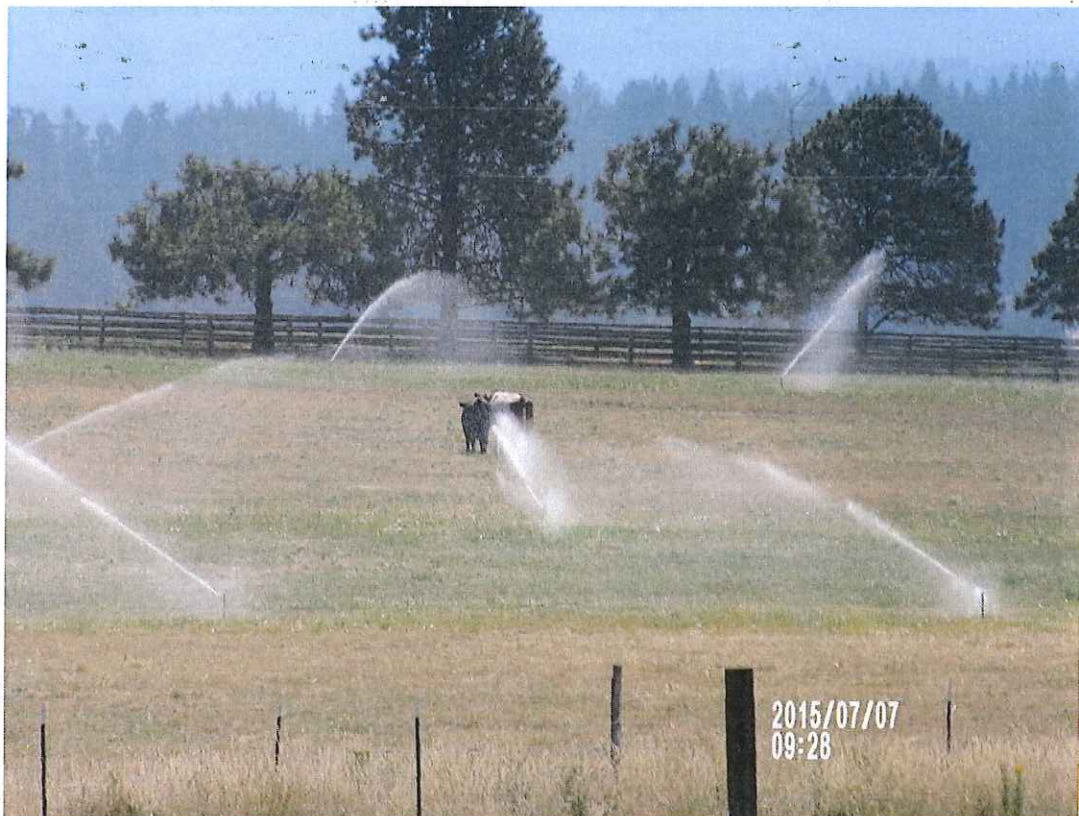
Photo 4. Coleman Ranch North, telephoto view.

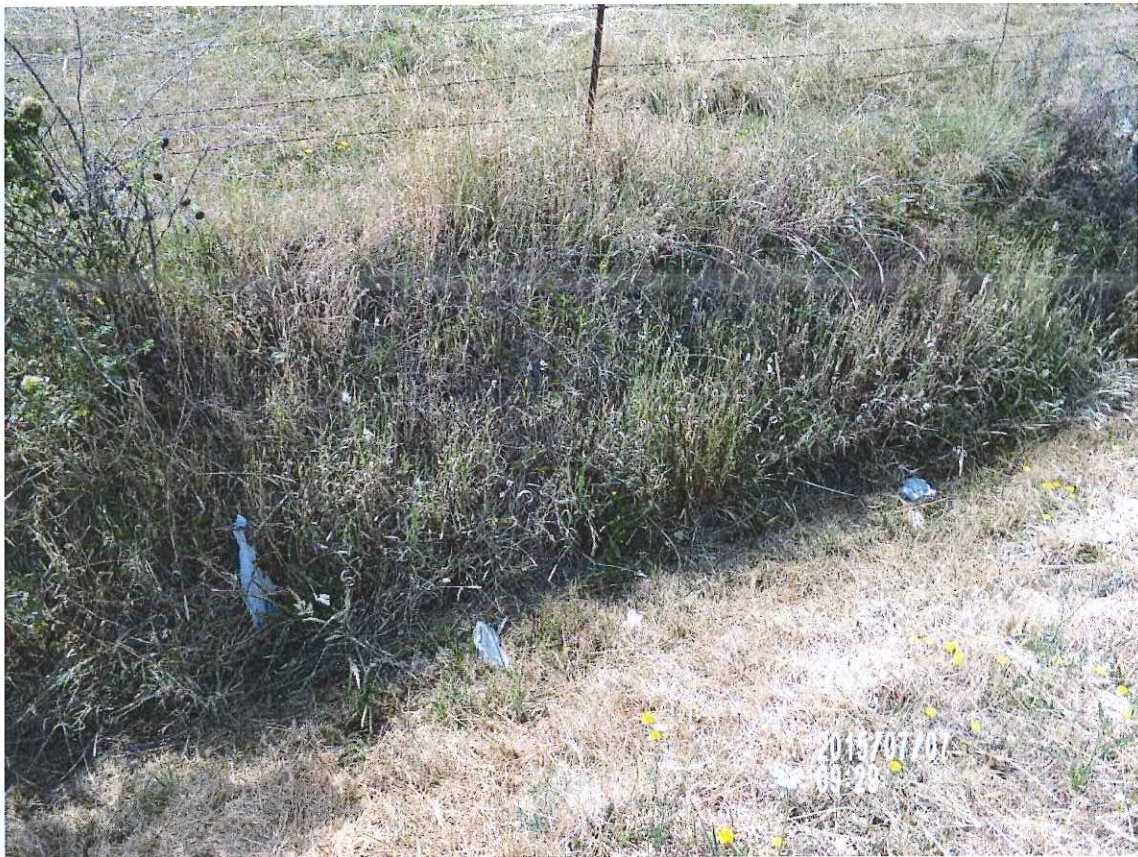
Photo 5. Dry ditch along west side of Coleman Ranch North property.

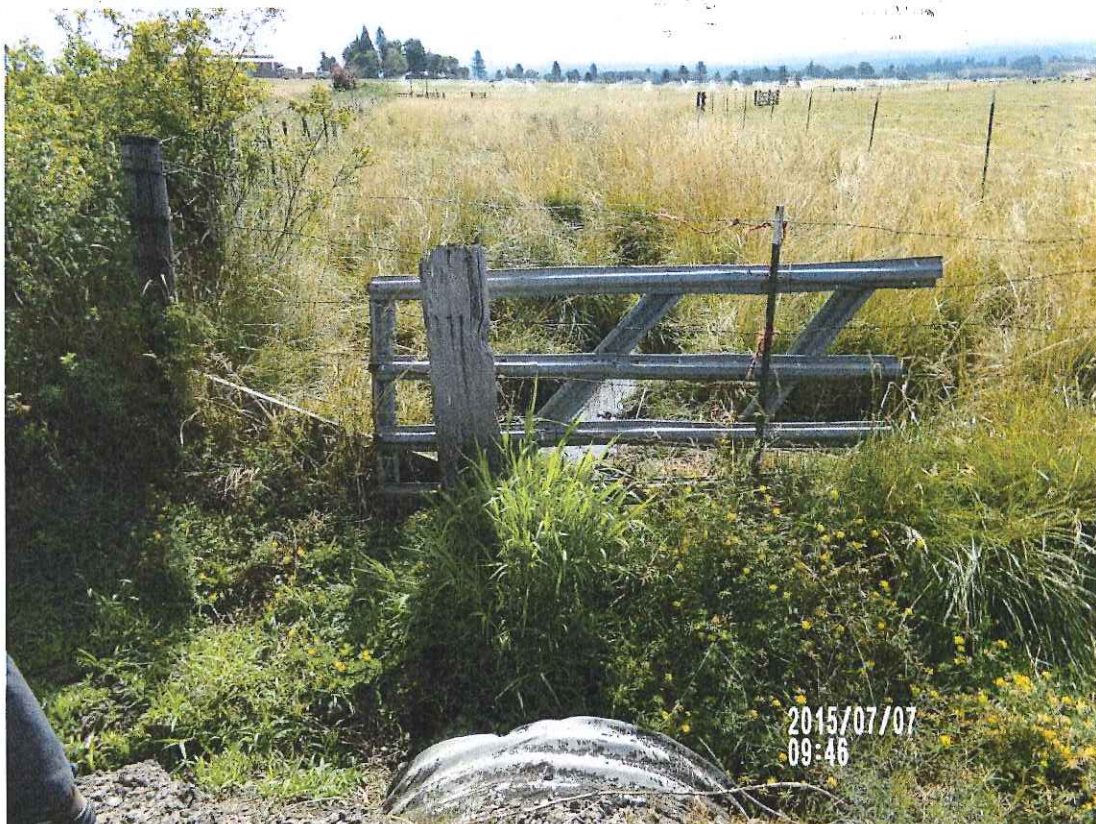
At the northeast corner of the property, where a culvert crosses under the road, we saw water flowing from the property into the culvert (see photo 6). This is the Creamery Creek drainage channel.

Photo 6. Water flowing from NE corner of Coleman Ranch North property into culvert.

On our way back, we saw a city truck at the entrance to the Coleman Ranch North property. We stopped and talked with the city personnel (James and Nikki). We told them about the water we saw flowing from the Creamery Creek channel, at the northeast corner of the Coleman Ranch North property, where a culvert leads under the road and discharges to the west, off site. They said they might turn off the hand lines near that area and see if the water flowing from the property into the culvert stops. We said if they take that action we'd like to know the outcome.
