# Basin L Stormwater Treatment System Performance Verification Report

Kinder Morgan Port of Portland Terminal 4, Slip 3

11040 North Lombard Street Portland, OR 97203 Multnomah County October 2, 2023 Project No. M1017.01.016

Maul Foster & Alongi, Inc. 3140 NE Broadway, Portland, OR 97232

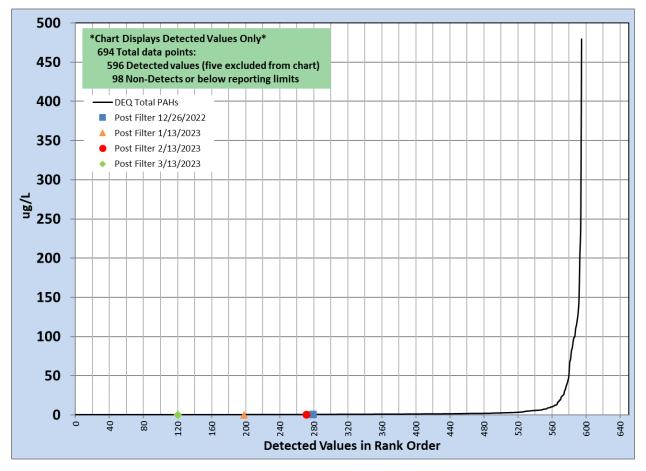
Figure 3-1: Kinder Morgan Stormwater Treatment System Effluent Total PAH Concentrations Compared to DEQ's PAHs in Stormwater Curve

The treatment system effluent total PAH concentrations fall below the knee of the curve, as shown in Figure 3-1, and are less than ten times the SLV, demonstrating that the Basin L stormwater treatment system is effective at reducing PAH concentrations in stormwater and achieving source control goals.

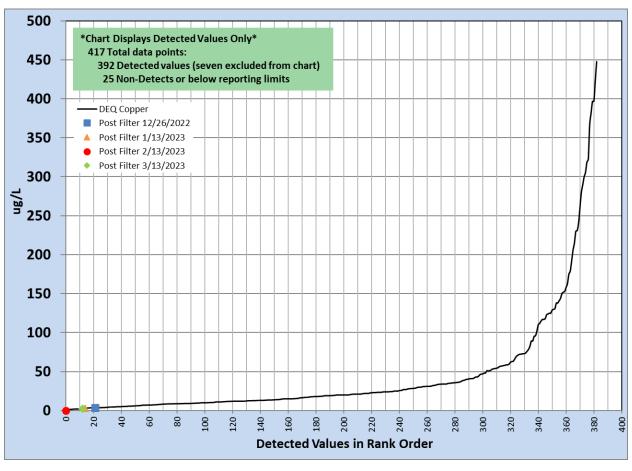
Figure 3-2: Kinder Morgan Stormwater Treatment System Effluent Total Copper Concentrations Compared to DEQ's Total Copper in Stormwater Curve

The treatment system effluent total copper concentrations fall below the knee of the curve, as shown in Figure 3-2. Two of the four sample results were below the SLV and the copper concentration in all four samples was less than ten times the SLV. Copper concentrations were also below the 1200-Z Permit benchmark for total copper. This demonstrates that the Basin L stormwater treatment system is effective at reducing copper concentrations in stormwater and achieving source control goals.

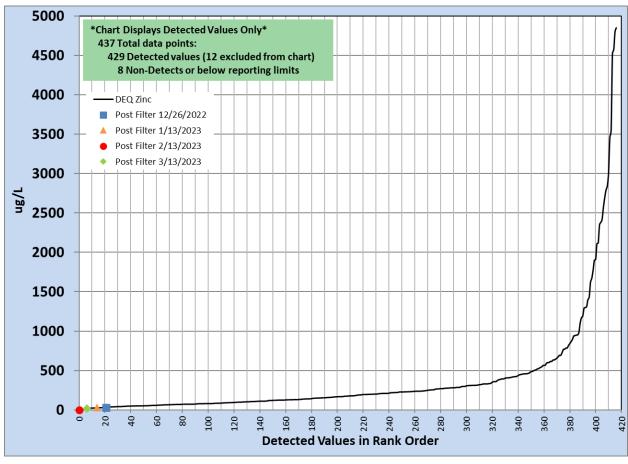
Figure 3-3: Kinder Morgan Stormwater Treatment System Effluent Total Zinc Concentrations Compared to DEQ's Total Zinc in Stormwater Curve

The treatment system effluent total zinc concentrations fall below the knee of the curve, as shown in Figure 3-3. The total zinc concentrations in all effluent samples were below the SLV. Zinc concentrations were also below the 1200-Z Permit benchmark for total zinc. This demonstrates that the Basin L stormwater treatment system is effective at reducing zinc concentrations in stormwater and achieving source control goals.

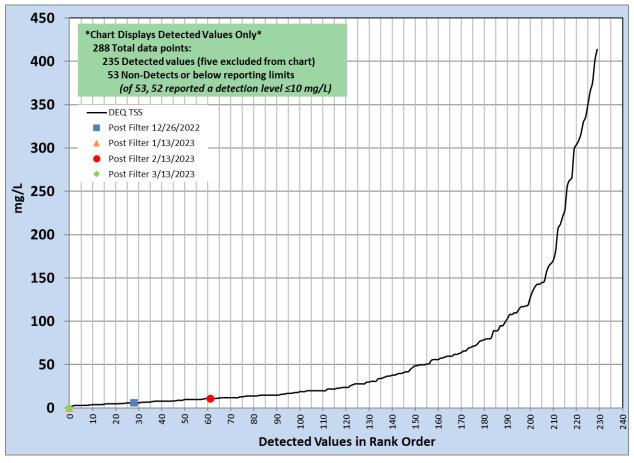
Figure 3-4: Kinder Morgan Stormwater Treatment System Effluent TSS Concentrations Compared to DEQ's Total Suspended Solids in Stormwater Curve

The treatment system effluent TSS concentrations fall below the knee of the curve, as shown on the above chart. The TSS concentration in all effluent samples was below the SLV. TSS concentrations were also below the 1200-Z Permit benchmark for TSS. This demonstrates that the Basin L stormwater treatment system is effective at reducing TSS concentrations in stormwater and achieving source control goals.

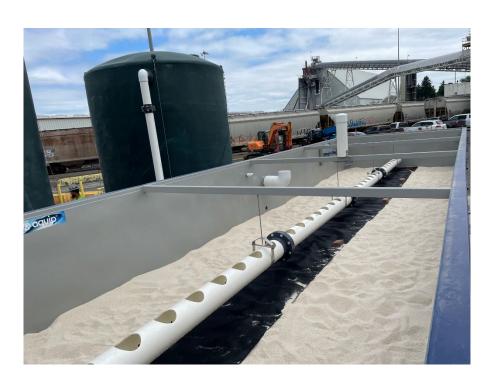
- October 25, 2022: Stormwater was observed to be ponding on top of the Aquip filter tarp cover. The tarp was installed to limit fugitive soda ash dust from entering the filter. The ponding did not affect the filter performance, but StormwateRx, LLC (StormwateRx) was notified.
- **November 9, 2022:** The tarp support bars were bent from the weight of stormwater ponding on the tarp.
- **November 15, 2022:** StormwateRx replaced two tarp support bars and tightened the tarp straps to prevent future ponding.
- **December 21, 2022:** StormwateRx added an additional support bar to prevent stormwater from ponding on the edges of the tarp cover.
- December 8, 2022: Black material accumulation was observed on the Aquip filter media surface.
   The surface of the media was scraped on December 16, 2022, and approximately 0.25 inches of accumulation was removed.

# Photo No. 4. Description Stormwater ponding on the filter tarp cover

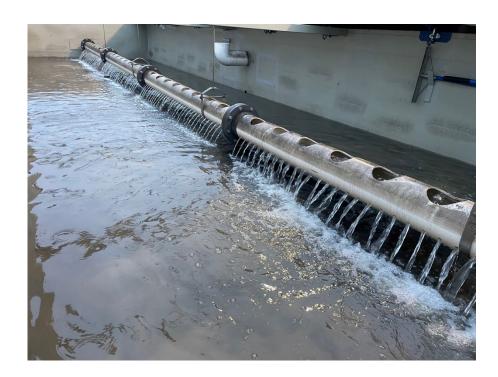
Photo No. 6. Description

- March 13, 2023: Sediment accumulation was observed on the Aquip filter media surface. The surface of the media was scraped and the sediment was removed on March 29, 2023.
- May 16, 2023: Pump floats were observed to be tangled up, causing the pump to run when no stormwater was present (i.e., running dry). The pumps were shut off and the float cords were untangled. The system was turned on the following day after the pump was inspected by an electrician to ensure the long pump run time did not damage the motor. Kinder Morgan began evaluating preventive measures to avoid this issue in the future. These measures were implemented in August 2023 and will be discussed in detail in the 2023—2024 treatment system performance evaluation report.
- May 23, 2023: StormwateRx raised the overflow indicator pipe elevation to match the overflow pipe elevation inside the Aquip filter.

Black material accumulated on the filter media surface prior to removal
