# Basin K1 Bioinfiltration Basin Operational Year 2 Comprehensive Report

**Kinder Morgan Port of Portland Terminal 4, Slip 3**

January 26, 2024

Project No. M1017.01.016

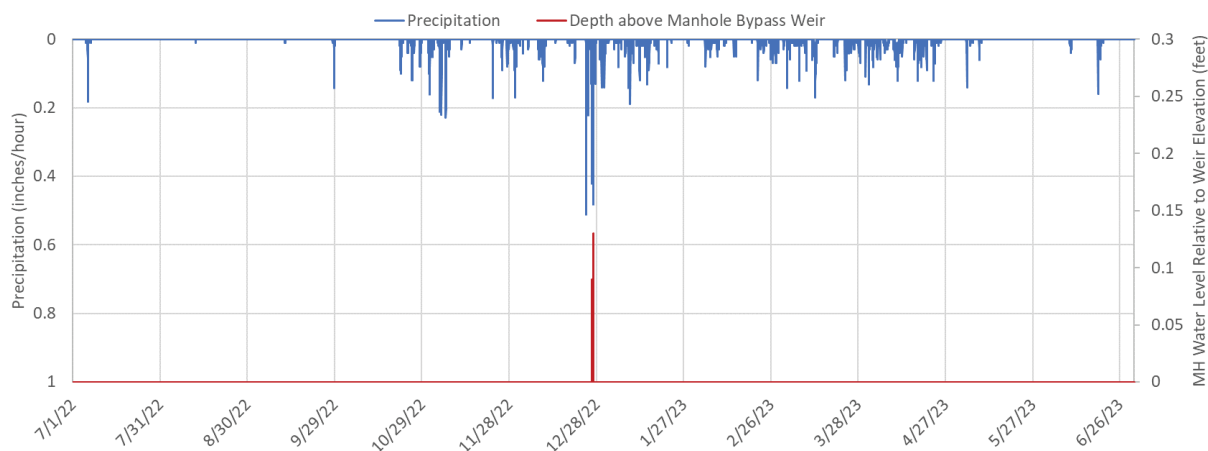
**Figure 3-1: Manhole Water Level Above the Bypass Weir Elevation**

Figure 3-1 indicates that a bypass from the flow-control manhole occurred once between July 1, 2022, and June 30, 2023, and Figure 3-2 shows that one overflow from the bioinfiltration basin occurred between July 1, 2022, and June 30, 2023. The bypass and overflow both occurred during the significant storm event on December 26, 2022. The flow-control manhole bypassed for approximately one hour and discharged approximately 6,600 gallons to the Willamette River. The bioinfiltration basin overflowed for approximately 45 minutes and discharged approximately 4,500

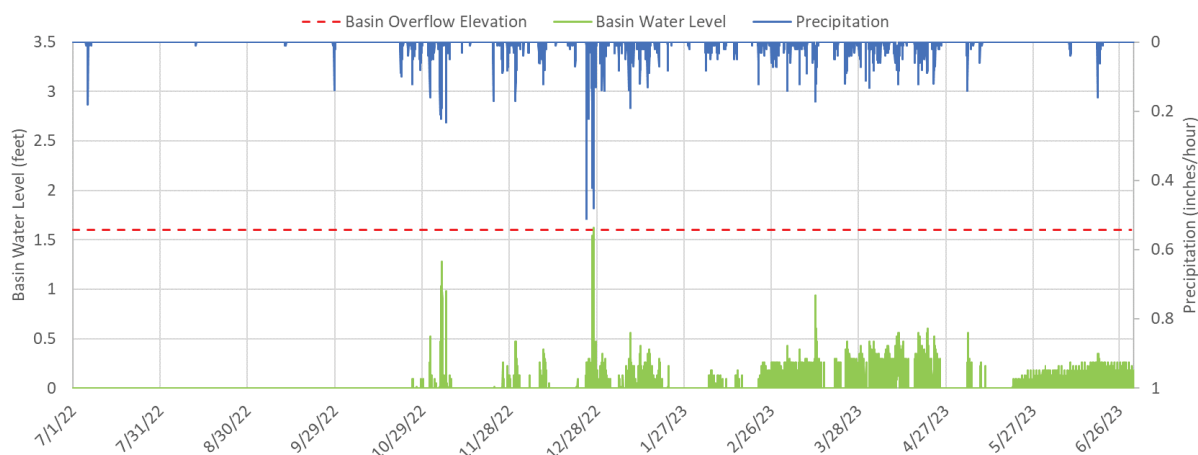
**Figure 3-2: Basin Water Level Relative to the Basin Overflow Elevation**

gallons to the Willamette River. The total volume of stormwater infiltrated in the basin was therefore 992,600 gallons, while the total volume discharged to the river was 11,100 gallons.

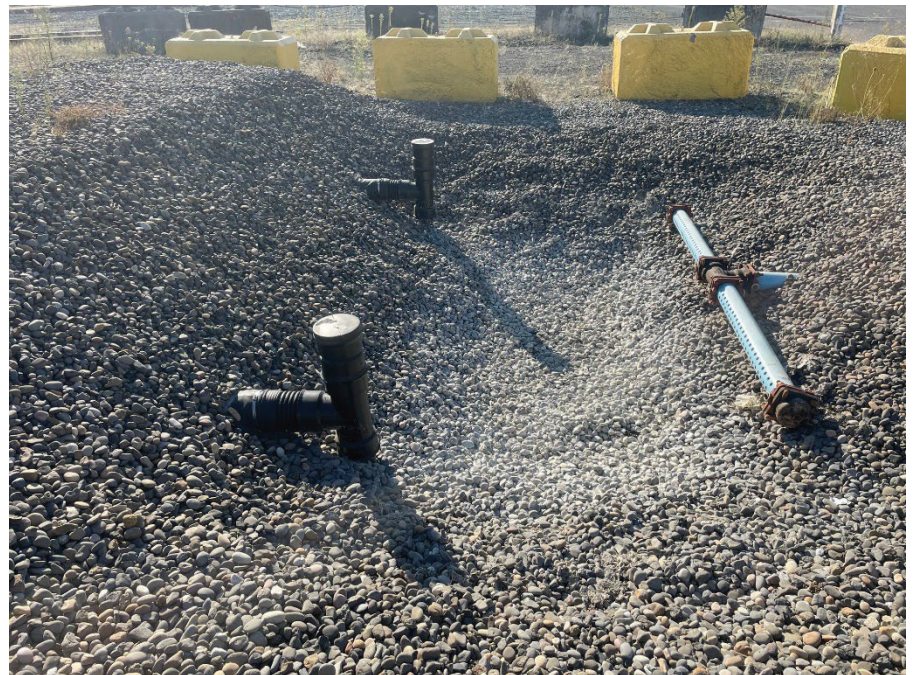
## Photo No. 4.

Forebay in September 2022

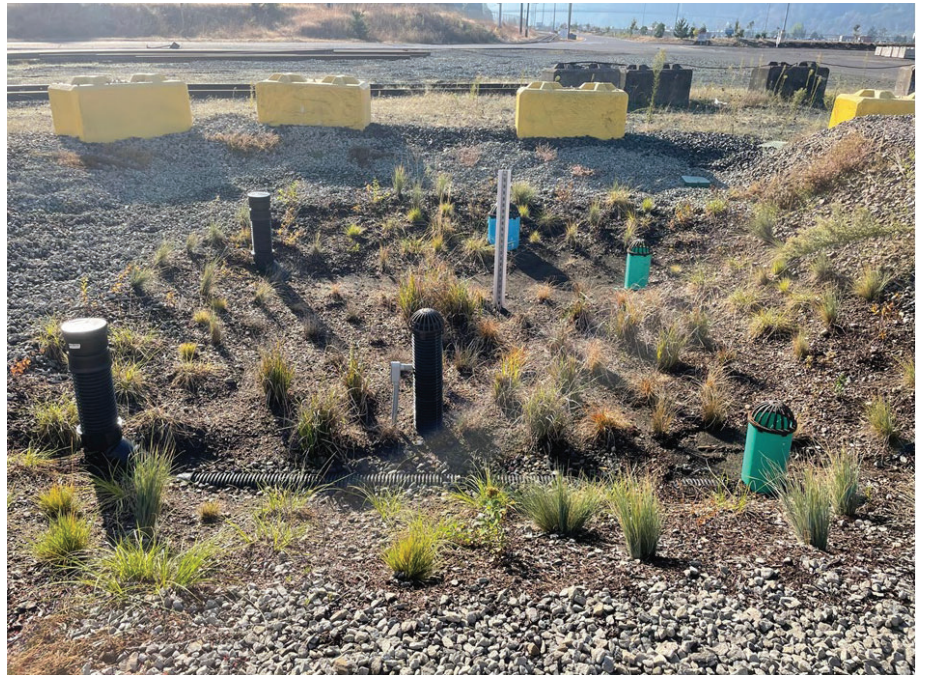
- **October 25, 2022:** Several plants appeared dormant or dead in the bioinfiltration basin. MFA consulted with a landscape contractor and the contractor recommended that the plants be replaced during the summer or fall of 2023.

Bioinfiltration basin in  
September 2022

Based on the results of the inspections conducted during the second year, vegetation replanting was warranted in portions of the bioinfiltration basin. Vegetation was replanted on November 2, 2023.

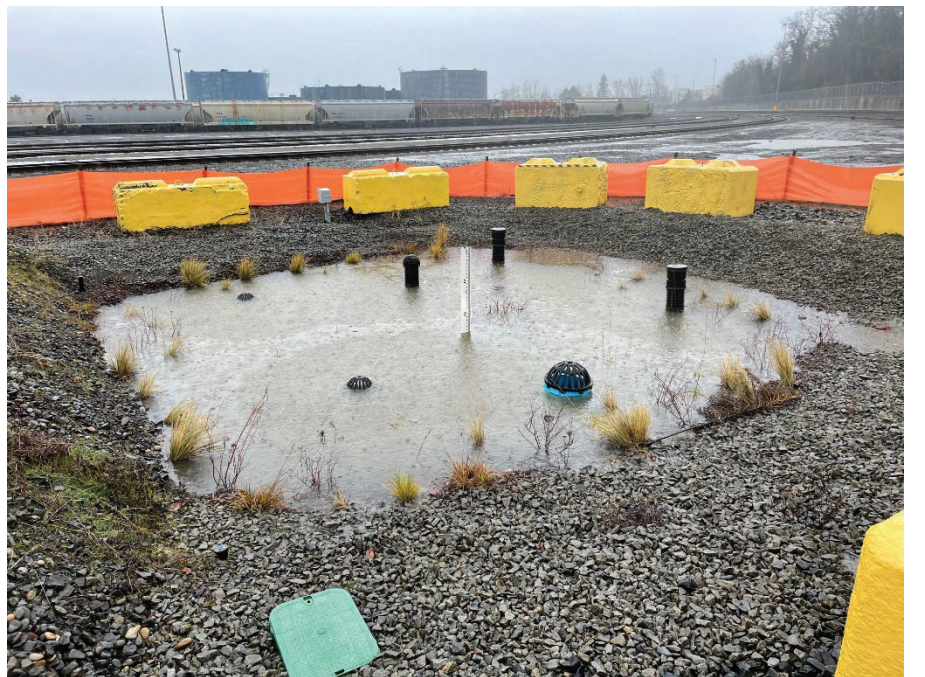
## Photo No. 6.

Infiltration rates could only be calculated using data obtained during the November 4 and December 26, 2022, storm events. The maximum ponding depth over the basin media bed did not exceed 1 foot during the November 6, 2022, and March 13, 2023, storm events; therefore, infiltration rates were not calculated for these storms. The maximum ponding depths over the basin media bed on November 4 and December 26 were 1.28 and 1.62 feet, respectively. The average infiltration rate when water ponding depth over the media bed was between 6 and 12 inches was 41 inches per hour. The average infiltration rate when water ponding depth was between 12 and 18 inches was 29 inches per hour.

Bioinfiltration basin on  
December 26, 2022, at  
12:57 p.m. with water  
level elevation at 1.4  
feet

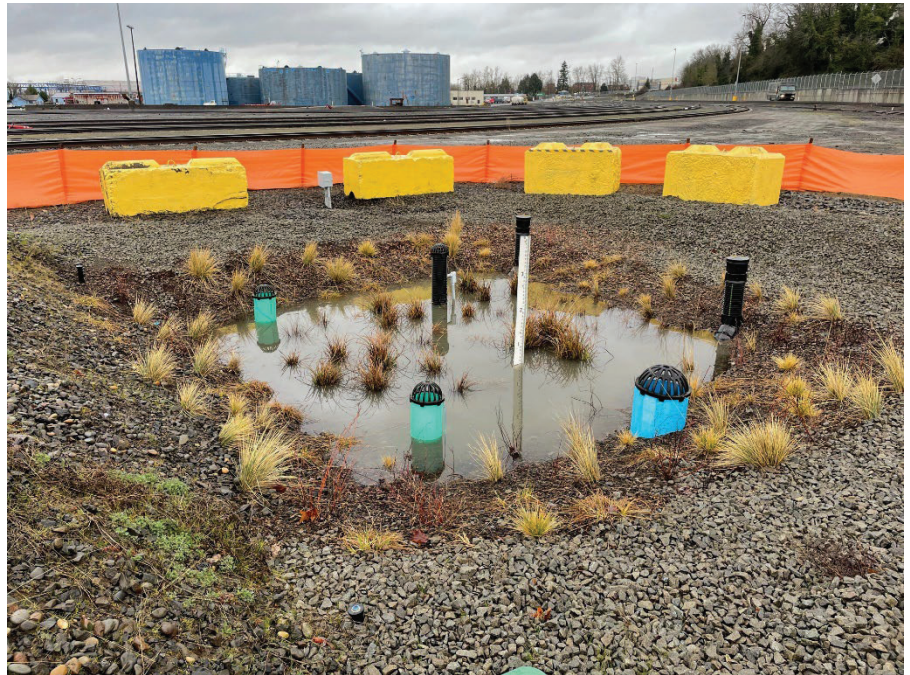
Bioinfiltration basin on March 13, 2023, at 3:47 p.m. with water level elevation at 0.4 feet.

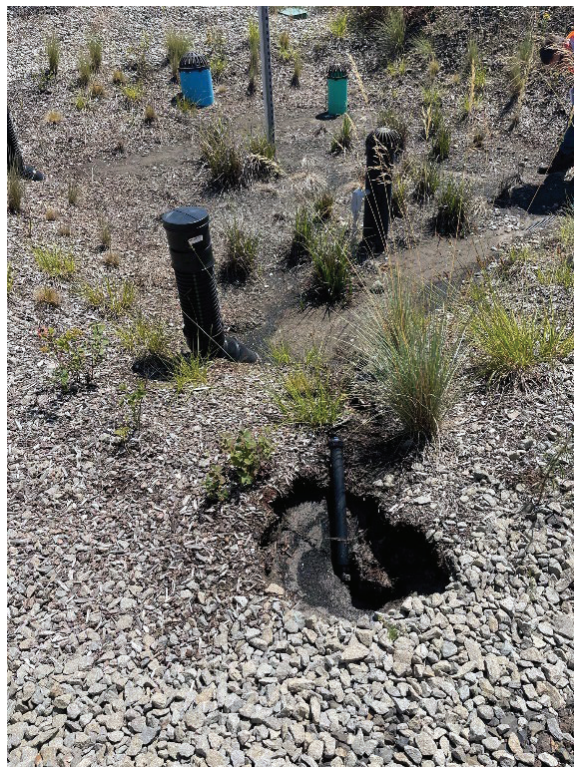
## Photo No. 8.

- **May 12, 2023:** The bioinfiltration basin irrigation system was turned on for the summer.
- **June 28, 2023:** The bioinfiltration basin irrigation line was observed to be damaged during a monthly inspection. The underground irrigation line elbow fitting that transitions from a horizontal line to the vertical riser that is connected to the sprinkler head had cracked sometime after the inspection on May 16, 2024 and resulted in a leak. Water from the damaged irrigation line eroded a small depression (approximately 12 by 12 by 6 inches) around the sprinkler head at the top of the slope.<sup>3</sup>

As described in Section 2.2, the bioinfiltration basin irrigation line was damaged between May and July 2023. The underground irrigation line elbow fitting that transitions from a horizontal line to the vertical riser that is connected to the sprinkler head had cracked and resulted in a leak. The broken fitting was replaced on July 17, 2023, and the irrigation system has been functioning properly since then.

Erosion at edge of the basin from sprinkler

<sup>3</sup> The sprinkler and surrounding erosion were repaired on July 17, 2023 (this date is past the 2022–2023 year discussed in this report). Plant replacement designed to increase plant coverage to 70-80 percent was conducted during the fall 2023 and will be reported in the 2023–2024 annual report.
