# **BASIN M VEGETATED INFILTRATION BASIN OPERATIONAL YEAR 2 COMPREHENSIVE REPORT**

## **Terminal 4 Slip 1**

**Port of Portland**

January 2024

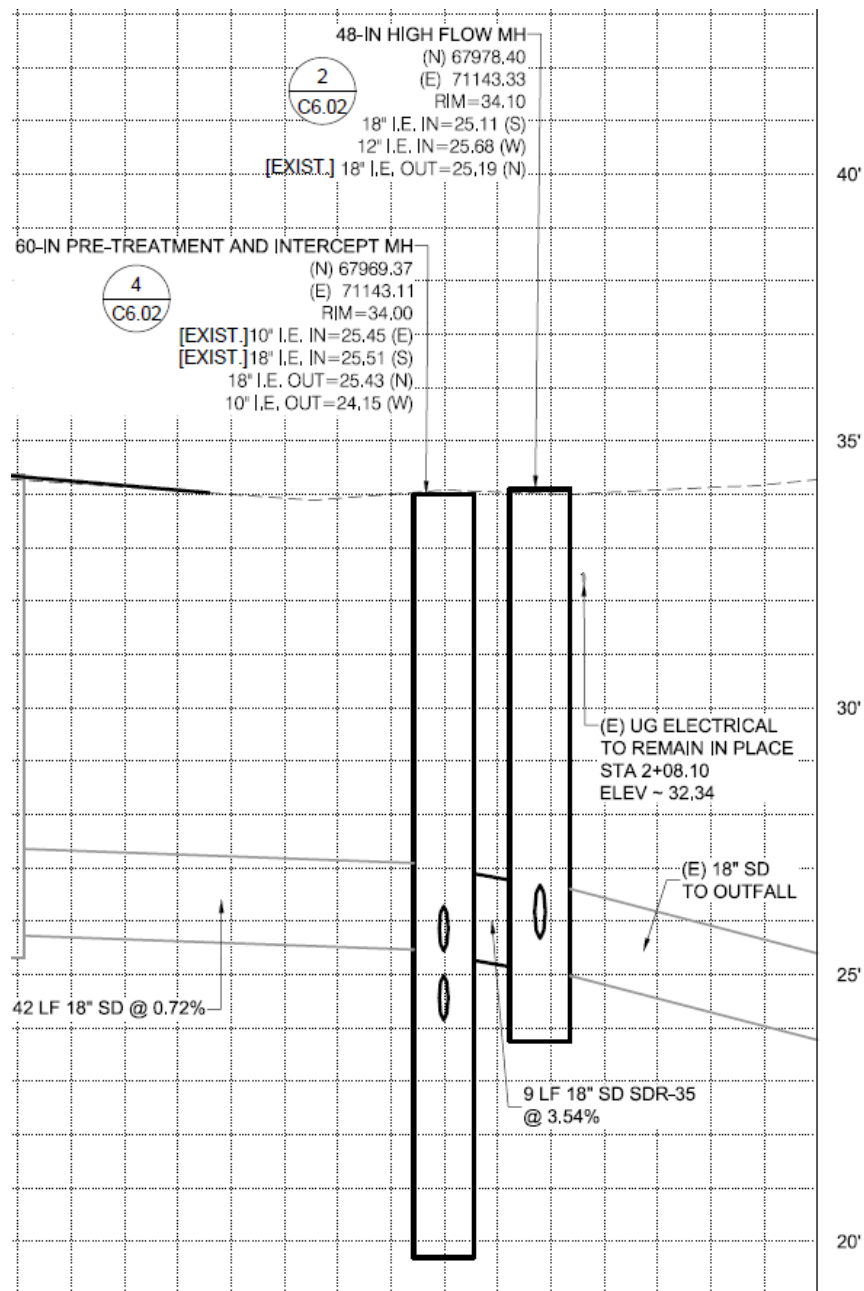
**Figure 7: Flow Path and Invert Elevations From Intercept Manhole to Outfall**

The volume of water discharged during each event was calculated using pressure transducer data and Manning's equation for bypass events, and a weir equation for overflow events. However, it should be noted that the Manning's equation calculations are very approximate and likely biased high. This is because Manning's equation assumes free and uniform flow, but the bypass pipe which conveys flow from the intercept manhole to the high flow manhole is always at least slightly backwatered due to the outlet pipe from the high flow manhole to the outfall being slightly higher (invert of 25.19 ft) than the inlet pipe from the intercept manhole (invert of 25.11 ft). Because this difference in elevation is small, the bias is likely minimal when the volume of bypass is small. On the other hand, when the volume of bypass is large, or when bypass and overflow occur at the same time, the discharge calculation could be biased significantly high. The flow path in question is reproduced from the design drawings as Figure 7.

Because the potential error in the bypass volume calculation is greatest during large bypass events, it most significantly affects the calculation of bypass volume for the late December 2022 storm. The magnitude of uncertainty caused by this condition is difficult to quantify, as the flow conditions in the system are difficult to accurately predict. The pipe between the intercept manhole and high flow manhole may have surcharged at the downstream end, or free flow may have continued throughout the storm. One way to estimate the magnitude of uncertainty is by calculating the total bypass volume using the currently assumed conservative slope of the

hydraulic grade line (HGL) that matches the pipe slope exiting the intercept manhole (3.54%) and comparing it to the same volume calculated using a less conservative HGL that matches the slope of the theoretical line connecting the invert of the overflow pipe exiting the intercept manhole to that of the outfall pipe exiting the high flow manhole (1.85%). The difference between the bypass volumes for these two slope values can be used to approximate the uncertainty in this calculation. The relative percent difference of bypass volumes calculated for these two methods is 32%.

Additionally, the Port intends to relocate the pressure transducer in the intercept manhole to the high-flow manhole so the effect of the backwater condition can be minimized for future calculations of overflow discharge volumes.

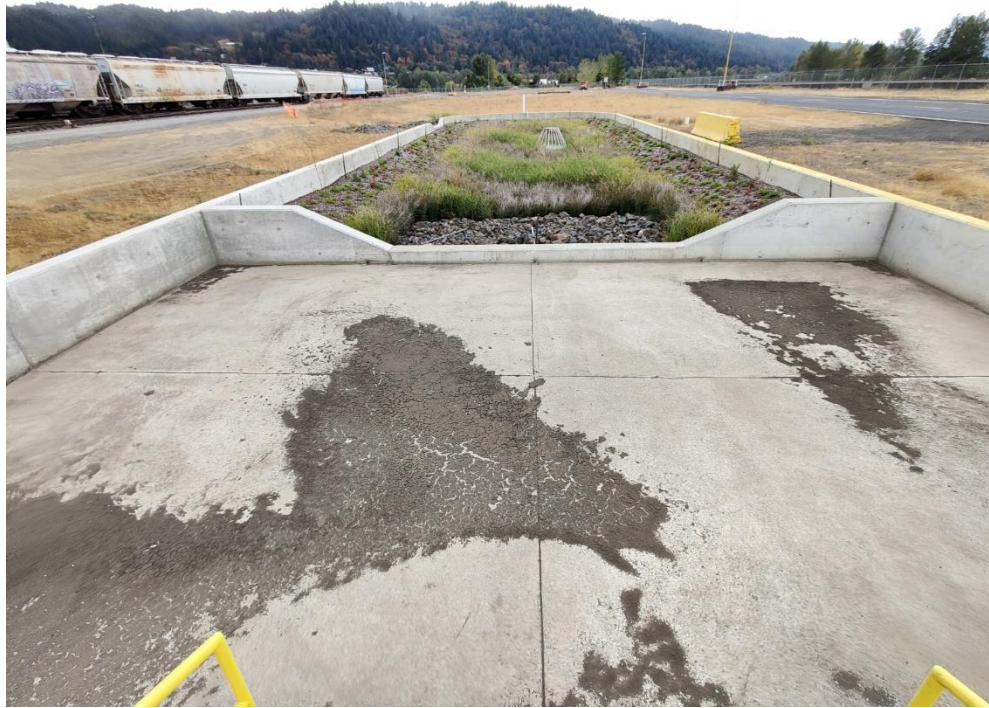
Bioinfiltration basin prior to the start of the wet season

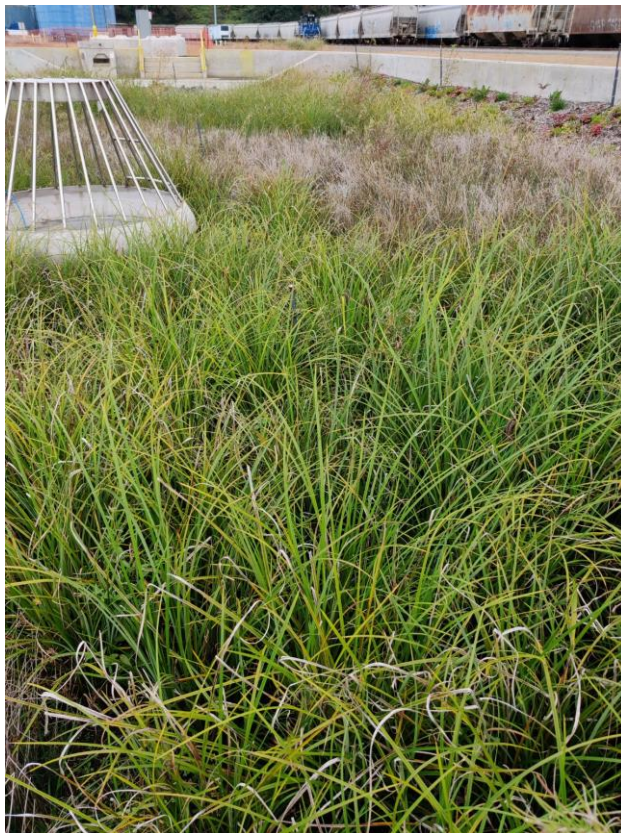
**Photo B-2**

Healthy vegetation at the end of the 2022 dry season

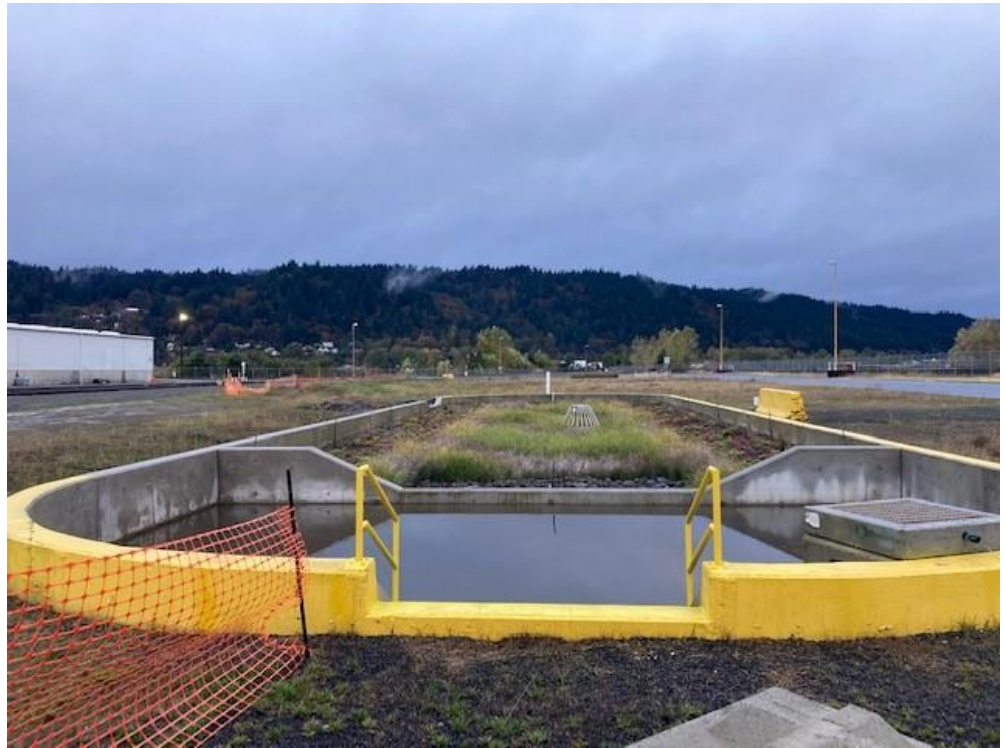
**Photo B-3**

Bioinfiltration basin on the first business day after a 2-year 24-hour storm

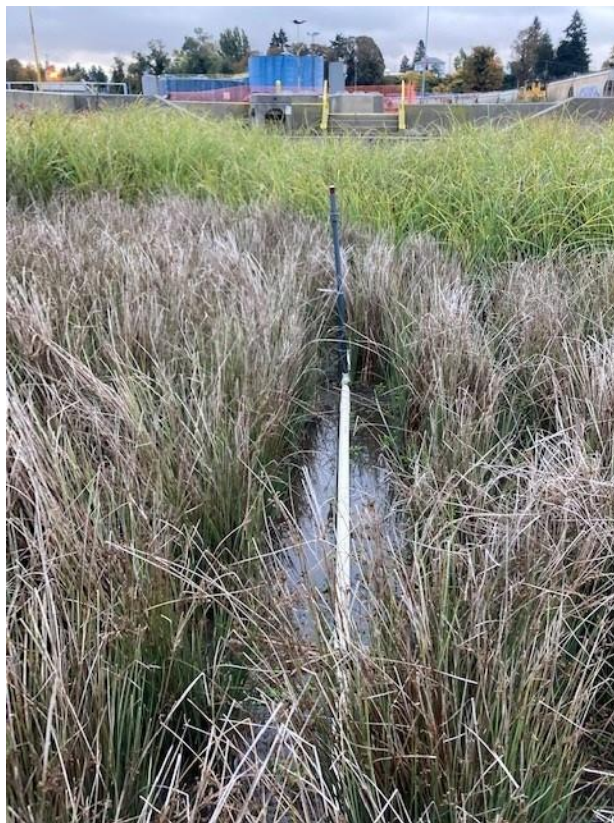
**Photo B-4**

Some ponding in basin following a 2-year 24-hour storm

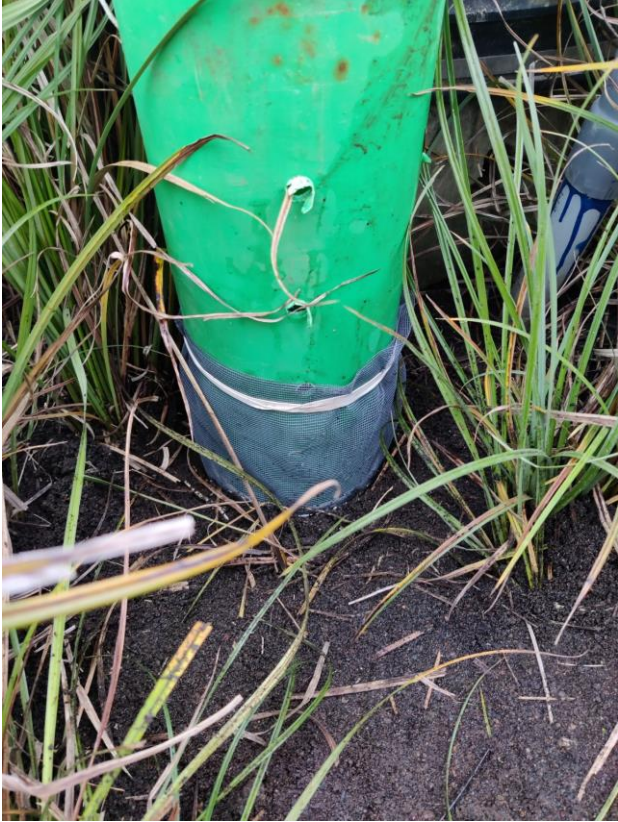
| <p><b>Photo B-5</b></p> <p><b>Date:</b><br/>12/7/2022</p> <p><b>Direction:</b> W</p> <p><b>Description:</b><br/>Mesh added to bottom of media basin stilling well to prevent migration of solids into standpipe</p> | |

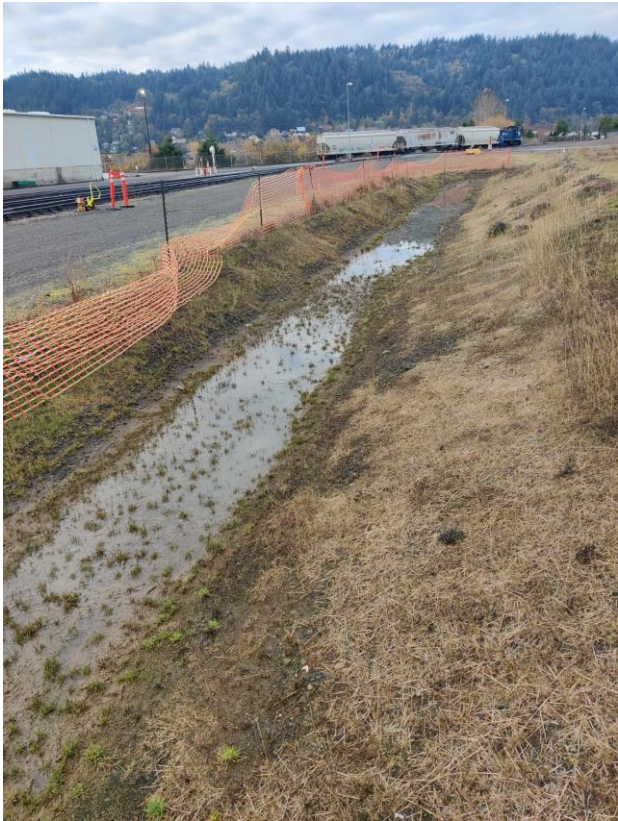
| <p><b>Photo B-6</b></p> <p><b>Date:</b><br/>12/12/2022</p> <p><b>Direction:</b> W</p> <p><b>Description:</b><br/>Conveyance swale showing minimal vegetation growth</p> | |

Finally, the Port will evaluate erosion control measures for the conveyance swale located south of the SCM, where regular inspections (Appendix A) have noted erosion.

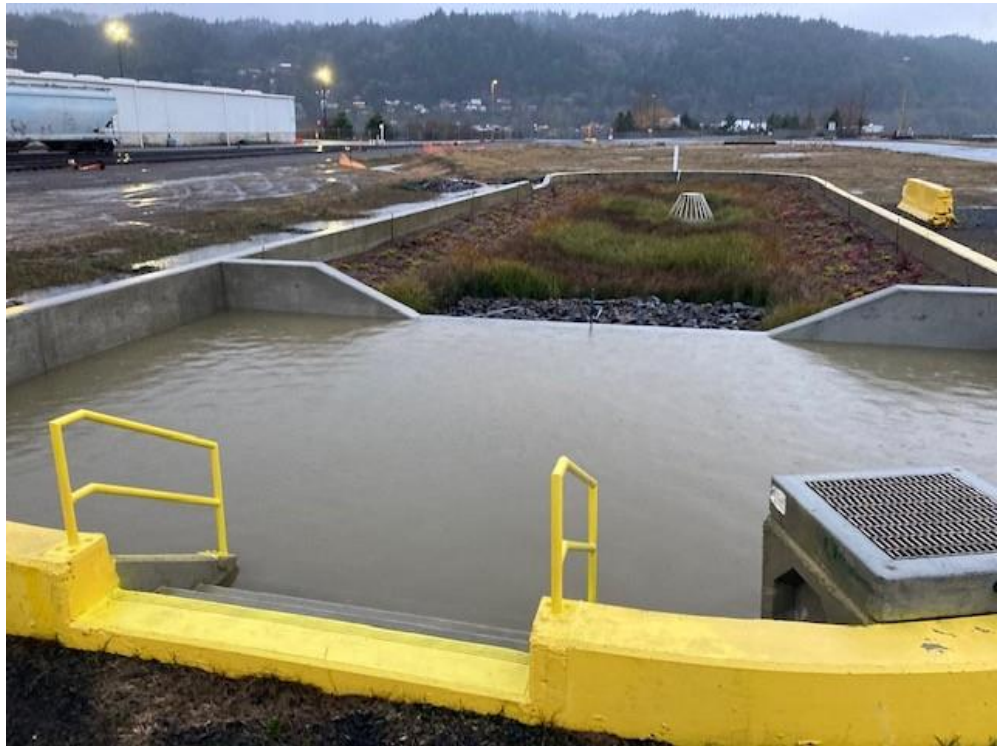
**Photo B-7**

Full forebay following 5-year 24-hour storm event

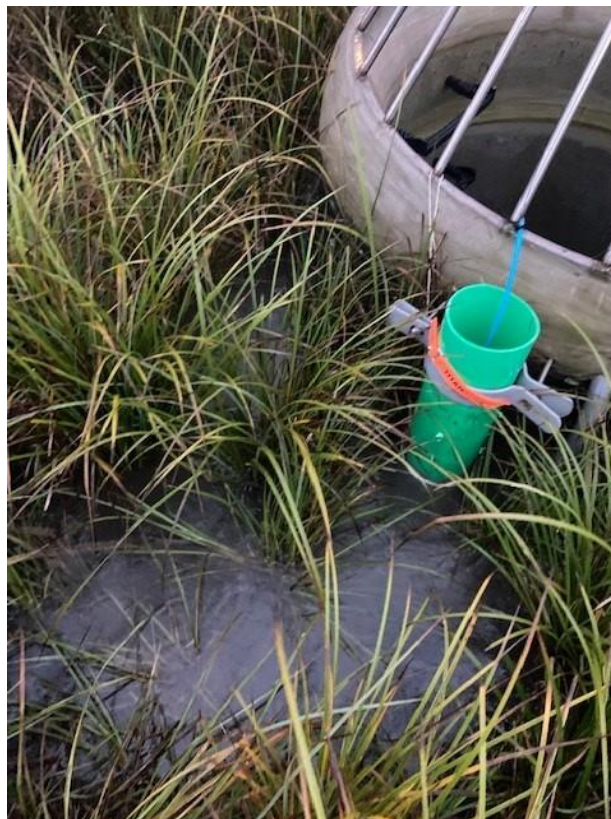
**Photo B-8**

Ponding in media basin following 5-year 24-hour storm event

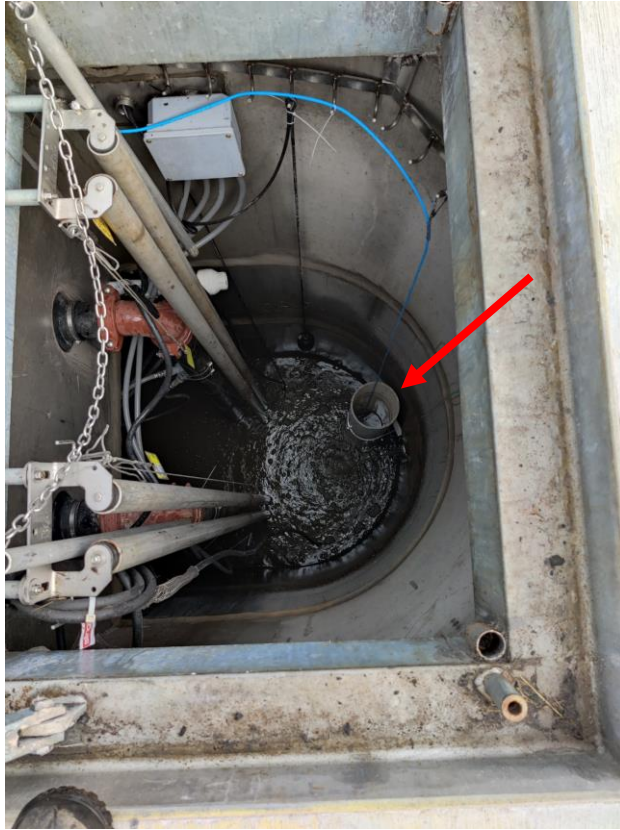
**Photo B-9**

- **27 December 2022:** Rainfall-triggered inspection.
- **4 January 2023:** Stilling well installed in wet well. Review of design drawings revealed a stilling well was included in the drawings but not specifically called out in the drawings, and so was not installed during construction. Agitation of the sensor caused by turbulence is one possible reason for the failure of this PT in October 2022. As such, the stilling well was installed, as originally intended, to better protect the PT. PT in wet well moved to stilling well. No change in datum.

Stilling well  
added to wet  
well to protect  
wet well  
pressure  
transducer

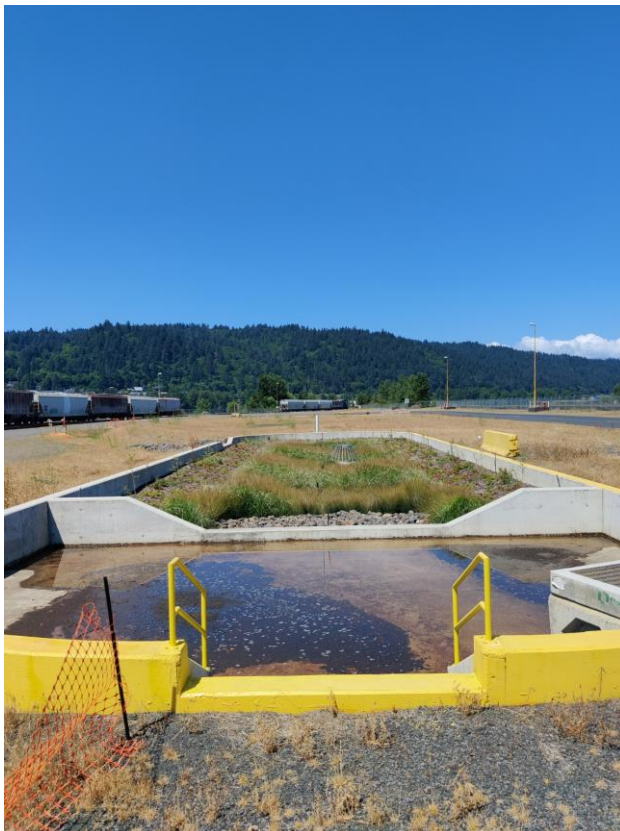
**Photo B-10**

Condition of  
pretreatment  
forebay at the  
start of the  
2023 dry  
season
