### MARINA ADVISORY COMMITTEE

February 26, 2024 at 2pm

HDR was retained by the City of Warrenton to perform an evaluation of the Warrenton Marina to assess general condition of the docks, identify any recommended repairs and/or replacement of the docks, and provide guidance on prioritization of upgrades and maintenance.

# **Underwater Condition Assessment of Warrenton Marina**

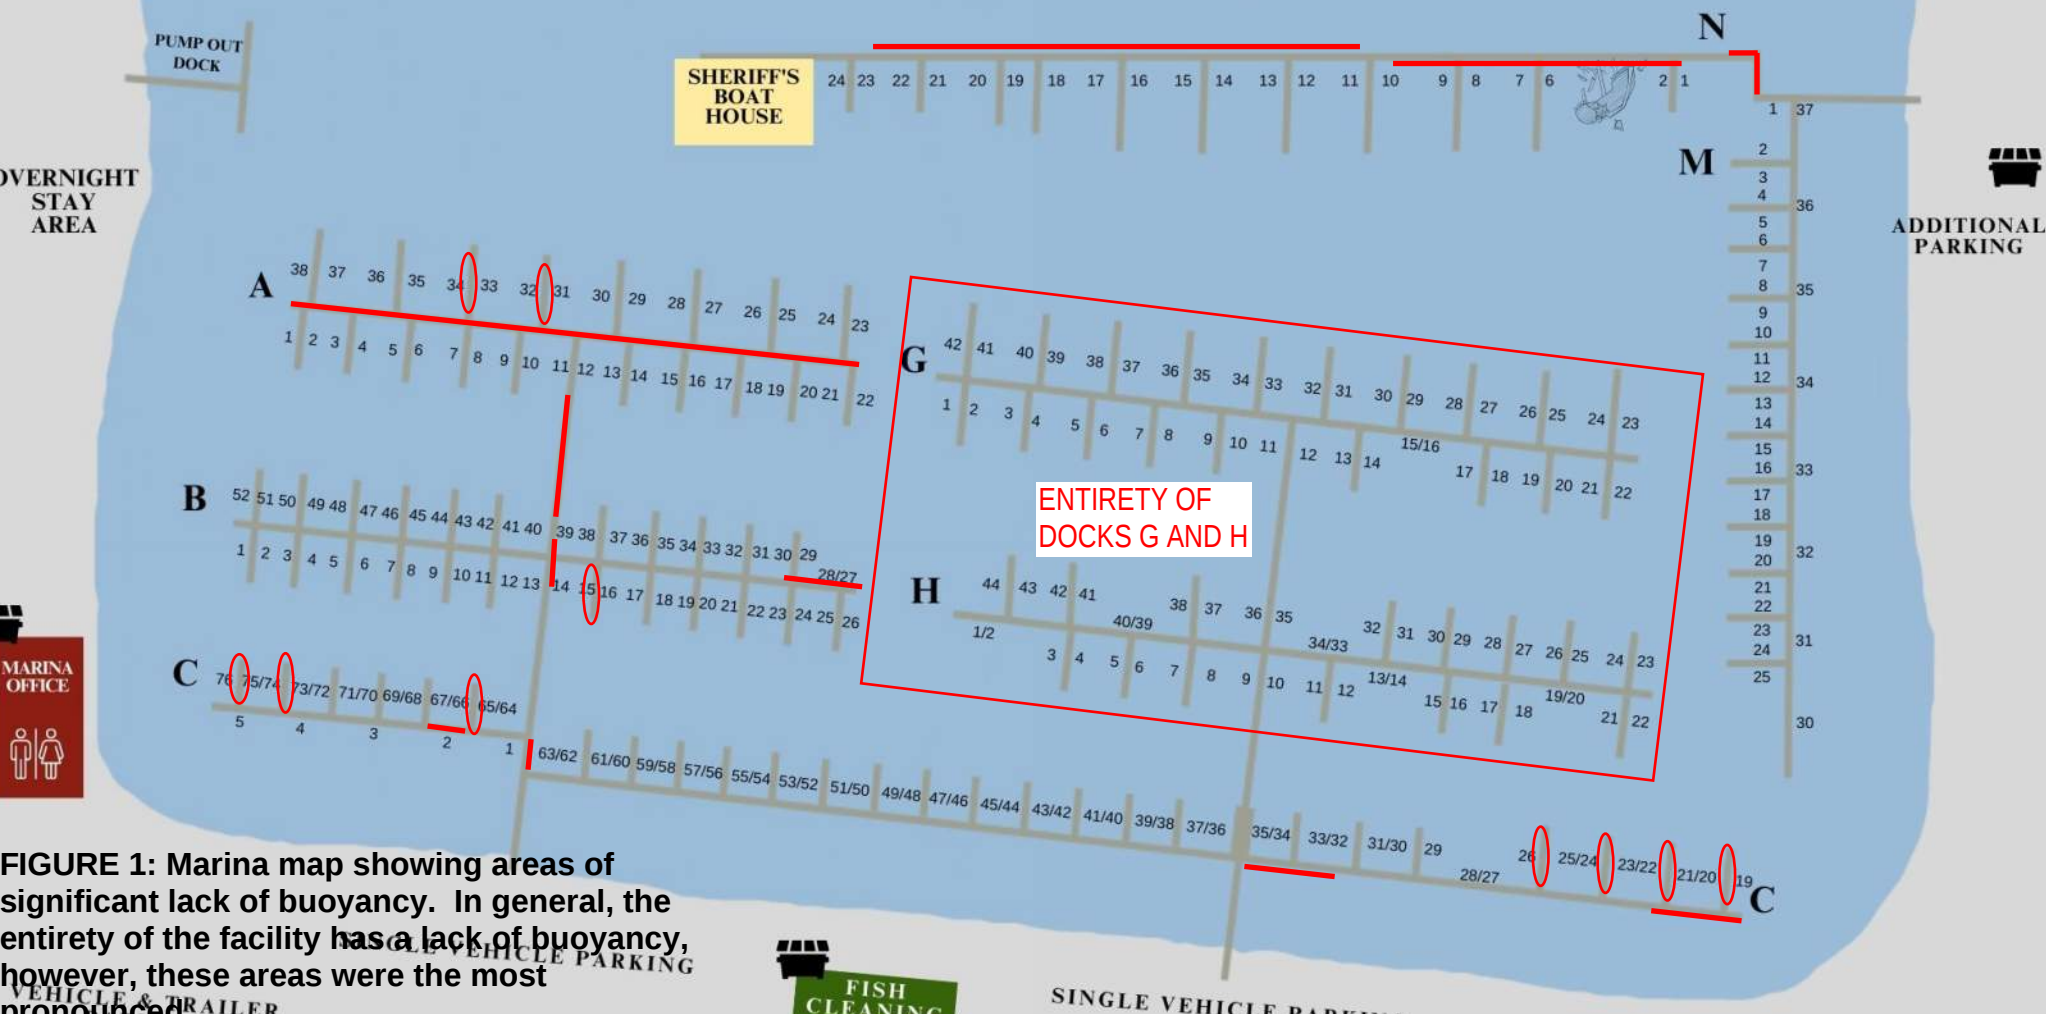
Throughout the facility, there are locations where the dock is not level under its own self weight (see Photos 7 and 8). Areas where this was particularly pronounced are noted in Figure 1. It should be noted that the entire facility exhibits a general lack of buoyancy and the deficiencies noted in Figure 1 are those areas that were particularly noticeable as having even less buoyancy than typical.

**FIGURE 1:** Marina map showing areas of significant lack of buoyancy. In general, the entirety of the facility has a lack of buoyancy, however, these areas were the most pronounced.

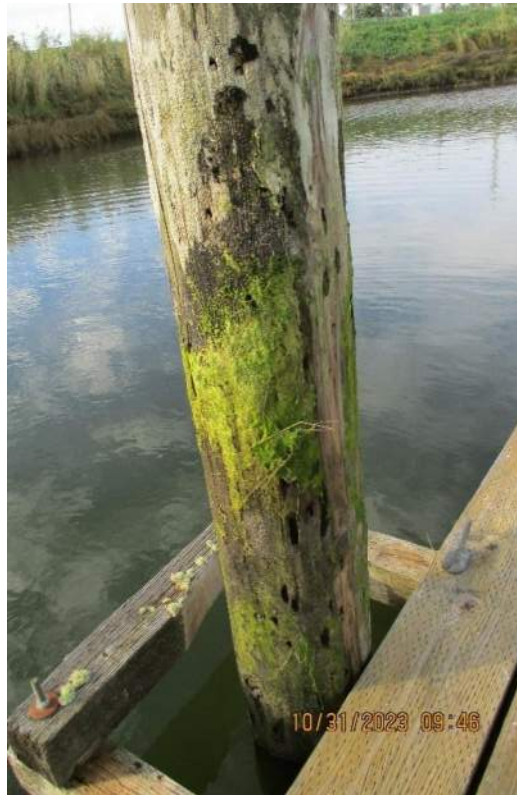
Examples of typical condition of the piles above water are shown in Photos 1 and 2. Typical pile hoop attachments are shown in Photos 3 through 5.

**Photo 1:**  
Typical condition of timber piling. Note marine growth near the waterline.

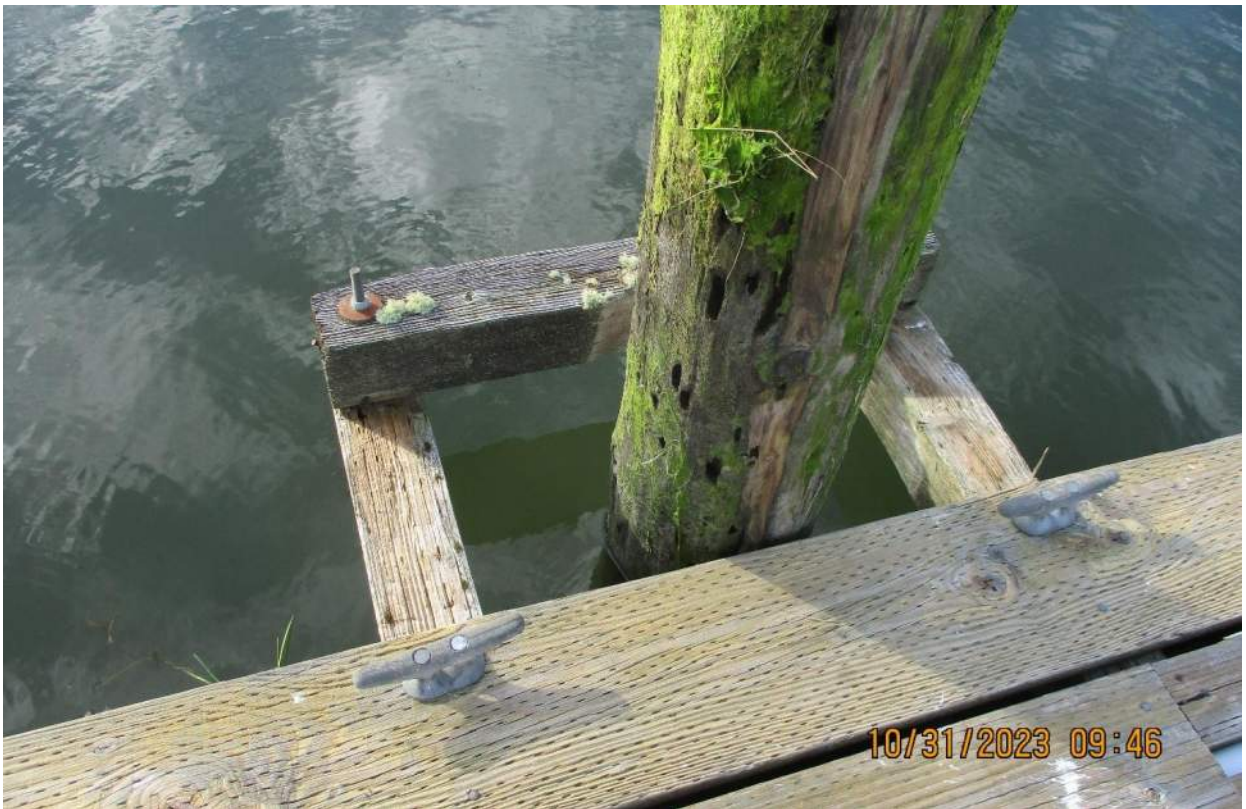
**Photo 2:**  
Close up showing possible marine borer activity.

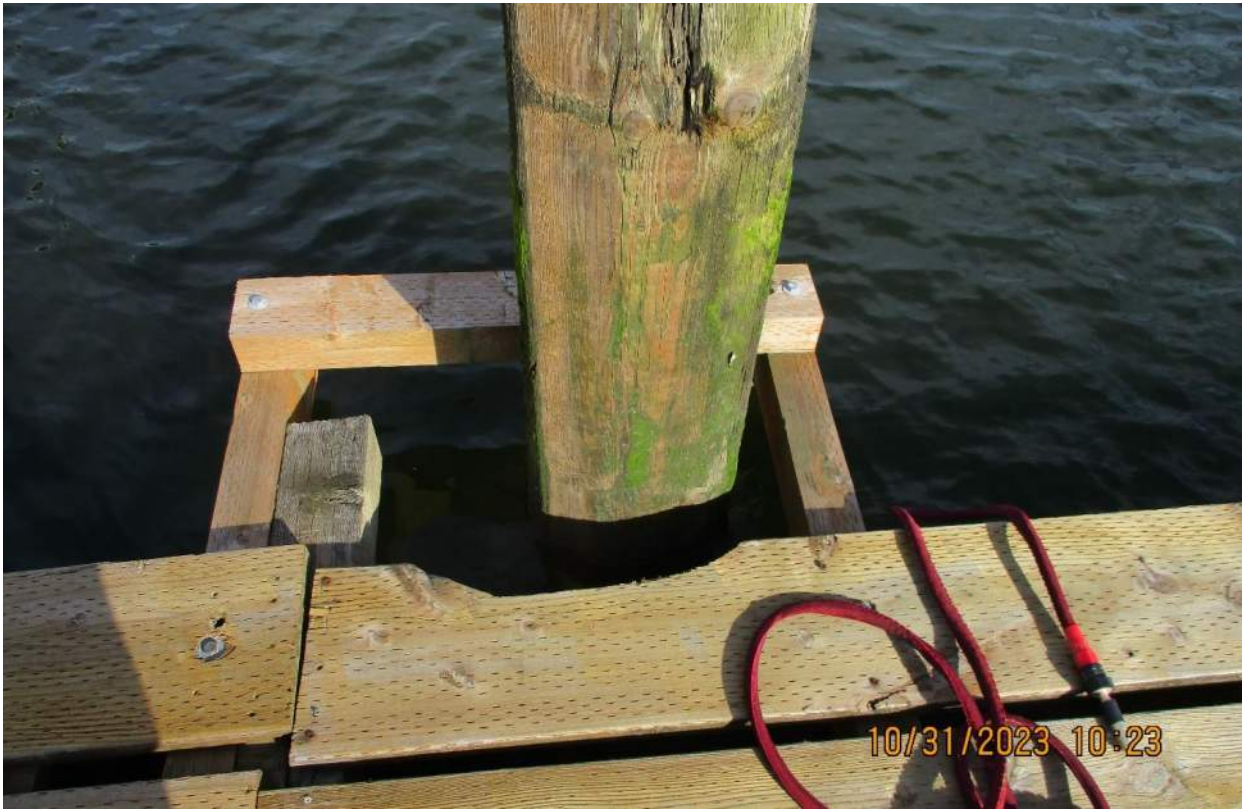
**Photo 3:**  
Recently replaced wooden pile hoop.

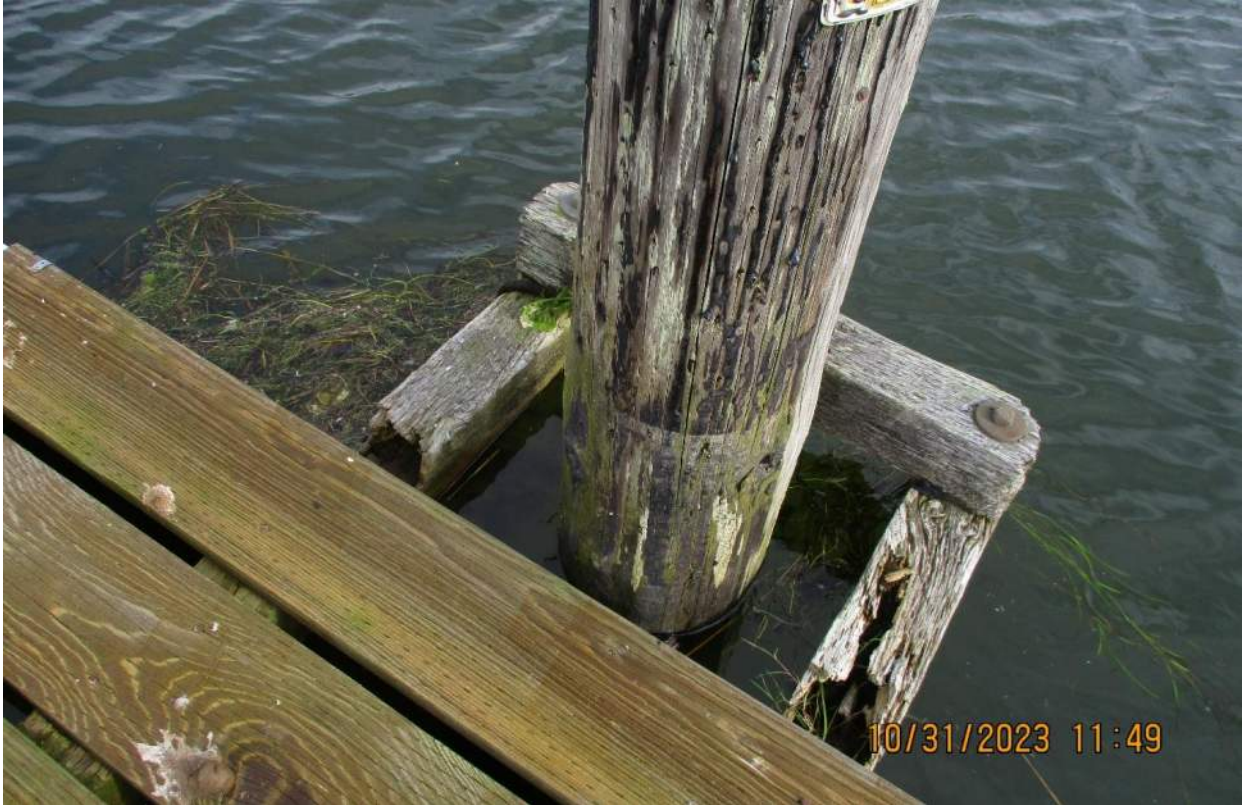
Piles are secured to the dock via wooden hoops above water or chains below water. Multiple piles, particularly on Dock C, G and H appeared to be lacking a positive connection to the float logs or severely decayed hoops; however, no lack of lateral stability of the dock was noted. The pile anchors and associated hardware that were visible appeared to be in fair condition; however, the capacity is limited by the level of decay in the float logs and stringers.

**Photo 5:**  
Severely decayed wooden pile hoop. Hardware appears to be intact, but timber is fully decayed.

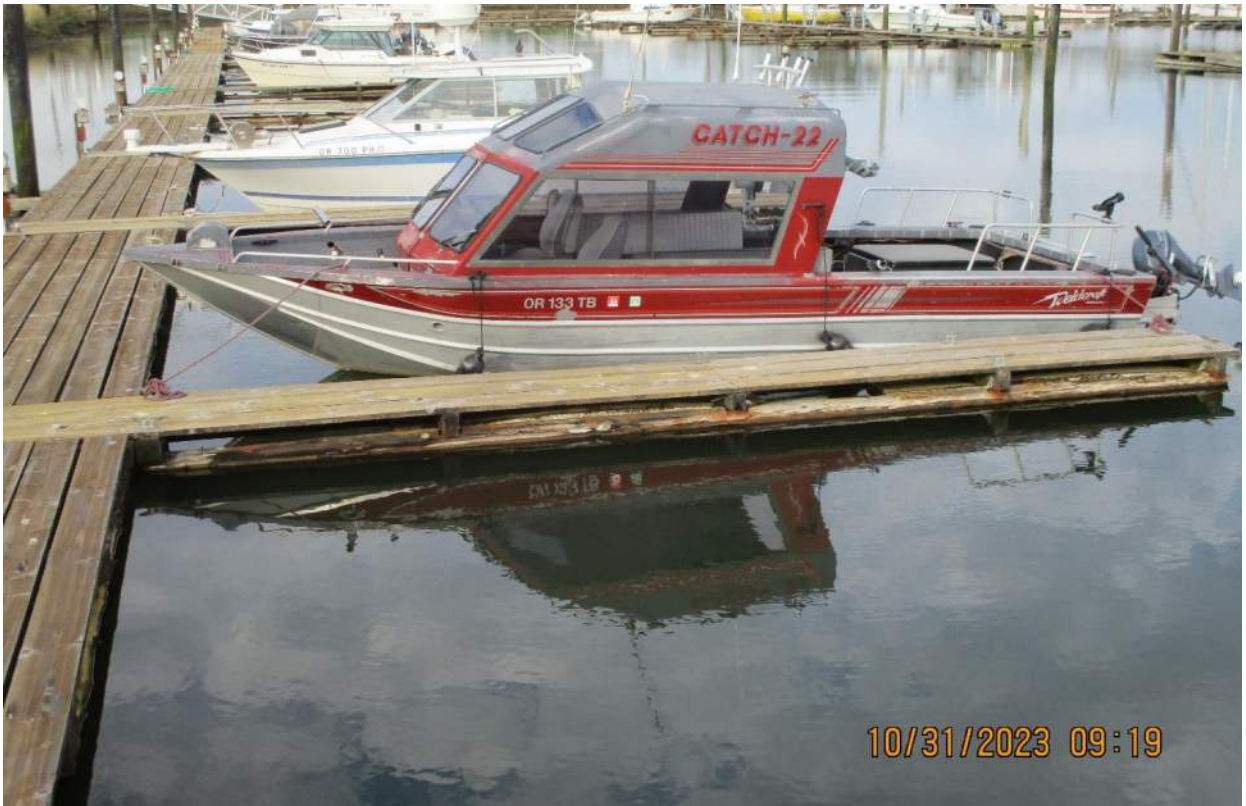
In general, the float logs are in poor condition. Multiple areas of obvious decay are noted, and a general lack of buoyancy is present throughout. Supplemental foam floats have been installed over time; however, these are beginning to fail as well. Photo 6 shows a representative condition of the float logs. Multiple areas were noted to lack stability while walking the dock, with it apparent that one float log was more buoyant than the other.

**Photo 6:**  
Typical float log condition. Can also see supplemental foam floats installed.

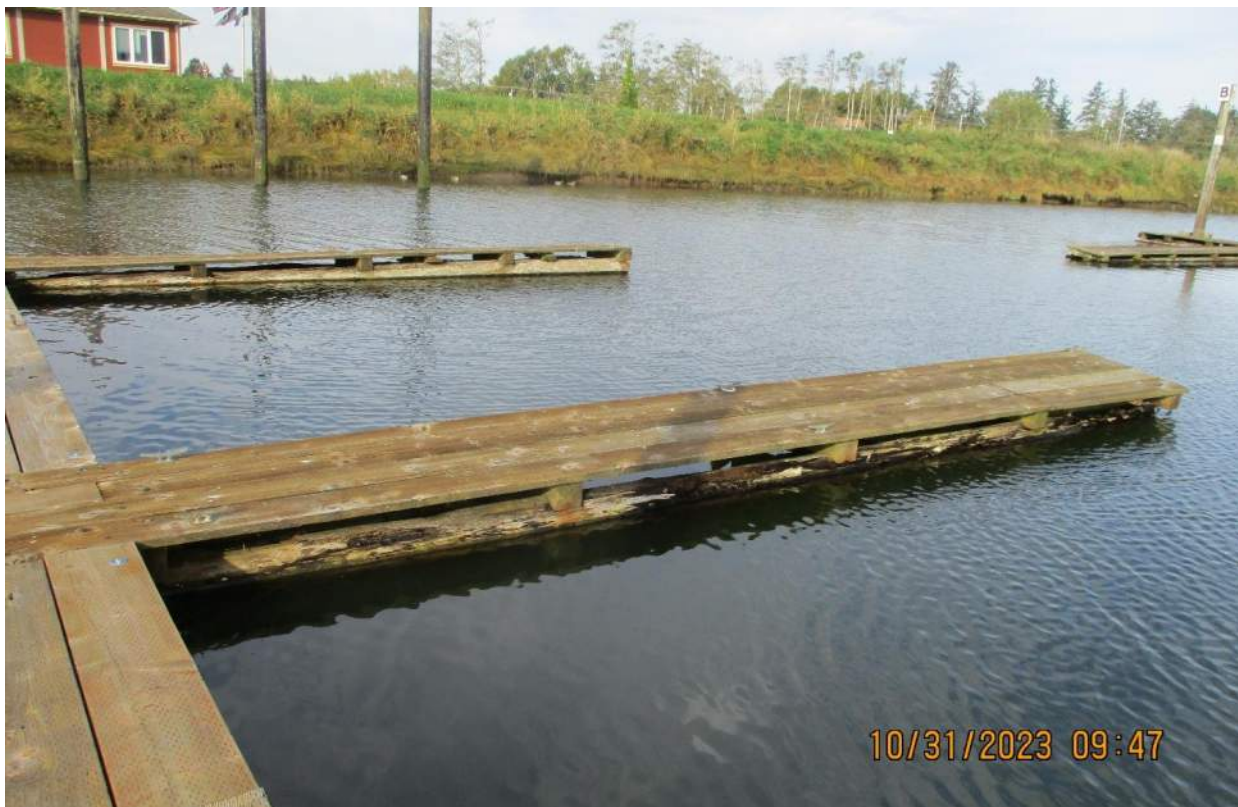
**Photo 7:**  
Uneven finger piers due to lack of buoyancy in float logs.

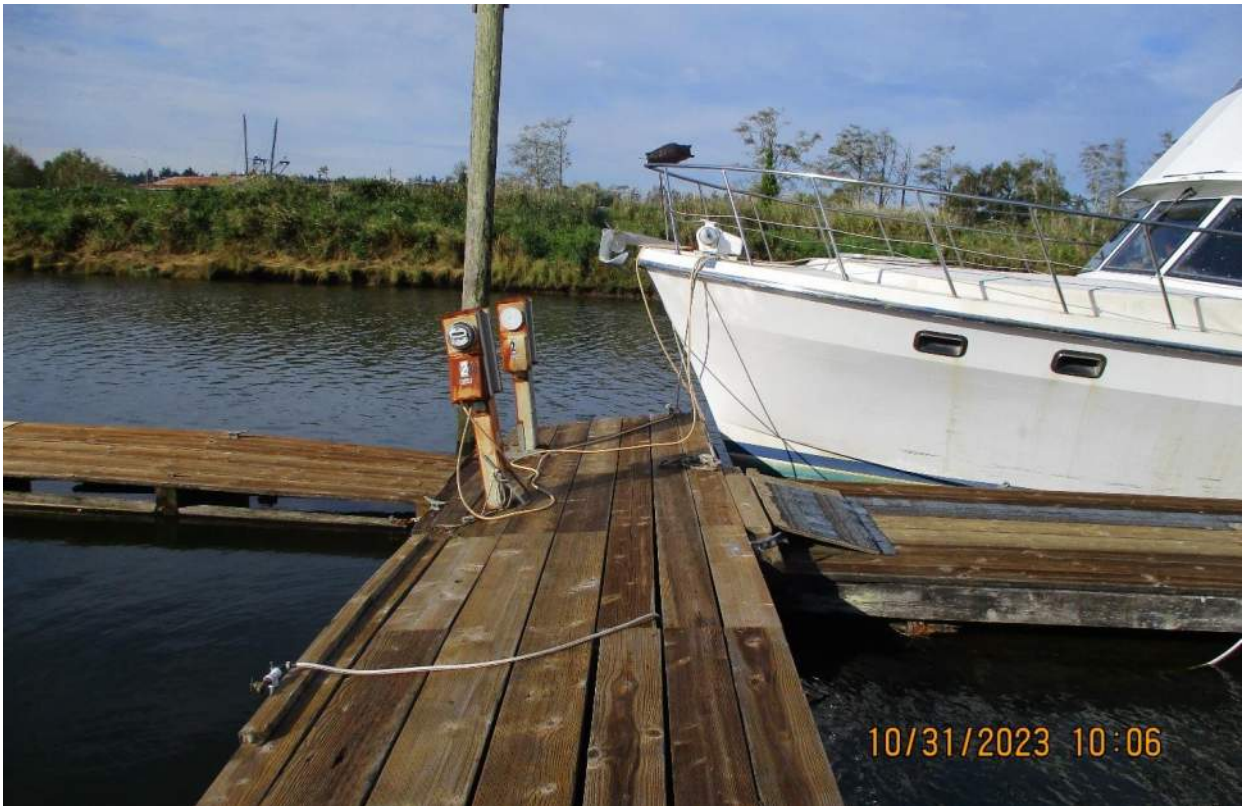
Dock A has had float logs replaced; however, logs of a different size than the original were installed, leading to significant racking of the walkway and finger piers. This is shown in Photo 10.

**Photo 10:**  
Significant heaving in Dock A due to an improperly sized float log replacement

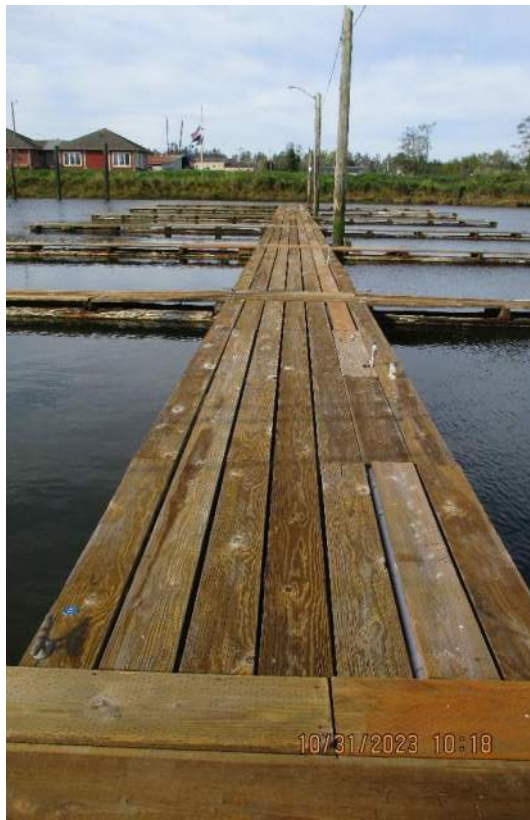
**Photo 11:**

The 2x6 decking is in generally fair to good condition, with no significant decay noted in the deck planks. Photo 11 shows a representative condition of the deck planks. Excessive deflections of the decking under pedestrian loading were noted throughout; however, this appears to be due to the long spans of the planks. The 6x6 and 6x8 stringers supporting the deck are on roughly 8-ft centers. It appears that the decking is regularly maintained and replaced when needed.

Typical deck condition. Note the finger pier decking intersecting and continuous over the main walkway.

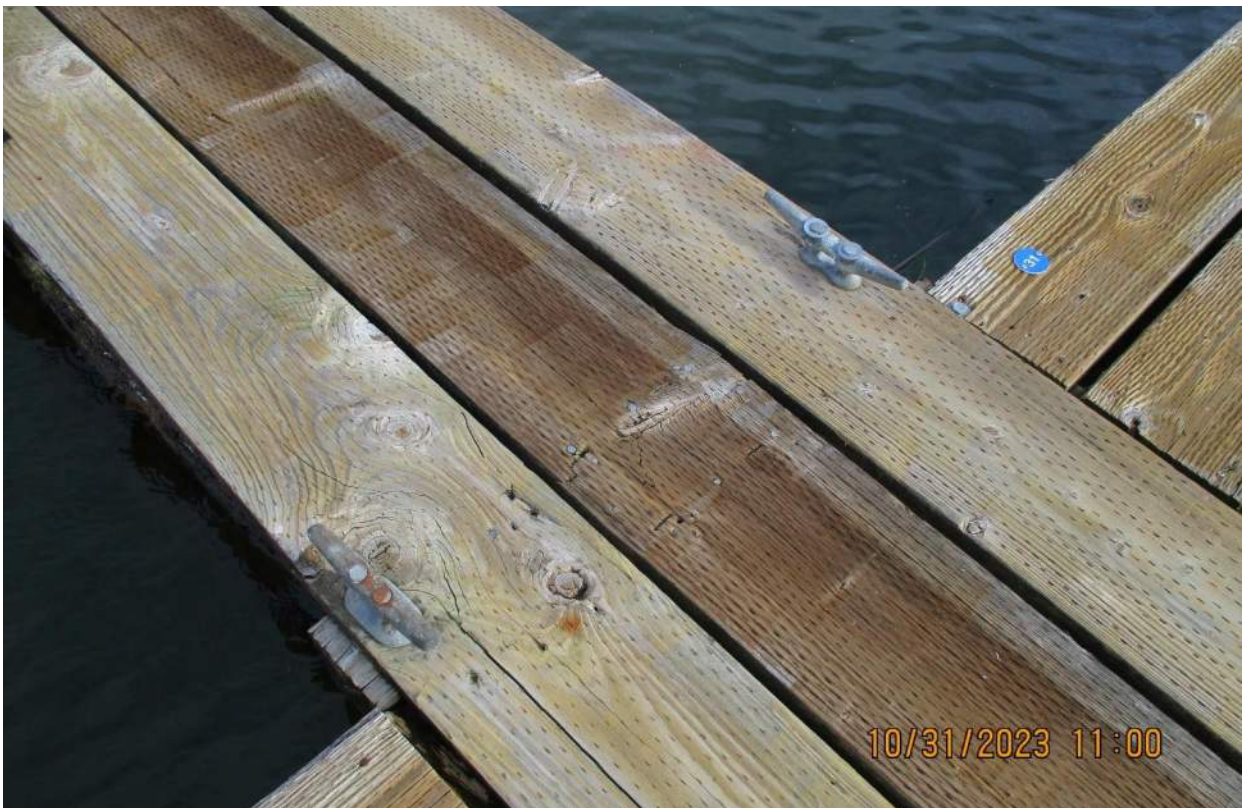
**Photo 12:**

Cracks in the decking are noted throughout the facility where the main walkway intersects the fingers. This occurs where the deck planks for the finger are tied into the main

walkway. This creates excessive stress in the deck as the finger and walkway are unable to move freely. The deck is cracking to create the joint that is not present. This is exacerbated where there are no piles present at the ends of the finger piers. Photo 12 shows the cracking in the deck planks (near the nail line), while Photos 11 and 13 shows a sample of the detail causing this.

Distress in the finger pier decking where it crosses over and is continuous with the main walkway.

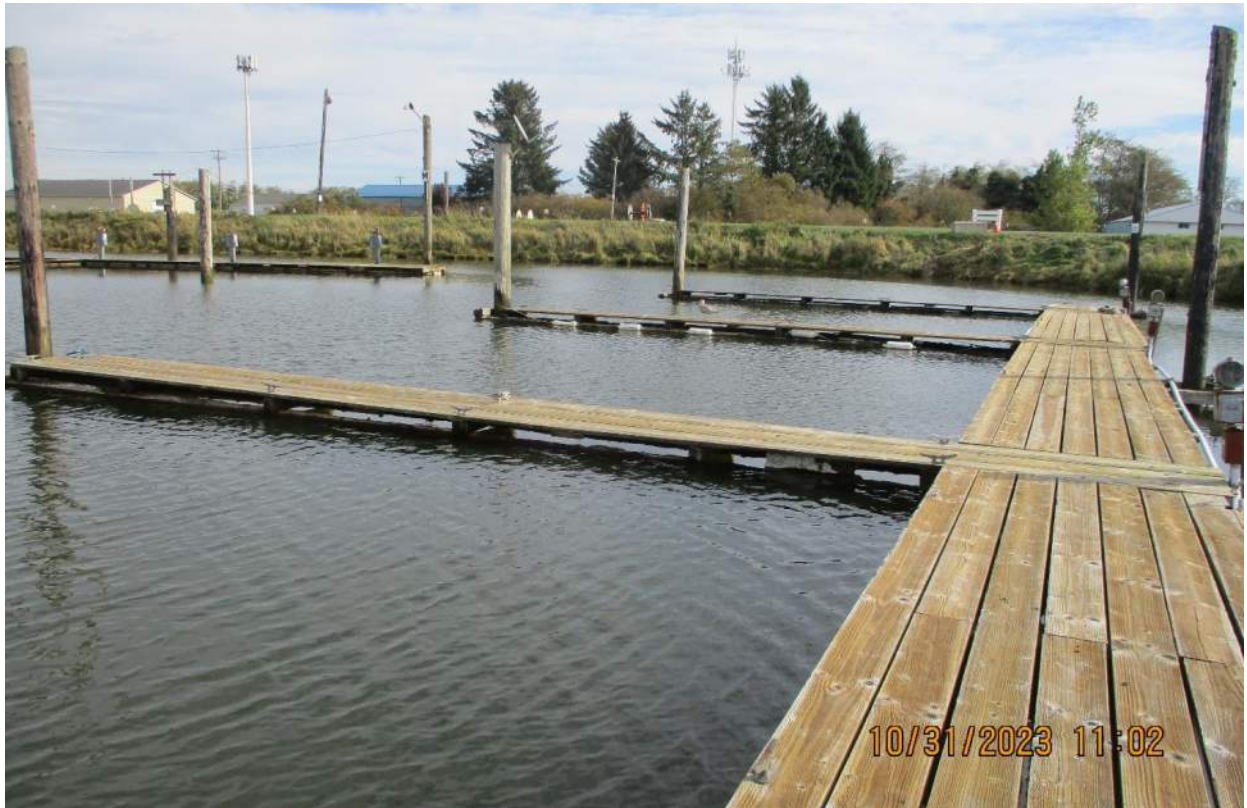
**Photo 13:**  
Another example of finger pier decking continuous into the walkway.

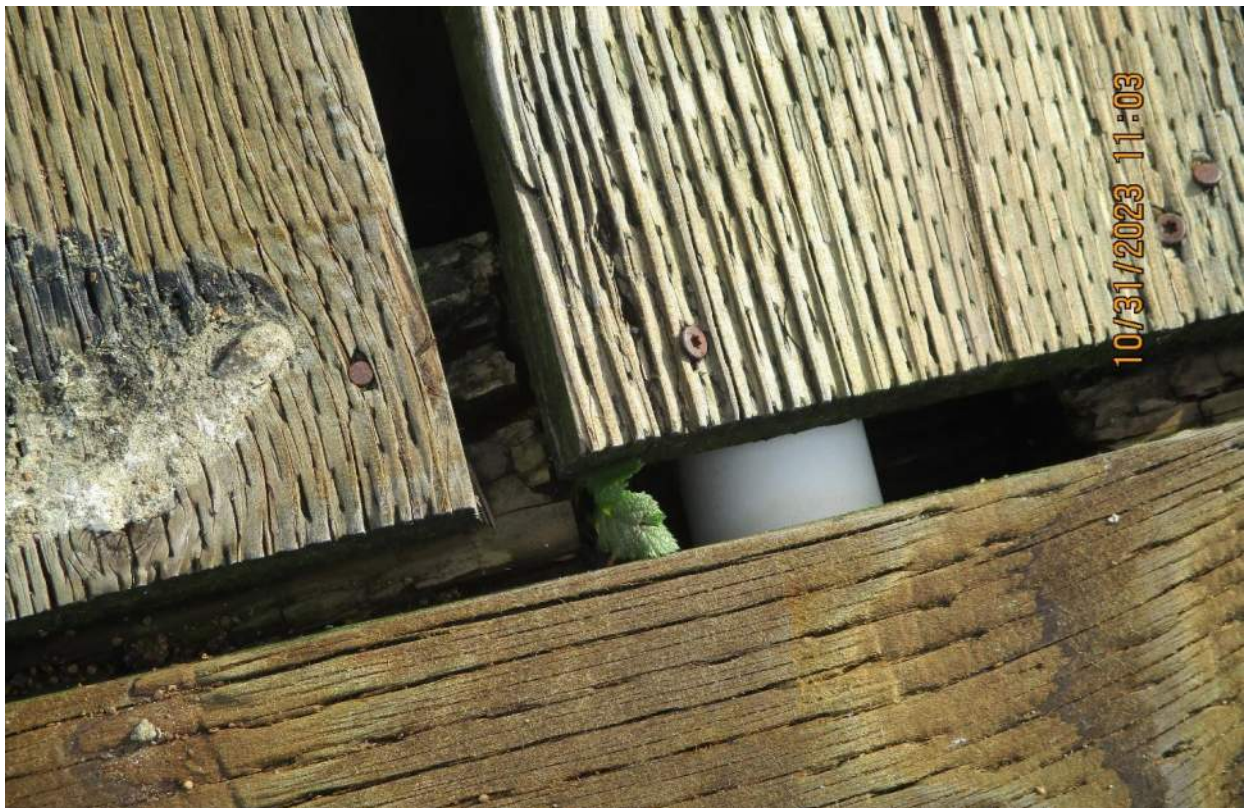
The stringers supporting the deck were noted to be in generally fair condition. Multiple stringers throughout the facility show signs of decay at the exposed ends; however, none were noted to be broken. There are locations throughout the facility where stringers have been cut to allow the passage of a PVC pipe for water distribution on the docks. In some instances, an additional member has been sistered in to reinforce the cut member, but in other locations, it is simply the deck planks passing over the top keeping the two halves together. This leads to a lack of support for the deck and areas that exhibit significant deflections under loading. In some cases, it also leads to a localized instability where the deck deflects along a longitudinal line under loading (see Photo 14).

**Photo 14:**  
Example of cut stringer to allow for water pipe to be installed below the deck.

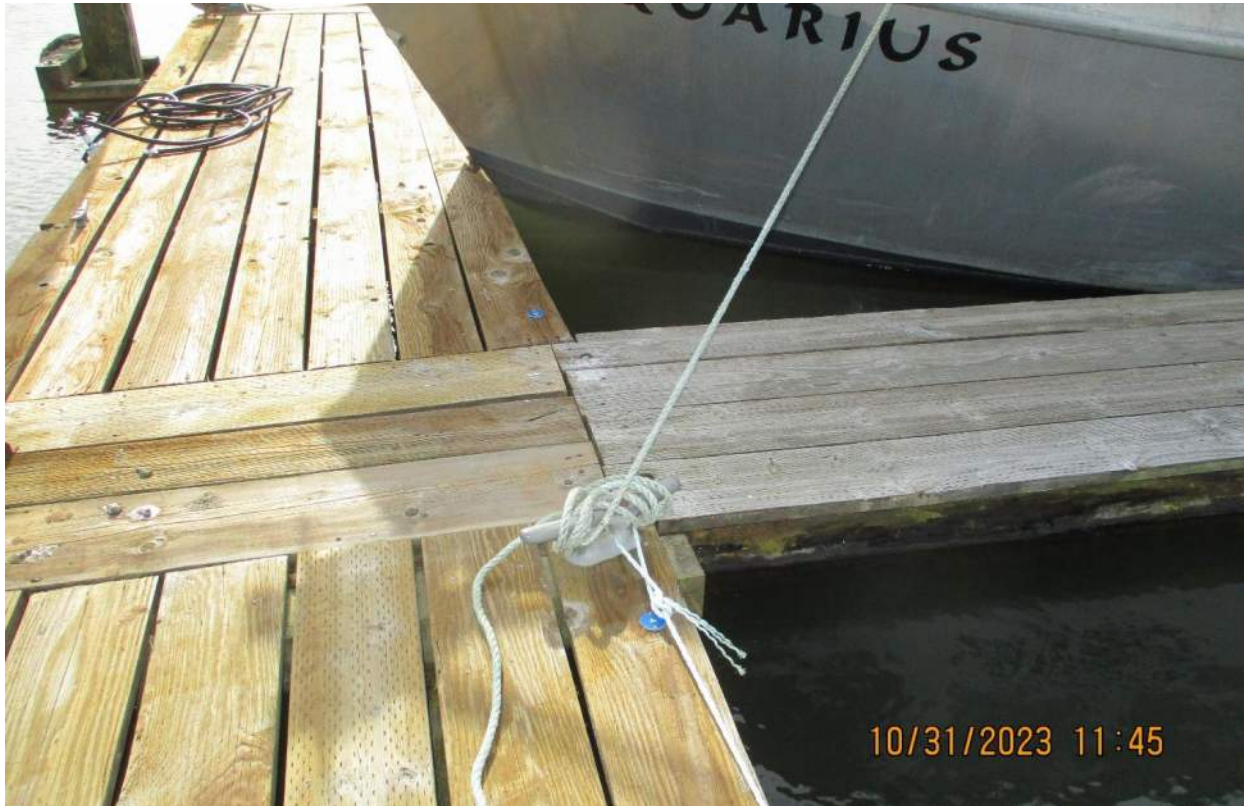
During HDR's visit, the vessel Aquarius was berthed in slips 5 and 6 of Dock M. It was noted that this vessel had inadequate springlines, and was riding up onto the dock, pushing the dock out of alignment and causing damage to the deck. It appears that a vessel (whether this one or others) is regularly moored there, as the damage to the deck did not appear to be recent. See Photo 15.

**Photo 15:**  
Vessel Aquarius riding up on the dock.

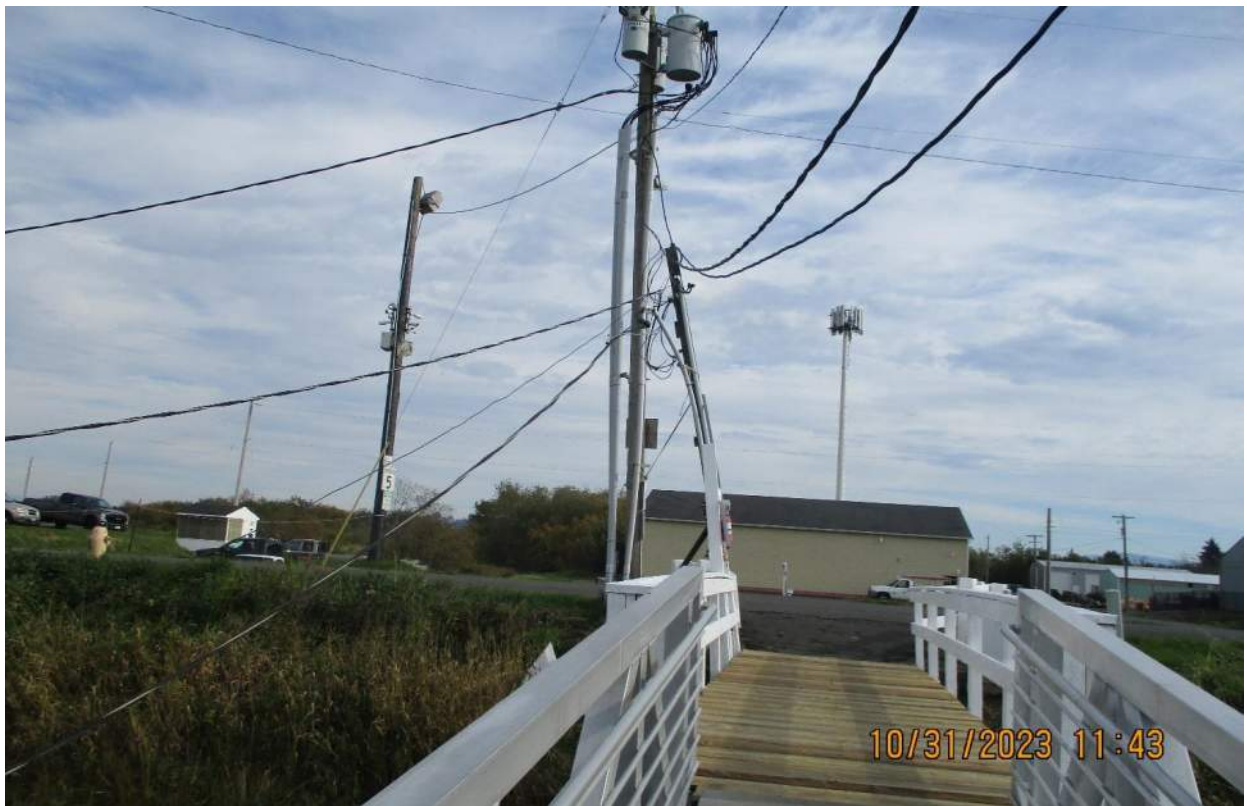
**Photo 16:**  
Handrail being pulled down by utility pole.

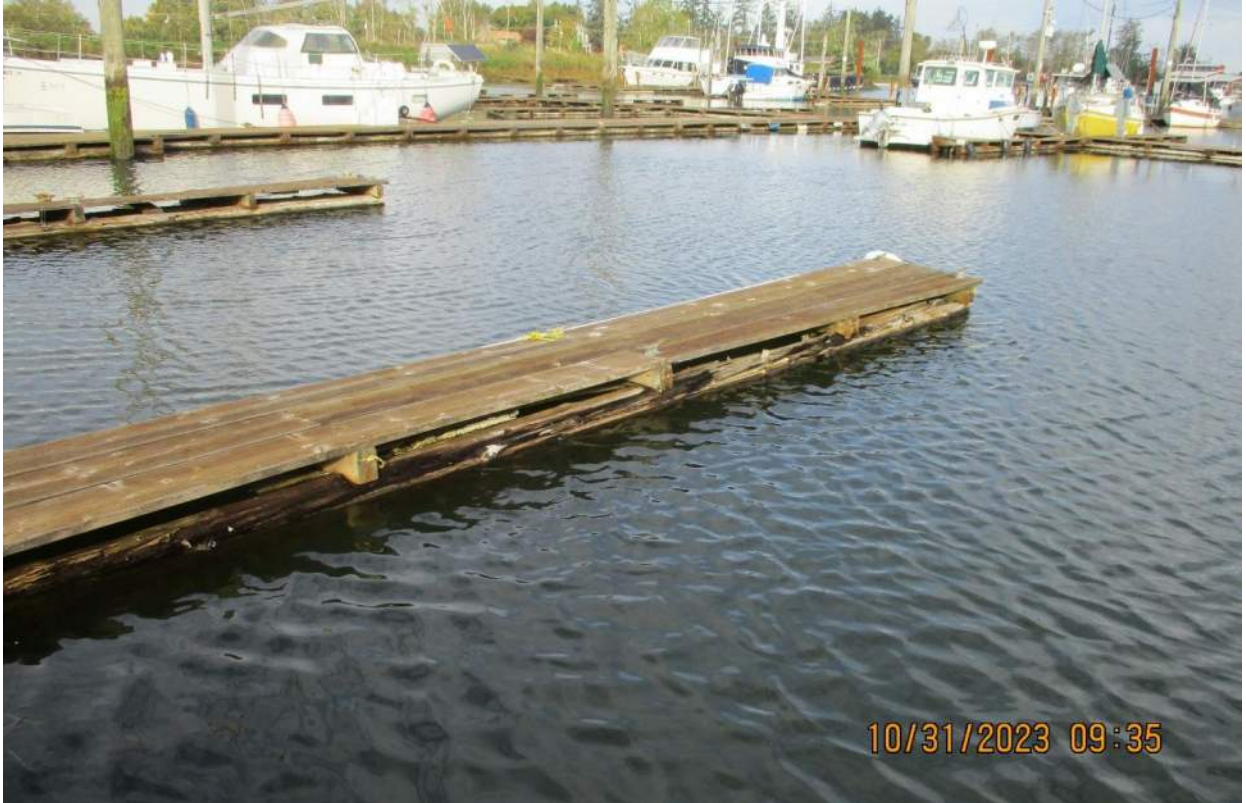
Photo 17 shows the existing trestle, with Photos 18 and 19 depicting the condition of the gangway.

**Photo 17:**  
Typical condition of existing trestles. Note the decay in the timber piling.

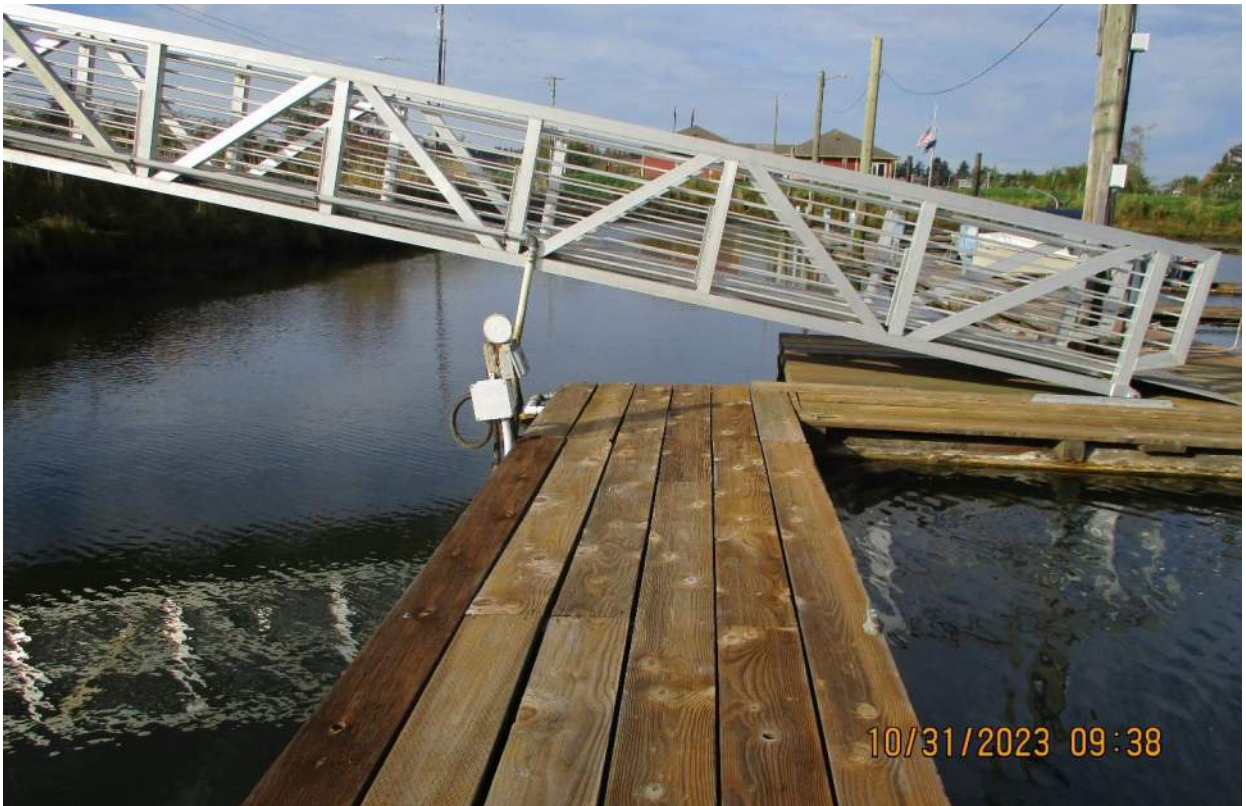
**Photo 18:**  
Typical condition of the gangway

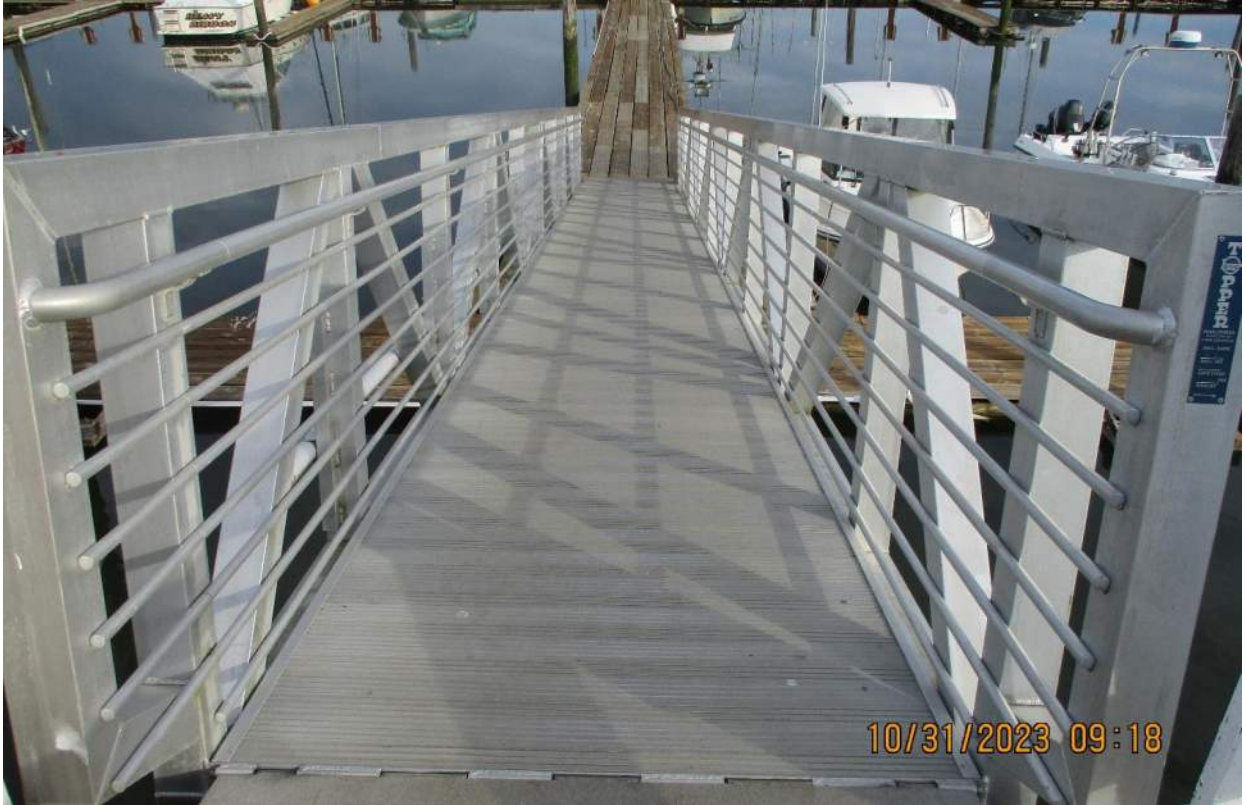
**Photo 19:**  
Another photo of the gangway.

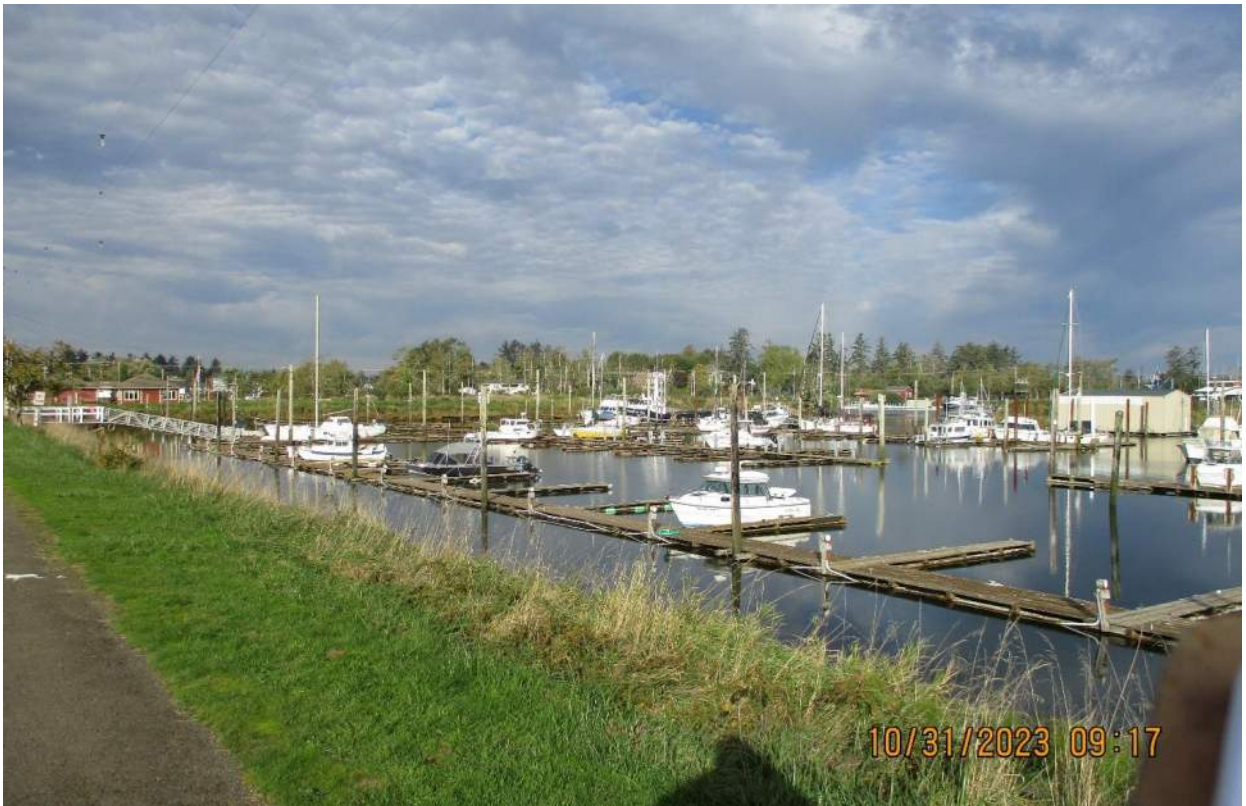
**Photo 20:**  
Overall view of the marina. Note the PVC conduits in the water.

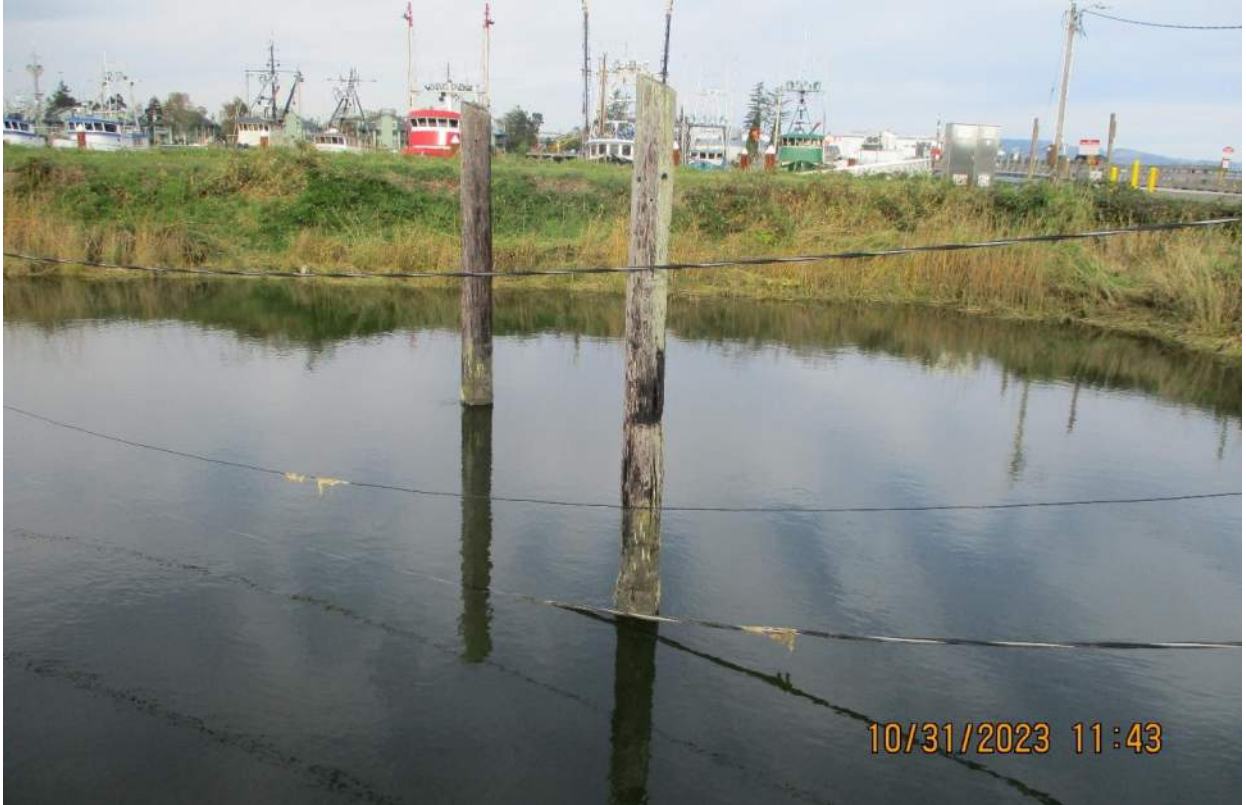
**Photo 21:**  
Utility drop in the water near Dock N.

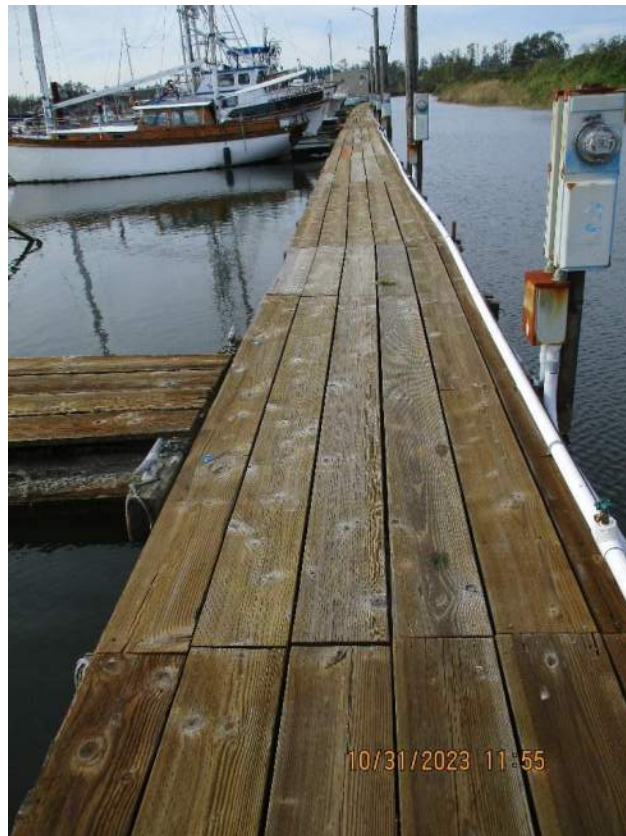
**Photo 23:**  
Recently replaced water piping along Dock N. Should be a model for future piping repairs.

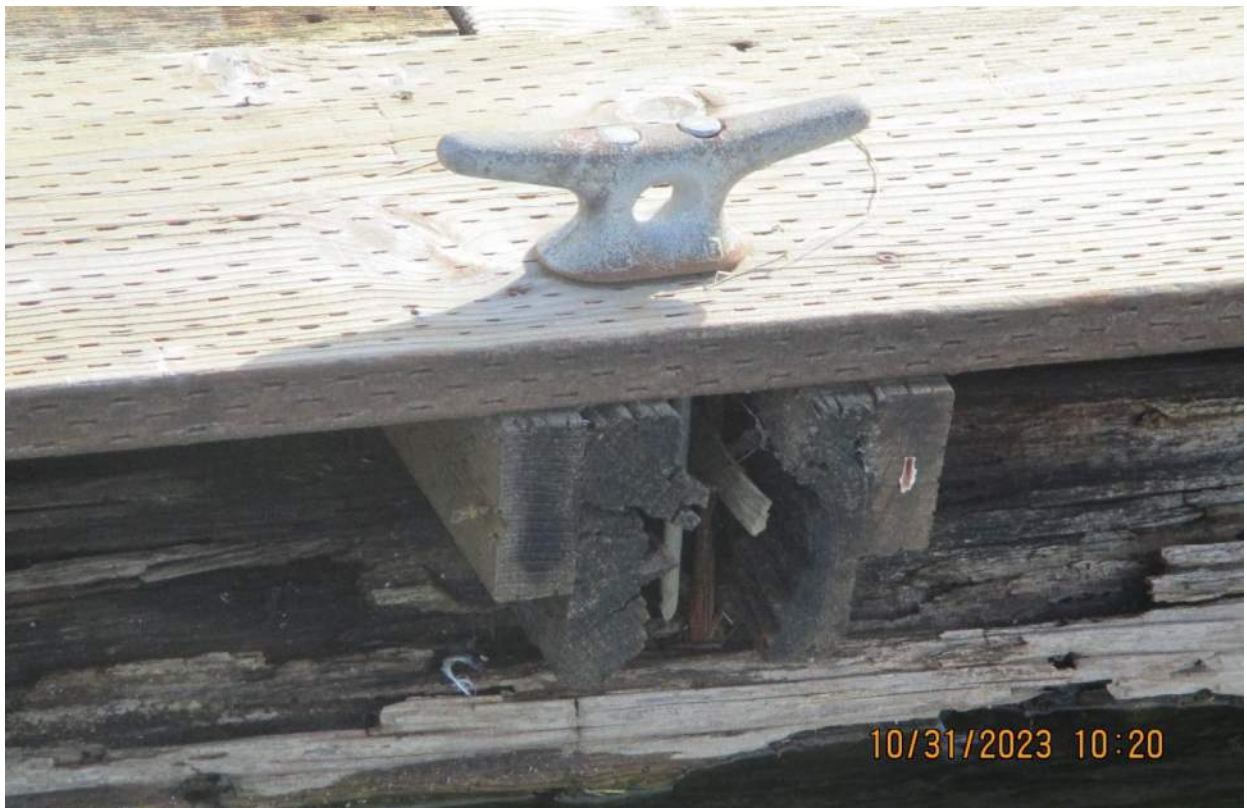
**Photo 24:**  
Typical condition of cleat. Cleat is only restrained by the deck, stringer below is decayed.

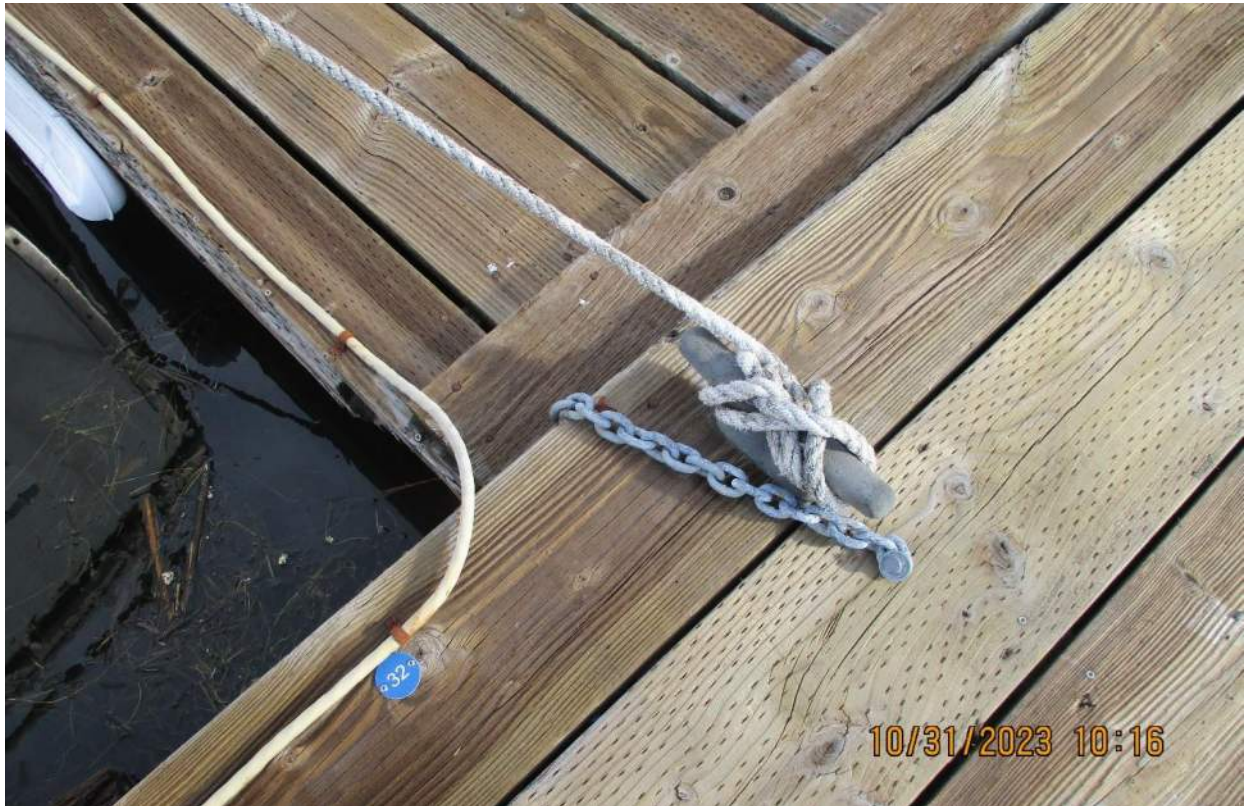
**Photo 25:**  
Chain connection, with lag bolt into the deck. Unclear if lag bolt is into stringer below.
