### MARINA ADVISORY COMMITTEE

February 26, 2024 at 2pm

HDR was retained by the City of Warrenton to perform an evaluation of the Warrenton Marina to assess general condition of the docks, identify any recommended repairs and/or replacement of the docks, and provide guidance on prioritization of upgrades and maintenance.

# **Underwater Condition Assessment of Warrenton Marina**

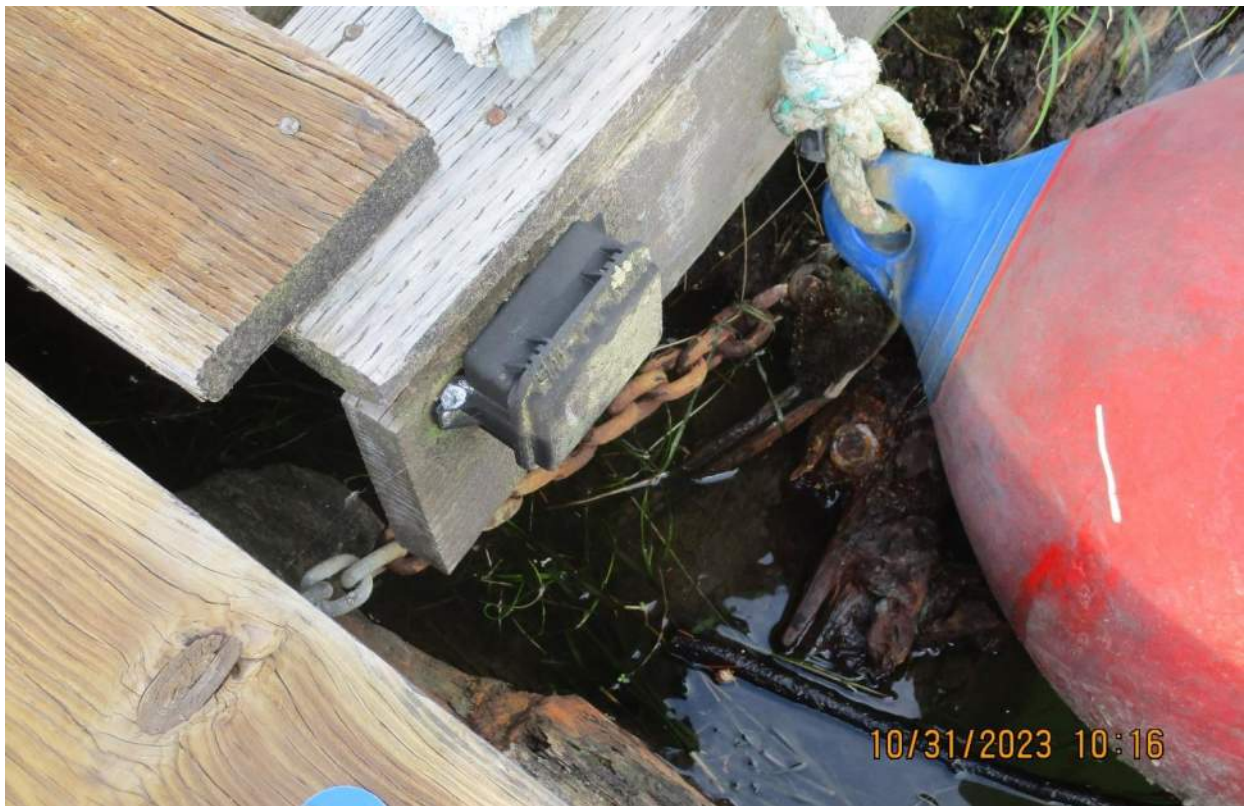
**Photo 26:**  
Decayed chain connect. Note corrosion in chain and heavily corroded hardware in float log.

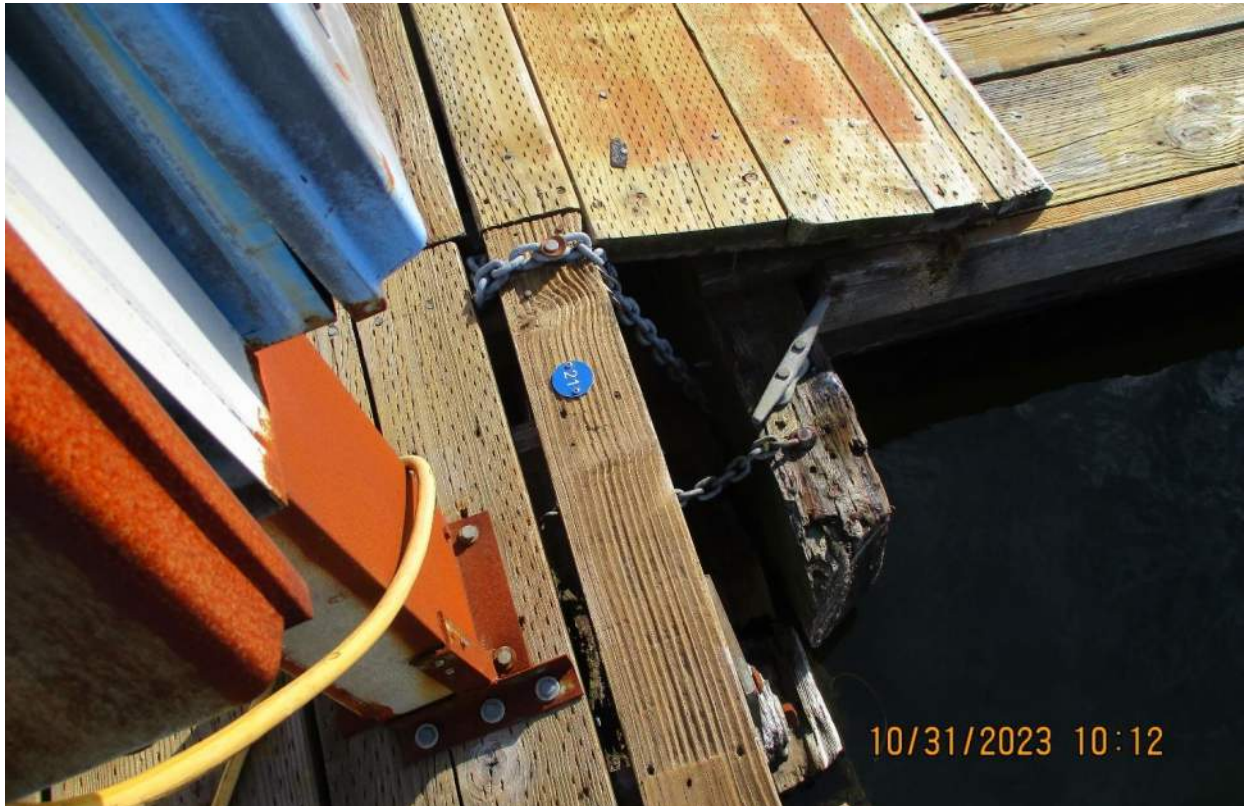
**Photo 27:**  
Chain connection, lagged into deck only.

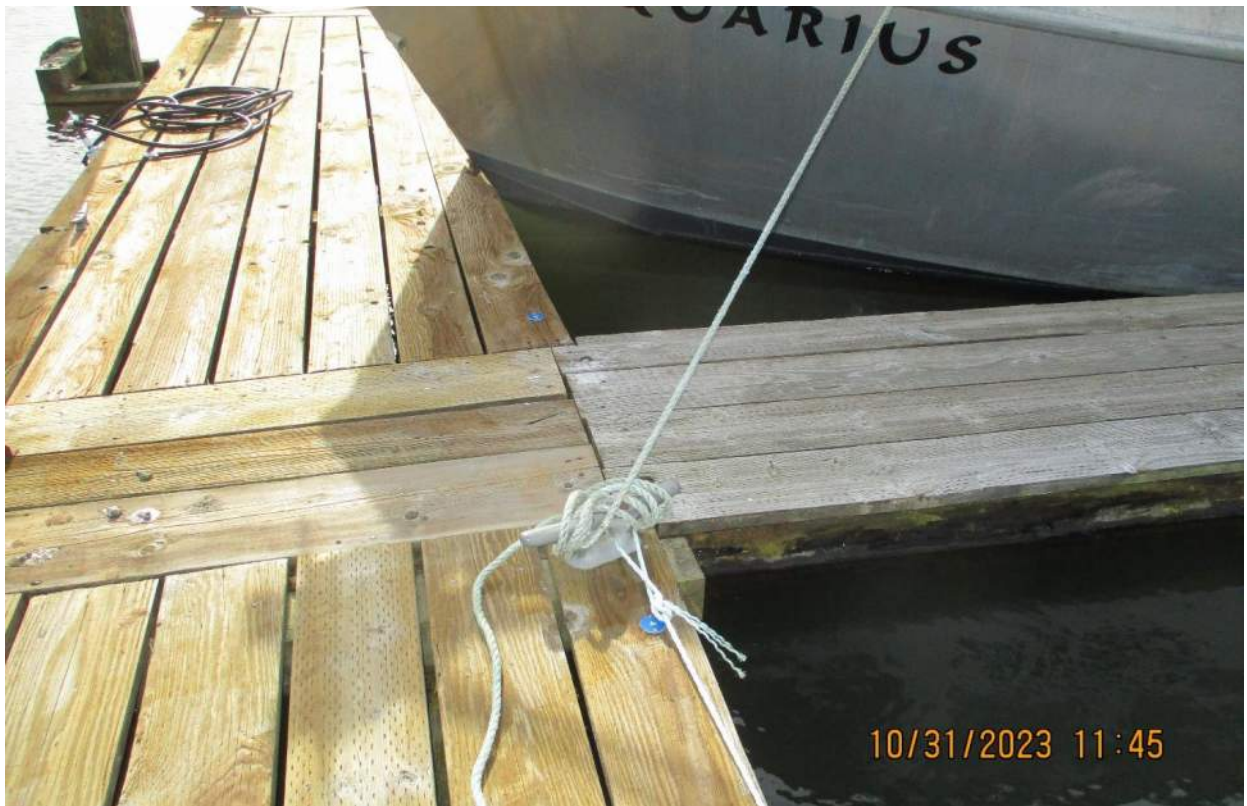
**Photo 28:**  
Ledger type connection where finger pier meets main walkway.

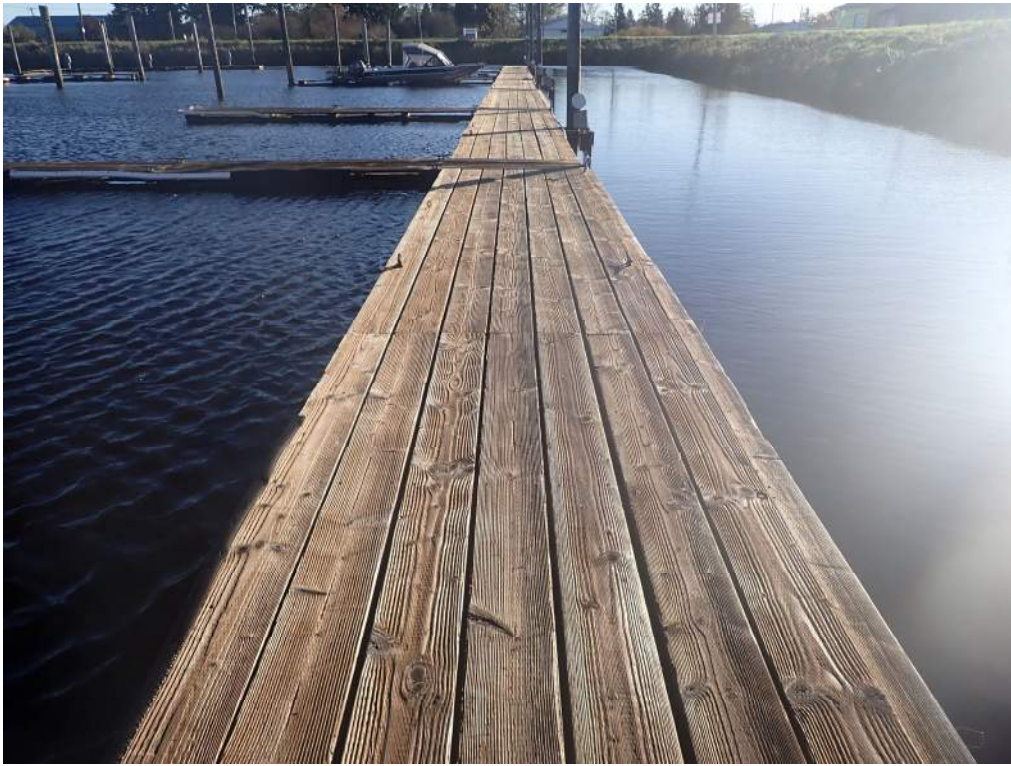
Photograph 7– Typical Main Floating Dock Condition

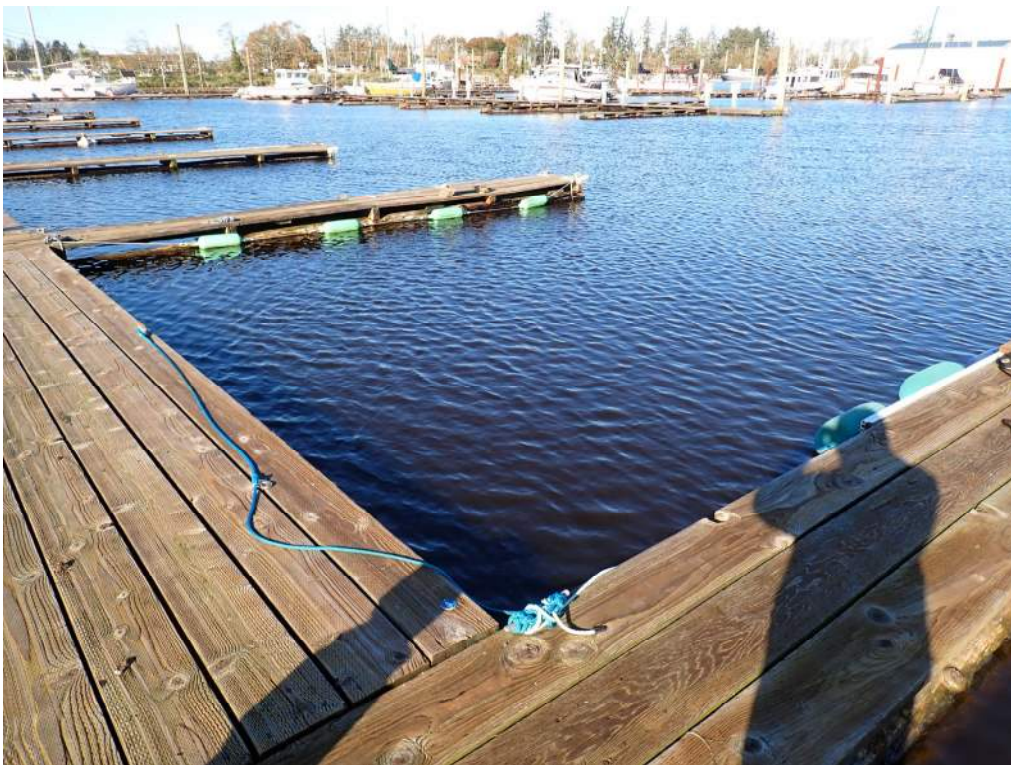
Photograph 8– Typical Finger Pier Condition

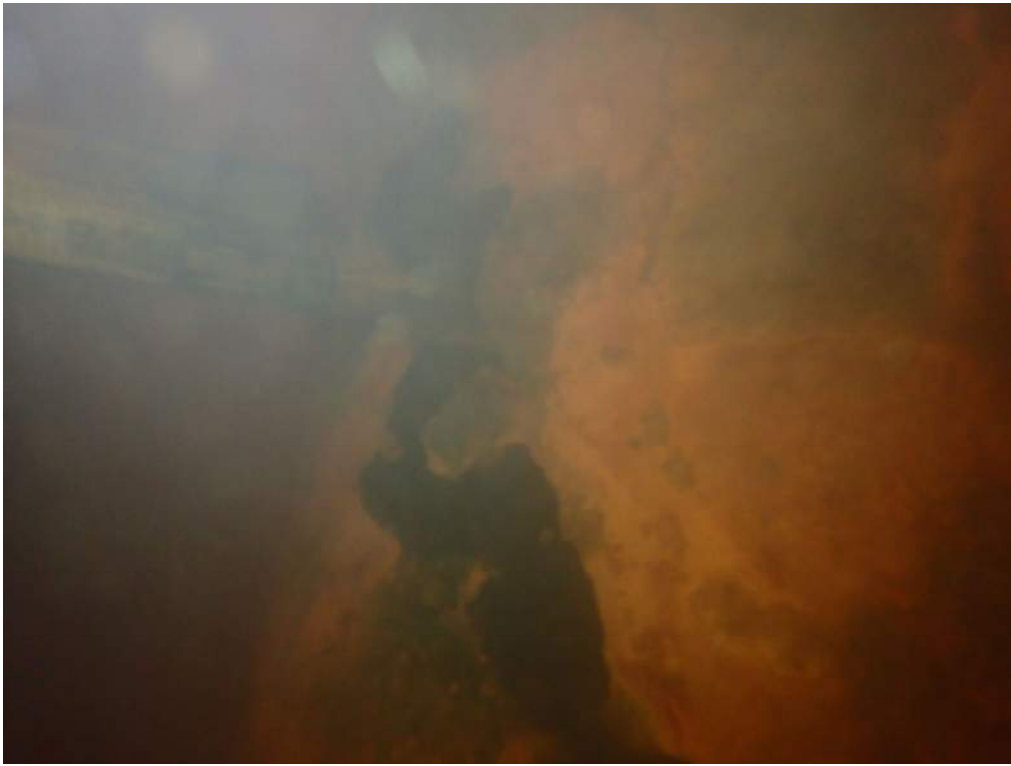
Photograph 21– Corrosion Hole in Steel Pile at Dock N , Between Slips 14 and 15

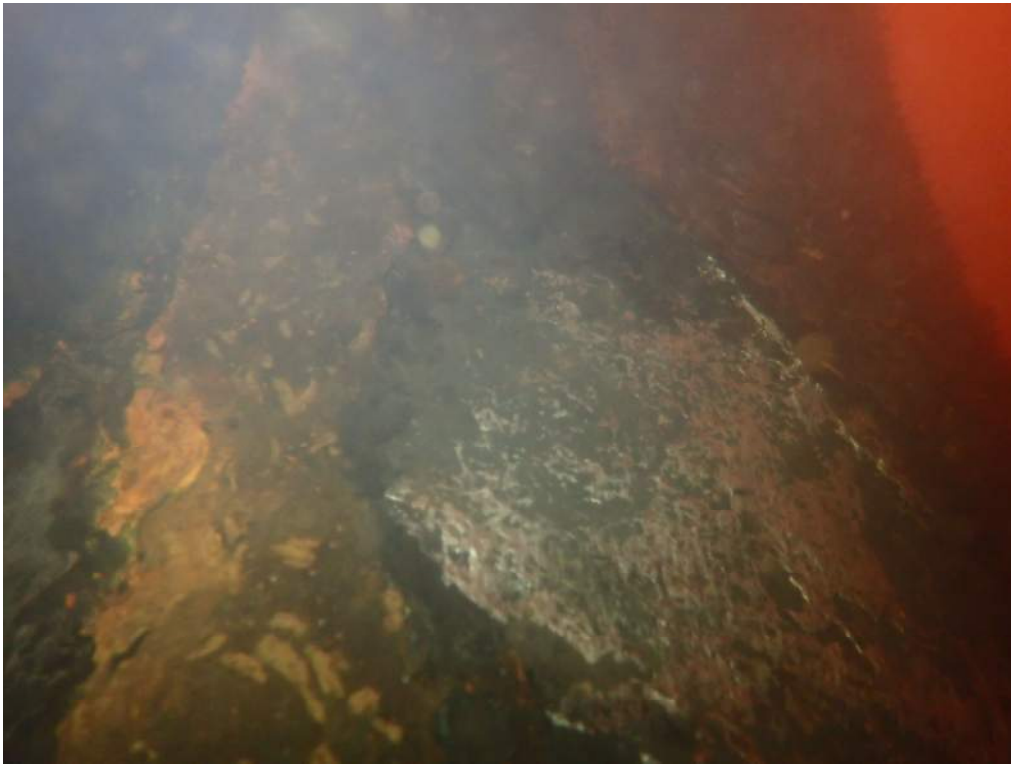
Photograph 25– Typical Flaking Corrosion on Steel Piles Below Water

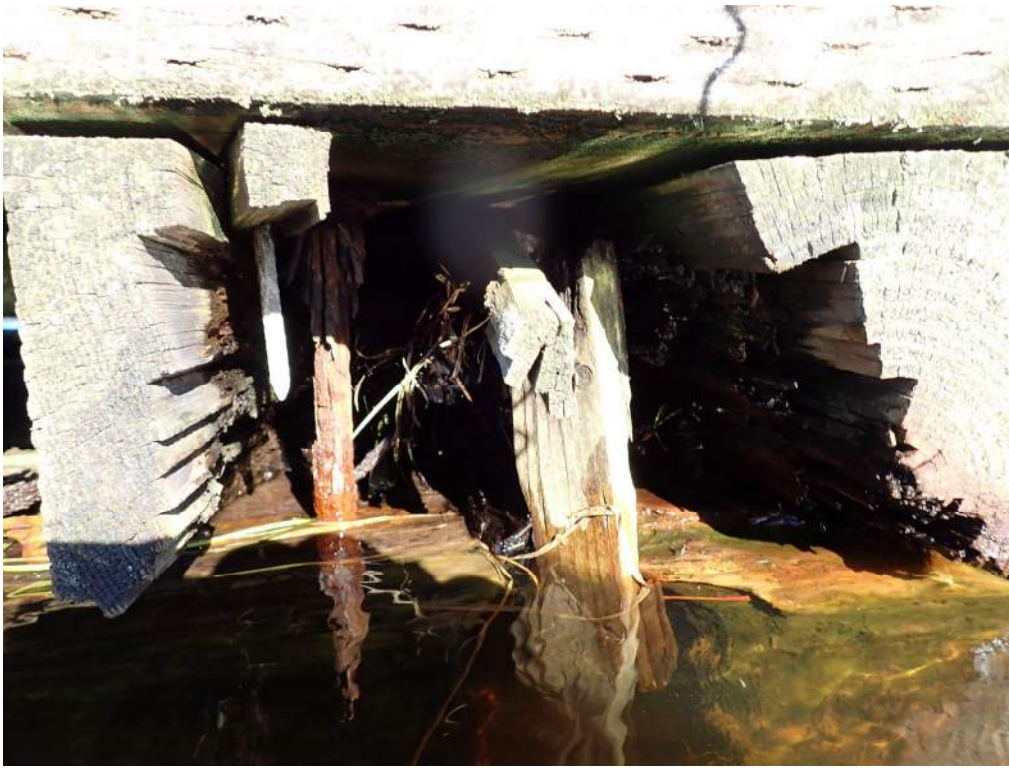
Photograph 29— Loose Connection Between Timber Float and Transverse Timber Support

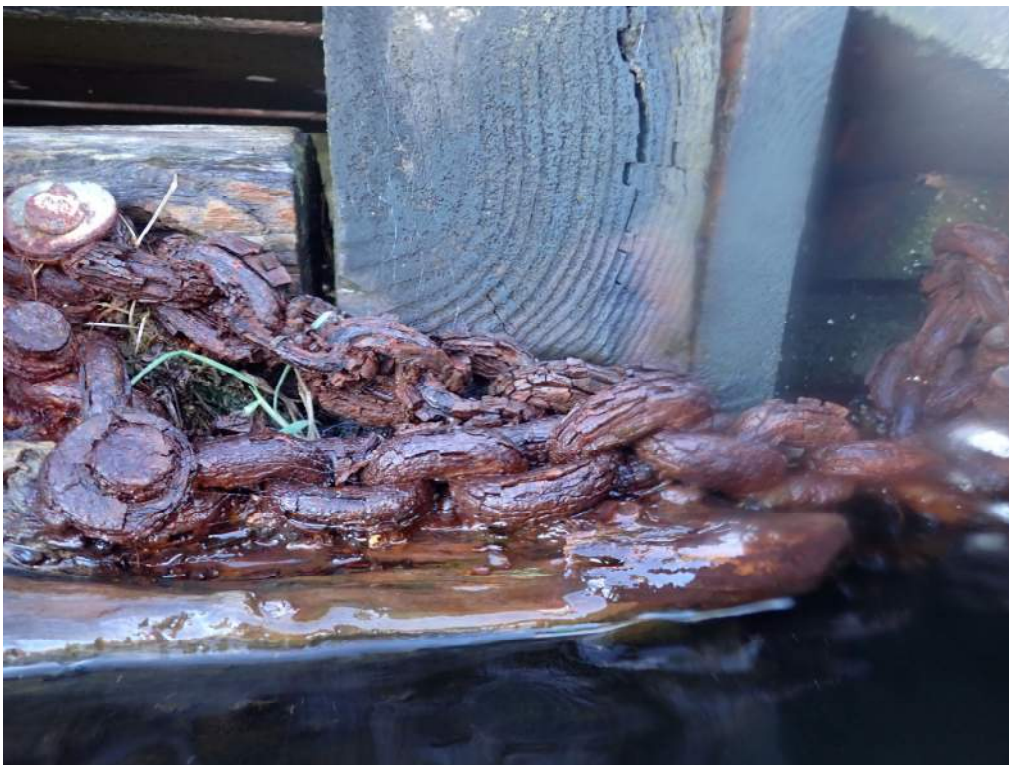
Photograph 30— Flaking Rust at Chain Connection at Dock C, Slip 36

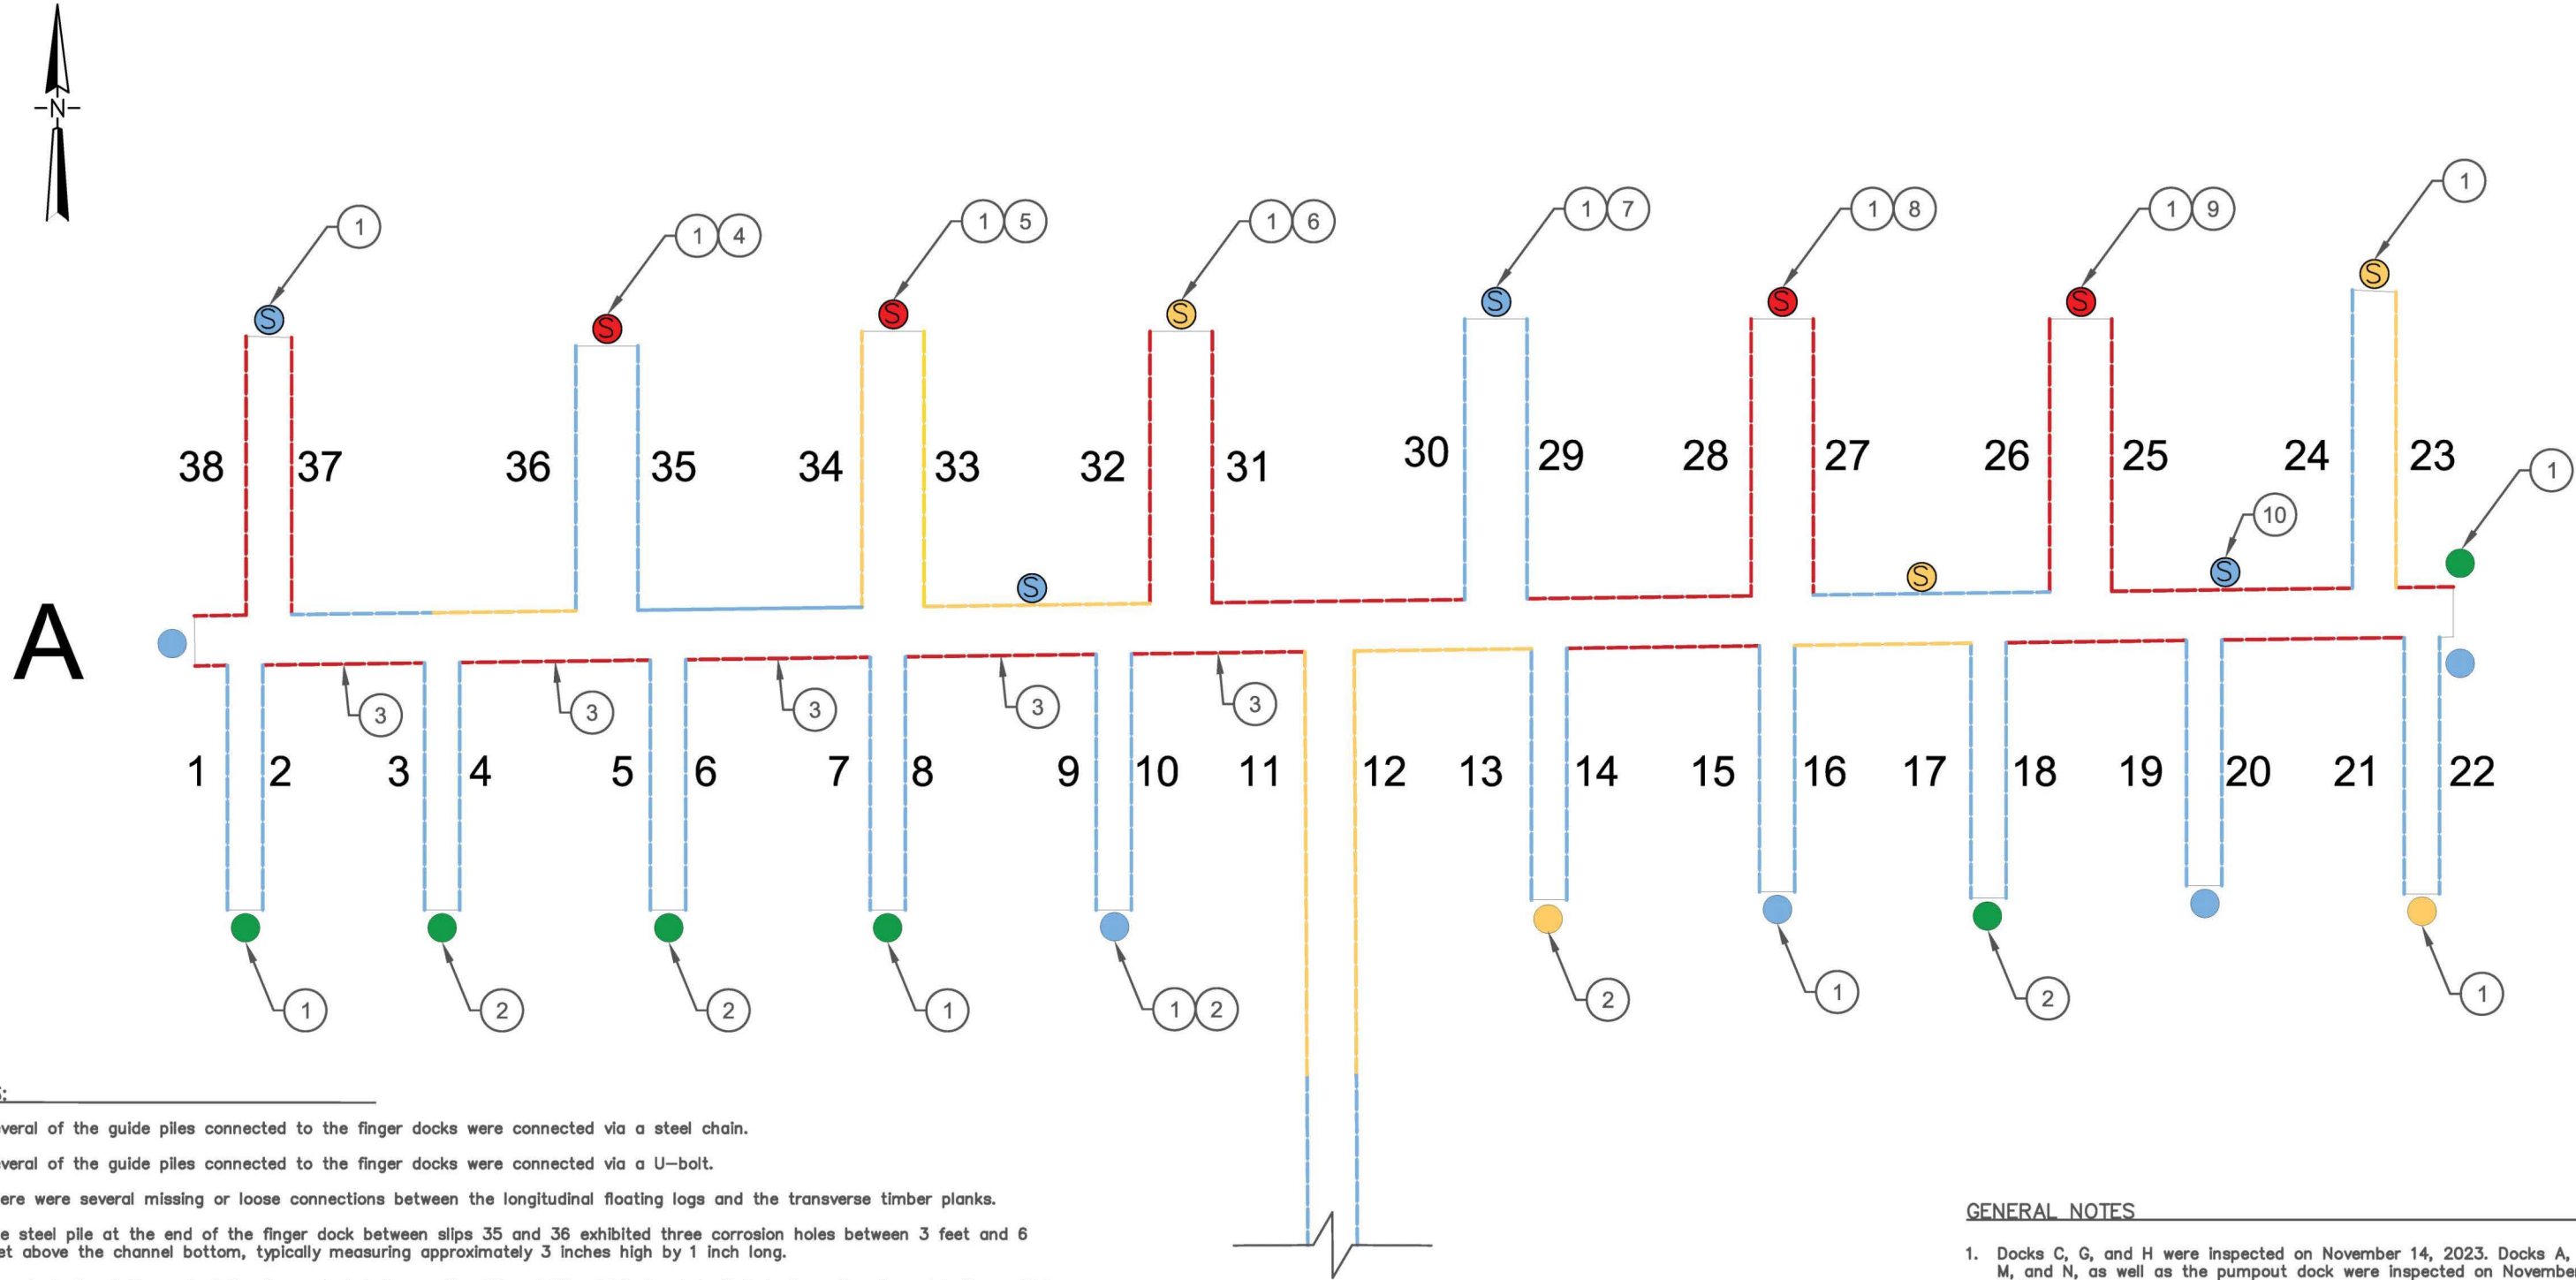
- ① Several of the guide piles connected to the finger docks were connected via a steel chain.
- ② Several of the guide piles connected to the finger docks were connected via a U-bolt.

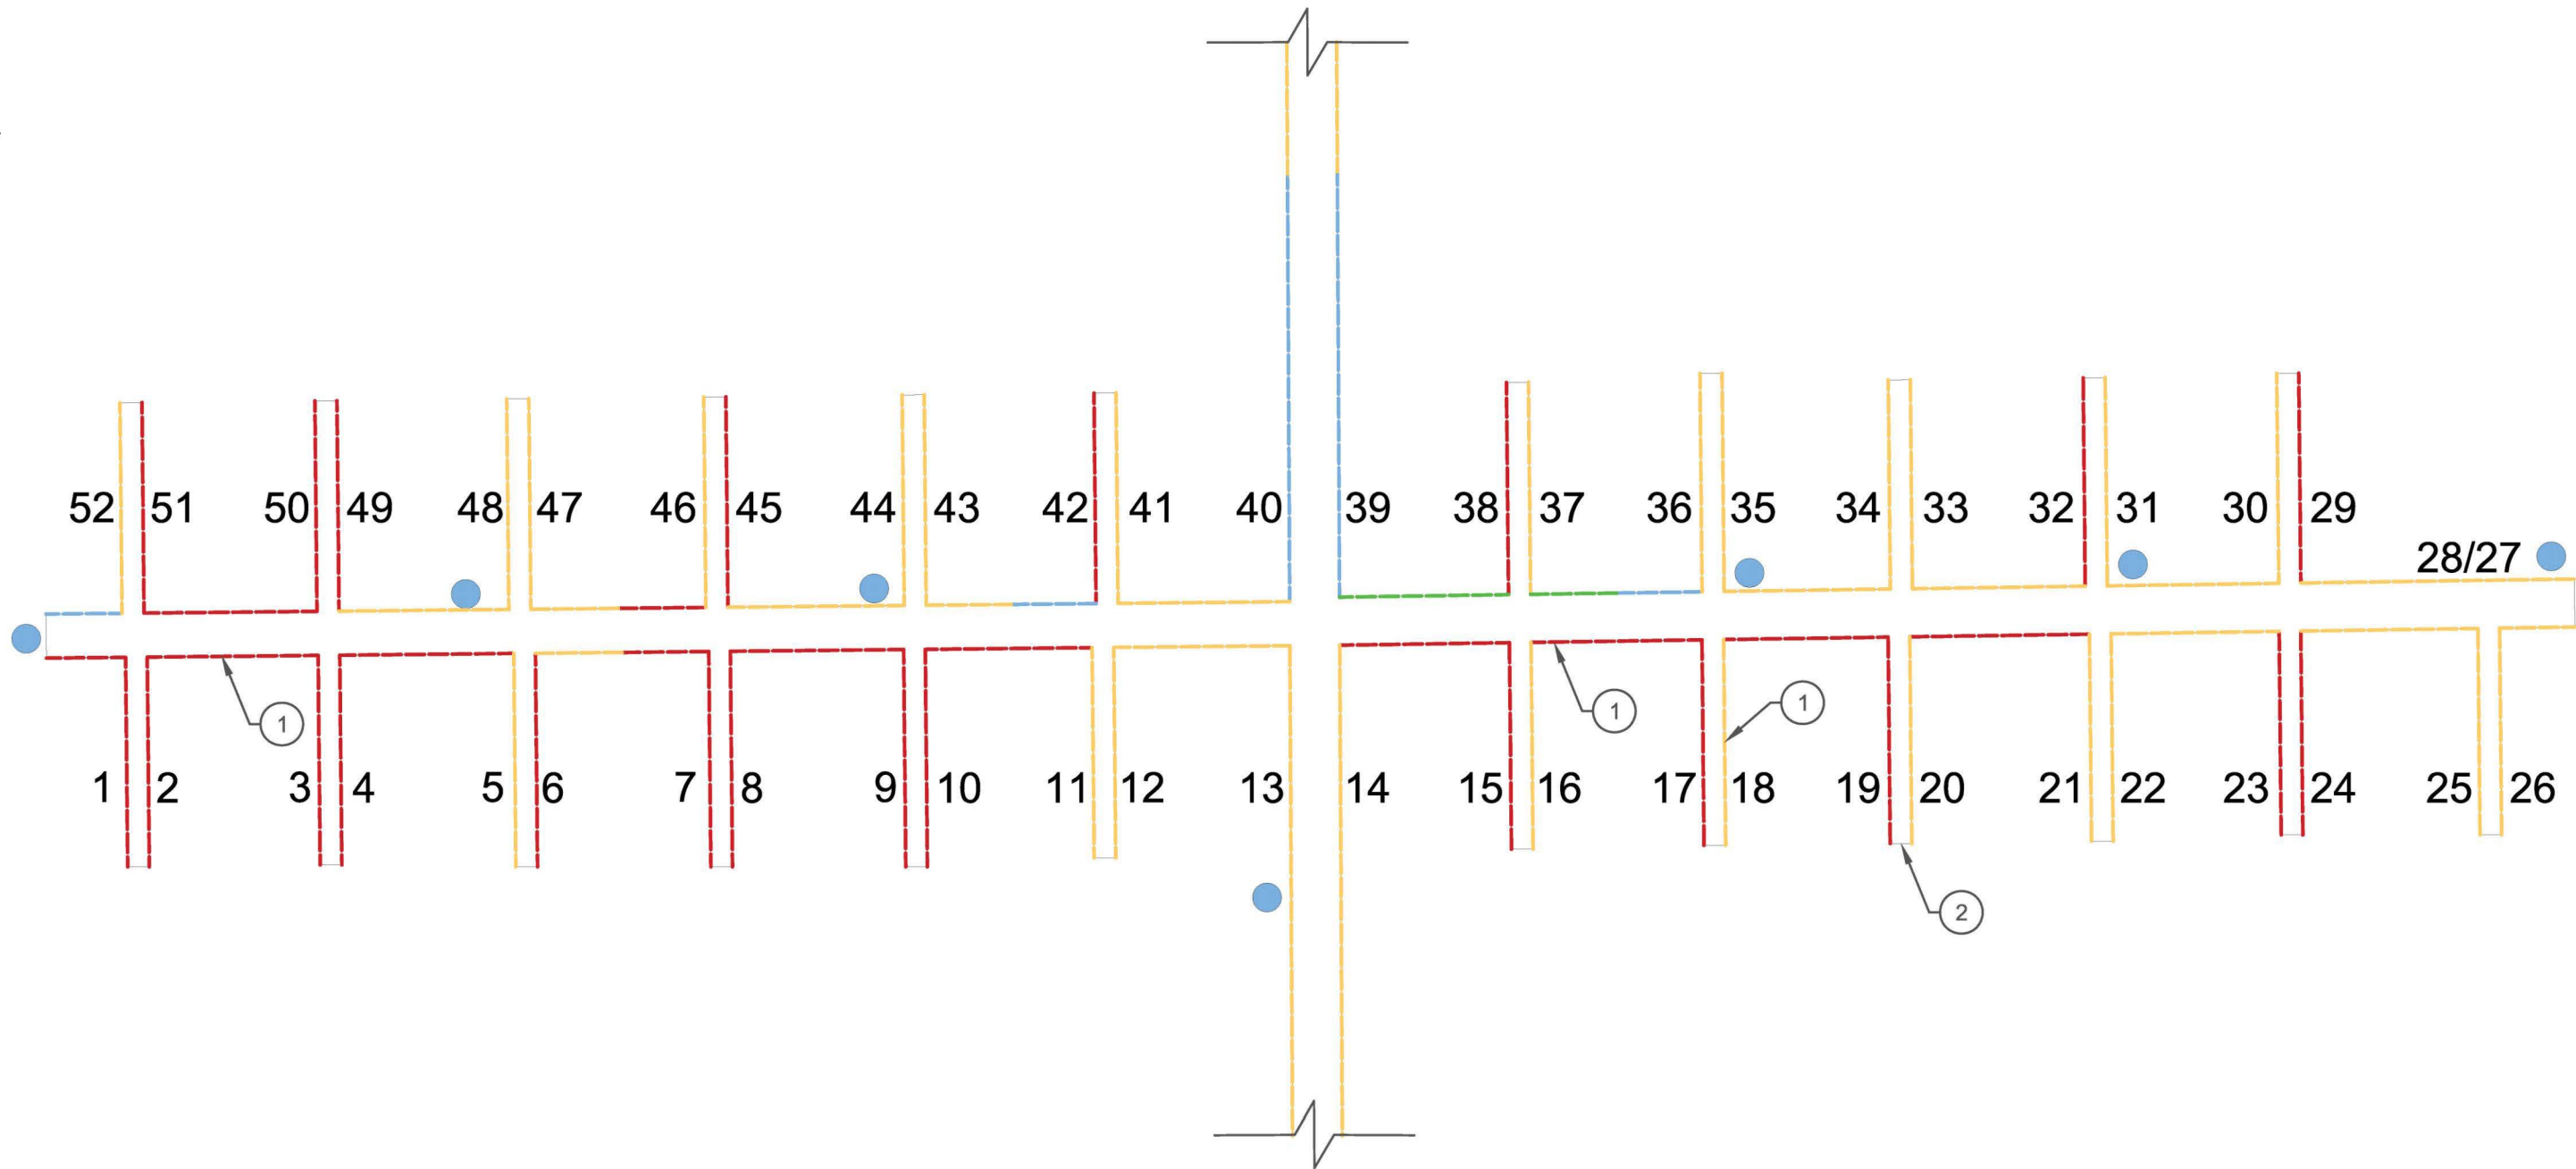
- NOTES:
- ① There were several missing or loose connections between the longitudinal floating logs and the transverse timber planks.
  - ② The finger pier between slips 19 and 20 was rotated and unstable.

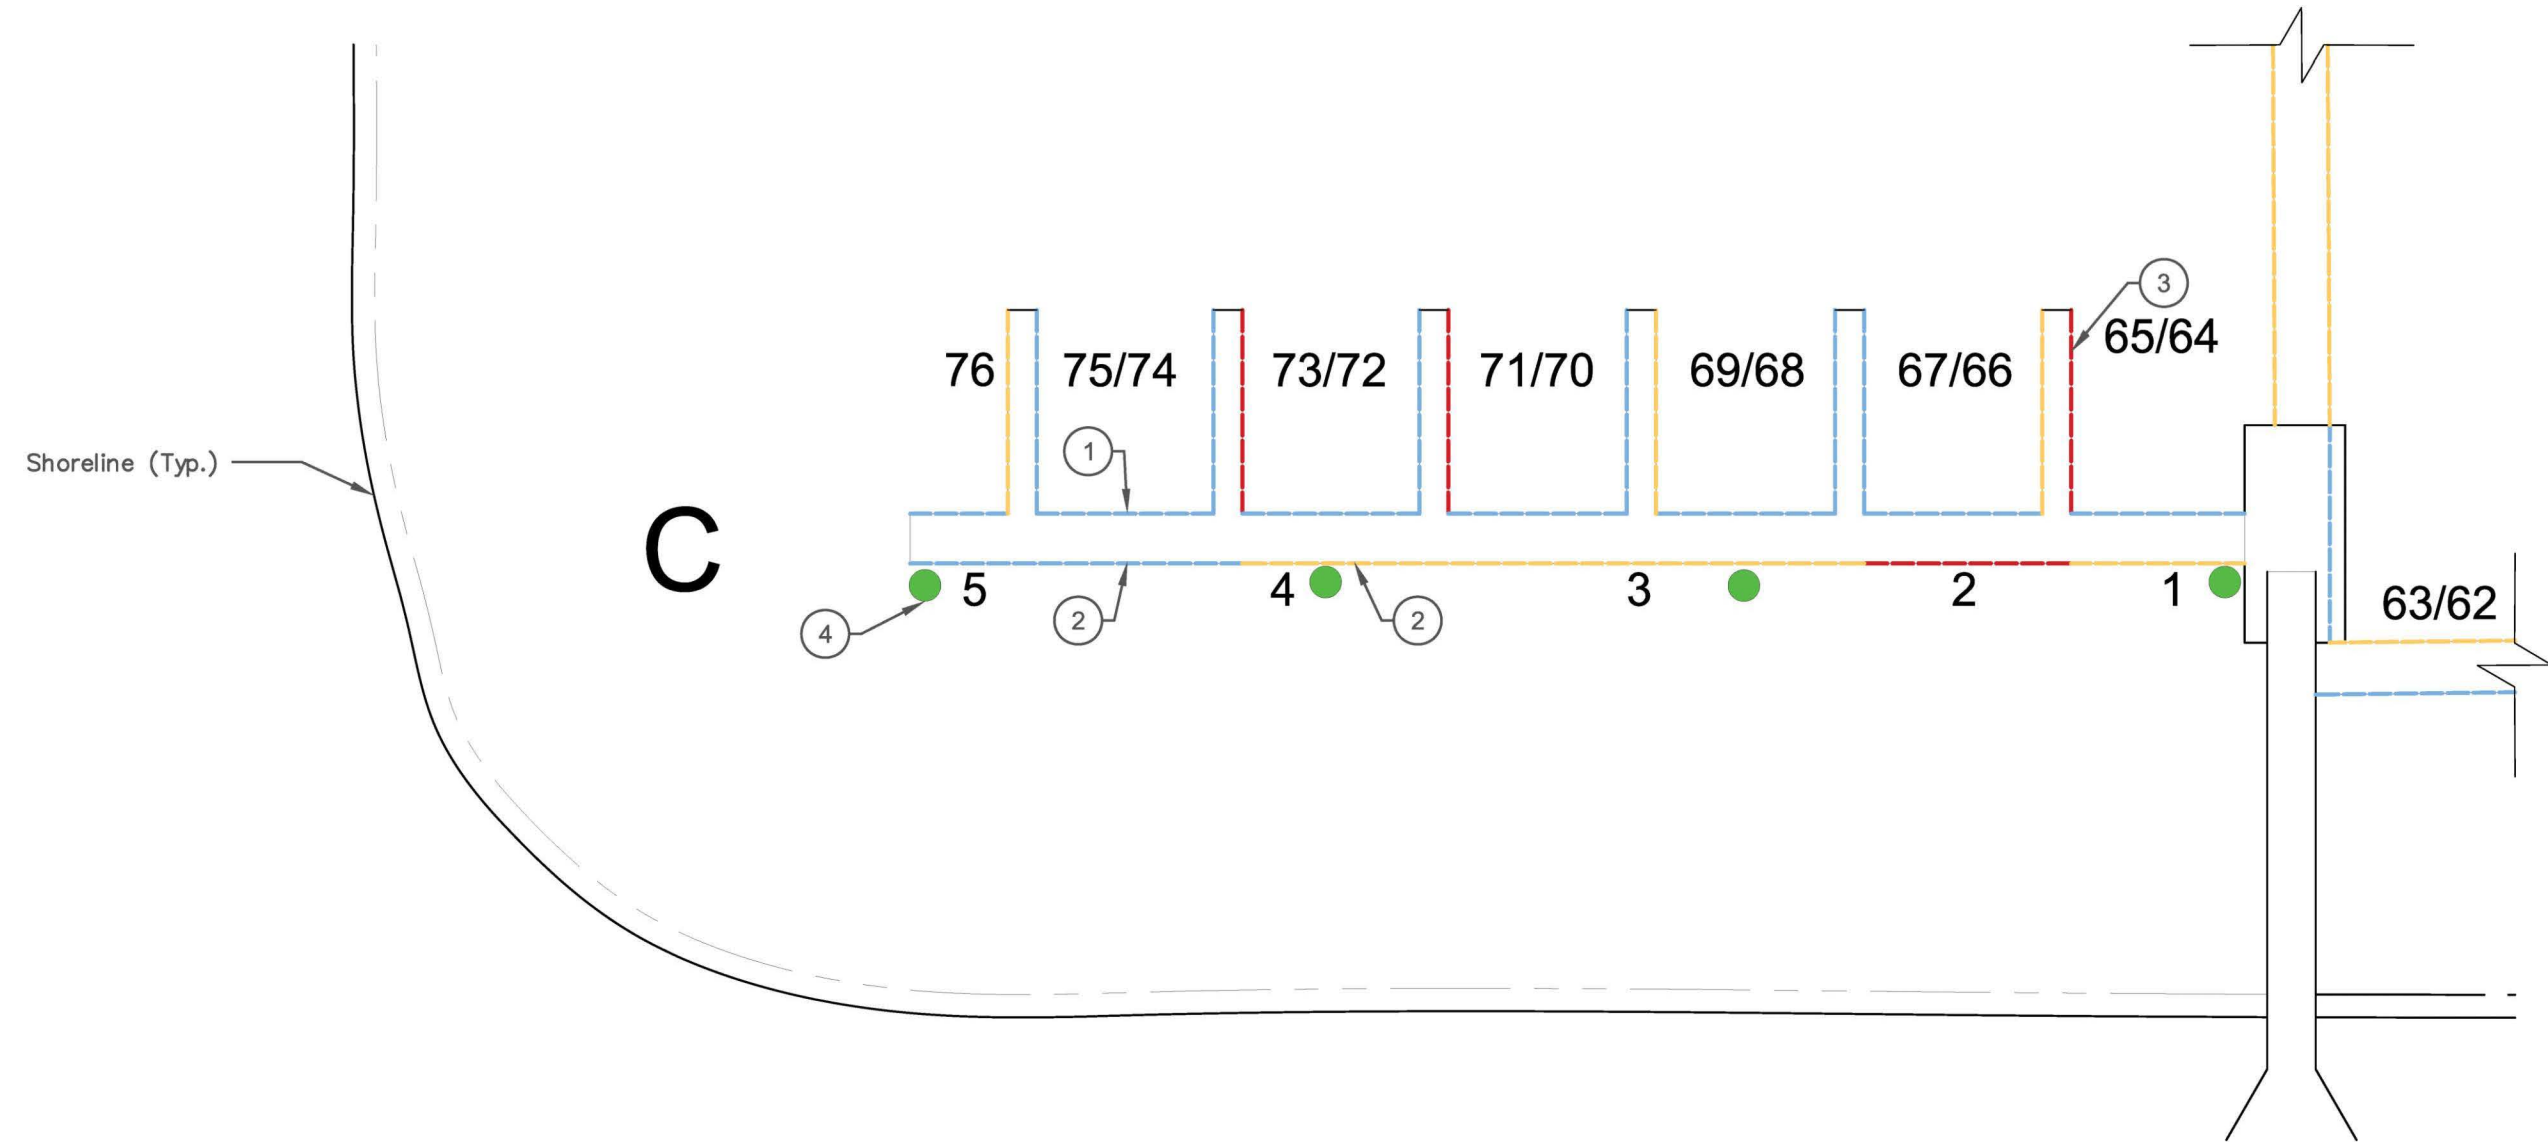
- NOTES:**
- ① There were several missing or loose connections between the longitudinal floating logs and the transverse timber planks.
  - ② There were several transverse timber planks with severe section loss.
  - ③ The finger pier between slips 65 and 66 was unstable.
  - ④ The transverse guide crib at the west most timber pile exhibited a split and severe section loss.

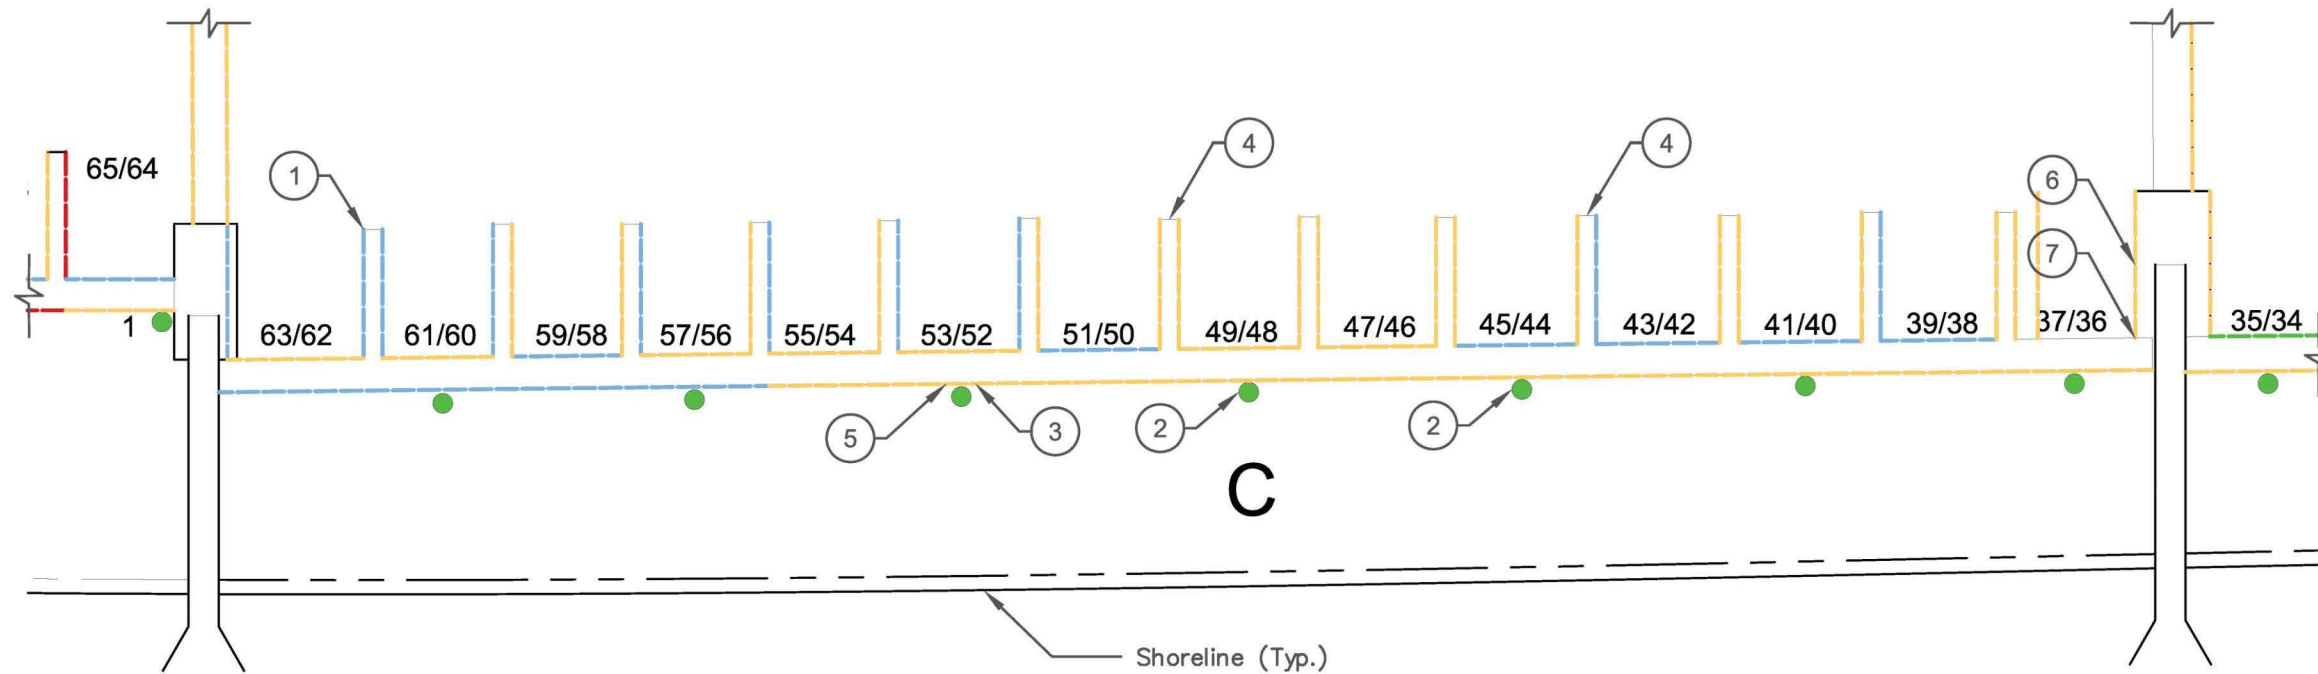
Date: 11/14/2023  
Scale: NTS  
Figure No.: I-05

- ① There were several missing or loose connections between the longitudinal floating logs and the transverse timber planks.
- ② Several of the guide piles connected to the dock were connected via a steel chain with rollers.
- ③ There was a transverse timber plank with severe section loss.
- ④ The finger docks between slips 49 and 50 and between slips 43 and 44 were unstable.
- ⑤ The transverse guide crib at timber pile between slips 52 and 53 had severe section loss.
- ⑥ The floating log adjacent to slip 36 was loosely connected.
- ⑦ There was a chain connecting the two floating logs adjacent to slip 36 which exhibited flaking rust.

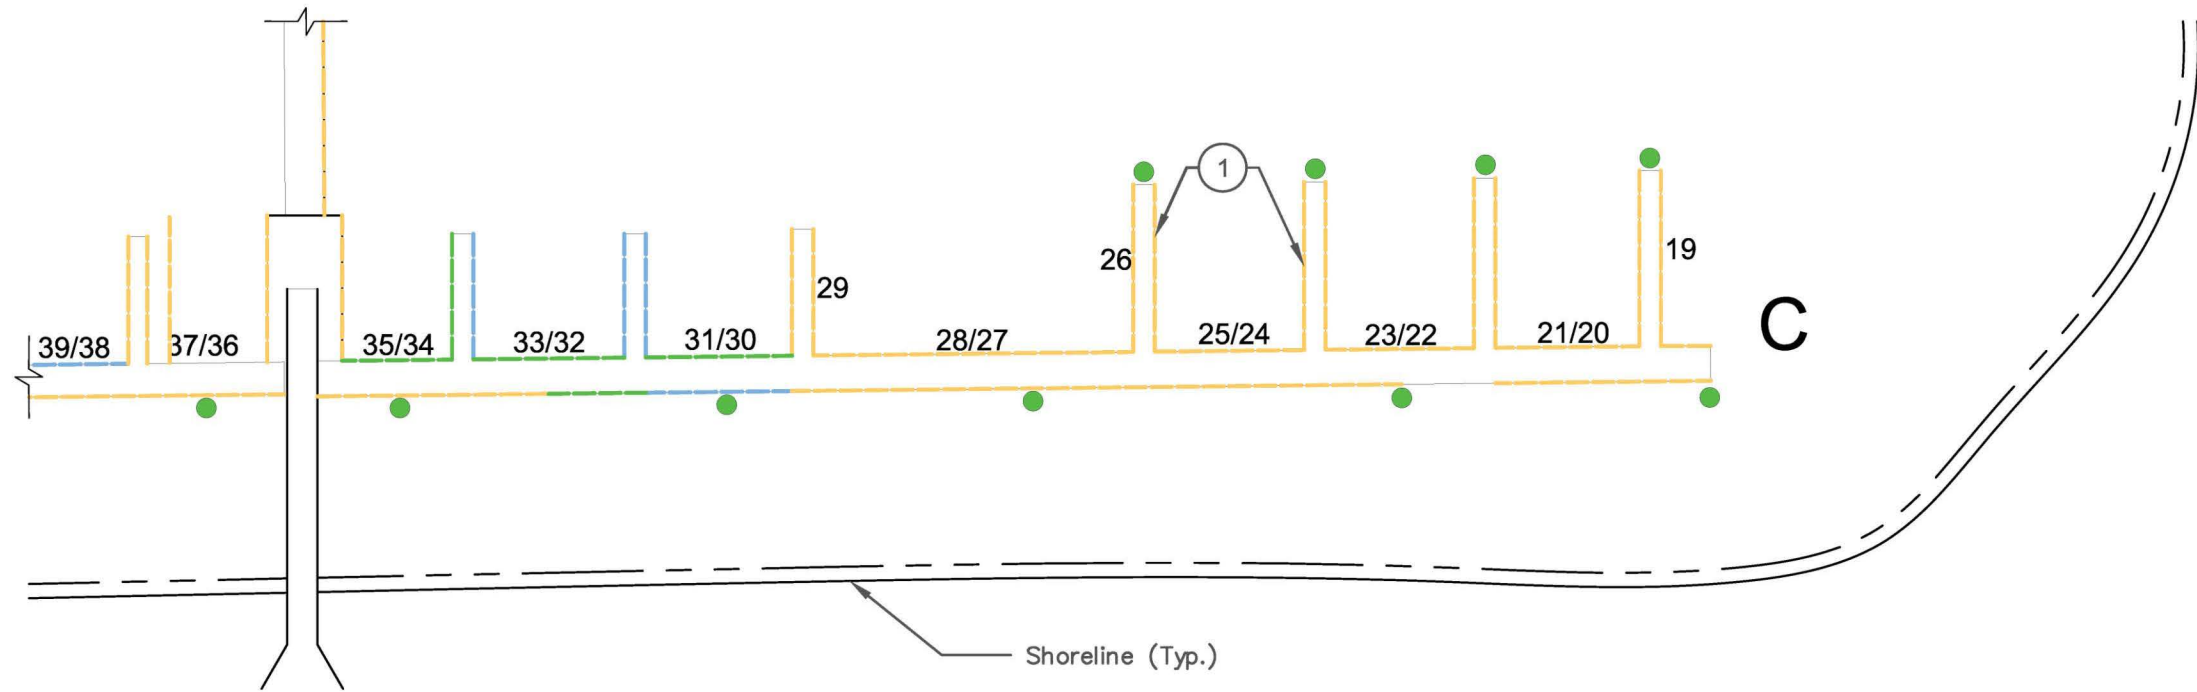
Figure No.: I-06

- ① The finger docks between Slips 23 and 24 and between Slips 25 and 26 were unstable.

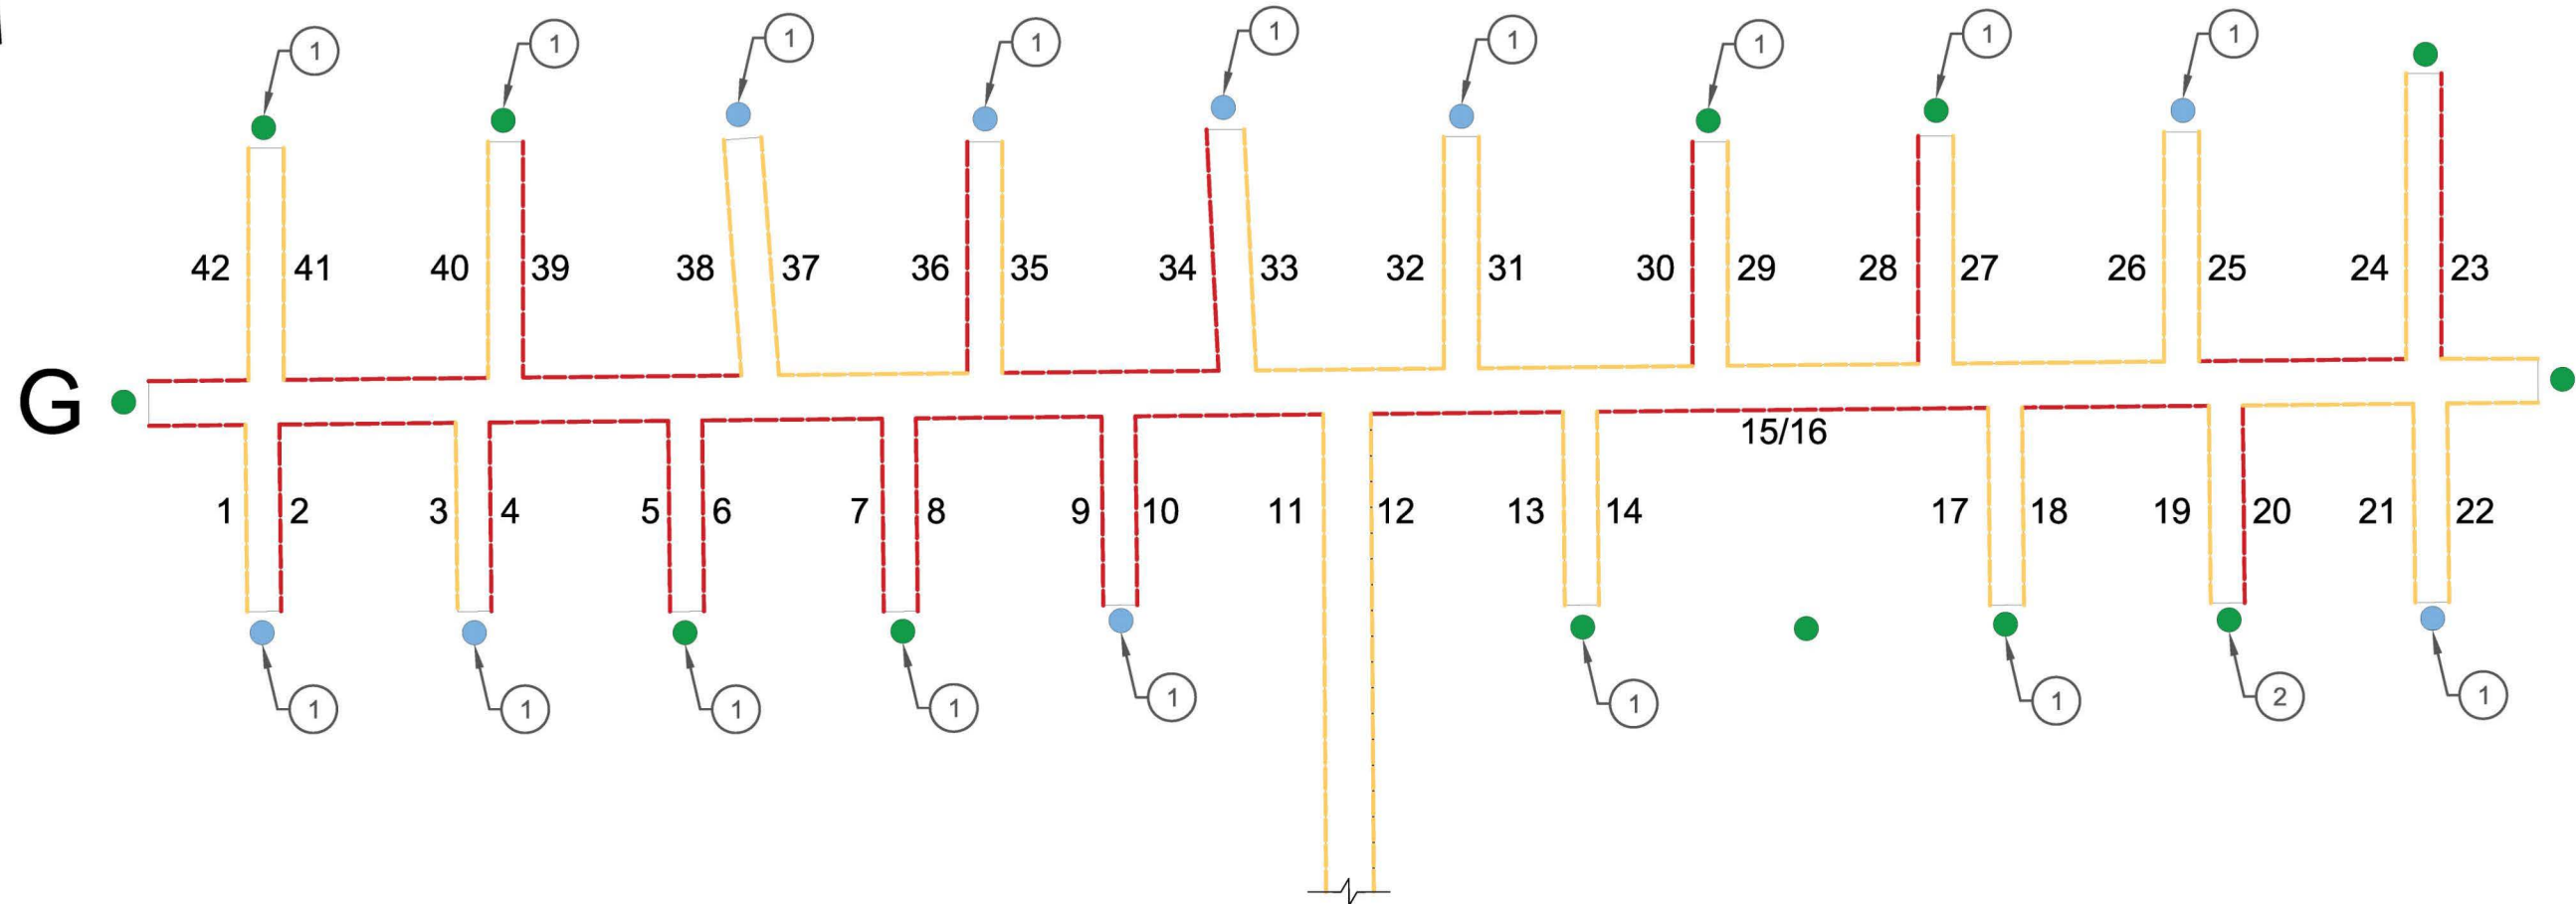
- NOTES:
- ① Several of the guide piles connected to the finger docks were connected via a steel chain.
  - ② Guide pile at the finger dock between slips 19 and 20 was connected to the finger dock via a steel tube.
