### MARINA ADVISORY COMMITTEE

February 26, 2024 at 2pm

HDR was retained by the City of Warrenton to perform an evaluation of the Warrenton Marina to assess general condition of the docks, identify any recommended repairs and/or replacement of the docks, and provide guidance on prioritization of upgrades and maintenance.

# **Underwater Condition Assessment of Warrenton Marina**

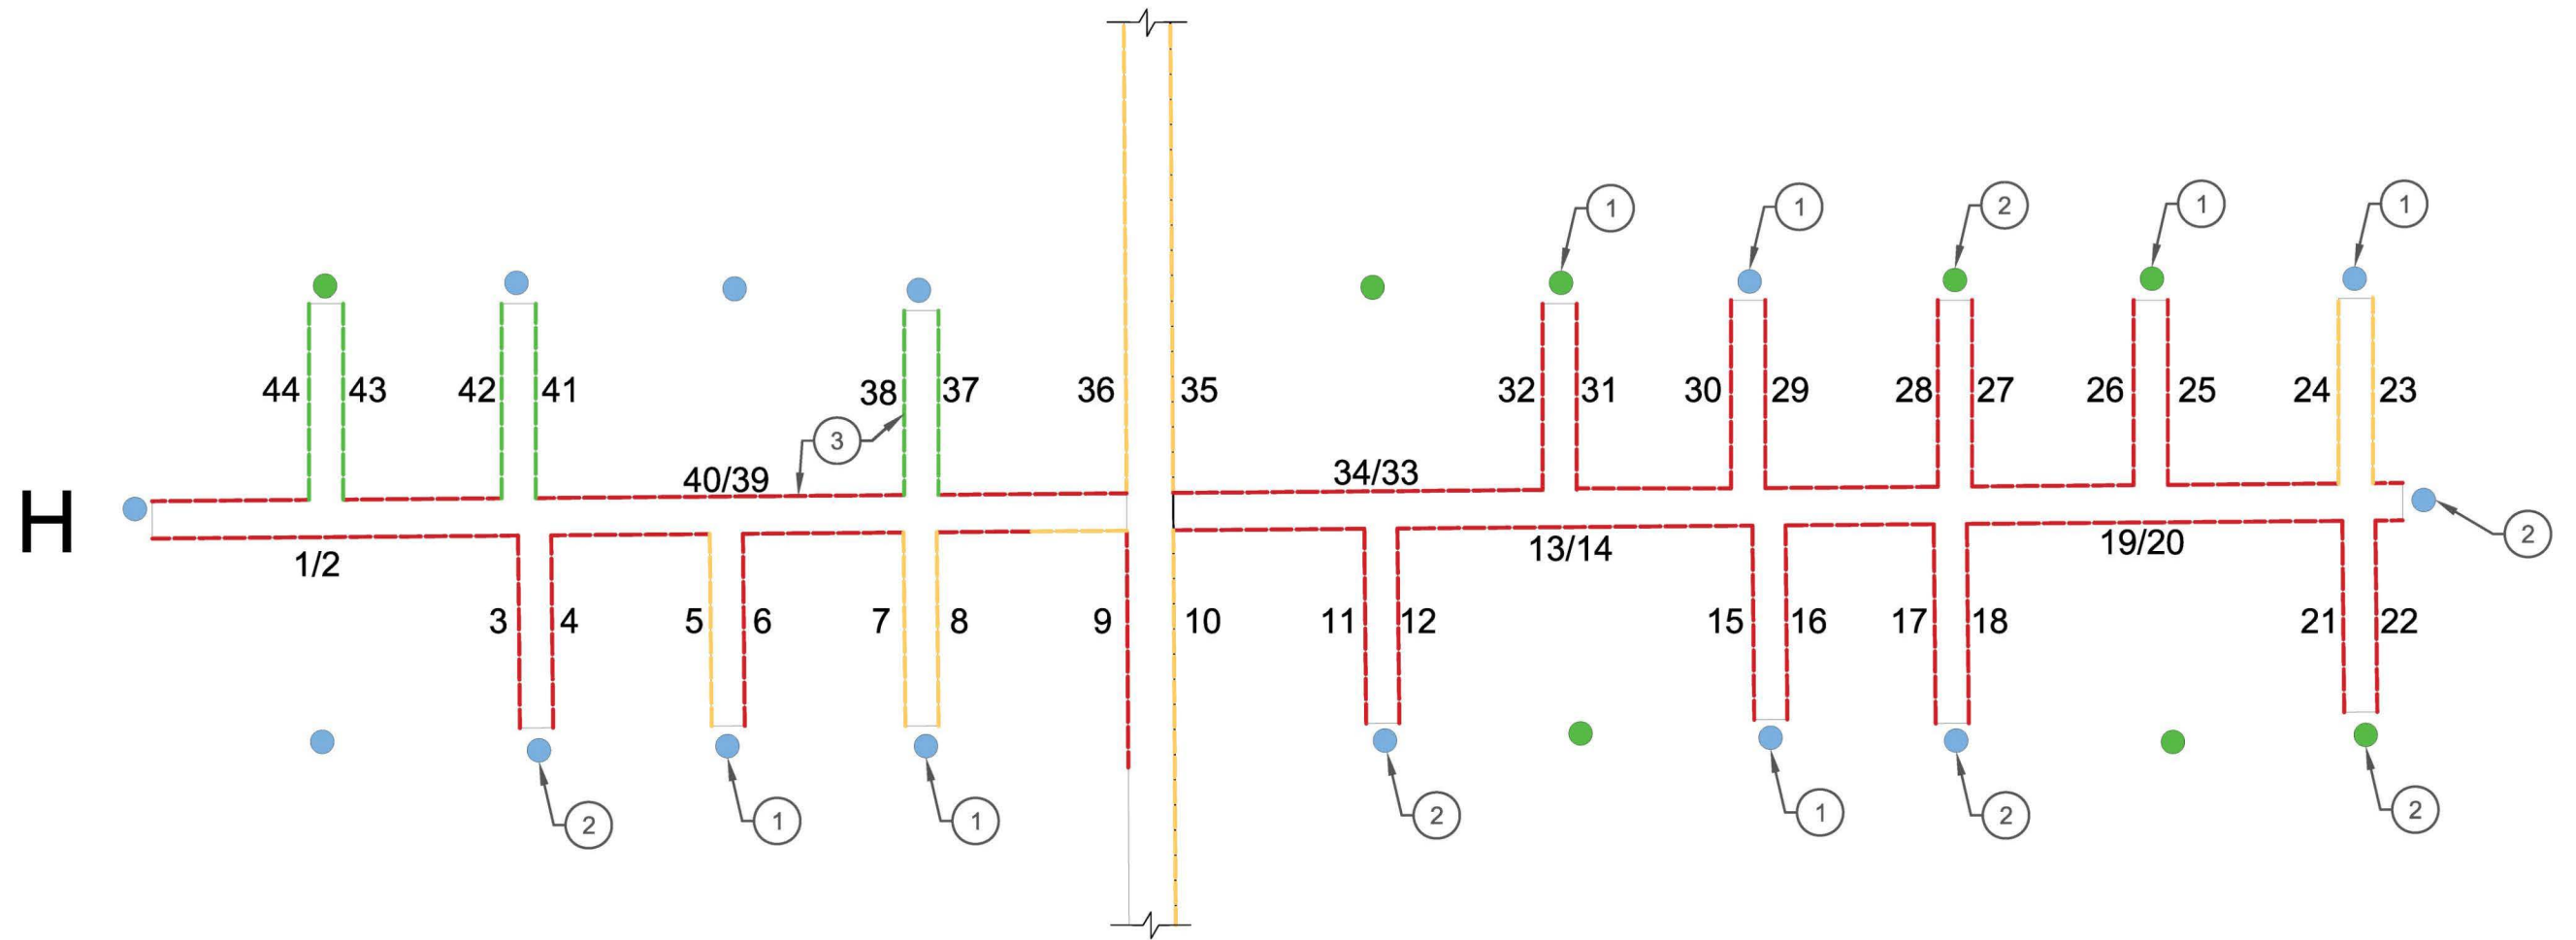
- NOTES:
- ① Several of the guide piles connected to the finger docks were connected via a steel chain.
  - ② Several of the guide piles connected to the finger docks were connected via a U-bolt.
  - ③ The area of the main dock at slips 39 and 40, as well as the finger dock between slips 37 and 38, were warped and uneven.

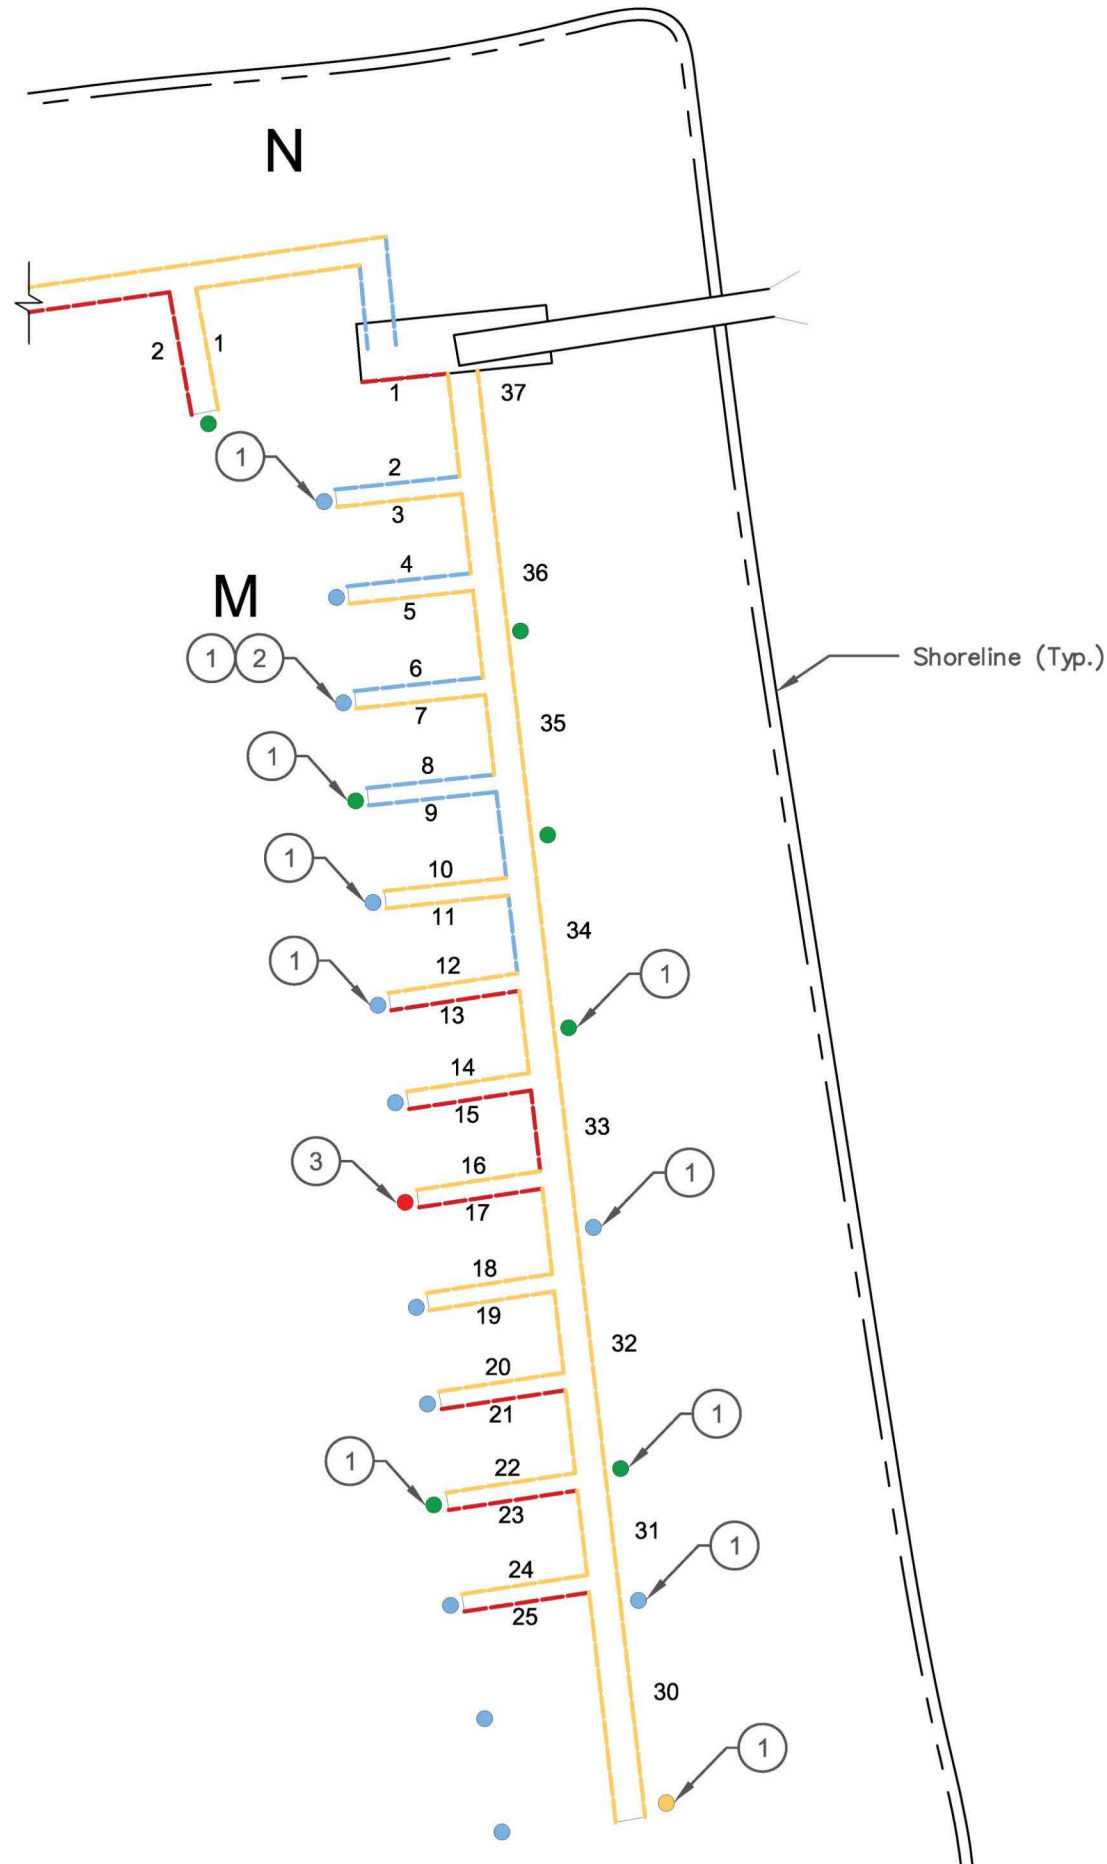
Figure No.: I-09

- ① Several of the guide piles connected to the finger docks were connected via a steel chain.
- ② The guide pile at the end of the finger dock between slips 6 and 7 was cut off 5 feet below the waterline and then extended with a PVC pipe. The PVC pipe did not appear to be hollow, but it was not evident what it was filled with, if anything.
- ③ The guide pile at the end of the finger dock between slips 16 and 17 had severe heartwood rot.

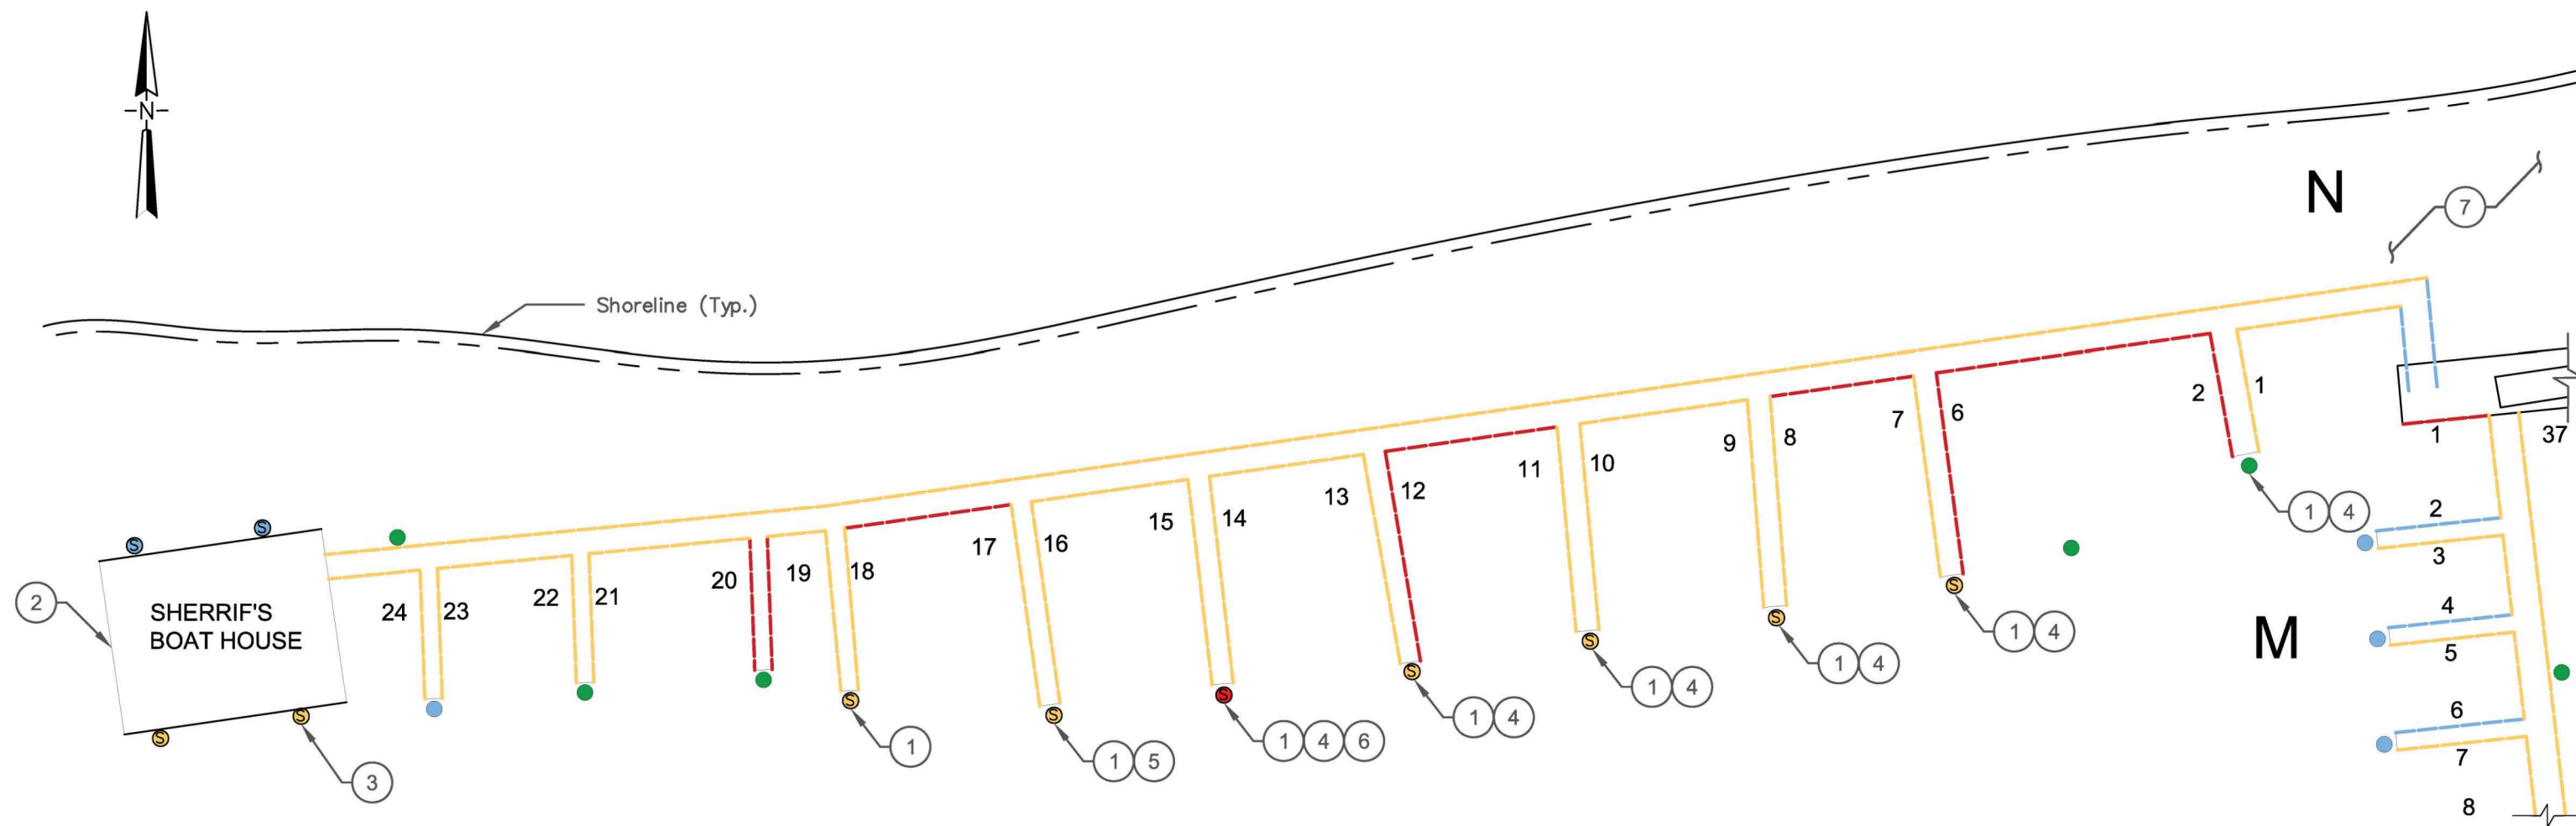
- 1 Several of the guide piles connected to the finger docks were connected via a steel chain.
- 2 The timber members supporting the Sherri's Boat House were in good condition with no significant defects.
- 3 Ultrasonic thickness measurements taken at the southeast steel pile of the Sherri's Boat House indicated up to 25% loss of section.
- 4 Several of the steel piles exhibited flaking corrosion.
- 5 Ultrasonic thickness measurements taken at the steel pile at the end of the finger dock between slips 16 and 17 indicated up to 43% loss of section.
- 6 The steel pile at the end of the finger dock between slips 14 and 15 exhibited a corrosion hole 6 feet above the channel bottom which measured approximately 1 foot high by 6 inches wide.
- 7 There was a cable in the water in the area where docks M and N meet. Due to safety concerns, this area was not inspected from the water

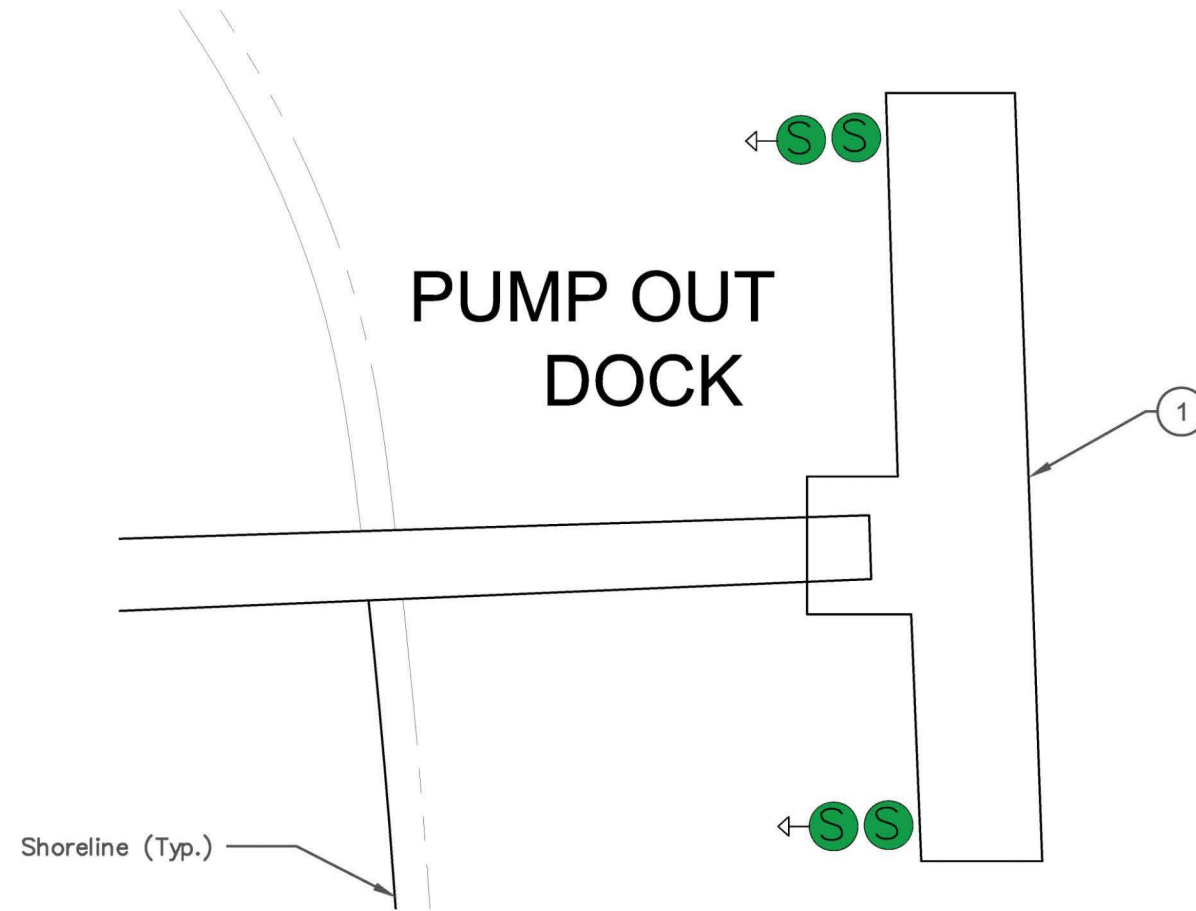
- ① The concrete blocks comprising the pump out dock typically exhibited abrasion that was approximately 1/16 inch deep.
