# River Mile 13.5 Year 7 Isolation Cap Inspection Report

Portland General Electric Company (PGE)

February 9, 2024

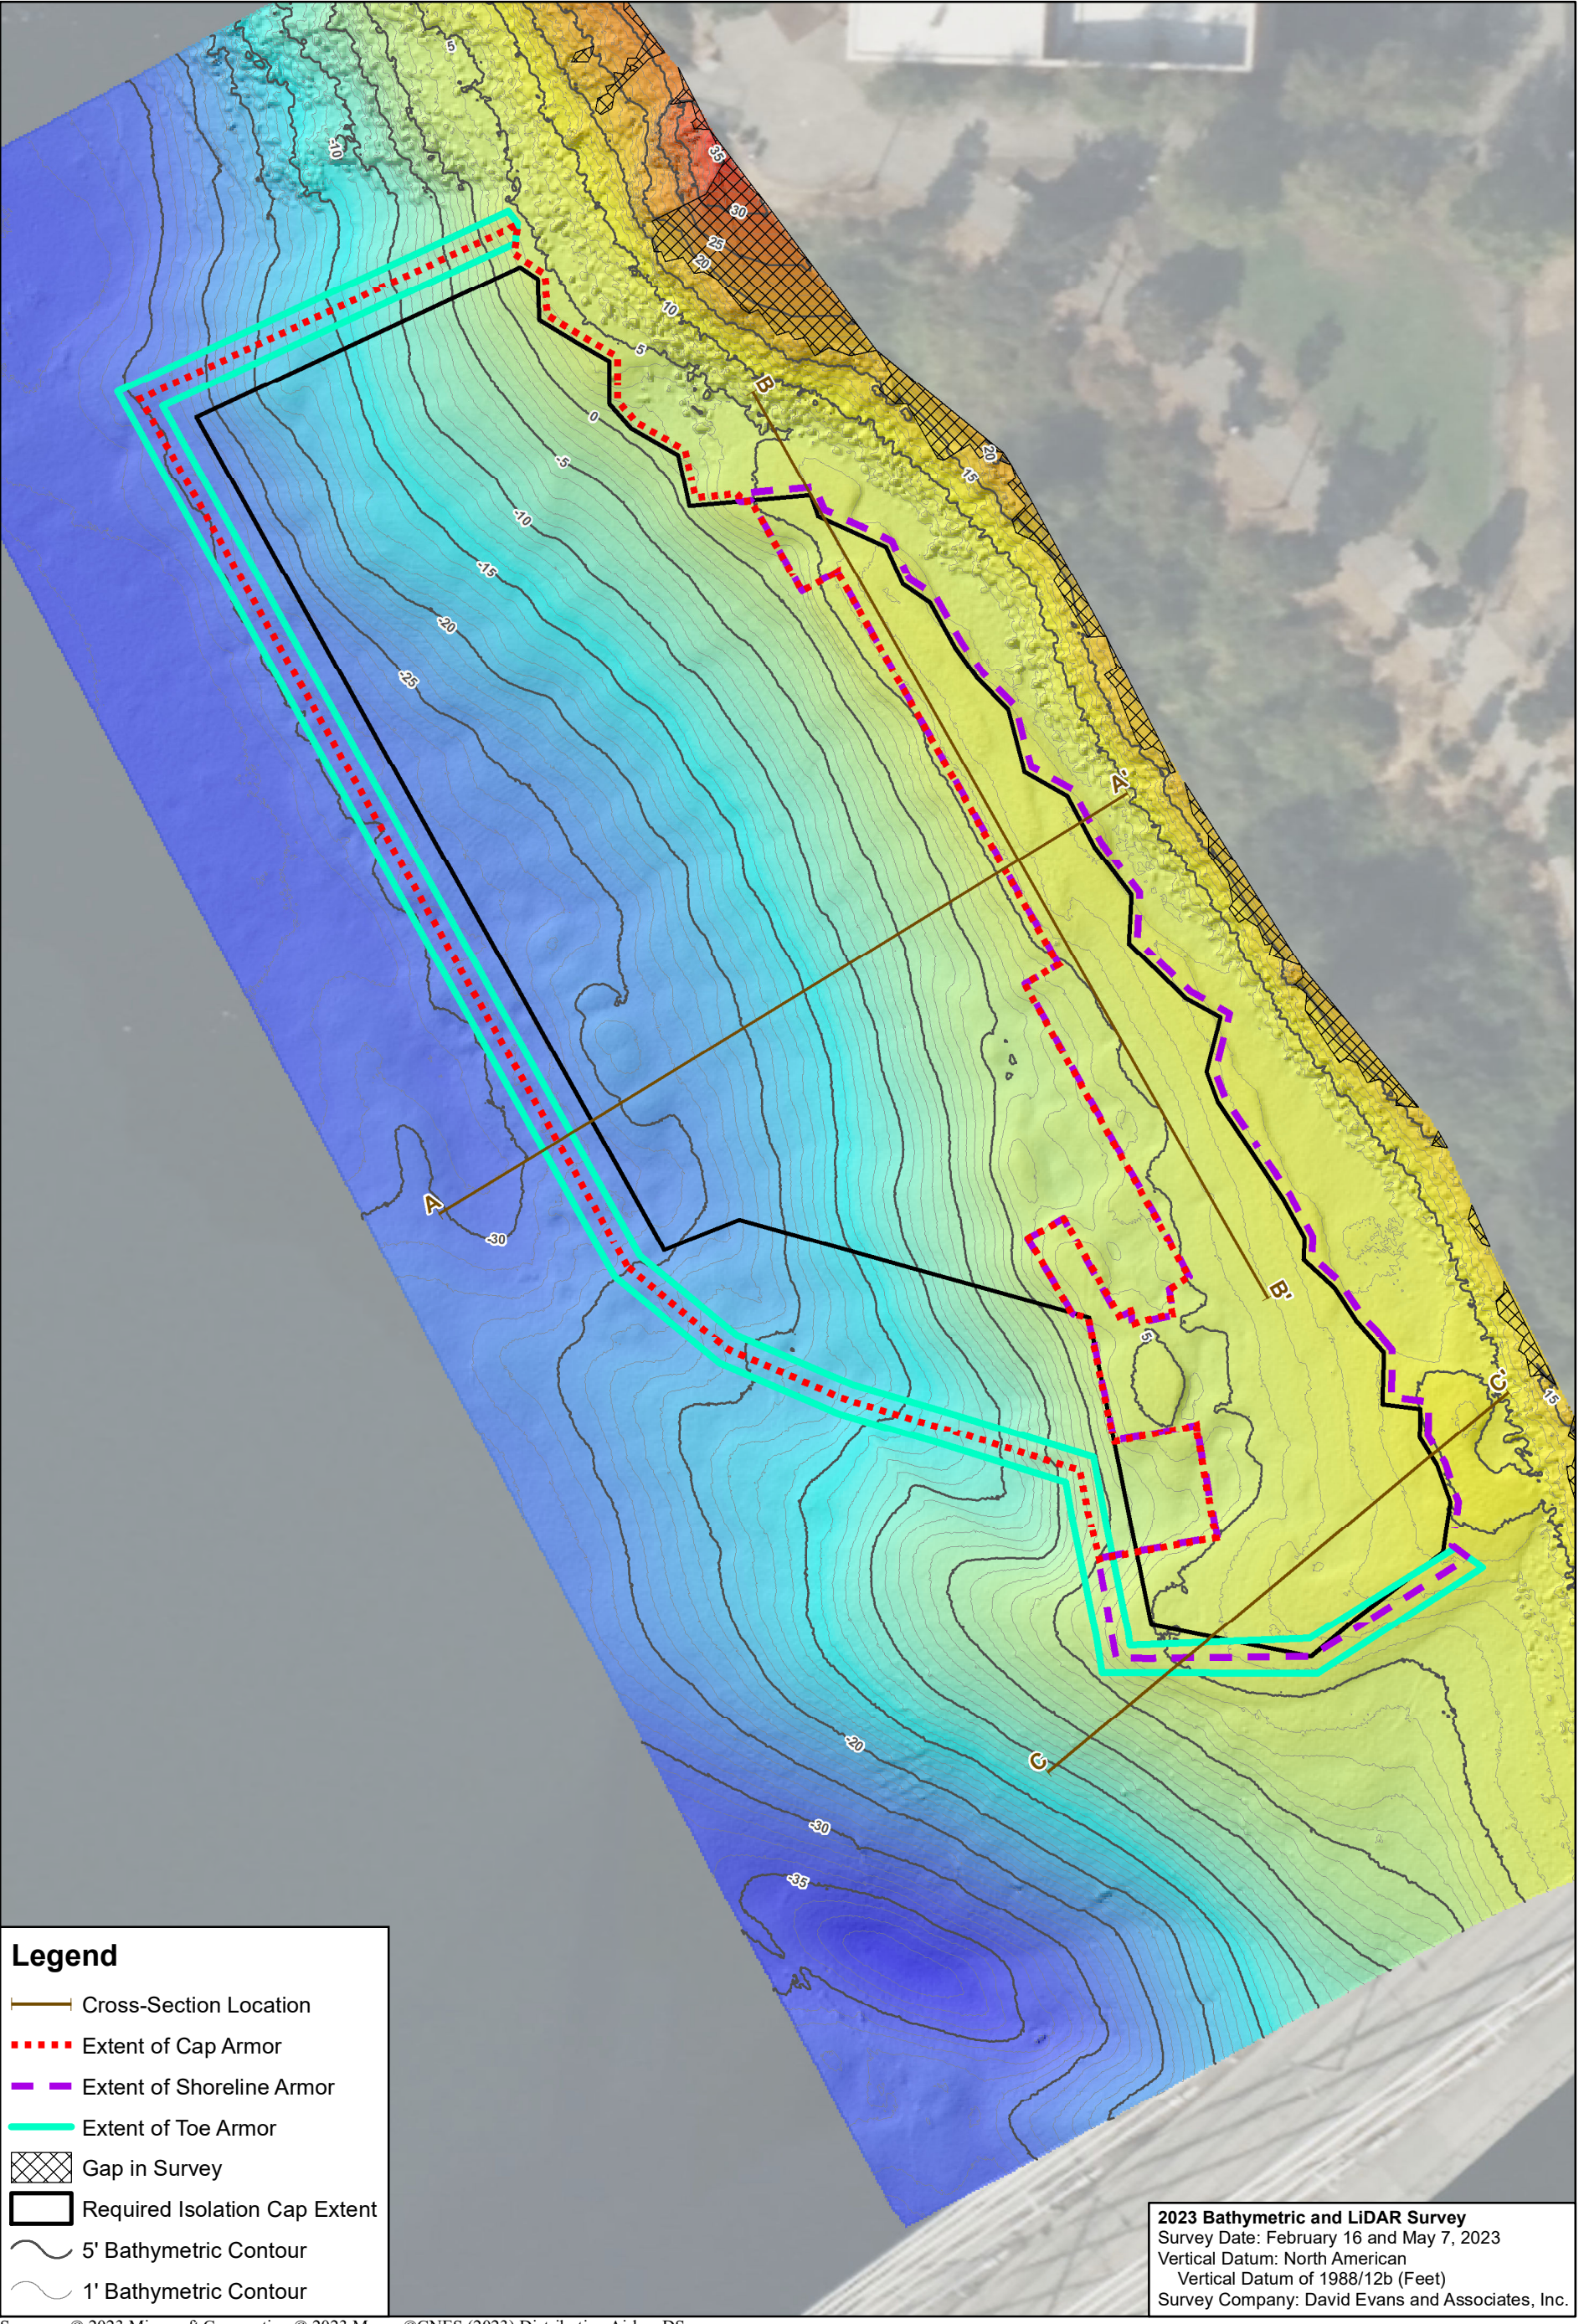
The laser scanning survey and bathymetric survey data were combined to depict one complete survey of the cap; results of the surveys are presented in Figure 2. The combined survey encompassed 100 percent of the isolation cap extent and data were collected at sufficient resolution to evaluate elevations and the condition of the cap.

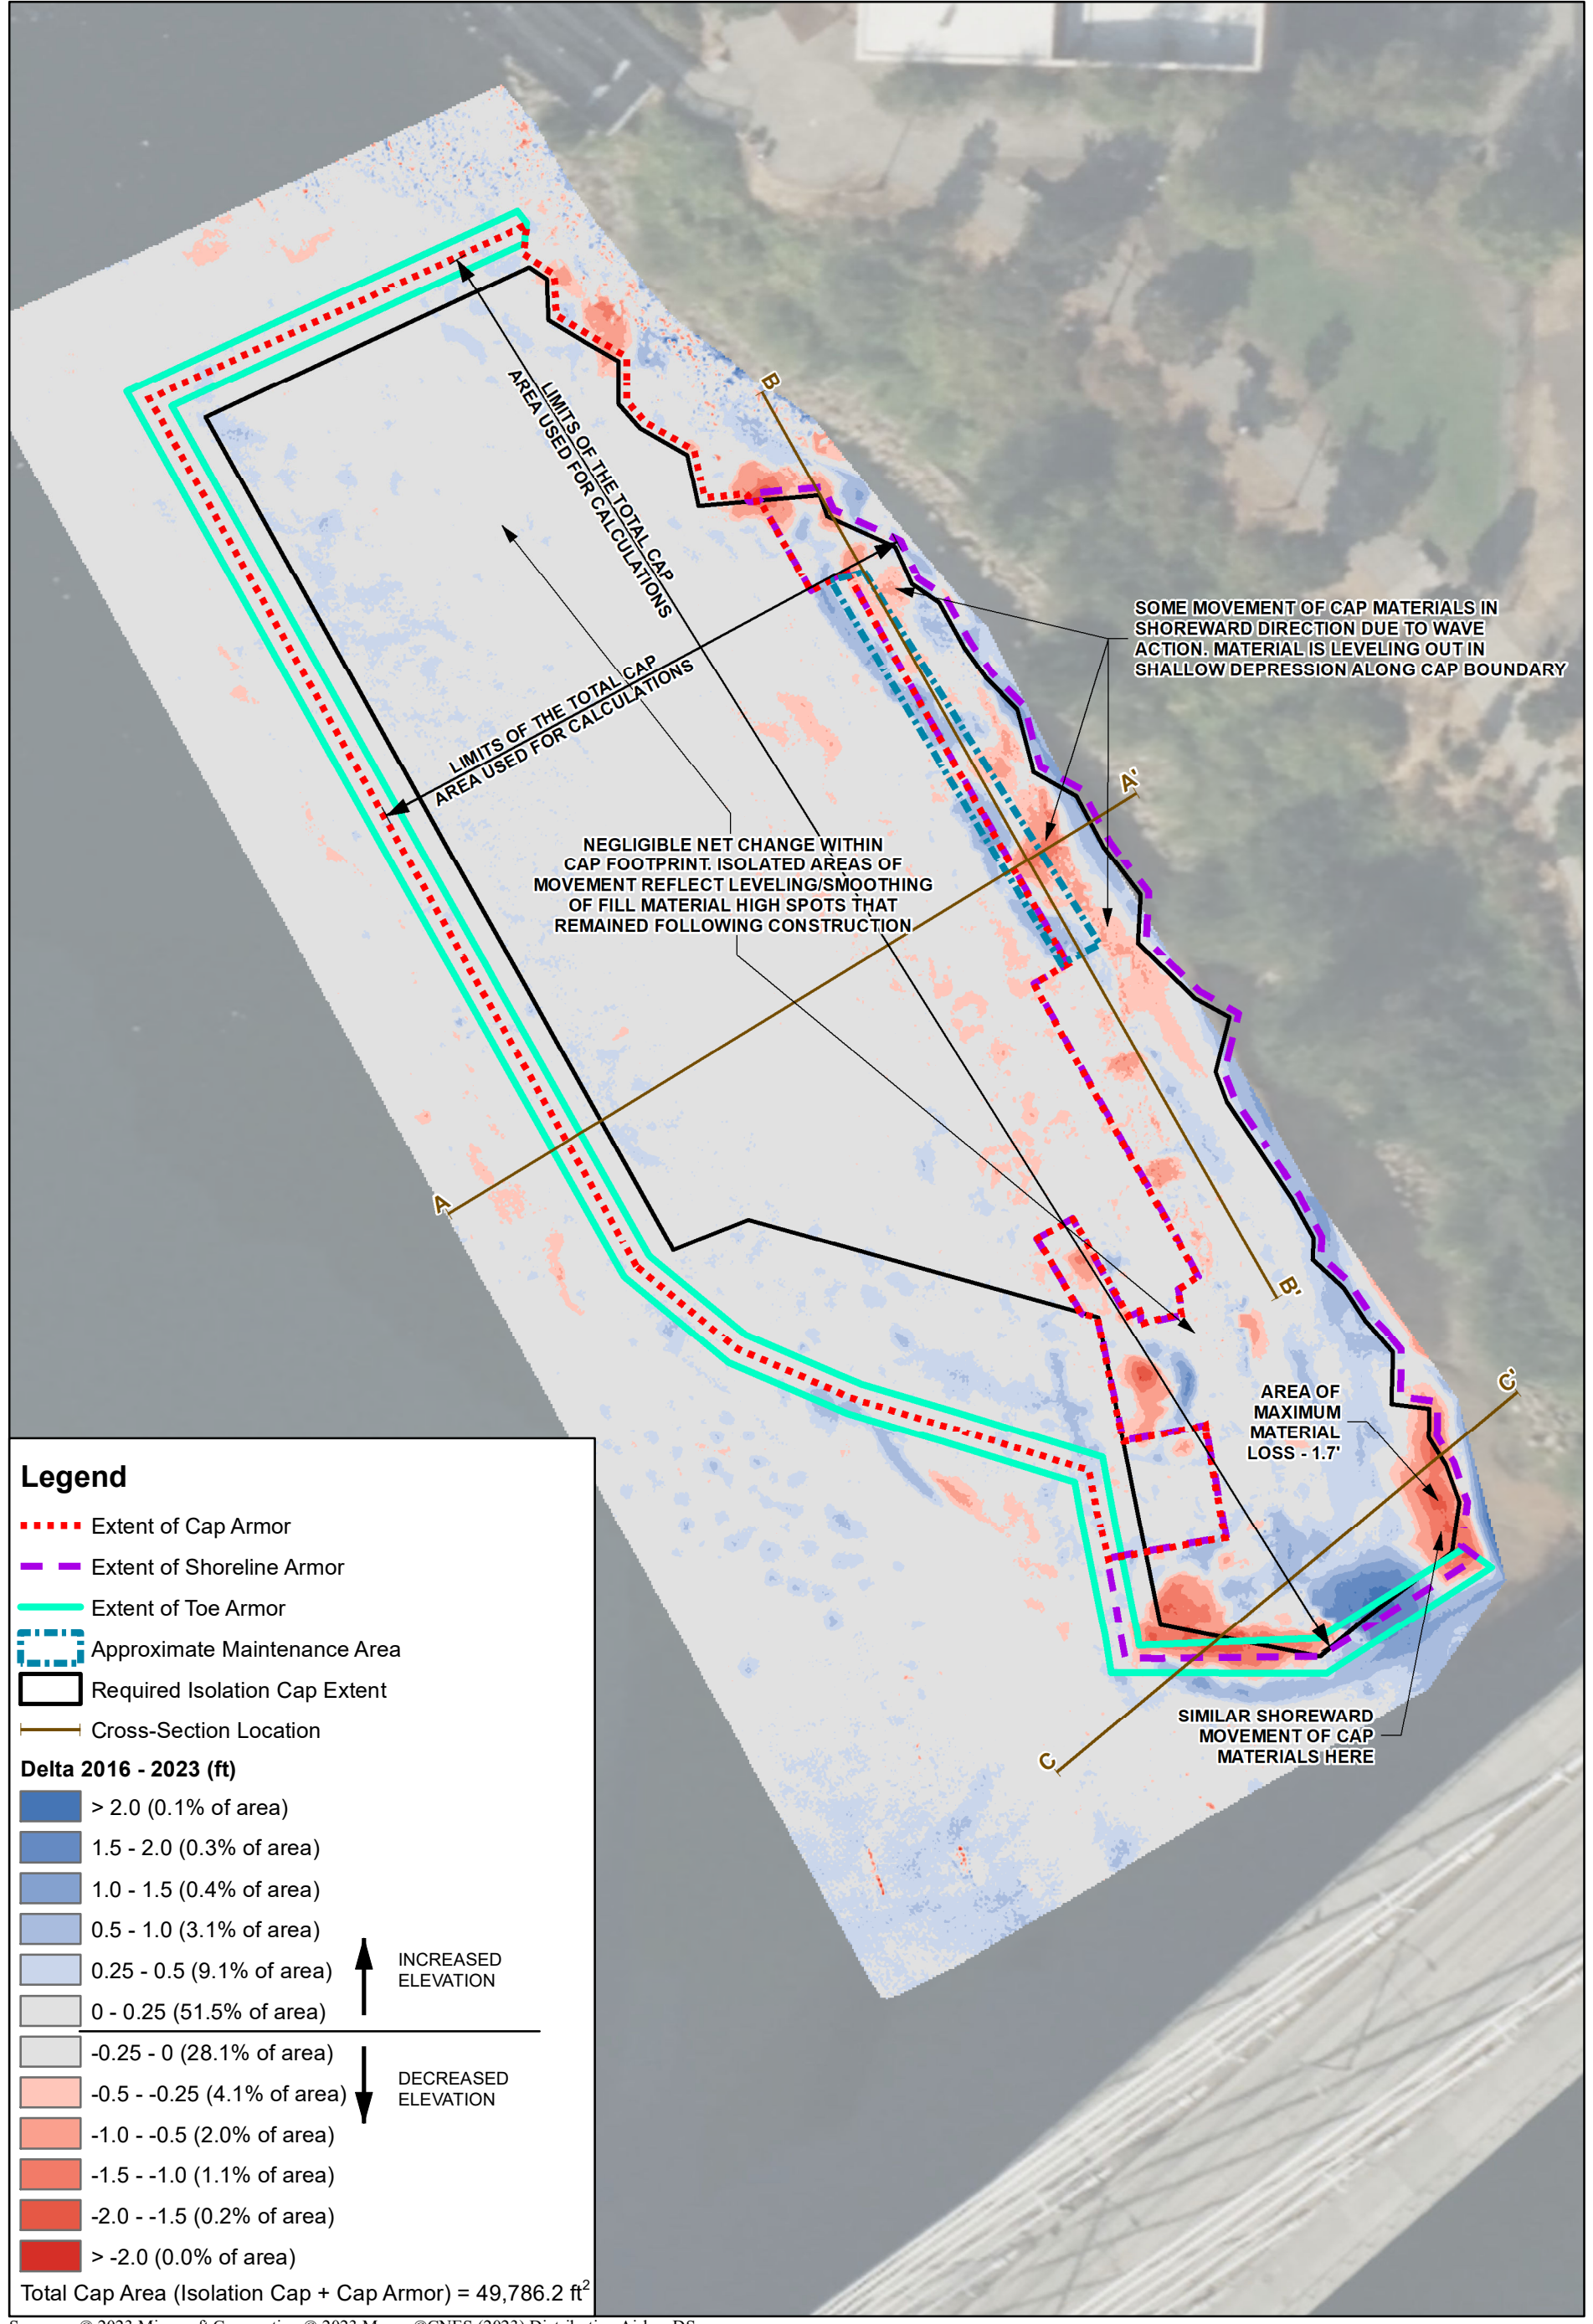
**FIGURE 3 - RM 13.5 2016-2023 CUT/FILL ANALYSIS**

In accordance with the IMMP, the area of the cap exceeding 3 inches of elevation loss was calculated using the 2016–2023 elevation difference map (Figure 3). The results indicate that an area of approximately 7.4% of the total cap surface, or 3,685 square feet, has experienced 3 inches or greater of elevation loss over the reporting period (2016–2023). This result is below the evaluation criteria of 10% of the total cap surface area. The Year 5 inspection results showed some continued movement of cap materials as the cap continued to equilibrate with the hydrodynamic conditions at the site and create a more uniform surface. Results of this Year 7 inspection support that assessment, as depicted in Figure 4, that movement of cap materials has become less over time. As shown in Figure 4, 0.1% of the cap experienced an elevation gain of 3 inches or greater between 2022 and 2023 and 0.6% of the cap experienced an elevation loss of 3 inches or greater. The results show minimal change to cap thickness over the last year as a more uniform surface has been reached.

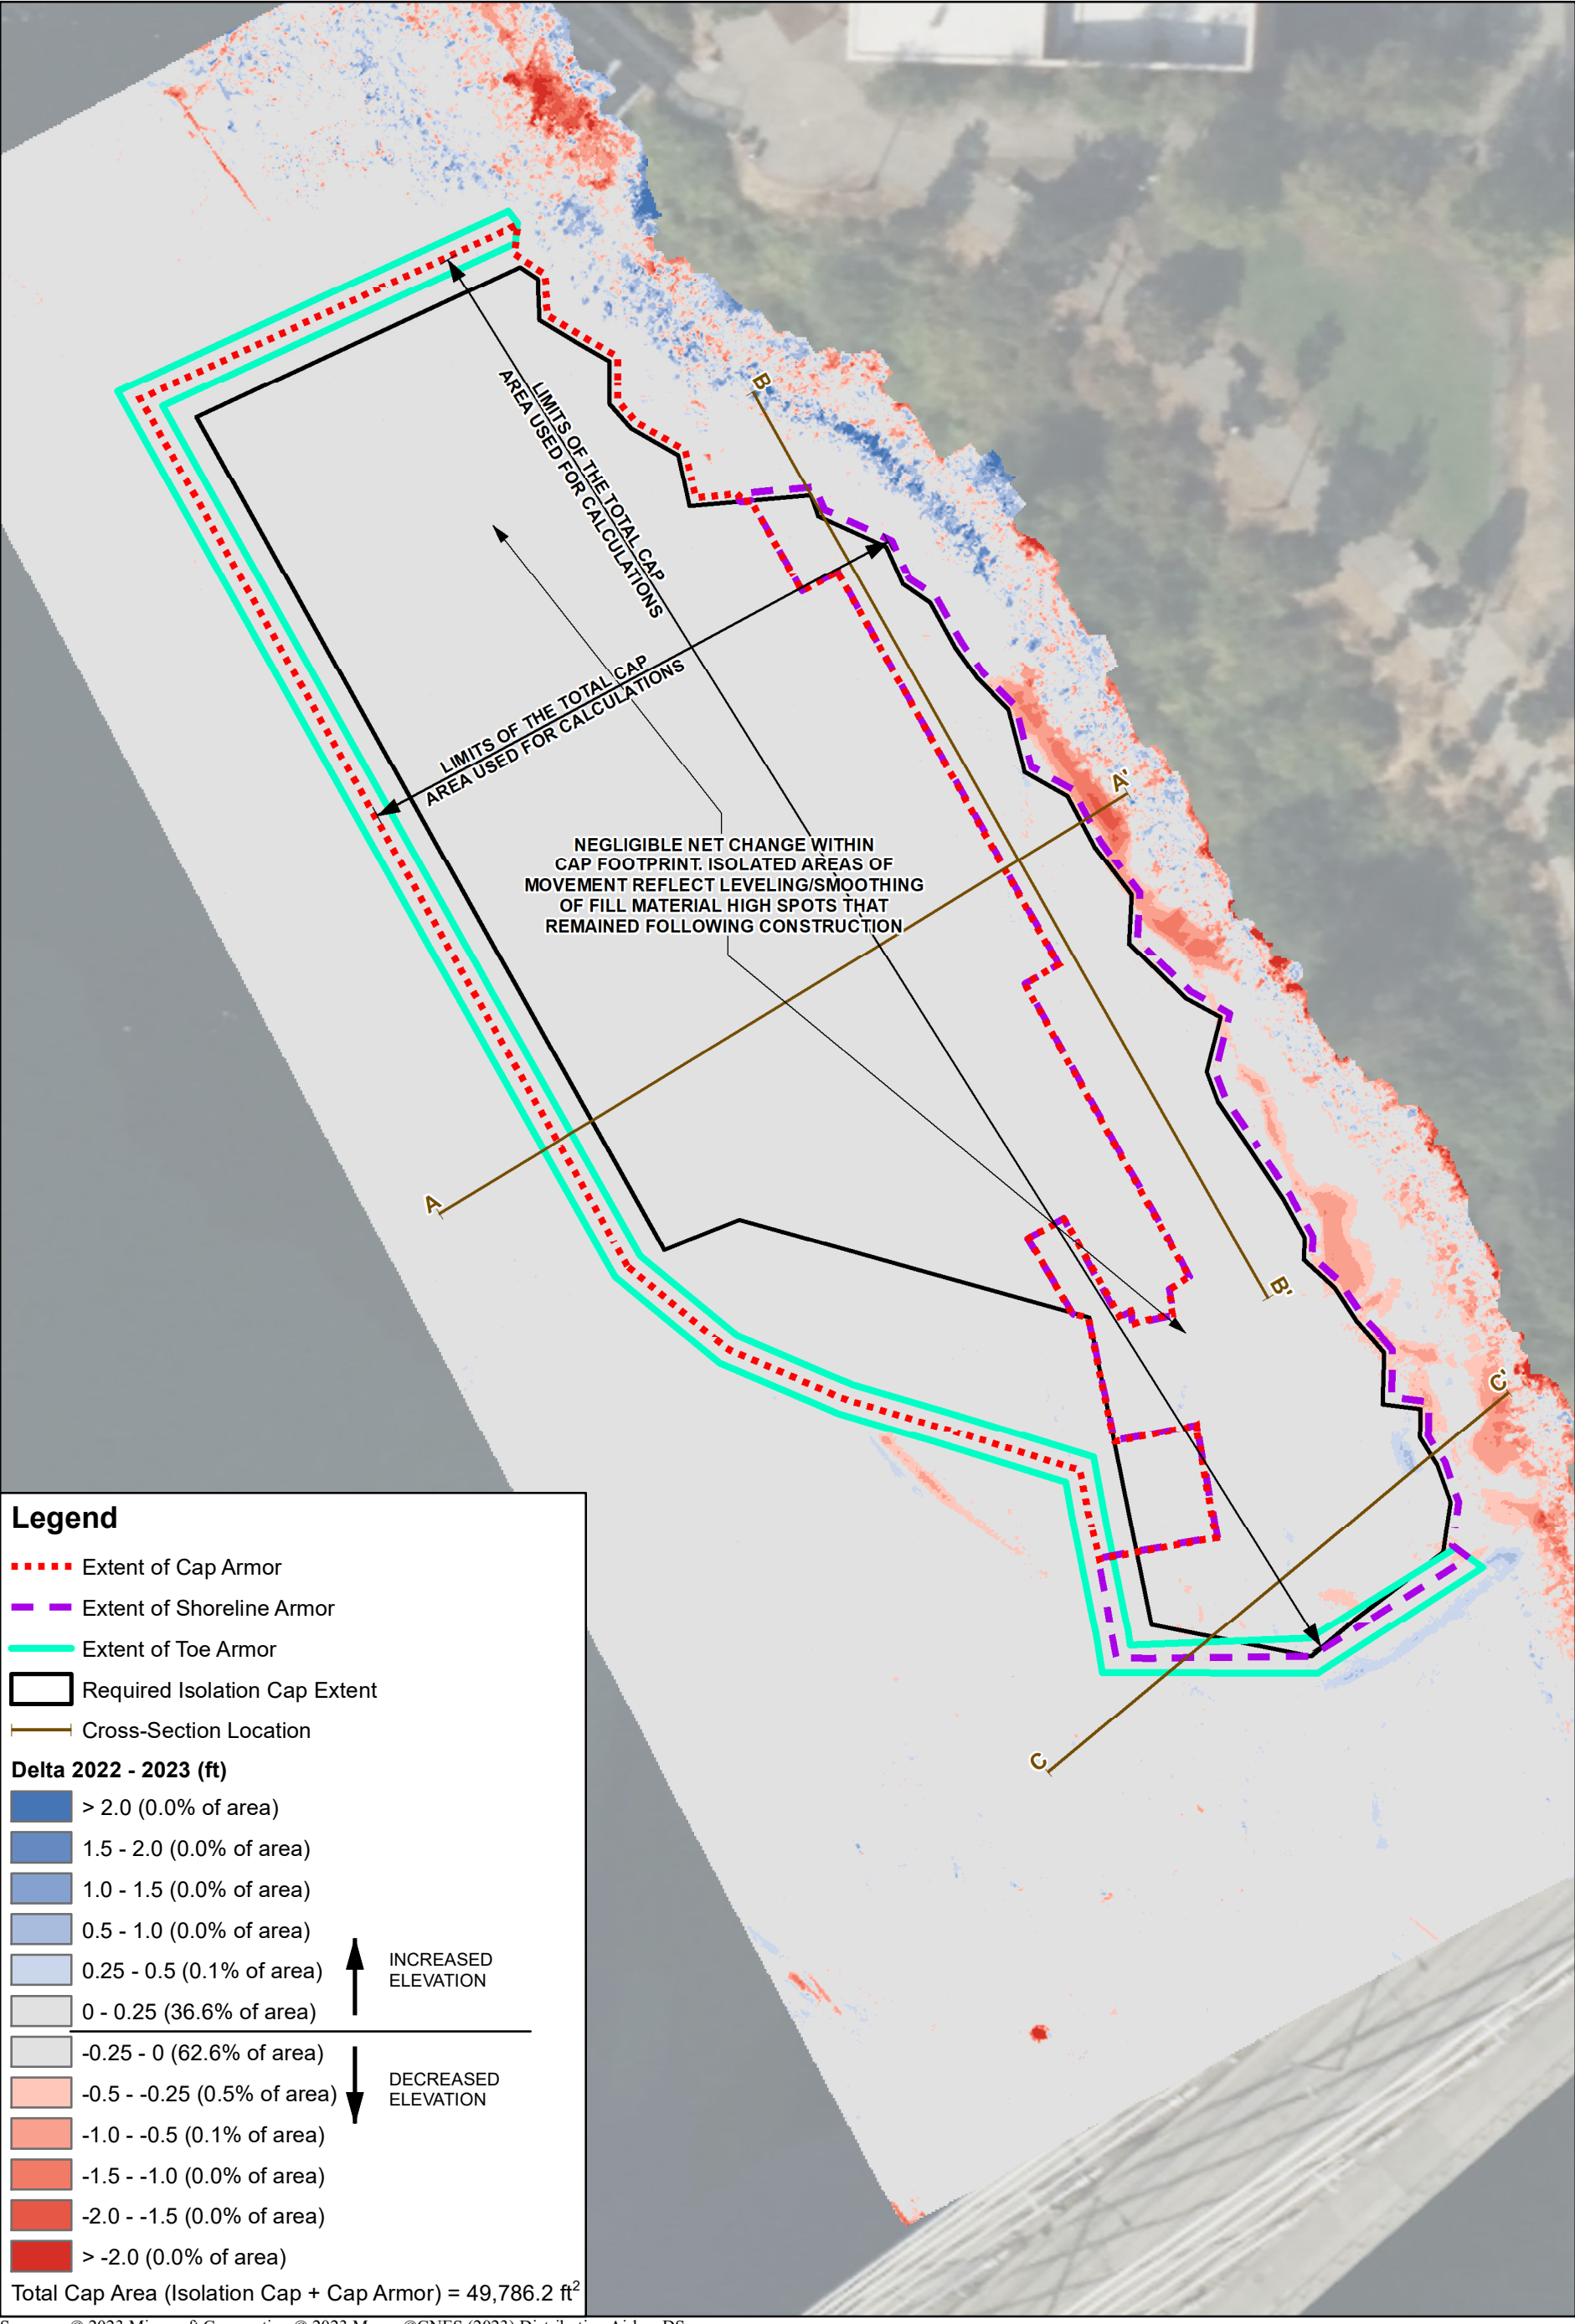
**FIGURE 4 - RM 13.5 2022-2023 CUT/FILL ANALYSIS**

Table 2 provides a summary of the cap performance evaluation criteria identified in the IMMP and the results of the current inspection. Figure 3 presents a comparison of the 2023 cap survey to the March 2016 6-month post-construction survey to assess potential excess cap erosion or evidence of slope instability. Figure 4 presents a comparison of the 2023 cap survey to the March 2022 cap survey (completed in support of the Year 5 cap inspection) to evaluate more recent potential cap erosion or evidence of slope instability. Representative cross-sections are presented in Figures 5, 6, and 7. Figure 8 shows areas of the cap that, through elevation loss, are under the minimum cap design thickness.

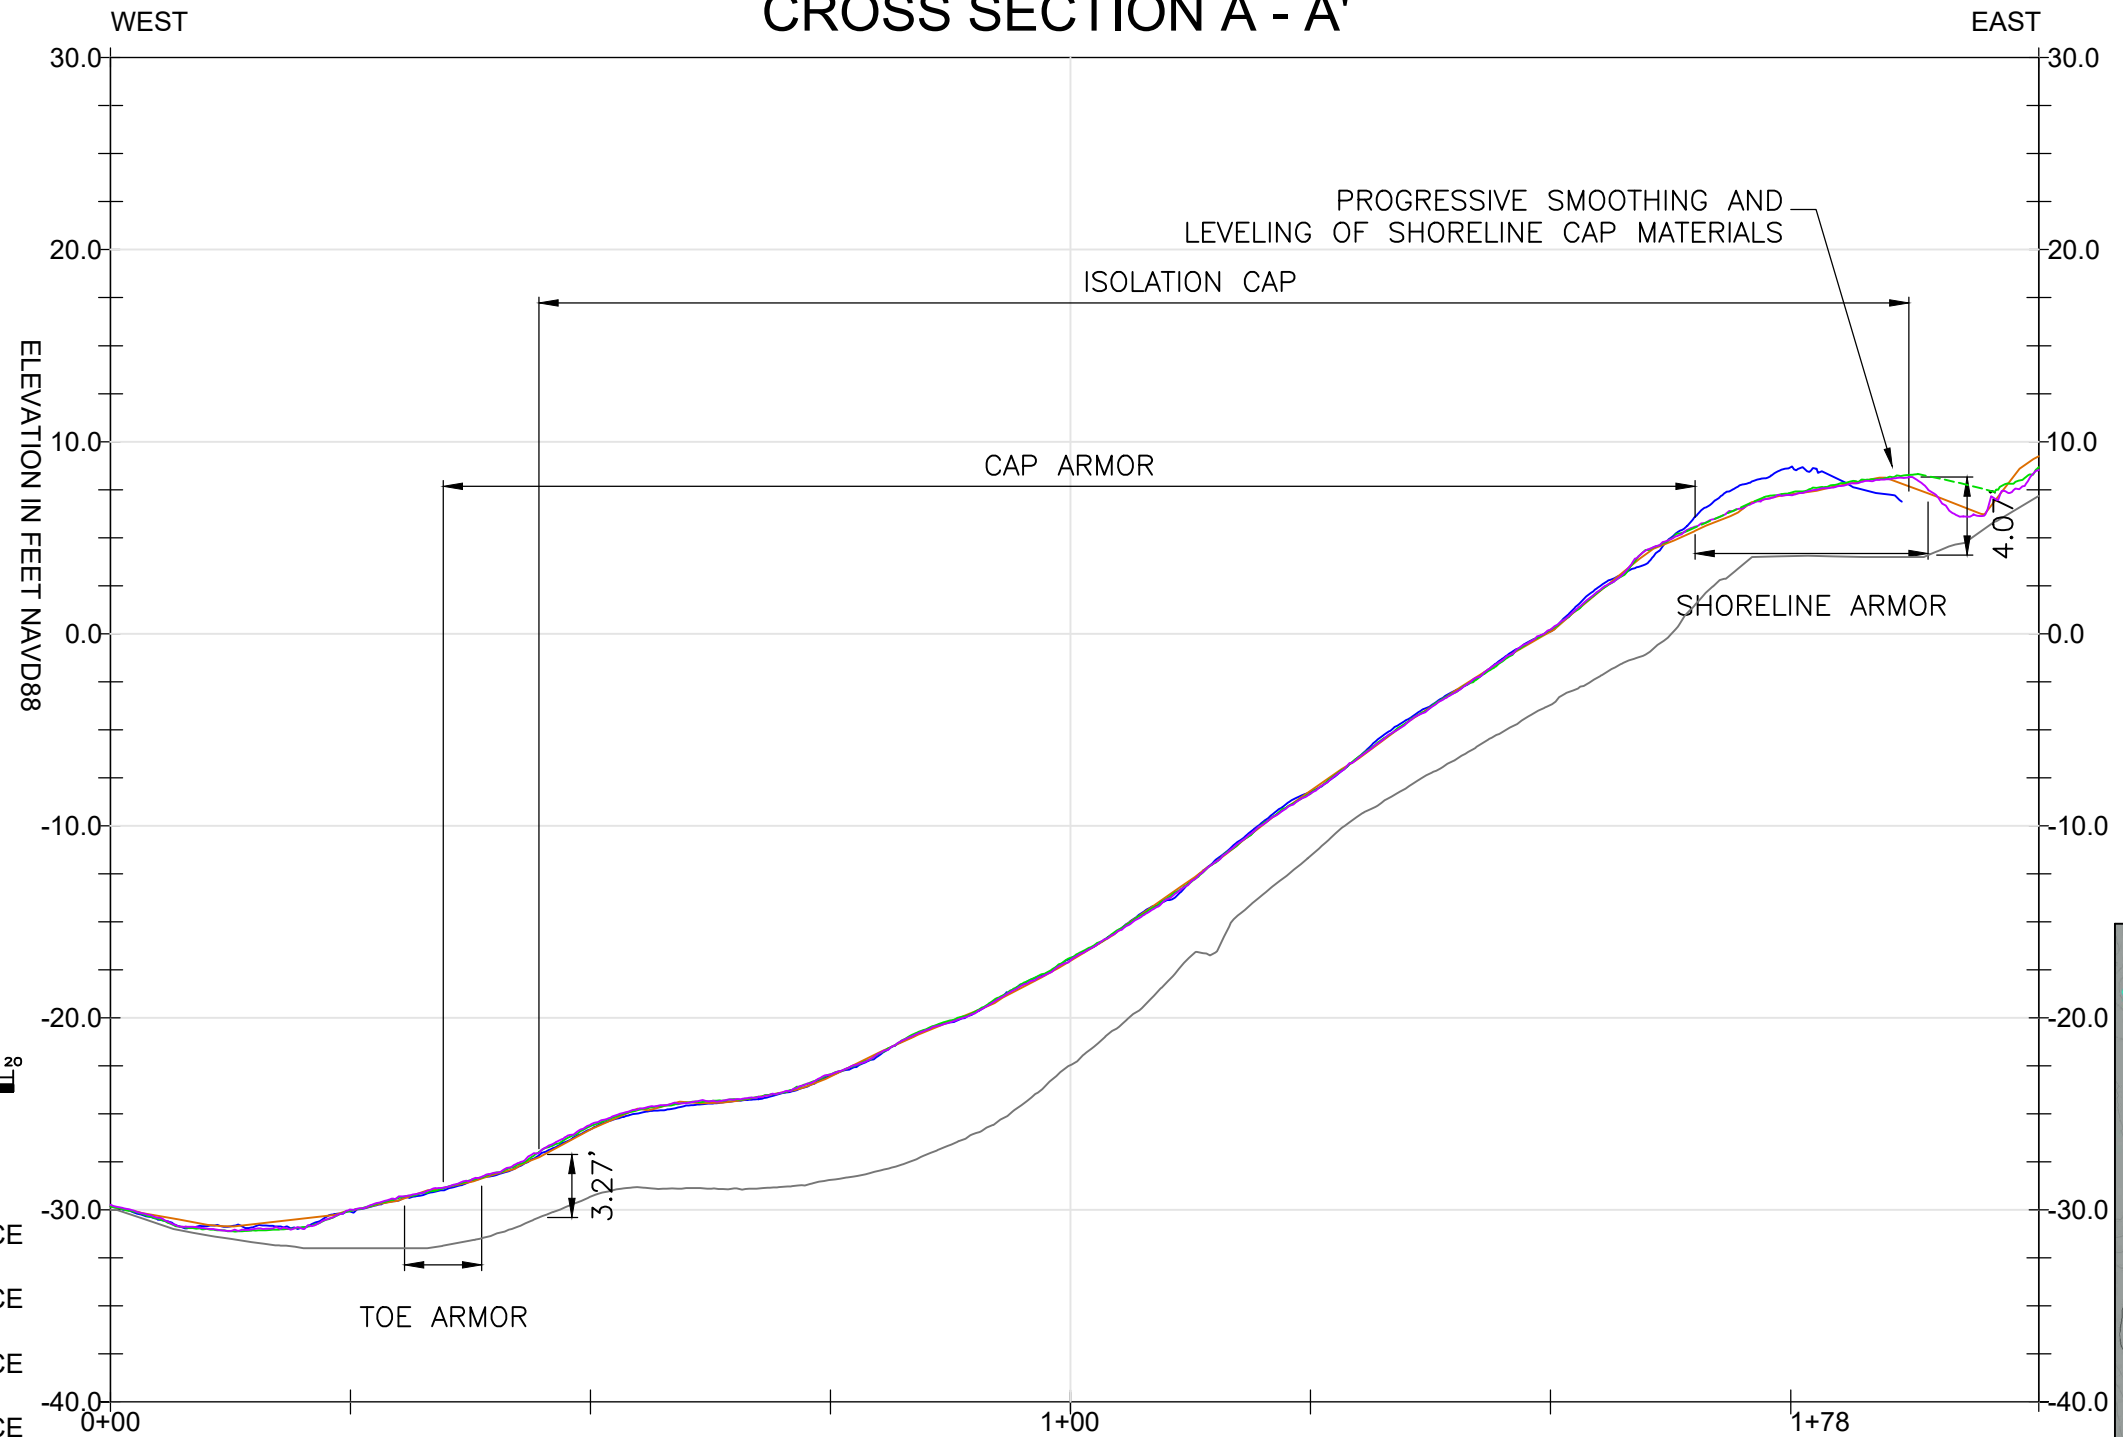
**FIGURE 5 - RM 13.5 CAP SECTION A - A'**

Evaluation of time series survey data (Figures 5–7) indicates continued but limited leveling and smoothing of localized areas of mounded capping material (high spots) that remained following construction of the cap in 2015. This is consistent with the 2019 and 2022 inspection findings, although the 2023 survey results indicate a substantial reduction in material movement and almost no material loss. The 2023 elevations are essentially the same as the 2022 elevations. No new areas of concern were identified as part of the Year 7 Investigation. Previous areas of concern that were evaluated in the Year 3 and Year 5 evaluations are shown on Figure 9, along with the 2017 cap maintenance area. Those areas were evaluated again during this inspection, as discussed below.

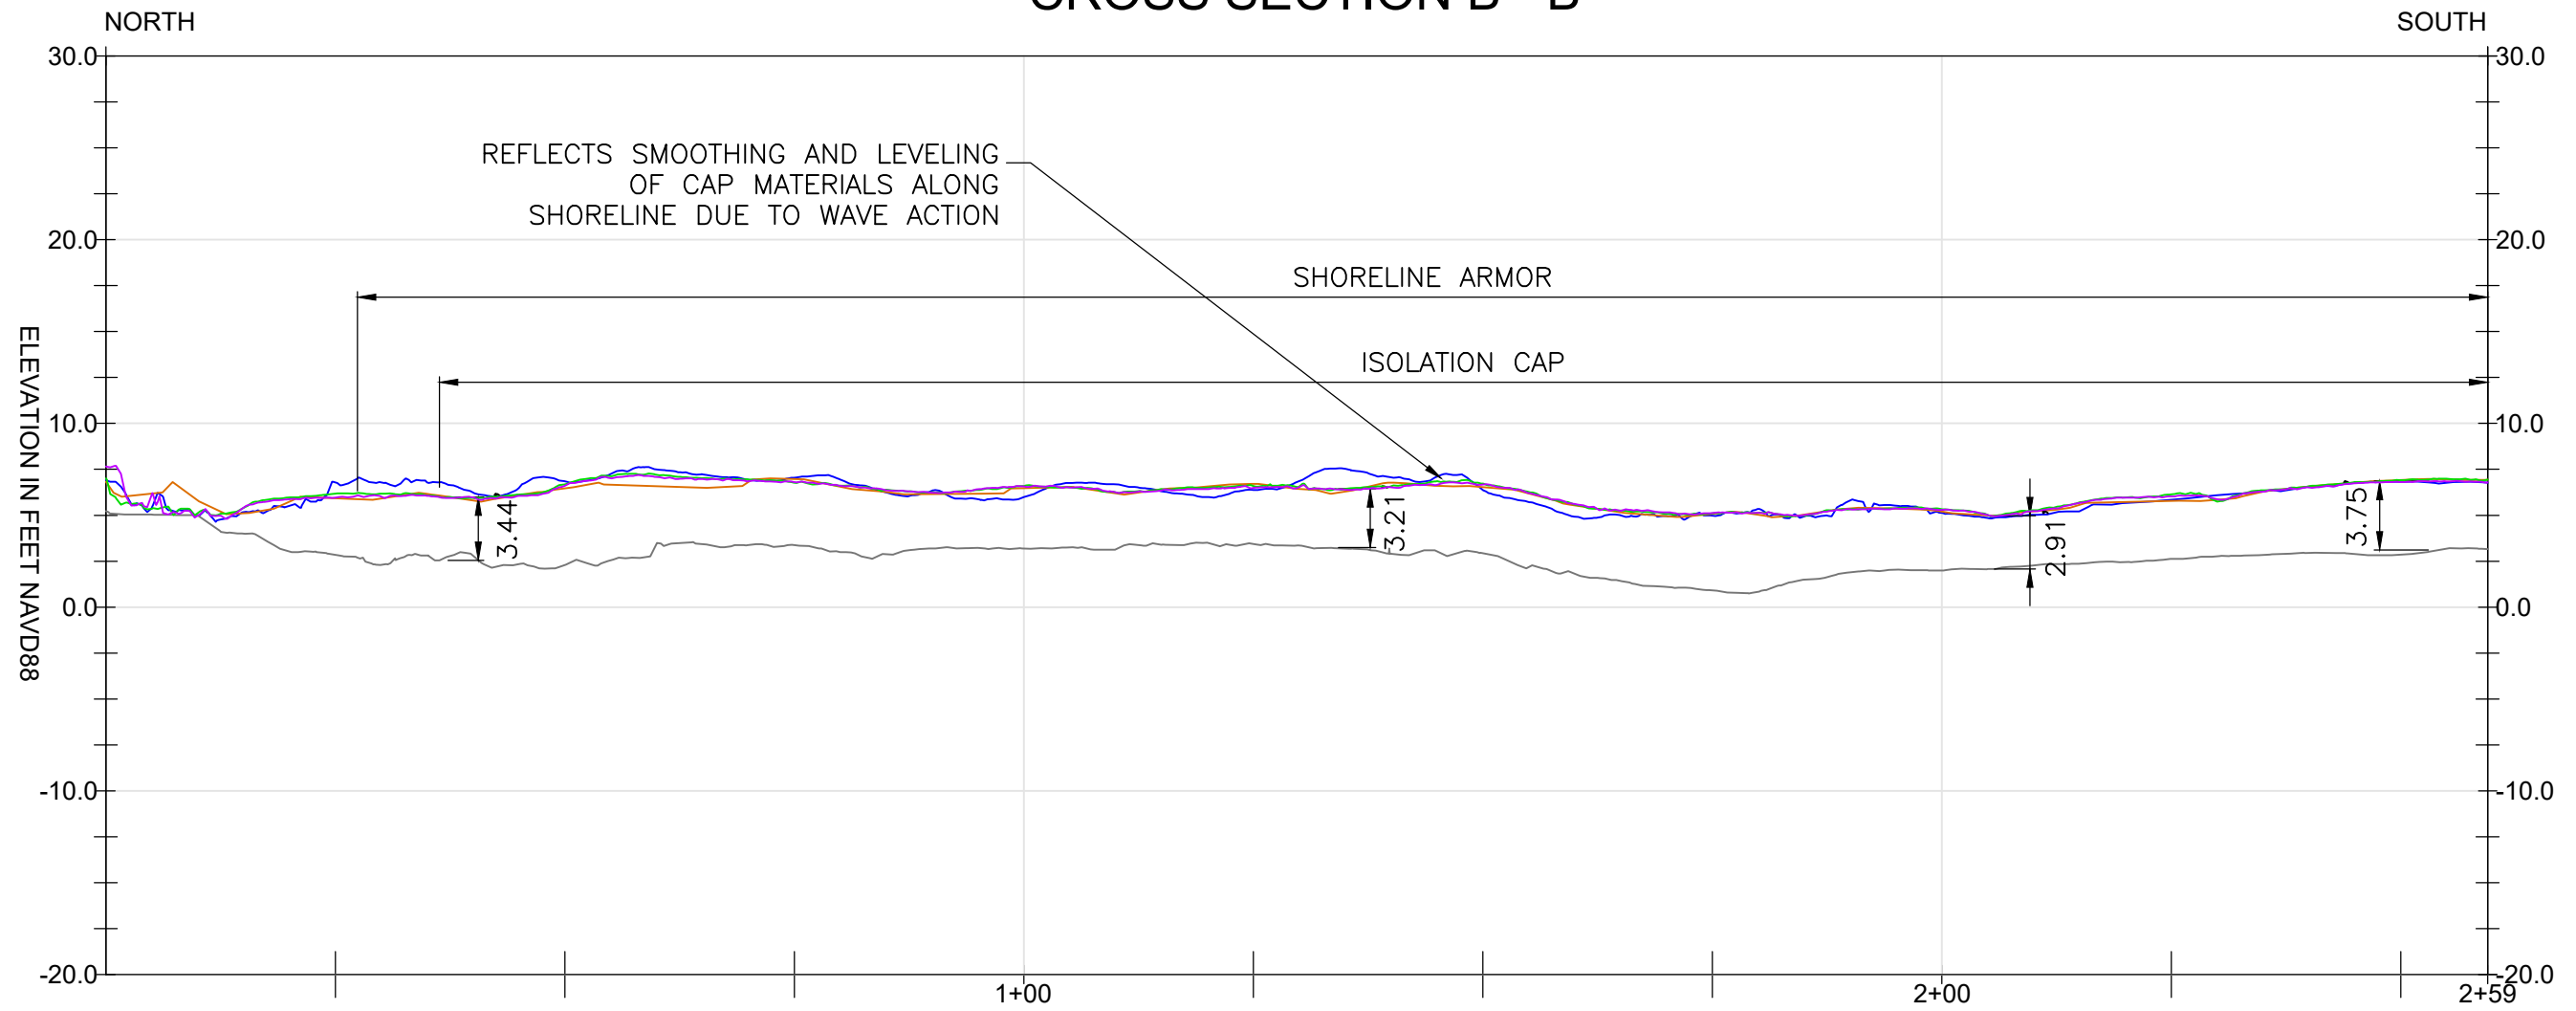
**FIGURE 6 - RM 13.5 CAP SECTION B - B'**

- The area along the shoreline, as portrayed in Figure 6 (cross section B-B'), has experienced transitory movement of armor materials since cap construction, primarily materials being pushed shoreward by wave action. This is also the area where the 2017 cap maintenance took place. The recent data suggest similar, limited ongoing material movement, but no new material loss. This may indicate a stabilization of the cap profile; however, the area will continue to be evaluated during future monitoring events. A discussion on remaining cap thickness and protectiveness is provided below.

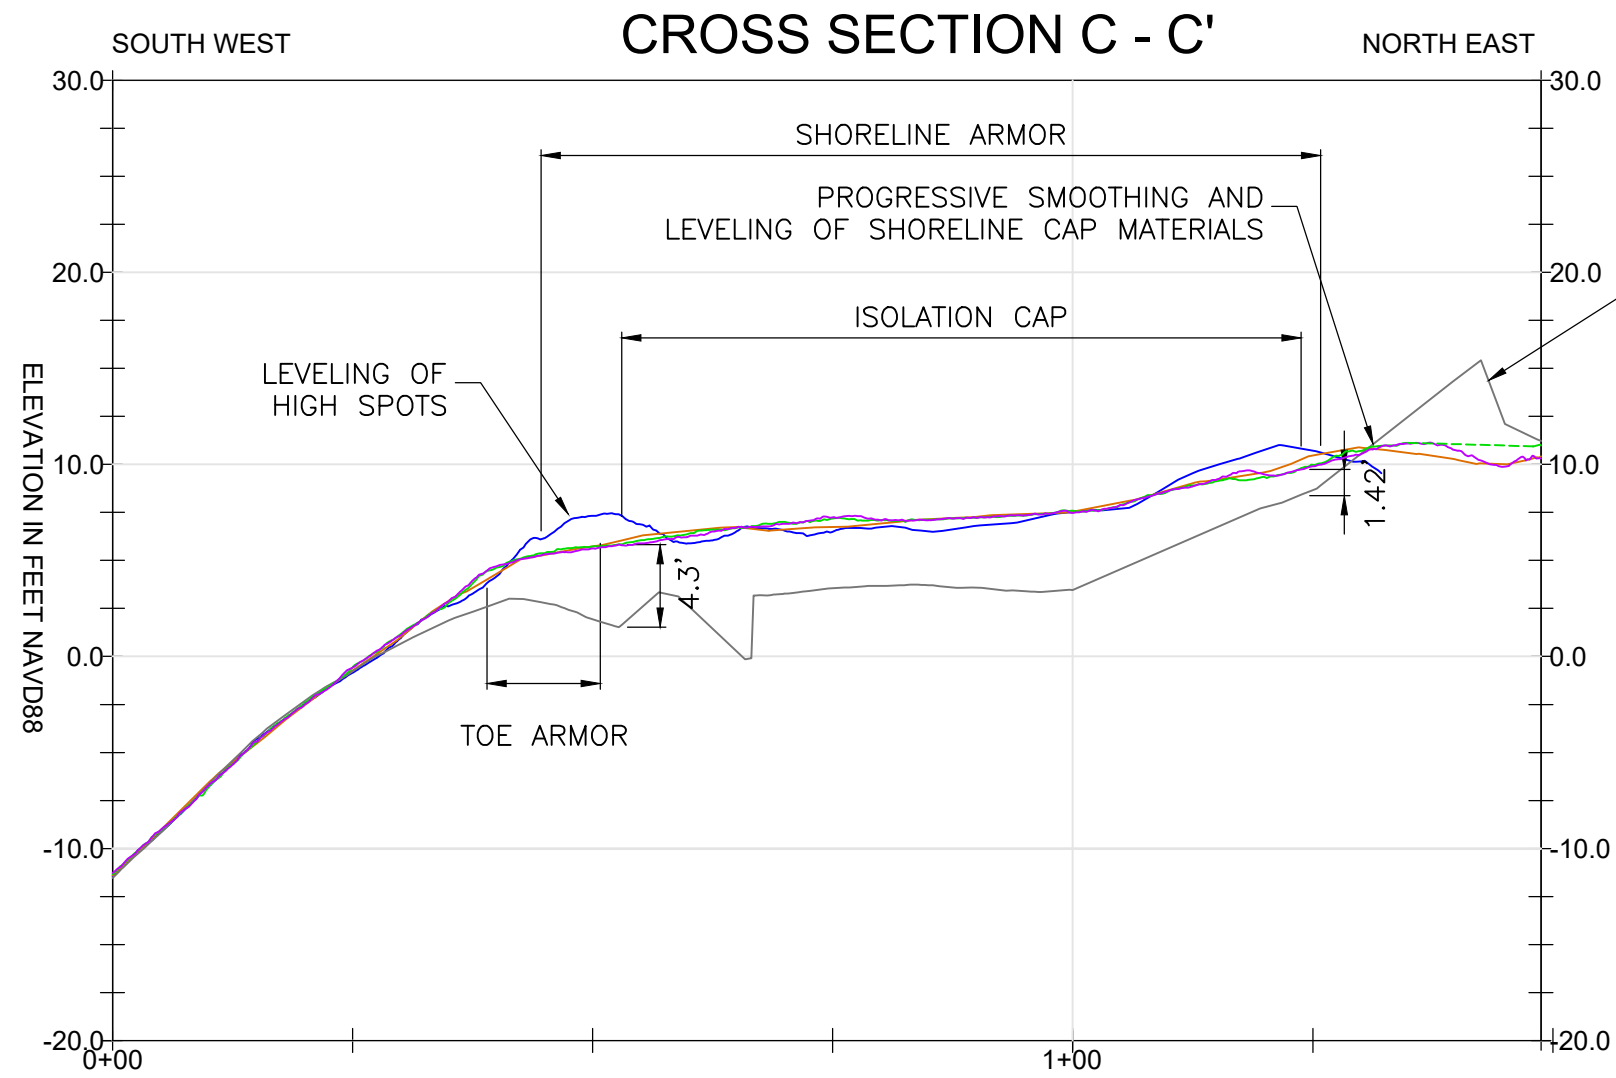
**FIGURE 7 - RM 13.5 CAP SECTION C - C'**

- The area in the southeastern corner of the cap, as portrayed in Figure 7 (cross section C-C'), has experienced the most elevation loss (approximately 1.7 feet) since 2015. The eastern-most portion of the cap was built up in a hump, which has been pushed shoreward by wave action. The visual inspection noted that armor material was still present in this area, so it is unclear what material has been displaced. Settlement of underlying cap materials may partially explain the elevation loss. Importantly, no additional material loss was identified between the 2022 and the 2023 surveys. This area will continue to be evaluated during future monitoring events. A discussion on remaining cap thickness and protectiveness is provided below.

- The area in the southwest corner of the cap, as portrayed in Figure 7 (cross section C-C'), that experienced greater than 1 foot of erosion between the 2016 and 2023 surveys (Figure 3) appears to have stabilized, with no additional notable erosion between the 2022 and 2023 surveys (Figures 4 and 7). This area was a high spot that has likely been leveled off due to wave action. This is primarily an area of toe armor; the current profile suggests sufficient toe armor remains to maintain slope stability, and there is no risk to the integrity of the cap. This area will continue to be evaluated during future cap inspections. As this area is outside of the required isolation cap footprint, there is no impact on environmental protectiveness.
