# River Mile 13.5 Year 7 Isolation Cap Inspection Report

Portland General Electric Company (PGE)

February 9, 2024

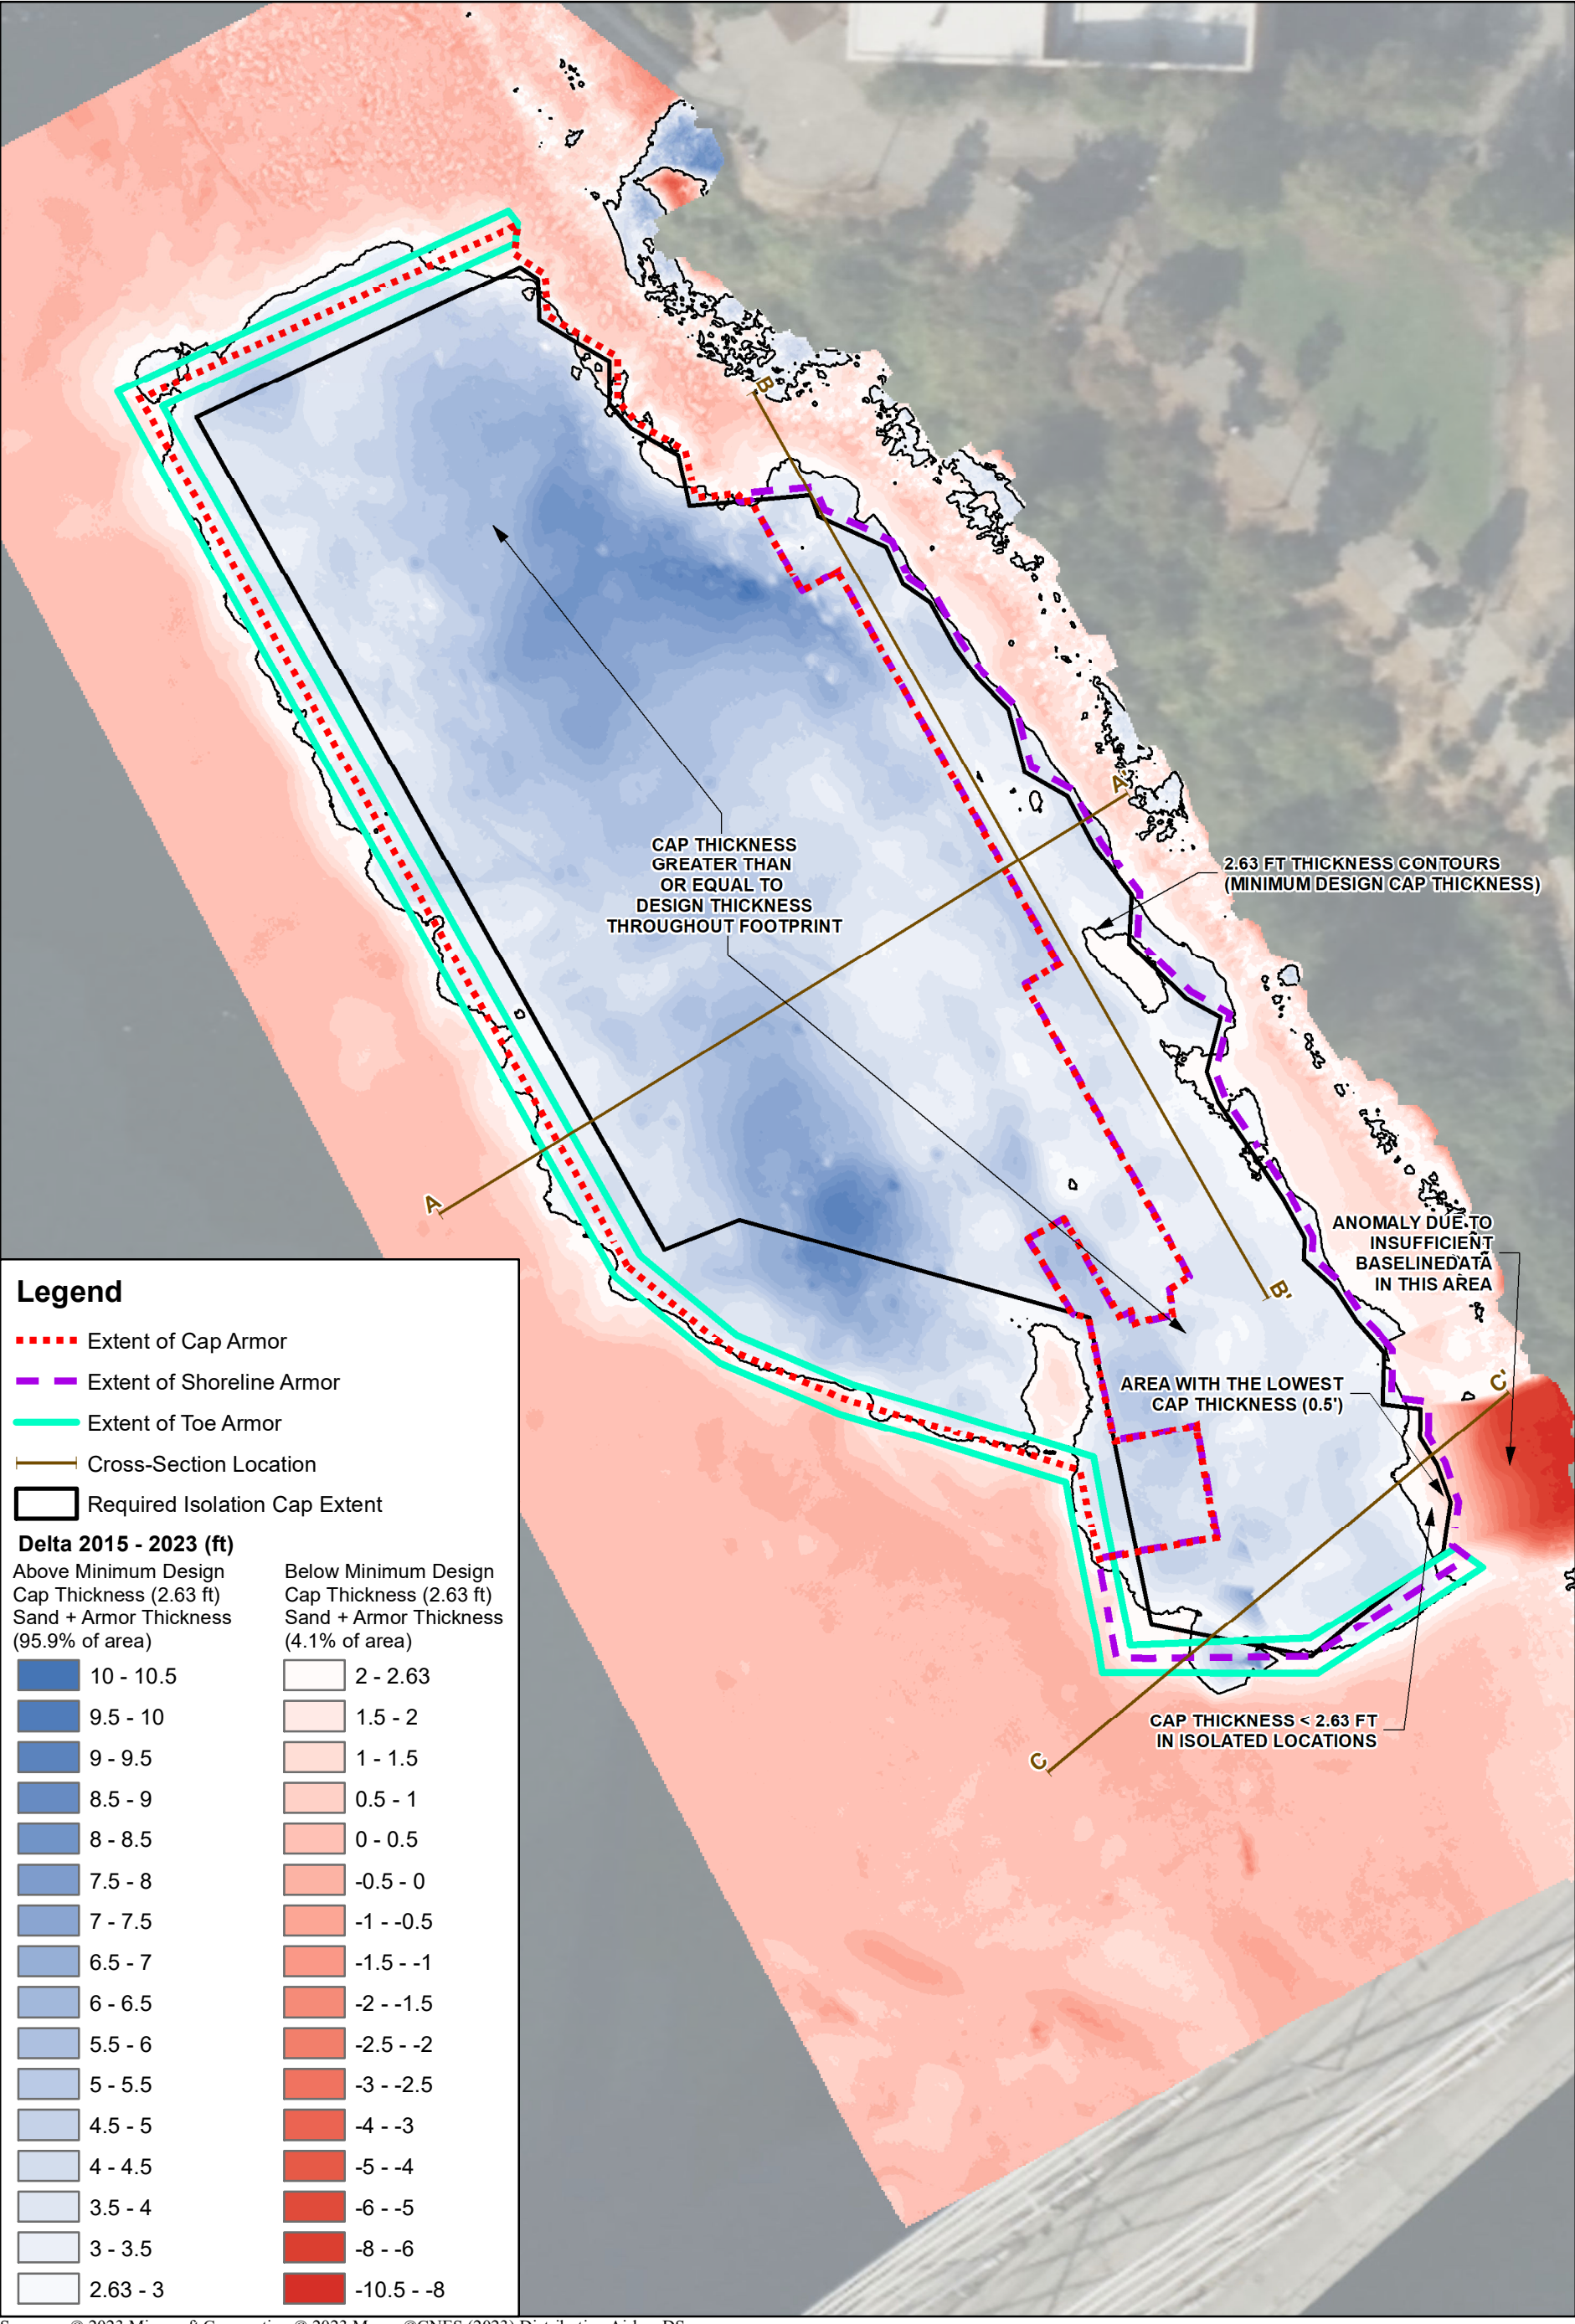
As indicated on Figure 8, the cap thickness remains greater than the design minimum of 2.63 ft across 95.9% of the isolation cap. The cap thins to less than the design minimum of 2.63 ft in isolated locations along the shoreline and the south end of the cap; the majority of these areas are just under the 2.63 foot minimum, although one small location (shown in Figures 7 and 8) has less than 2 feet of cap thickness. As discussed above, the data indicate localized movement of cap material. The displaced material appears to be moving into adjacent depressions in the cap surface and along the shoreline. High spots along the upstream crest of the cap also continue leveling out over time due to wave and river current forces. While this movement is resulting in localized areas of decreased cap thickness, the progression is limited and has not compromised the overall integrity or performance of the cap.

Even though the cap thickness is less than the design minimum of 2.63 ft in localized areas, the isolation layer thickness was designed to be protective for a minimum of 100 years. A limited reduction in armor or isolation material thickness does not currently represent a risk to human or ecological health. However, it will be important to continue monitoring these isolated areas to ensure that the rate and extent of movement remains low, particularly along the upstream edge of the cap that is exposed to combined head-on river currents and wave forces.

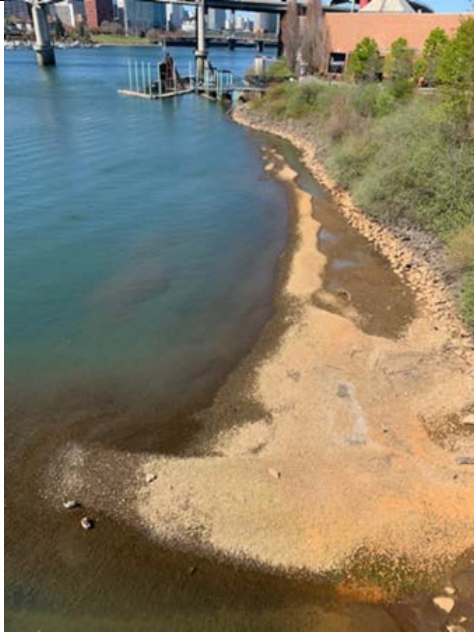
April 12, 2021

*View looking south to north of the RM 13.5 sediment cap shoreline from the Tilikum Crossing Bridge showing the visible armor stone, riprap and vegetation.*

*Some potential settlement of sand observed in the south portion of the Armor Stone on April 12, 2021.*

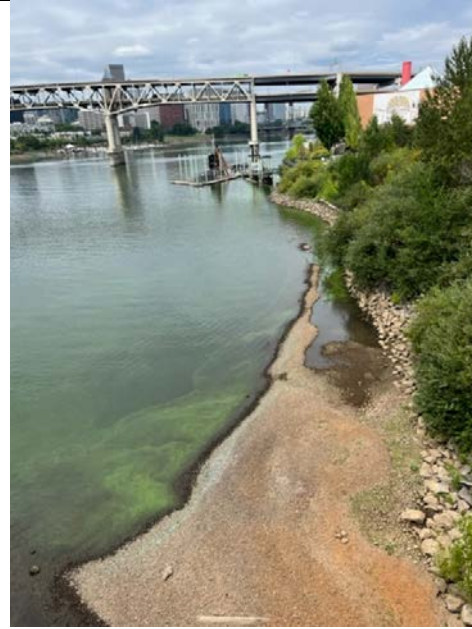
August 9, 2023

*Algae Bloom visible at the time of the visual inspection on August 9, 2023.*

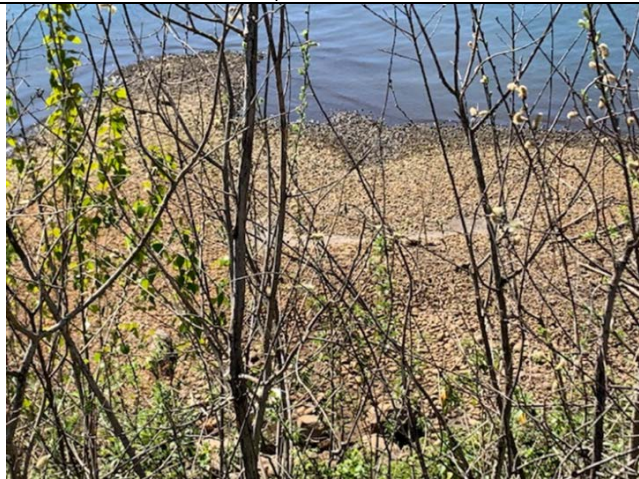
April 12, 2021

*Closer (zoomed in) view of the RM 13.5 sediment cap area looking south to north from the walking path just north of Tilikum Crossing Bridge on April 12, 2023.*

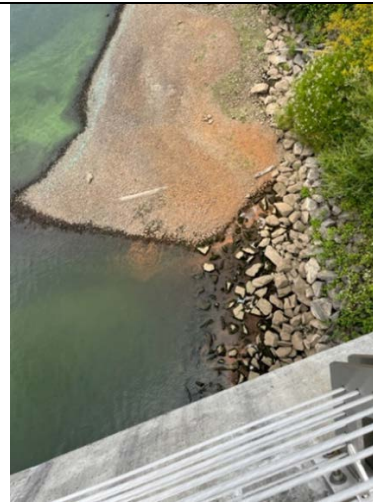
August 9, 2023

*Another view of the Algae Bloom visible at the time of the visual inspection looking down from the Tilikum Crossing Bridge on August 9, 2023.*

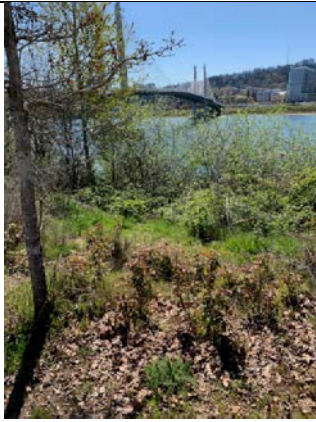
April 12, 2021

*Observed camping activities by unhouse people along walking path during both inspections on April 12, 2021.*

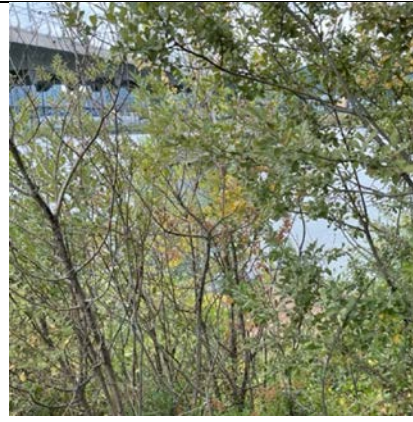
August 9, 2023

*Photos taken from Springwater Trail above cap and riprap area due accessibility issues to the river level on August 9, 2023.*
