Subject: Willamette River Mile 13.1
Final Six-Month Post-Construction Survey
Isolation Cap Inspection Report
ESCI #5249

Portland General Electric Company
River Mile 13.1 Six-Month Post Construction Survey
Isolation Cap Inspection Report
ESCI #5249
October 2018

**Portland General Electric Company (PGE)
River Mile (RM) 13.1
Six-Month Sediment Cap Visual Shoreline Inspection
Field Notes & Observations**

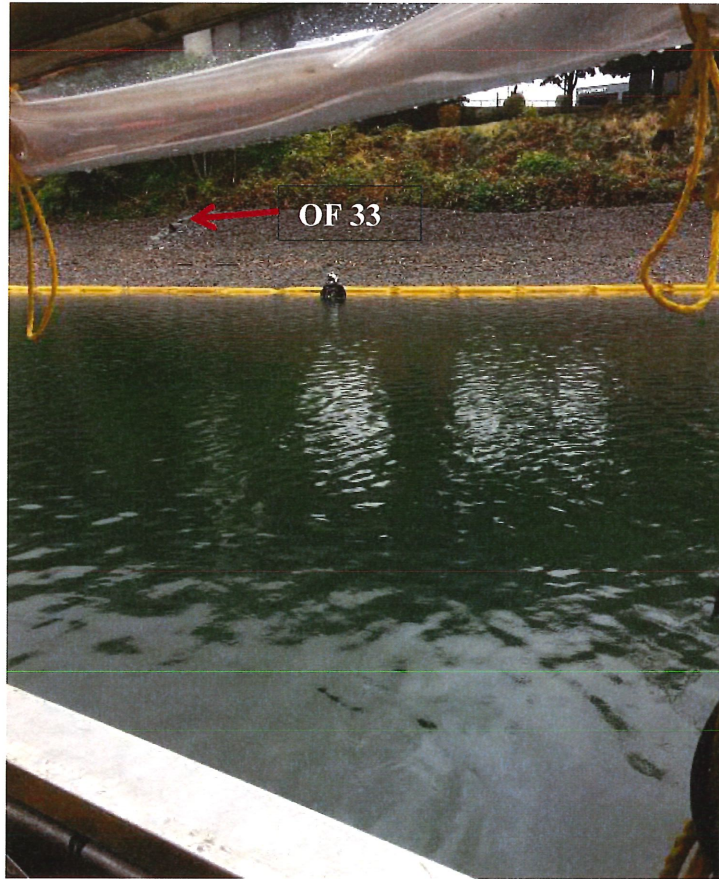
Outfall (OF) 33 Pipe / RM 31.1 Cap Construction – Fall 2017

The bathymetric survey field work was completed on April 9, 2018 by Solmar Hydro Inc. with the data being provided to PGE on May 4, 2018. The data and figures showed a potential low-spot of the cap on the shoreline near the Outfall (OF) 33 pipe. The following are photos showing OF 33 during the cap construction and OF 33 more recent on June 13, 2018. Per further evaluation, PGE found no

sluffing or low-spot adjacent to the OF 33 pipe. The potential low spot identified on the cut/fill analysis is believed to be an anomaly between survey data or interference from the outfall pipe.

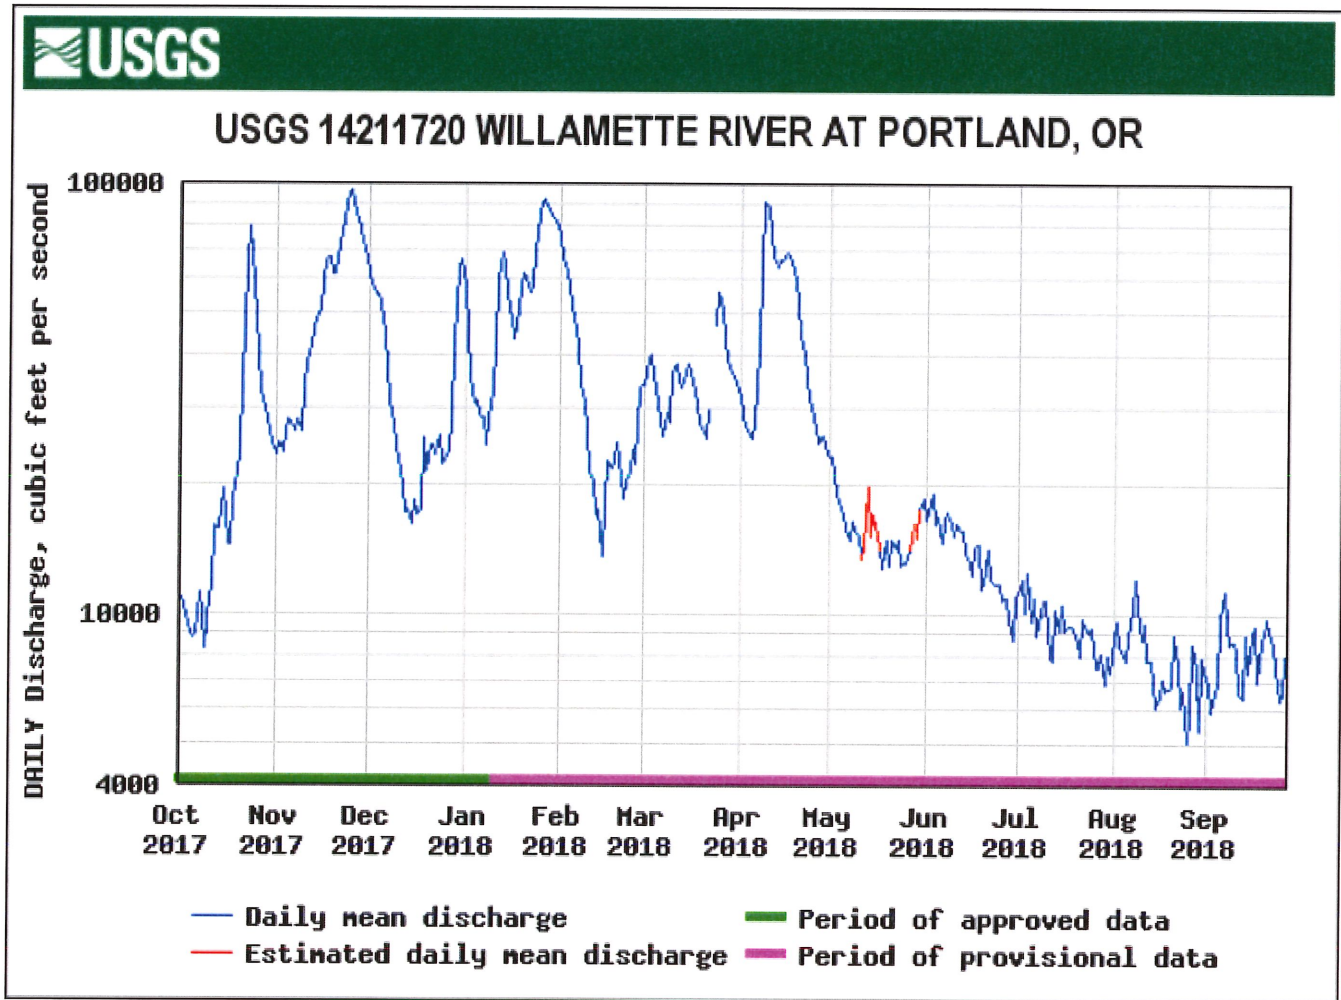
USGS Water Discharge (Mean)
Willamette River at Portland, Oregon
October 2017 to September 2018
Graph

Appendix A shows the river flows from October 2017 through September 2018. No floods or high river flow event occurred since construction of the cap in 2017.

A 100-year flood event in the lower Willamette River is defined as a discharge of 375,000 cubic feet per second (cfs).

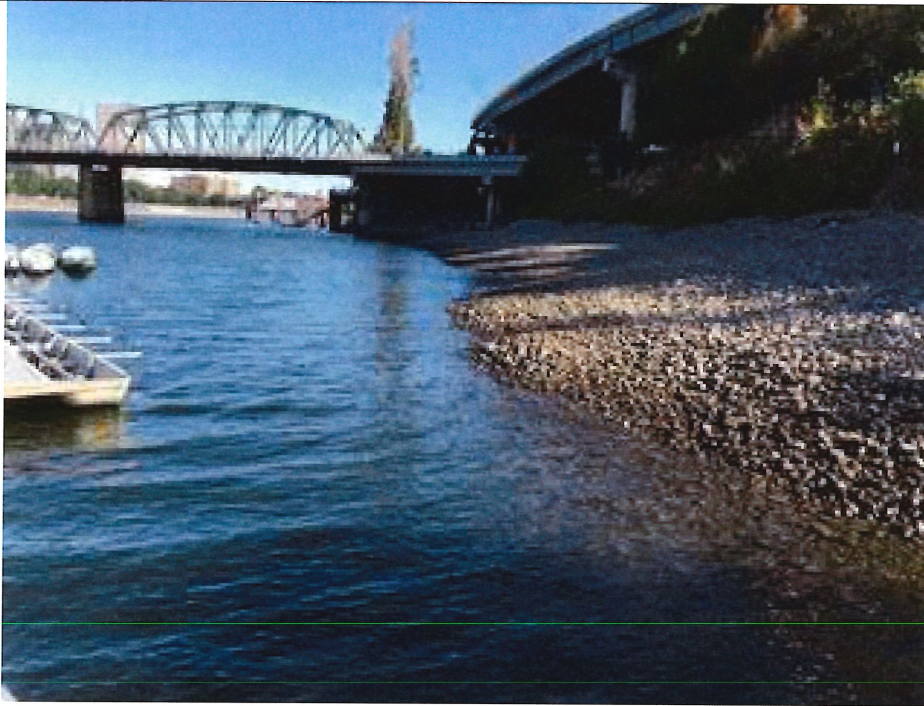
Photo 1

Looking south to north at the RM 13.1 Sediment Cap from the public dock.

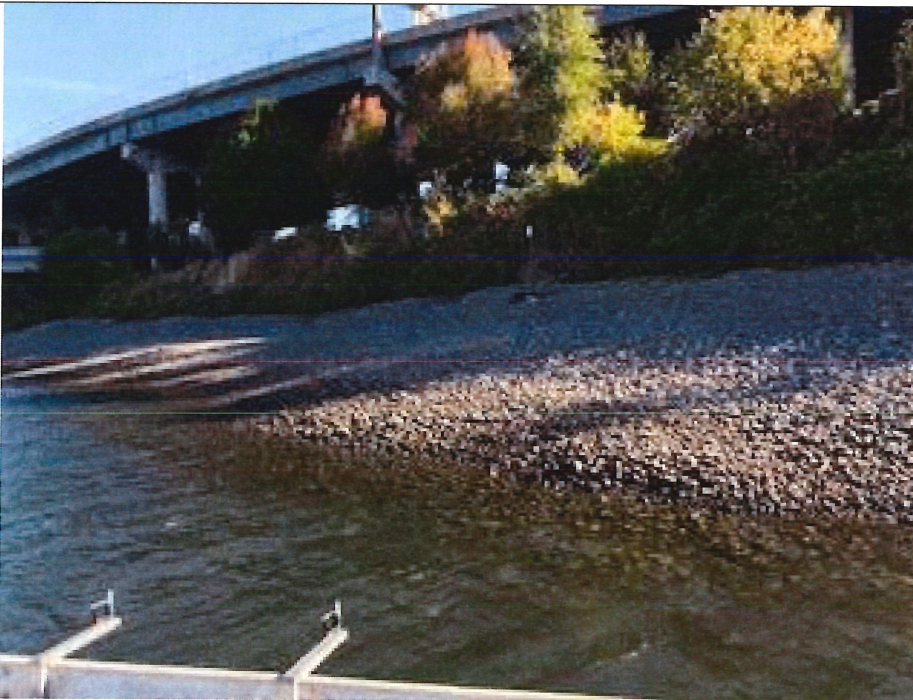
Photo 2

Another view (south to north) at the riprap and shoreline from the public dock.

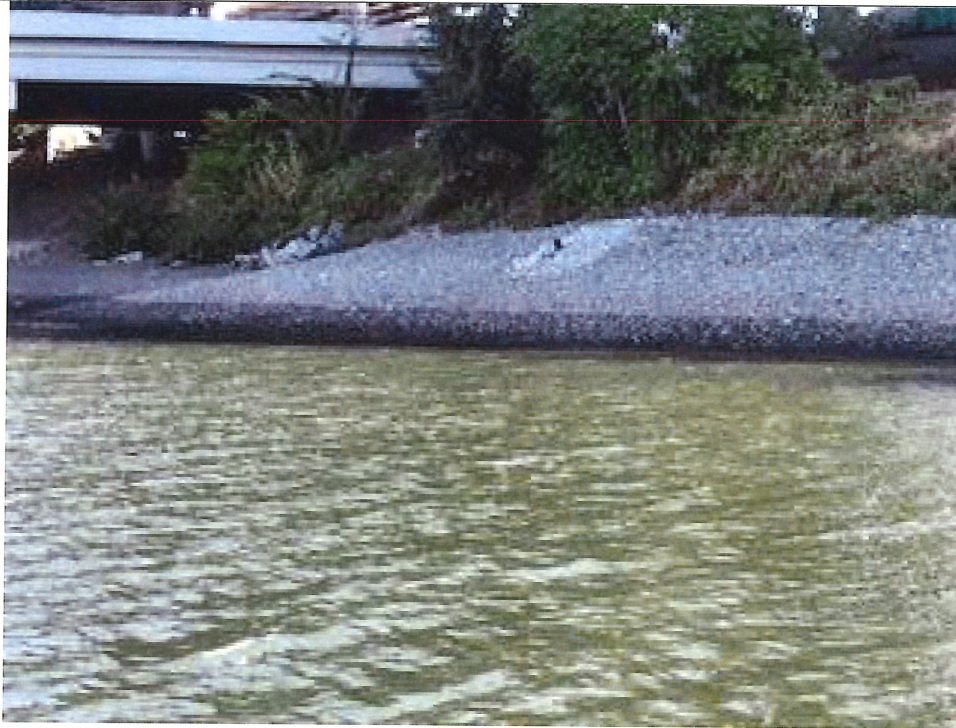
Photo 3

Another view at the riprap, shoreline and Outfall (OF) 33 pipe from the public dock.

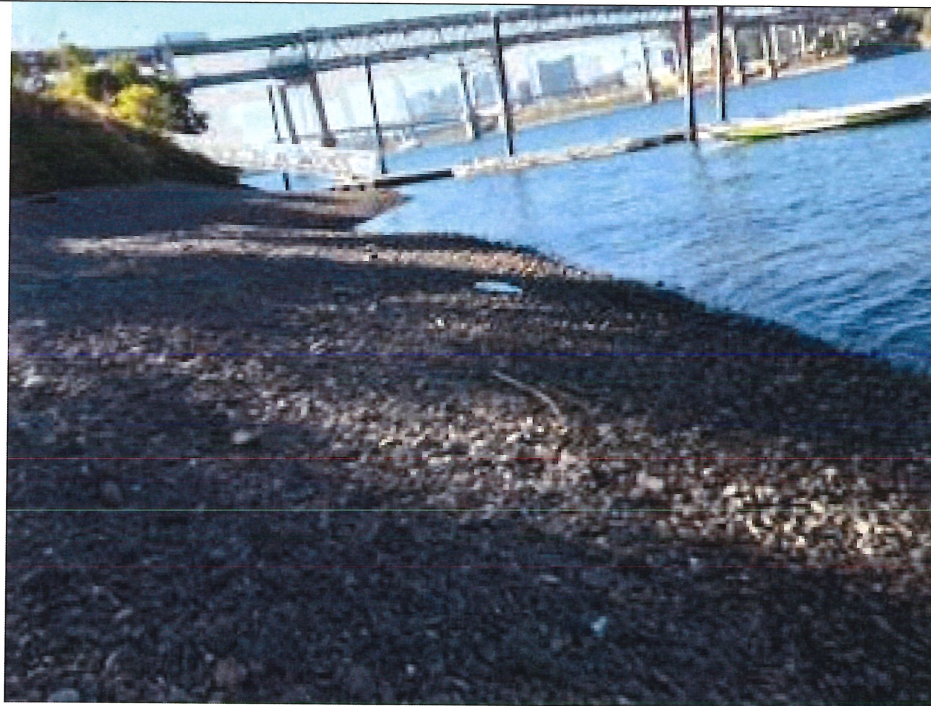
Photo 4

Looking north to south from riprap and shoreline.

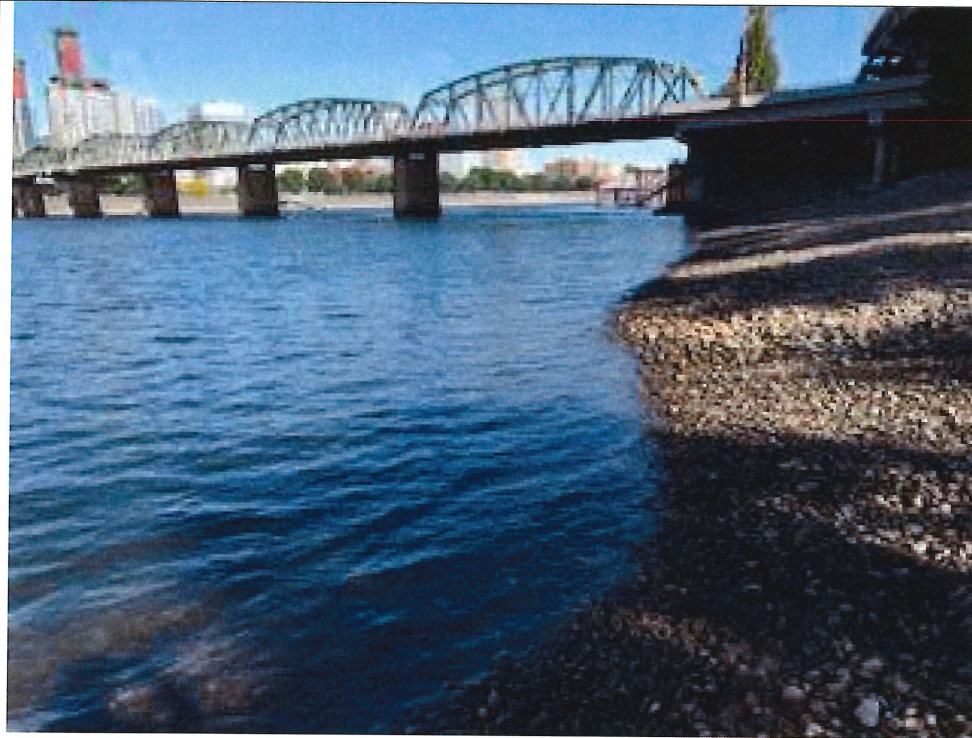
Photo 5

Looking south to north from riprap and shoreline.

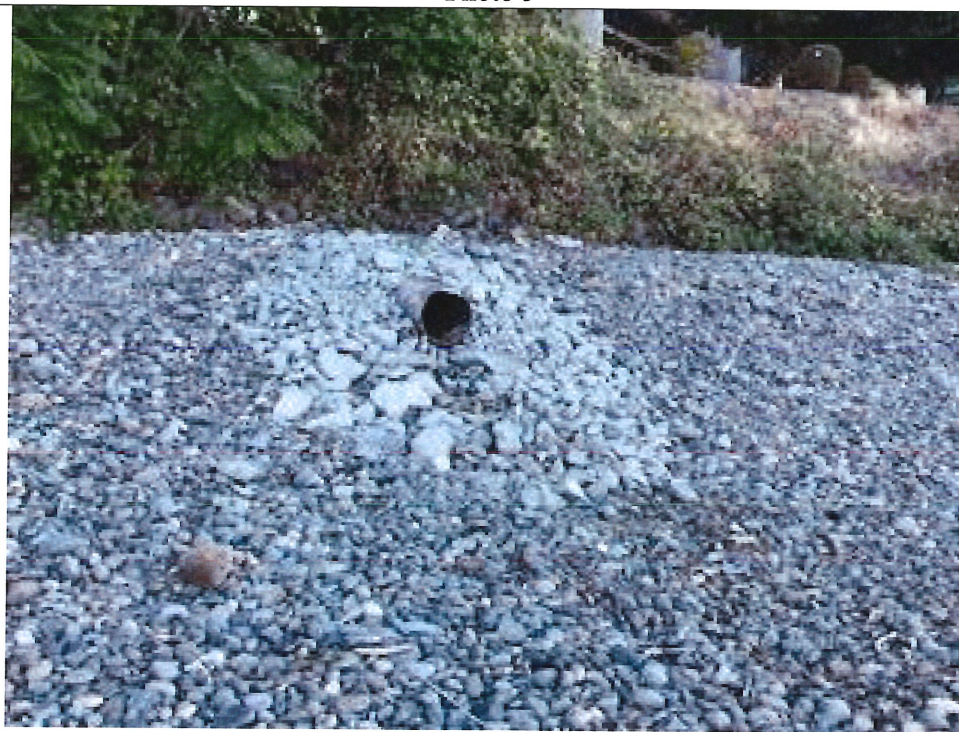
Photo 6

View of OF 33 pipe looking up from river shoreline.
