River Mile 13.1 Year 3 Isolation Cap Inspection Report

ESCI #5249

Portland General Electric Company, (PGE)

September 21, 2021

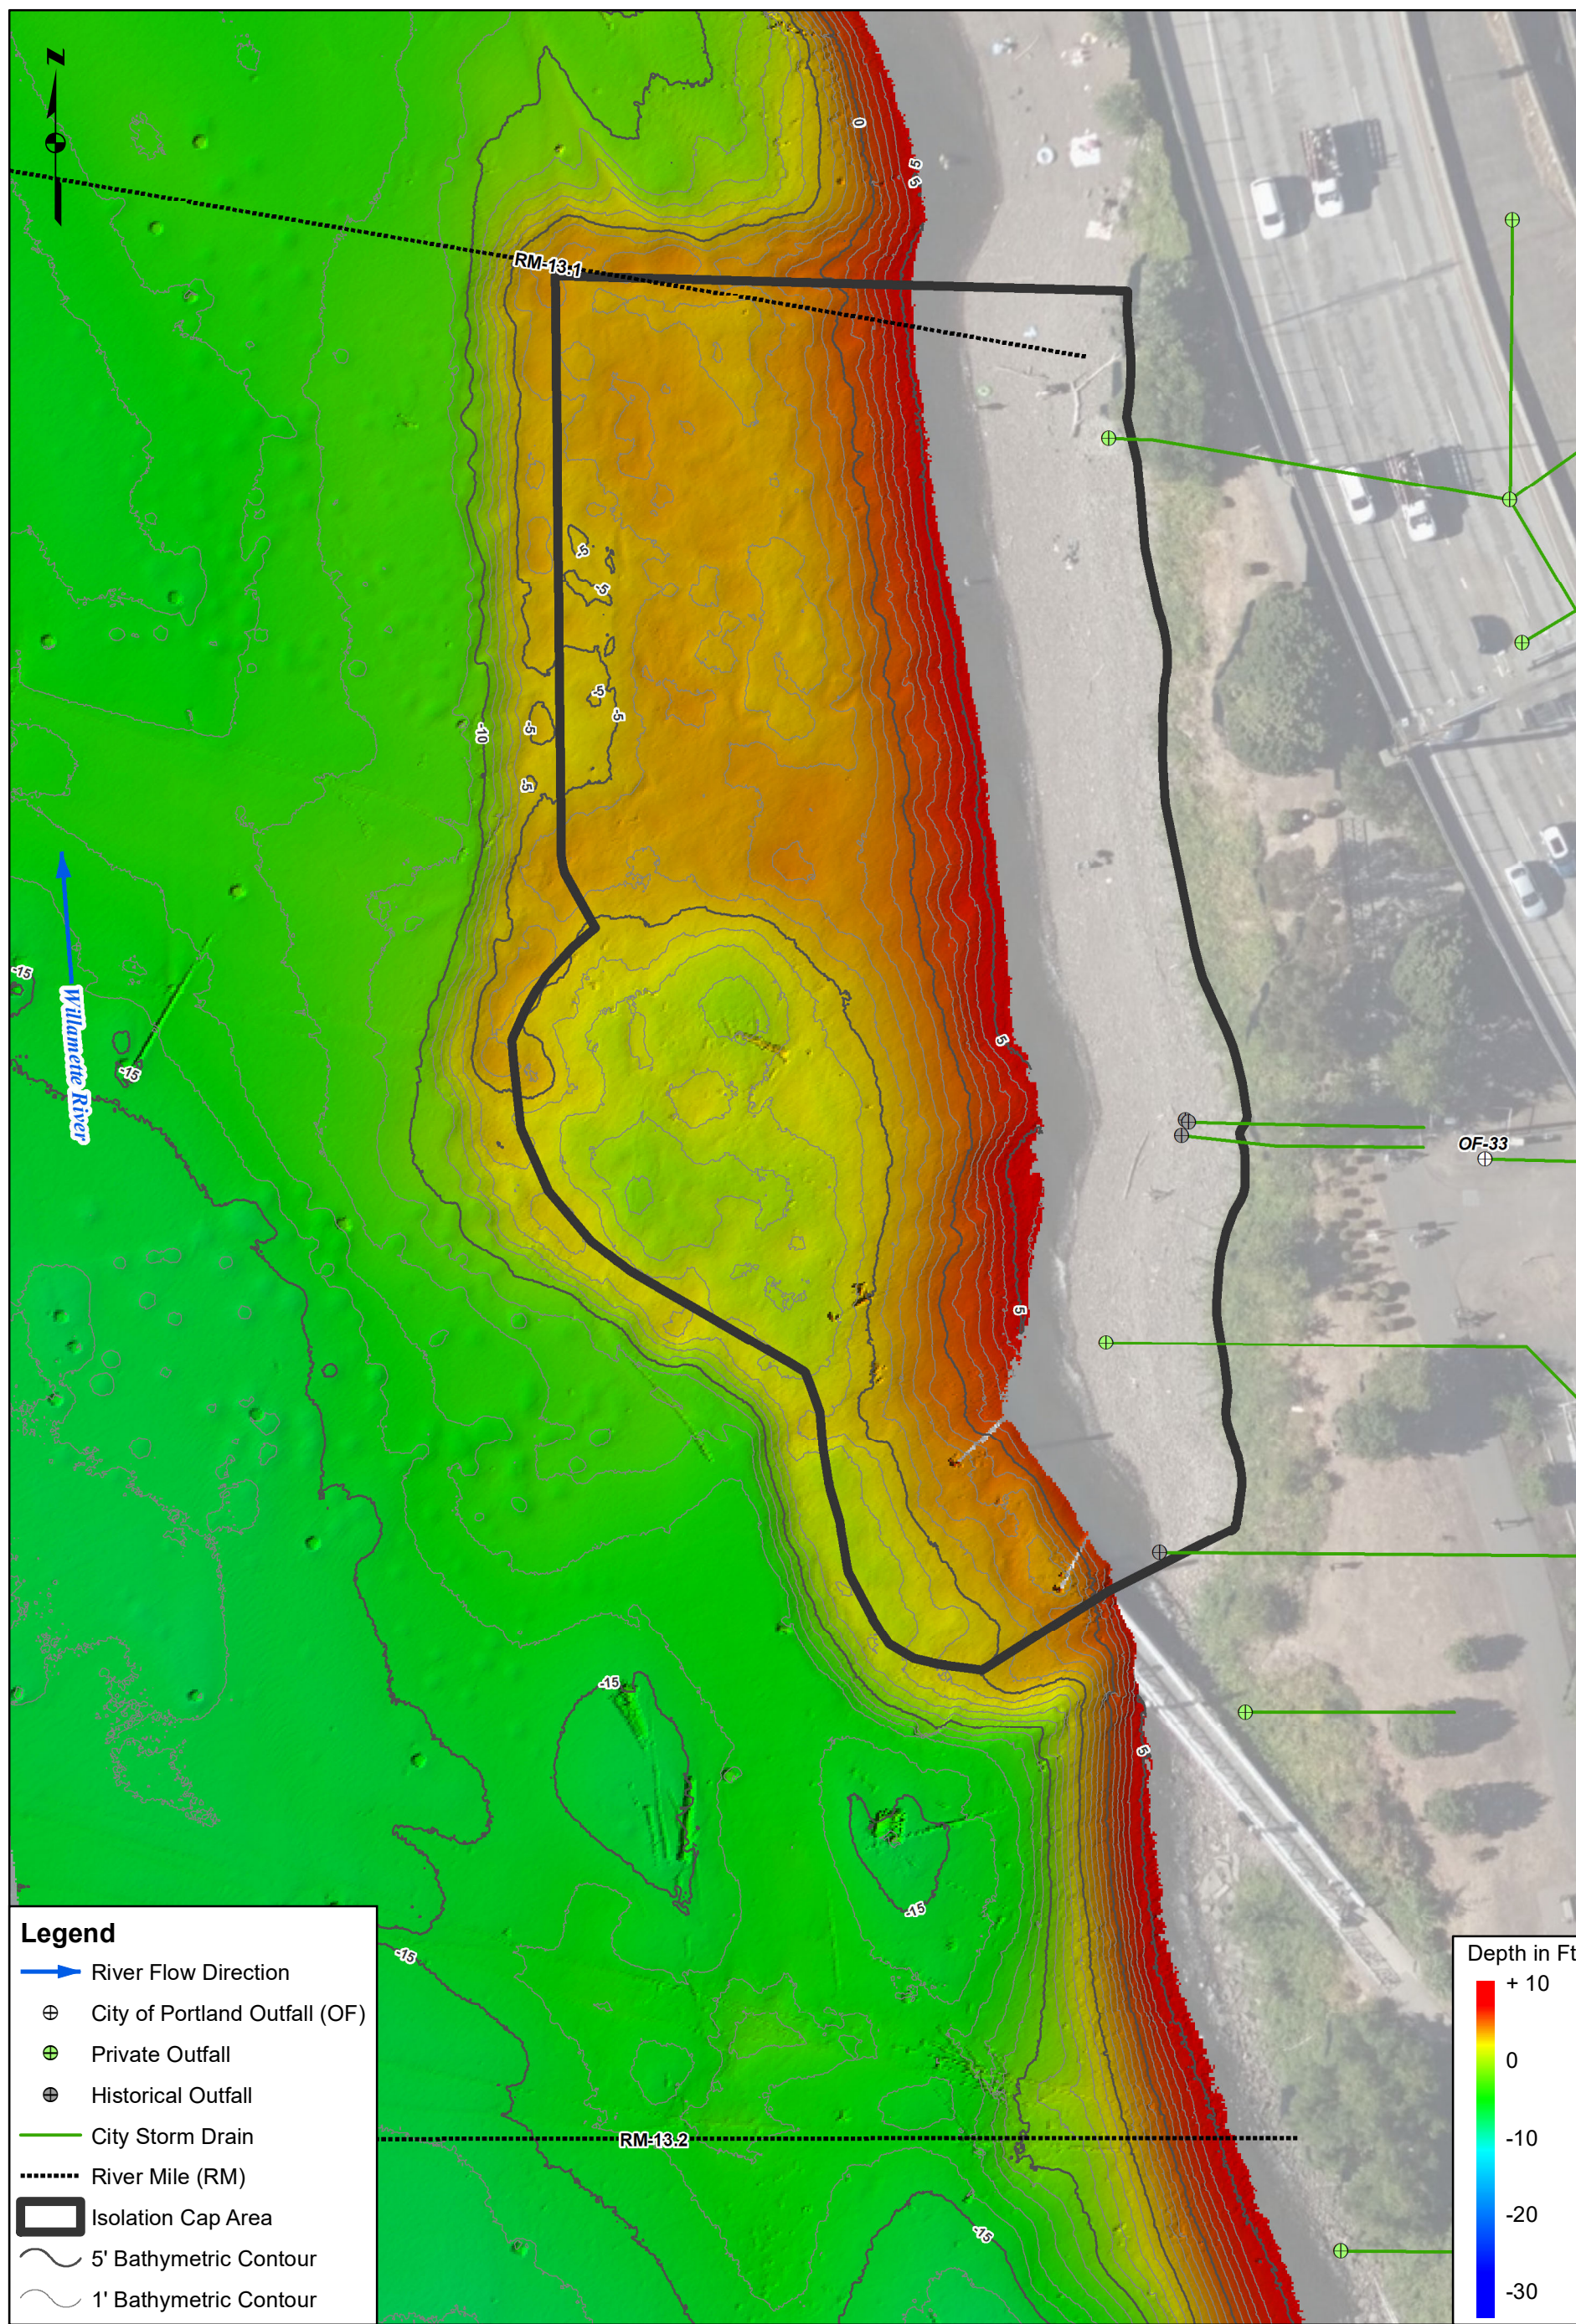
**FIGURE 2 – RM 13.1 BATHYMETRIC SURVEY
SUN-ILLUMINATED DIGITAL TERRAIN MODEL**

A review of the bathymetry (Figure 2) and backscatter results (Figure 5) does not indicate significant scour holes or evidence of cap stability issues such as a slope failure. It is likely that the cap surface is continuing to 'smooth', as high spots are slowly leveled off and low spots filled in. The smoothing process is most pronounced closer to the shoreline. The April 2021 visual inspection of the shoreline, where bathymetric data is unavailable, confirmed the armor stone was still present and in good condition. Both the sun-illuminated and backscatter results (Figure 2 and Figure 5 respectively) show no significant surficial debris or large obstructions in the cap area.

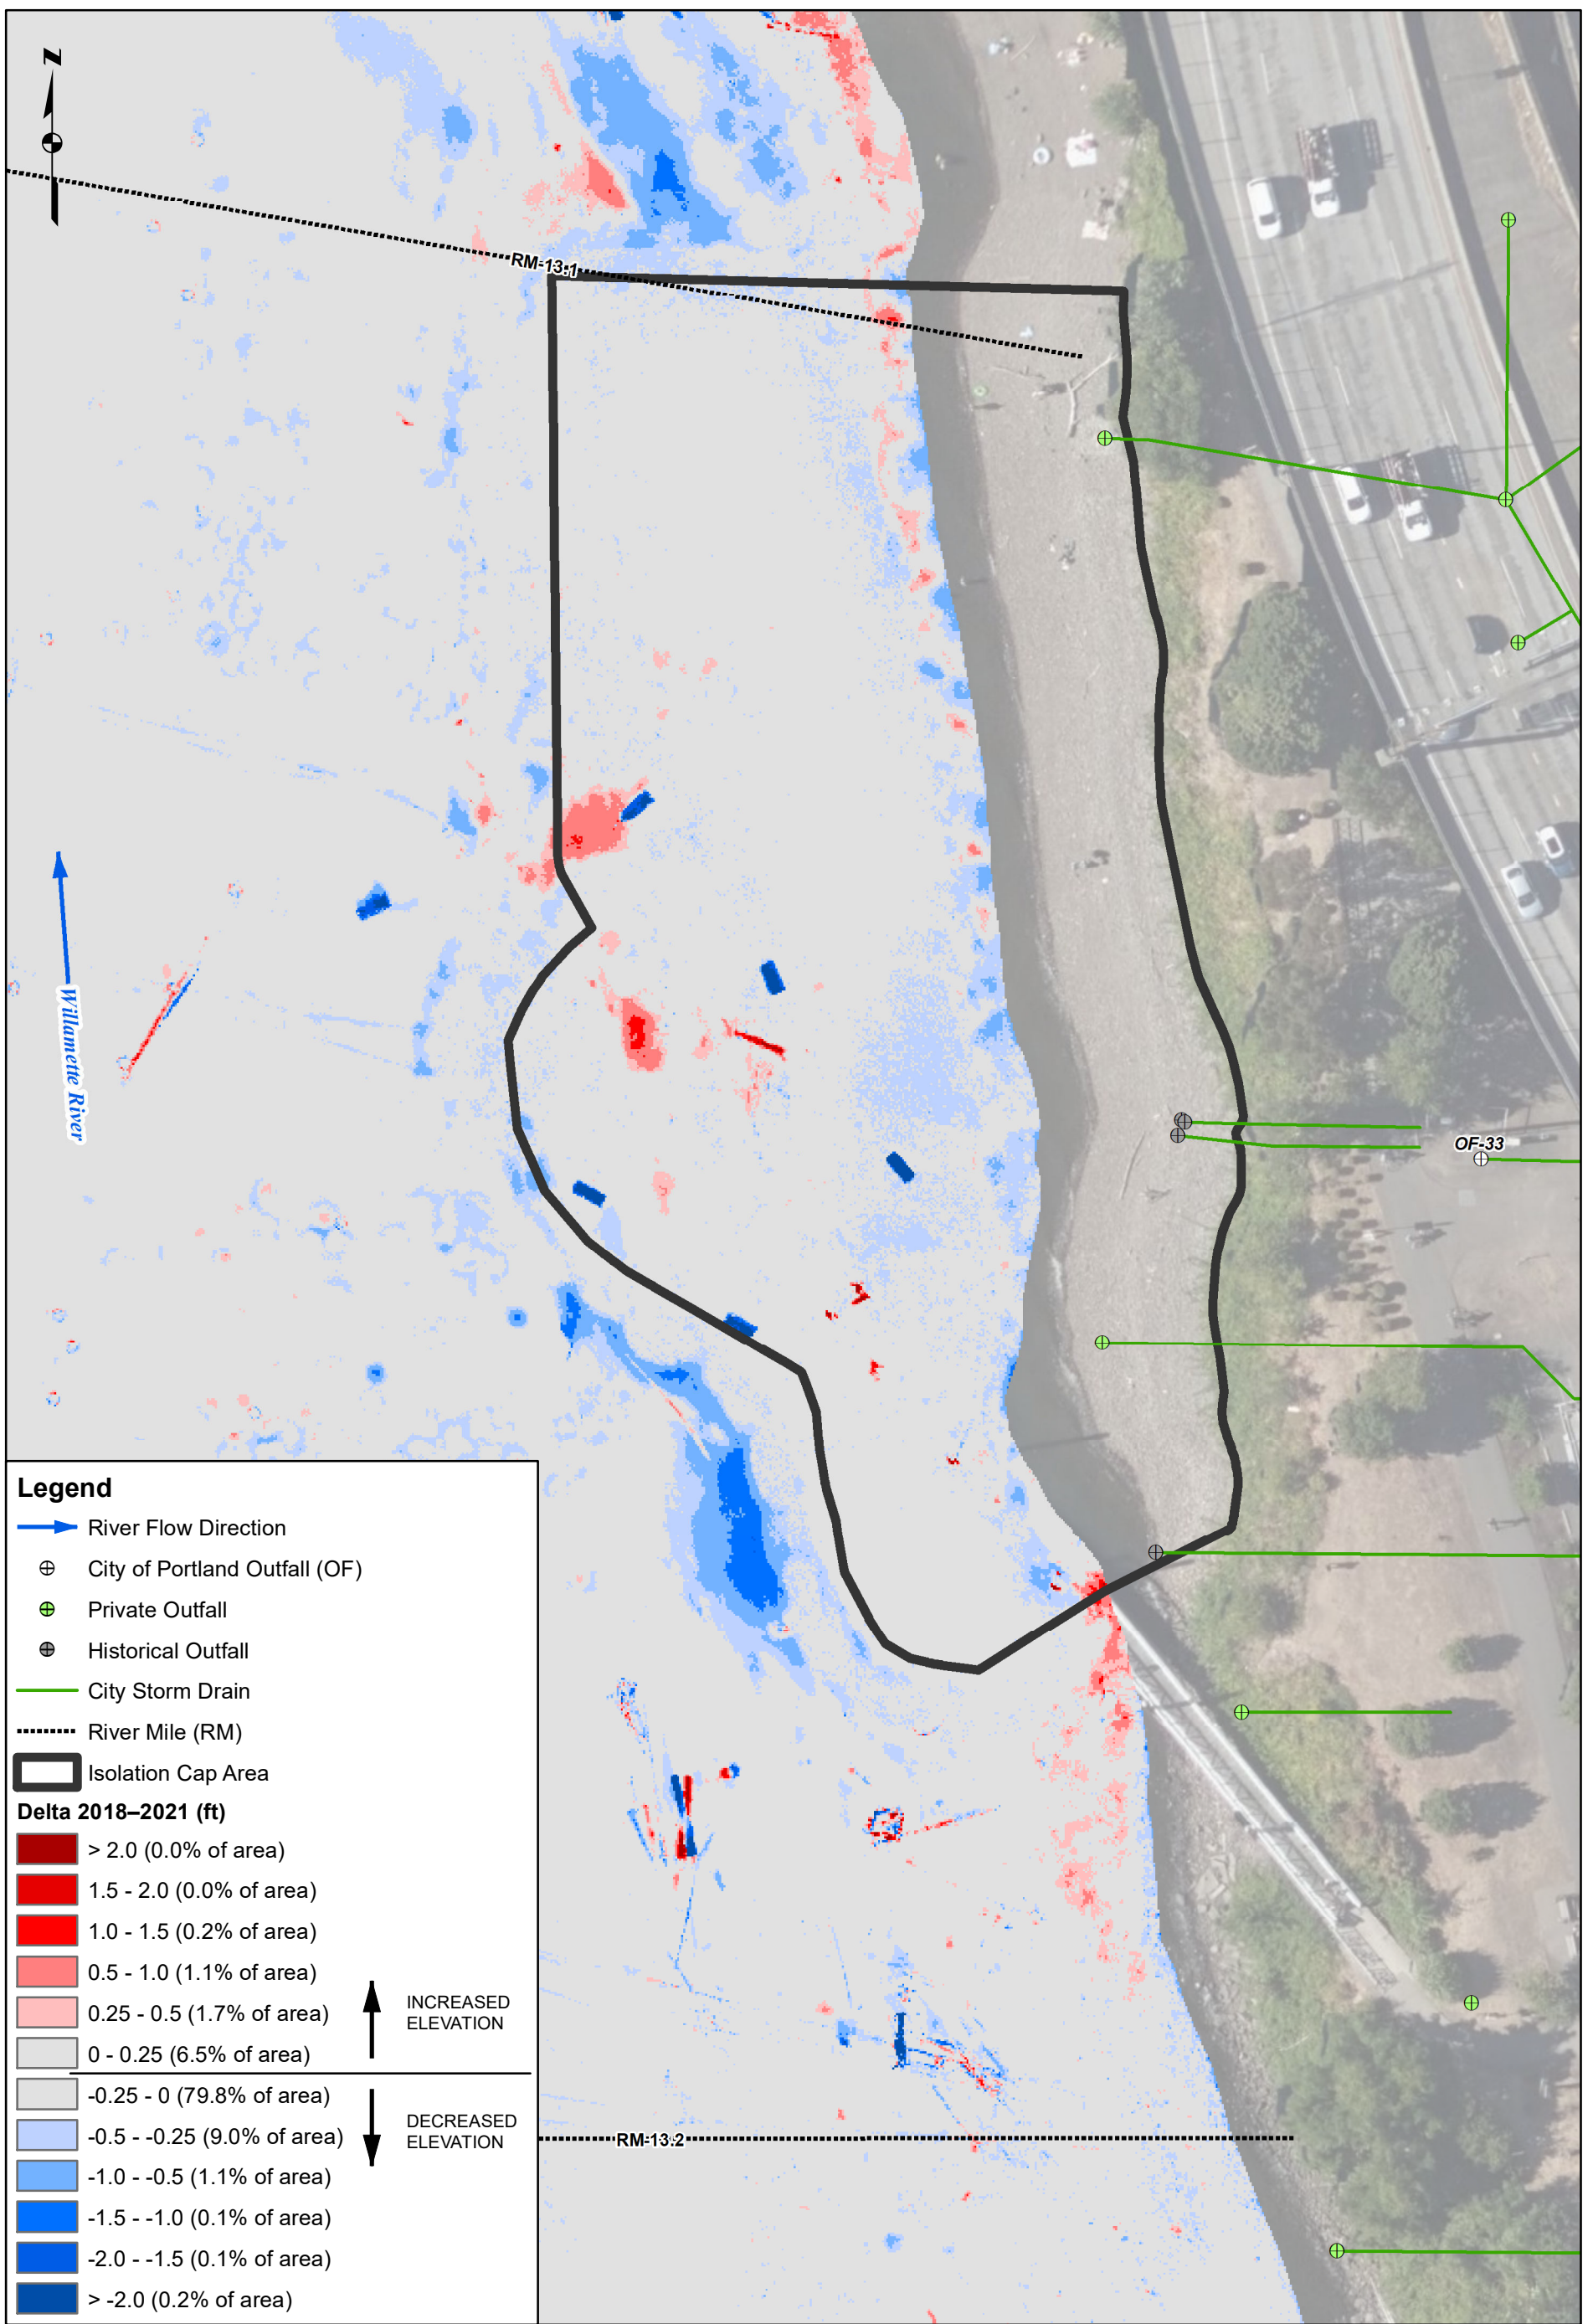
FIGURE 3 - ISOLATION CAP ANALYSIS: 2018 TO 2021 SURVEY

The current Year 3 assessment (April 2018 to June 2021) as shown on Figure 3 indicates that 10.5% of the cap has experienced 3 inches or greater net elevation loss since the installation of the cap based on the current survey comparison. The results of the 2019-2021 difference map (Figure 4) indicates that a total area of approximately 3.8% of the cap surface has experienced 3 inches or greater net elevation loss in the two-year time period.

As the area exhibiting 3 inches or greater of net elevation loss since the installation of the cap slightly exceeds the criterion of 10% identified in the IMMP (Table 1), the data were further evaluated to determine if these areas represent a potential risk to the integrity and performance of the cap. Areas greater than 10 feet by 10 feet were specifically evaluated. Generally, the areas of elevation loss are limited in size and occur intermittently across the entire cap area (Figure 3). The largest area exhibiting erosion greater than 3 inches is approximately 530 square feet (sq.ft.) in size. The cap material in this area consists of 6 inches of 1-3 inch well-graded rounded gravel over a sand isolation layer. There are three areas along the shoreline exhibiting erosion greater than 3 inches and are approximately 250 sq.ft., 220 sq.ft., and 210 sq.ft. in size (exceeding the default 100 sq.ft. de minimis area). The cap material in these areas consist of 1 foot of 3-6 inch well-graded rounded stone over a sand isolation layer. One smaller area exhibiting erosion greater than 3 inches is located at the geocell cap. This area is approximately 150 sq.ft. in size and consists of a 1-foot thick cap comprised of geocell infilled with 2-4 inch angular stone. This area is just outside of the carbon amended area. Finally, there are five small regularly shaped areas within the cap showing several feet of elevation loss (Figures 3 and 4) that are associated with the removal of ecology block anchors which were part of the previous dock at the site. The dock was permanently removed in early 2021. The dock (and anchors) was removed during cap construction and the ecology block anchors placed on top of the cap when the dock was replaced; therefore, these areas do not represent a loss of cap material or armor stone, but of material placed on top of the cap.

As was described in the Year 1 report, areas of minor elevation change are likely a smoothing of the cap surface or settling of the cap materials rather than a loss of cover material. None of the areas exhibiting signs of erosion are in areas where amendment material was placed to isolate impacts to surface water; consequently, the loss or smoothing of cover material does not constitute a lack of environmental protection.

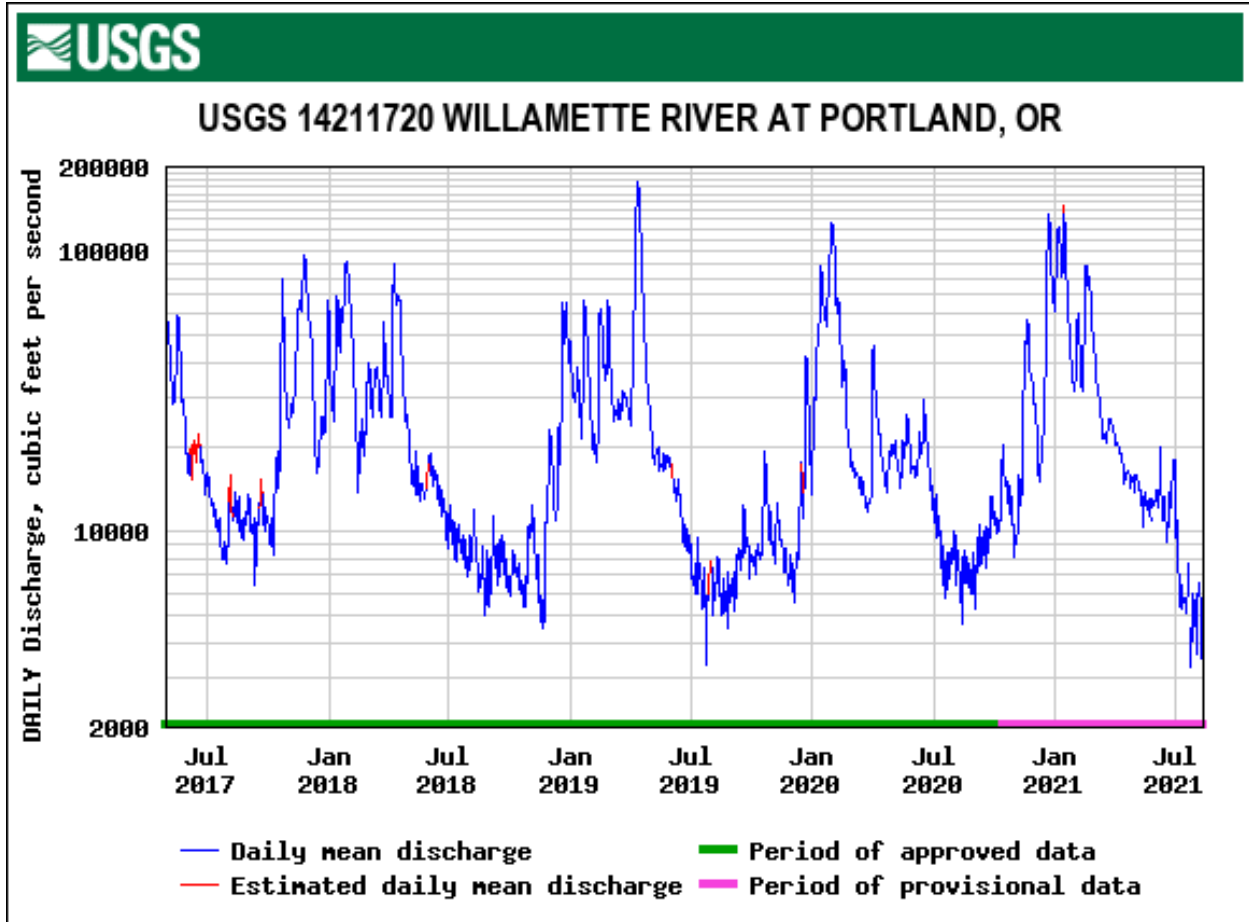
Willamette River at Portland Oregon May 2017 to August 2021 Graph

A 100-year flood event in the lower Willamette River is defined as a discharge of 375,000 cubic feet per second (cfs).
