RE: 2022 Johnson Lake, Fish Tissue Sampling  
ECSI #2086

# DRAFT JOHNSON LAKE, UPLAND SOURCE CONTROL REVIEW REPORT

OWENS BROCKWAY GLASS CONTAINER, INC.

JL East Stormwater Culvert Cleanout Observations

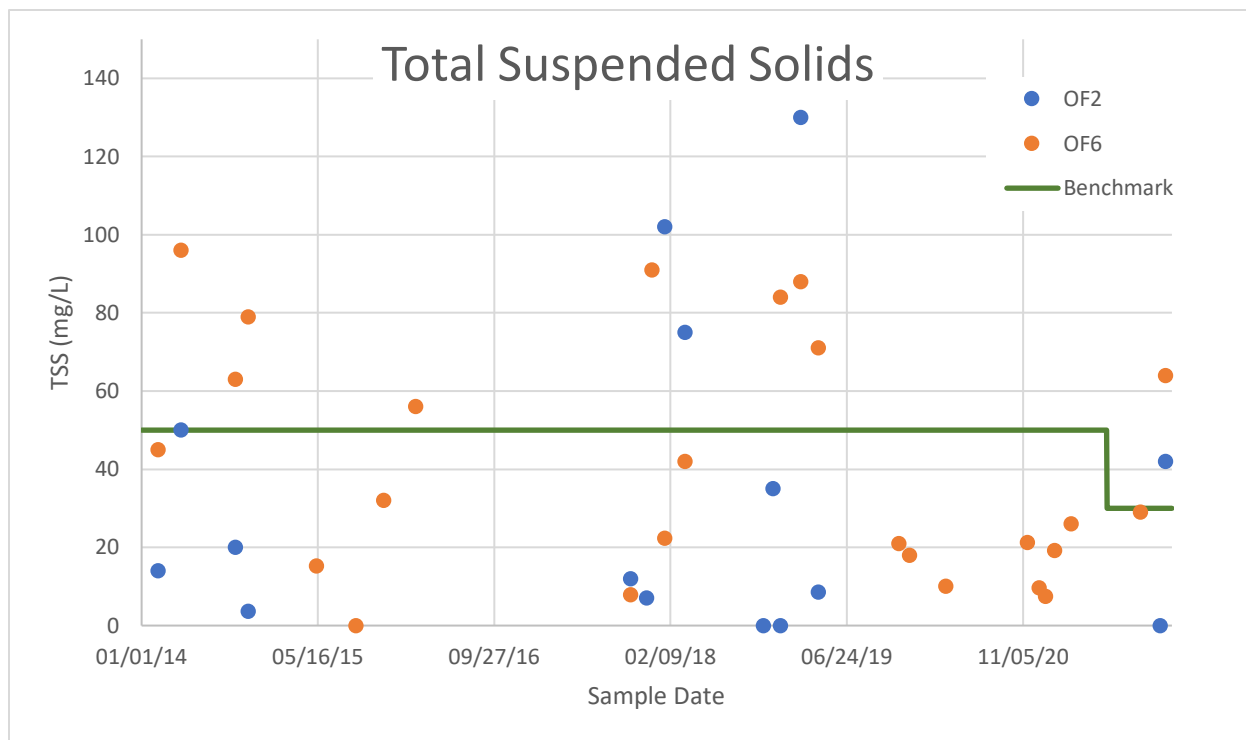
Based on the monitoring data, it appears that TSS and phosphorus are not ongoing issues for Outfall 6 (phosphorus was not part of the Tier II Corrective Action for Outfall 6 and there has not been an exceedance of the phosphorus benchmark at this outfall since 2017). There has been a recent benchmark exceedance at Outfall 6 and Outfall 2 for TSS, but per Owens' Tier I report, the likely source

Figure 5.1 Total Suspended Solids from Outfalls 2 and 6 from NPDES monitoring data compared to statewide benchmarks.

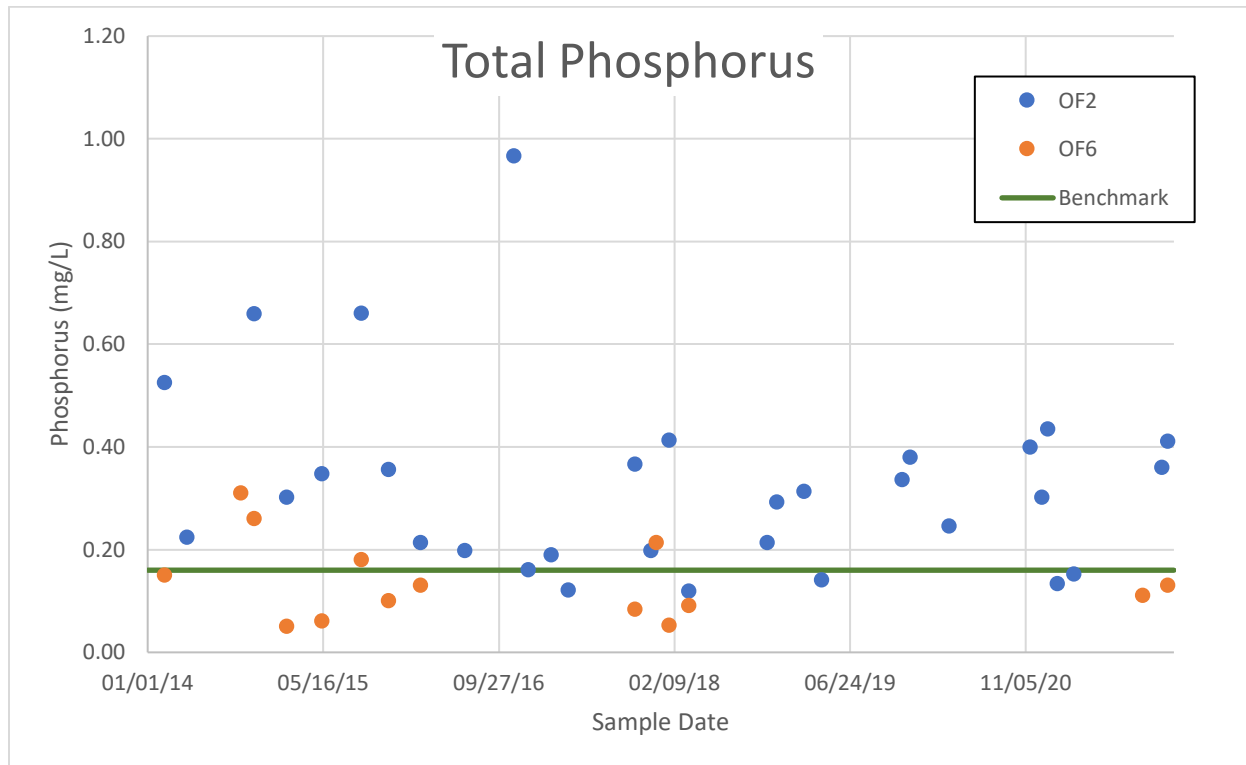
Figure 5.2 Phosphorus from Outfalls 2 and 6 from NPDES monitoring data compared to statewide benchmarks.

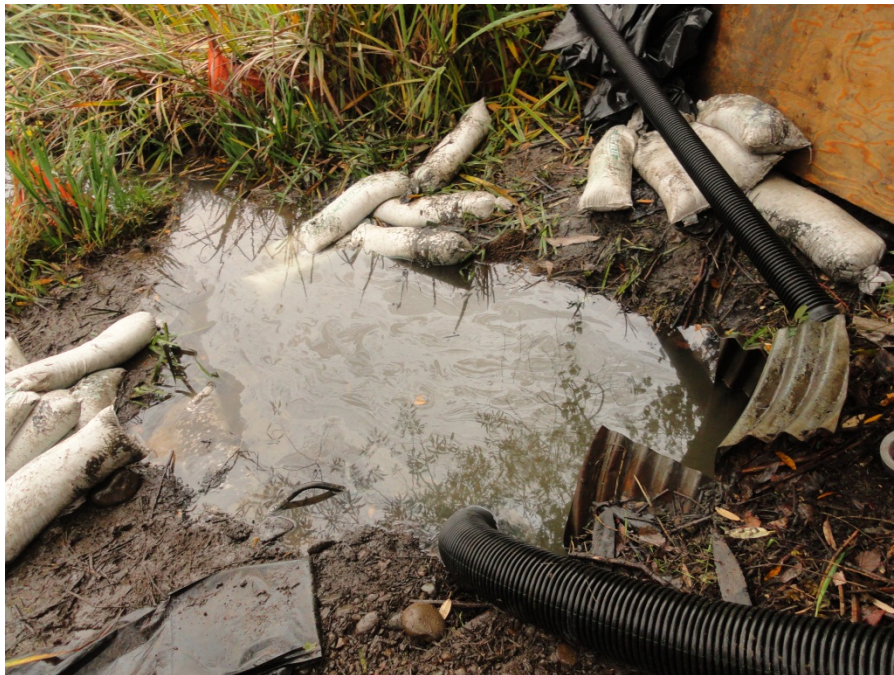
**P-2:** Sheen was observed at the outfall entering Johnson Lake.

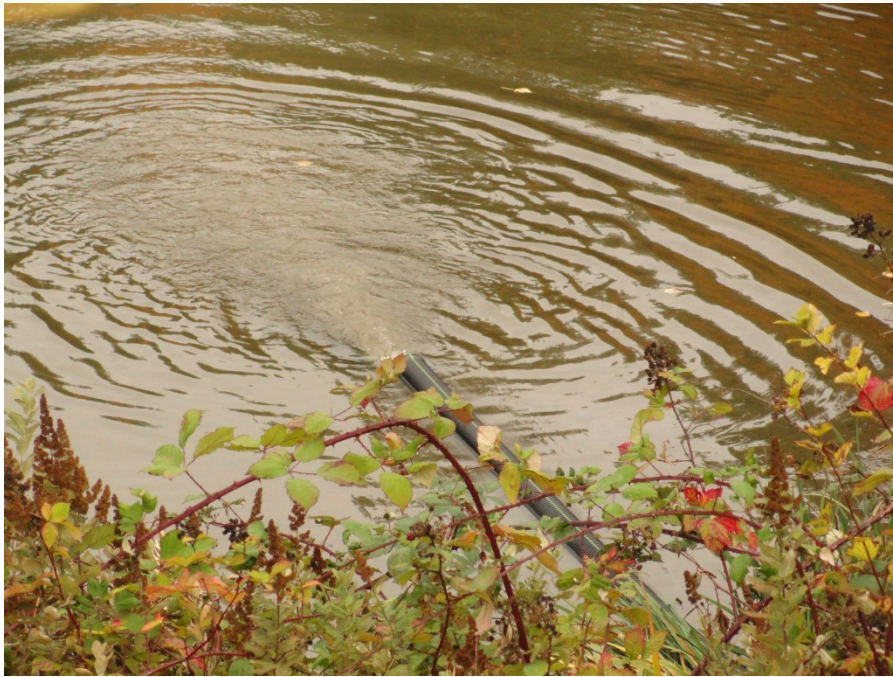
Bravo reconstructed the sandbag berm. Similar to the previous day, the standing water in the culvert was then pumped into JL (see Figure P-3) using the four inch pump. The dewatering process took approximately 7 minutes during which time a turbidity plume was again observed entering the lake from the pumps discharge pipe as shown in Figure P-4. DOF representative was informed that WTP not plumbed correctly; reducing the plant's capacity. The WTP was replumbed prior to the restart of the culvert cleanout. Culvert cleanout continued throughout the morning. Work was stopped to empty the sediment box and to refill the jet-truck's water tank. Prior to the restart of the culvert cleanout in the afternoon the four inch pump was again used to remove standing water that had collected in the culvert by again pumping the water into JL. The dewatering process took approximately 60 seconds during that time a plume was again observed entering the lake. At the end of the shift the berm was removed and an oil sheen was again observed entering JL from the outfall. This completed cleaning of the western portion of the culvert (pending video inspection).

**P-3:** Water pump discharge from the storm water outfall into Johnson Lake.

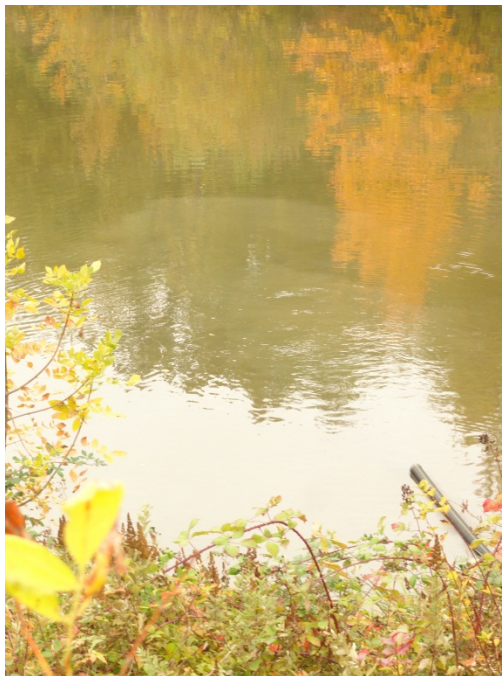
**P-4:** Turbidity plume observed in Johnson Lake after water in culvert was pumped into the lake from the culvert.

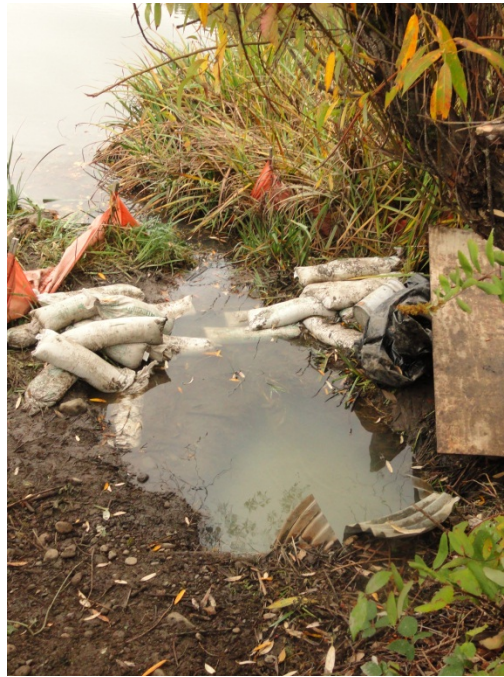
**P-5:** Stormwater runoff into Johnson Lake before the clean out of the eastern portion of the culvert had started.

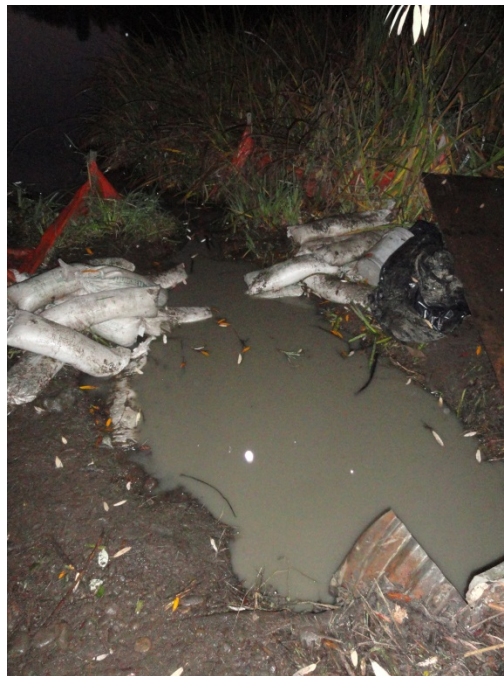
**P-6:** Highly turbid water observed entering Johnson Lake during the clean out of the eastern portion of the culvert.

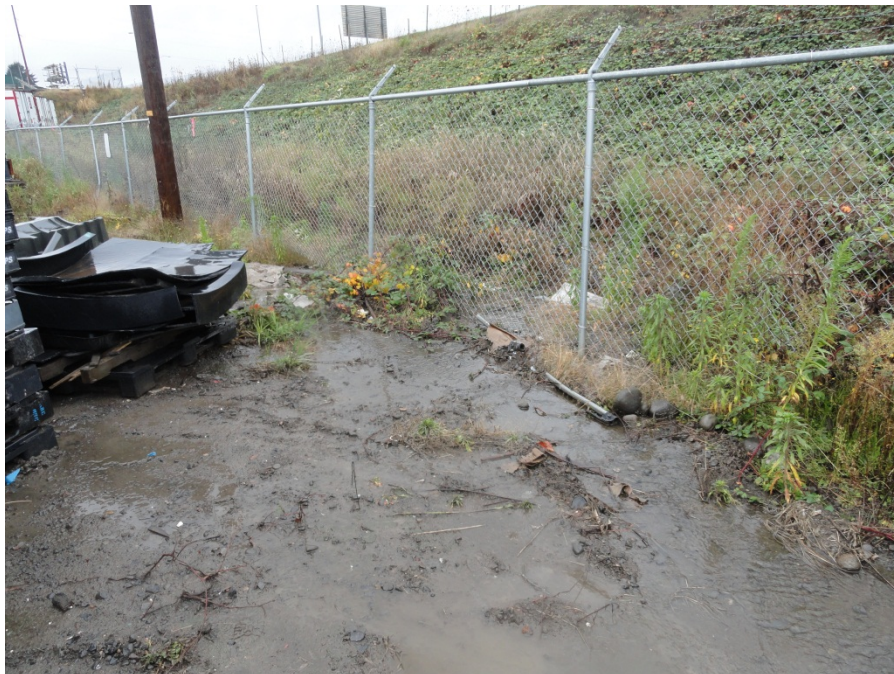
**P-8:** Storm water runoff on Myers Container property to culvert inlet observed during a rain event.

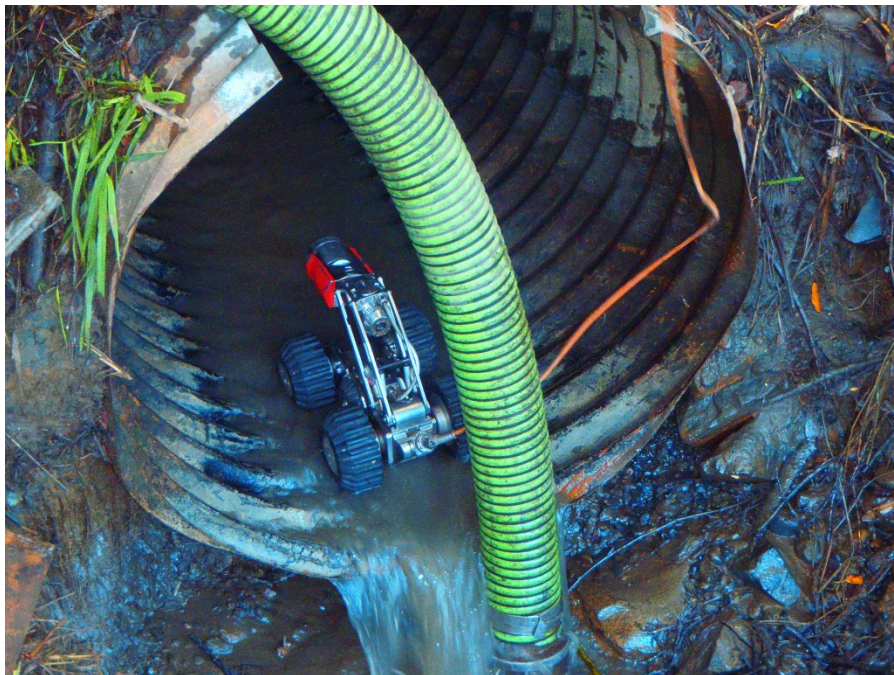
**P-10:** Remote controlled wheel camera unit enters the culvert to perform post cleanup inspection.
