REVISED JOHNSON LAKE, UPLAND SOURCE CONTROL REVIEW REPORT

OWENS BROCKWAY GLASS CONTAINER, INC.

5850 NE 92ND DRIVE
PORTLAND, OREGON

Revised May 2022

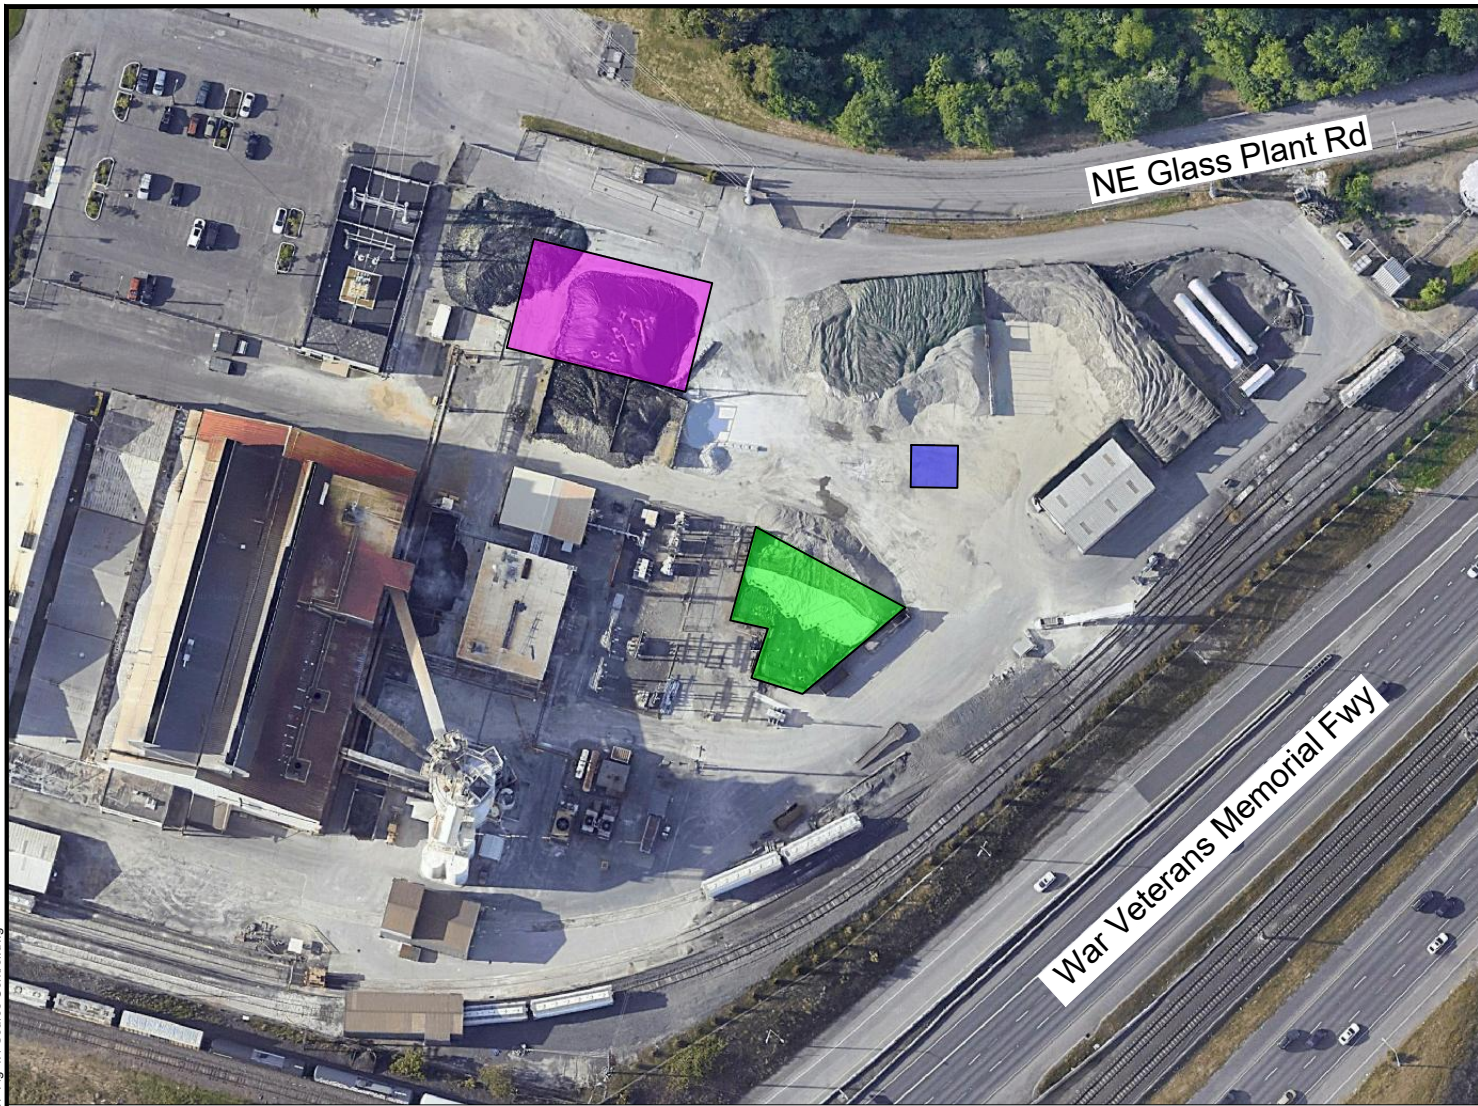
DOF DALTON OLMSTED FUGLEVAND
FIGURE 4.1
02/08/2022

An investigation of the phosphorus benchmark exceedances in stormwater discharge from Outfall 2 showed that the likely source was the outdoor cullet storage. The following two control measures were selected for the Property, and approved by the City of Portland in a letter dated April 23, 2021, and shown on Figure 4.1:

- 1) *Source Control – Structure to Cover Raw Materials* – A portion of the outdoor long-term cullet storage is now covered by tarps, so they are no longer exposed to stormwater. This was implemented in May 2020. A permanent structure is currently being constructed over a portion of the short-term cullet storage area and is expected to be completed in May 2022. The combination of these two measures should reduce the amount of phosphorus at Outfall 2 by up to 50%, based on the footprint of cullet and what will no longer be exposed to stormwater.

- 2) *Stormwater Treatment System* – At catch basin 11, which receives the majority of the stormwater adjacent to the remaining uncovered cullet piles, a Modular Wetland system will be installed. The system is designed to target both dissolved and suspended phosphorus. Construction and installation of this system is currently being done and is expected to be completed in May 2022.

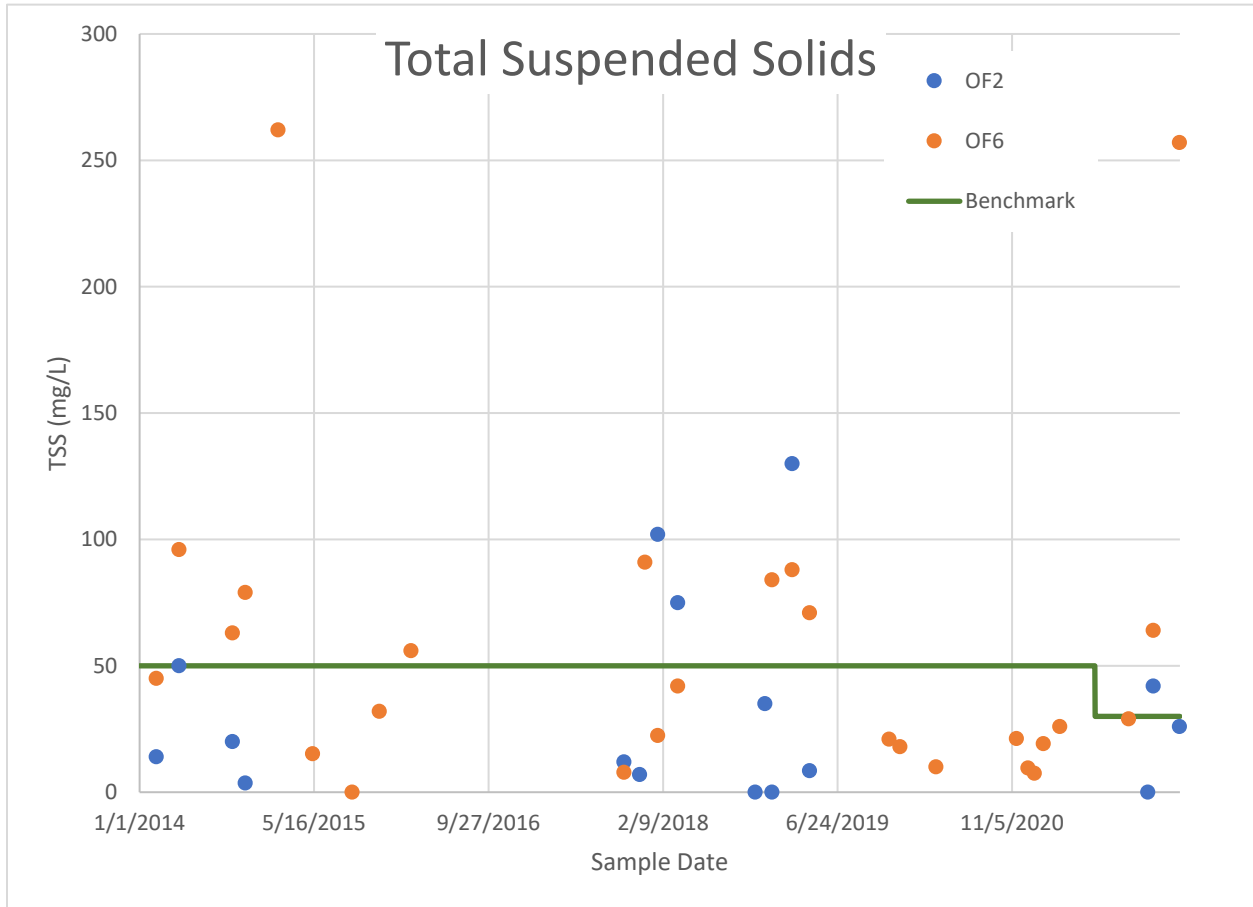
The investigation of the exceedances of Total Suspended Solids (TSS) at Outfall 6 determined that the likely cause of the high TSS was from clean soil stockpiles of import material located in the drainage that were there during the construction of a new transformer site. Prior to the Tier II report, the facility had already made updates to the swale, including removal of the soil stockpiles, and the addition of six (6) rock check dams in the swale, north of the concrete weir located within the swale, and a rock apron just prior to the discharge point into Johnson Lake (Figure 2.2). These updates allow for stormwater to move more slowly through the swale, allowing for a longer settling time for solids. It was determined that no further corrective measures were needed for this outfall.

Figure 5.1 Total Suspended Solids from Outfalls 2 and 6 from NPDES monitoring data compared to statewide benchmarks.

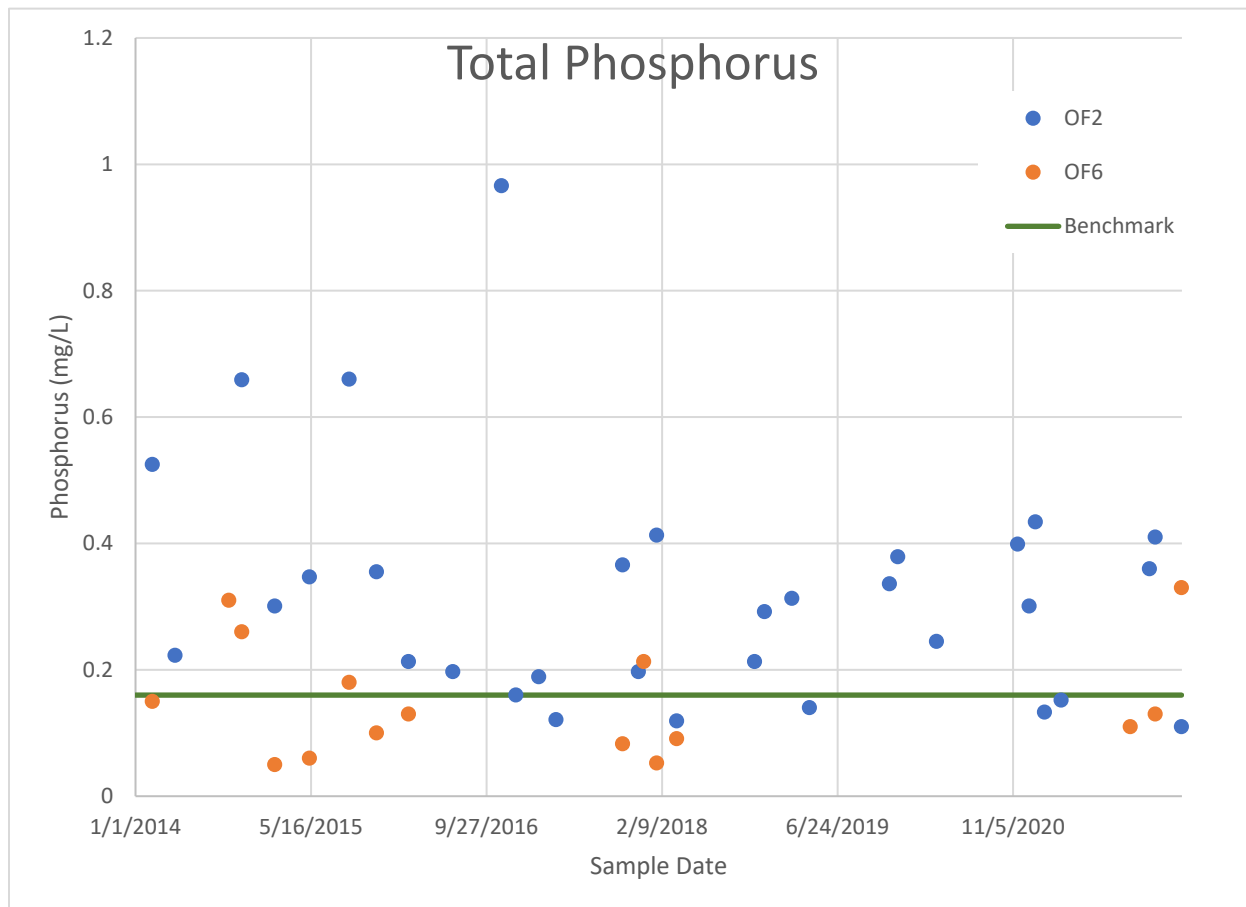
Figure 5.2 Phosphorus from Outfalls 2 and 6 from NPDES monitoring data compared to statewide benchmarks.

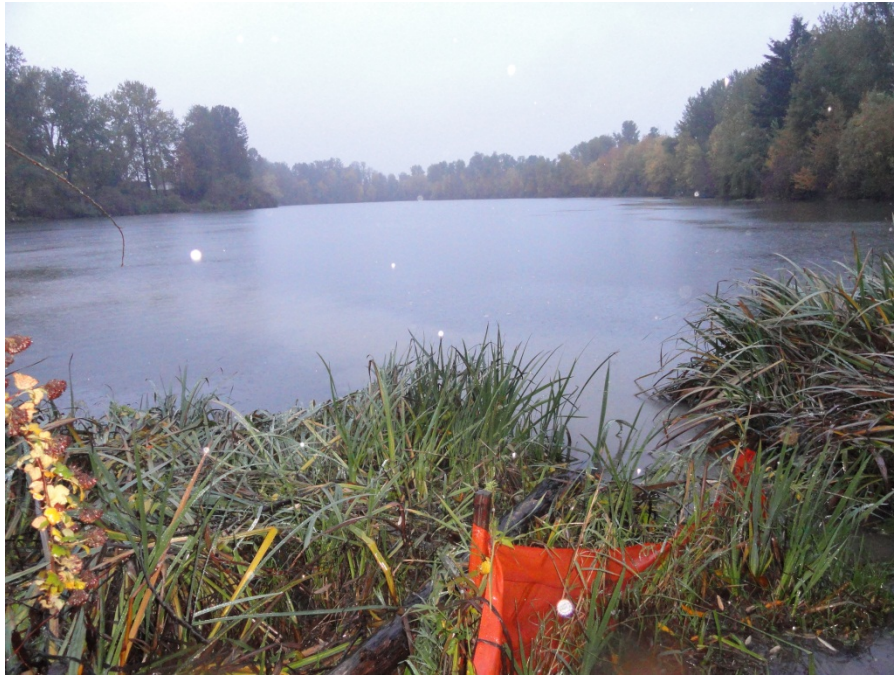
DOF representative arrived at the site during an ongoing storm event and observed a large sediment plume entering Johnson Lake from the culvert as shown in Figure P-1. Sediment plume persisted for several hours until storm event was finished. Bravo arrived onsite and mobilized a 25 yard roll-off box that was staged on Glass Plant Rd. No other work performed by Bravo this day.

P-1: Turbidity plume observed extending approximately 75 feet out into Johnson Lake from storm water outfall.

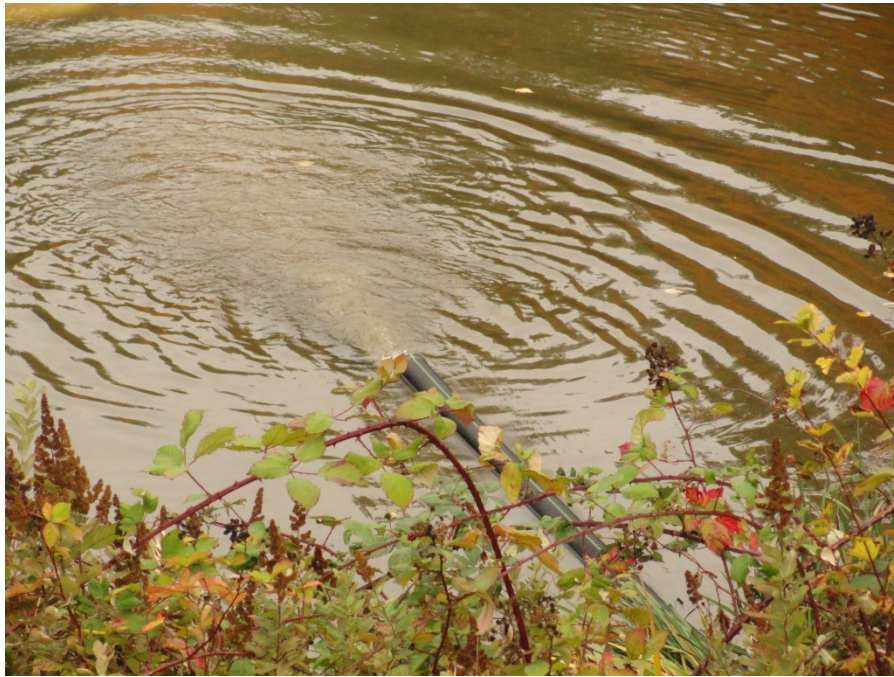
Bravo reconstructed the sandbag berm. Similar to the previous day, the standing water in the culvert was then pumped into JL (see Figure P-3) using the four inch pump. The dewatering process took approximately 7 minutes during which time a turbidity plume was again observed entering the lake from the pumps discharge pipe as shown in Figure P-4. DOF representative was informed that WTP not plumbed correctly; reducing the plant's capacity. The WTP was replumbed prior to the restart of the culvert cleanout. Culvert cleanout continued throughout the morning. Work was stopped to empty the sediment box and to refill the jet-truck's water tank. Prior to the restart of the culvert cleanout in the afternoon the four inch pump was again used to remove standing water that had collected in the culvert by again pumping the water into JL. The dewatering process took approximately 60 seconds during that time a plume was again observed entering the lake. At the end of the shift the berm was removed and an oil sheen was again observed entering JL from the outfall. This completed cleaning of the western portion of the culvert (pending video inspection).

P-3: Water pump discharge from the storm water outfall into Johnson Lake.

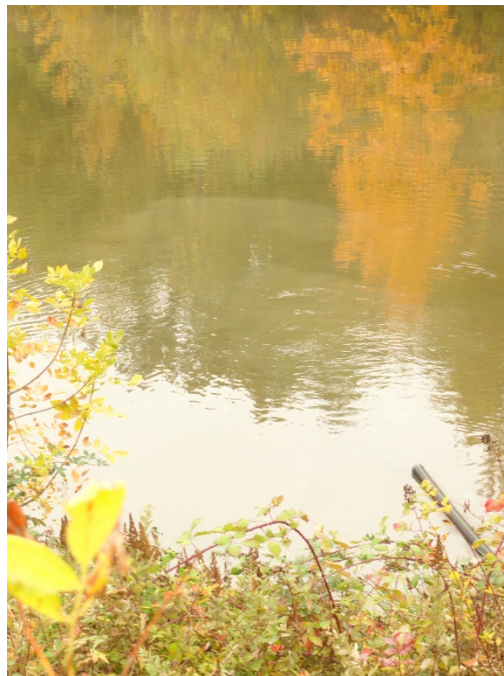
P-4: Turbidity plume observed in Johnson Lake after water in culvert was pumped into the lake from the culvert.

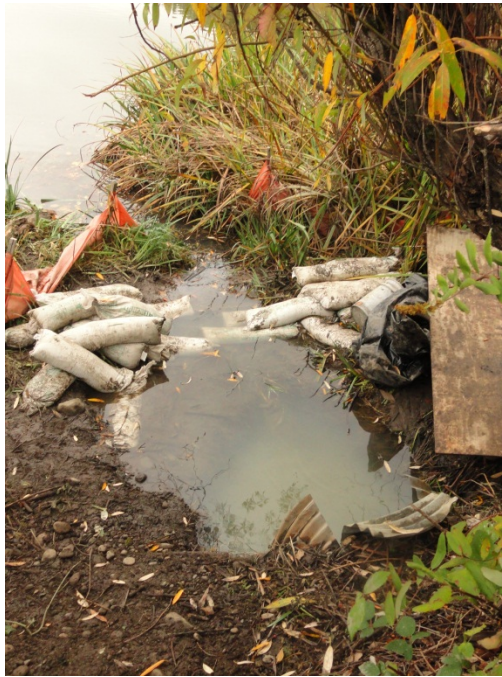
P-5: Stormwater runoff into Johnson Lake before the clean out of the eastern portion of the culvert had started.

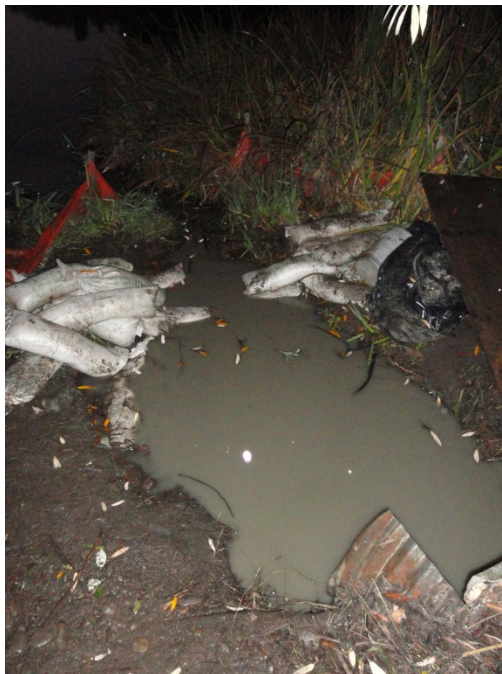
P-6: Highly turbid water observed entering Johnson Lake during the clean out of the eastern portion of the culvert.

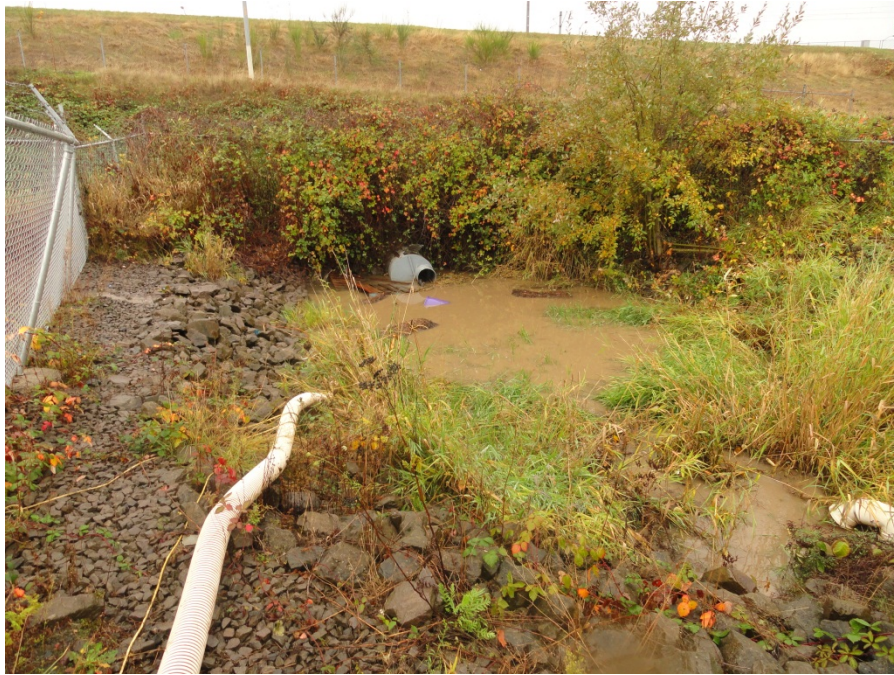
P-7: Storm water culvert inlet located on Myers Container property east of I205.

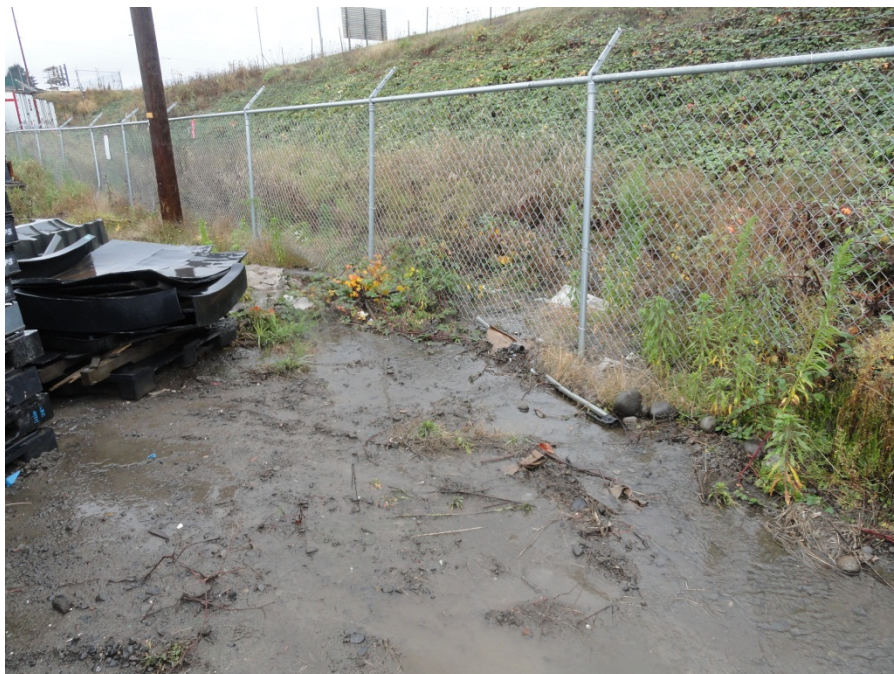
P-8: Storm water runoff on Myers Container property to culvert inlet observed during a rain event.

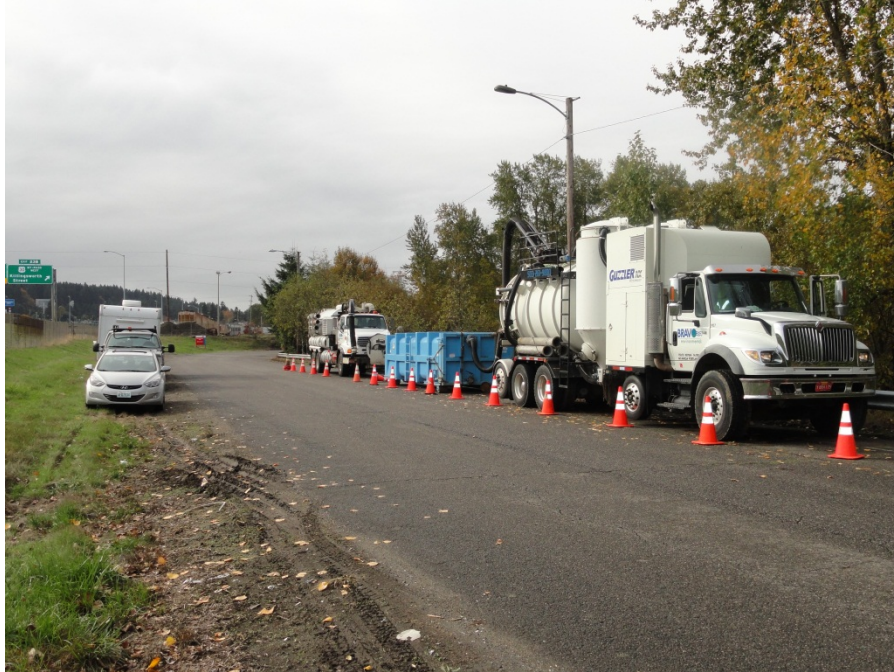
P-9: Vac-truck, jet-truck, and sediment roll-off box staged on Glass Plant Rd east of Johnson Lake.

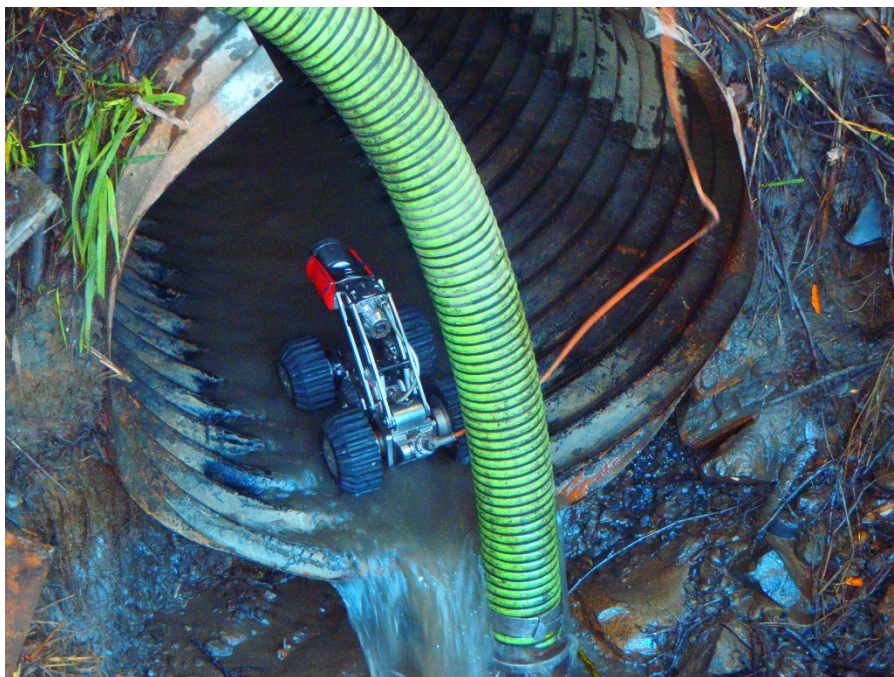
P-10: Remote controlled wheel camera unit enters the culvert to perform post cleanup inspection.
