## ST HELENS FIBERBOARD FACILITY UPLAND REMEDY

### Third Quarter 2022 Progress Report

**Third Quarter 2022 Upland Cap Inspection Form and  
Cap Inspection Photo Logs**

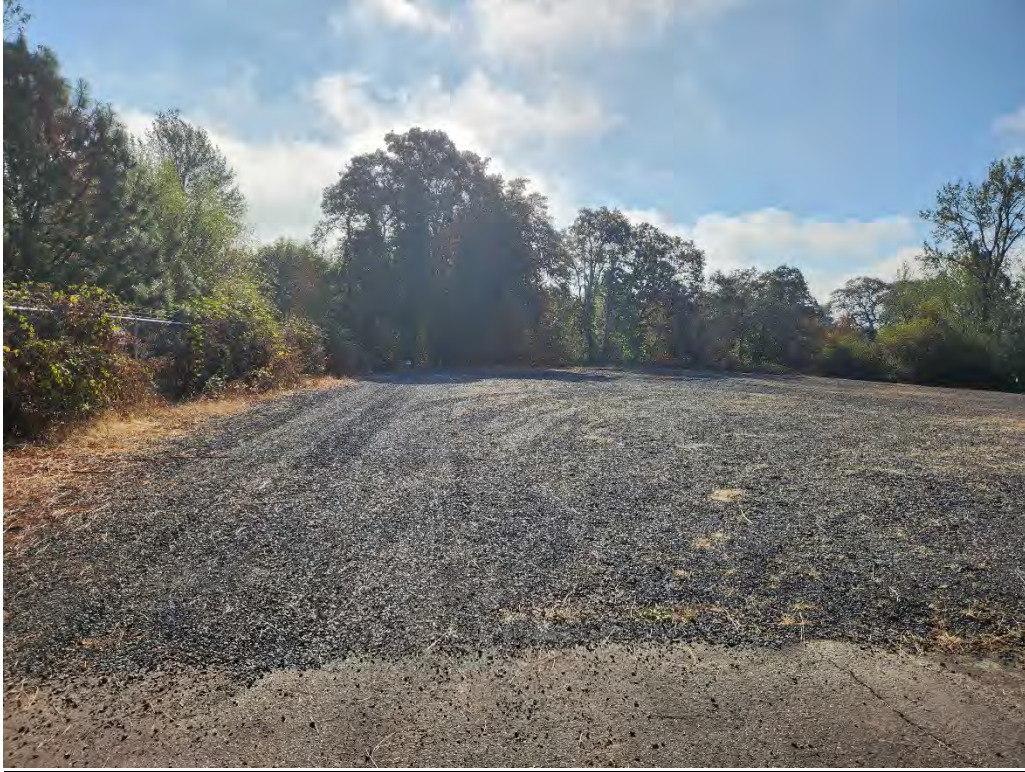
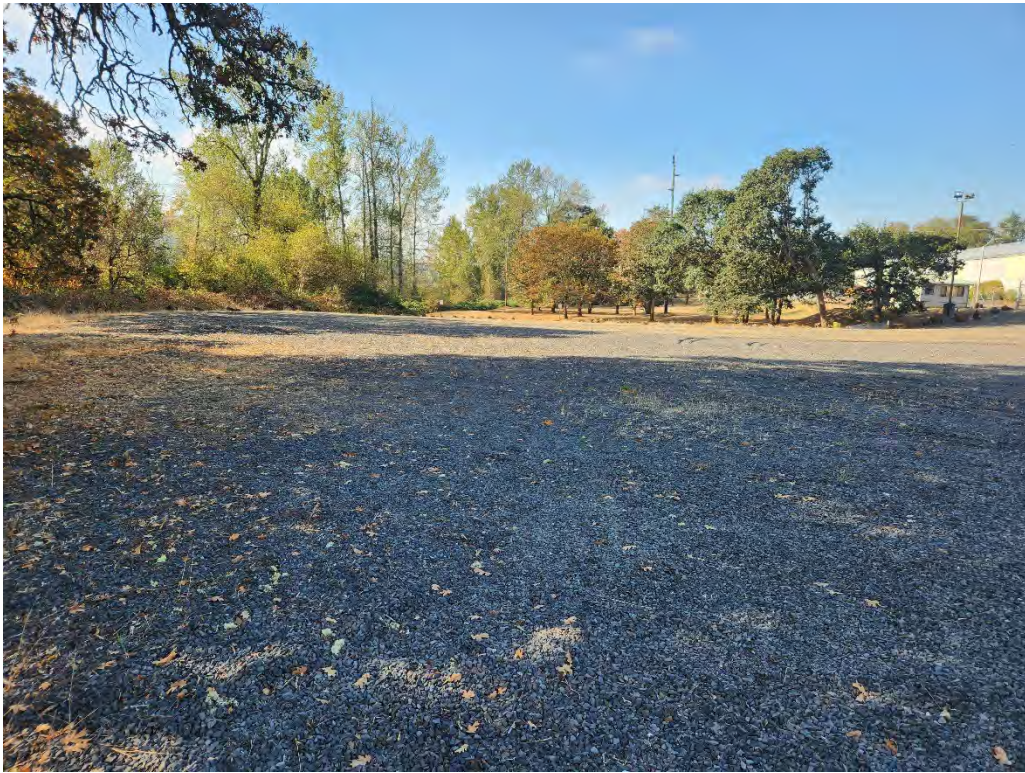
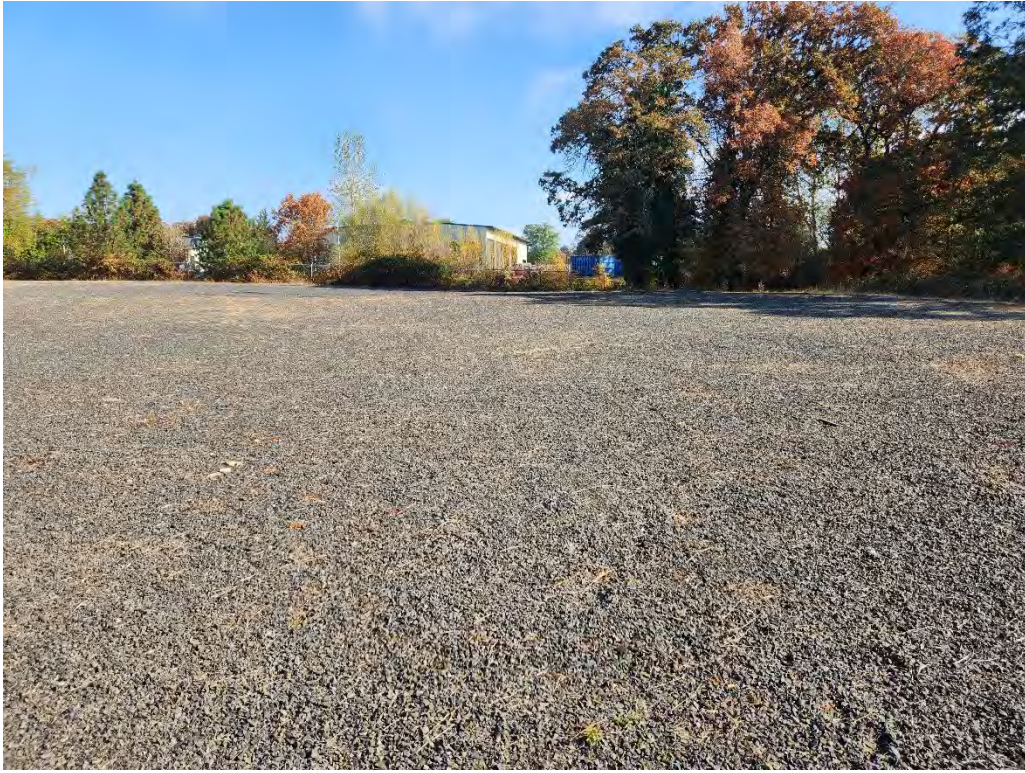
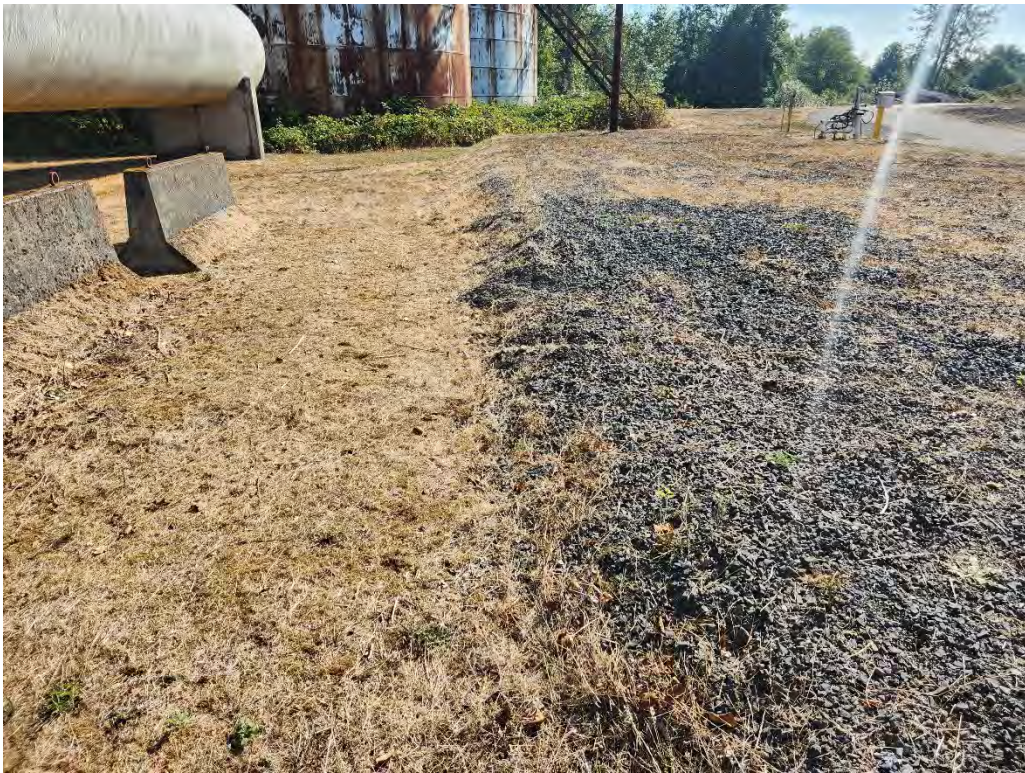
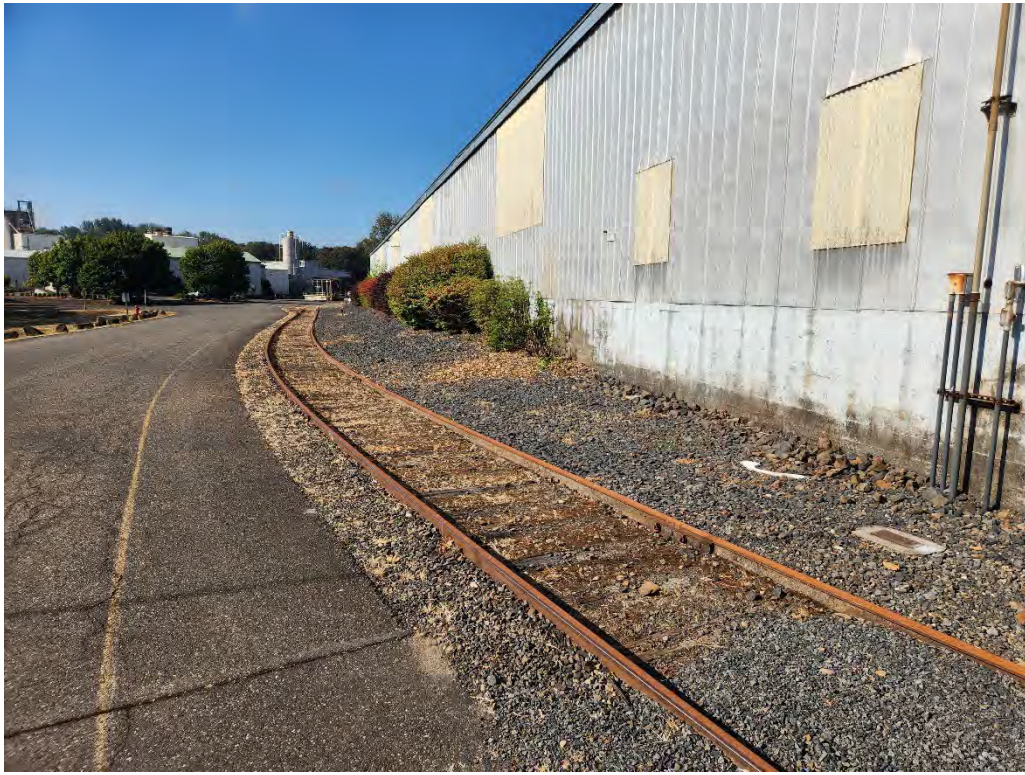
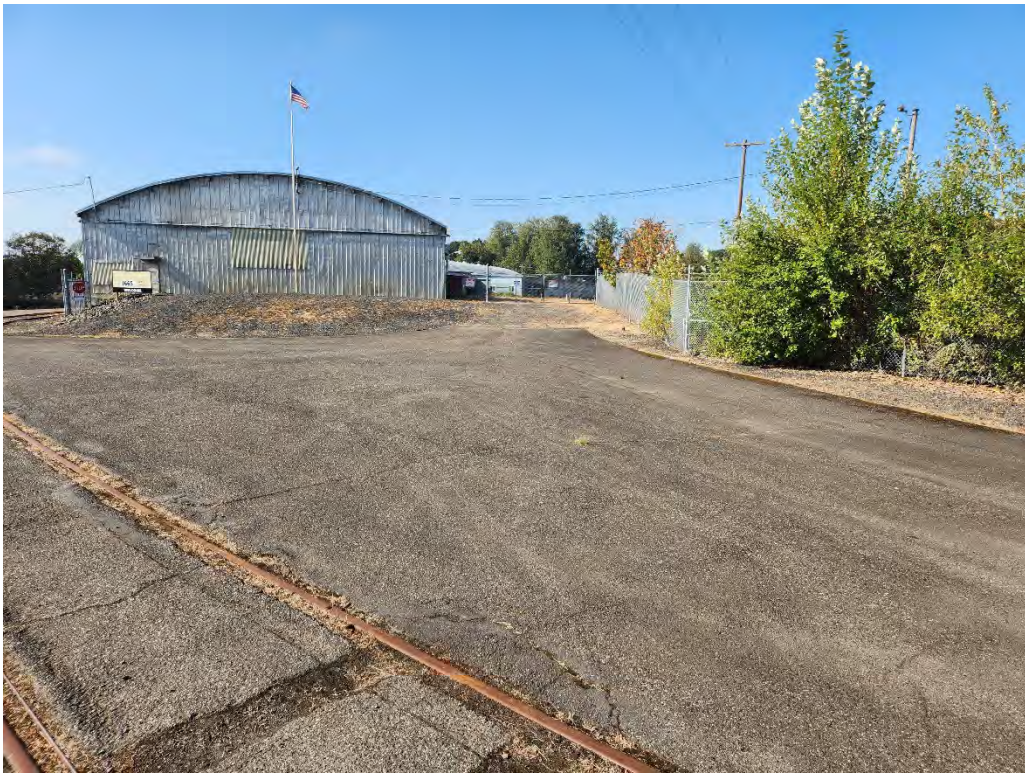
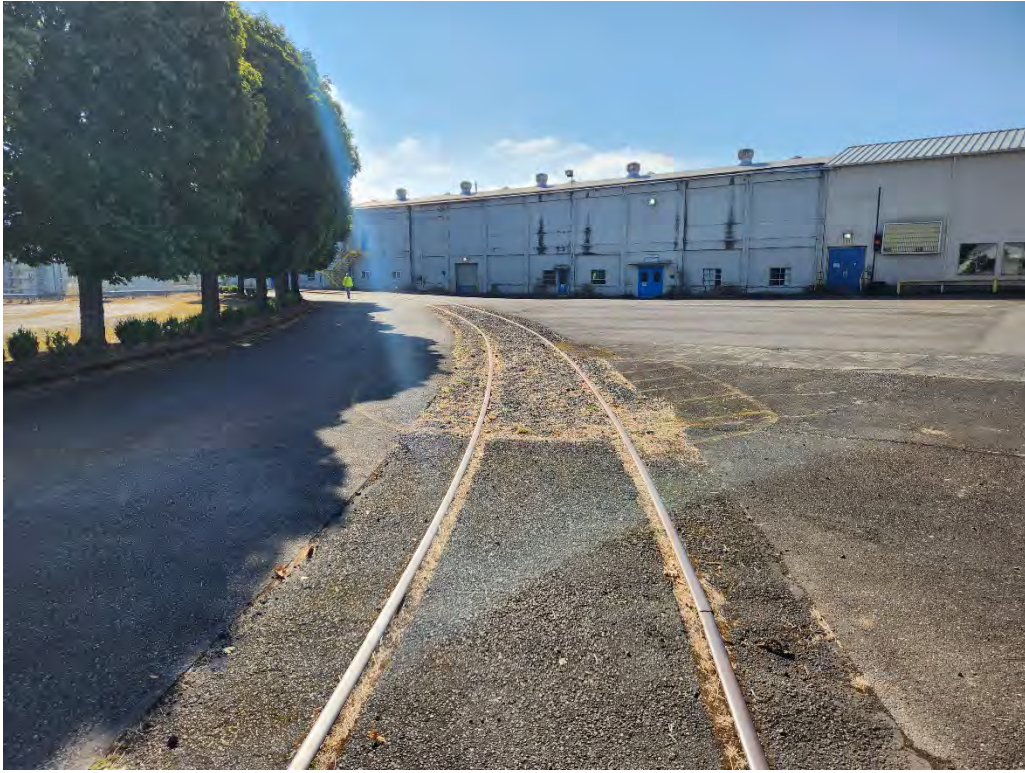
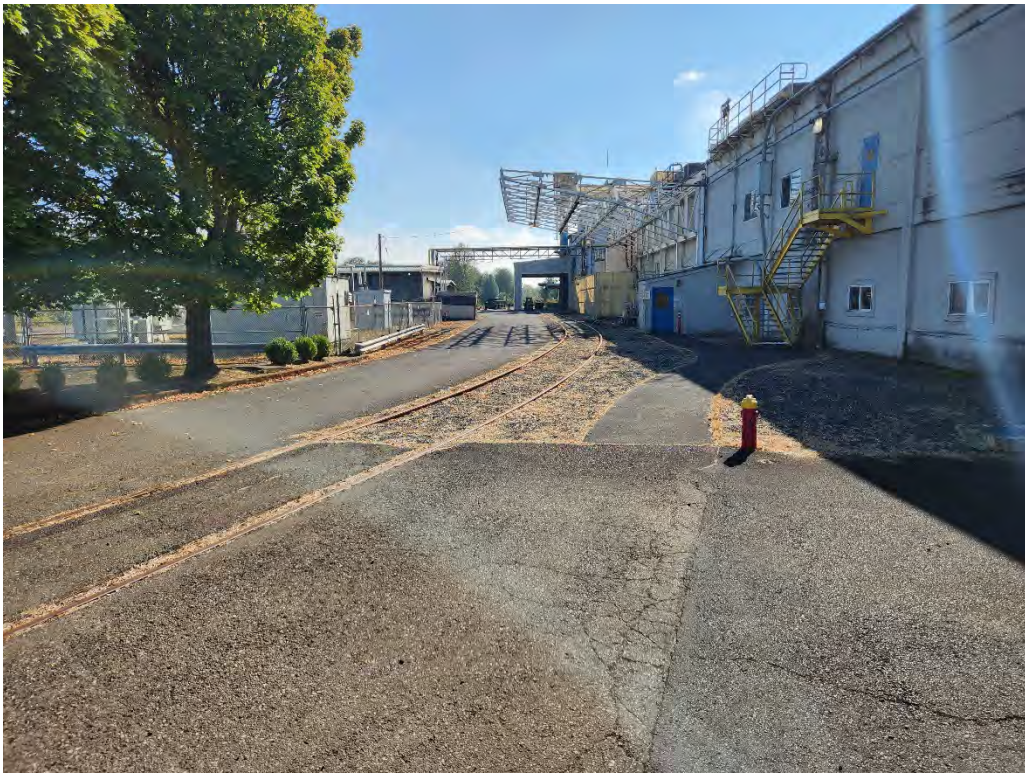
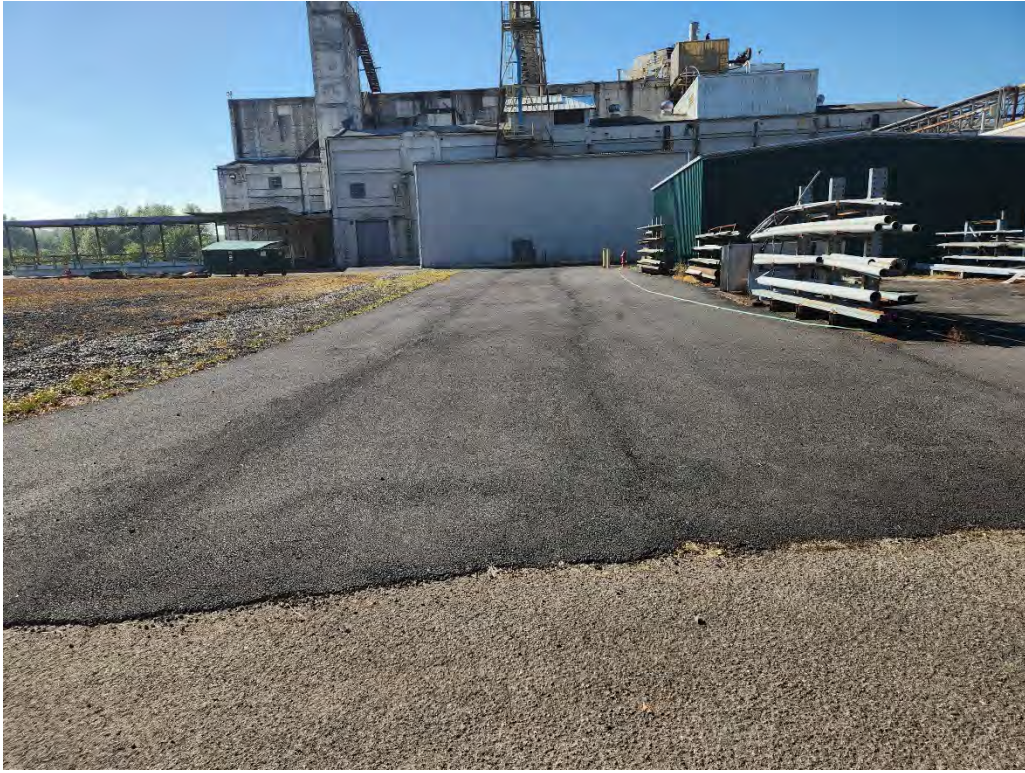
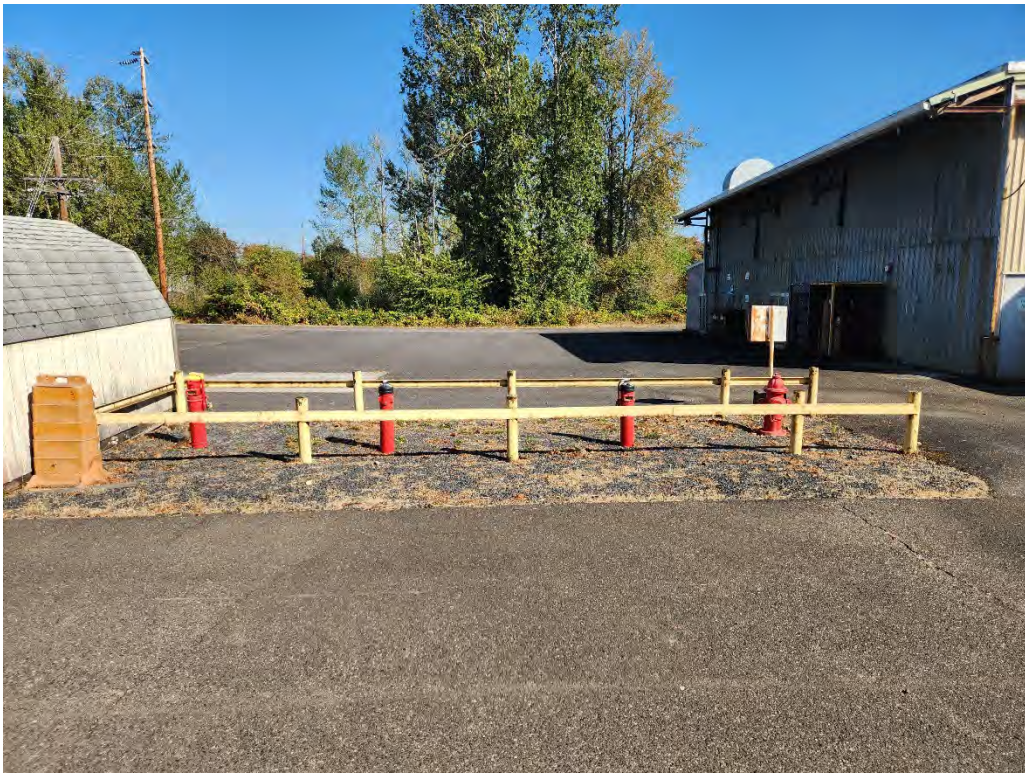
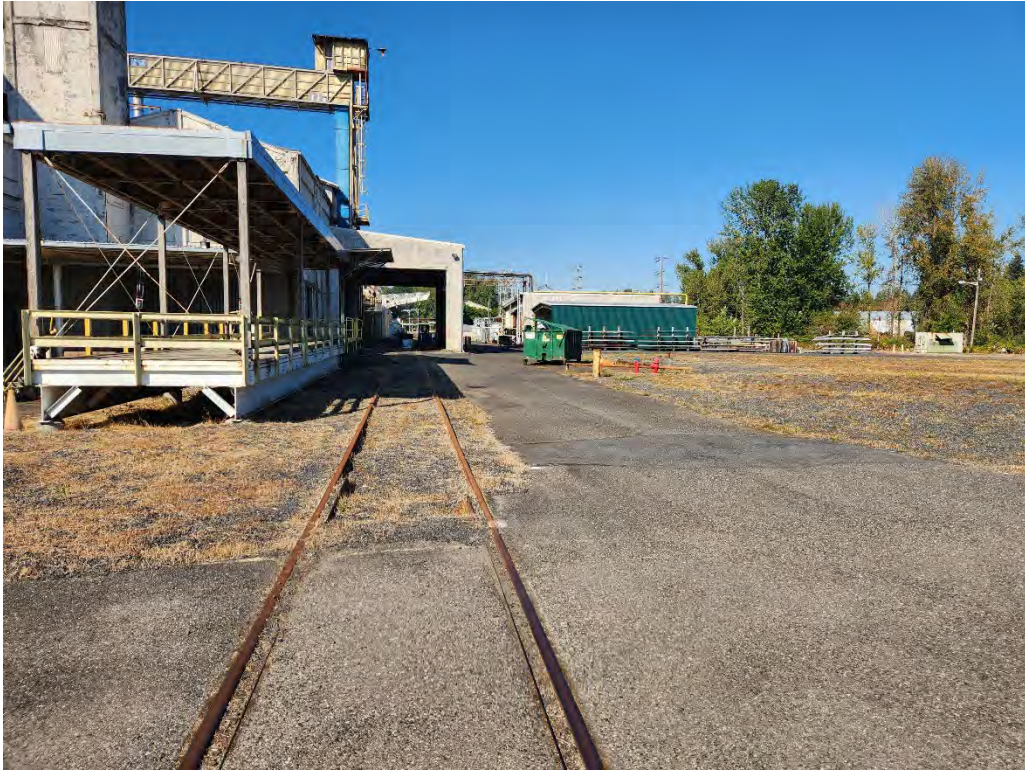
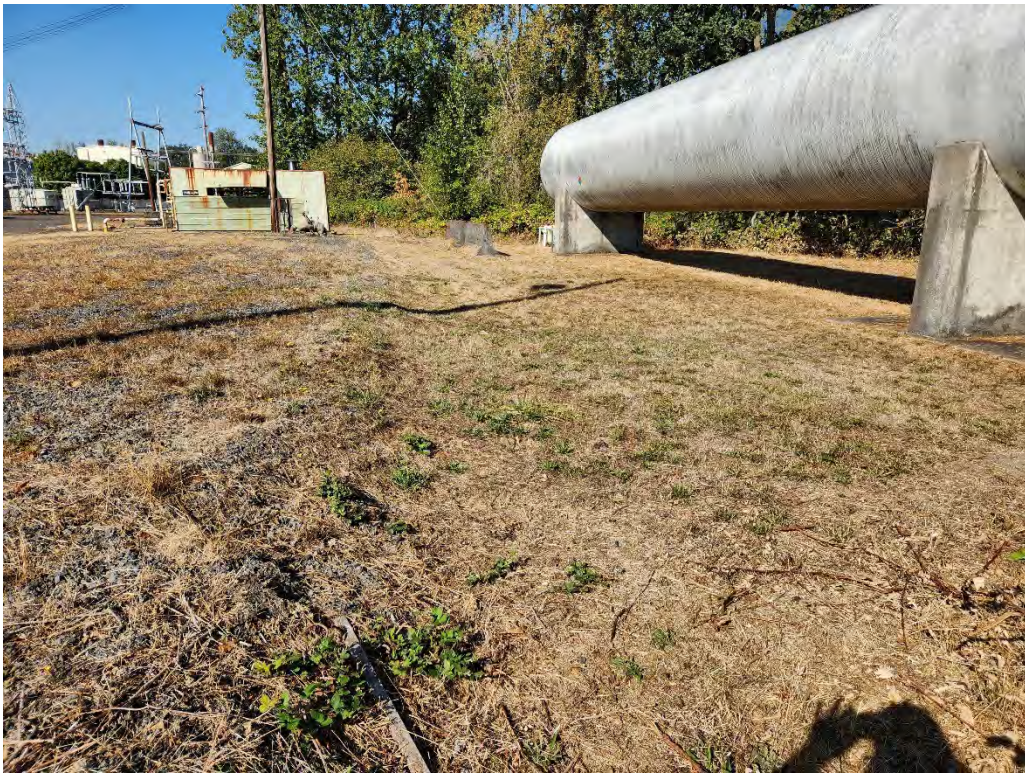
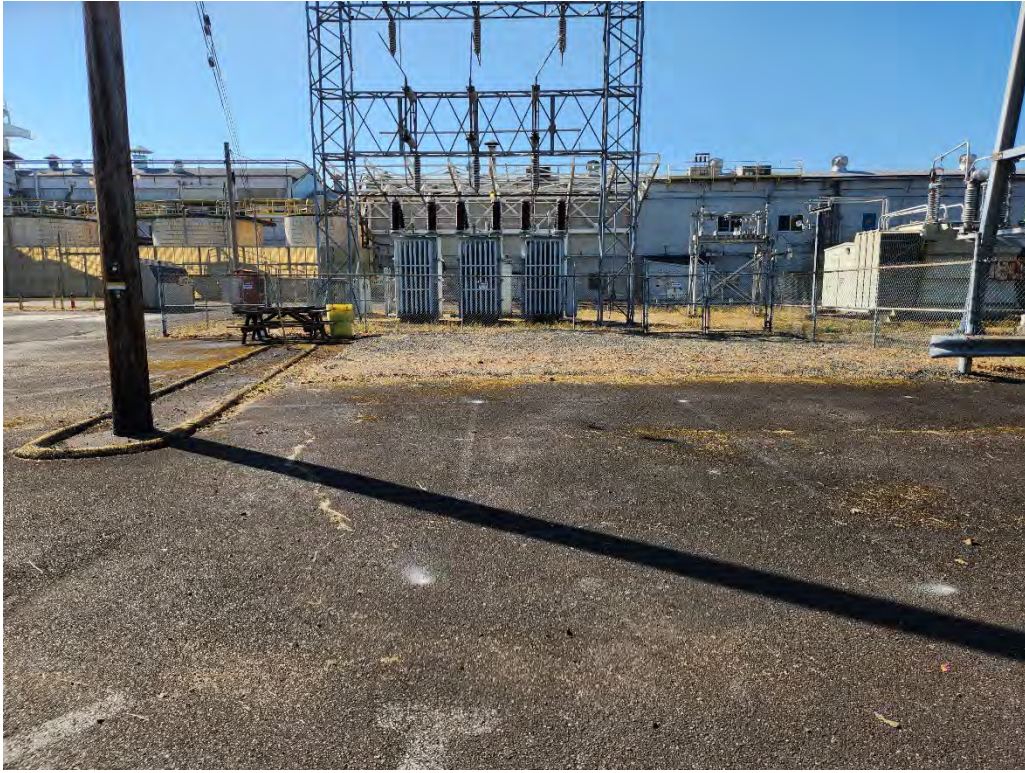
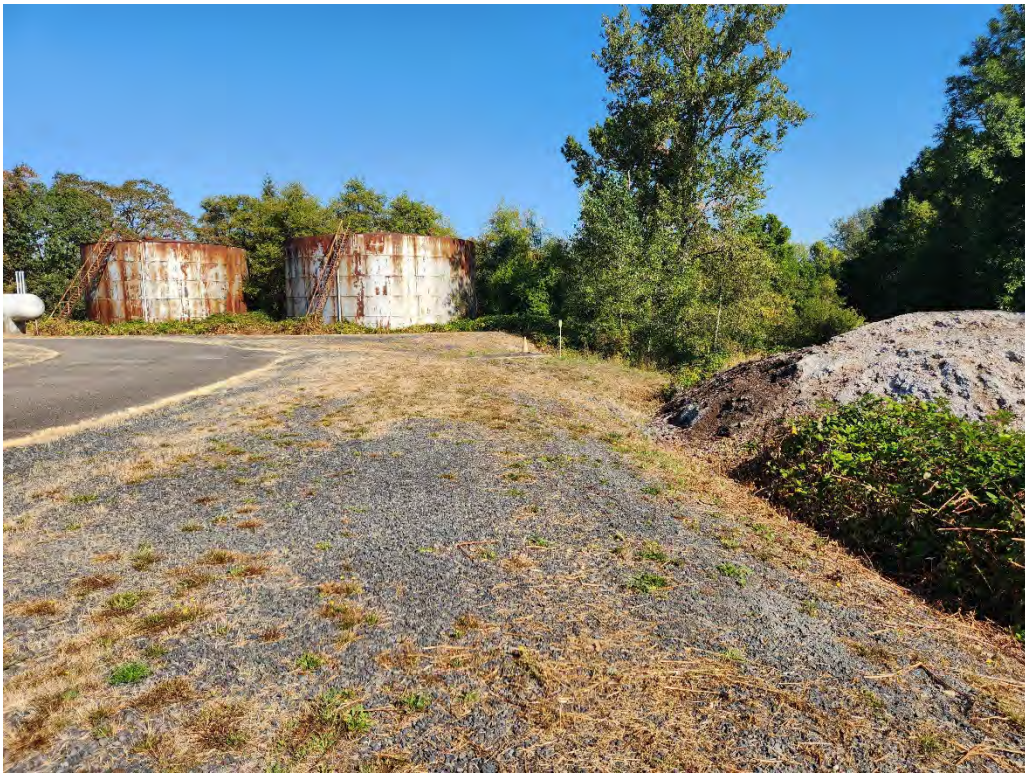
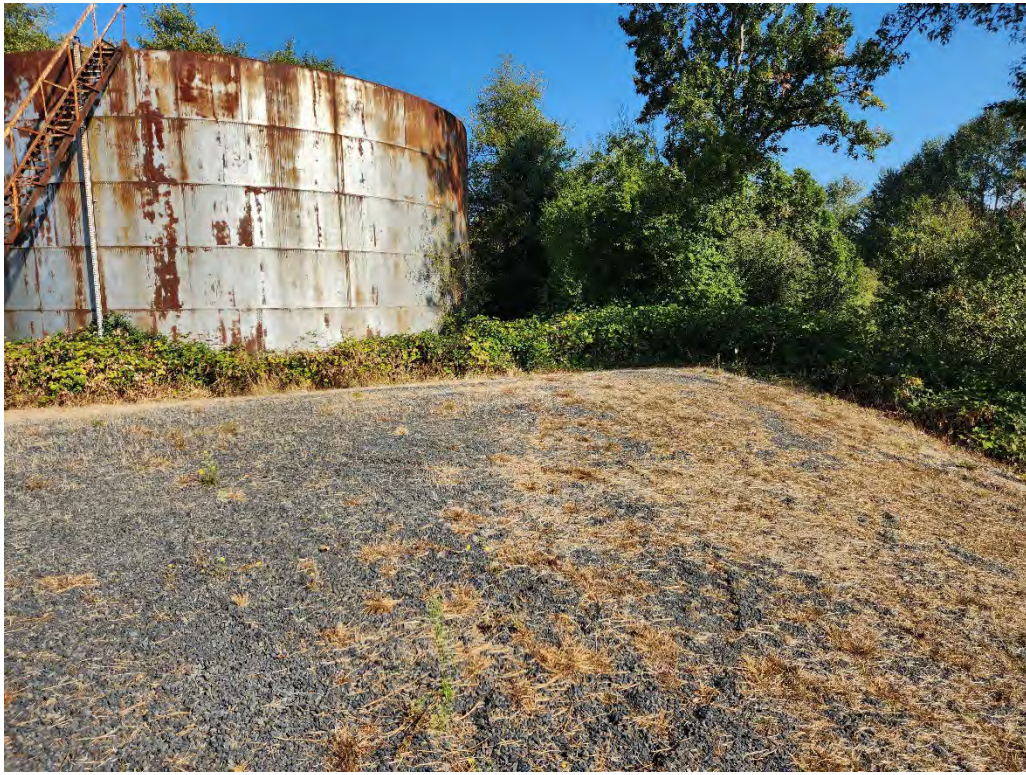
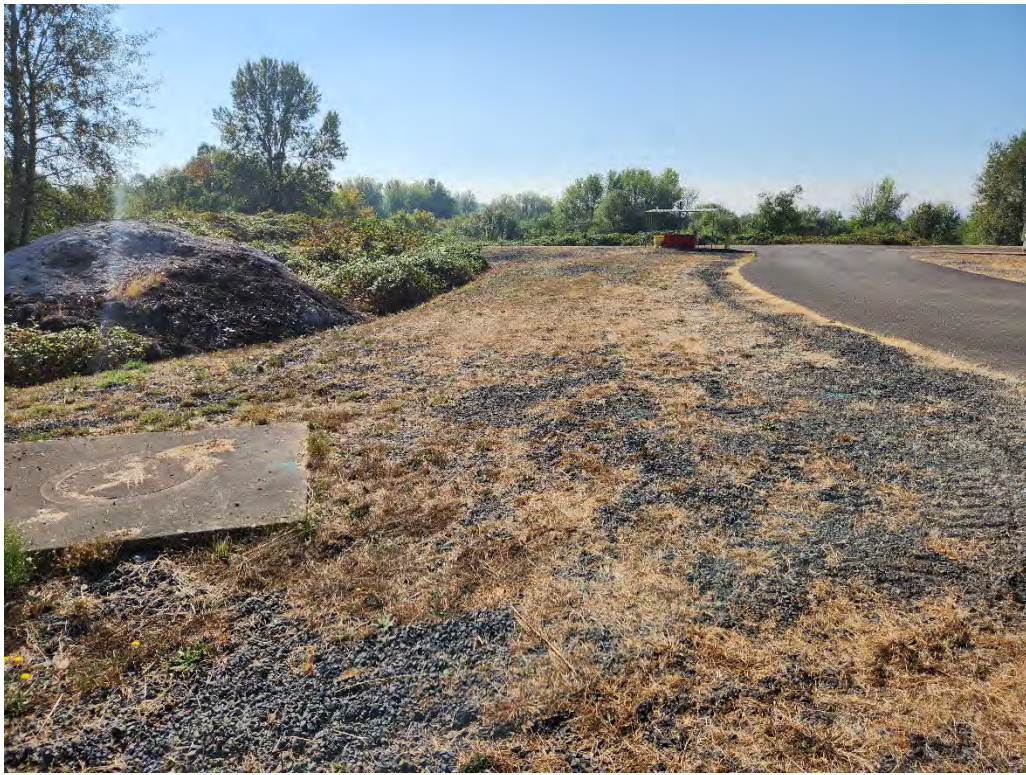
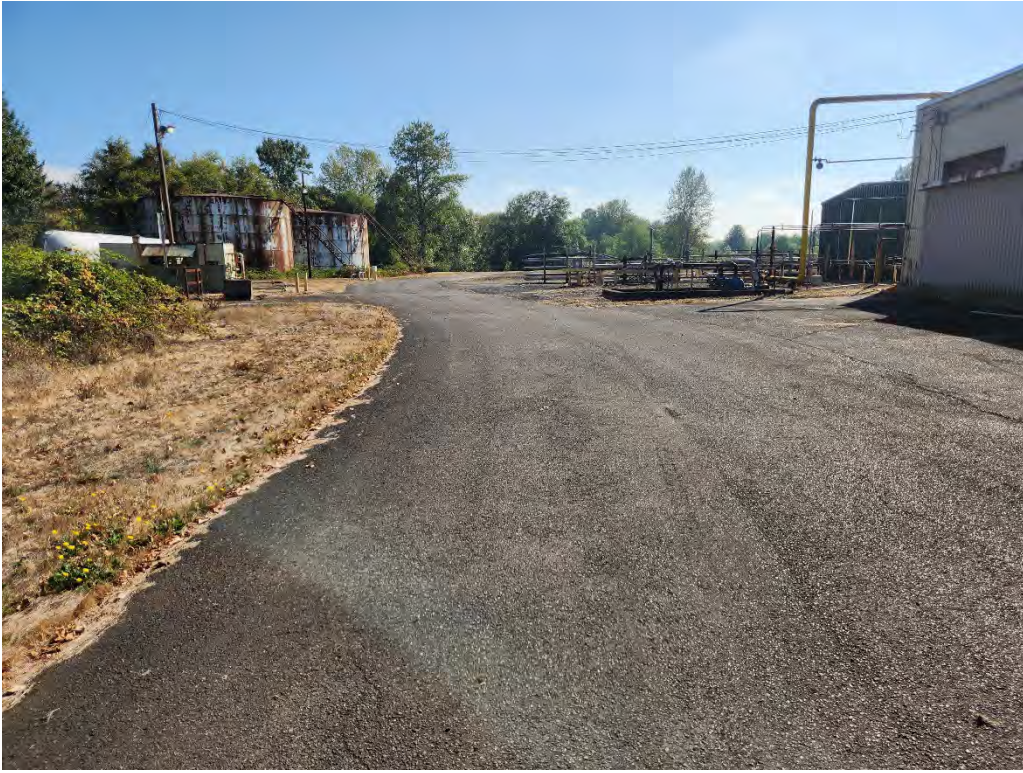
**Cap Inspection Area 1 – Soil and Gravel Cap**

Location: Area wide  
Condition: Some shrubbed rooted vegetation mostly dead. Edge of cap looks well defined.

AWI Cleared vegetation and mounded
