## ST HELENS FIBERBOARD FACILITY UPLAND REMEDY

### Third Quarter 2022 Progress Report

**Third Quarter 2022 Upland Cap Inspection Form and  
Cap Inspection Photo Logs**

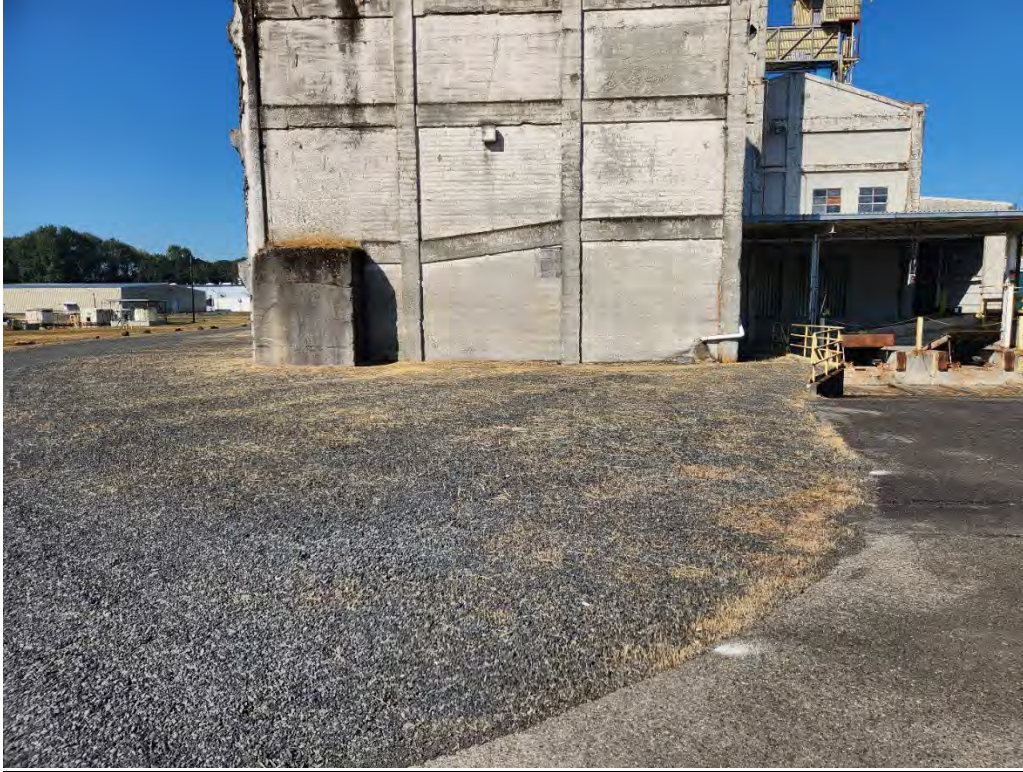
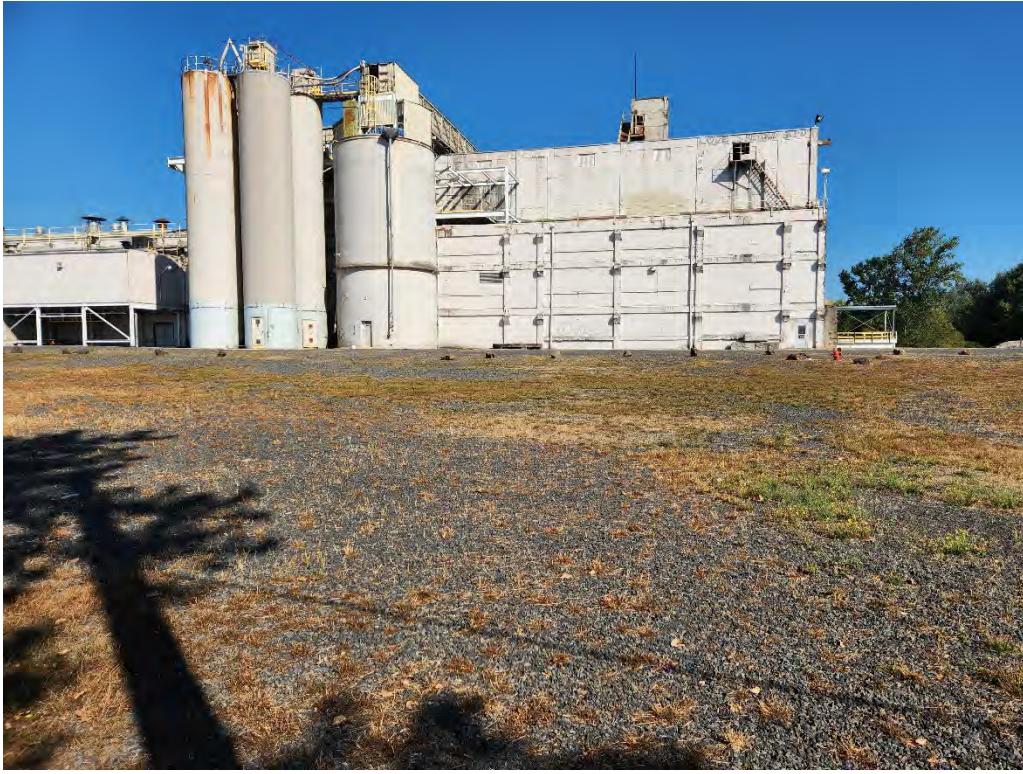
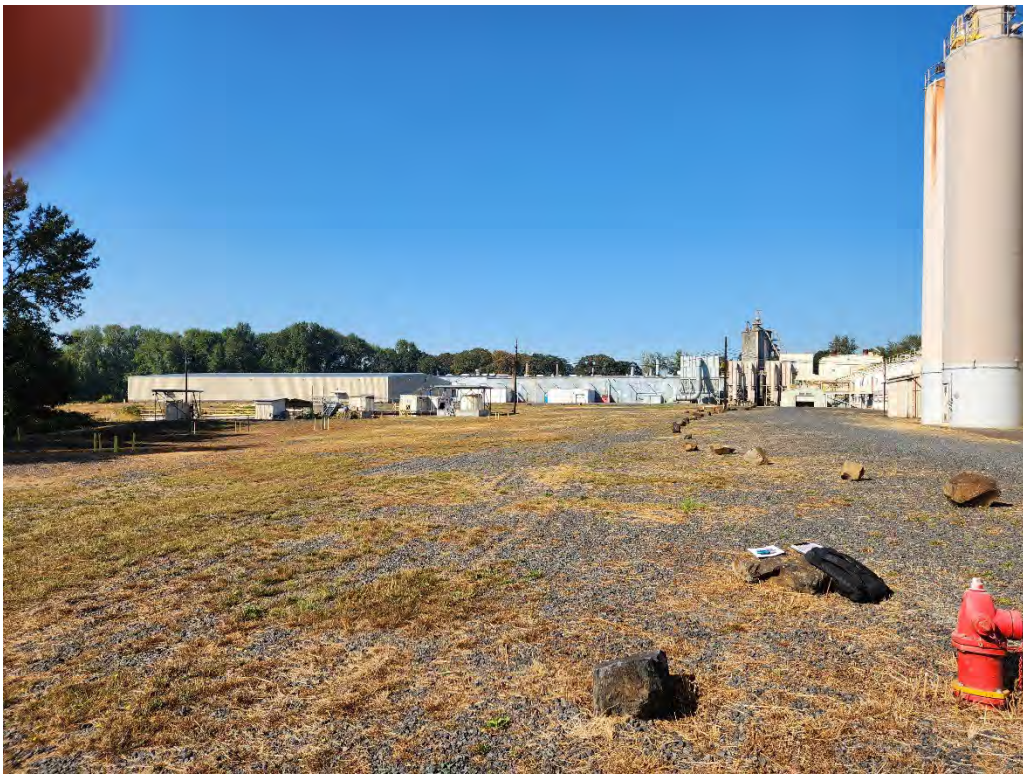
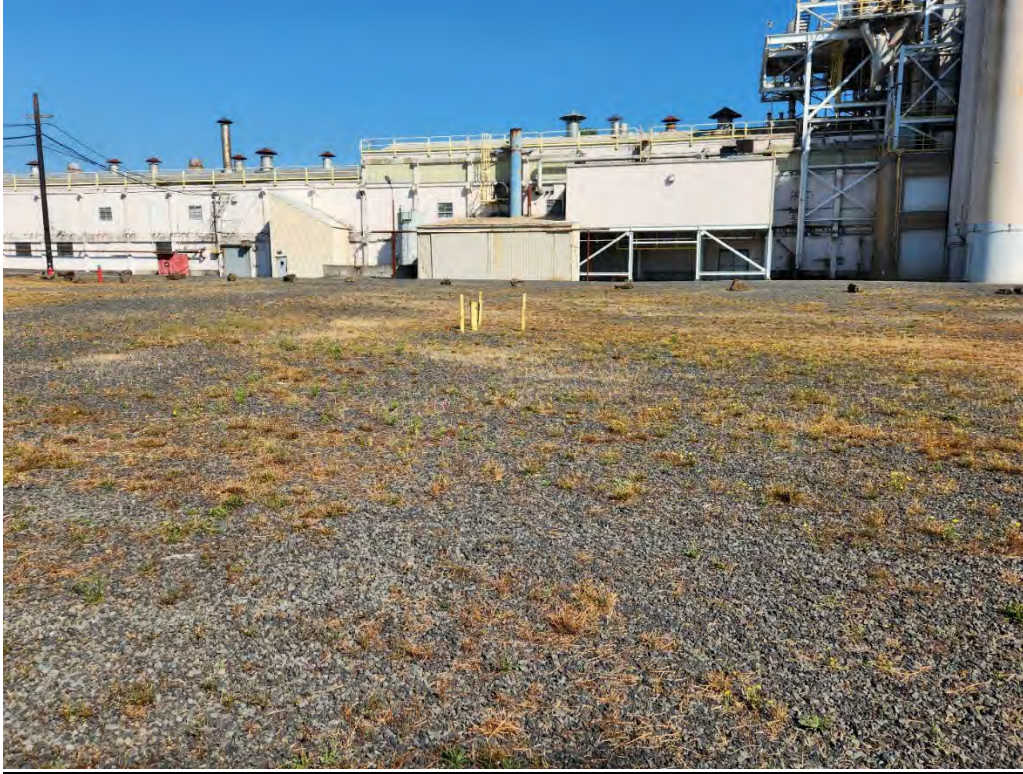
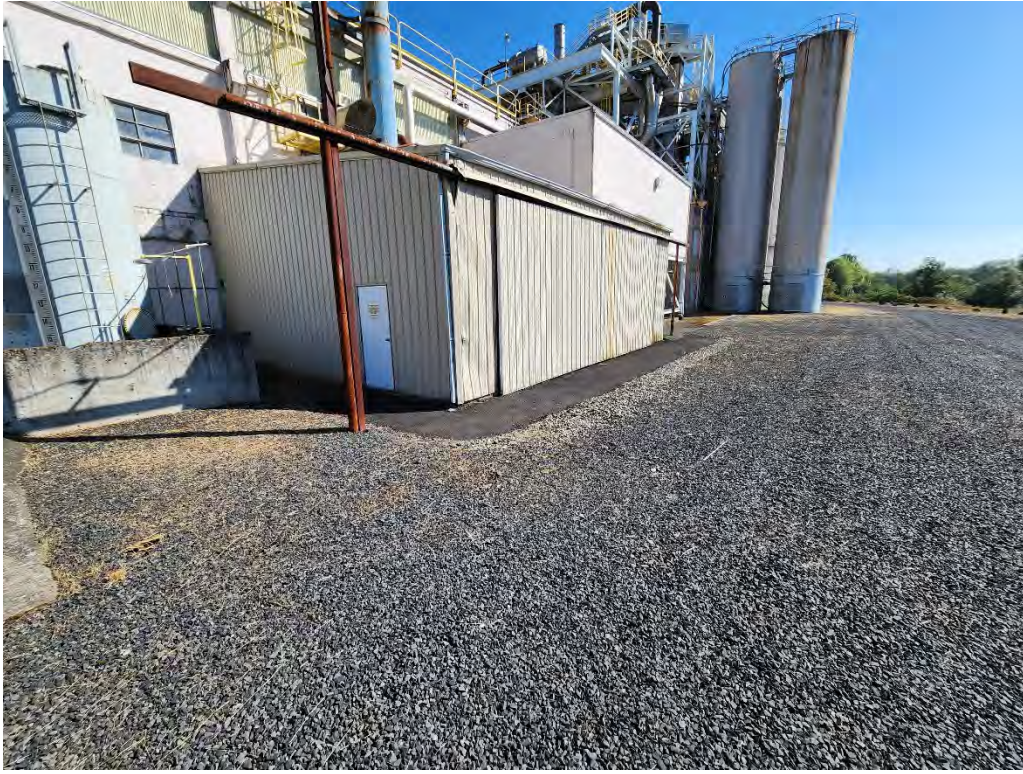
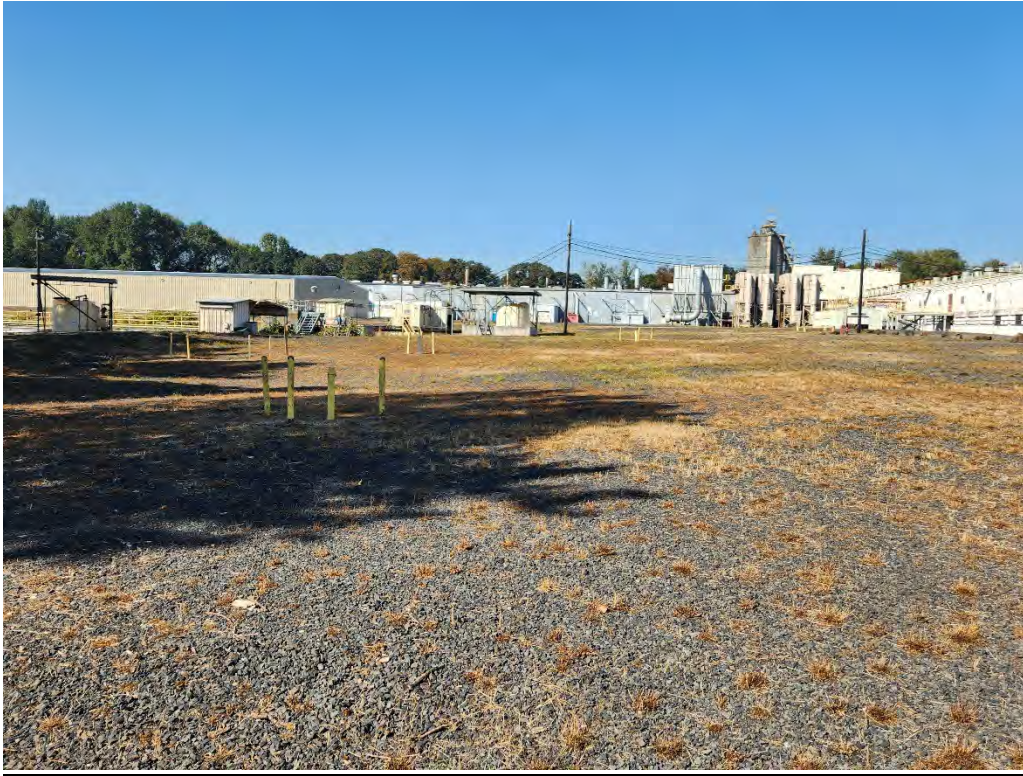
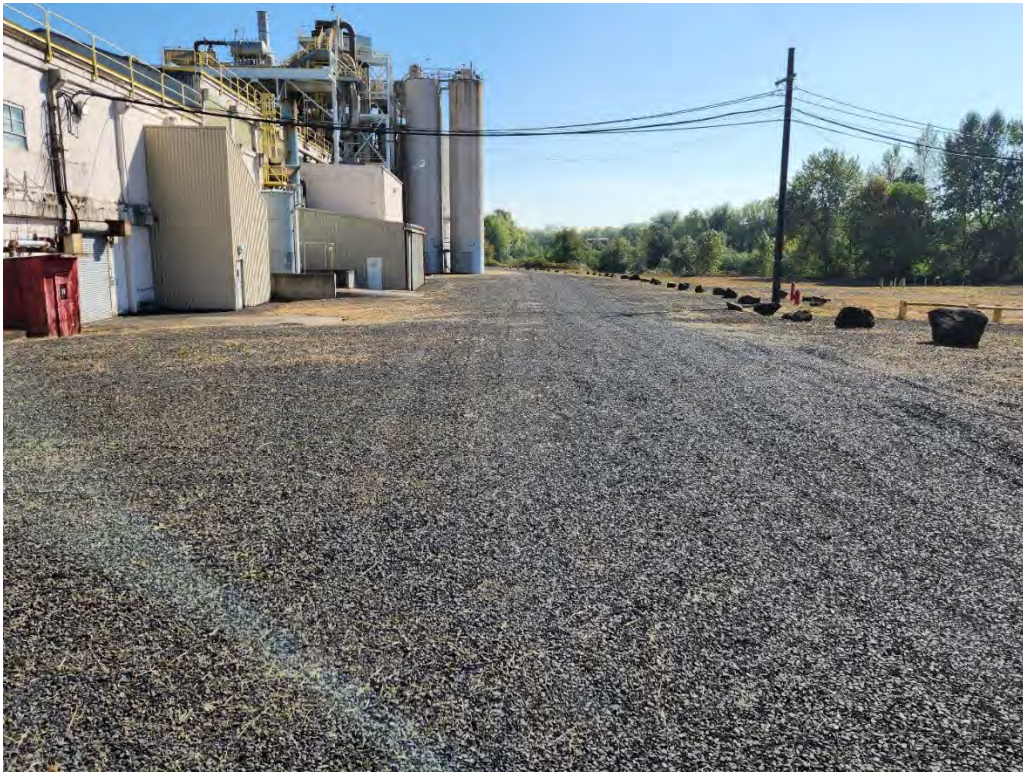
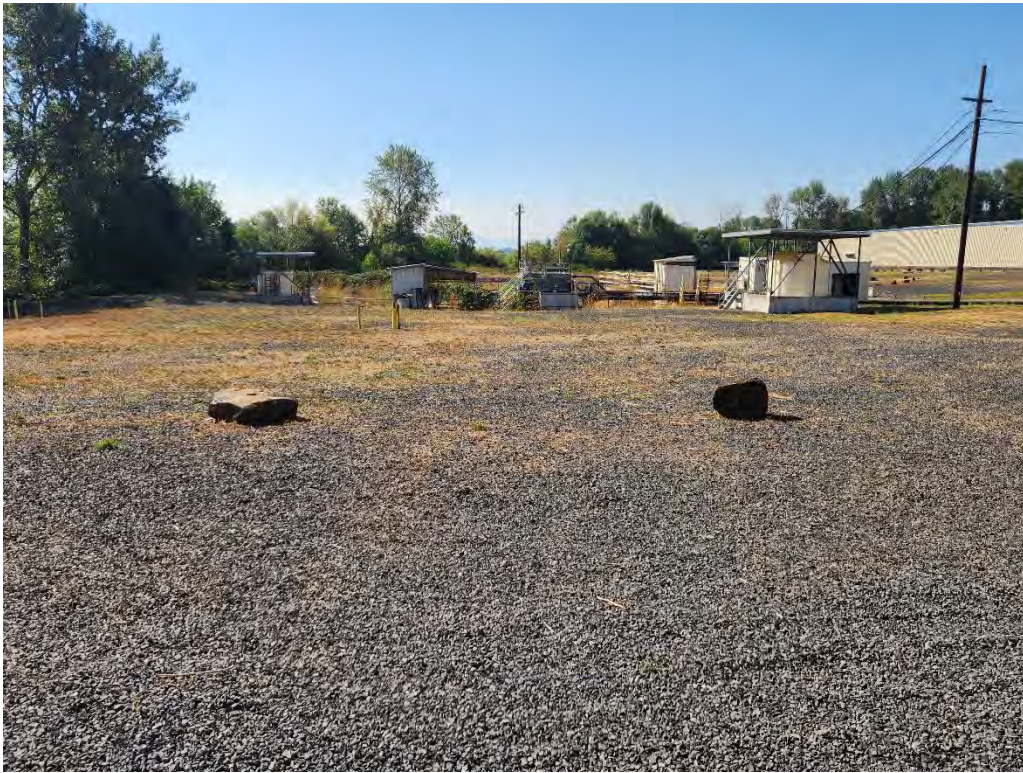
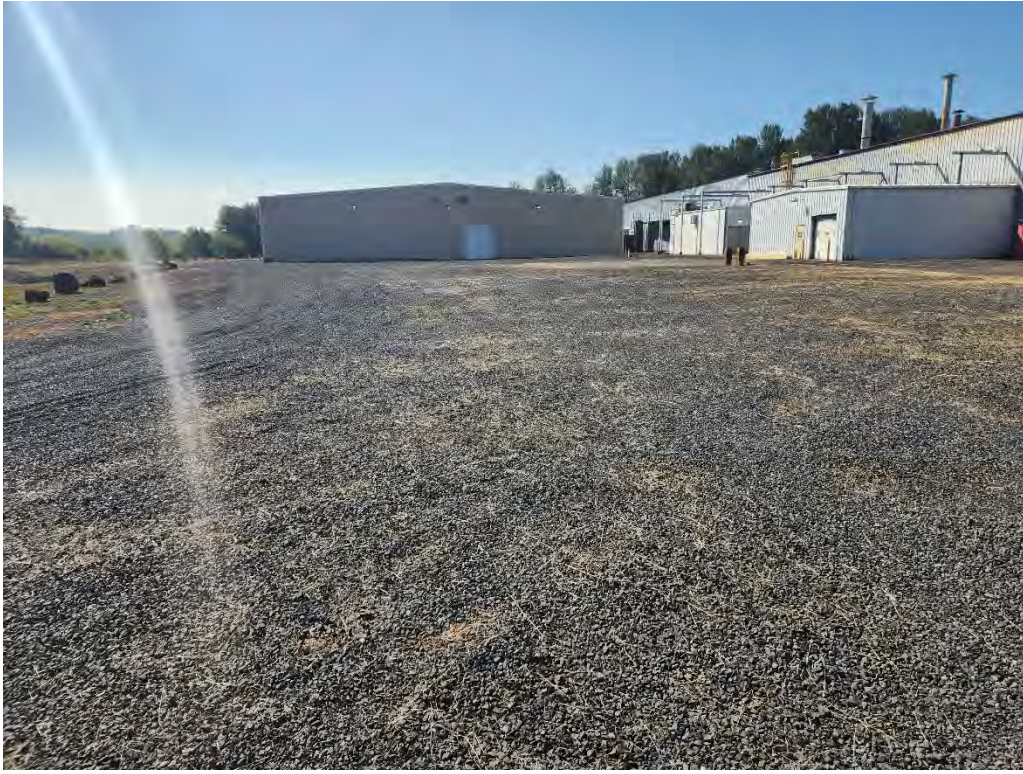
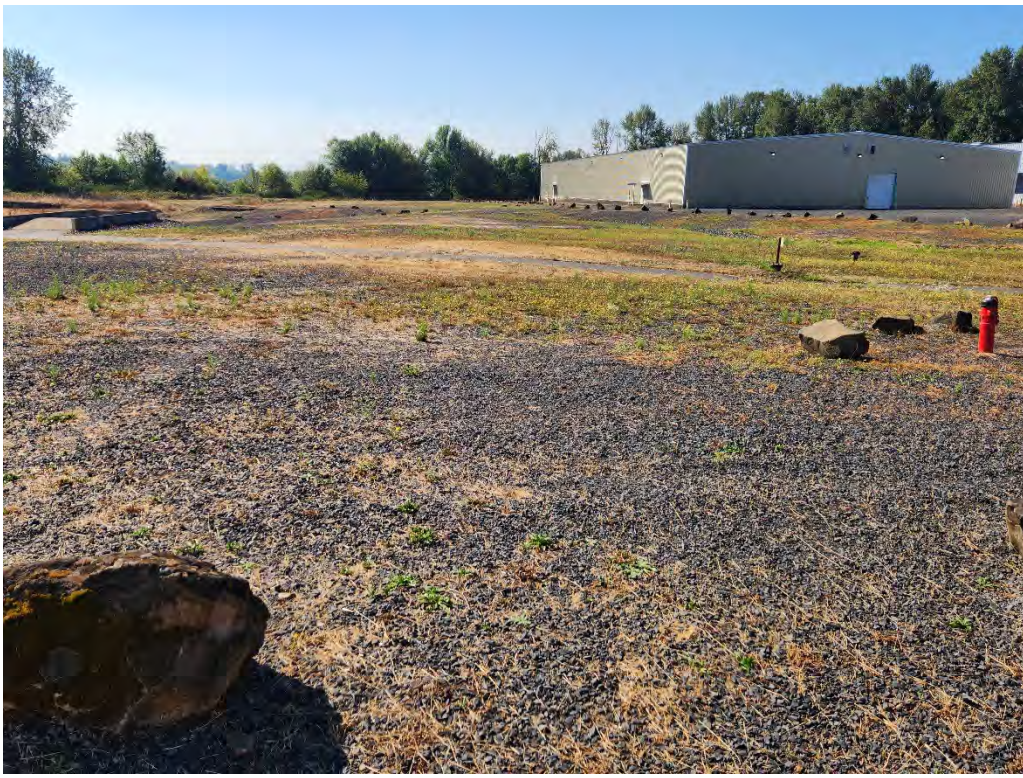
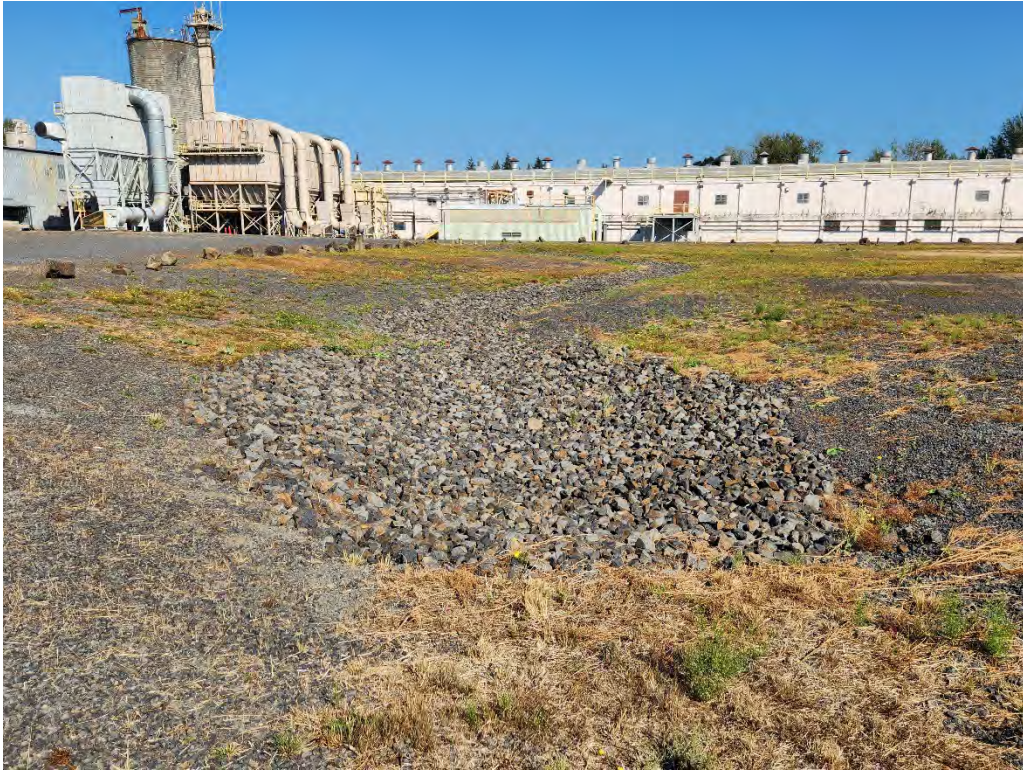
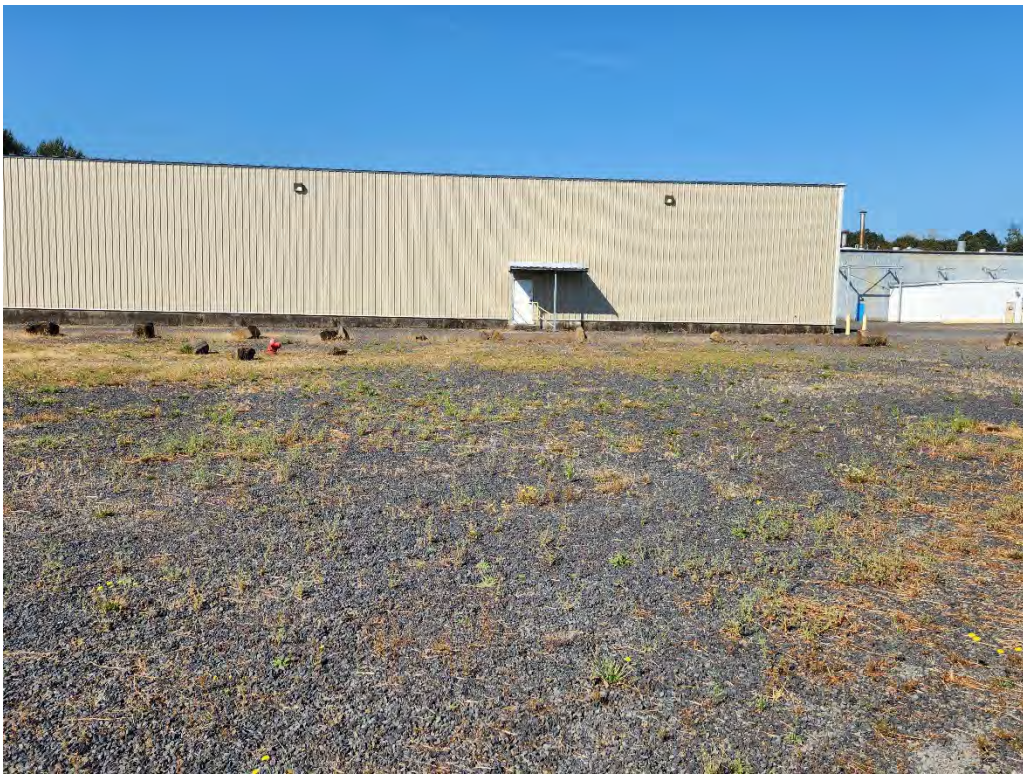
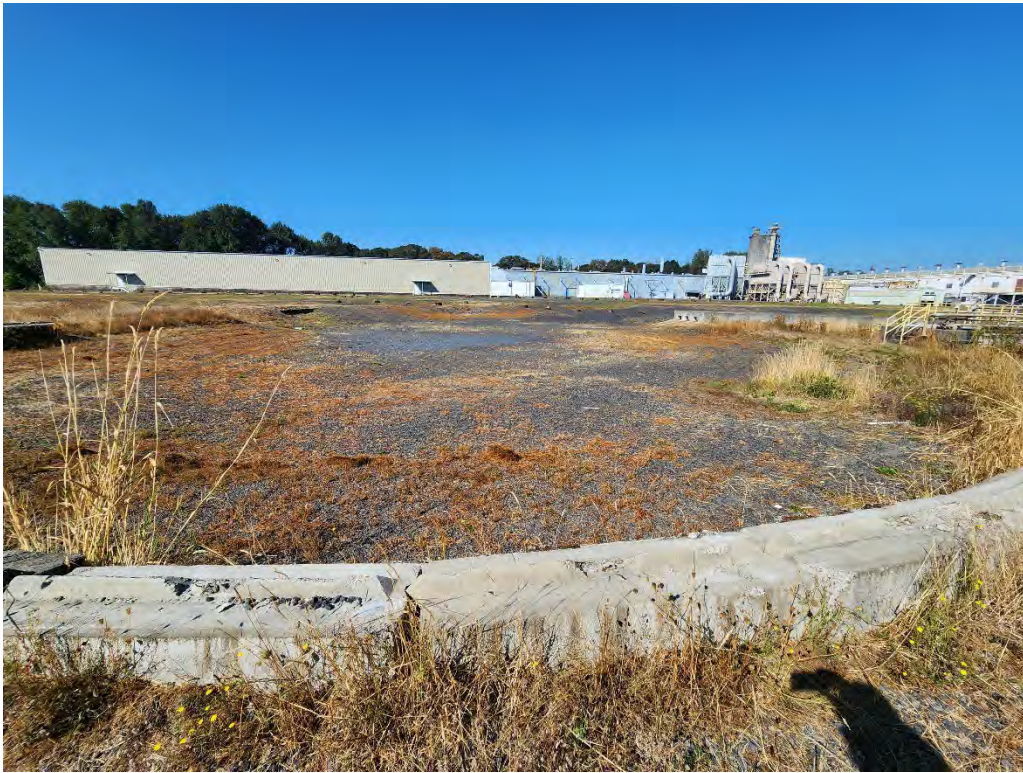
**Cap Inspection Area 2 – Soil and Gravel Cap**

Location: Suble - at treatment plant.

Condition: Good south end of suble and east side of treatment plant black berries and sealed biomass near edges of cap at suble slopes.

mowing and vegetation removal

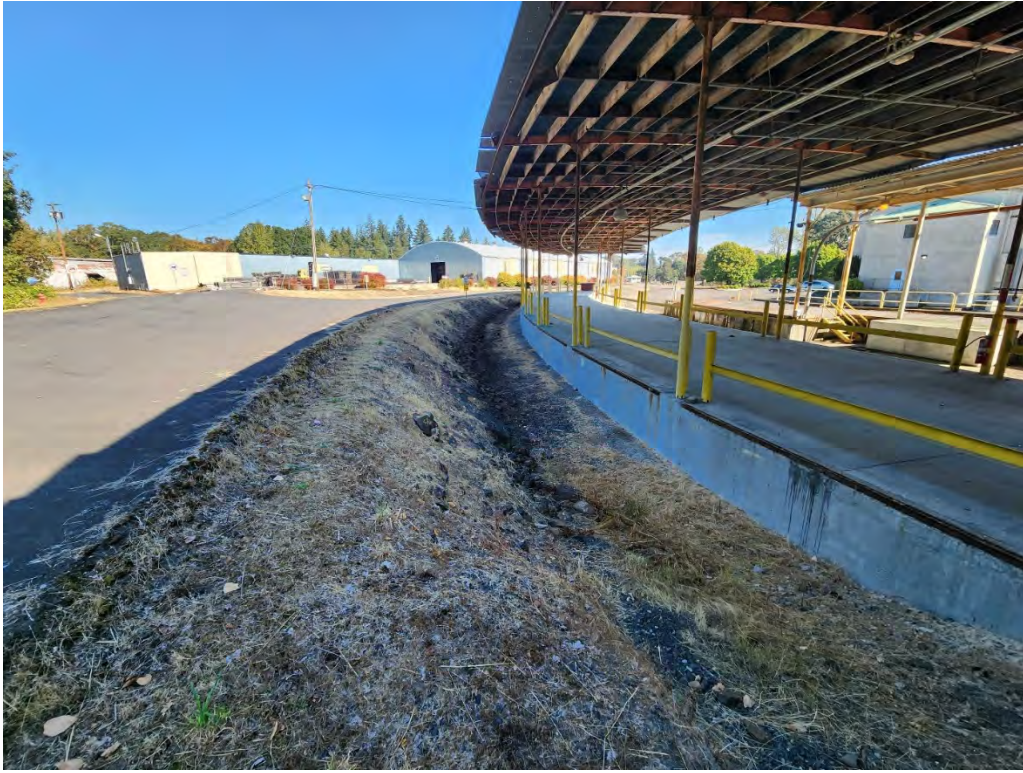
**Cap Inspection Area 3 – Soil and Gravel Cap**

Condition: Good condition

viewing and vegetation management

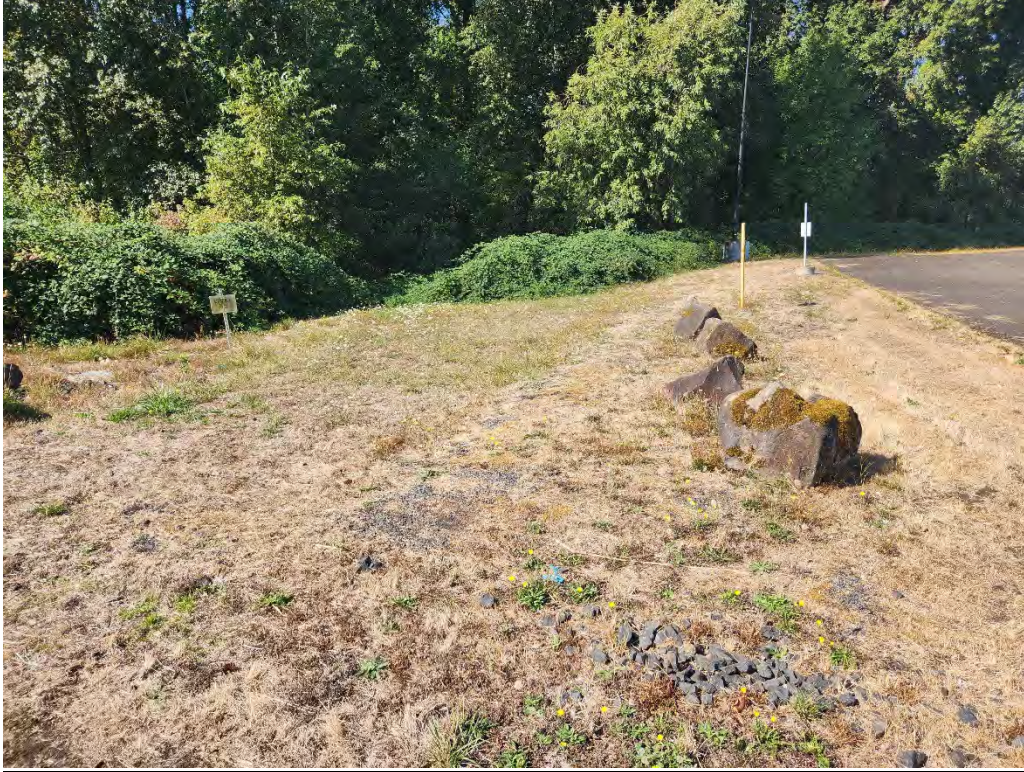
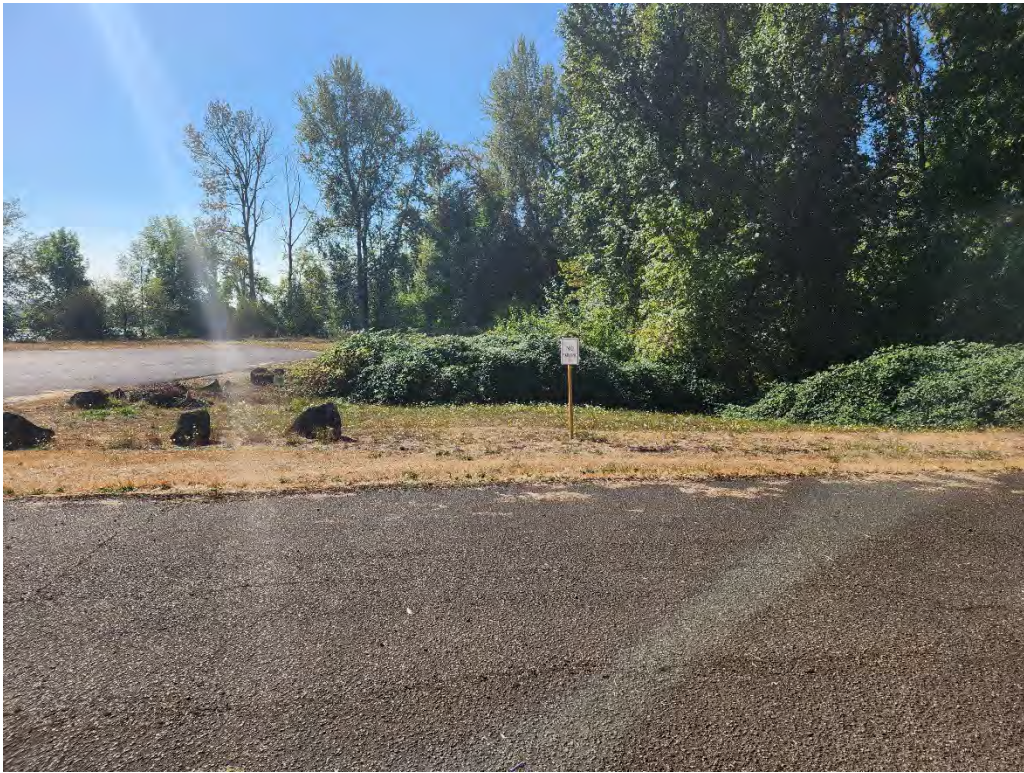
**Cap Inspection Area 3 – Limited Access Areas**

Condition: N/A <sup>BT</sup> Good Condition

Mowing and vegetation management
