## ST HELENS FIBERBOARD FACILITY UPLAND REMEDY

### First Quarter 2022 Progress Report

# UPLAND CAP INSPECTION FORM

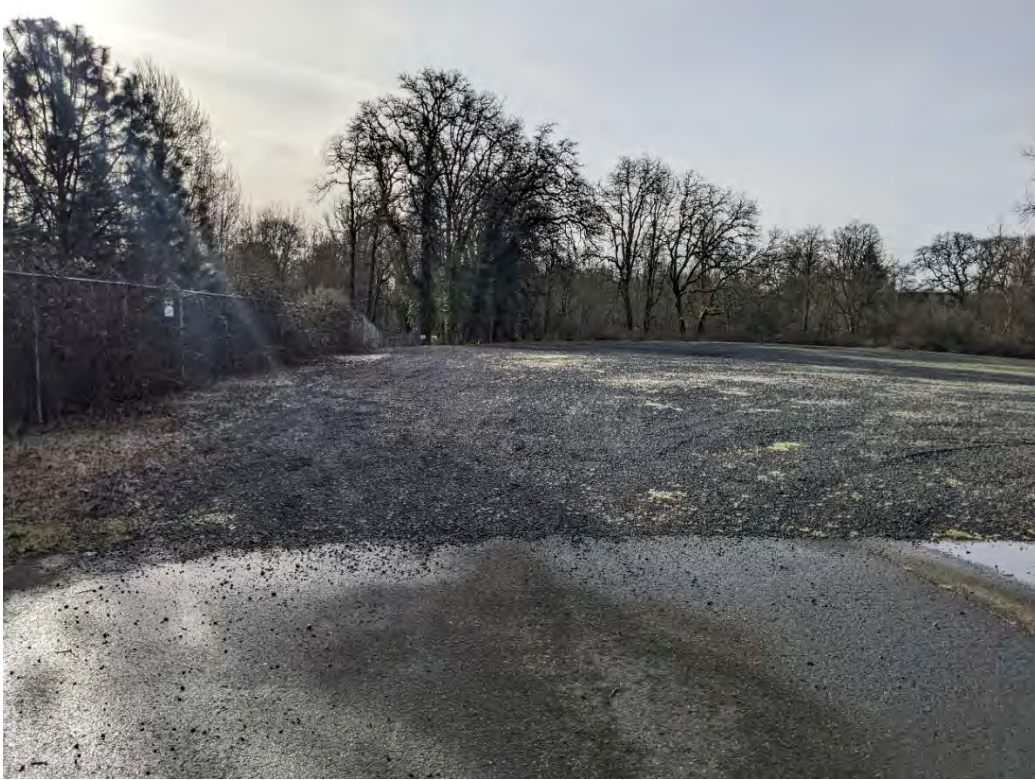
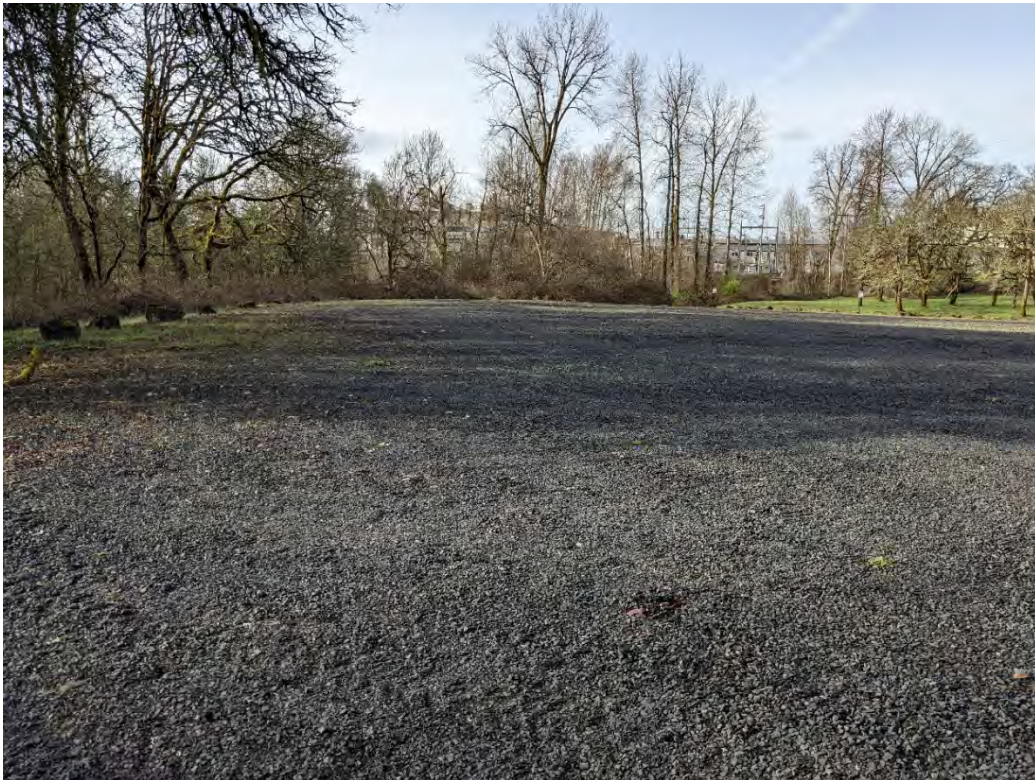
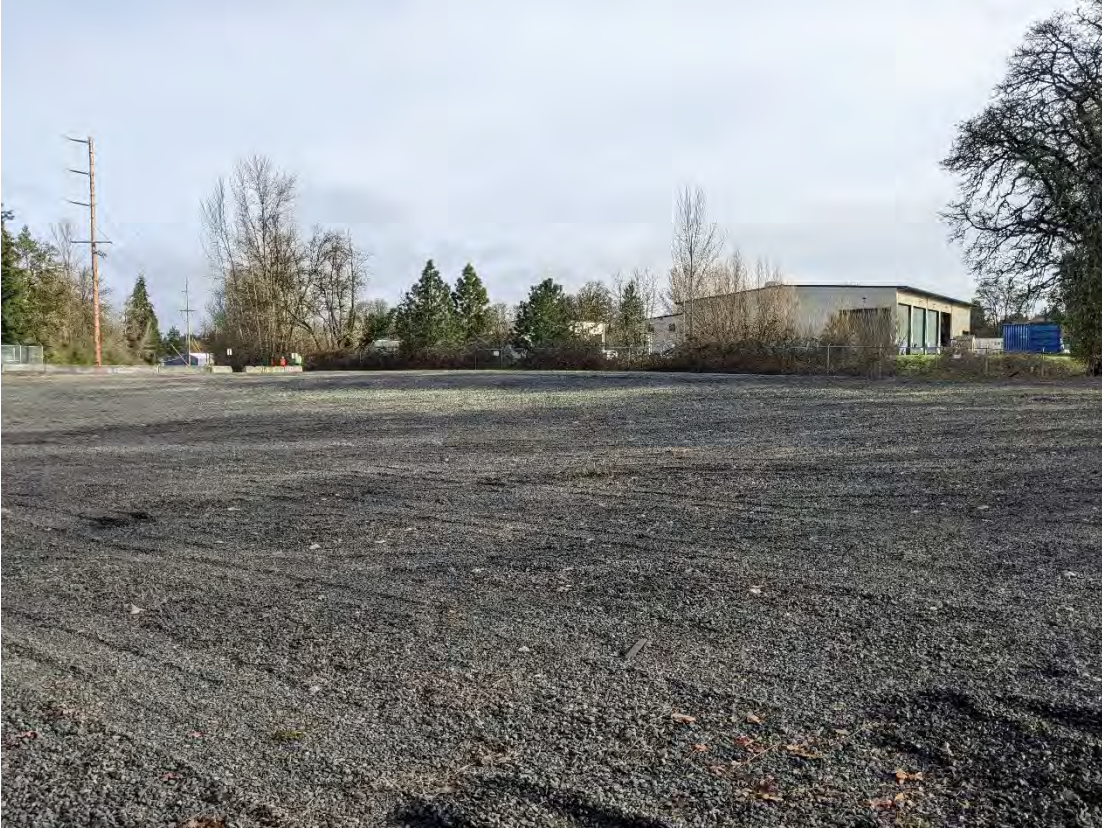
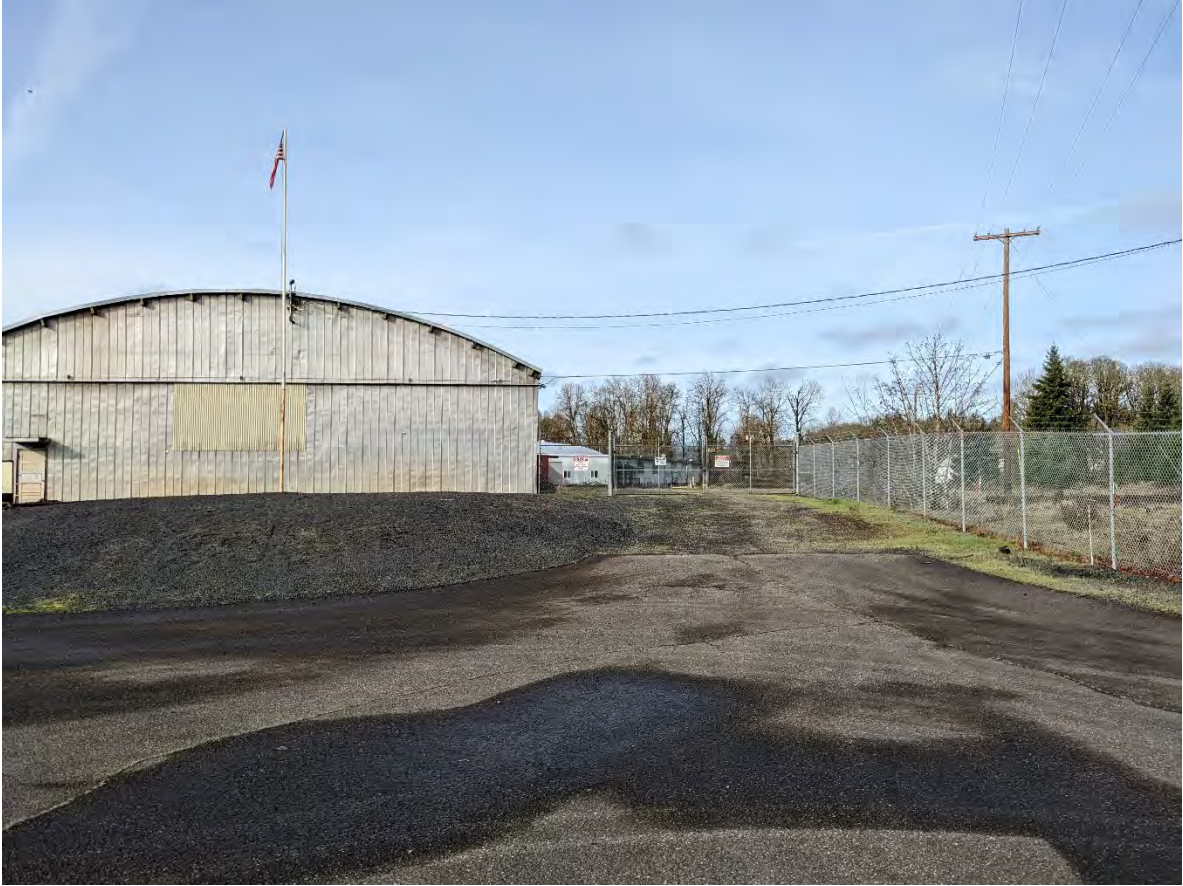
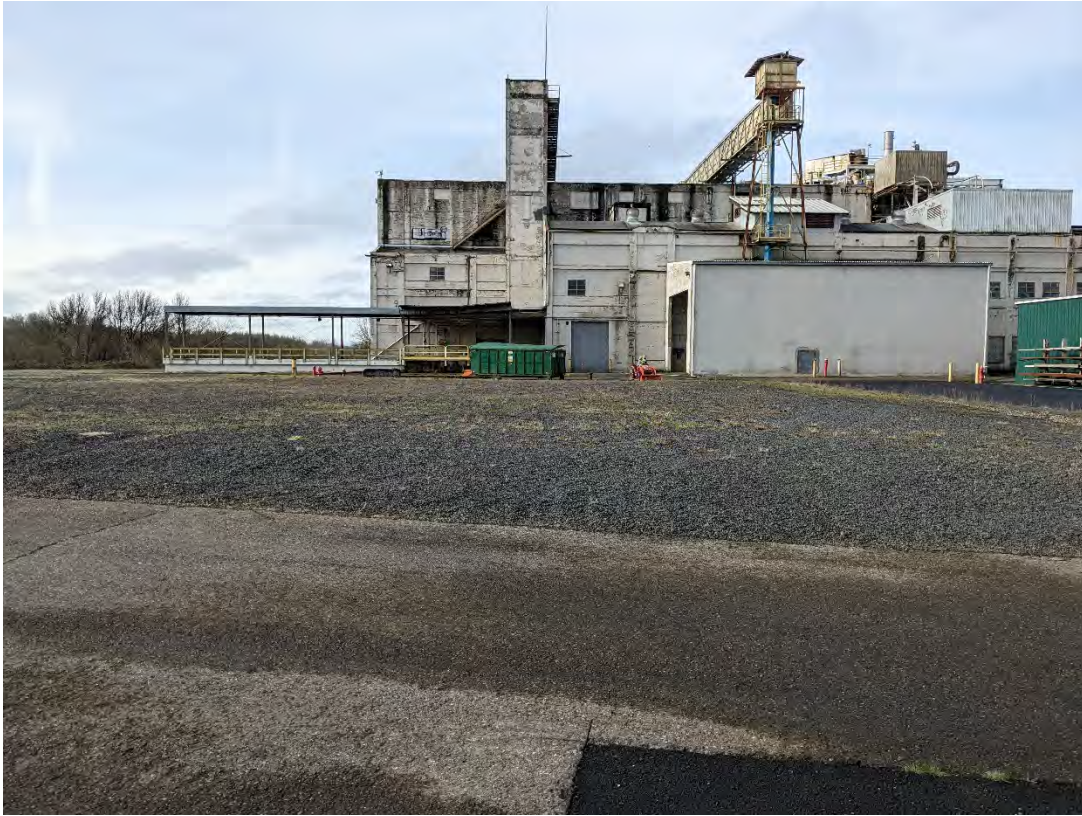
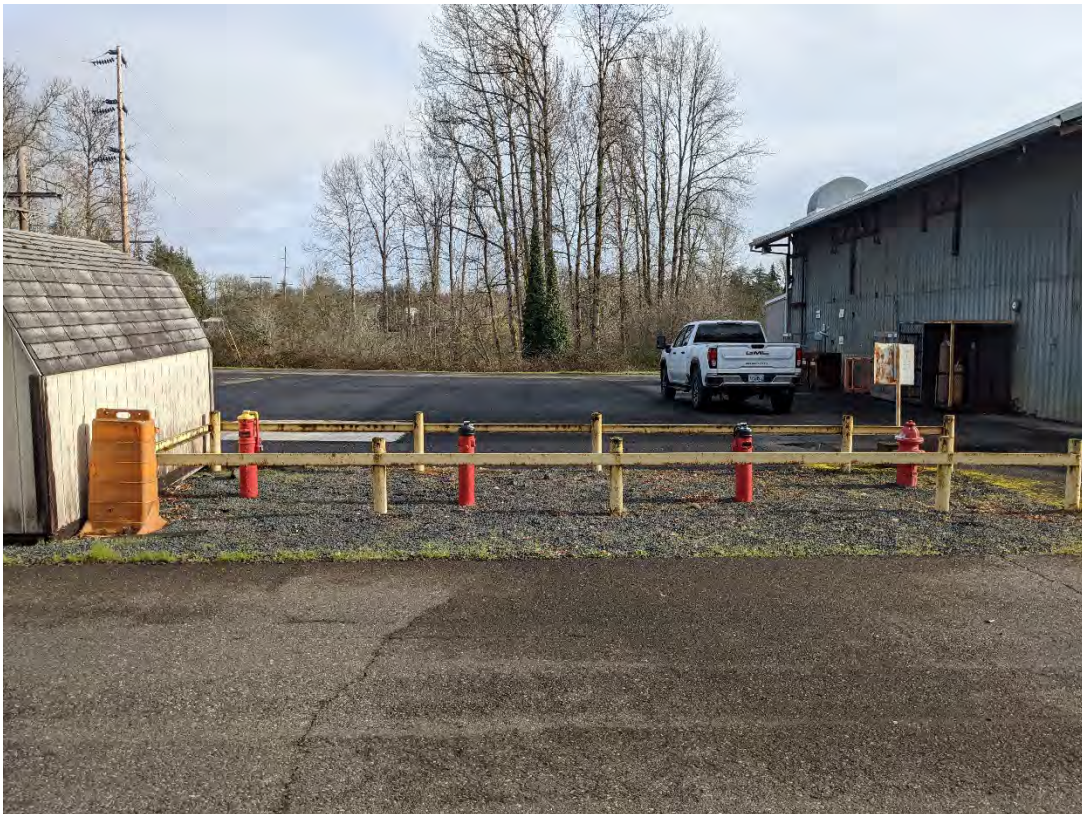
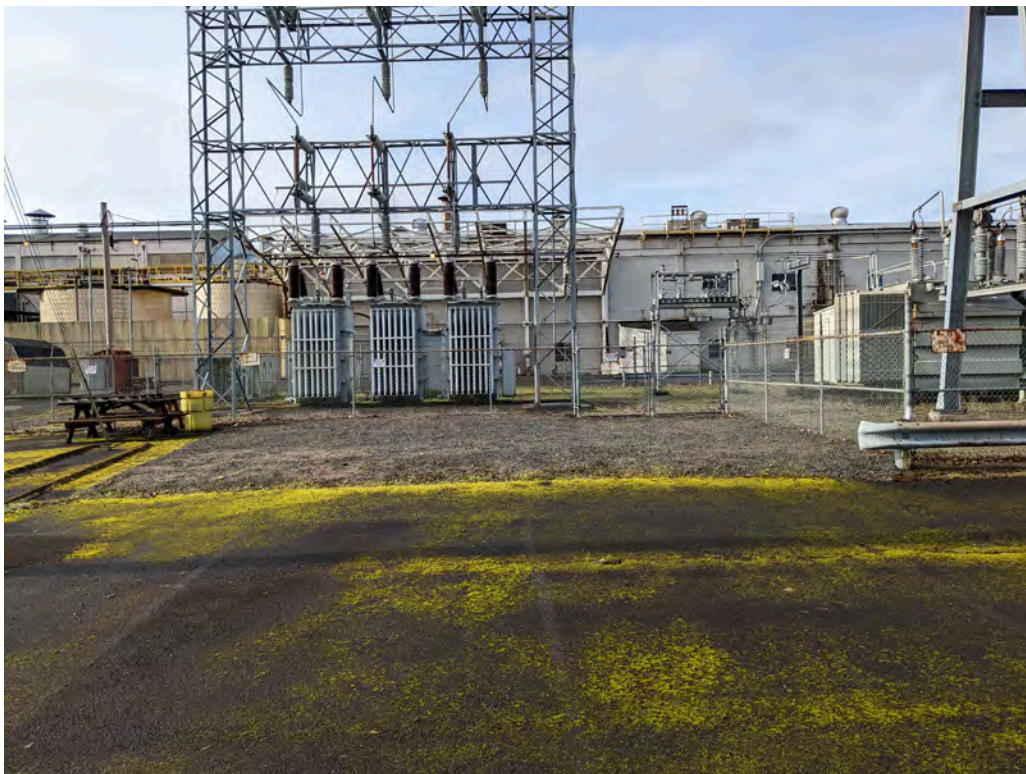
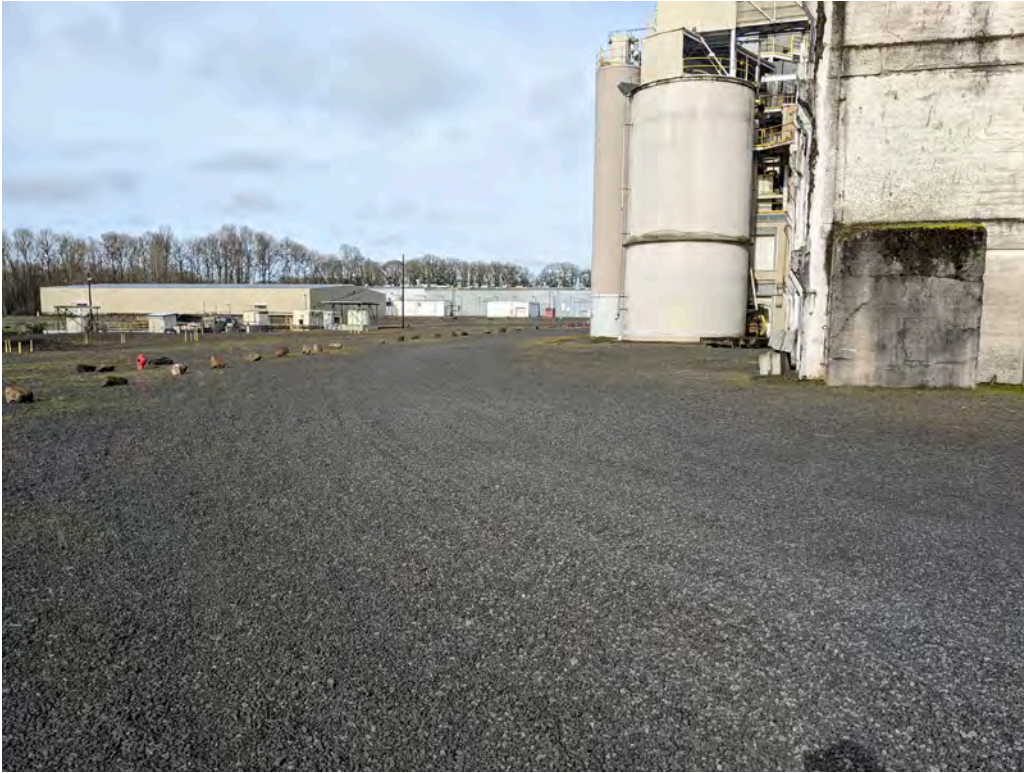
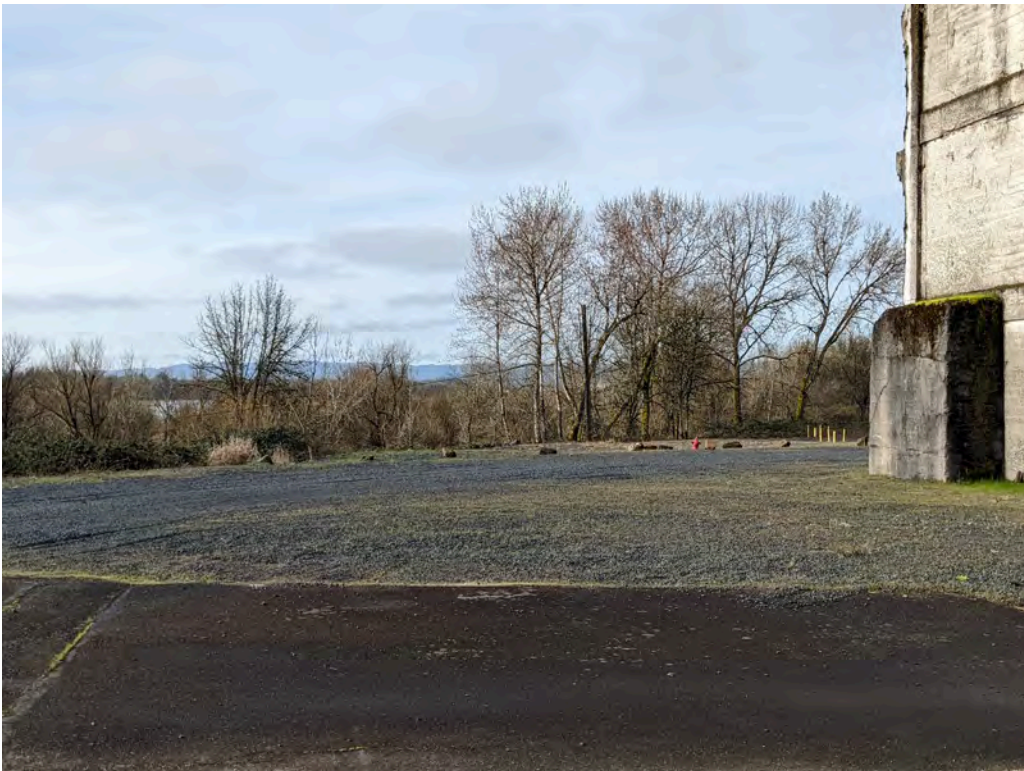
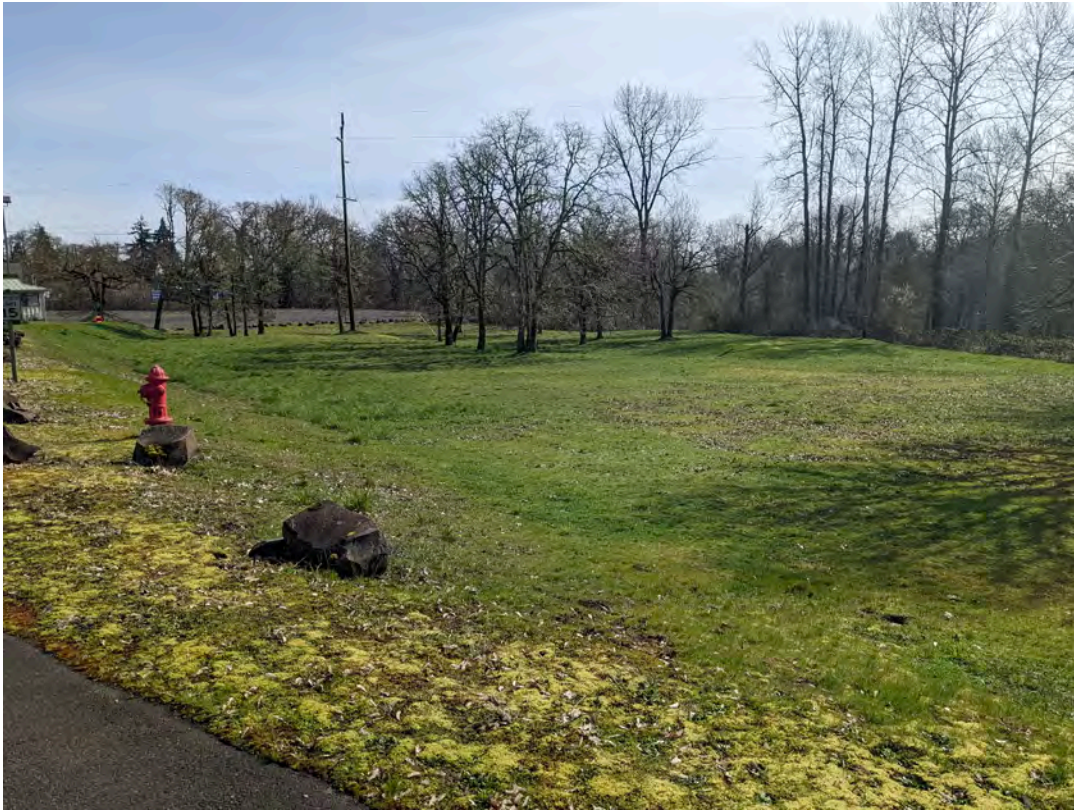
**Cap Inspection Area 1 – Soil and Gravel Cap**

Condition: The gravel cap is in good condition throughout area #1. Some invasive weeds are encroaching on the gravel cap near the sand test pile. Moss present on asphalt.

AWI cleared vegetation from the cap, reestablished the cap boundary, and knocked back blackberry. More vegetation management needed near sand test pile.

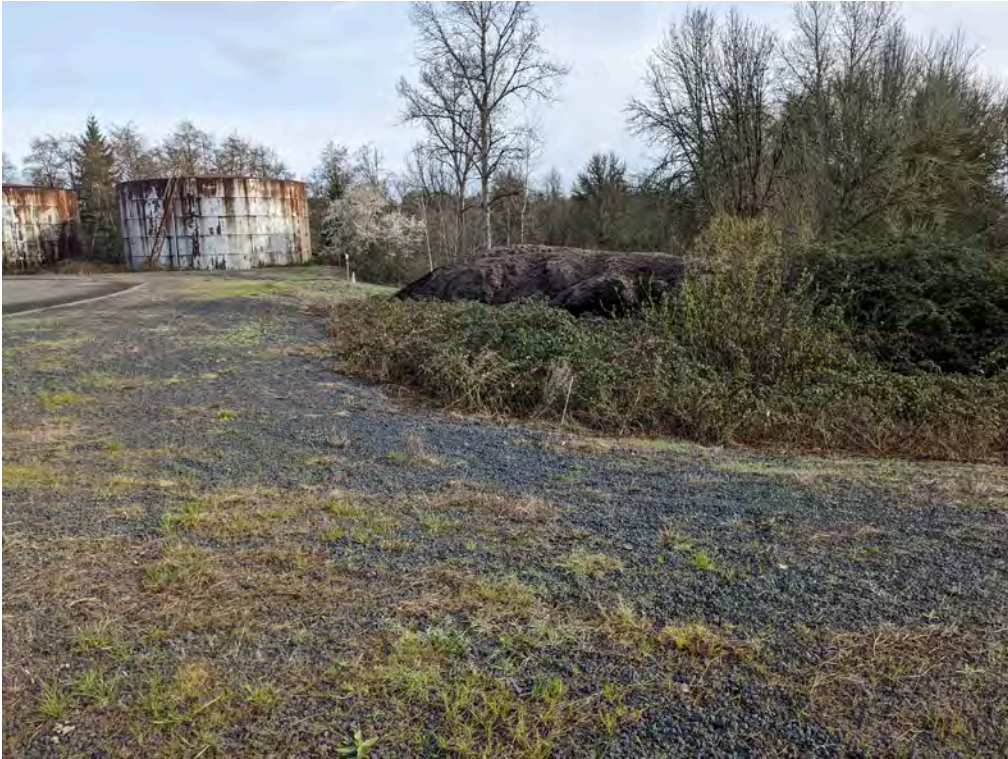
**Cap Inspection Area 1 – Soil and Gravel Cap (cont.)**

Vegetation management may be needed in this area to prevent encroachment on the cap.
