## ST HELENS FIBERBOARD FACILITY UPLAND REMEDY

### First Quarter 2022 Progress Report

# UPLAND CAP INSPECTION FORM

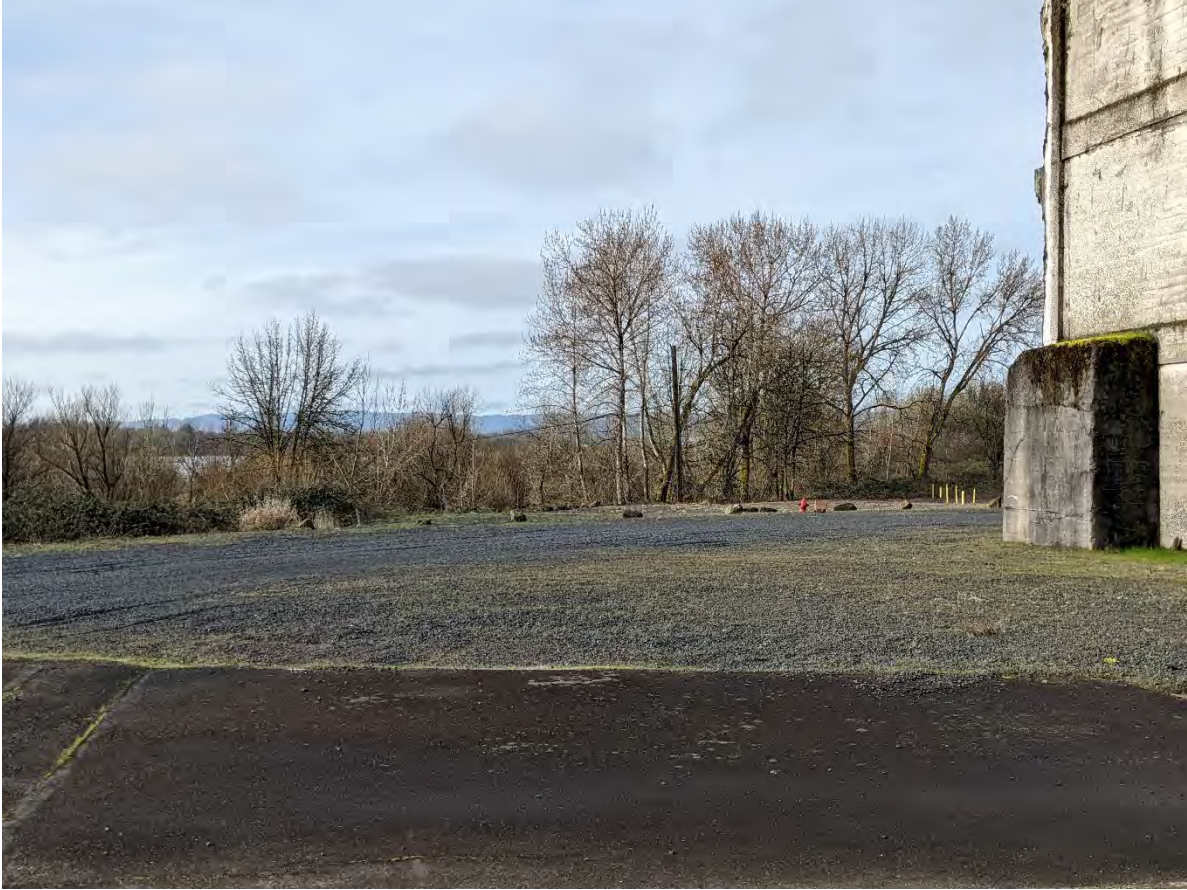
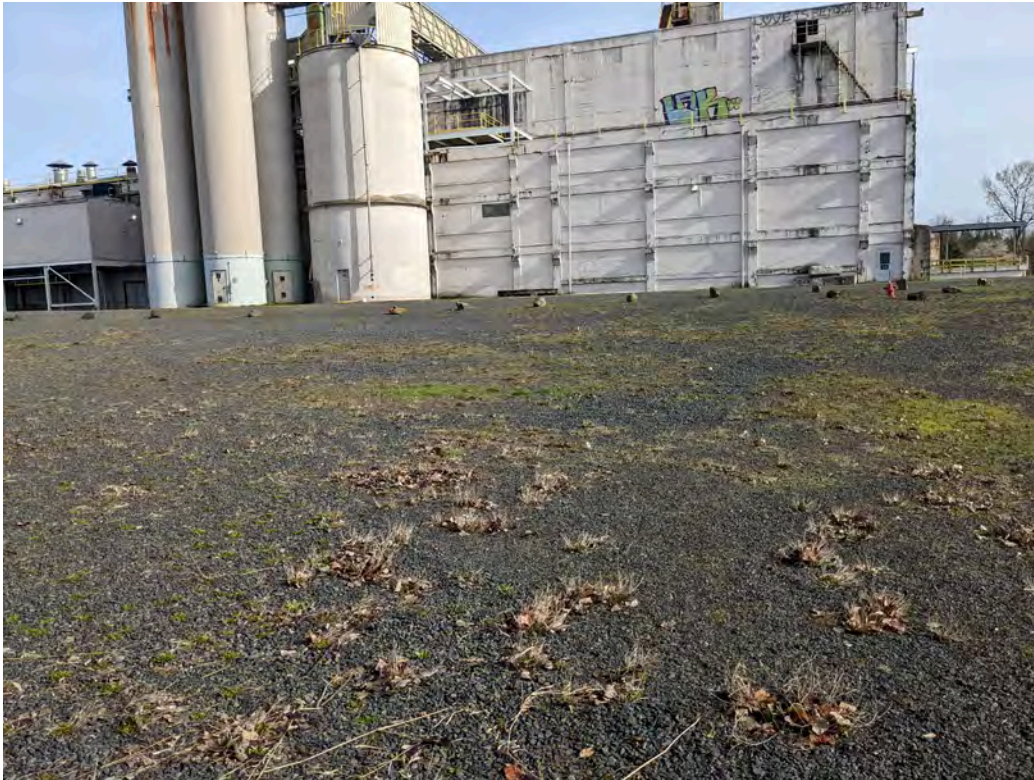
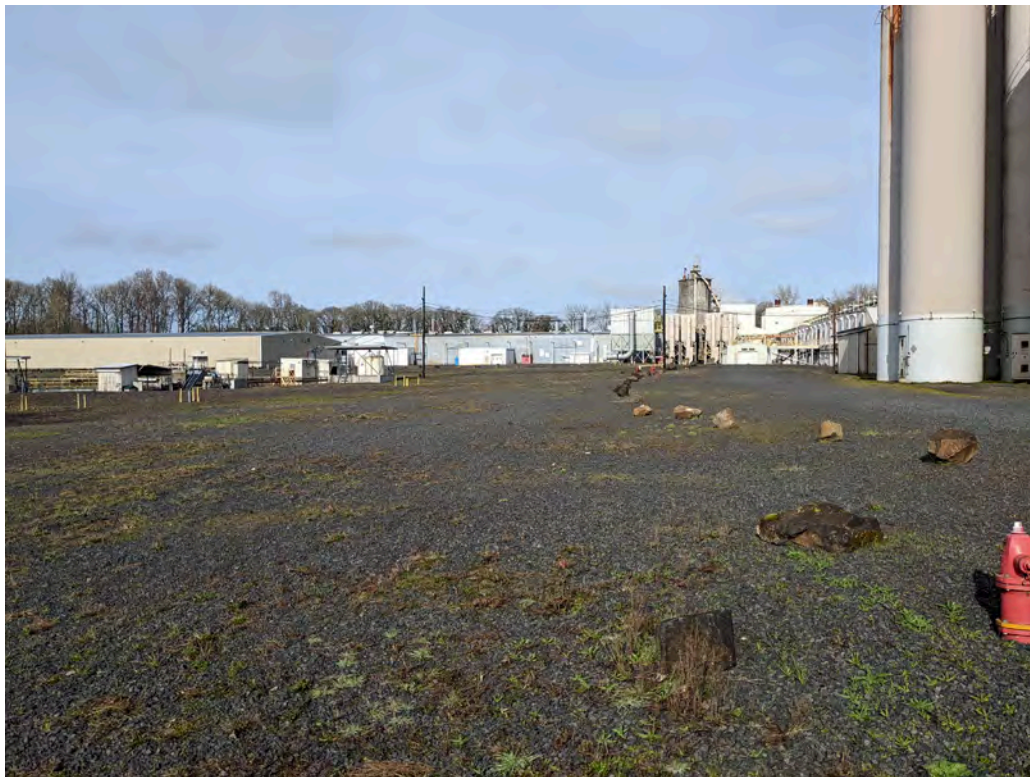
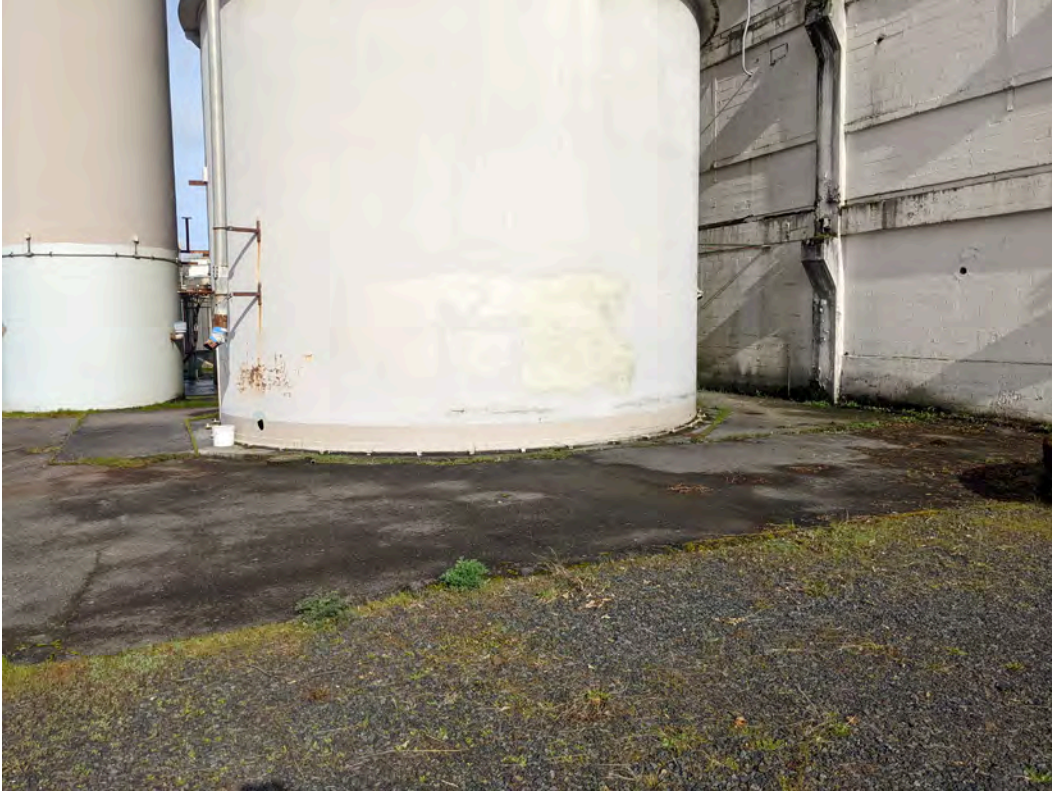
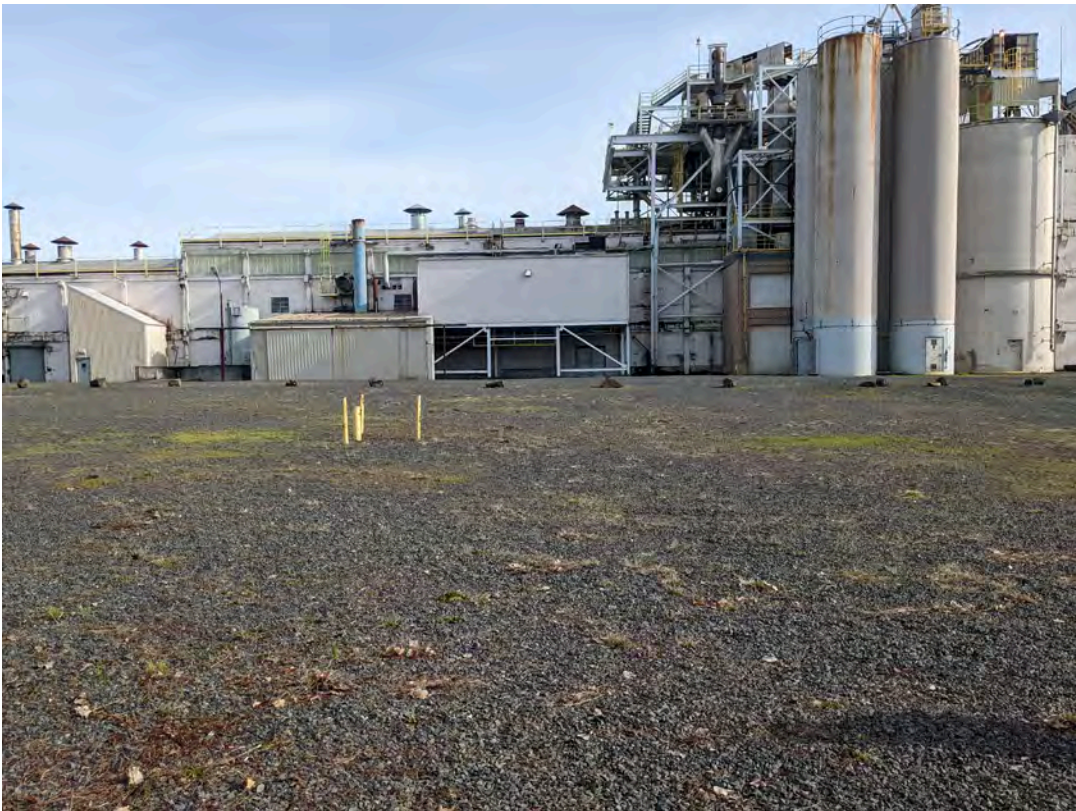
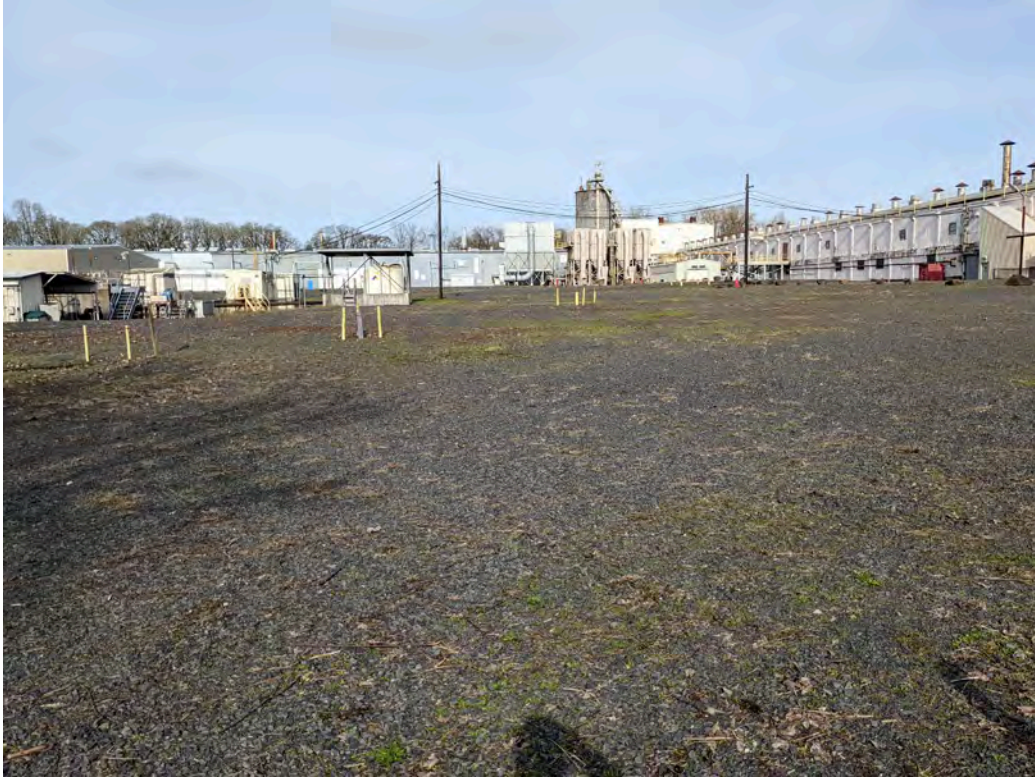
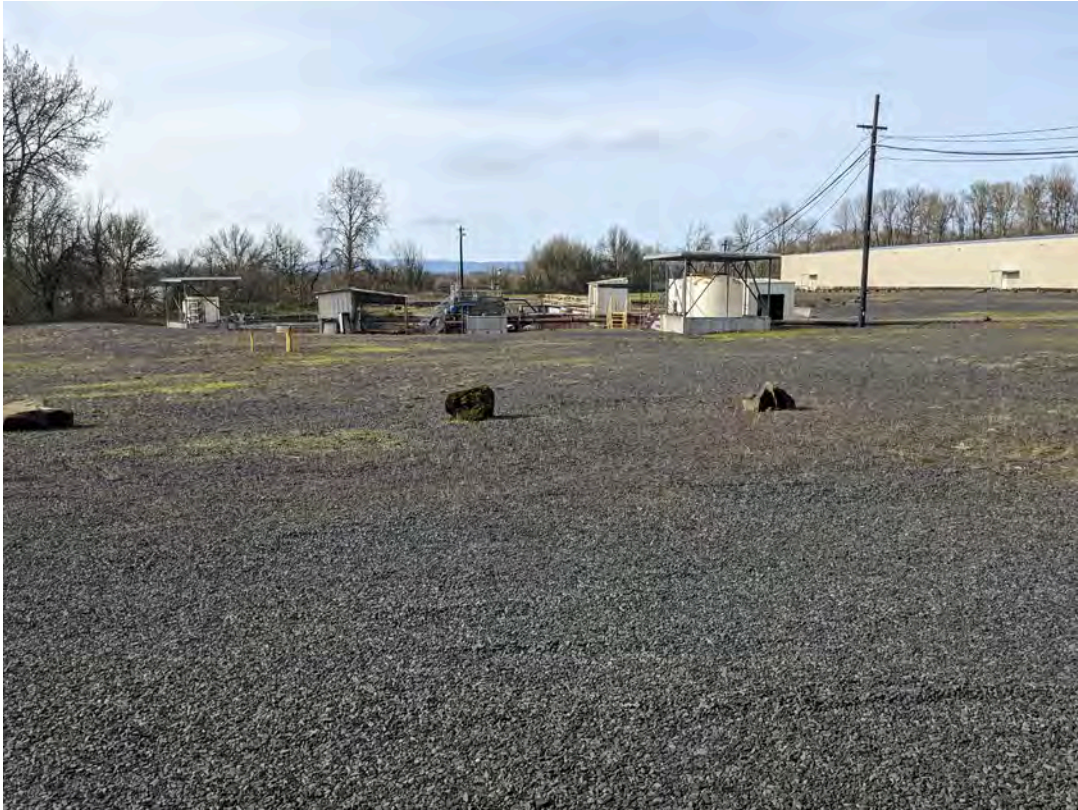
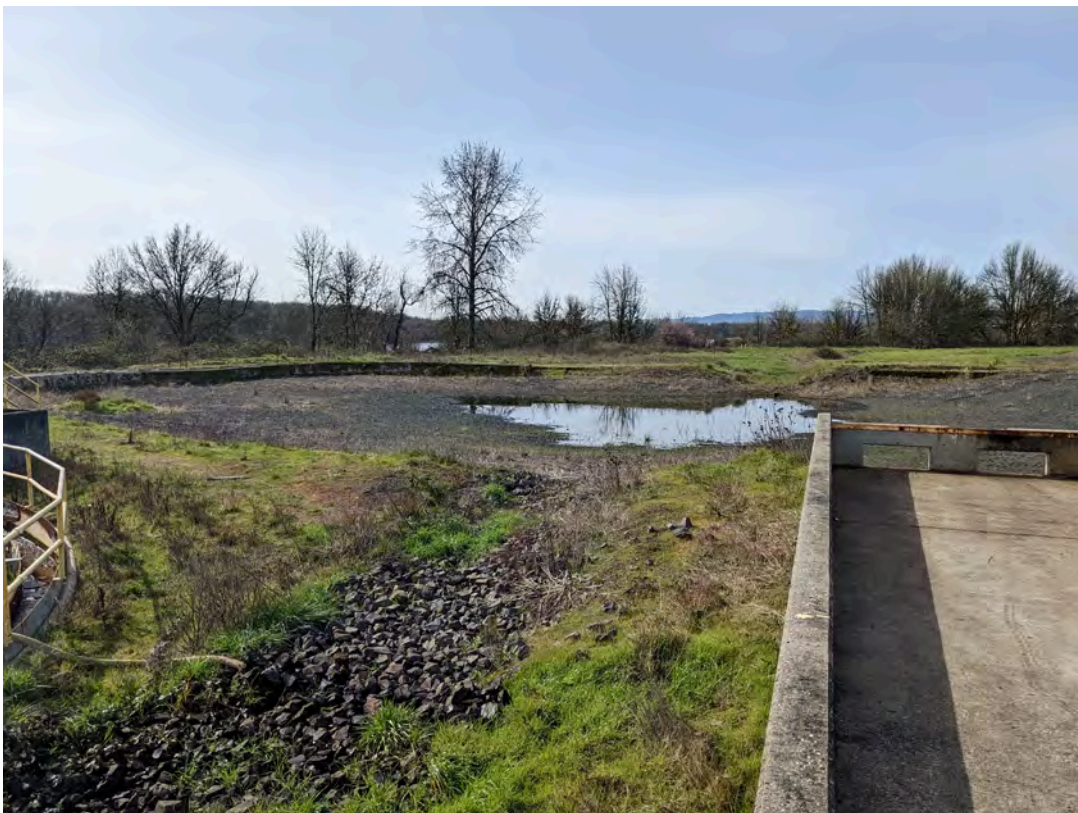
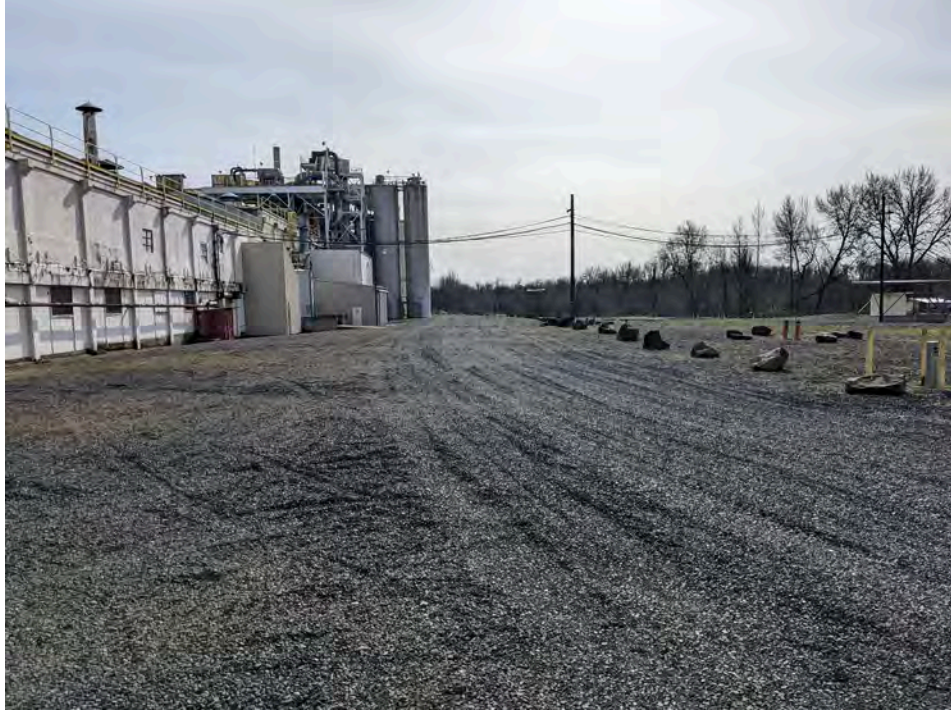
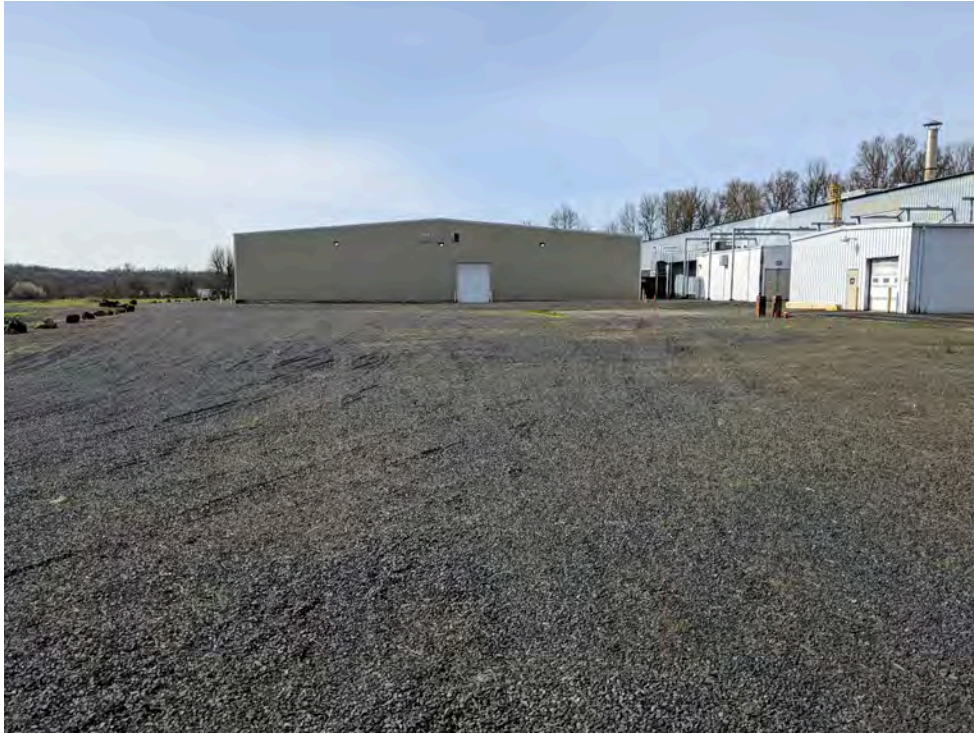
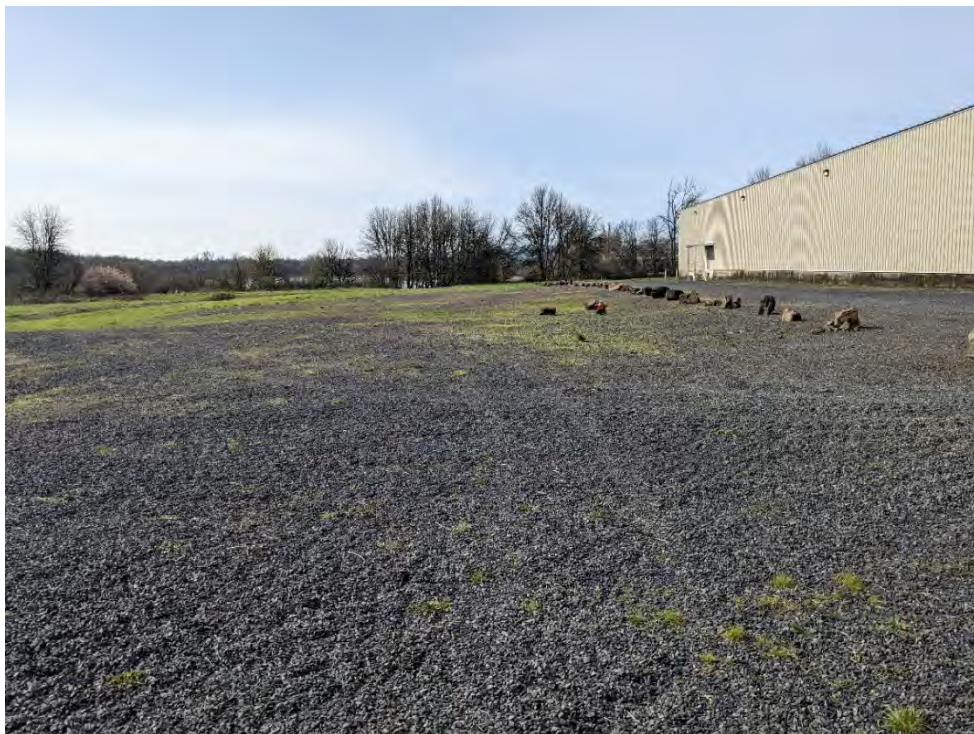
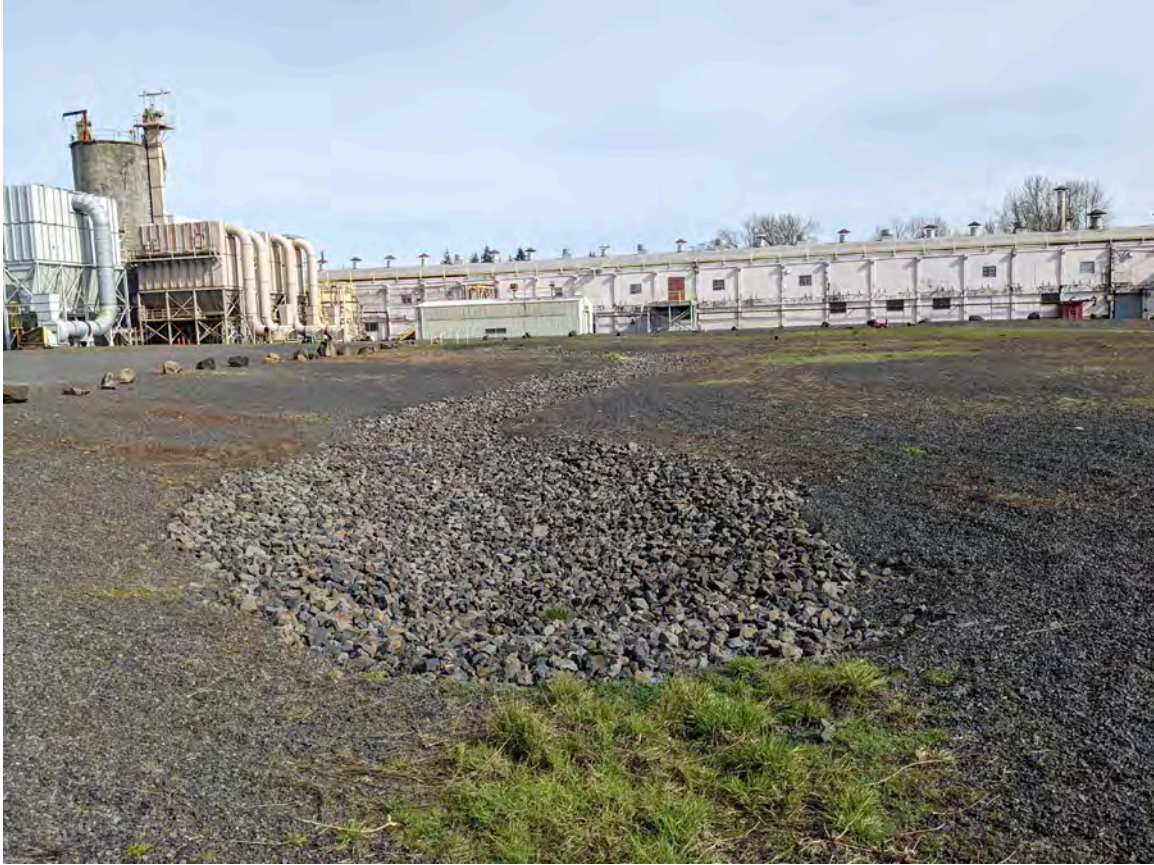
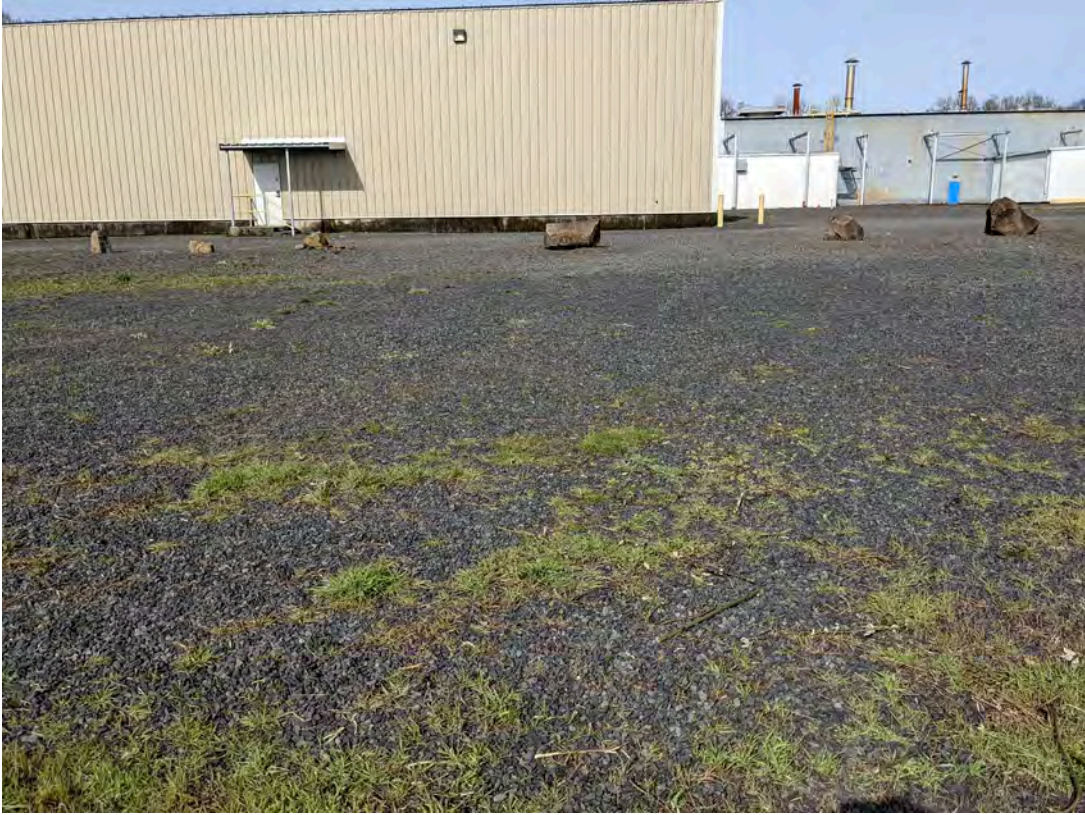
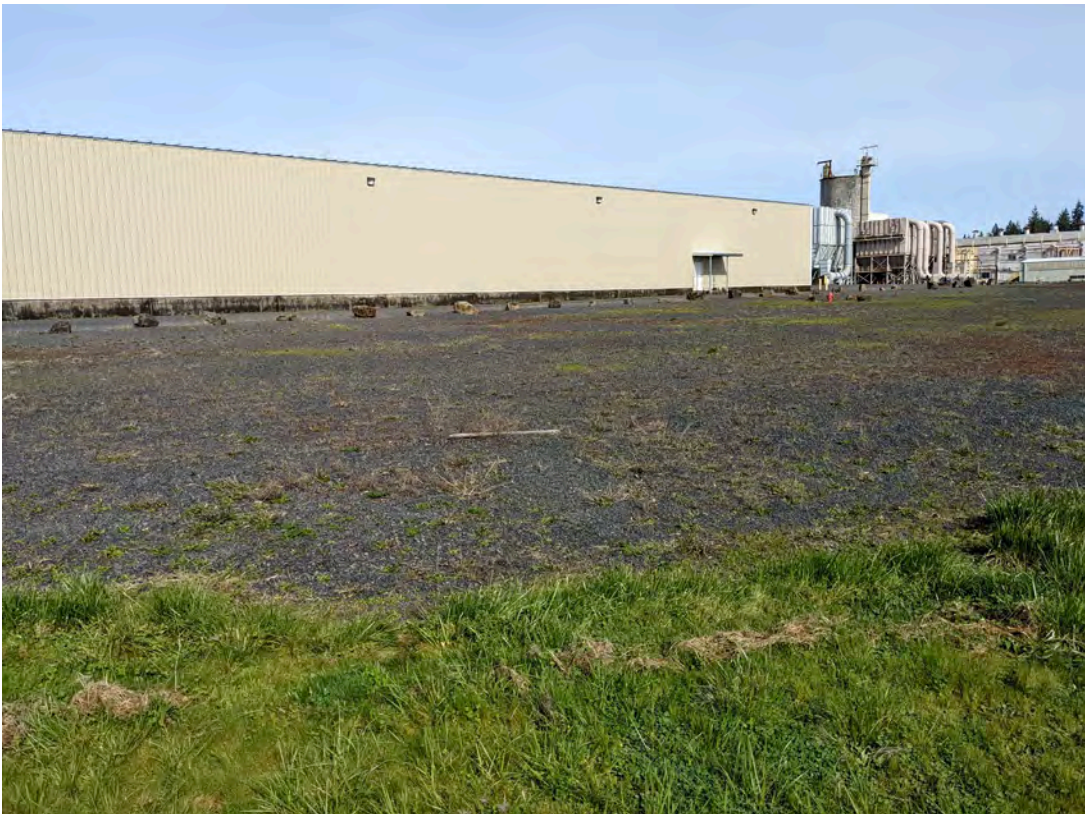
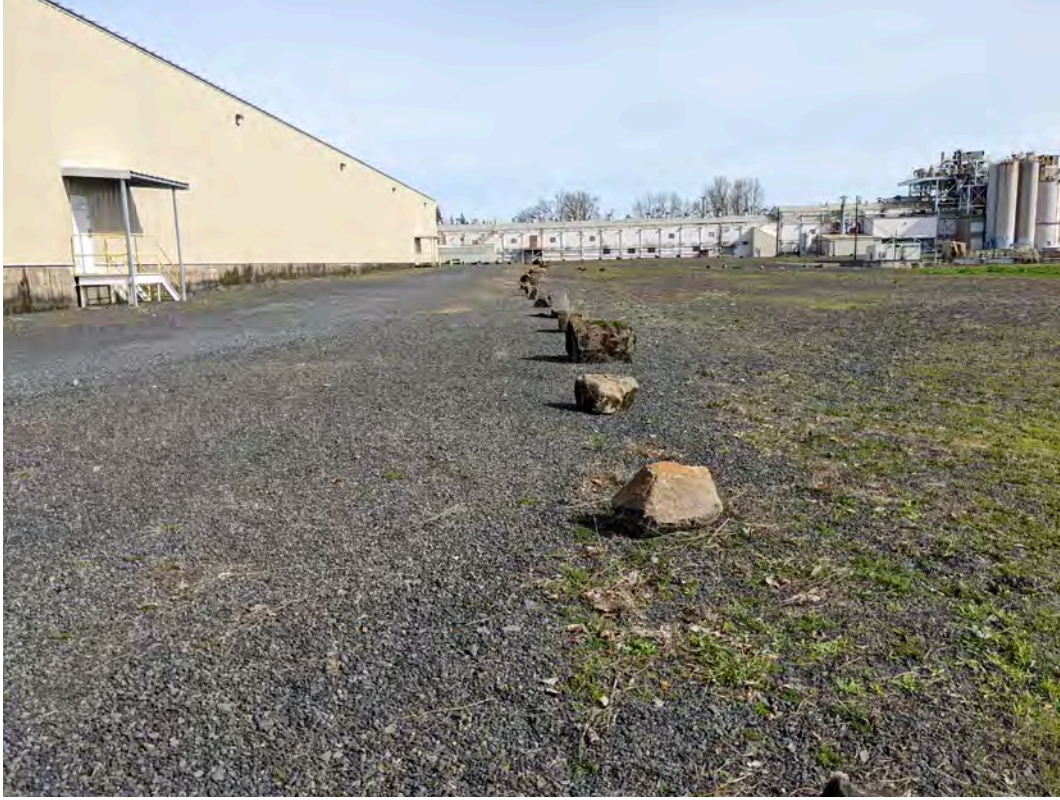
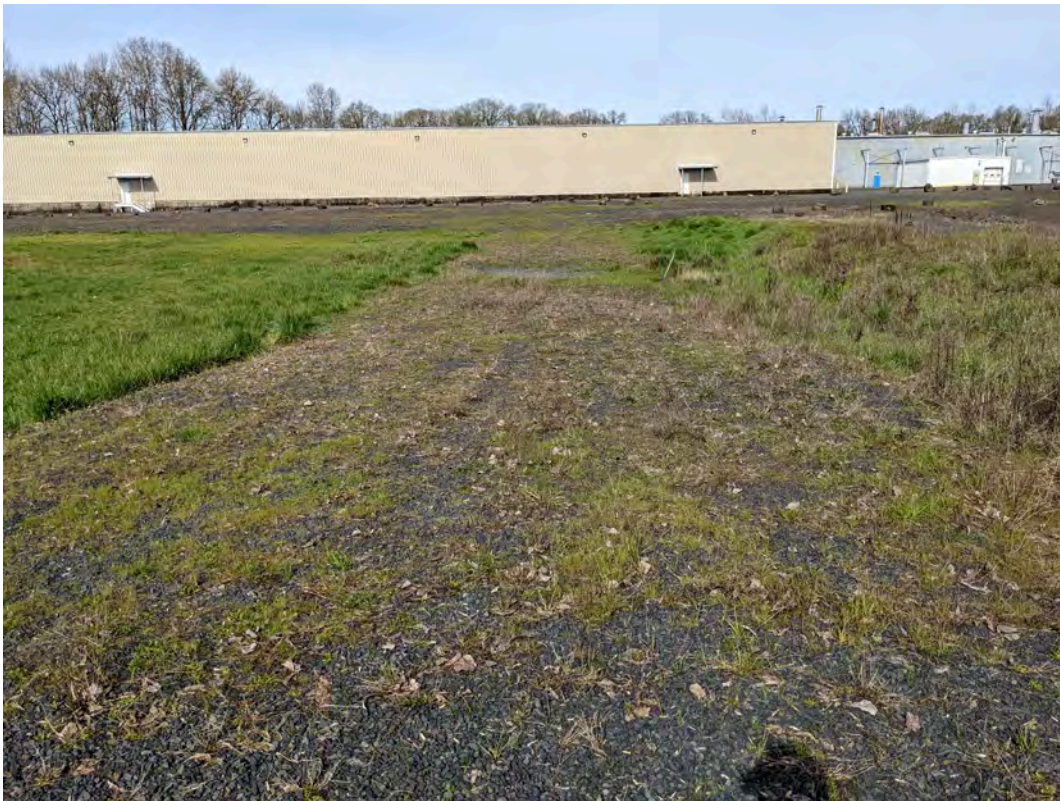
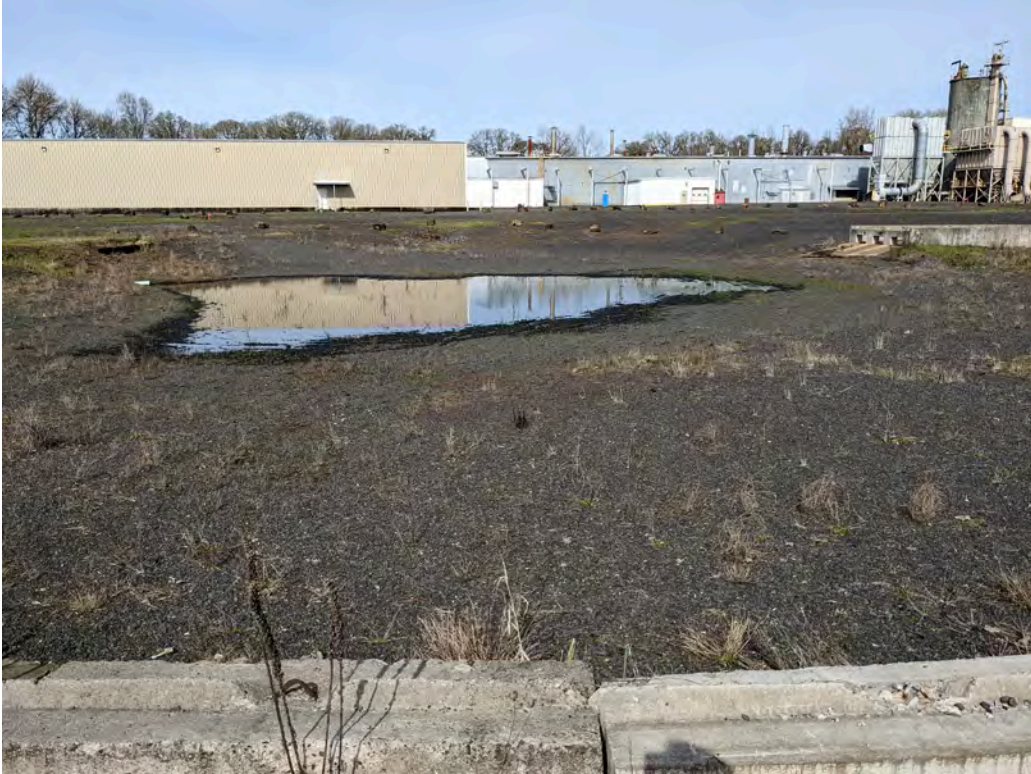
**Cap Inspection Area 2 – Soil and Gravel Cap**

Condition: Native and invasive grasses present in upper portions of cap.

AWI cleared larger deep rooting vegetation.

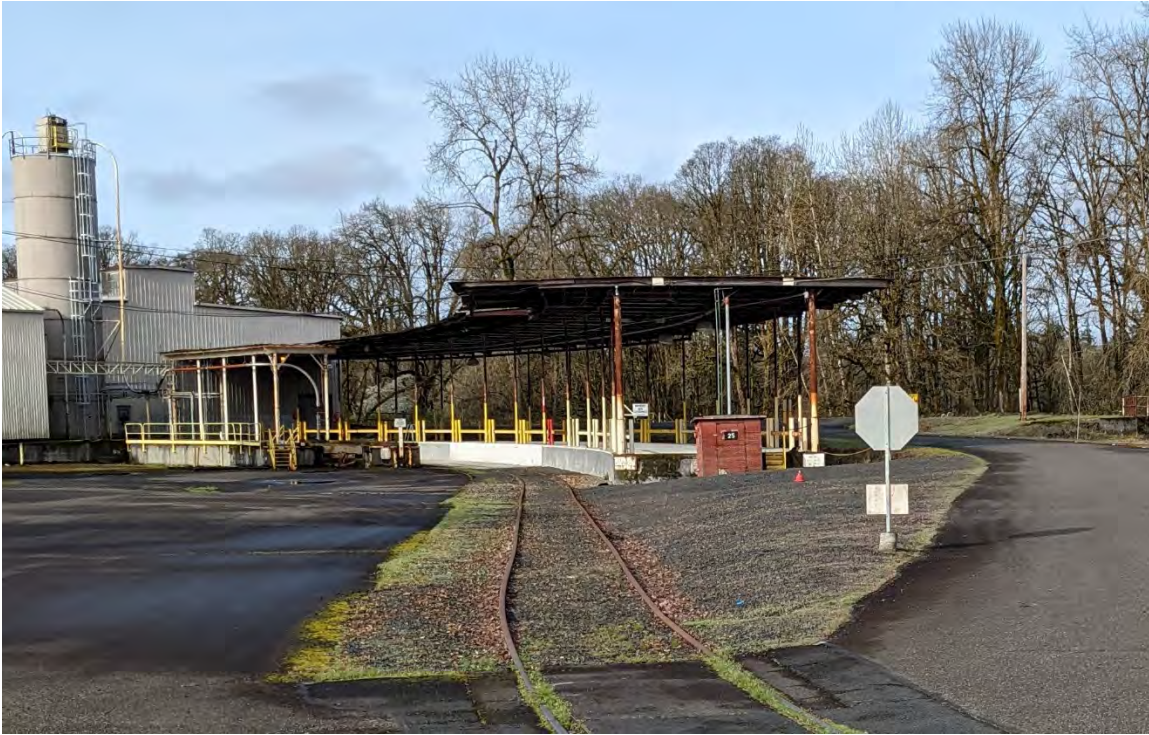
**Cap Inspection Area 3 – Soil and Gravel Cap**

Condition: Good, some g-r-sses.  
\_\_\_\_\_  
\_\_\_\_\_
