ST HELENS FIBERBOARD FACILITY UPLAND REMEDY

Fourth Quarter 2022 Progress Report

UPLAND CAP INSPECTION FORM

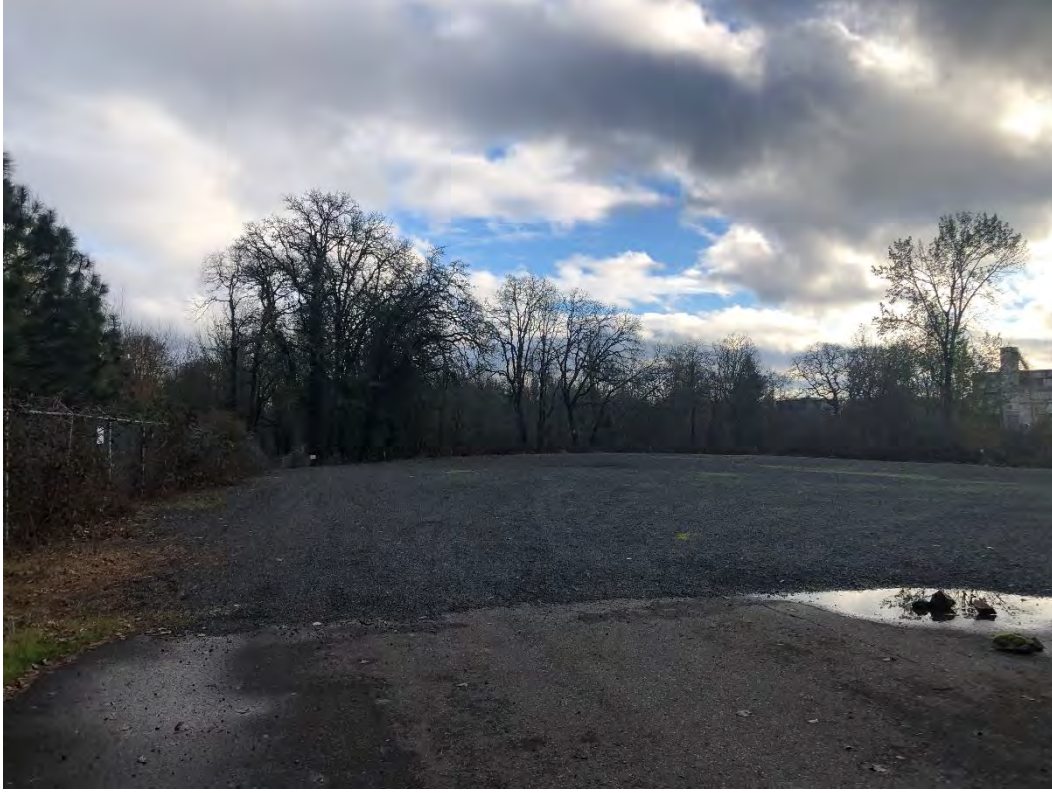
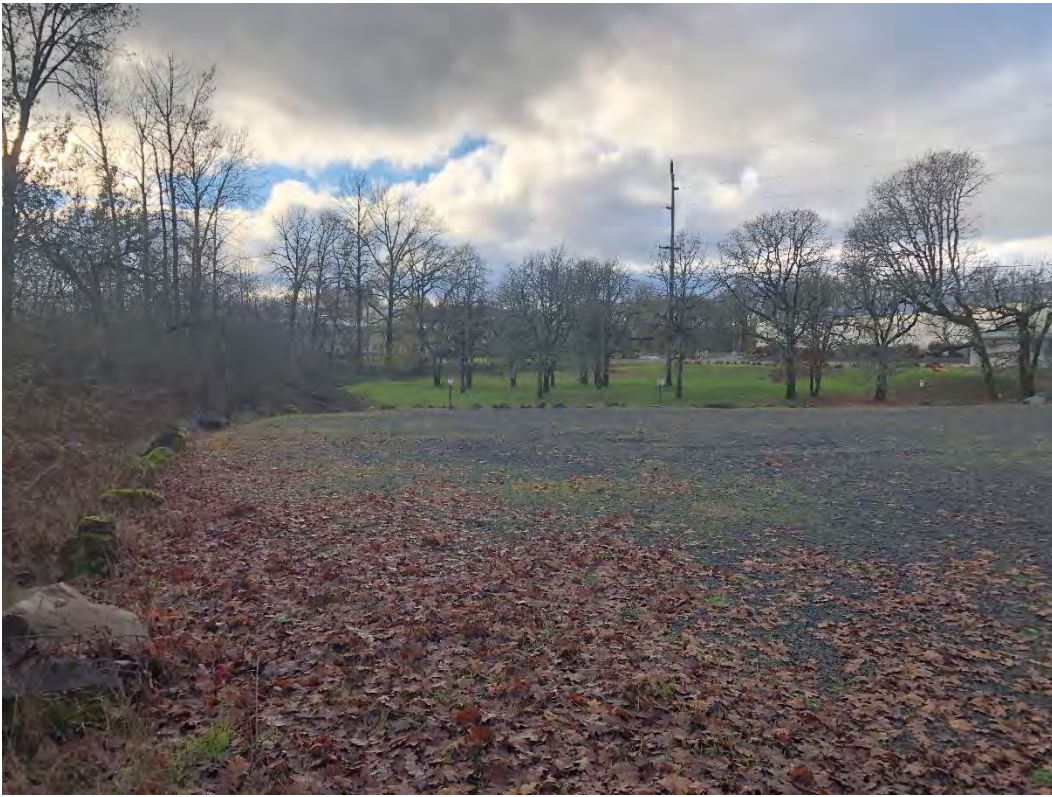
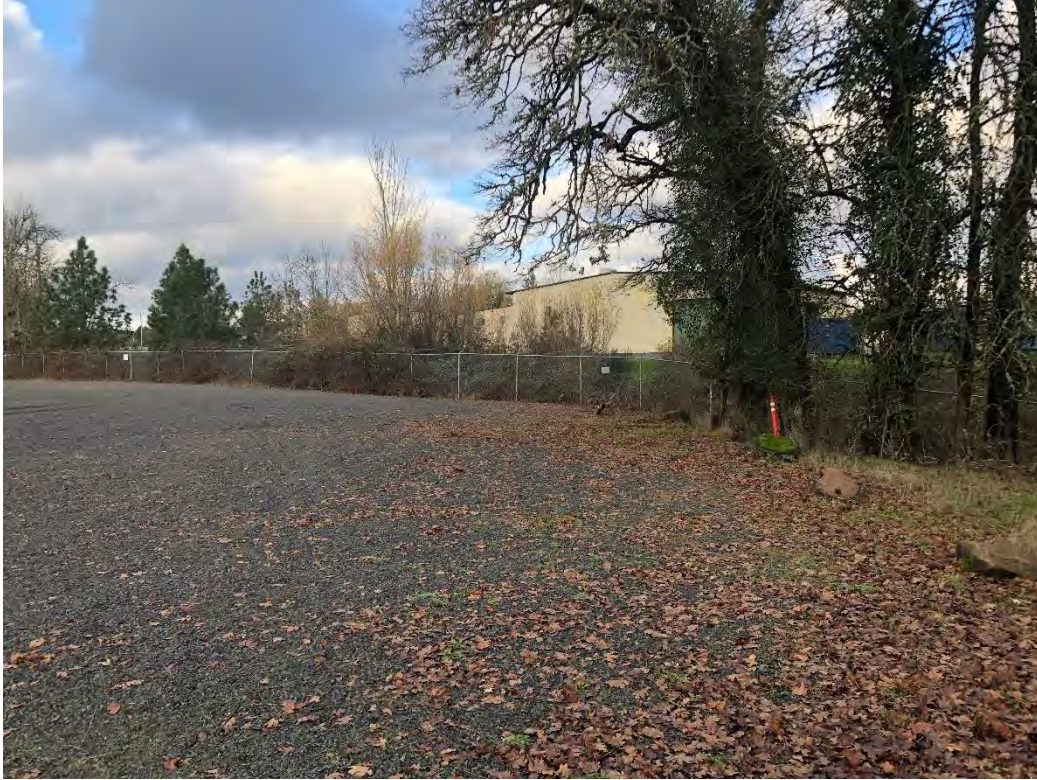
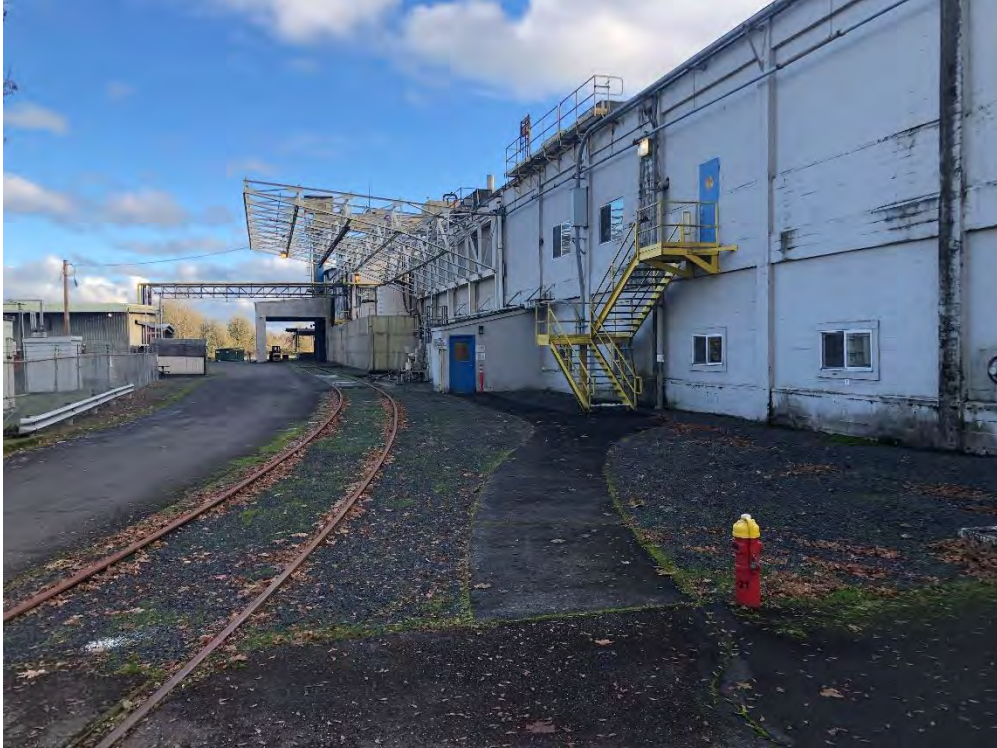
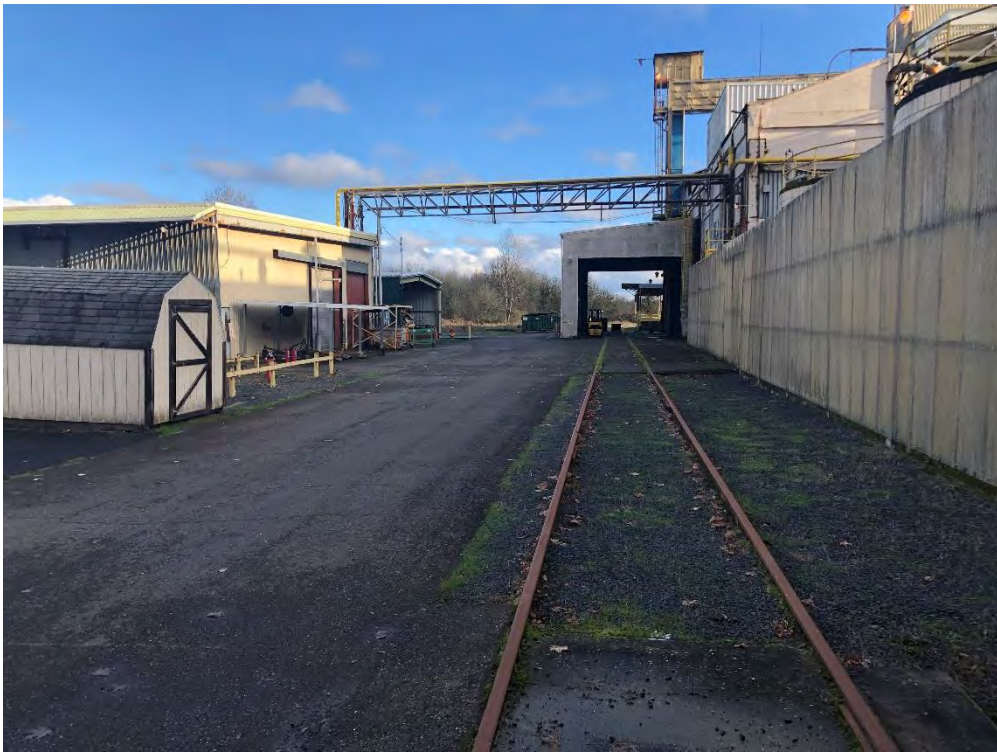
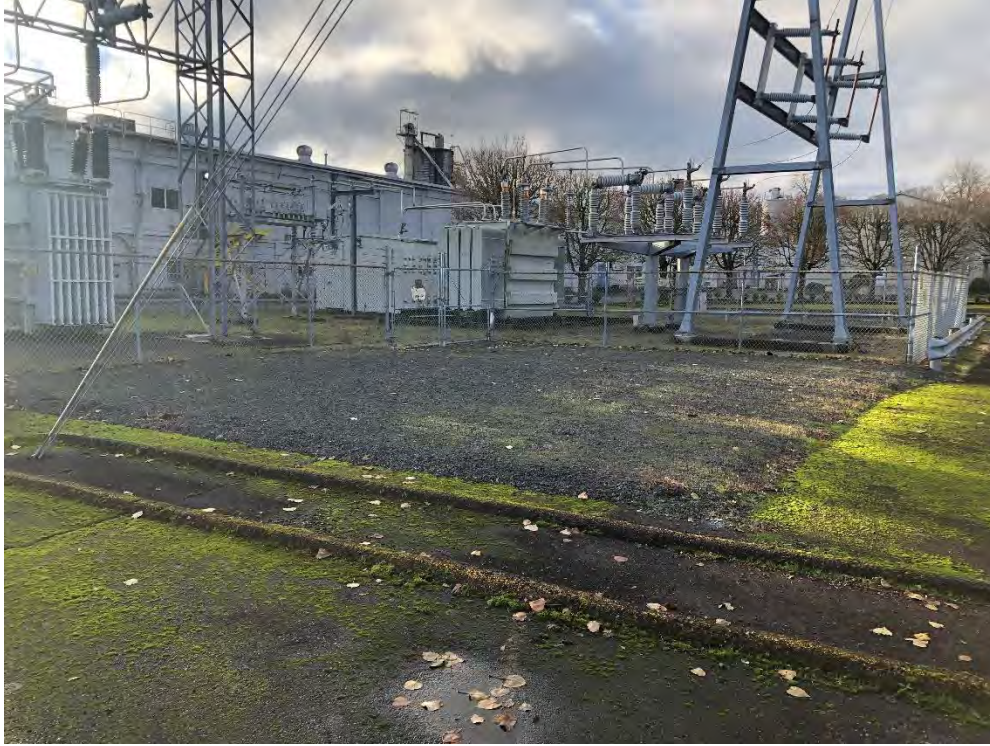
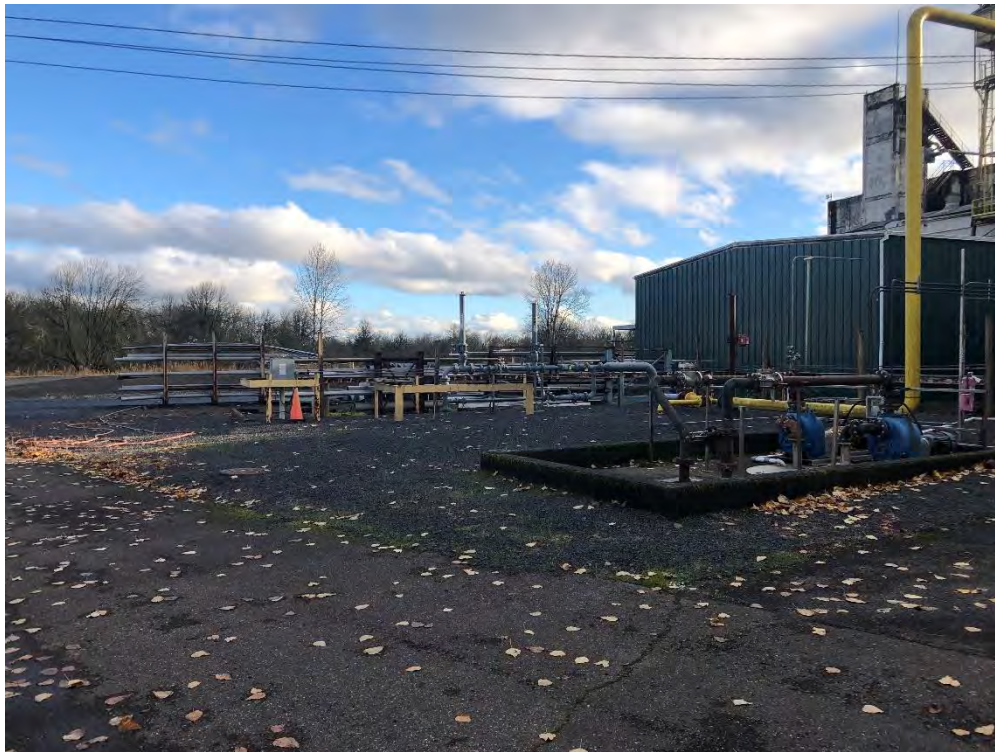
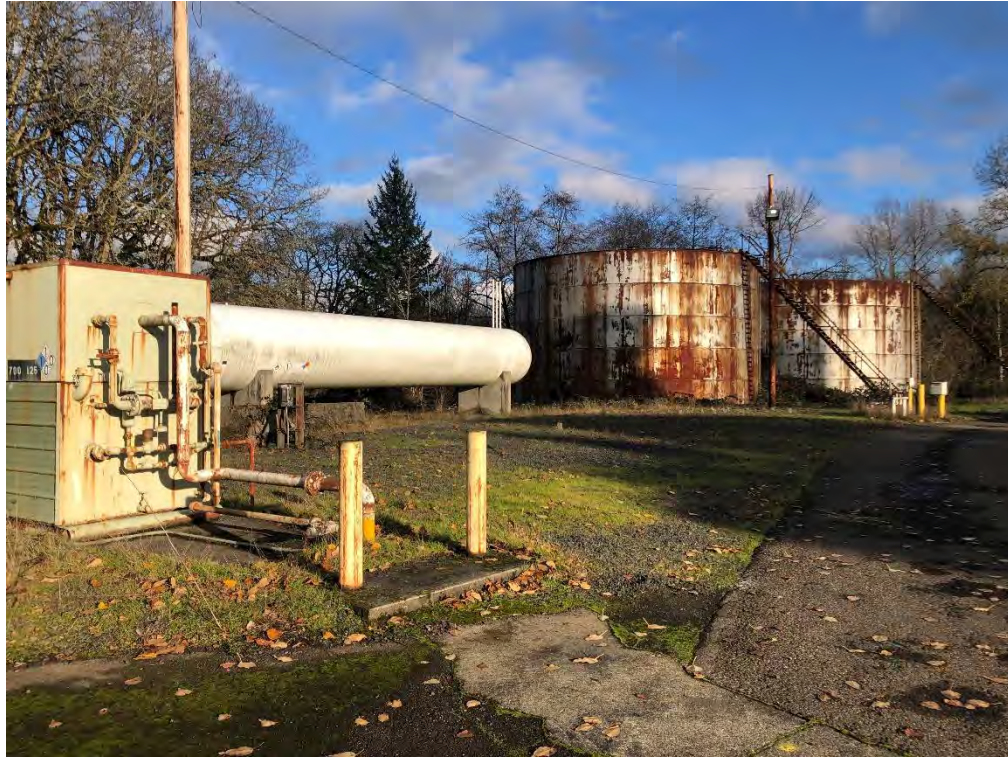
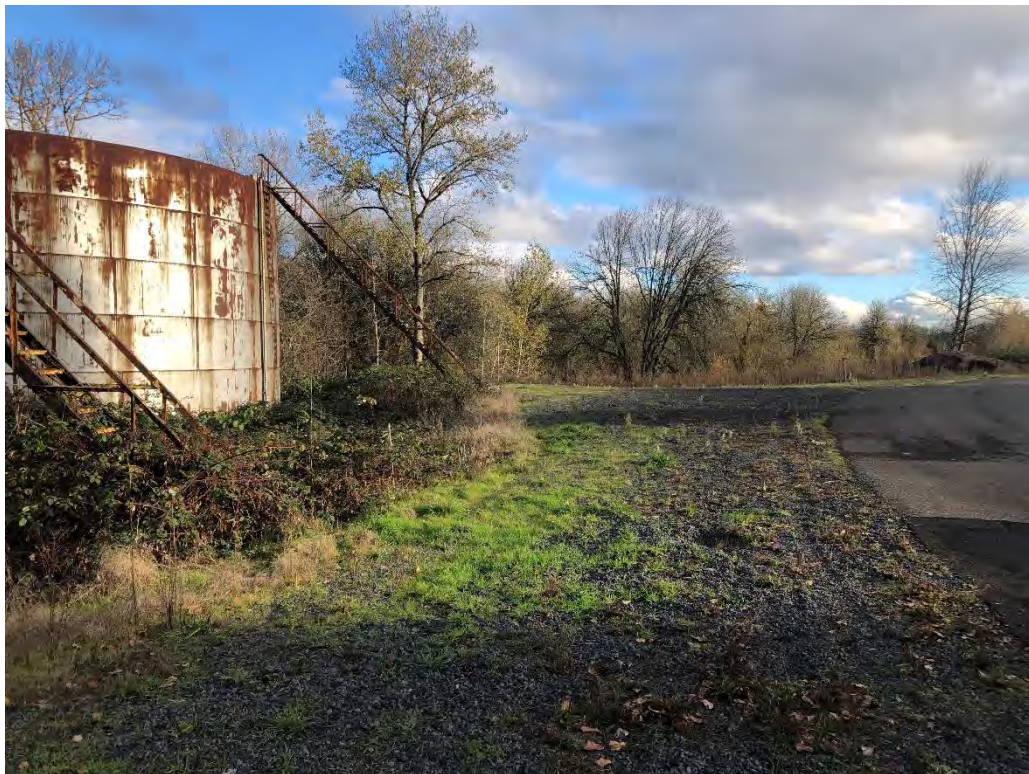
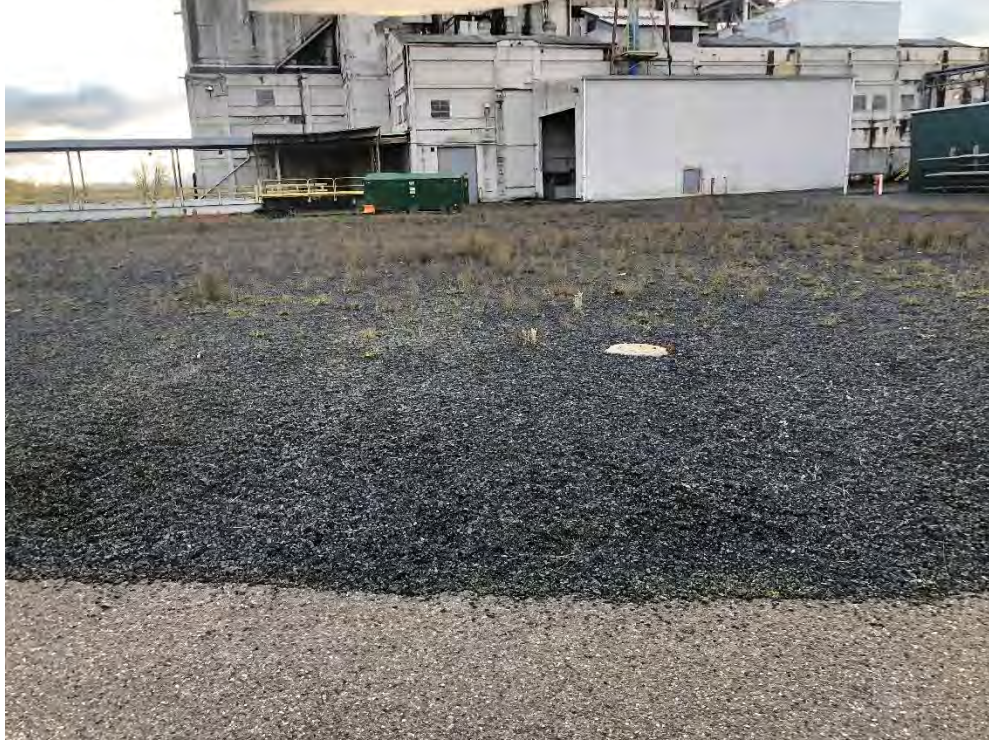
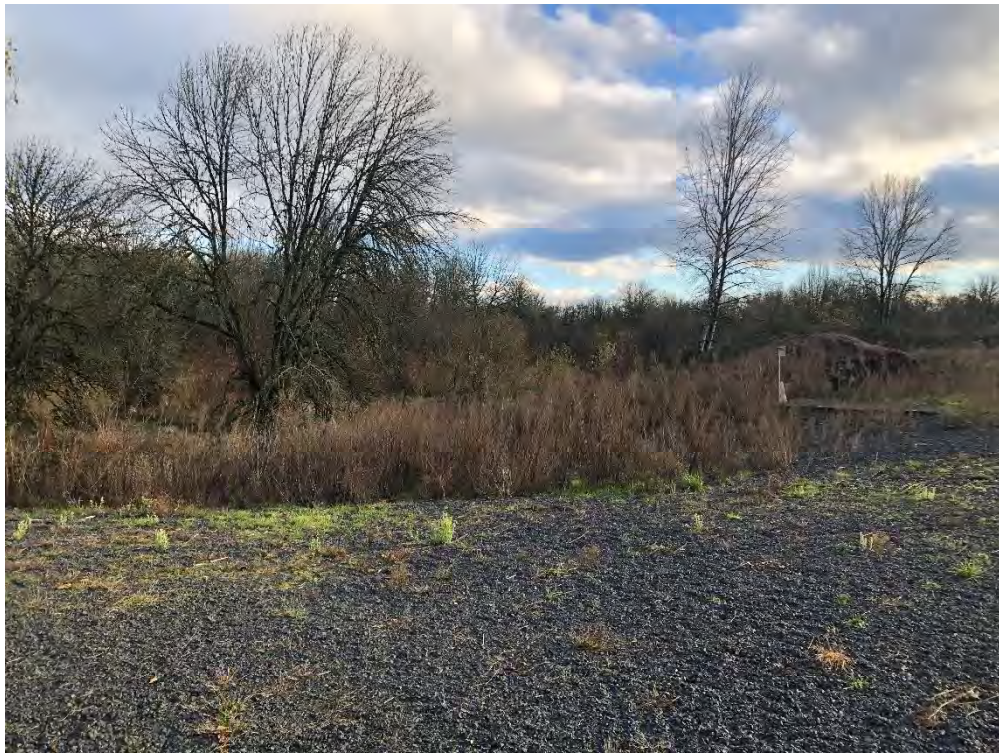
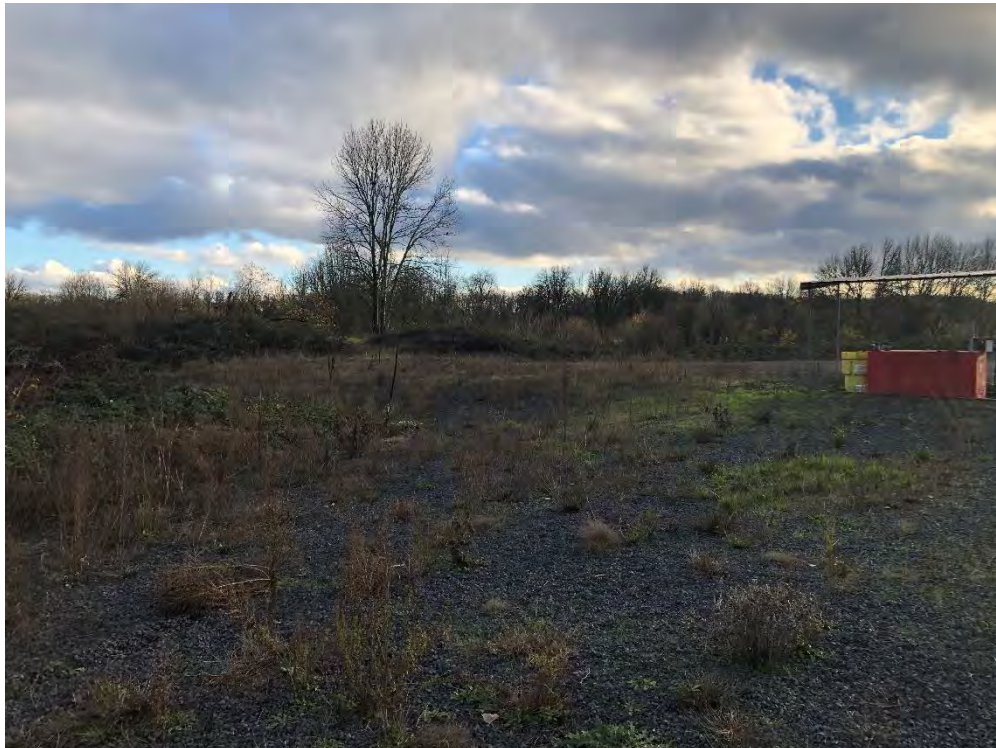
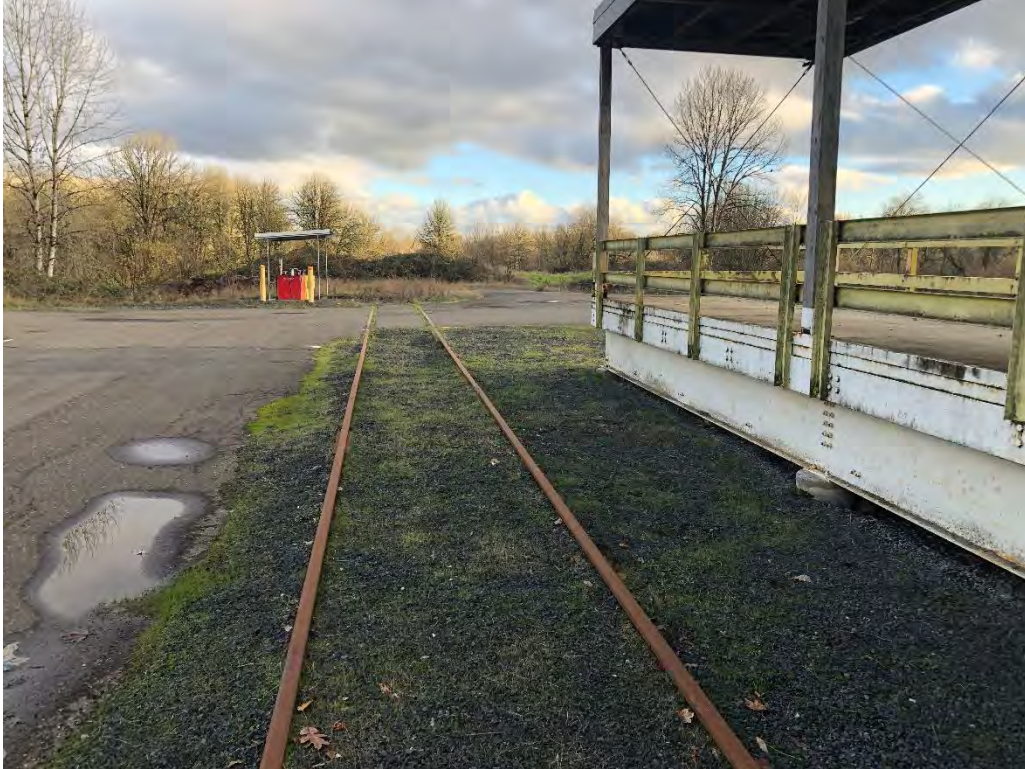
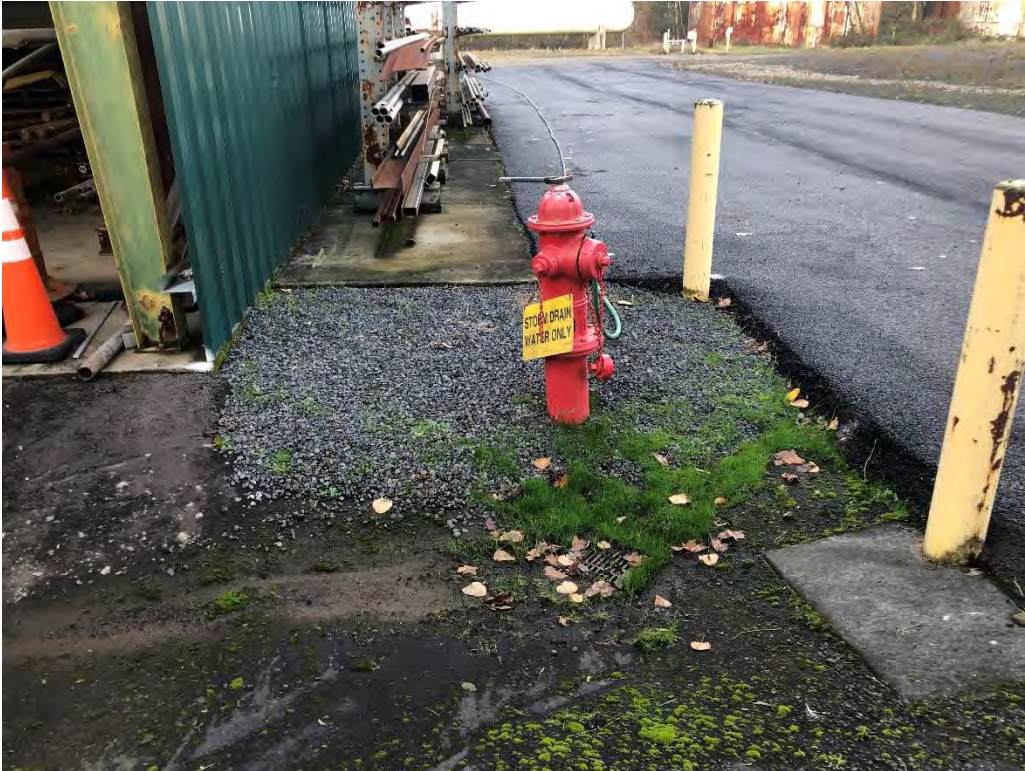
Cap Inspection Area 1 – Soil and Gravel Cap

Condition: The condition of the gravel cap remains good in all portions of cap inspection area 1, but invasive weeds have established in some areas of the cap, particularly along the Upland/Lowland Boundary.

AWI should take more action in the next quarter to control weed growth on the gravel.

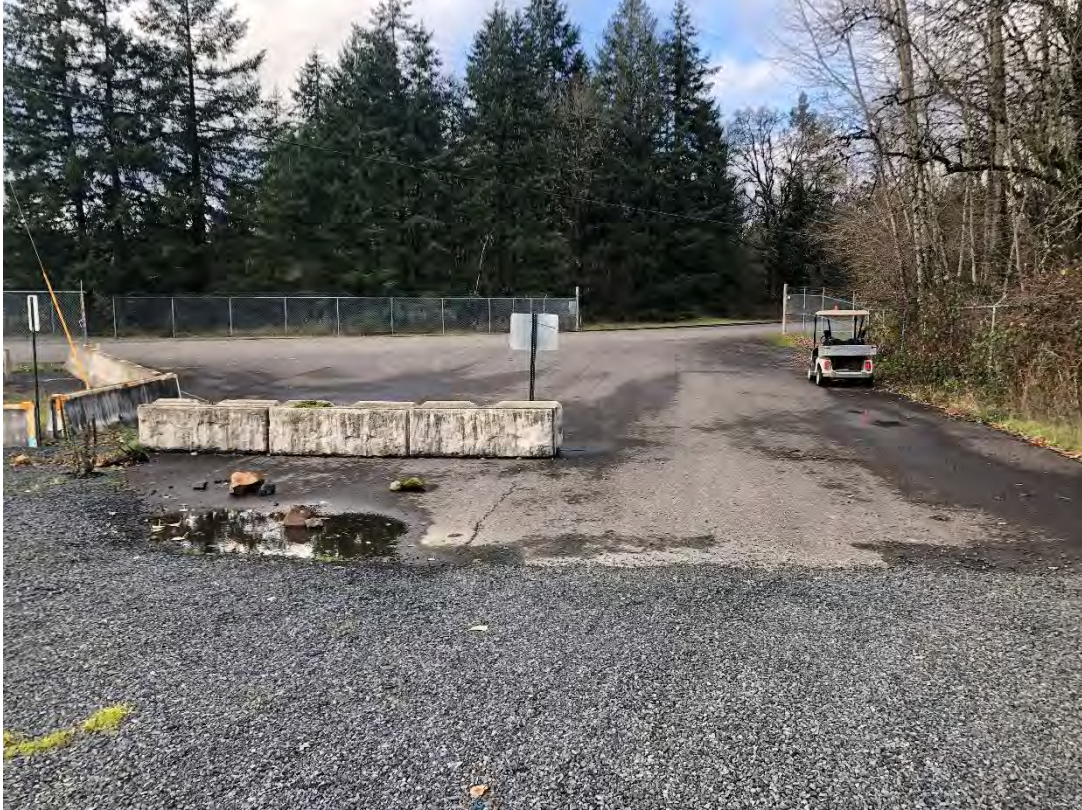
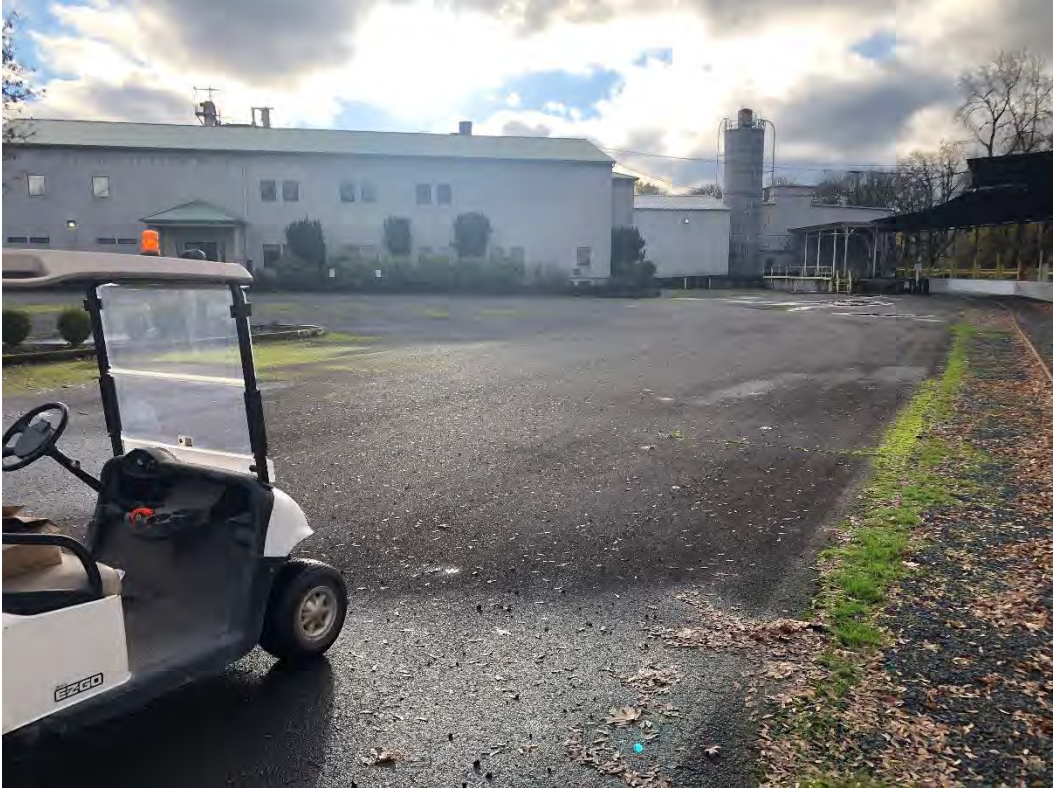
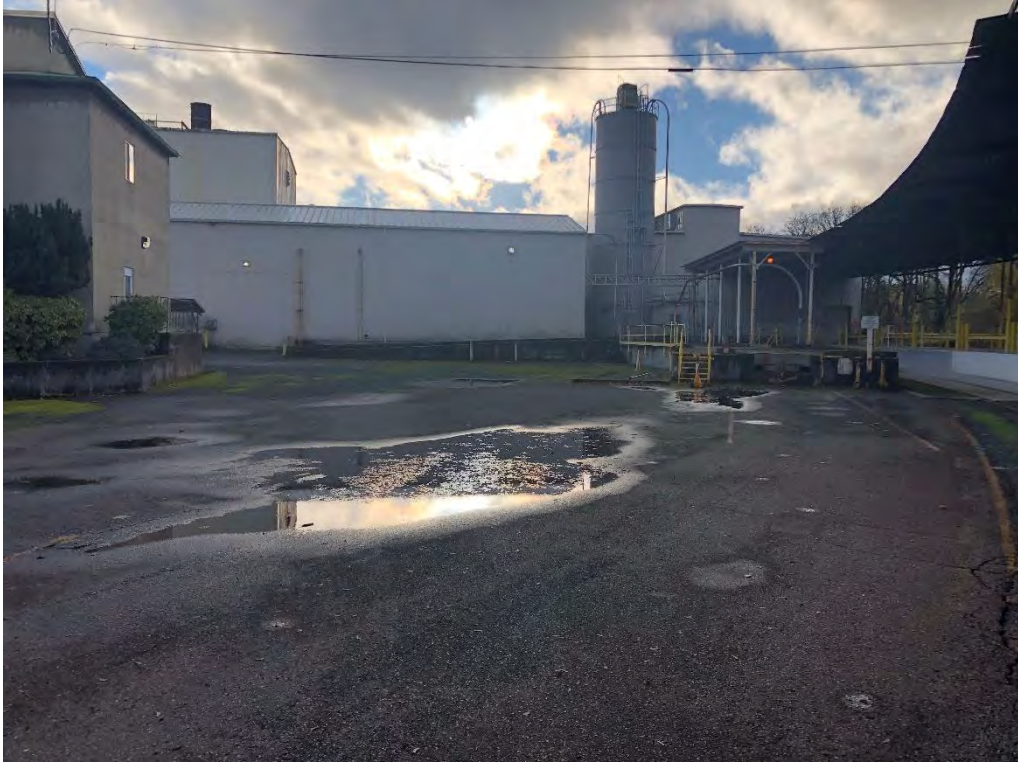
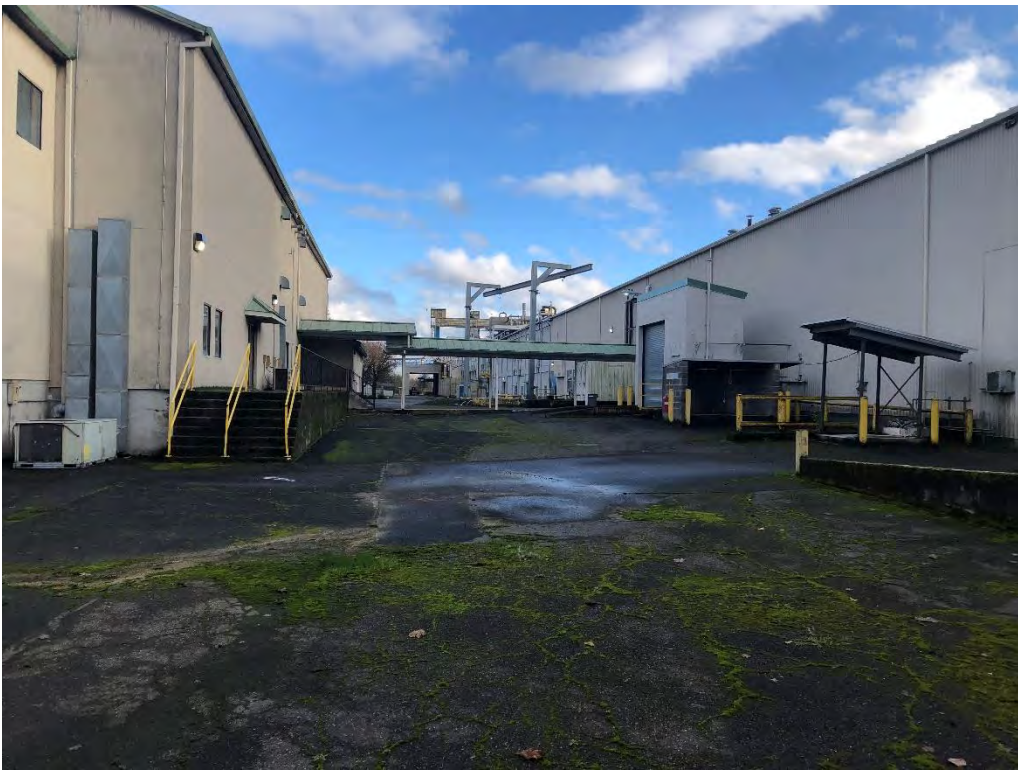
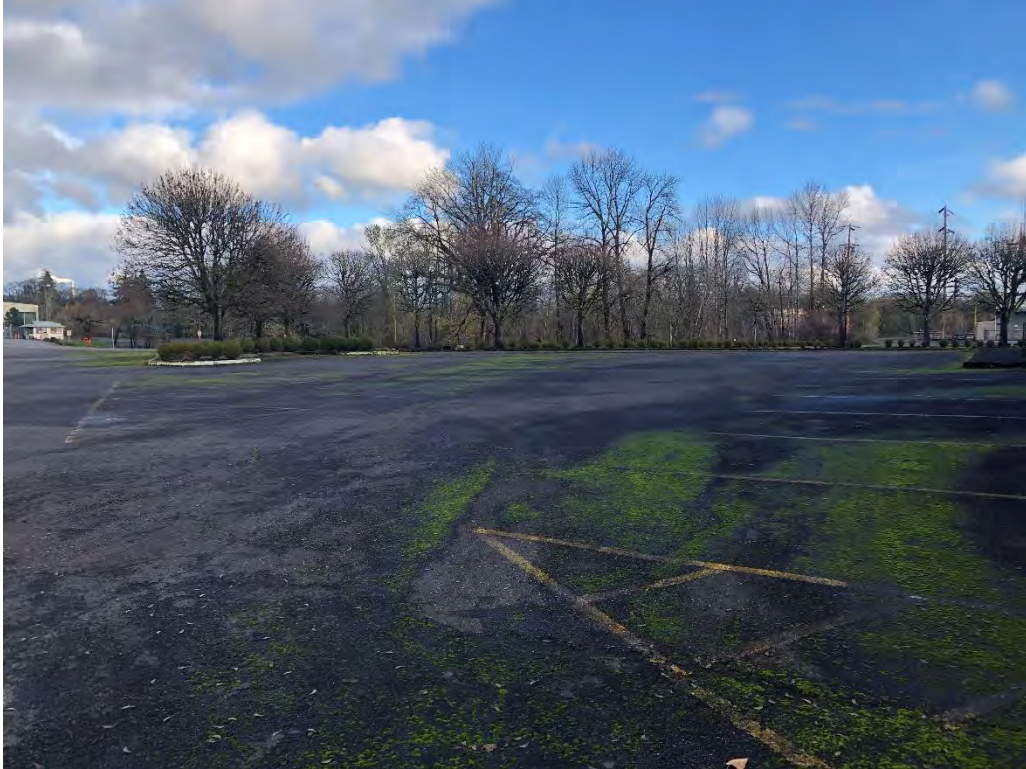
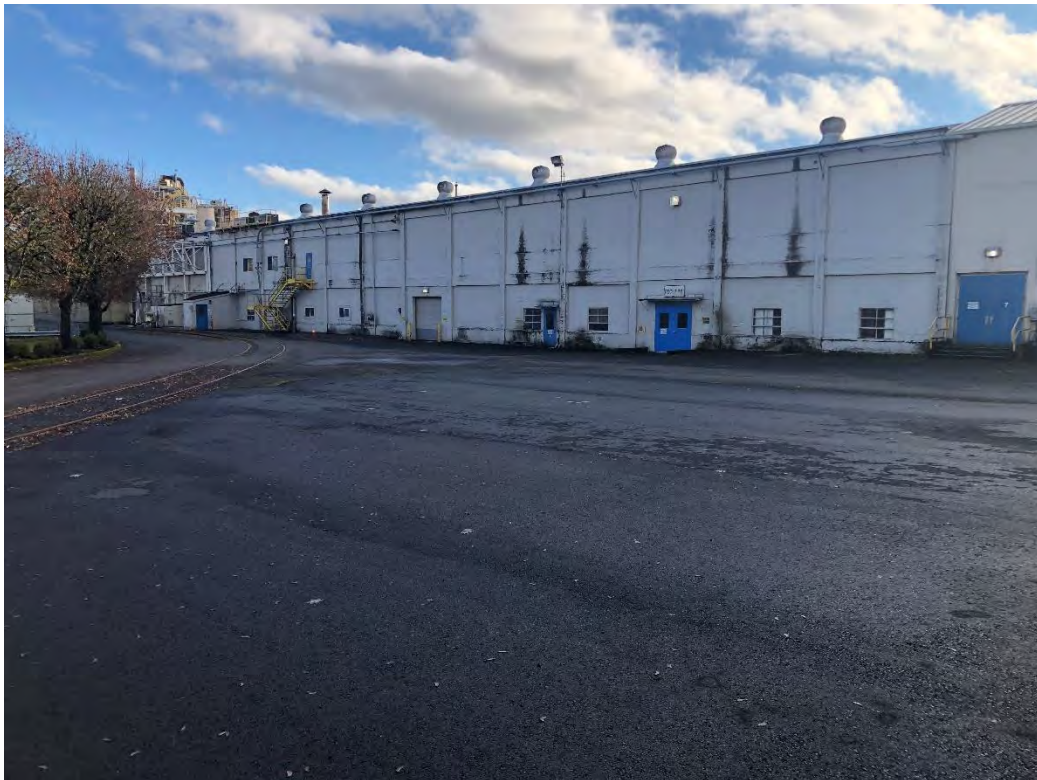
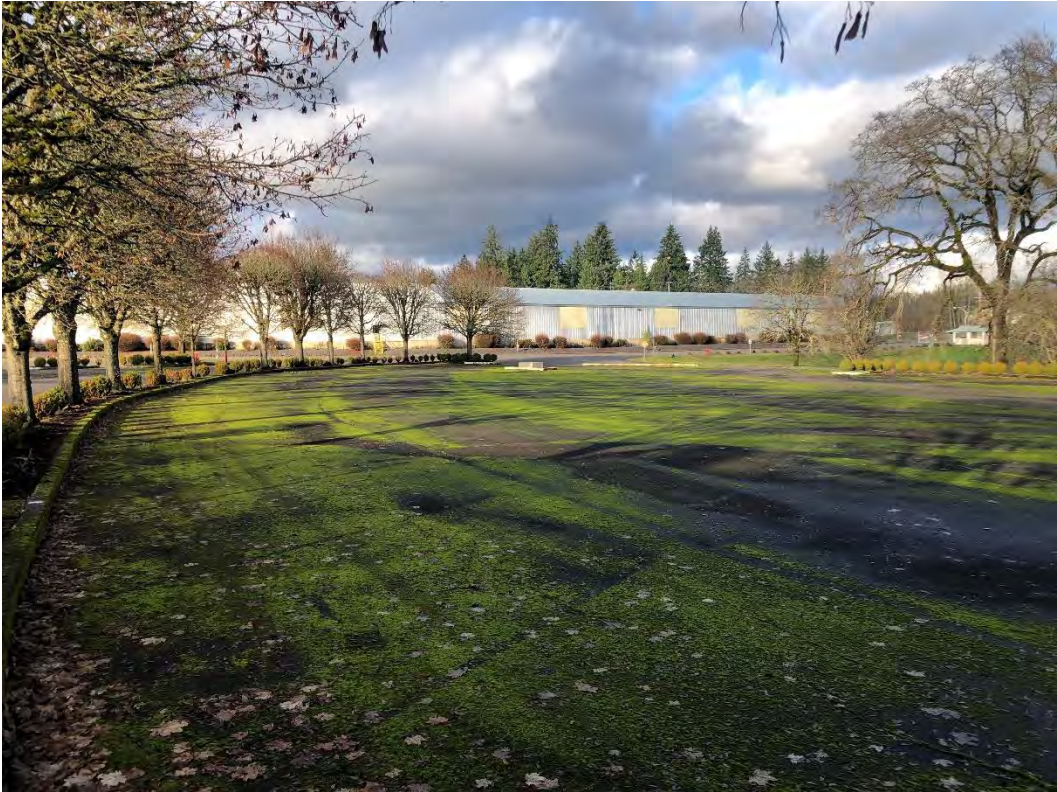
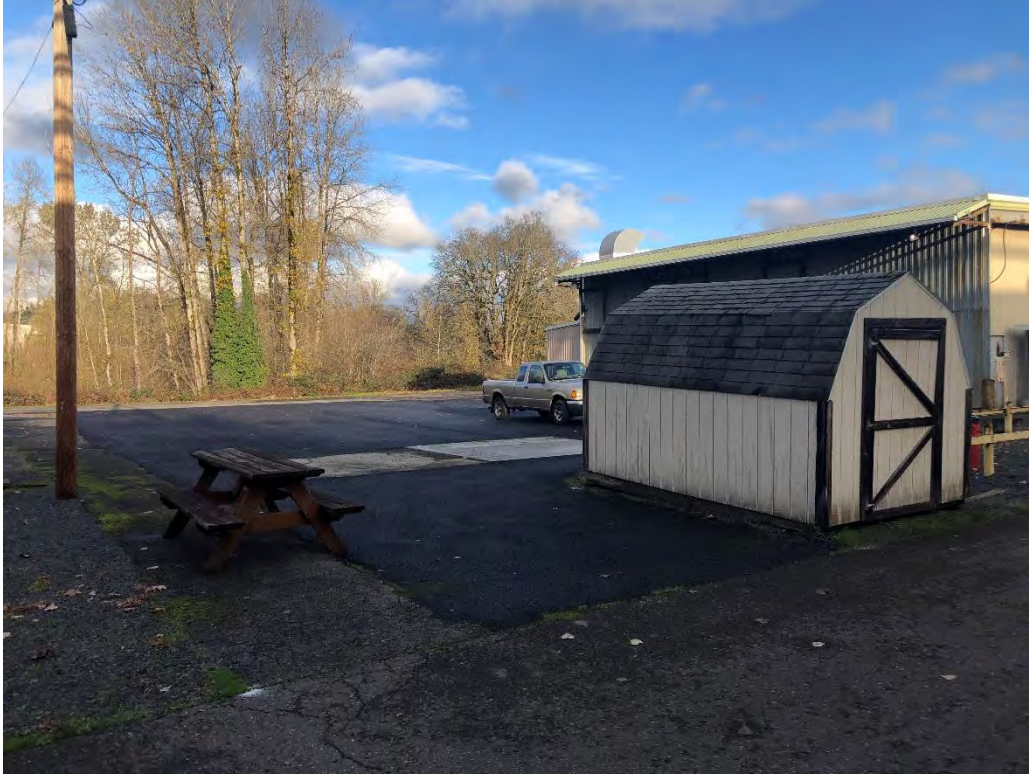
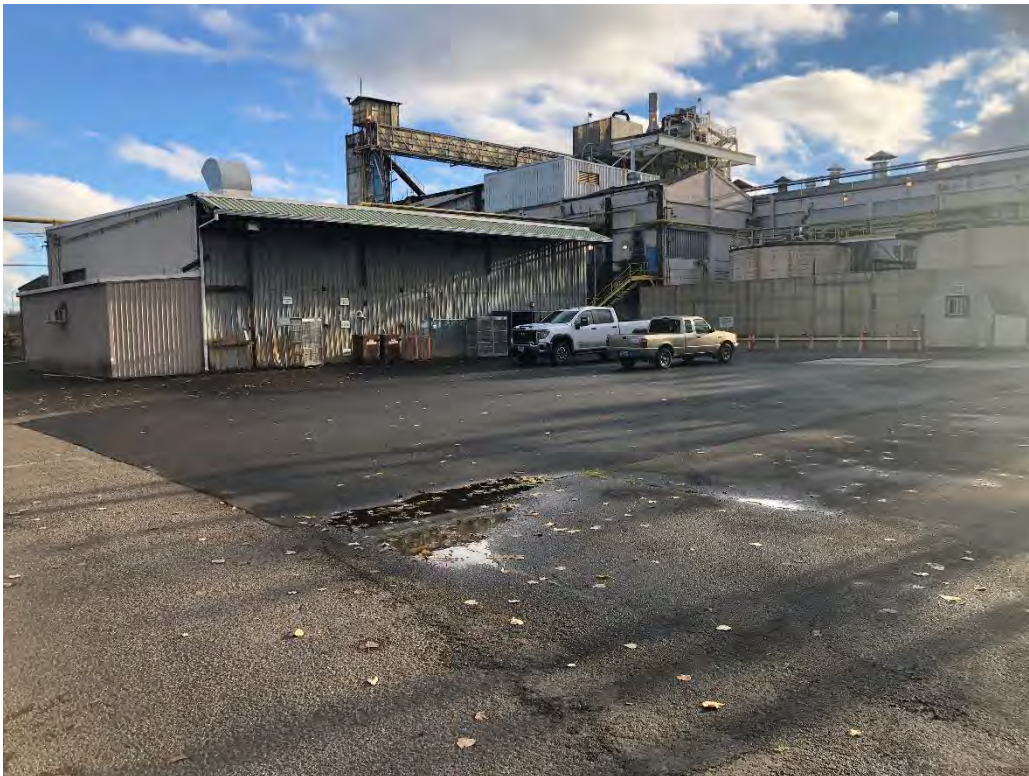
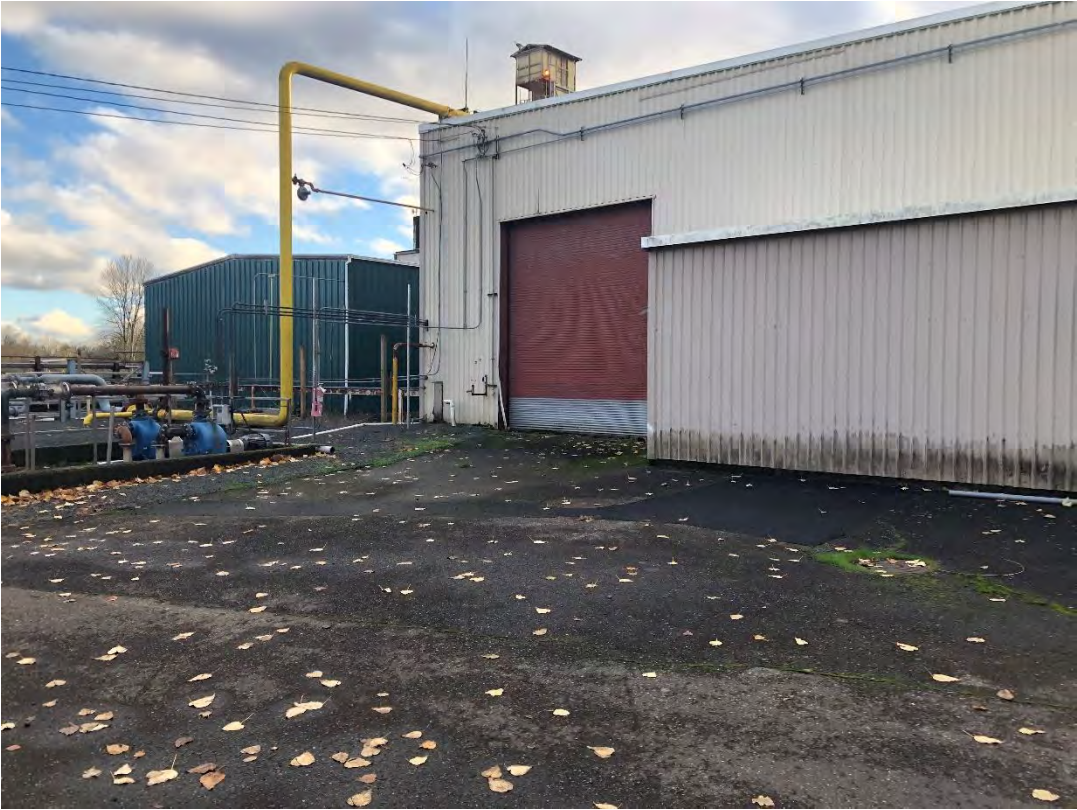
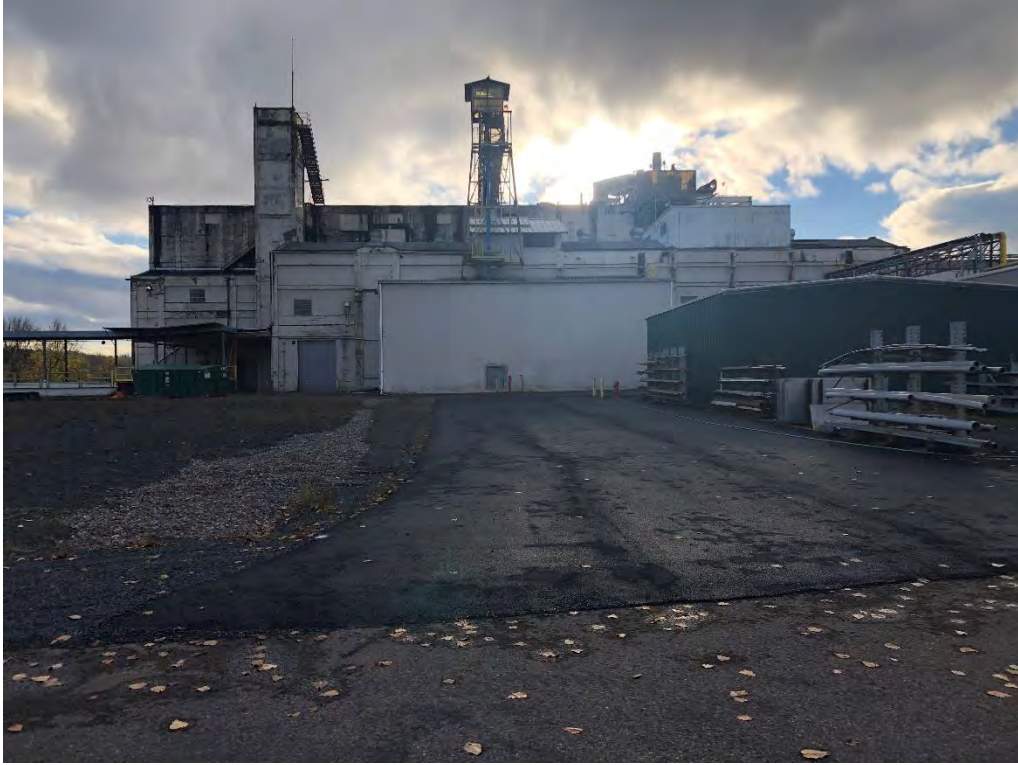
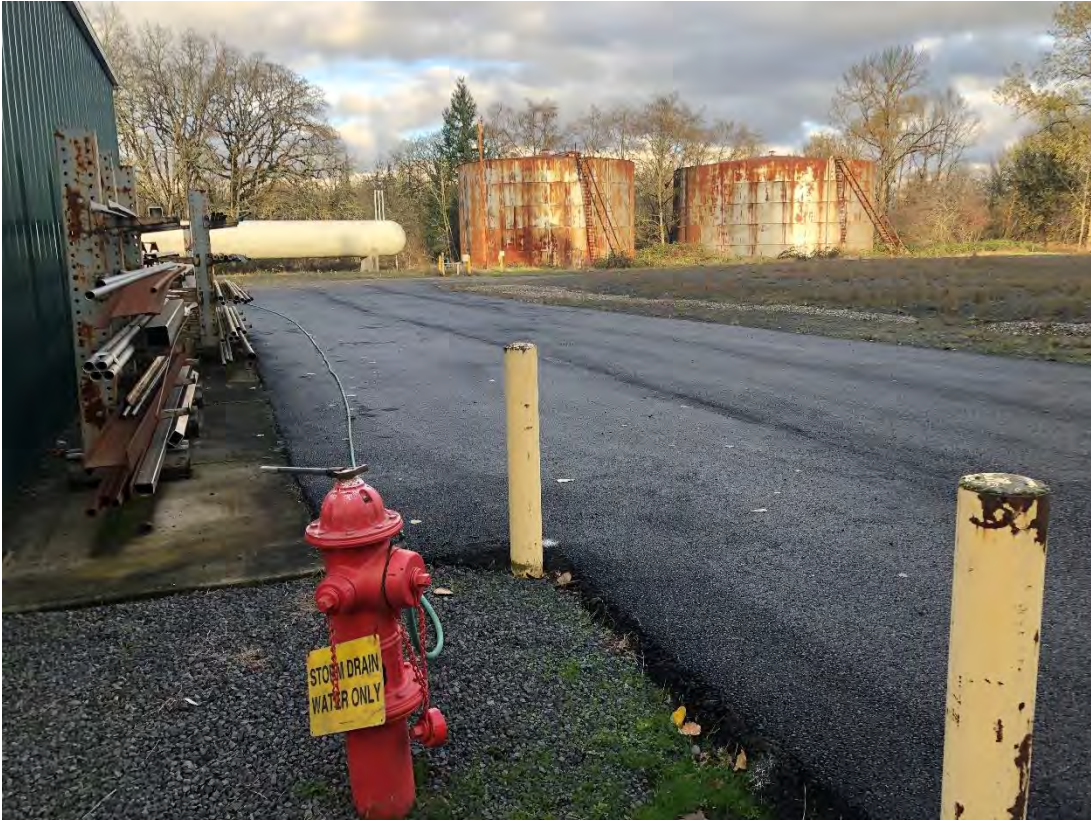
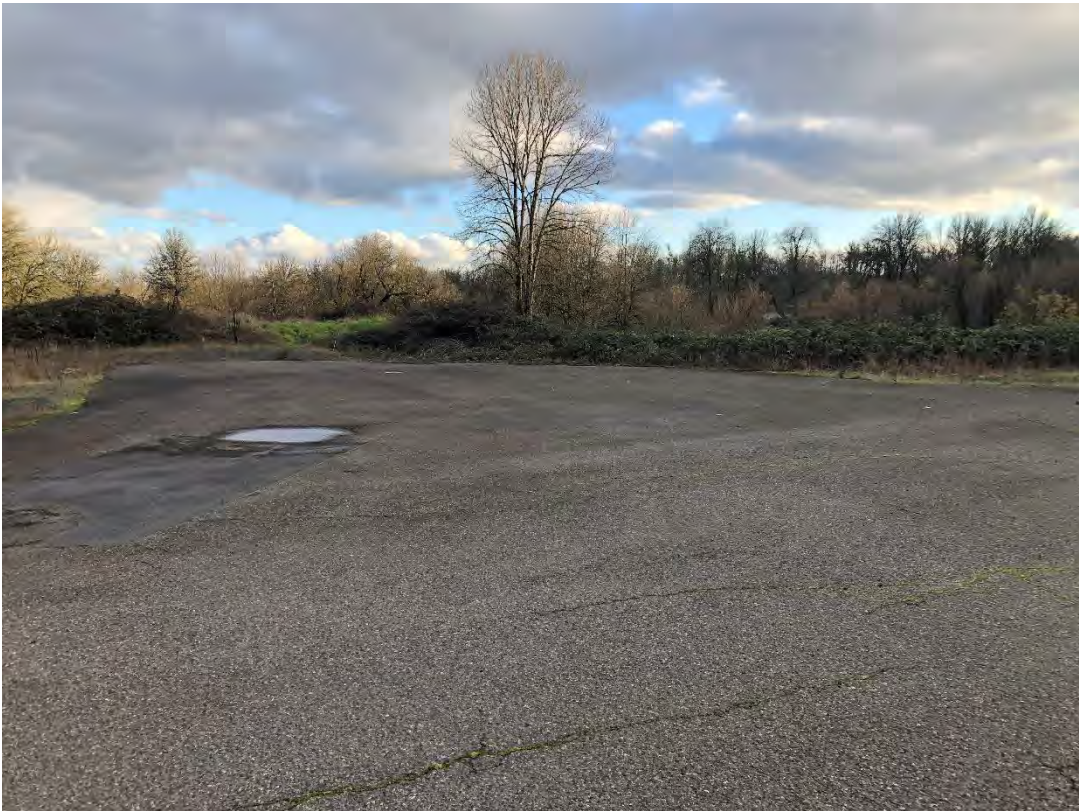
Cap Inspection Area 1 – Asphalt and Concrete Pavement

None taken. Cracks in existing pavement continue to be monitored. Cracks do not appear to have changed since monitoring began in 2019, and do not yet warrant repair.
