ST HELENS FIBERBOARD FACILITY UPLAND REMEDY

Fourth Quarter 2022 Progress Report

UPLAND CAP INSPECTION FORM

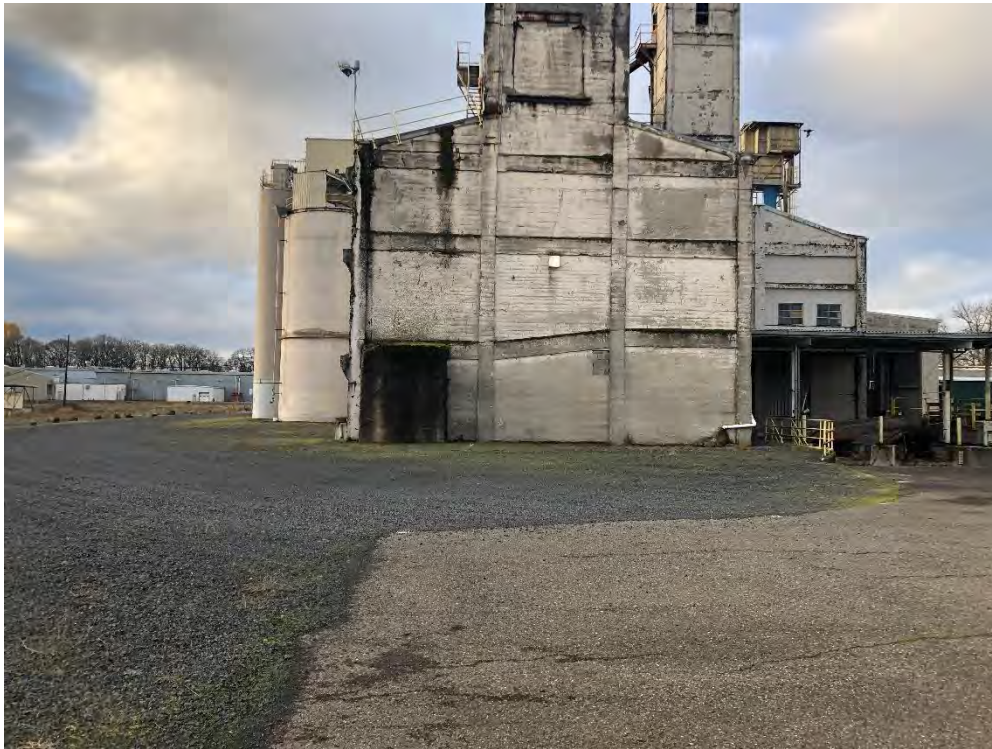
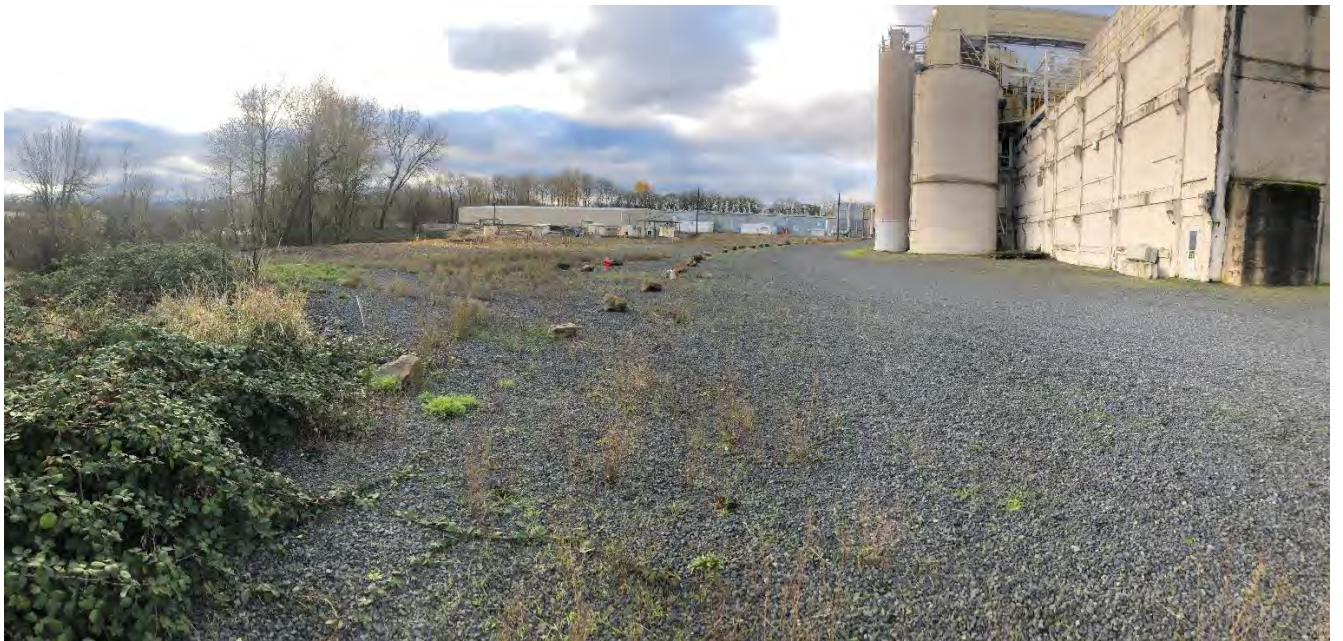
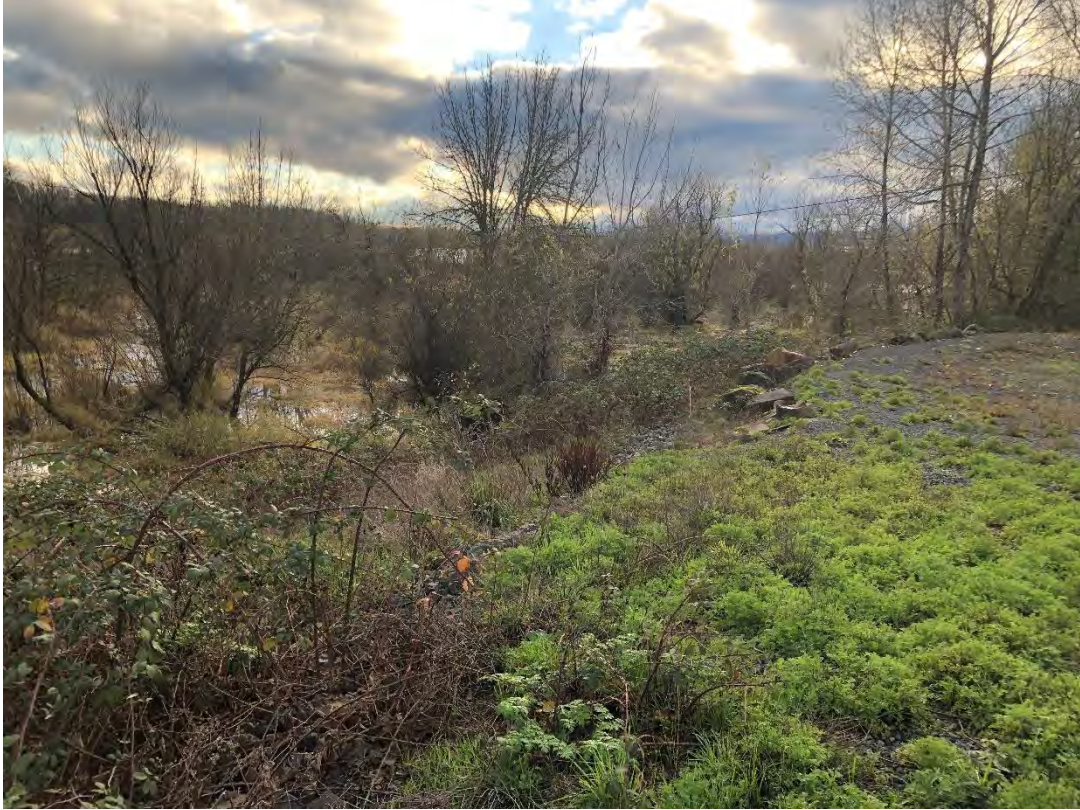
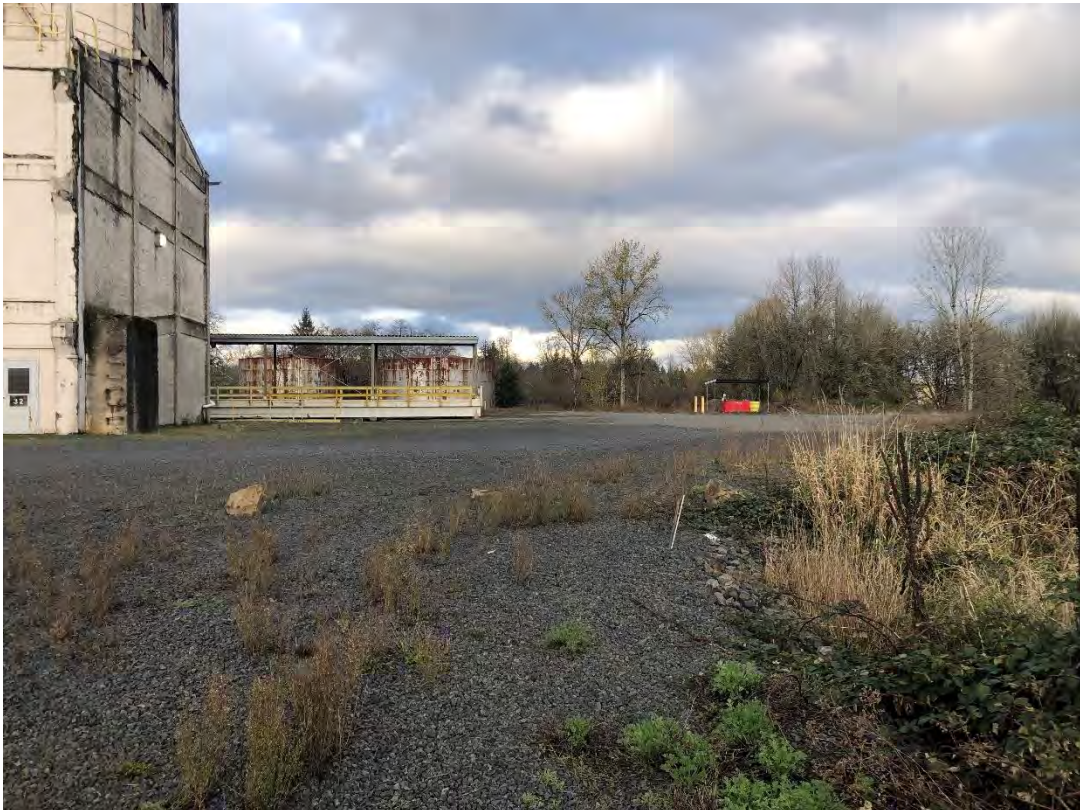
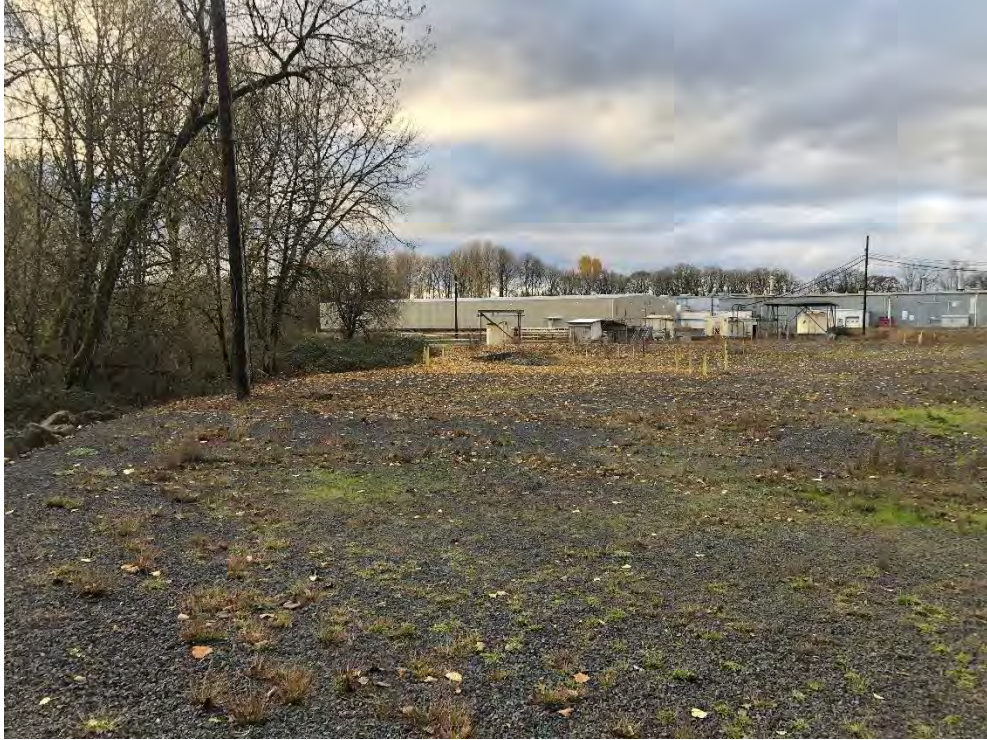
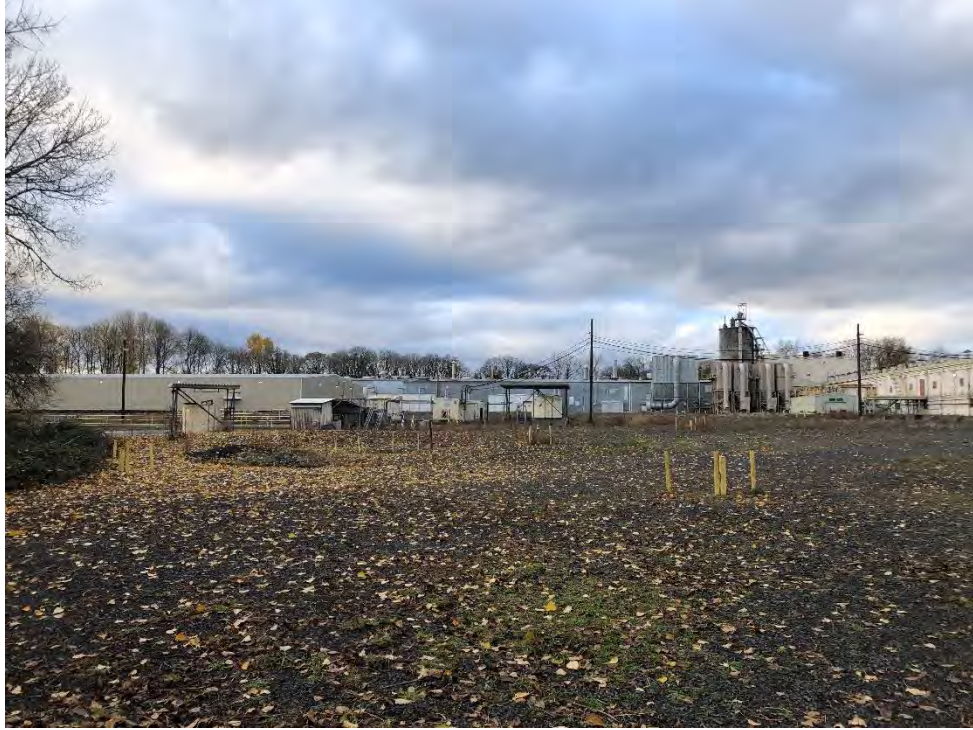
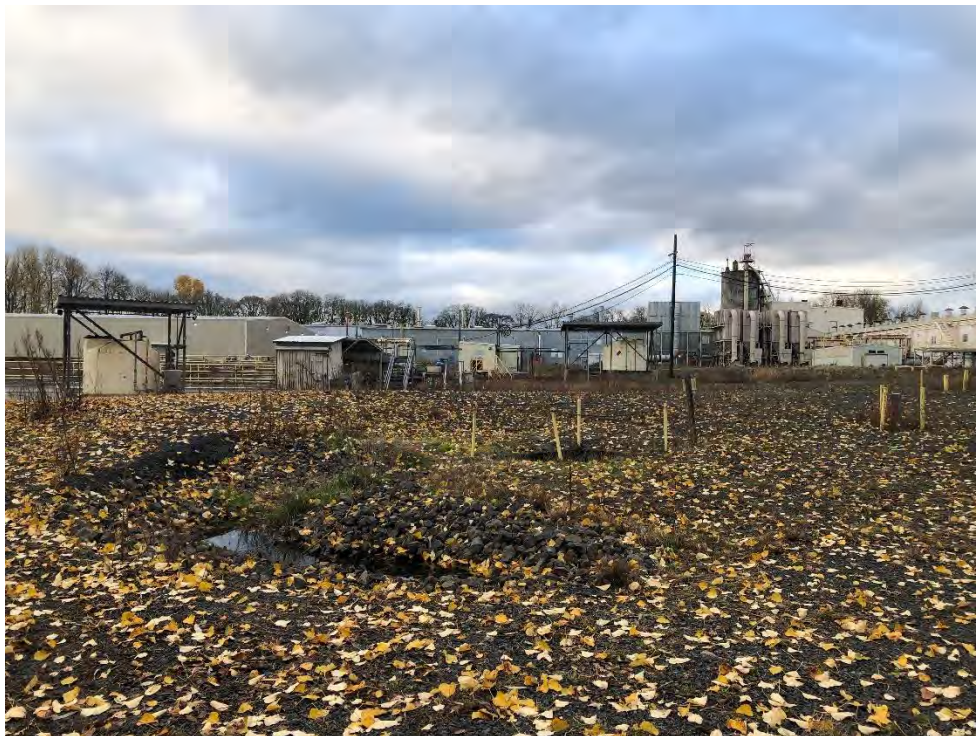
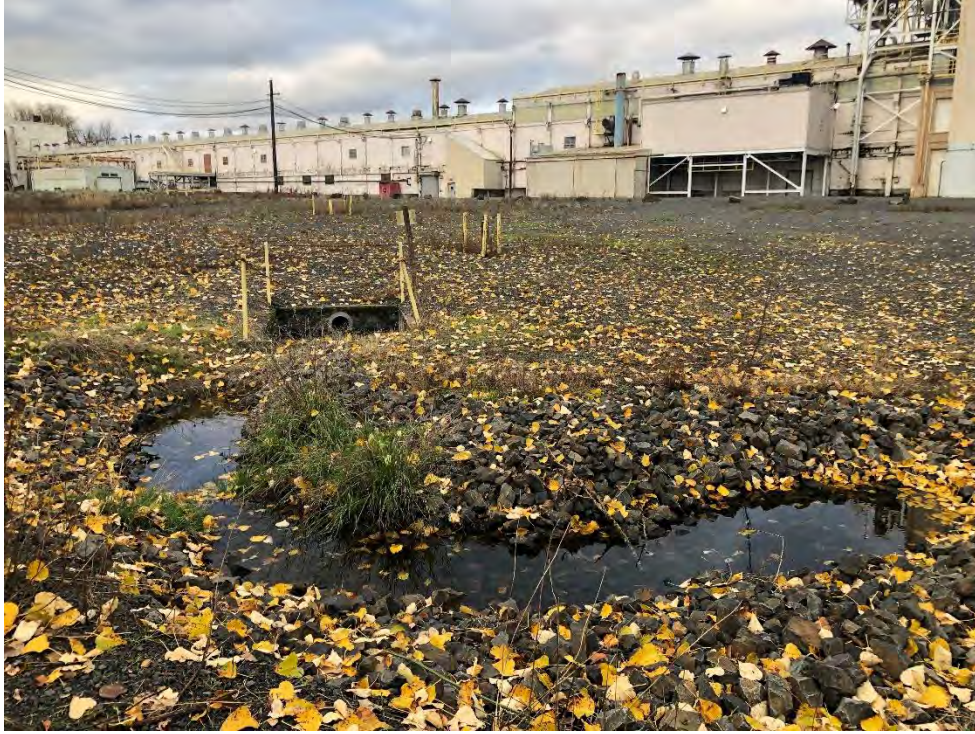
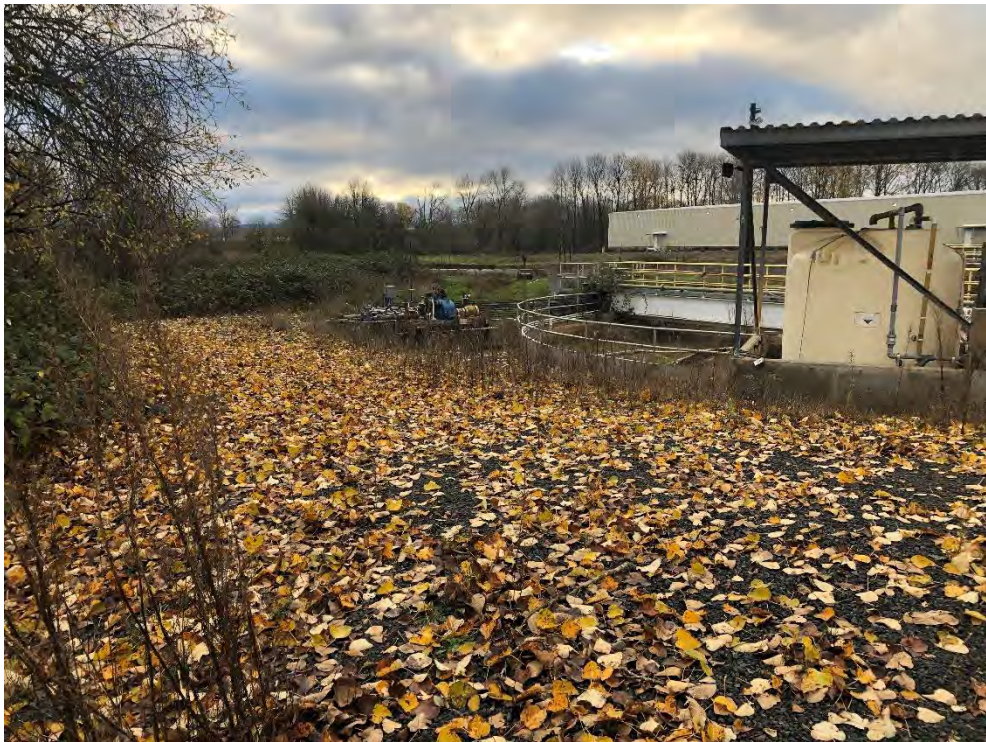
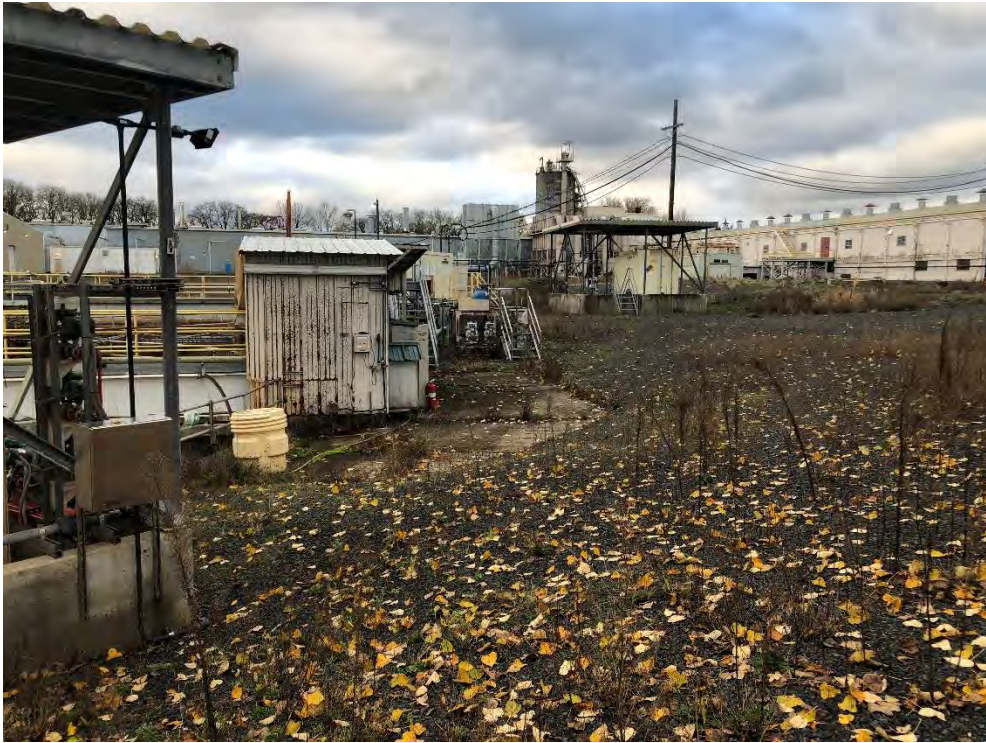
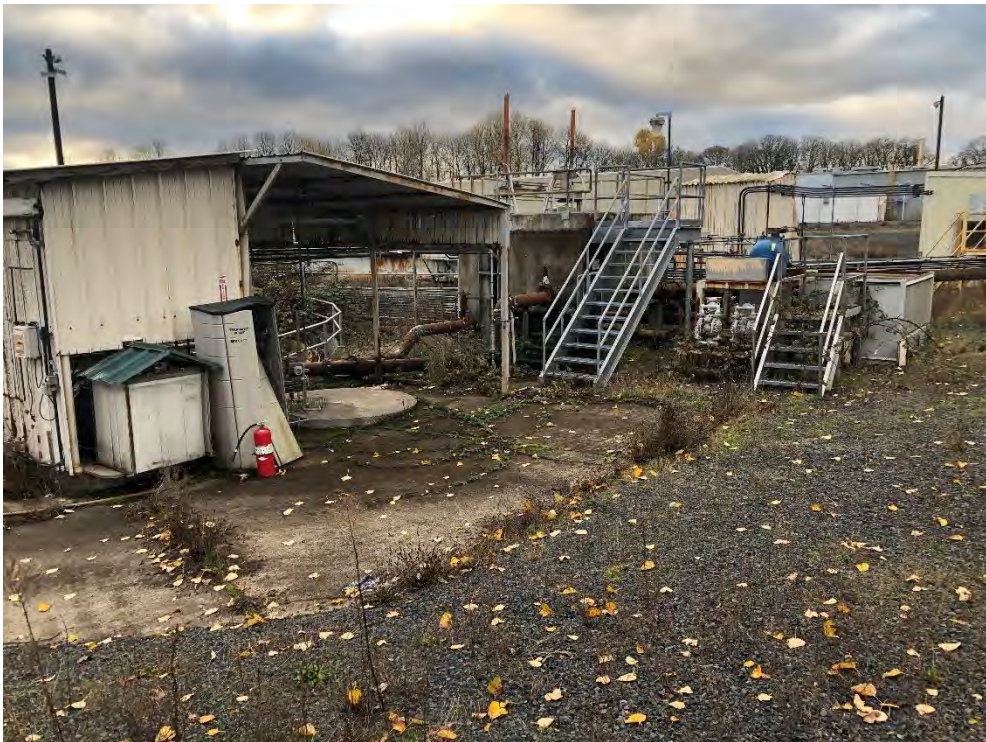
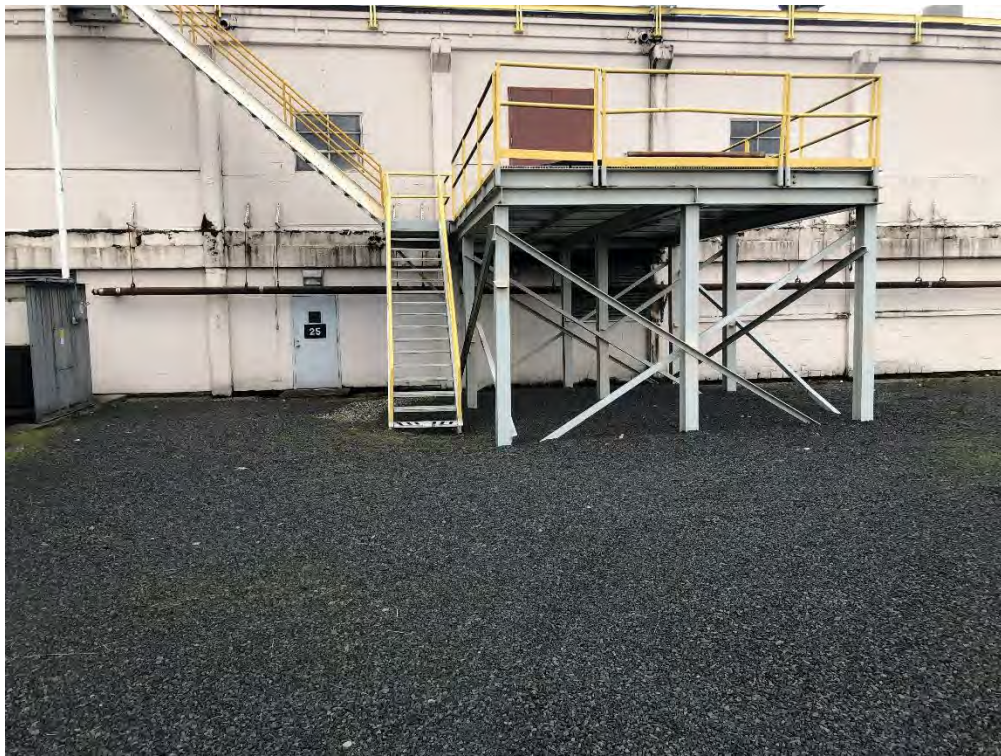
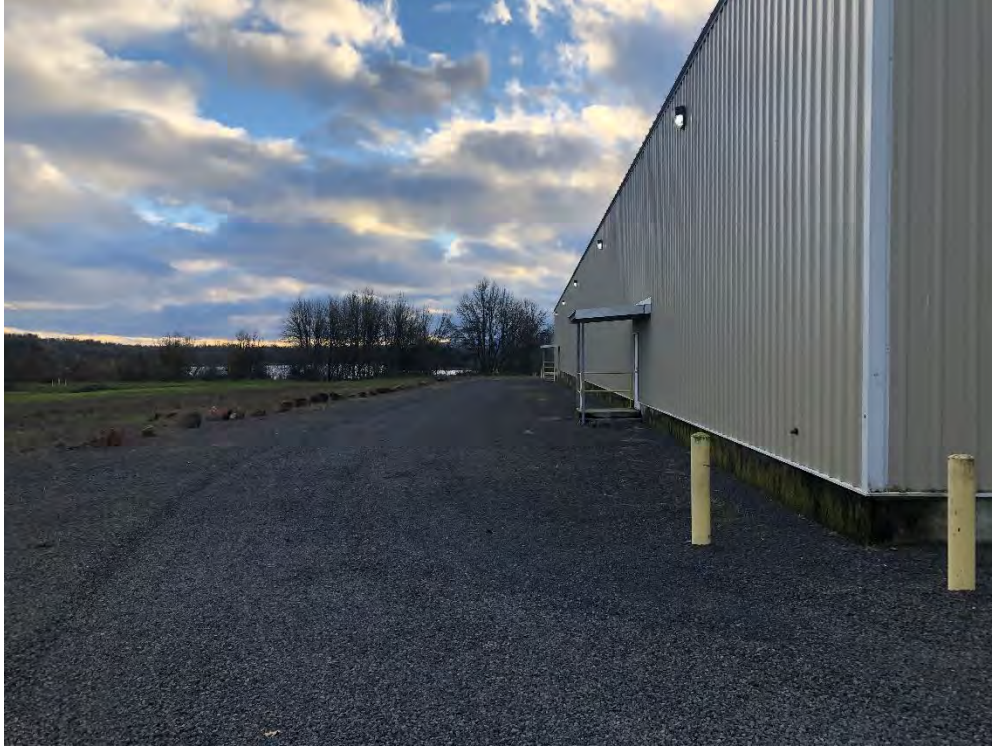
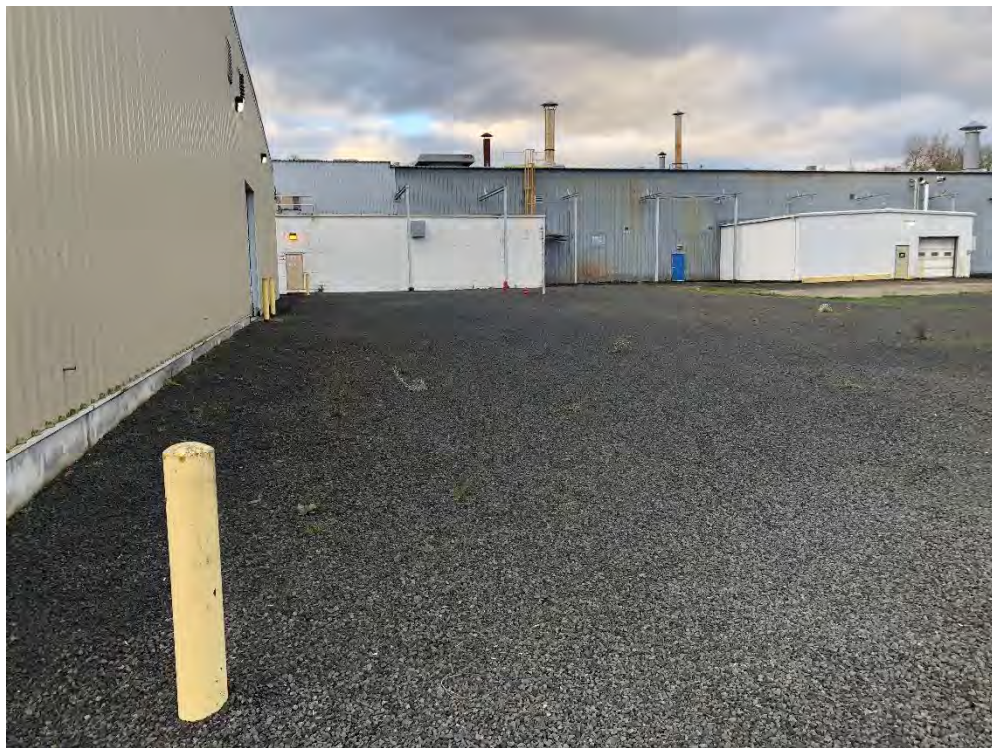
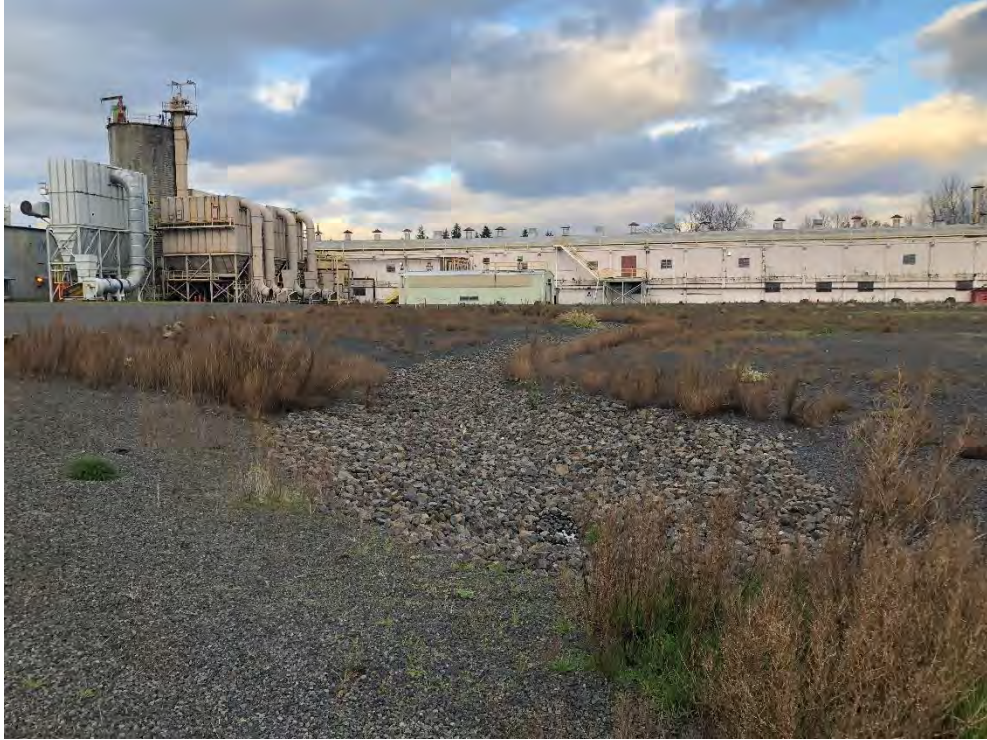
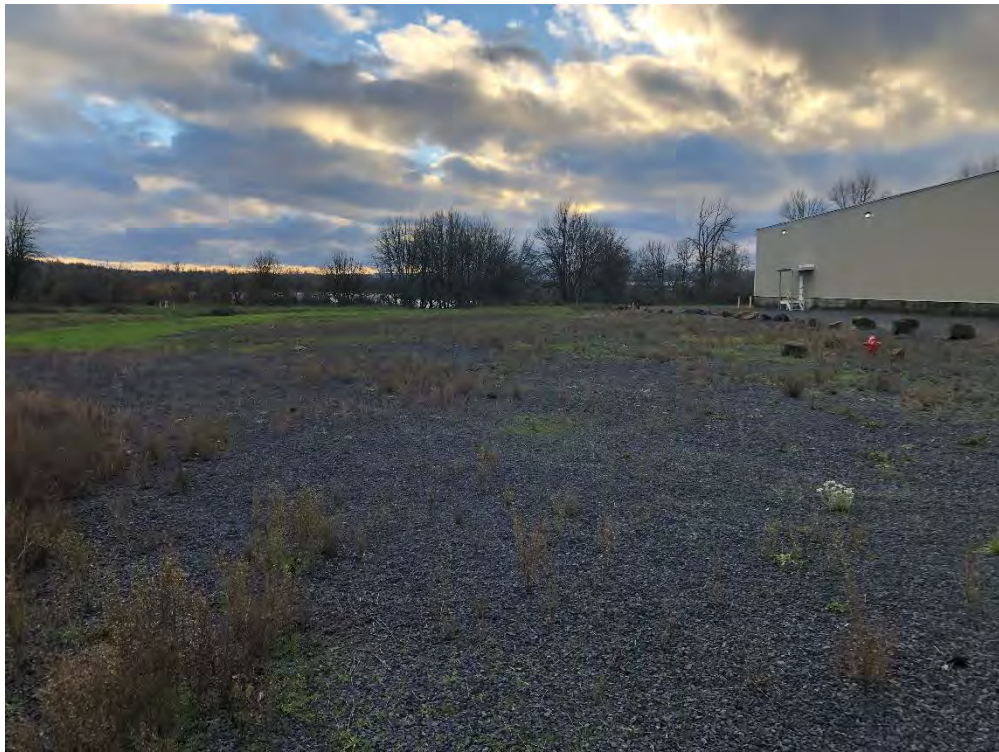
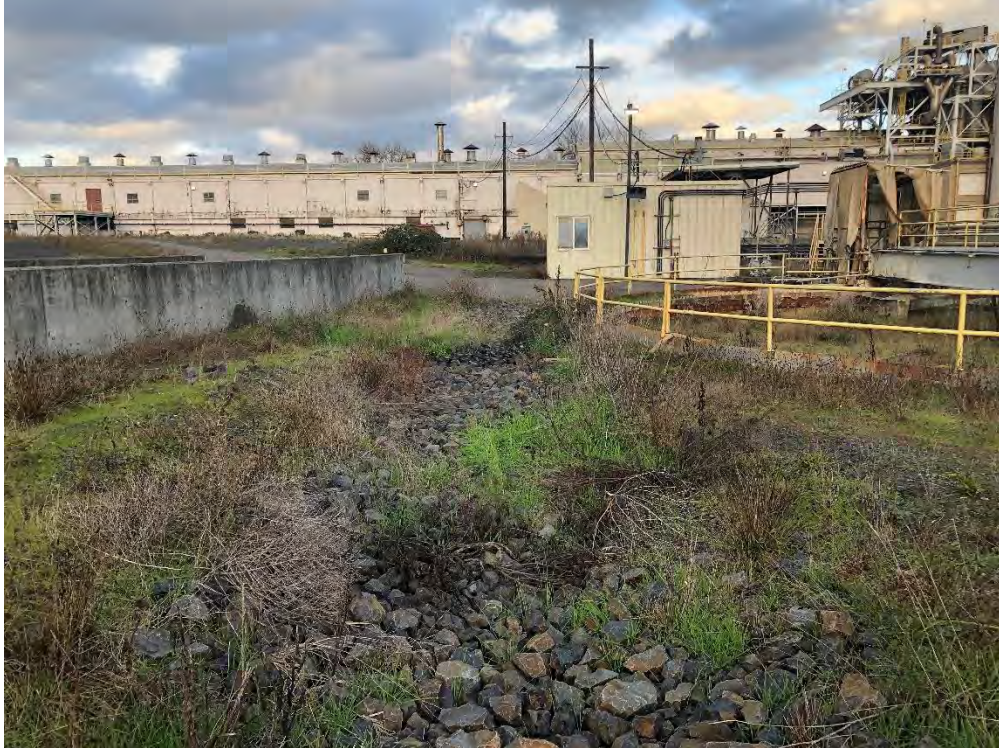
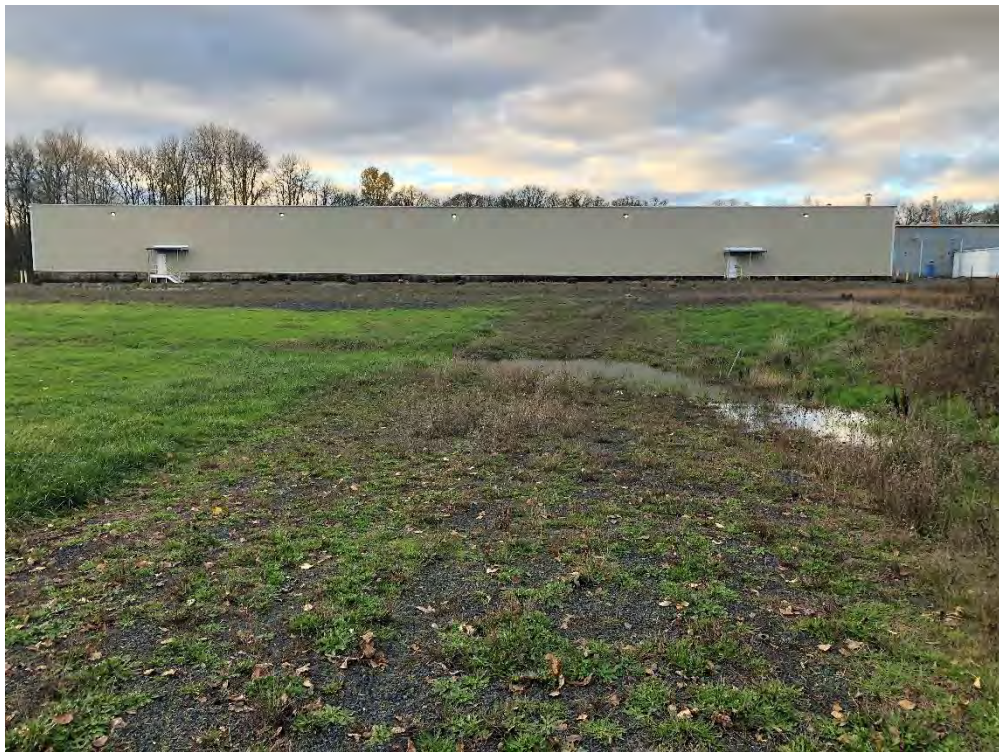
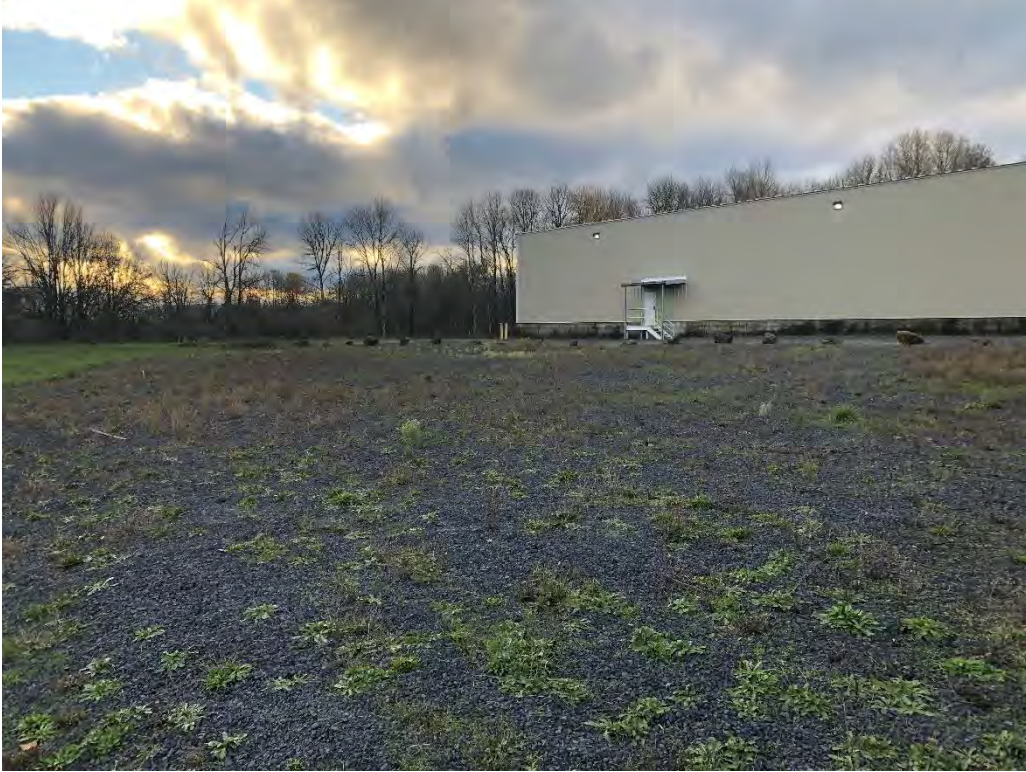
Cap Inspection Area 2 – Soil and Gravel Cap

Condition: Native and invasive weeds continue to be present in upper few inches of gravel throughout the cap, and particularly along the Upland/Lowland boundary.

AWI should take more action in the next quarter to control weed growth on the gravel.

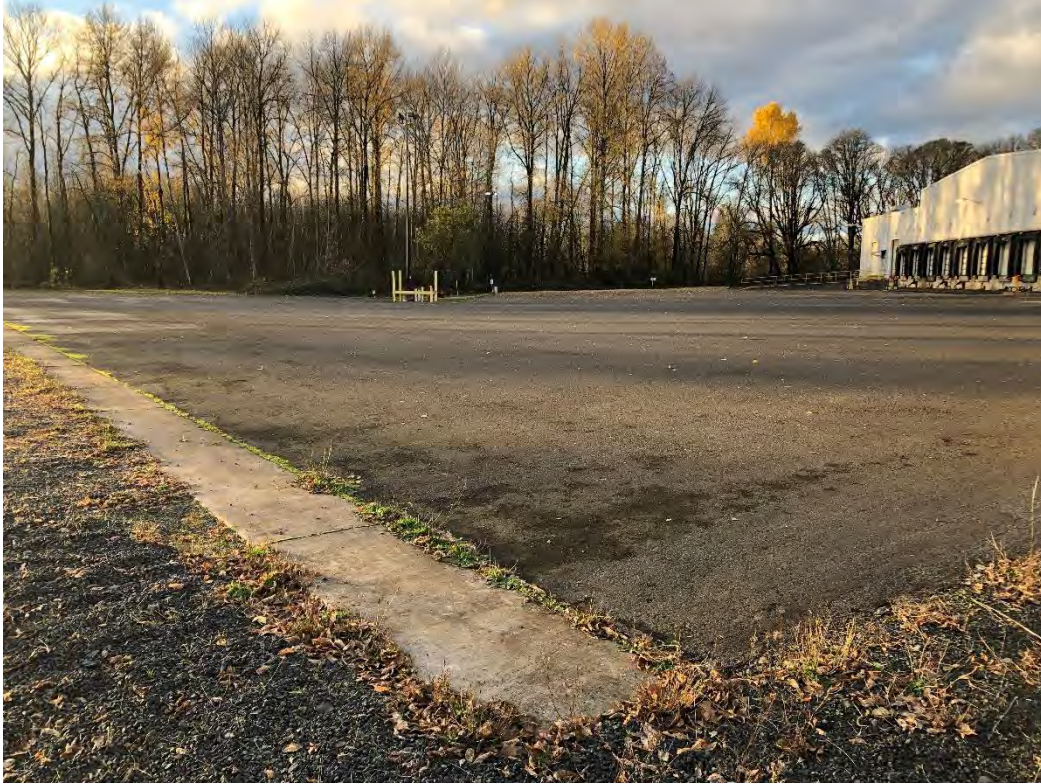
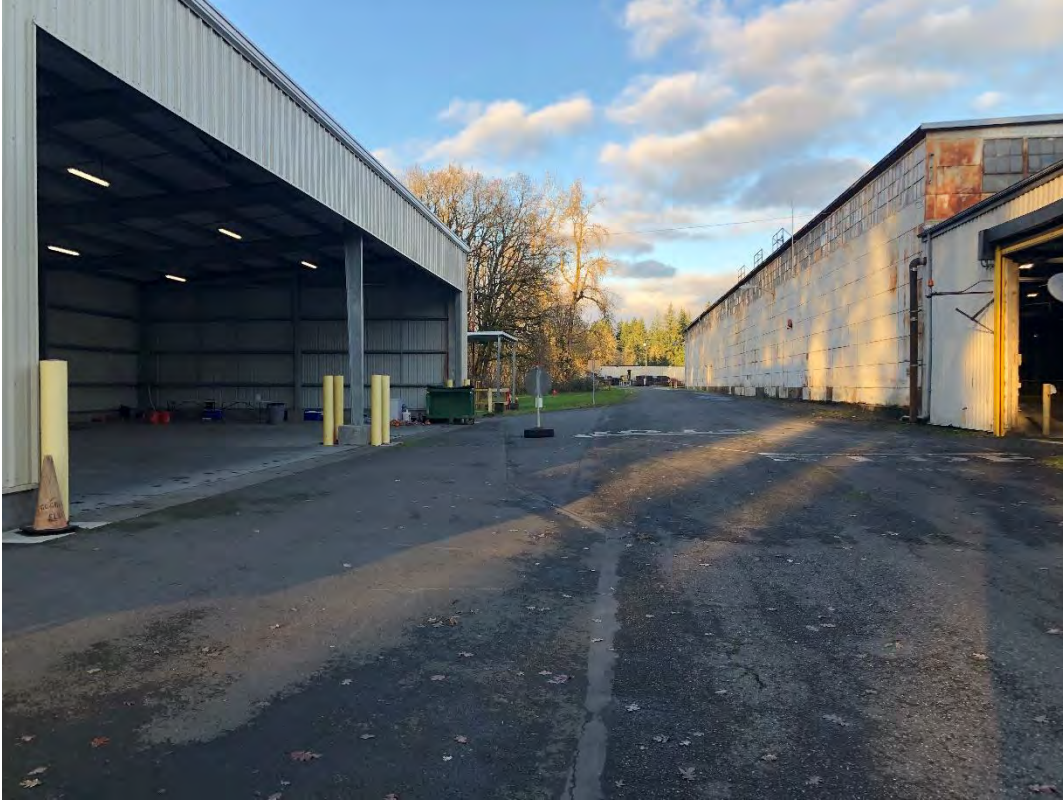
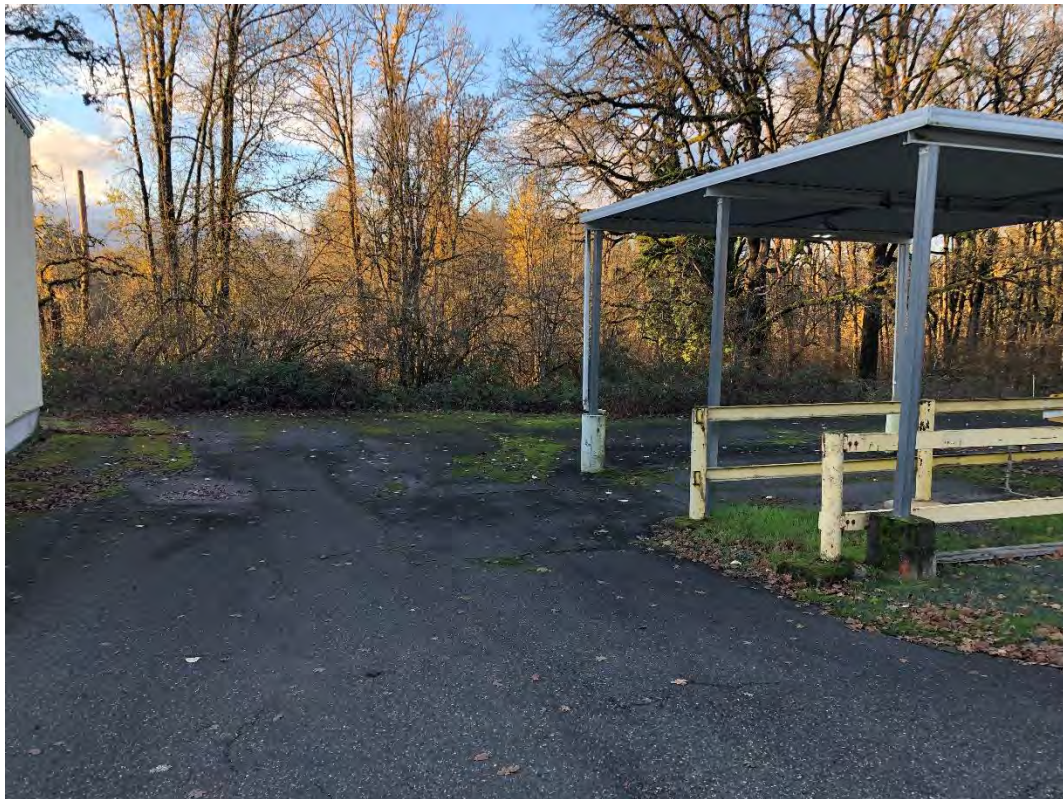
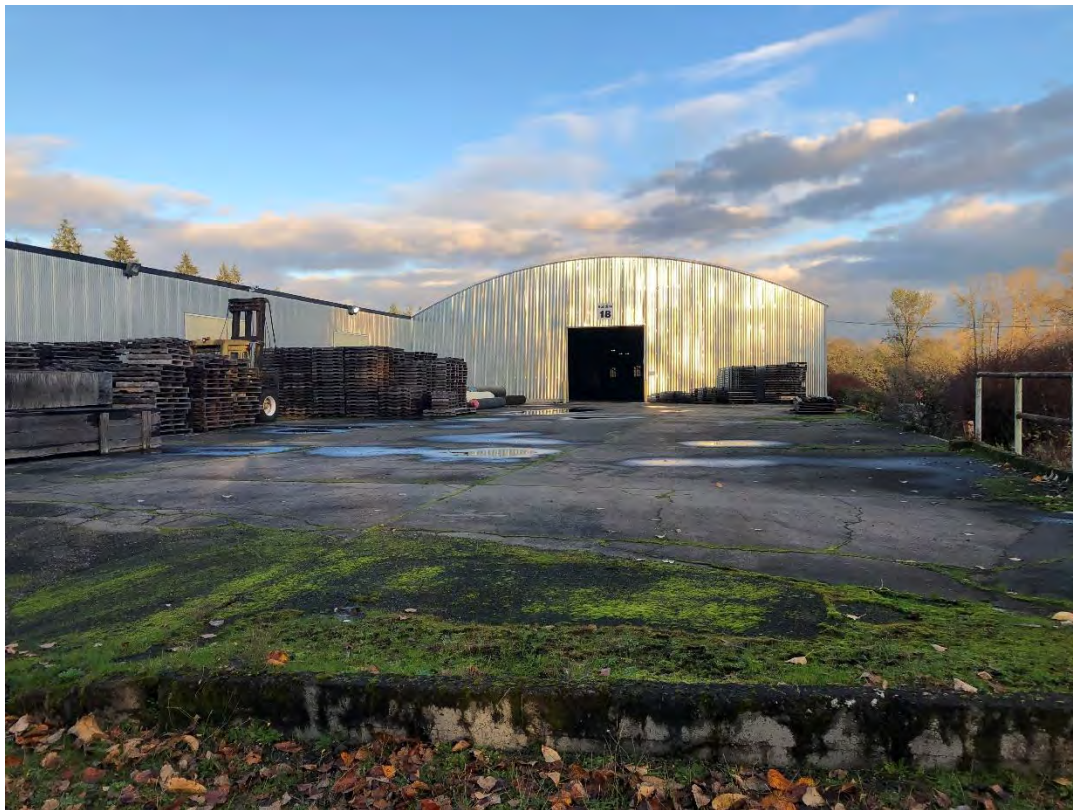
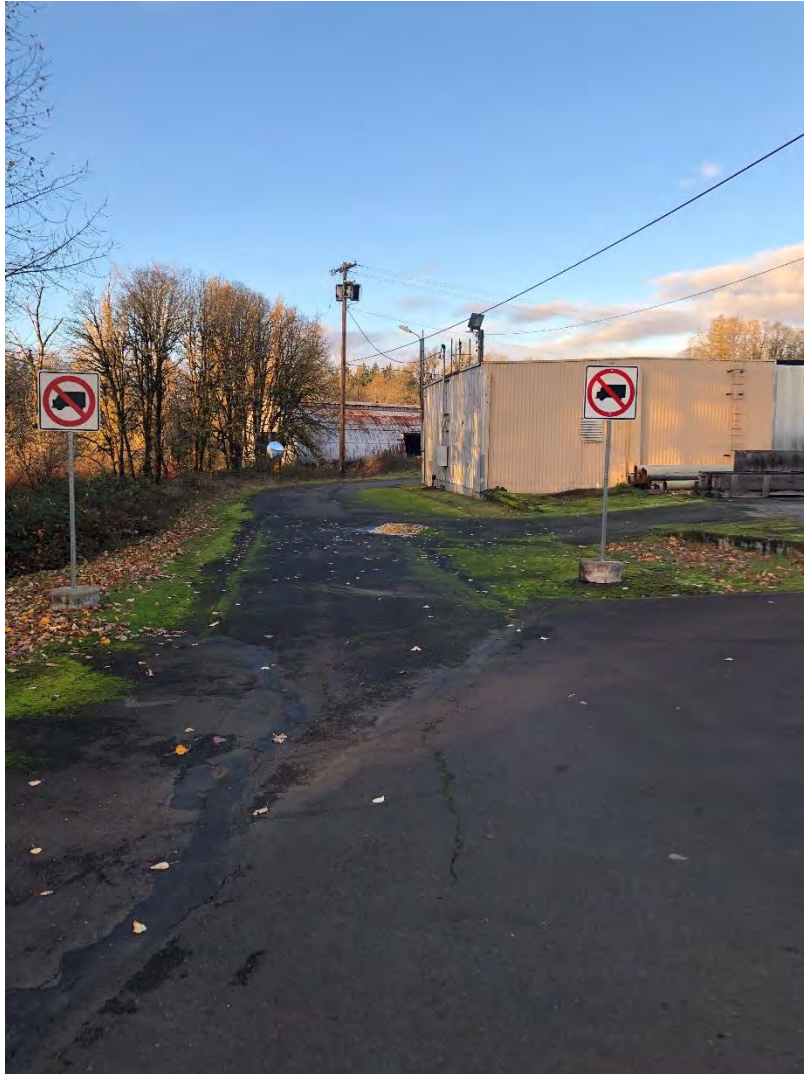
Cap Inspection Area 3 – Asphalt and Concrete Pavement

None taken. Existing asphalt pavement in good repair,
and small cracks do not yet warrant any action.
Will continue to monitor.
