## DIKE PROGRESS MEMORANDUM

Date: October 23, 2020  
Project No.: 1653.01.01

RE: AMCCO Dike Restoration Progress, End of 2020 Season Update

Project Name: Astoria Marine Construction Company  
Project Number: 1653.01.01  
Location: Astoria, Oregon

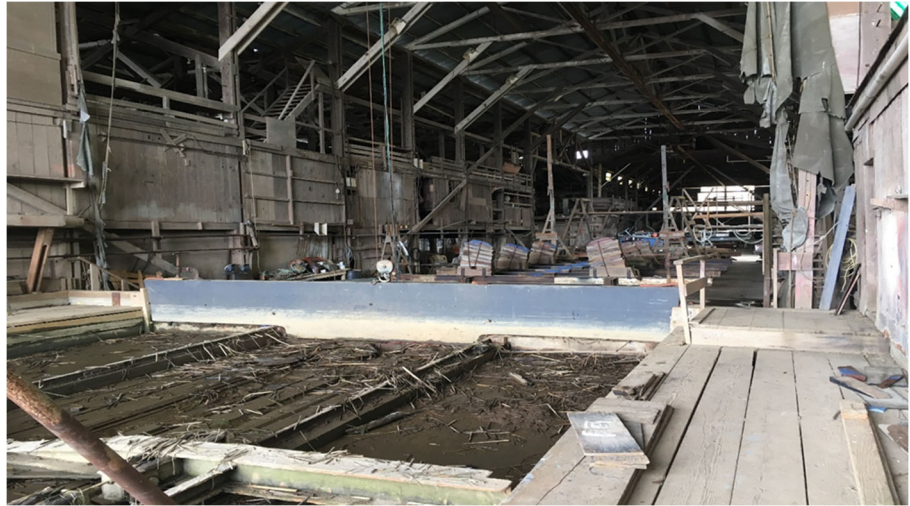
#### Photo No. 1.

Pre-existing Marine Way No. 3 floodwall in main ship repair building (south side).

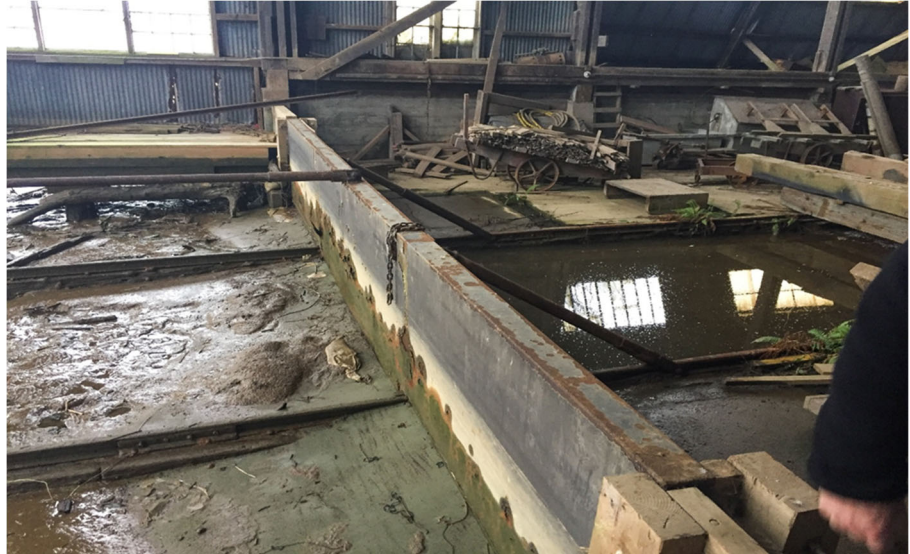
#### Photo No. 2.

Pre-existing Marine Way No. 4 floodwall in main ship repair building (north side).

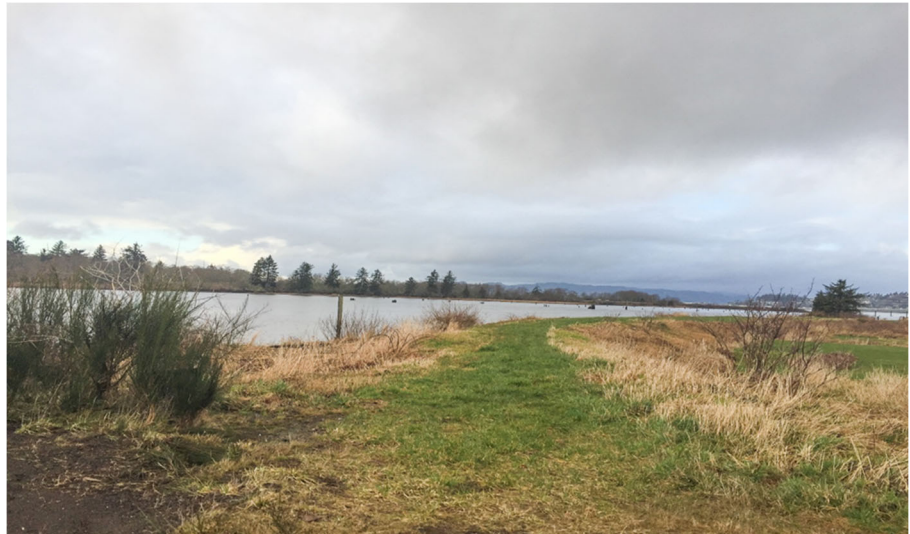
### **Photo No. 3.**

Pre-existing dike crest looking north, toward adjacent property.

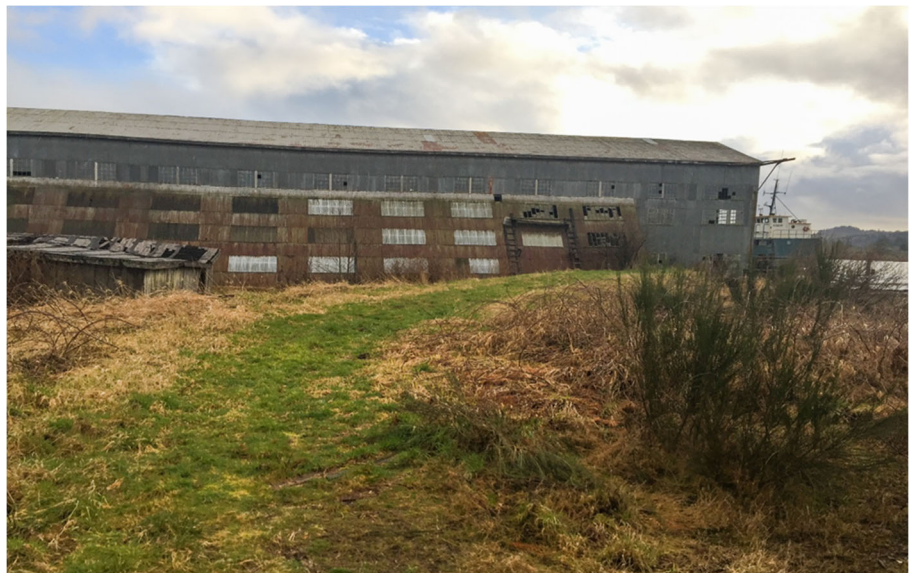
### **Photo No. 4.**

Pre-existing dike crest looking south, toward main ship repair building.

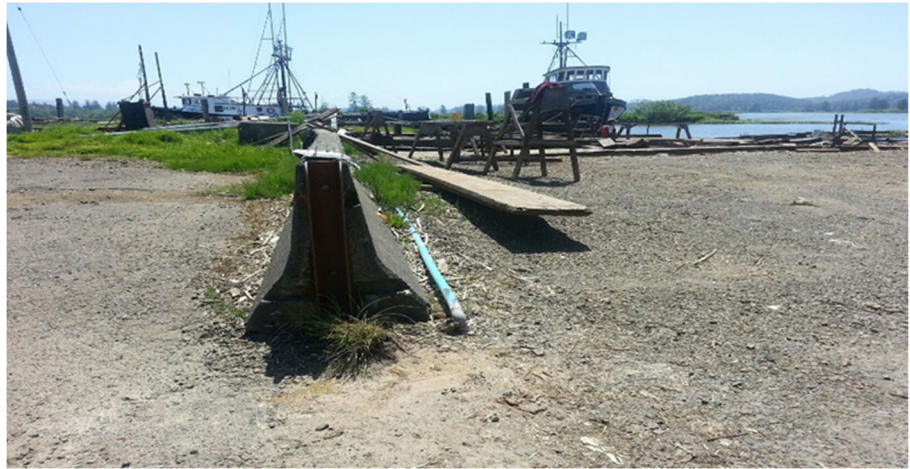
### **Photo No. 5.**

Pre-existing concrete floodwall south of main ship repair building.

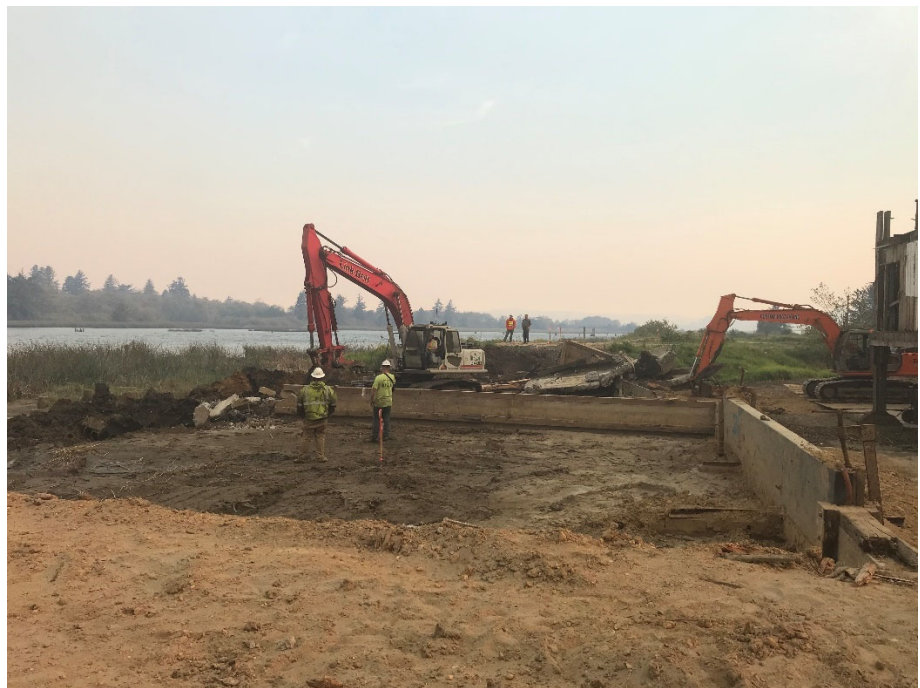
### **Photo No. 6.**

Contractor demolishing the concrete-steel floodwall at Marine Way No. 4.

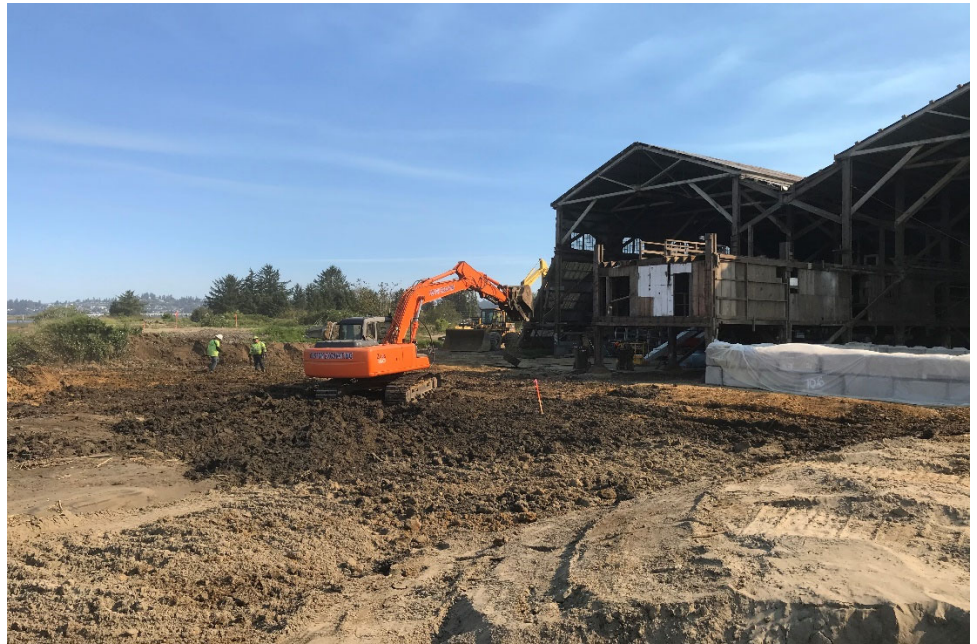
### **Photo No. 7.**

Scarification of dike subgrade at Marine Way Nos. 3 and 4.

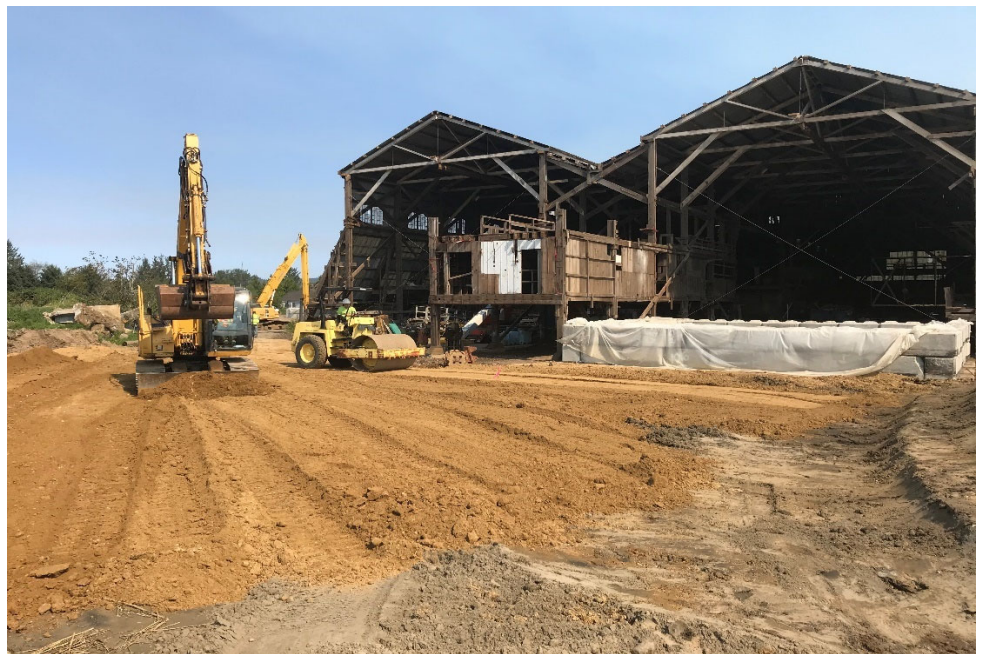
### **Photo No. 8.**

Installation of first lift through Marine Way Nos. 3 and 4.

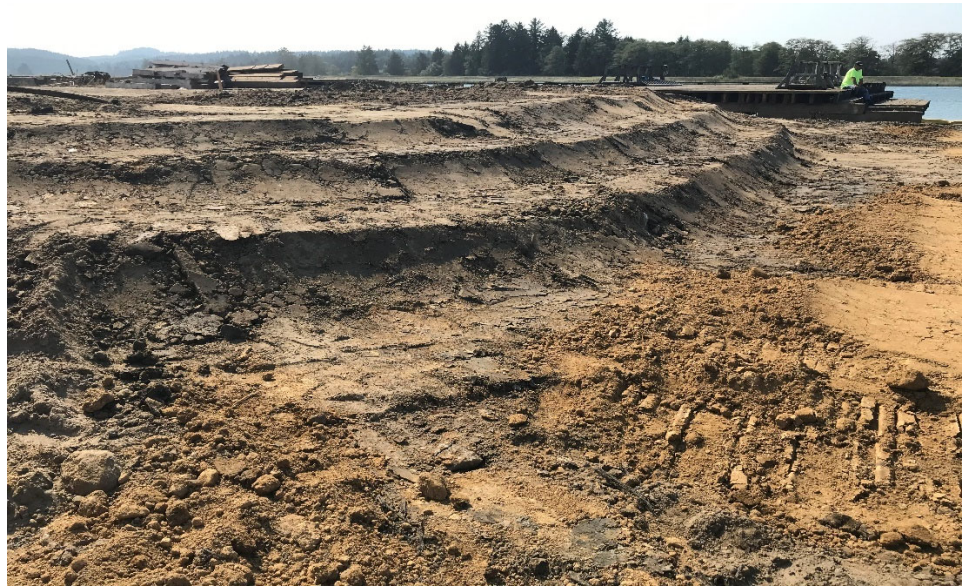
### **Photo No. 9.**

Excavated steps for connection to the existing dike on the south side of the former building.

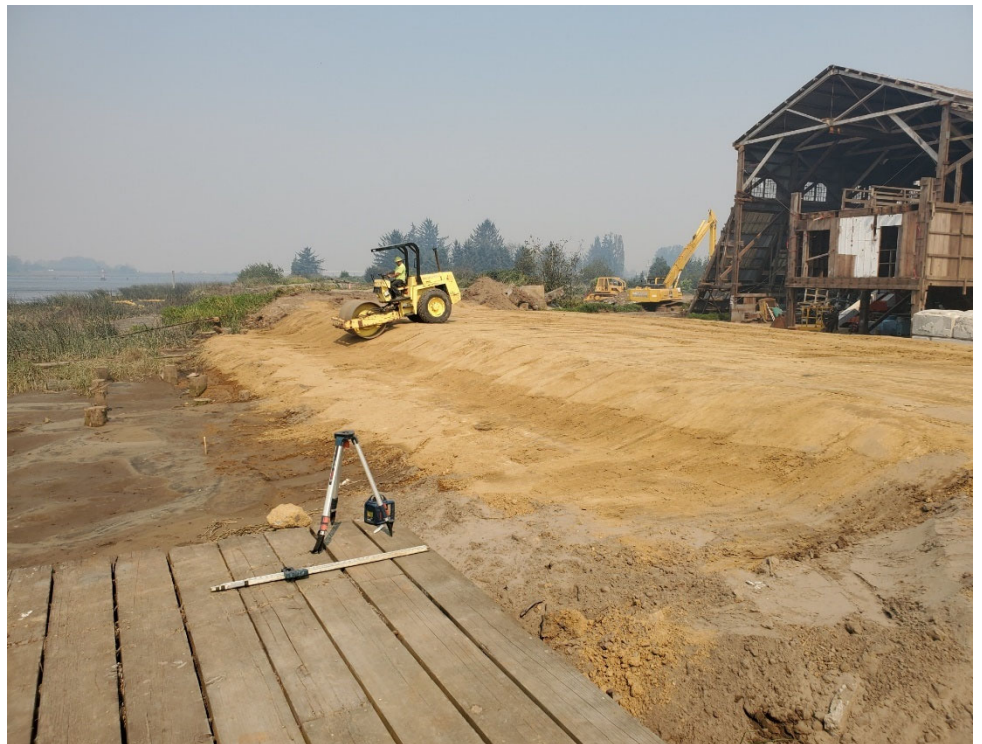
### **Photo No. 10.**

Compaction effort on riverward slopes.

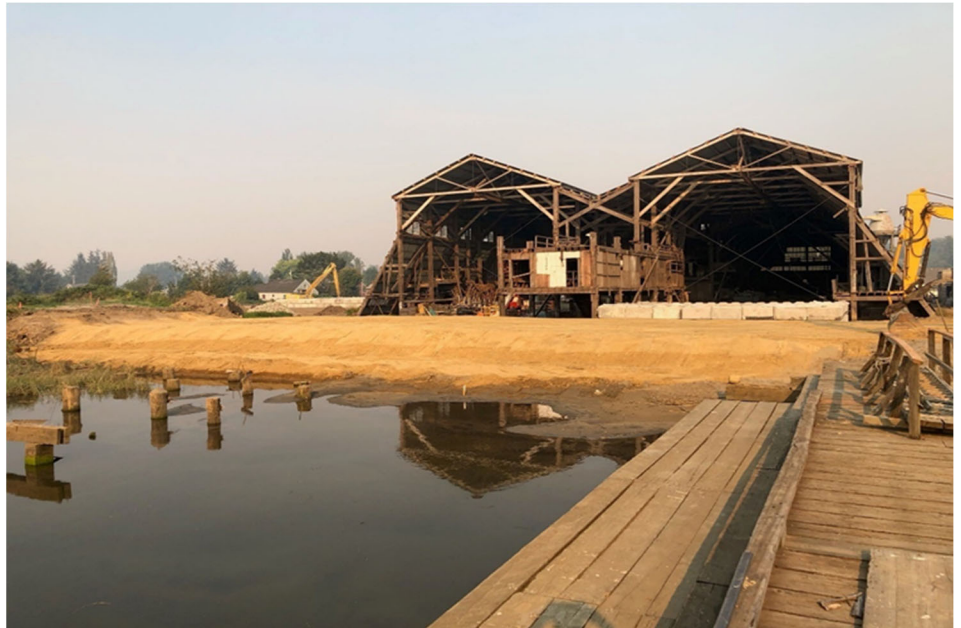
### **Photo No. 11.**

End of second day of dike embankment work, four lifts in place and compacted per specifications. Top of embankment shown in this photo was 11 feet.

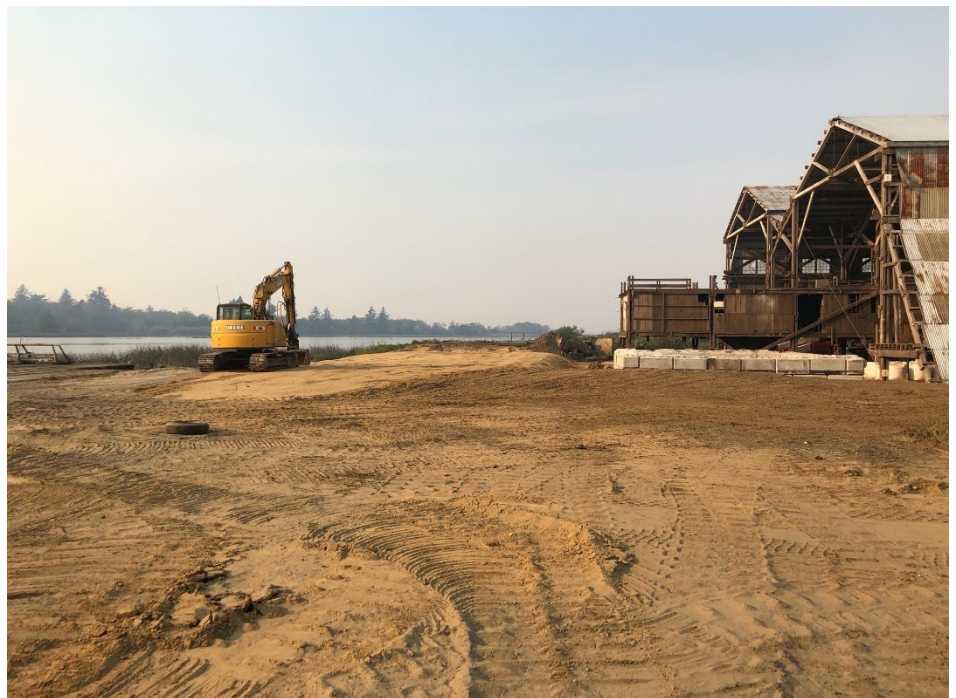
### **Photo No. 12.**

End of second day, toward the north, new dike embankment (through Marine Way Nos. 3 and 4) connected to the southern side of the existing dike.

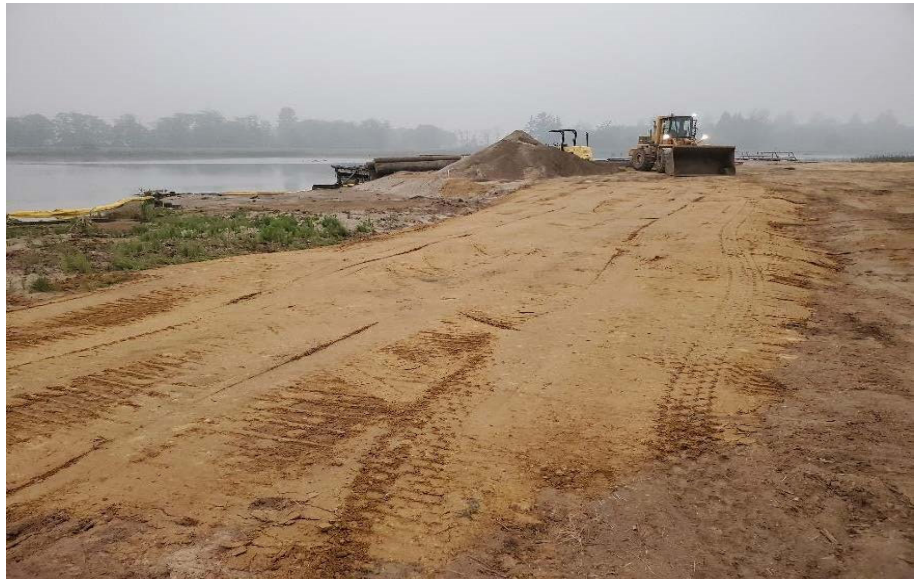
### **Photo No. 13.**

Dike restoration  
south of Marine Way  
Nos. 3 and 4, to  
southern terminus of  
restoration project.

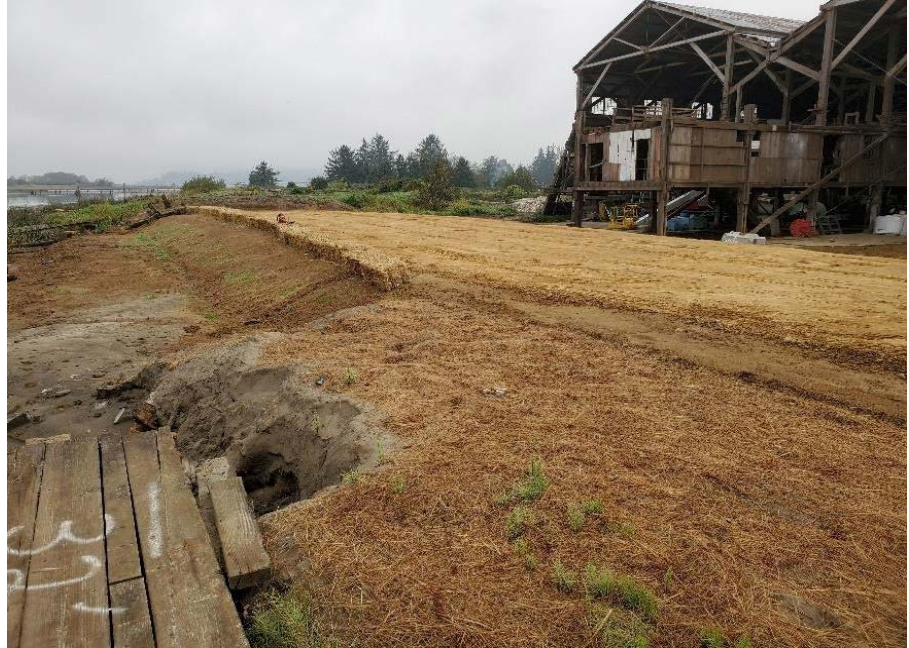
### **Photo No. 14.**

Looking toward  
north end of restored  
section of dike.  
Photo showing top  
of certified lifts  
(elevation 12.5 ft).

The uncertified lifts in the new dike section (embankment above elevation 12.5 feet) will be removed/reworked to meet project specs. Up to 2-feet of additional dike soil will be placed within the agreed project limits. Separation fabric will be placed on the crest and then crushed rock will be placed in accordance with the design report to raise the top of dike to the federally authorized elevation. The dike slopes will be cleared of winterization rock and separation fabric, so that they may be seeded with the Diking District approved seed mix.

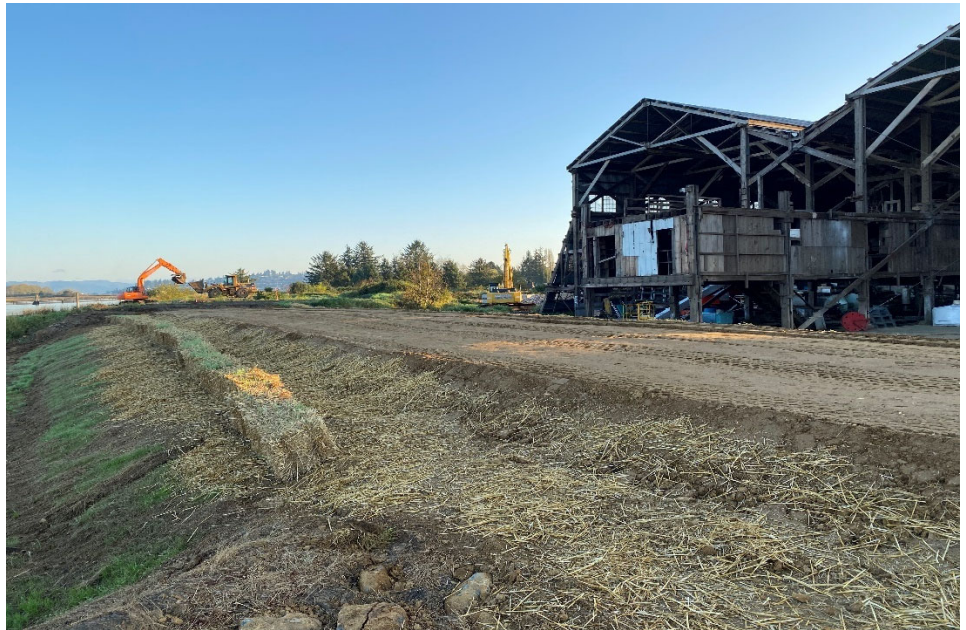
### **Photo No. 15.**

End of season top of earthen dike after freeboard embankment installation; crest elevation shown is approximately 13.8 feet. Also shown are vegetated riverward side slopes. Straw bales added for enhanced temporary erosion and sediment control.

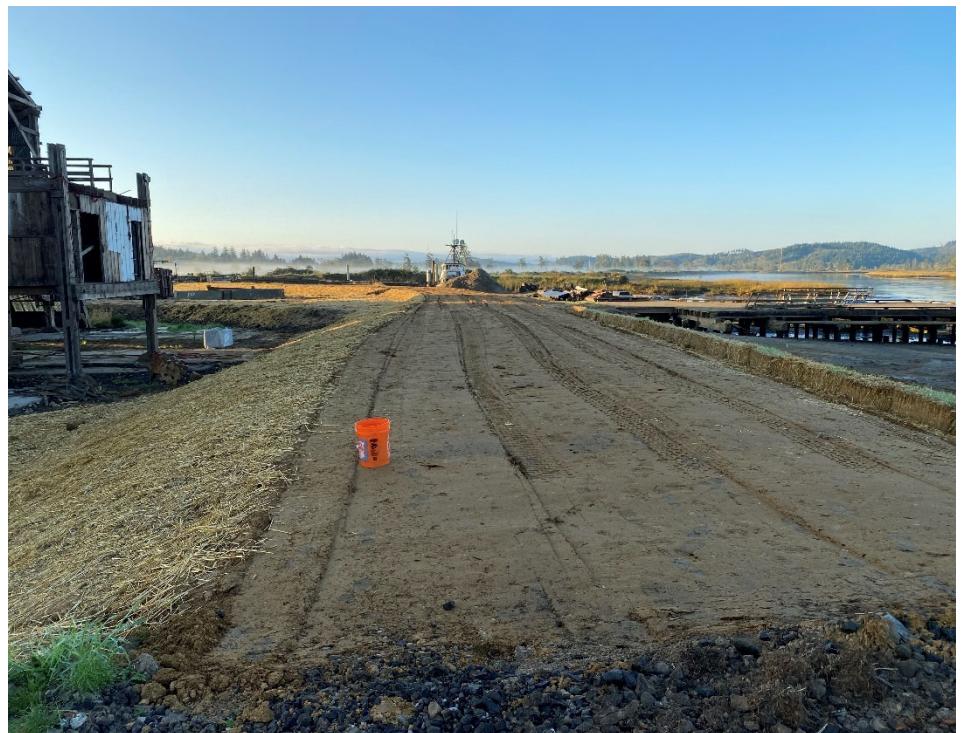
### **Photo No. 16.**

End of season top of earthen dike embankment (matching existing top of northern dike) prior to rock placement.

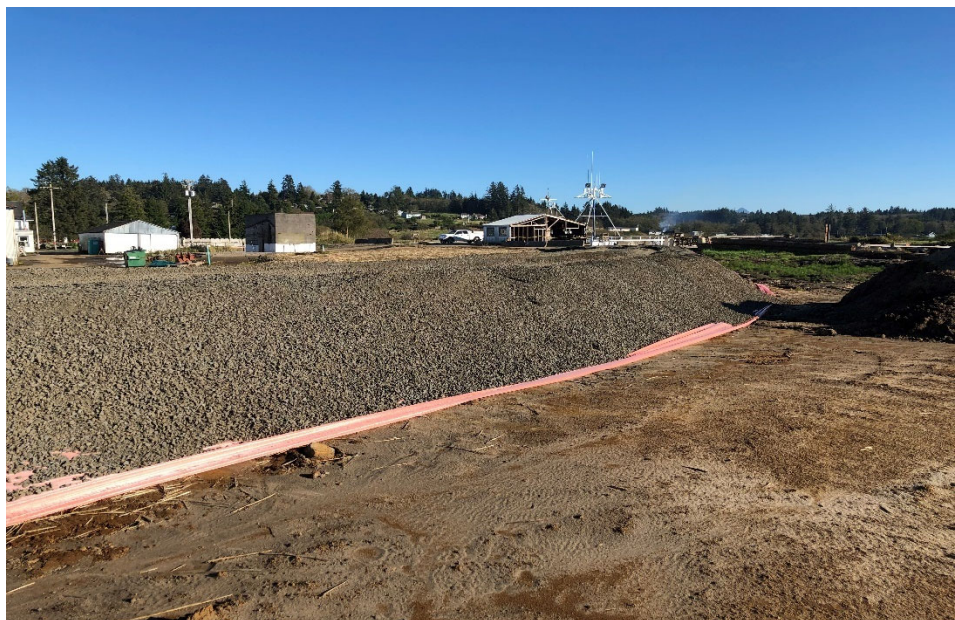
### **Photo No. 17.**

Winterization  
crushed rock  
surfacing installed on  
separation fabric  
over the restored  
dike.

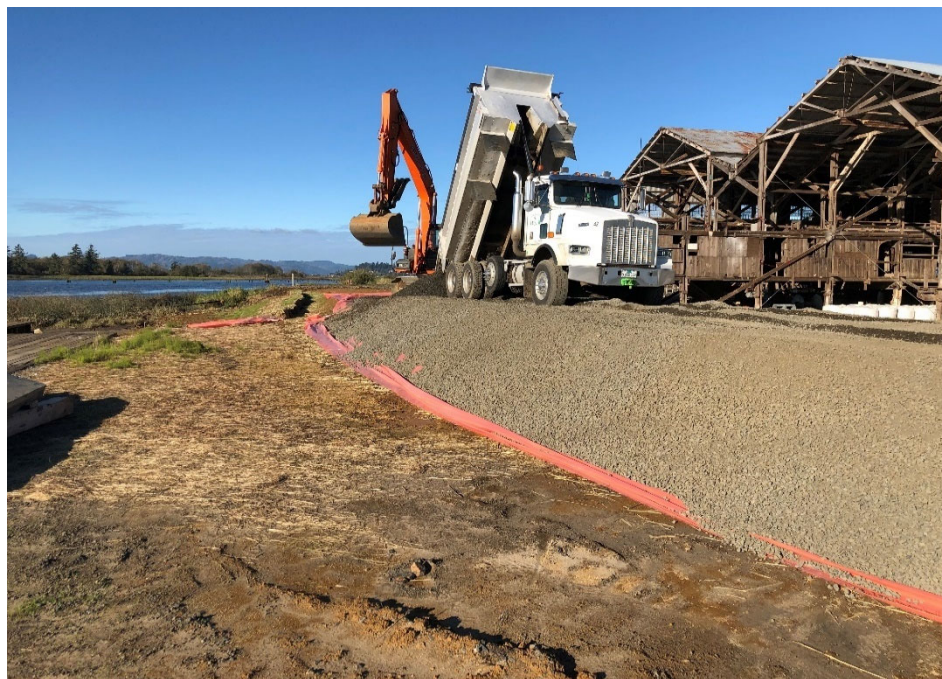
### **Photo No. 18.**

End of season /  
winterization crushed  
rock installed on  
separation fabric on  
the restored dike.

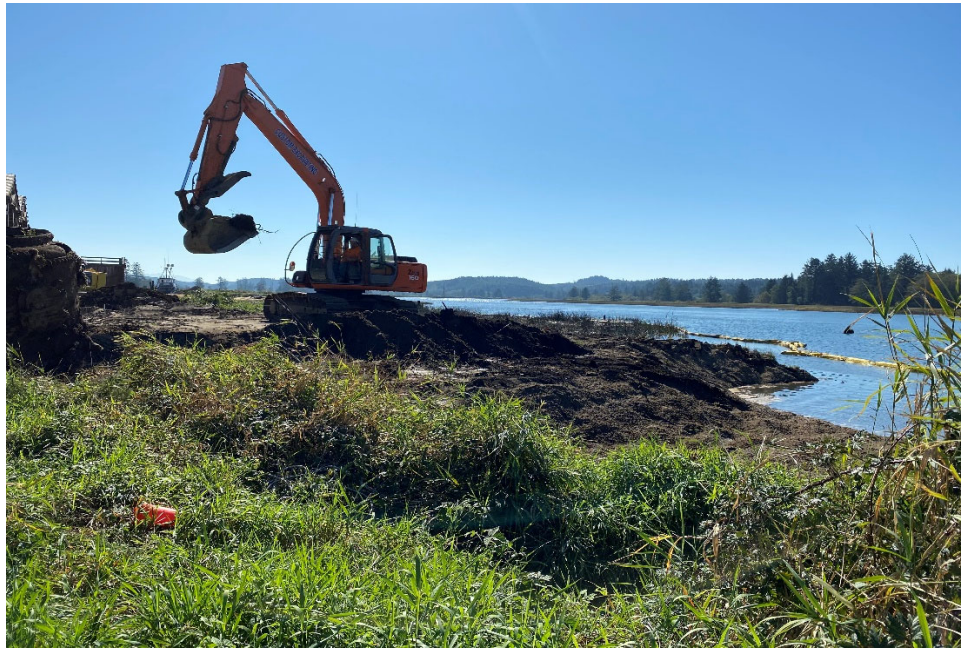
### Photo No. 19.

During historical site operations, soil fill and burned debris had been placed in the overbuild zone of the riverward dike face north of the main ship repair building, at a location called the Burn Pit. During the week of October 5, approximately 2,000 cubic yards of contaminated soils and burned debris were removed from the Burn Pit area. Up to 10 feet of material were removed to expose the pre-existing dike fill soil. The excavation was backfilled with clean dike soil and seeded; satisfying the specifications established in the design report. Excavations were laid out to avoid disturbance to the dike prism. Approximately 400 cubic yards of contaminated nearshore sediments to a depth of 4 feet was removed at the toe of the existing dike (within Zone C) and then backfilled with clean sand.

Burn Pit Hotspot excavation and backfill at overbuilt section of the northern dike.

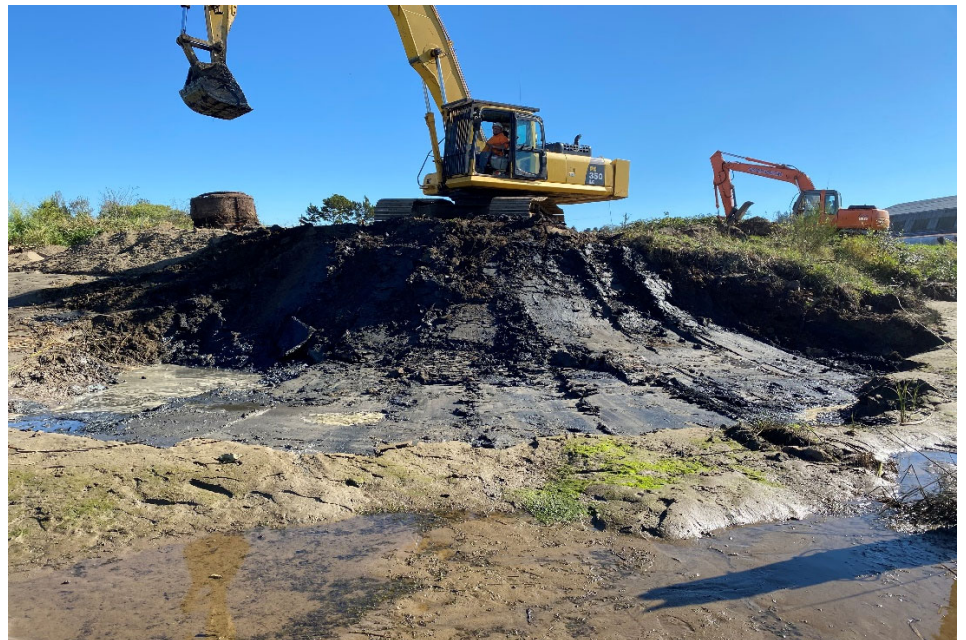
### Photo No. 20.

Burn Pit Hotspot excavation at overbuilt section of the northern dike

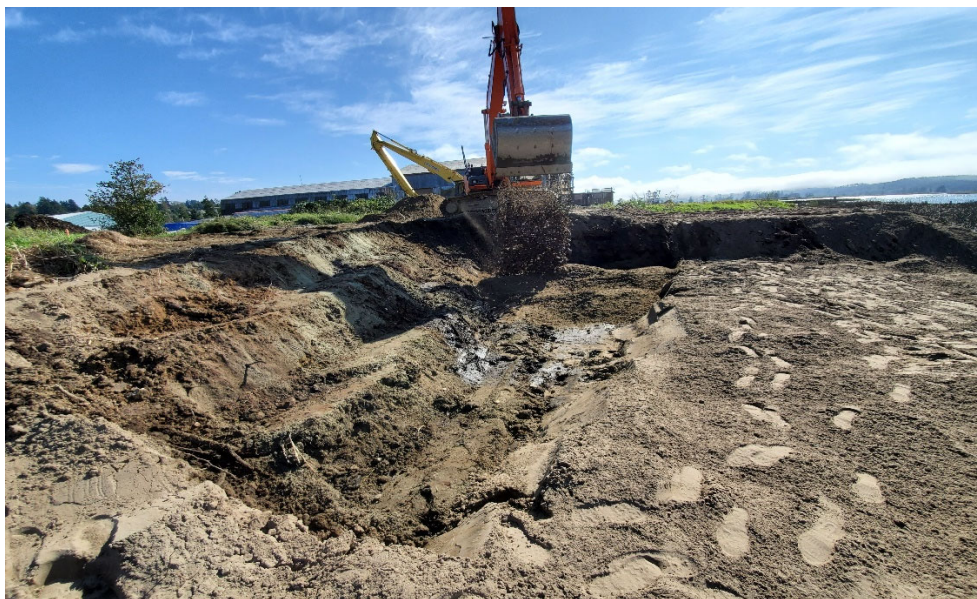
### Photo No. 21.

Burn Pit Hotspot excavation and backfill at overbuilt section of the northern dike. Stepped connection for slope grading on overbuilt section of dike

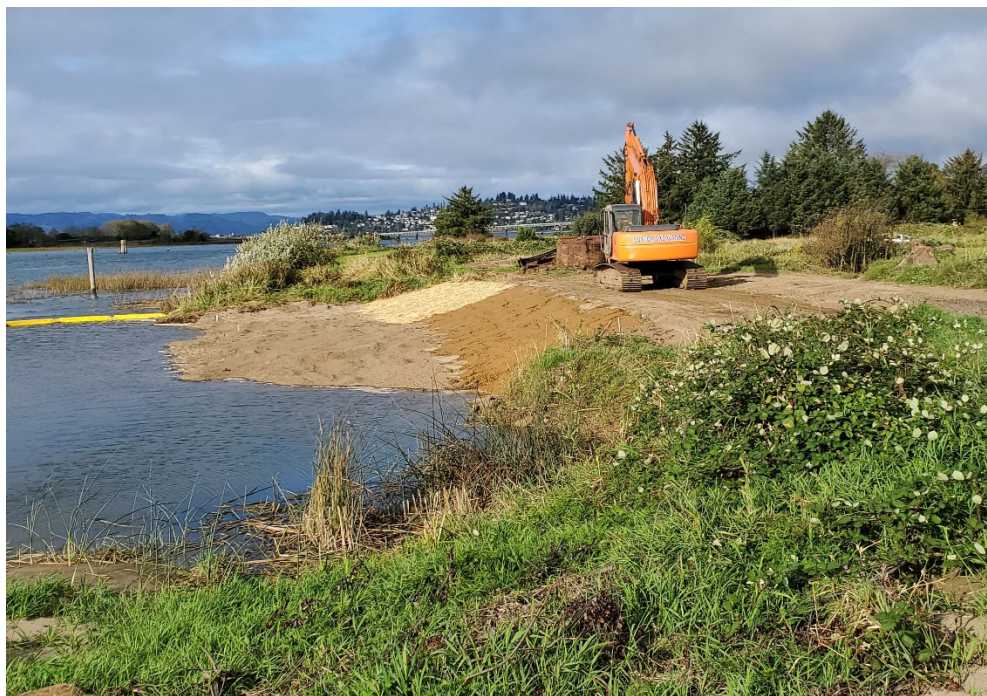
### Photo No. 22.

Burn Pit Hotspot excavation/backfill completed with restored overbuilt slope
