Final Summary Report Geotechnical Construction Observation Services

AMCCO Remediation 92134 Front Road Astoria, Oregon

Project: MFAInc-25-03

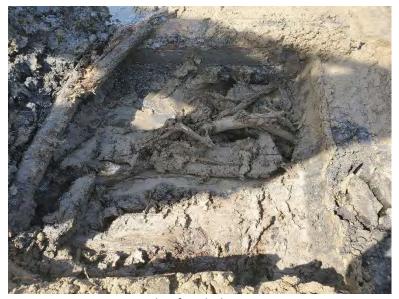
Example of Pothole Location

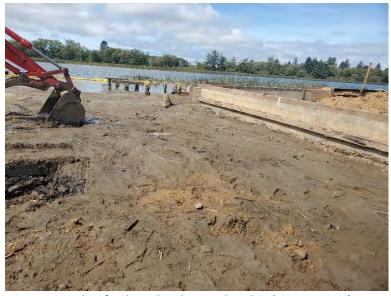
Upon arrival, I met with earthwork crew and Tim Fastabend (Astoria Marine). I was directed to the location of the proposed dike resolution. I observed that dike location had been excavated to planned subgrade elevation and that approx. half of the subgrade was covered with a layer of sand for erosion control purposes. I requested potholing through the sand layer to observe the underlaying soil. I observed the soil to consist generally of silt with sand. I observed wood debris and wooden beams within the potholed location. Subgrade was wet and ground water was observed seeping into the potholed location. Based on conversations with Shawn Dimke (GeoDesign Principle Engineer). We believe the subgrade to be adequate for dike construction, following being sacrificed as stated in our geotechnical report. We recommend that wooden beams, along with large diameter wood debris encountered during the scarification process be fully removed from the subgrade. Conversation was had onsite with earthwork contractor about the placement of embankment material. We recommend that a thicken, approx. 16in to 18in lift of soil be placed initially to create a solid working surface and prevent disturbing the wet/ soft subgrade soil.

Example of Subgrade Observed Today (Facing West)

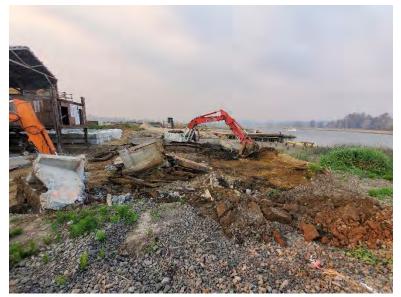
Concrete Wall being Removed (Facing South)

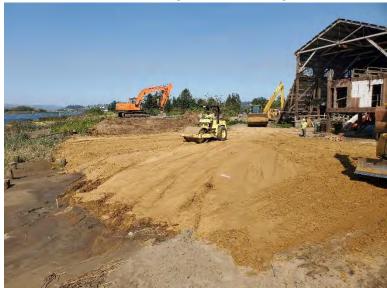
Fill being Placed Today (Facing North)

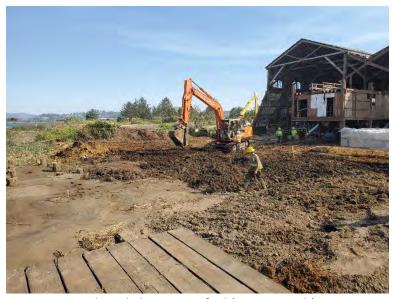
Subgrade being Scarified (Facing North)

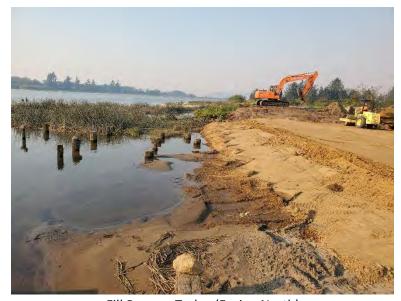
Fill Process Today (Facing North)

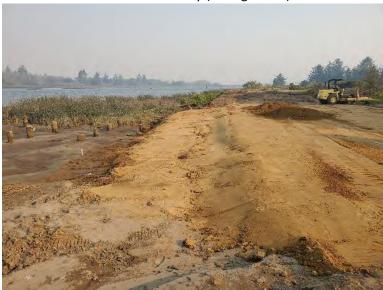
Fill Process Today (Facing North)

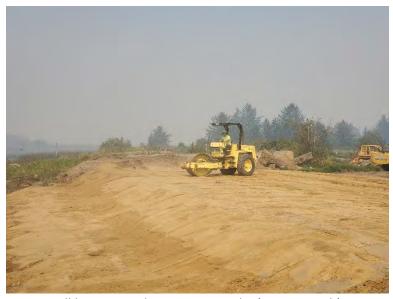
Fill being Keyed into Existing Dike (Facing North)

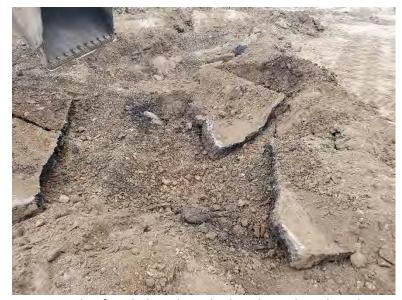
Upon arrival, I observed Custom Excavation crew in the process of stripping dike subgrade of vegetation and debris. During stripping efforts, Custom Excavation crew encountered asphalt with an underlying section of crushed rock. After conversations with Shawn Dimke (GeoDesign Principal Engineer) were recommend that existing asphalt section be fully removed. Crushed rock layer can be fully removed or be evenly mixed into embankment soil. I observed Custom Excavation removing asphalt section today and mixing crushed rock into embankment soil.

Example of Asphalt and Crushed Rock in Dike Subgrade

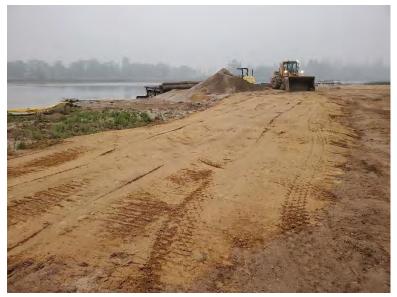
Southern Dike Fill (Facing North)

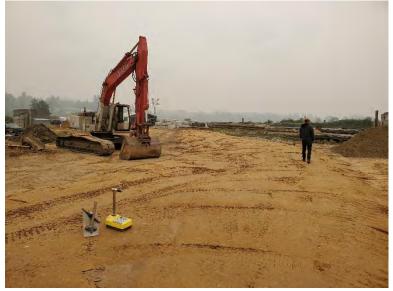
Southern Dike Fill (Facing South)

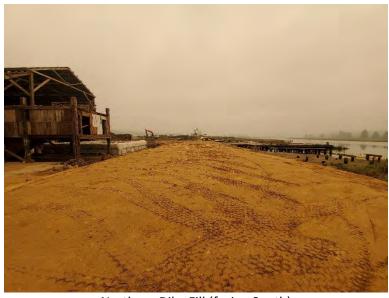
Northern Dike Fill (facing South)

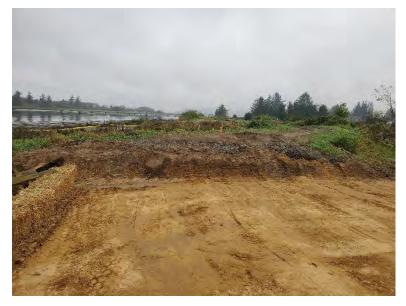
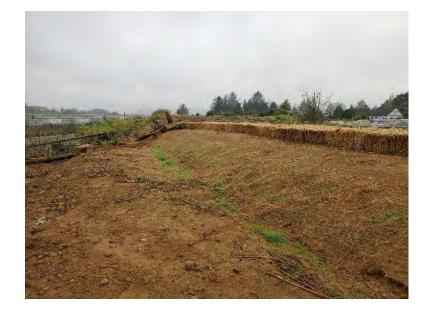
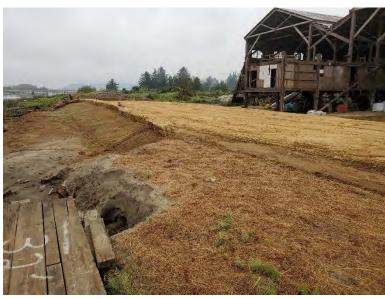
Fill Observed Today (All Facing North)

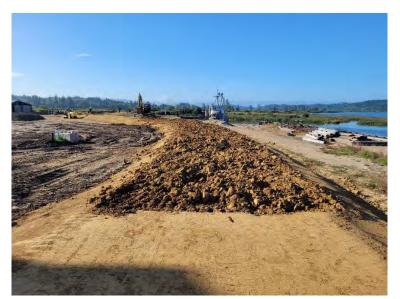
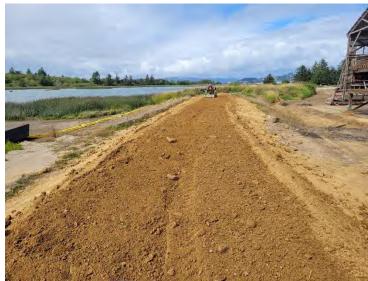
Soil being moisture conditioned

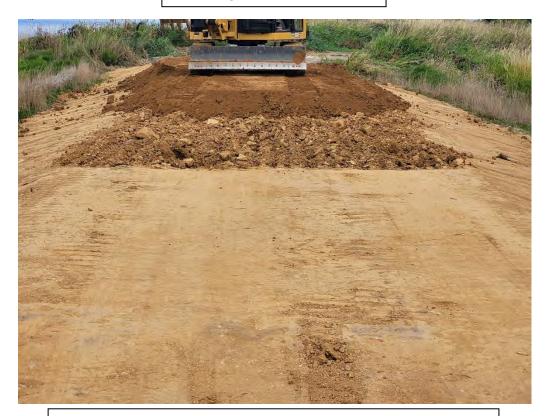
Example of soil being scarified prior to placement of additional lift
