# APPENDIX D EMNR CORE SAMPLING CQA REPORT

Daily Repor	t Number:	AMCCO-090	1420-GRK						
<b>Date:</b> 9/4/2020				MAULFOS	TER ALONGI				
W H		AM: Overcast							
Weather:  Temperature:  24hr Precipitation:		PM: Sunny							Broadway Street
		Min:		54 °F		Portland, OR 97232 971-544-2139			
		Мах:		68 °F		-	97	1-544-2139	
		None				Dust Conditions: Light			
Completed by: Garrick Kalmeta, EIT Number of Contractor Emplo							Employees	Ligiti	
Completed	by:	Gaillek Kalli	ieta, cii						1
Contractor:							Supervisory	Operators	Laborers
							0	0	0
					Work Perfor	med Today			
lo.	cation	1	Sub Location		Description of V		Time Charled	Time a Frederic

Daily Report Number:	AMCCO-081121-GRK					
Date:	8/11/2021	MAULE	MAUL FOSTER ALONGI			
M4	AM: Sunny					
Weather:	PM: Sunny		3140 NE Broadway Street			
T	Min: 64 °F			and, OR 97232 1-544-2139		
Temperature:	Max: 84 °F		7/1-544-213/			
24hr Precipitation:	None	Dust Conditions:	Dust Conditions: Light			
Completed by:	Garrick Kalmeta, EIT	Number of Contra	Number of Contractor Employees			
Combrantor	NI/A	Supervisory	Operators	Laborers		
Contractor:	N/A	0	1	0		
		Work Performed Today				
Location	Sub Location	Description of Work	Time Started

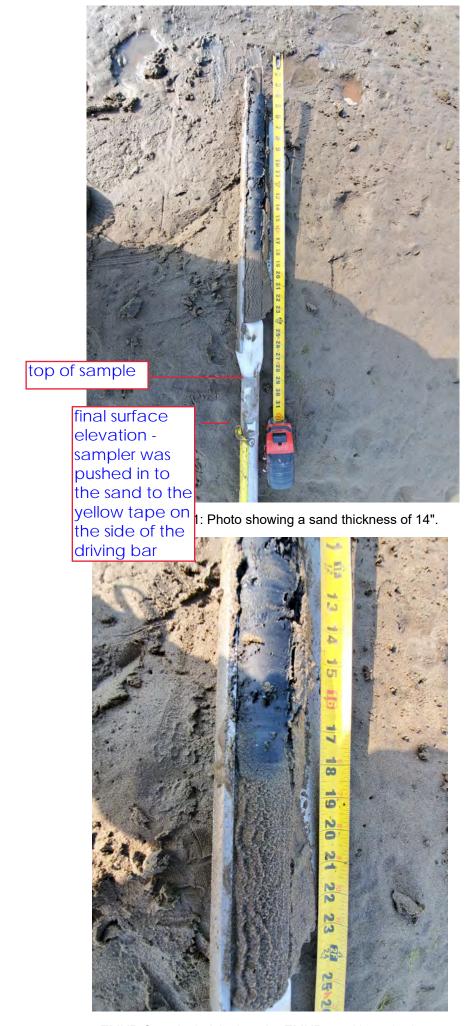
EMNR Sample 1: A look at the EMNR sand layer horizon.

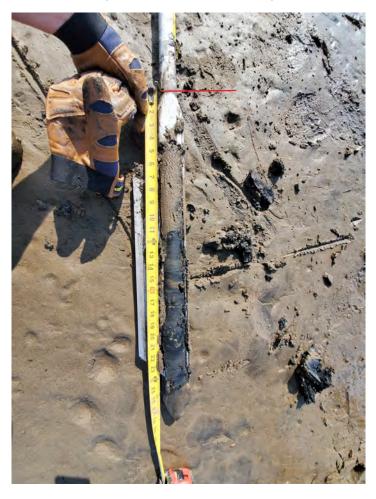
EMNR Sample 2: Photo showing a sand layer thickness of 11".

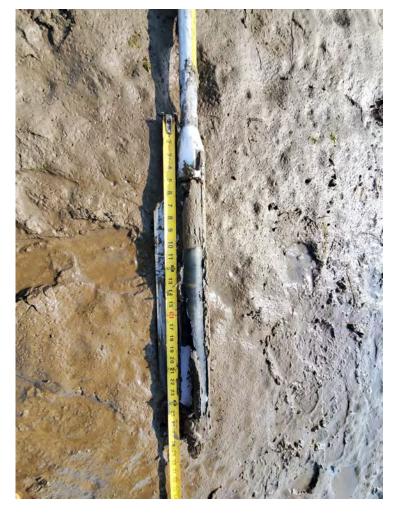
EMNR Sample 3: Photo showing a sand layer thickness of 10".

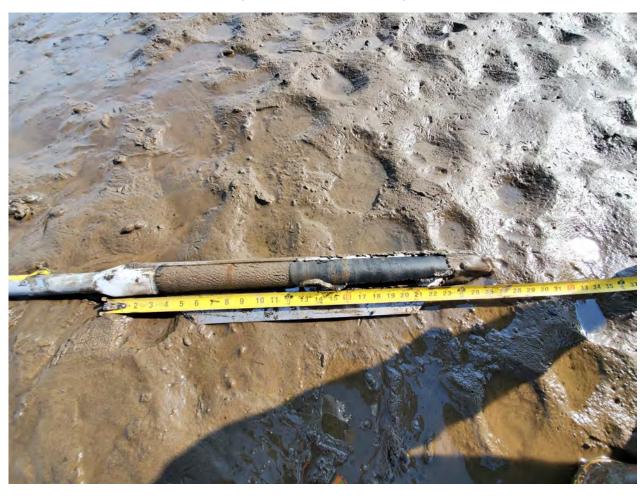
EMNR Sample 4: Photo showing a sand layer thickness of 12".

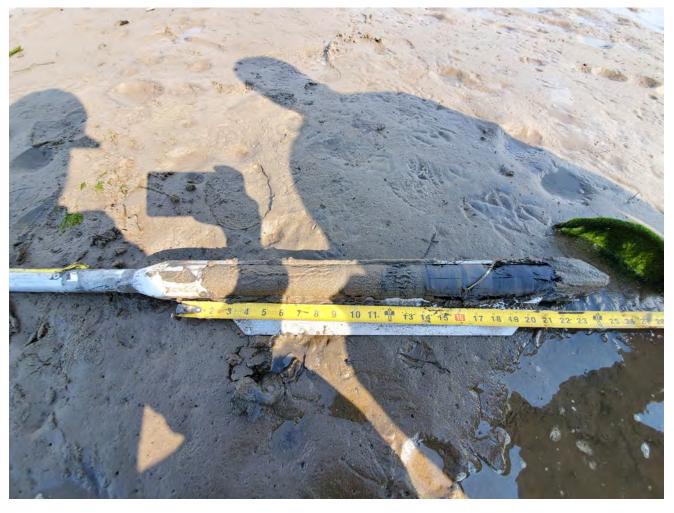
EMNR Sample 5: Photo showing a sand layer thickness of 14".

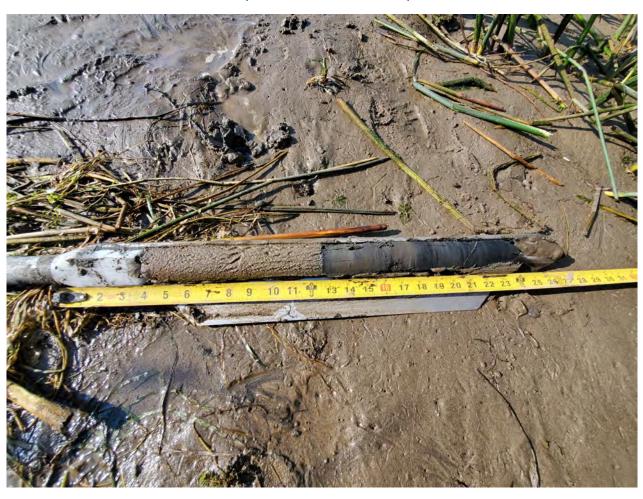
EMNR Sample 6: Photo showing a sand layer thickness of 12.5".

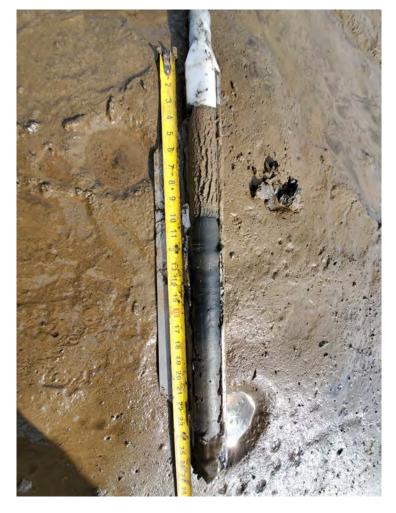
EMNR Sample 7: Photo showing a sand layer thickness of 10".

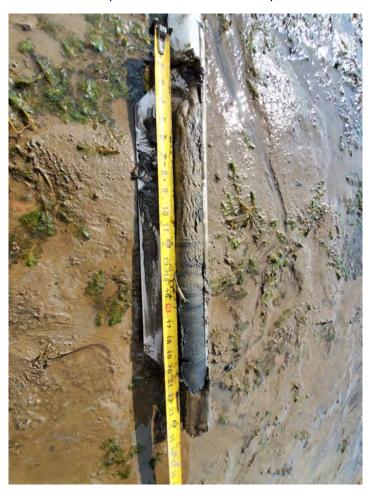
EMNR Sample 8: Photo showing a sand layer depth of 15".

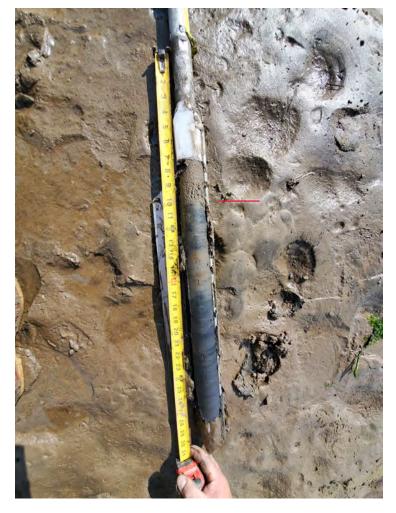
EMNR Sample 9: Photo showing an EMNR layer depth of 10".

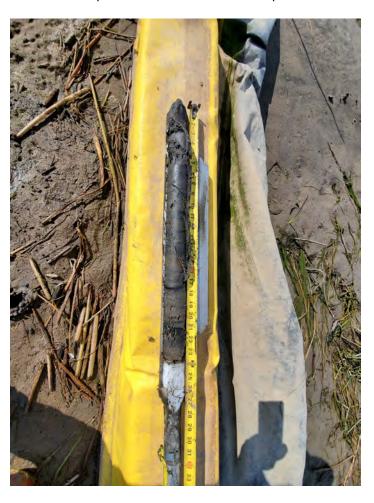
EMNR Sample 10: Photo showing a sand layer depth of 14".

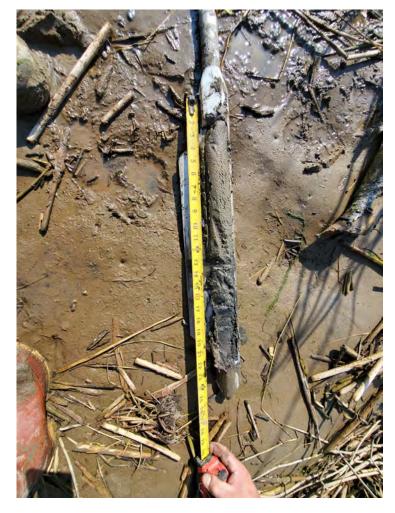
EMNR Sample 10: Photo showing a sand layer depth of 13".

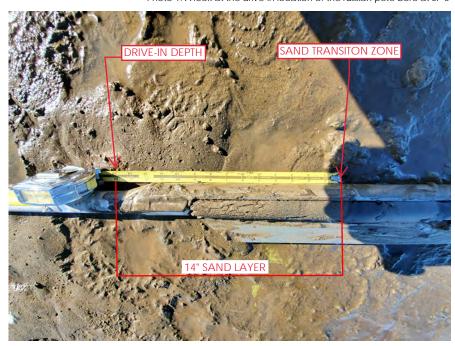
Photo 2: A look at the sampled EMNR Sand profile collected at SP 5, with a depth of approximately 14"

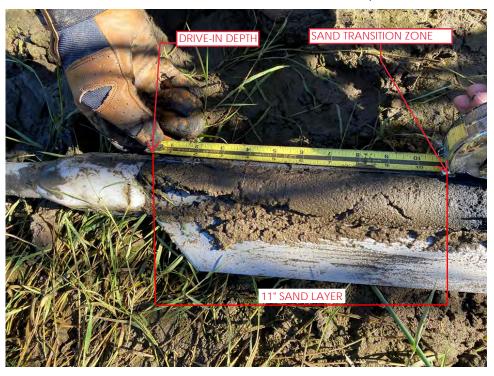
Photo 4: A look at the sampled EMNR Sand profile collected at SP 11, with a depth of approximately 11"

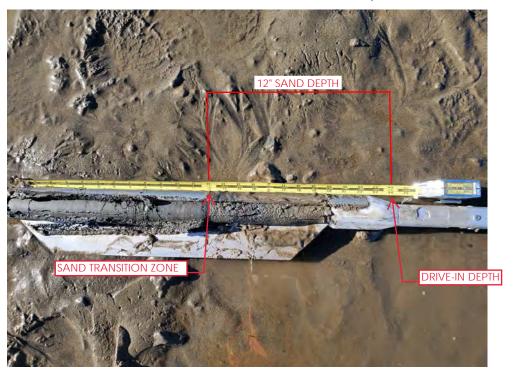
$Photo \ 6: A \ look \ at \ the \ sampled \ EMNR \ Sand \ profile \ collected \ at \ SP \ 12, \ with \ a \ depth \ of \ approximately \ 12"$

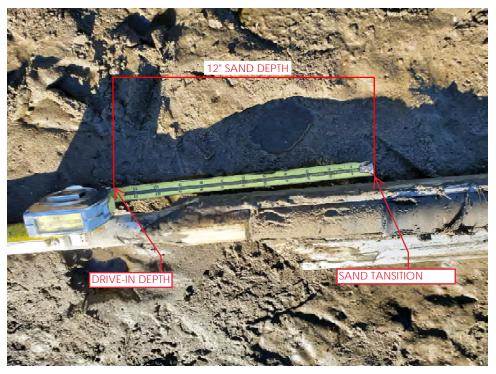
Photo 8: A look at the sampled EMNR Sand profile collected at SP 13, with a depth of approximately 12"

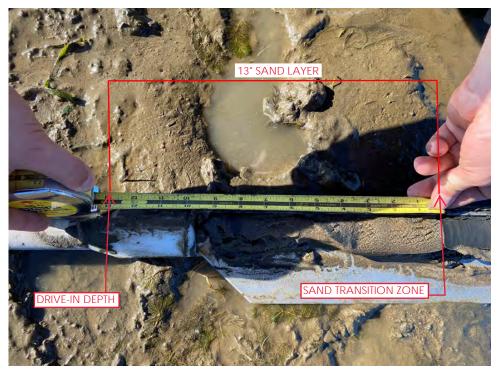
Photo 10: A look at the sampled EMNR Sand profile collected at SP 14, with a depth of approximately 13"

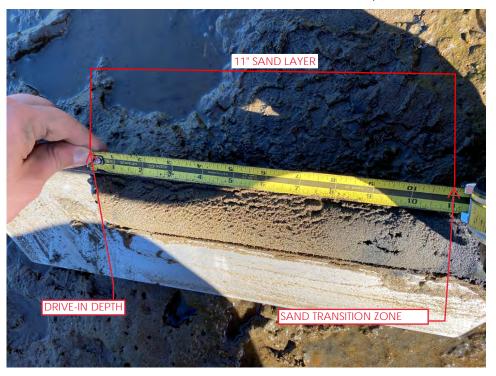
Photo 12: A look at the sampled EMNR Sand profile collected at SP 15, with a depth of approximately 11"

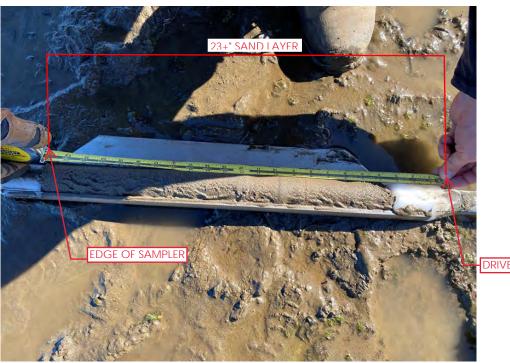
Photo 14: A look at the sampled EMNR Sand profile collected at SP 16, with a depth of over 23" (located within the transition/overlap zone near north dredge area prism)

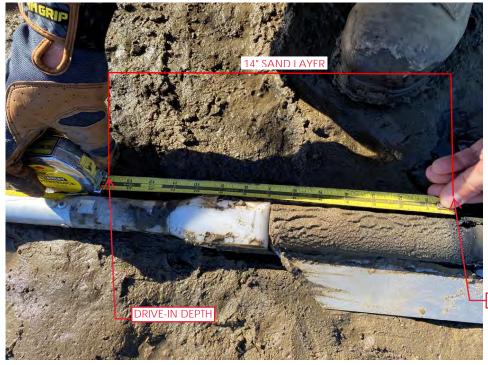
Photo 14: A look at the sampled EMNR Sand profile collected at SP 17, with a depth of approximately 14"

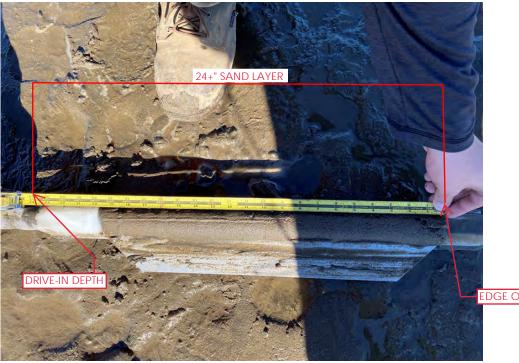
Photo 14: A look at the sampled EMNR Sand profile collected at SP 18, with a depth of over 24" (located within the transition/overlap zone near north dredge area prism)

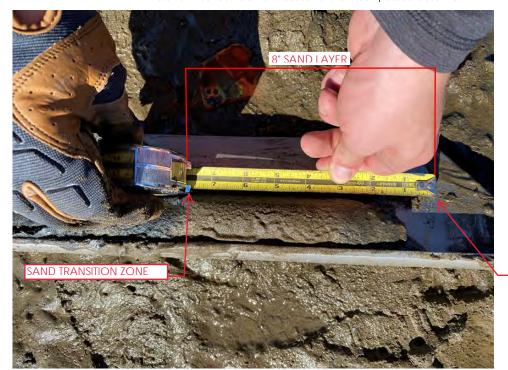
Photo 14: A look at the sampled EMNR Sand profile collected at SP 20, with a depth of approximately 8"

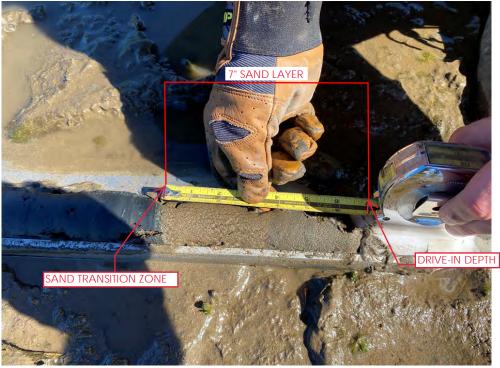
Photo 14: A look at the sampled EMNR Sand profile collected at SP 21, with a depth of approximately 7"

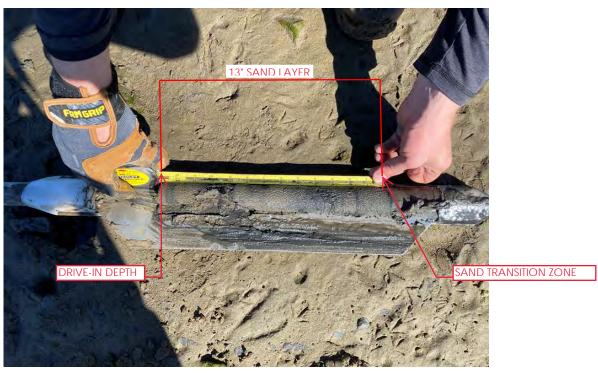
Photo 14: A look at the sampled EMNR Sand profile collected at SP 22, with a depth of approximately 13"

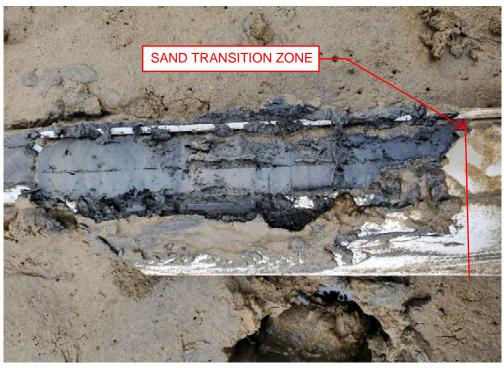
Photo 4: A look at the event horizon (transition zone between sediment and sand) for SP-2

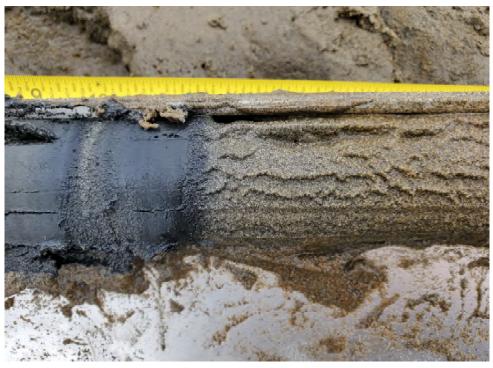
Photo 8: A look at the event horizon (transition zone between sediment and sand) for SP-5

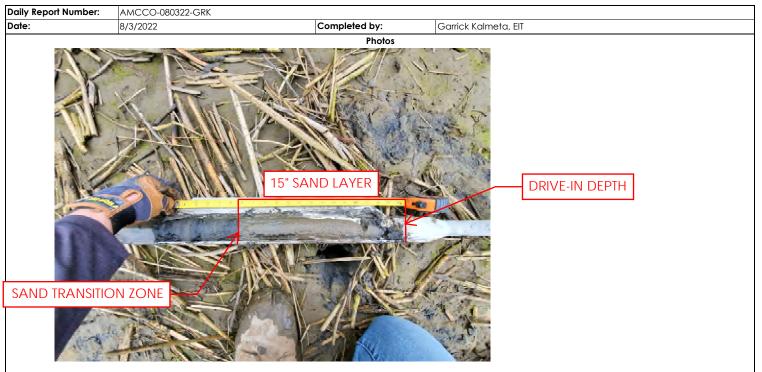
Photo 11: A look at the sampled EMNR Sand profile collected at SP-11, with a depth of approximately 15"

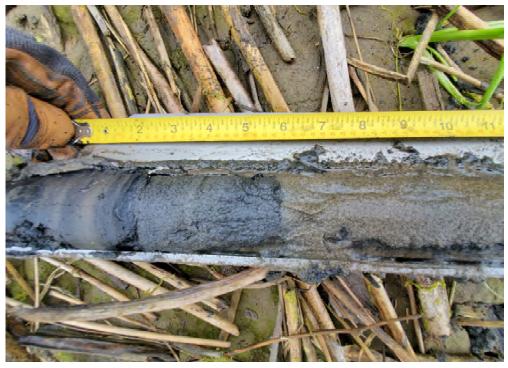
Photo 12: A look at the event horizon (transition zone between sediment and sand) for SP-11

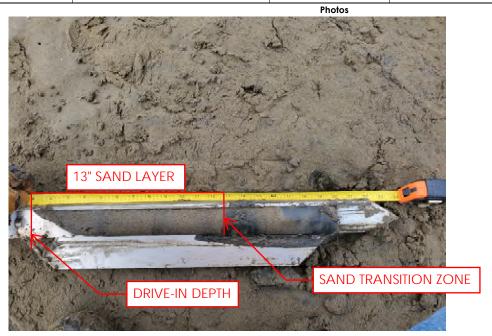
Photo 15: A look at the sampled EMNR Sand profile collected at SP-12, with a depth of approximately 13"

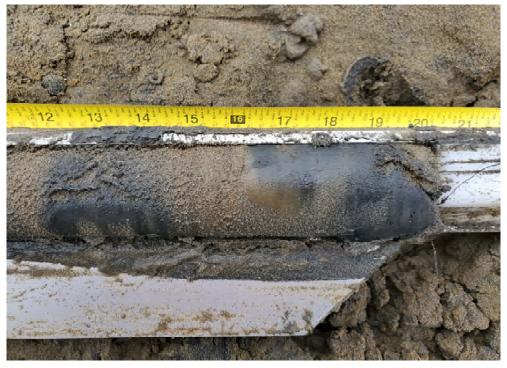
Photo 16: A look at the event horizon (transition zone between sediment and sand) for SP-12

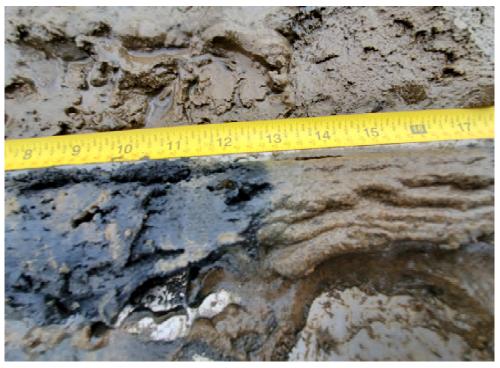
Photo 20: A look at the event horizon (transition zone between sediment and sand) for SP-14
