APPENDIX F MARINEWAY#3 REMEDIATION SUMMARY MEMO

RE: Marine Way #3 Remediation Summary

CONSTRUCTION DAILY REPORT AMCCO Upland and Sediment Remediation Project

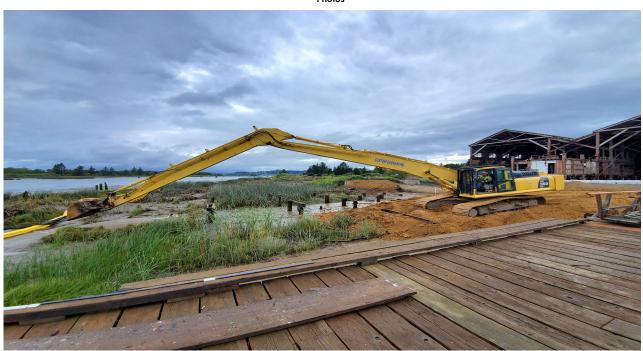
Photo 1: Custom Excavating beginning dredging work at marine way 3. Long reach excavator is operating on a temporary operation pad that was constructed with clean dike material.

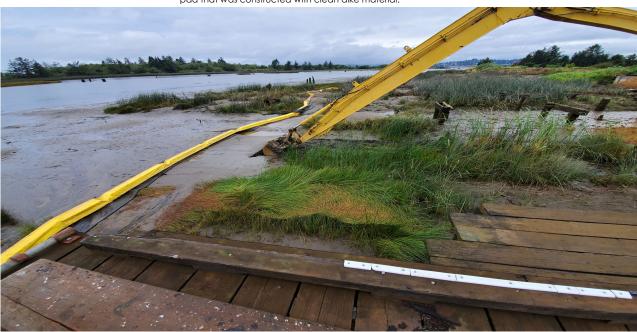
Photo 2: Custom Excavating removing top layer of sediment located above the marine way 3 rail support structure at the western most end of the dredge area

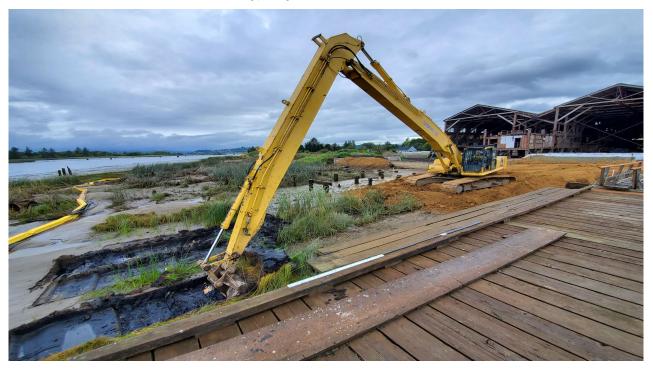
Photo 4: The top layer of sediment being removed in the western third portion of marine way 3

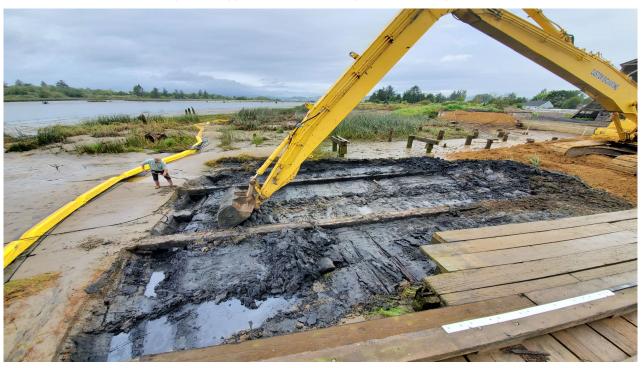
Photo 6: Custom Excavating removing sediment between the rail support structure

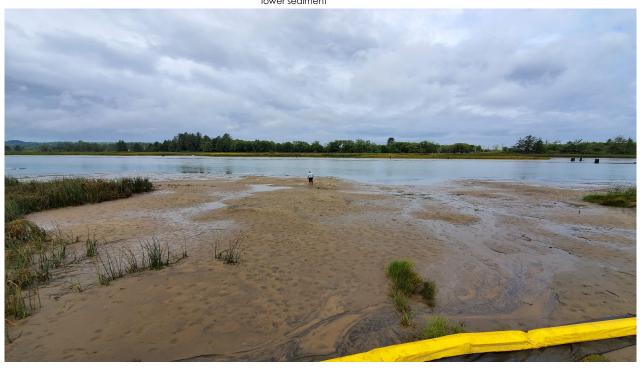
Photo 8: A look at the previously placed EMNR sand layer west of marine way 3 dredge area during low tide

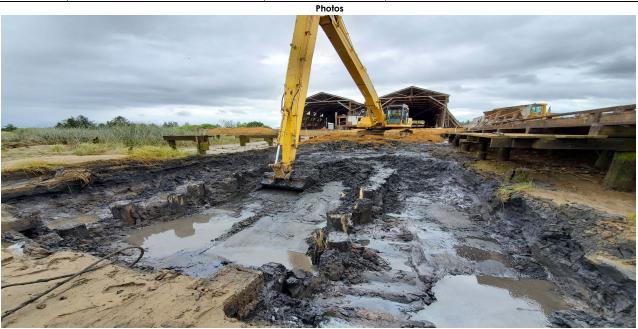
Photo 9: Custom Excavating dredging between pilings in marine way 3

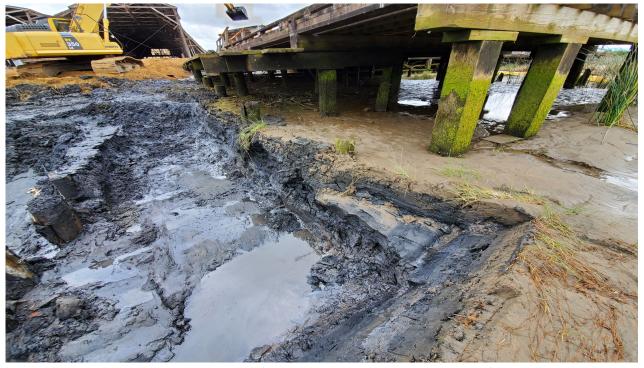
Photo 10: A look at the southern extents of the marine way 3 dredge area, along walkway platform

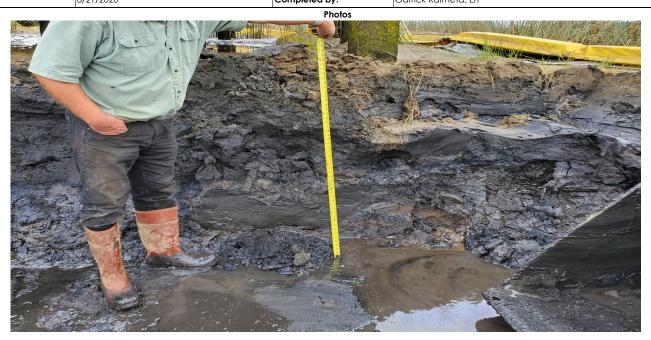
Photo 11: A dredge depth of 4 feet at the southern extents of marine way 3 dredge area

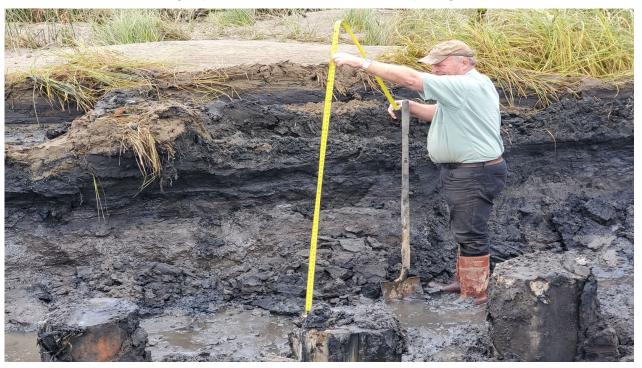
Photo 12: Measured dredge depth of approximately 5 feet at the north edge of marine way 3 dredge area

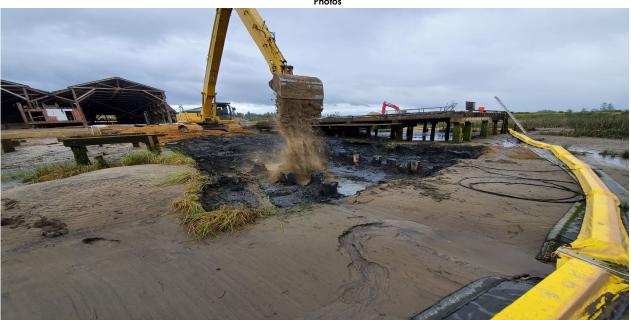
Photo 13: Custom Excavating backfilling marine way 3 dredge area with clean sand. Existing untreated pilings, that are approximately 18-inches apart, left in place and will have up to 18-24 inches of clean sand cover

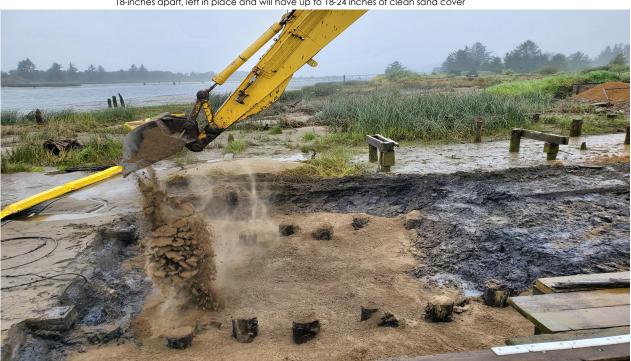
Photo 14: Custom Excavating backfilling marine way 3 dredge area with clean sand

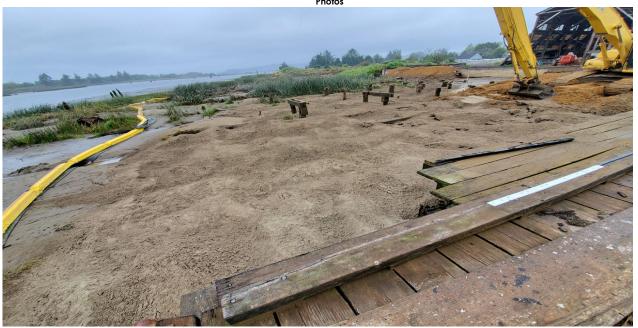
Photo 15: The work area covered with clean layer of sand. Placement of clean sand overlapped previously placed EMNR Sand Layer by couple feet.

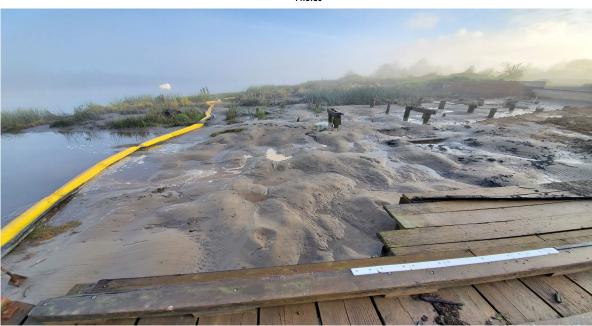
Photo 1: Clean sand-backfilled western most section of MW#3 dredge area

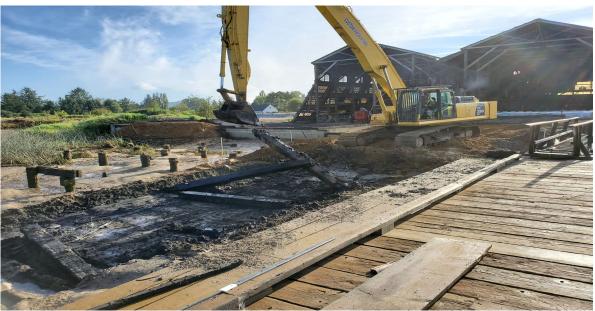
Photo 2: Custom Excavating removing wooden beams that had supported the former rail system for sediment excavation at the central portion of MW#3 dredge area

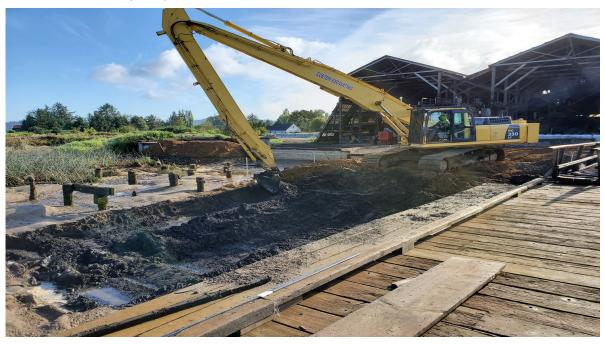
Photo 4: Custom Excavating dredging central portion of MW#3 dredge area

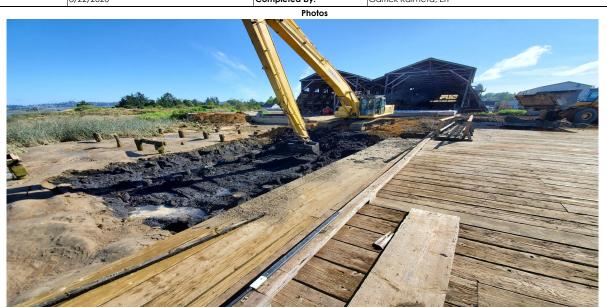
Photo 7: Custom Excavating excavating sediment at MW#3 dredge area, left-in-place, non-treated pilings are approximately 2 feet apart, and sticking up approximately 2 feet from the bottom of the excavation

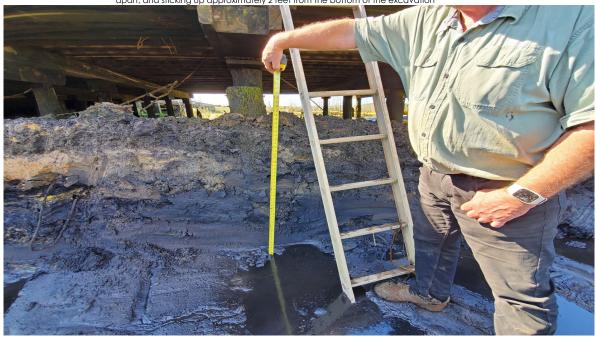
Photo 8: Depth of the southern dredged portion of MW#3, adjacent to walkway, measuring approximately 42 inches

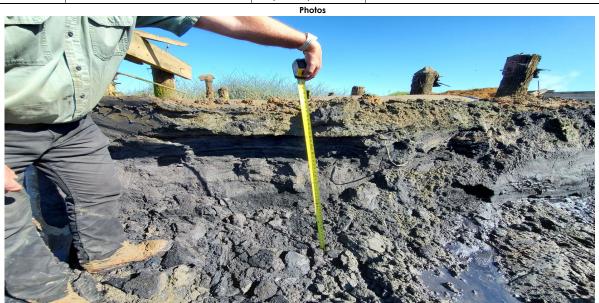
Photo 9: Measuring approximately 44-inches from the bottom of the excavation to the adjacent existing surface at north edge of MW#3 dredge area

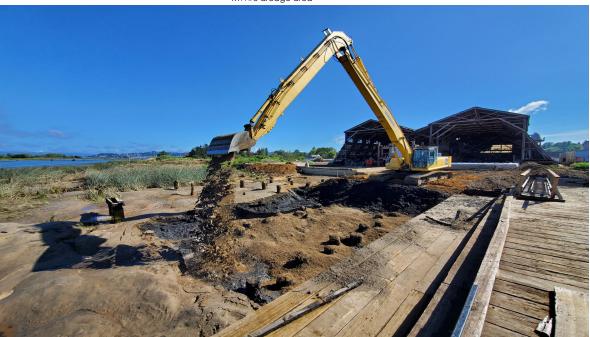
Photo 10: Custom Excavating backfilling dredged section of MW#3 dredge area with clean sand

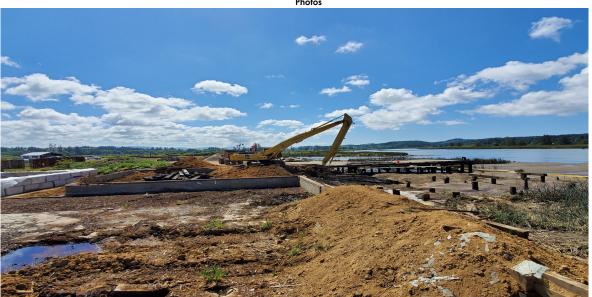
Photo 13: Custom Excavating dredging eastern portion of MW#3 dredge area, looking south from north section of existing dike wall

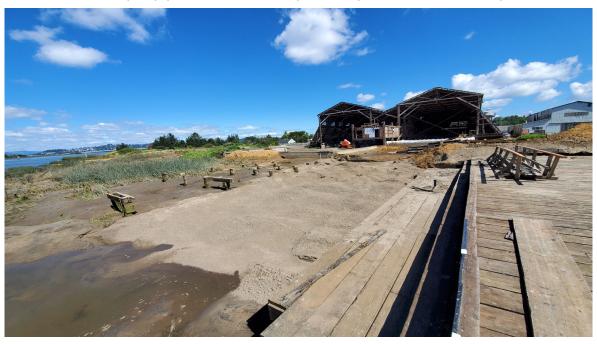
Photo 14: 2/3 of MW#3 dredge area final surface: backfilled and received EMNR Sand layer

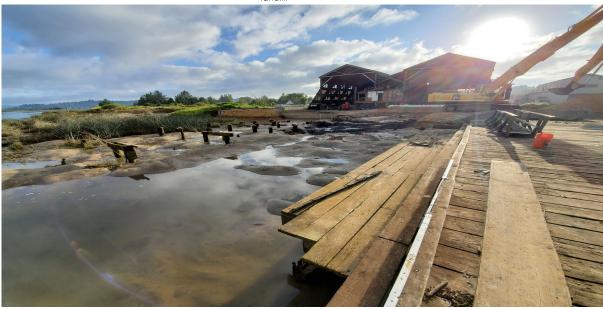
Photo 2: MW#3 progress view showing backfilled sand on the western two third, eastern third remaining to be dredged and backfill

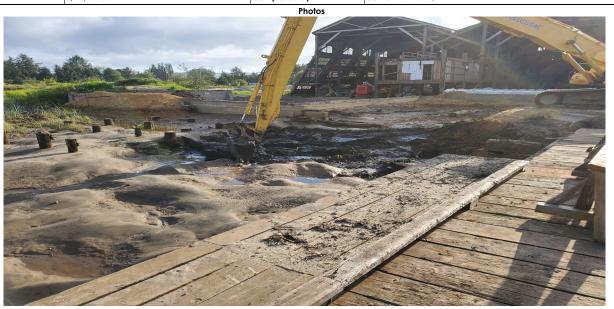
Photo 3: Custom Excavating started working on sediment excavation at the eastern third of MW#3 dredge area

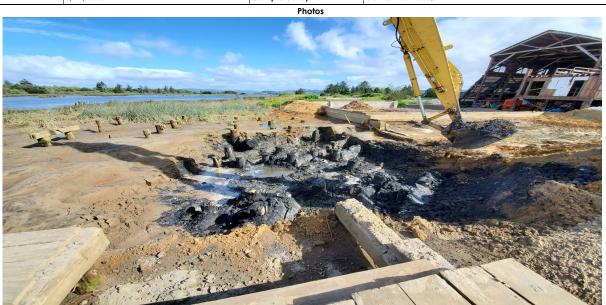
Photo 5: Custom Excavating eastern third of MW#3 dredge area, excavating between existing pilings that are approximately 18-24"

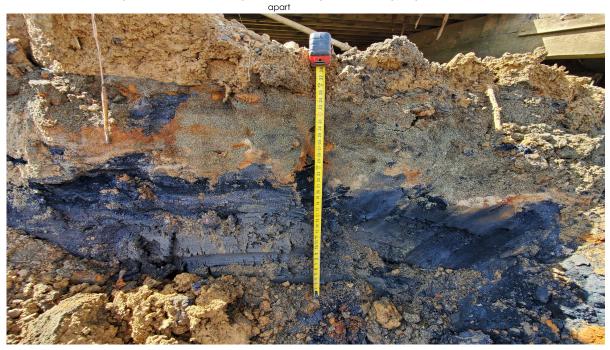
Photo 6: Measuring approximately 38-inches of excavation depth at south edge of dredge area, by walkway

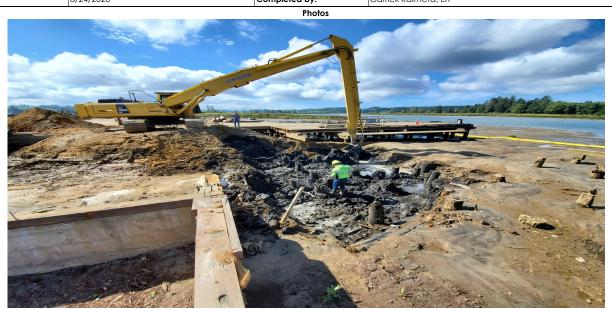
Photo 7: Custom Excavating removing sediment between existing pilings with the help of manual labor within the dredge boundary

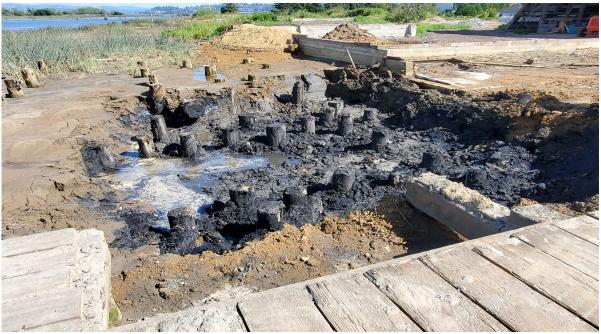
Photo 8: Bottom of sediment excavation at MW#3, untreated pilings terminate approx. 18-24 inches from the bottom, will receive 24-30 inches of clean sand cover

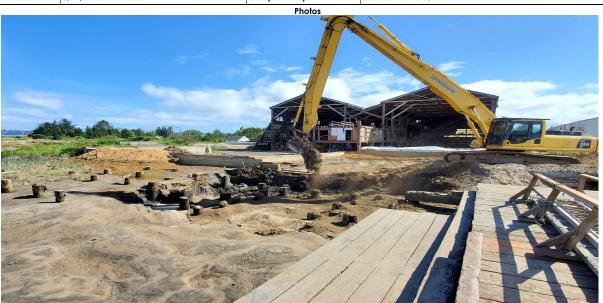
Photo 9: Custom Excavating backfilling eastern most section of the dredged area with clean sand, temporary clay work platform has been removed

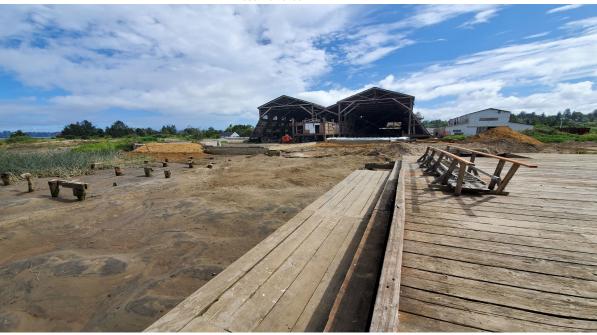
Photo 10: Final Surfacing at MW#3 Dredge Area: dredge and backfill work completed
