# AMCCO REMEDIAL ACTION CONSTRUCTION COMPLETION REPORT

ASTORIA MARINE CONSTRUCTION COMPANY  
ECSI NO. 1898

ASTORIA, OREGON  
*January 25, 2024*  
*Project No. M1653.01.002*

*Prepared by*  
*Maul Foster & Alongi, Inc.*  
*3140 NE Broadway Street, Portland, OR 97232*

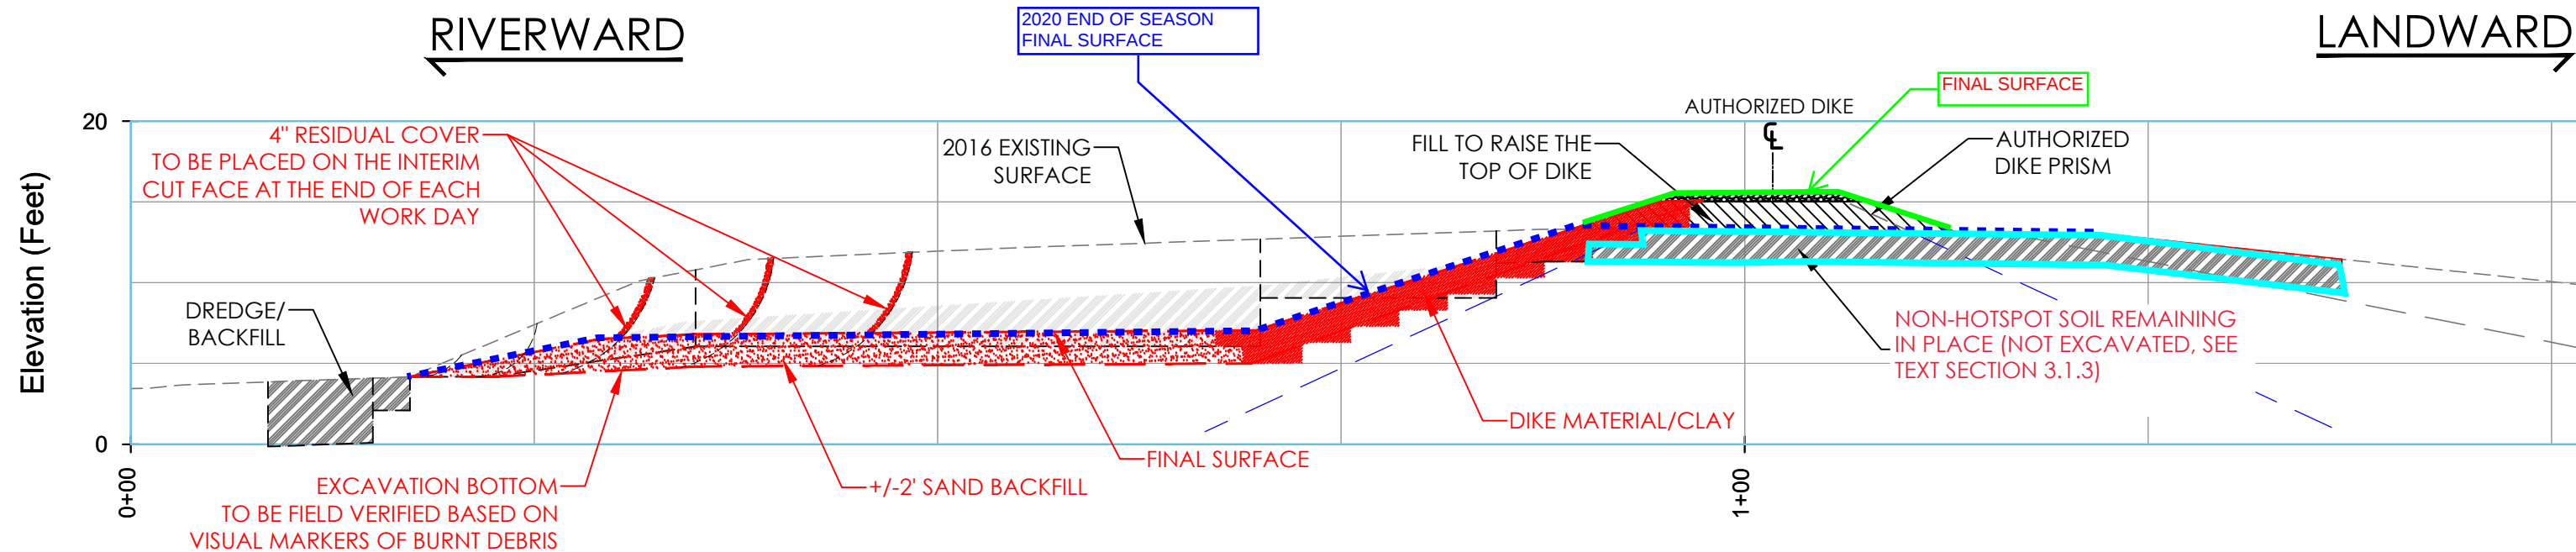
FIGURE 2-1 BURN PIT EXCAVATION DETAIL

During initial excavation, it was discovered the burnt debris extended past the originally anticipated 3-foot depth, to more than 6 feet below the preconstruction grade. All excavated material was transported and placed in the north sediment containment area via a front-end loader that was loaded by the excavator. The excavated bottom was dark brown to gray color with no significant odor. The subgrade soils were generally consistent with the material that had been observed at the bottom of the sediment excavation at the toe of the dike.

The Former Burn Pit Area Excavation bottom was approximately 36 inches below grade and tied into the sediment hot spot excavation bottom at the toe of the dike. The resulting excavation removed over 10 feet of material from the dike surface. Excess soil and debris were physically removed from the excavator bucket over the excavation, before beginning backfill operations. The excavation subgrade (i.e., newly exposed dike) was stair-stepped in accordance with dike restoration plans and backfilled with clean clay, as shown in Figure 2-1.

Figure 2-1 shows the Burn Pit excavation reflecting the daily residual covers and the sand-to-dike material transition.

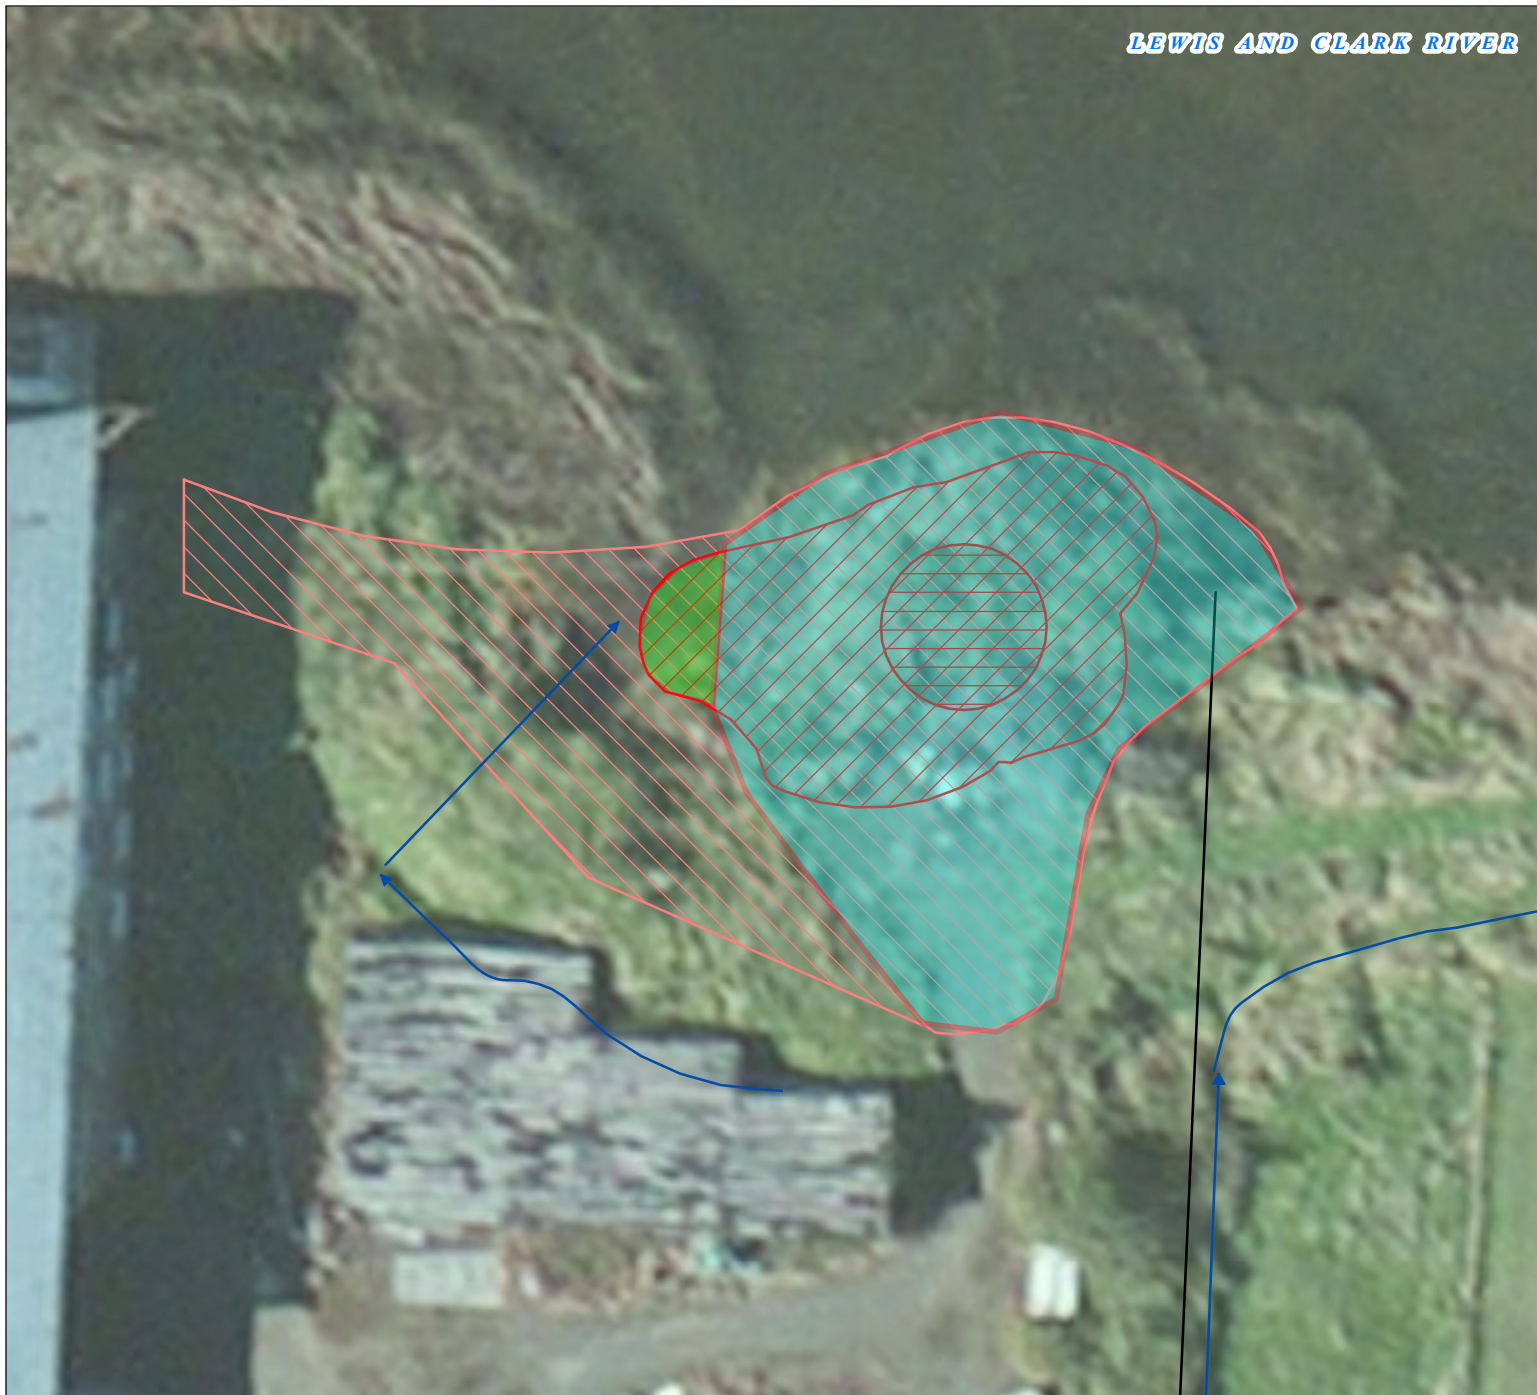
# FIGURE 3-1

Prior to the former Burn Pit area excavation, a test pit was excavated to establish the northern excavation limit prior to hot spot excavation. The test pit showed that there was a significant amount of burnt debris at the northern corner of the hot spot (extending outside the excavation boundary defined by the remedial investigation). The excavated area was backfilled with sand to allow time for review with the DEQ.

The DEQ and MFA reviewed the photos of the excavated material (approximately 5 cy of burnt debris had been removed and stockpiled at the north containment area). MFA and the DEQ agreed that the burnt debris buried under the Burn Pit was the most critical environmental concern on the Site and that the burnt debris material needed to be removed to the maximum extent practicable.
