PHASE I ENVIRONMENTAL SITE ASSESSMENT

4.212-ACRE INDUSTRIAL PROPERTY
5605-5621 Northeast 105th Avenue
Portland, Multnomah County, Oregon 97220

Prepared for:
Crest Partners

January 25, 2023
Project Number: CRPTCA003.05

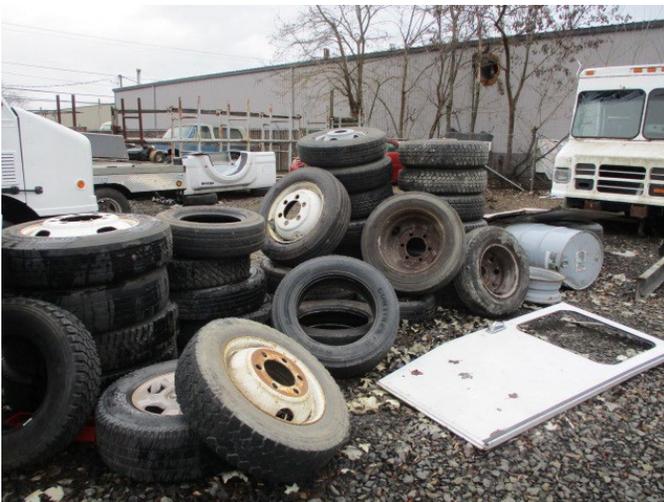
PHOTOGRAPH 11

- **Hazardous Substances:** Blackstone observed used tires, engine parts, a 55-gallon drum (labeled as Mercedes Benz Genuine Engine Oil that appeared to be empty), and numerous 5-gallon buckets of hydraulic oil on the ground surface throughout the subject property storage yard. Considering Blackstone observed no physical evidence of spills or releases related to these specific materials, the observed on-site hazardous substances are not considered a REC. However, Blackstone recommends properly storing (i.e., with secondary containment and/or spill protection) and/or disposing of these materials in accordance with all applicable regulations.

Tires and a 55-gallon oil drum (possibly empty) stored on the ground (southeast part of storage yard)

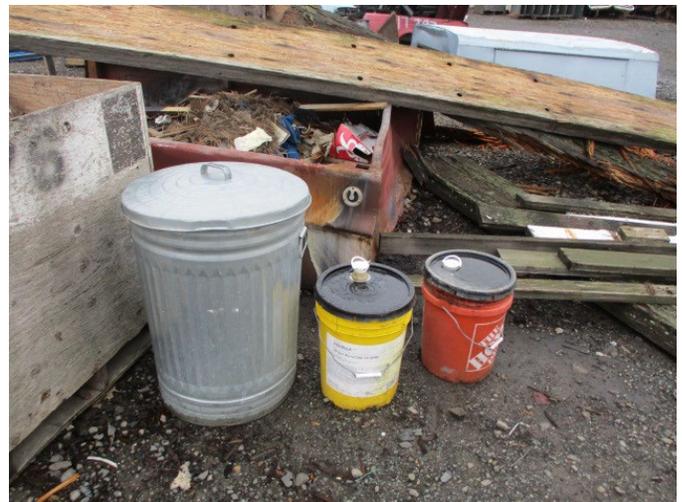
PHOTOGRAPH 12

5-gallon oil buckets stored on the ground (north part of storage yard)

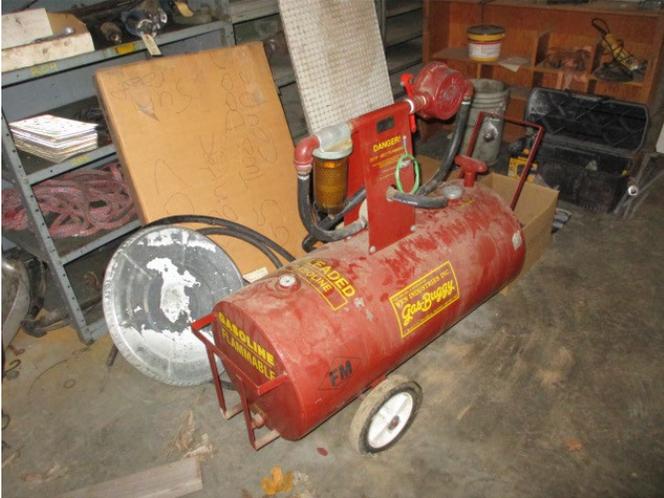
PHOTOGRAPH 13
Portable AST for unleaded gas

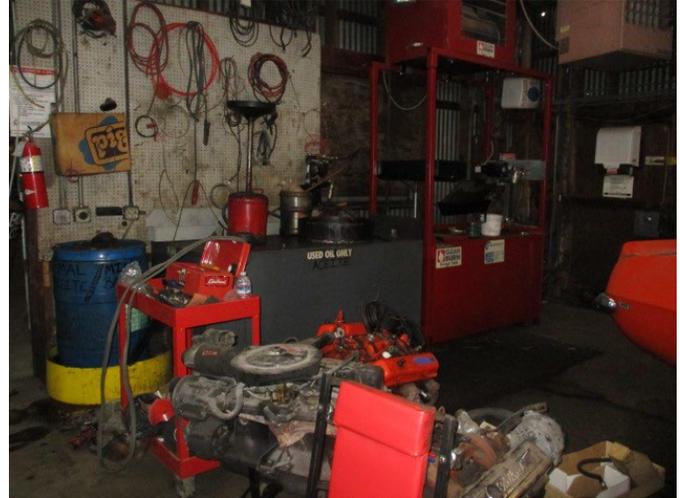
PHOTOGRAPH 13
Two used oil ASTs (reportedly empty) and one 55-gallon drum of "milky" oil

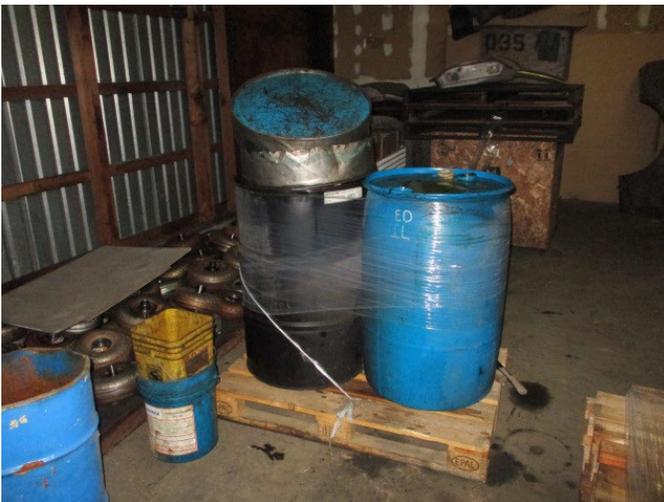
PHOTOGRAPH 15
Storage of 55-gallon drums of oil on pallets in the warehouse

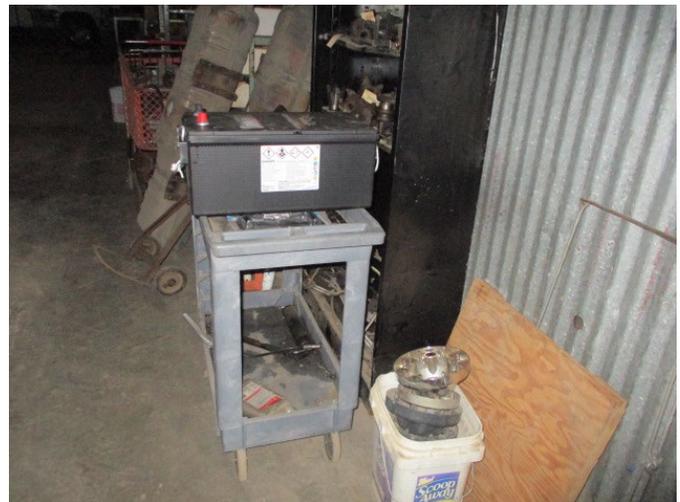
PHOTOGRAPH 16
Automobile batteries

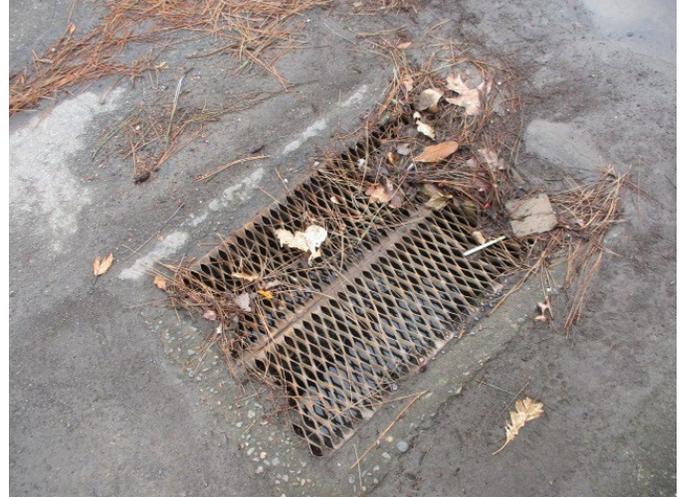
PHOTOGRAPH 22
Storm drain in the parking area near the office

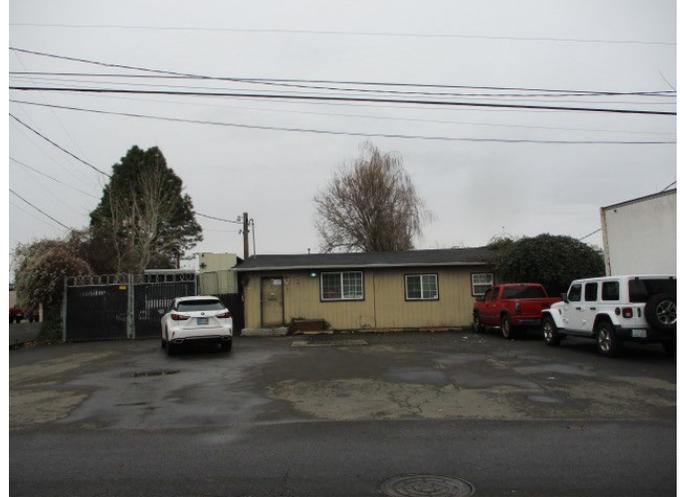
- **Current/Prior Use of Adjoining Properties:** Recycling operations (including metal recycling) have been identified at the west-southwest adjoining property since the 1970s, and the south adjoining property since the early 2000s. Regulatory listings associated with the west-southwest adjoining property identified hazardous waste generation and management (before the establishment of modern regulations), and ODEQ involvement recommending further investigation. Blackstone encountered no evidence of comprehensive environmental investigations into historical adjoining property uses from ODEQ online resources; therefore, based on the inferred groundwater flow direction to the north-northeast (toward the Columbia River) and the close proximity to the subject property, the use of the south and west-southwest adjoining properties as recycling facilities are considered a REC.

PHOTOGRAPH 30
South adjoining metal recycler

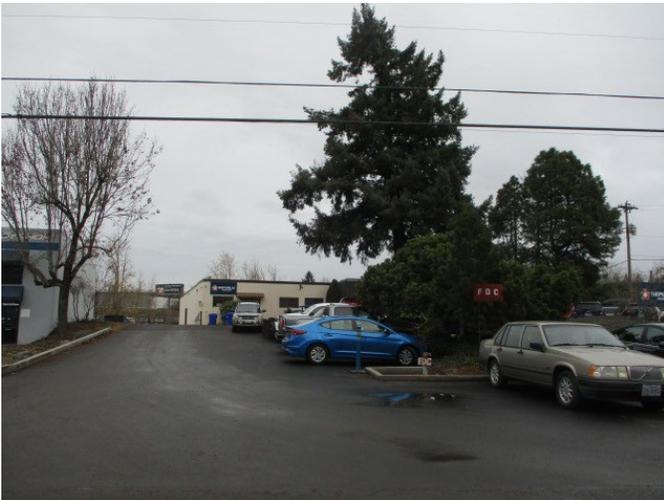
were reported; however, Mr. Gossett stated that it was from the southwest adjoining Republic facility improperly hosing down their waste bins, and trucks and the run-off coming on his property, and he indicated that the issue has been resolved (no sampling has been conducted in the past 2-3 years).

PHOTOGRAPH 31
West-southwest adjoining Republic Services facility
