PHASE 1 ENVIRONMENTAL SITE ASSESSMENT

**OCHOCO LUMBER COMPANY
200 SE COMBS FLAT ROAD
TAX LOTS: TOWNSHIP 15S, RANGE 16E,
SECTION 4B - 7200, 7300, 7101, SECTION 4C - 2900
PRINEVILLE, CROOK COUNTY, OREGON 97754**

Project Number O002-1

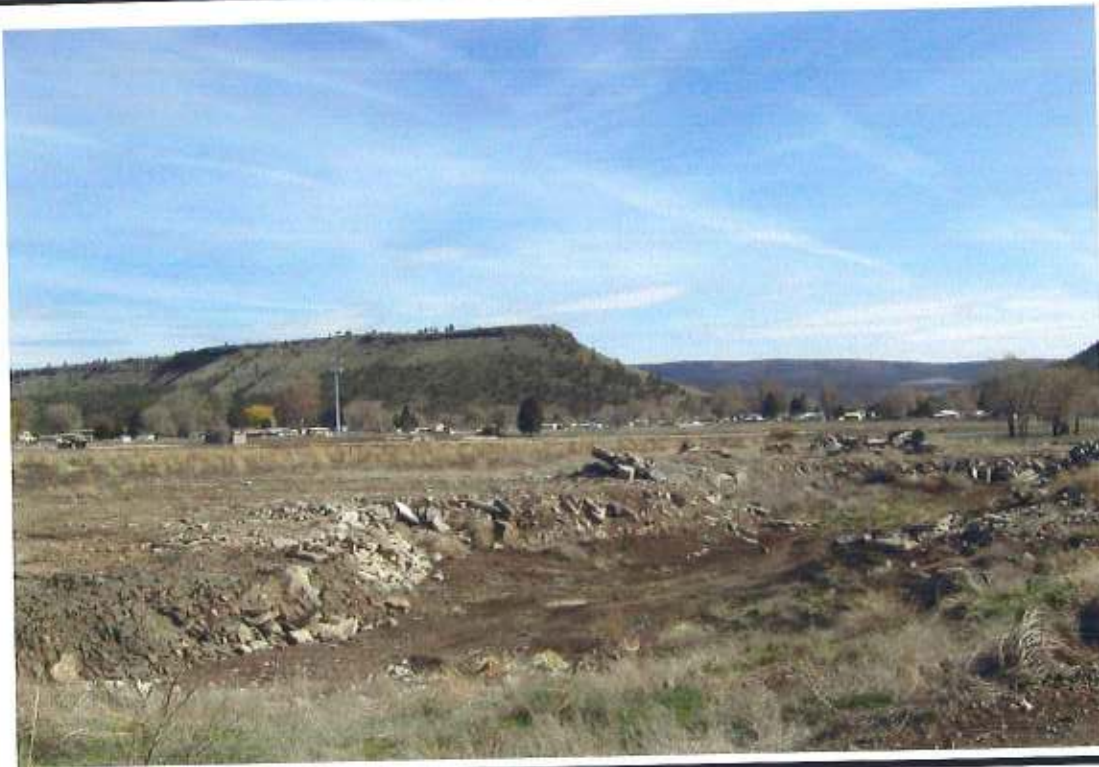
View of former log pond filled with rubble from the northwest.

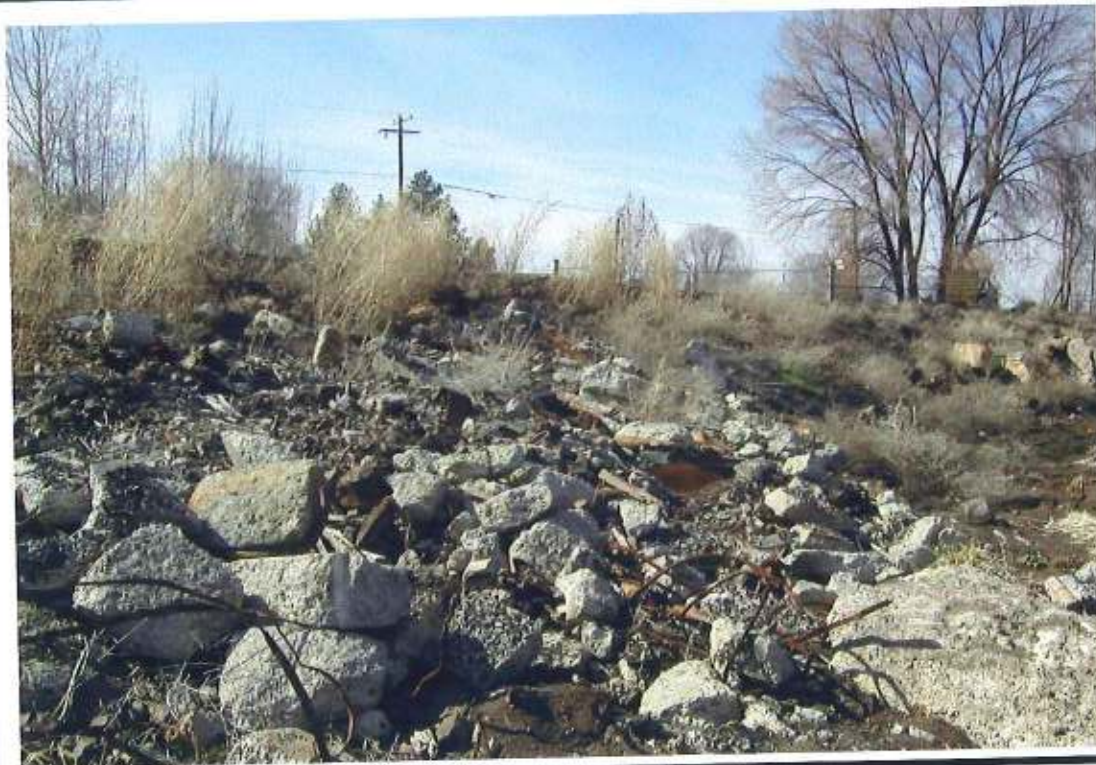
Detailed view of concrete rubble used as log pond fill materials.

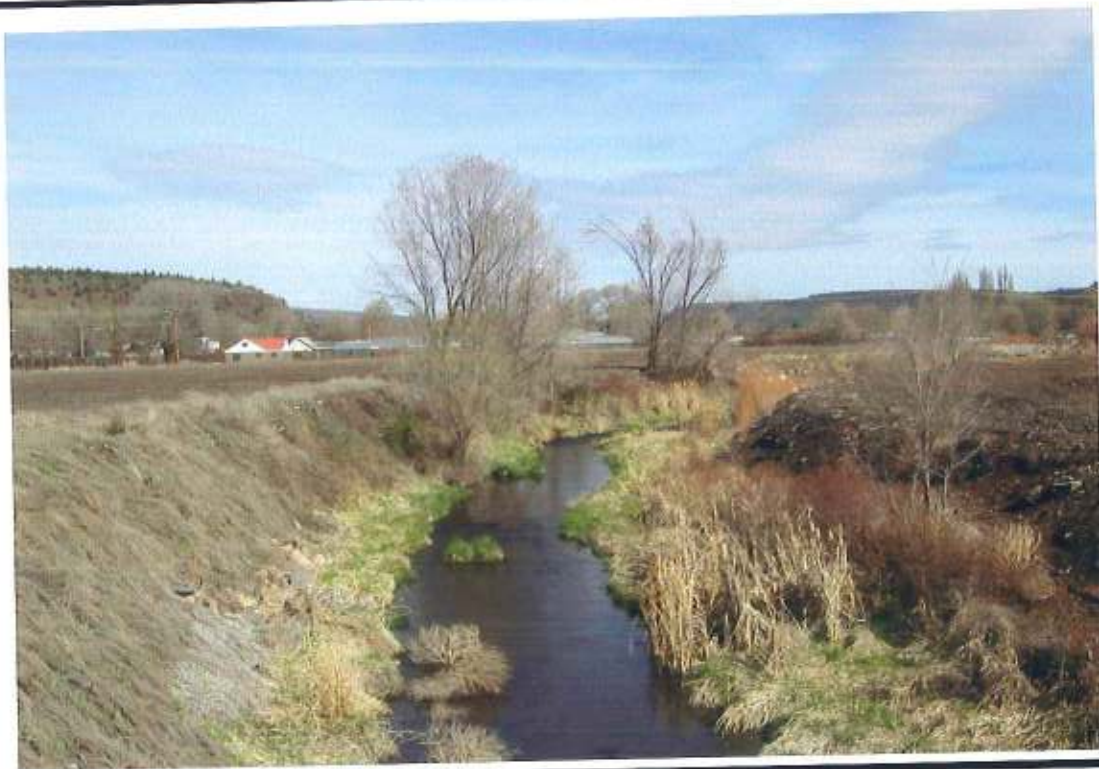
View of fill materials along Ochoco Creek.

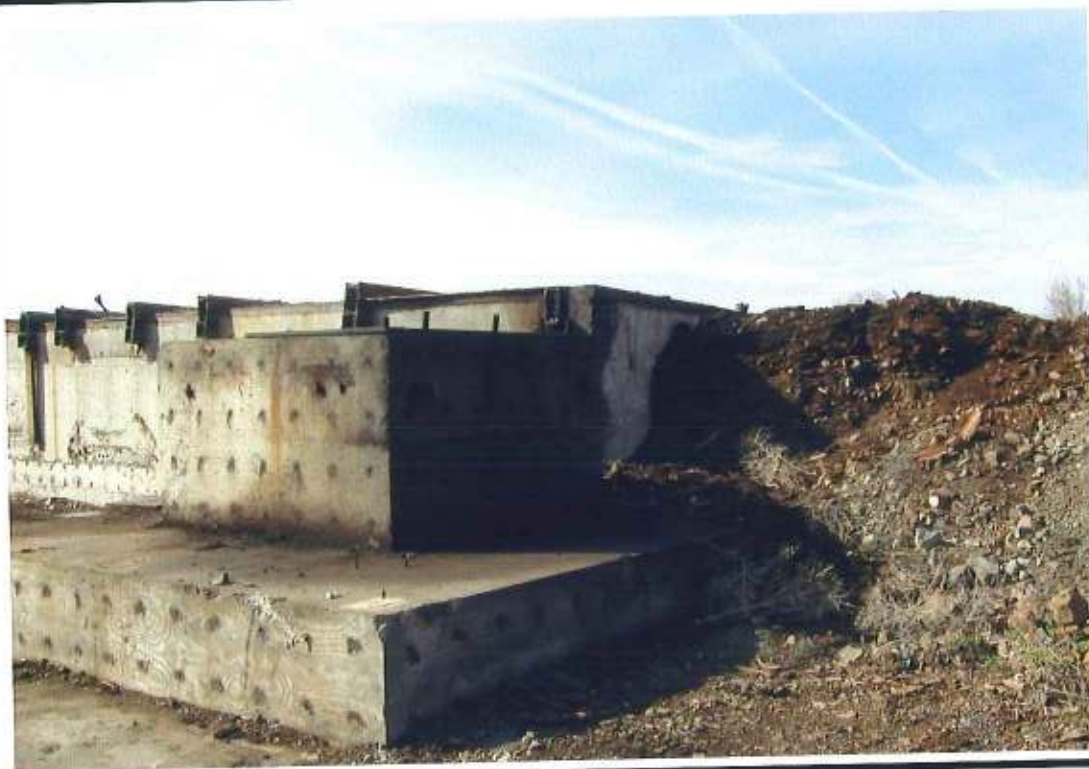
Detailed view of heavily stained concrete at former Small Log Mill debarker.

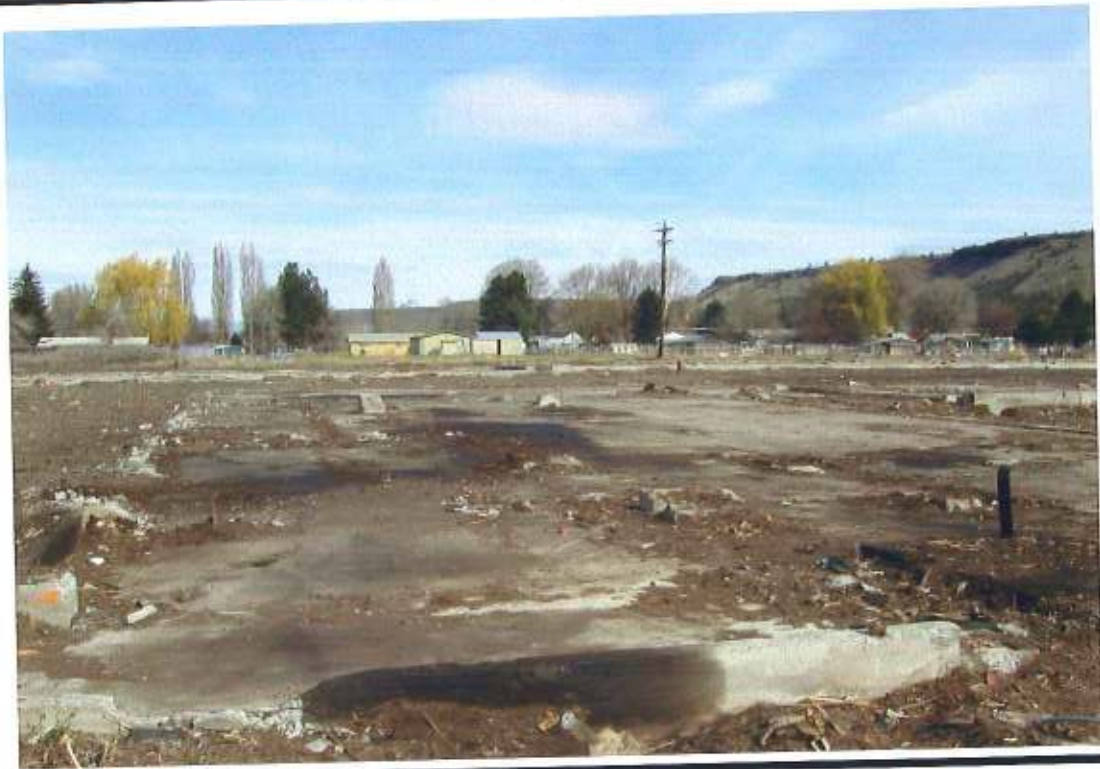
View of heavily stained foundations and soil at the former Green Chain.

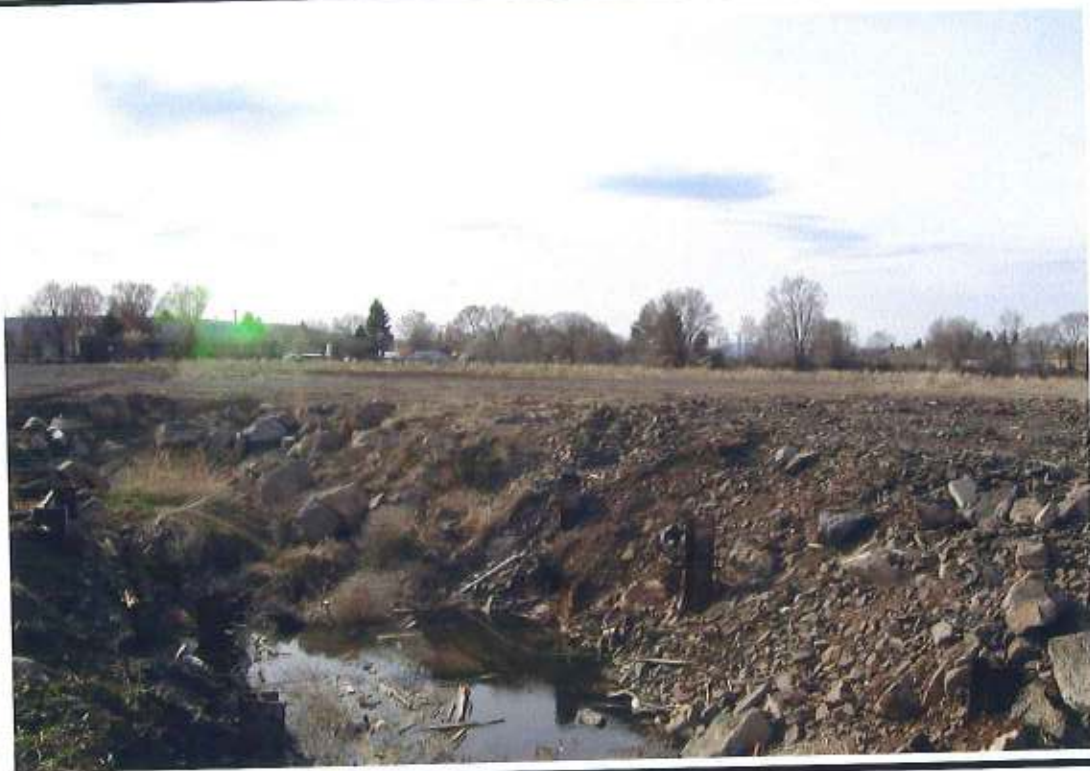
View of former log intake area of the Large Log Mill at the former Log Pond.

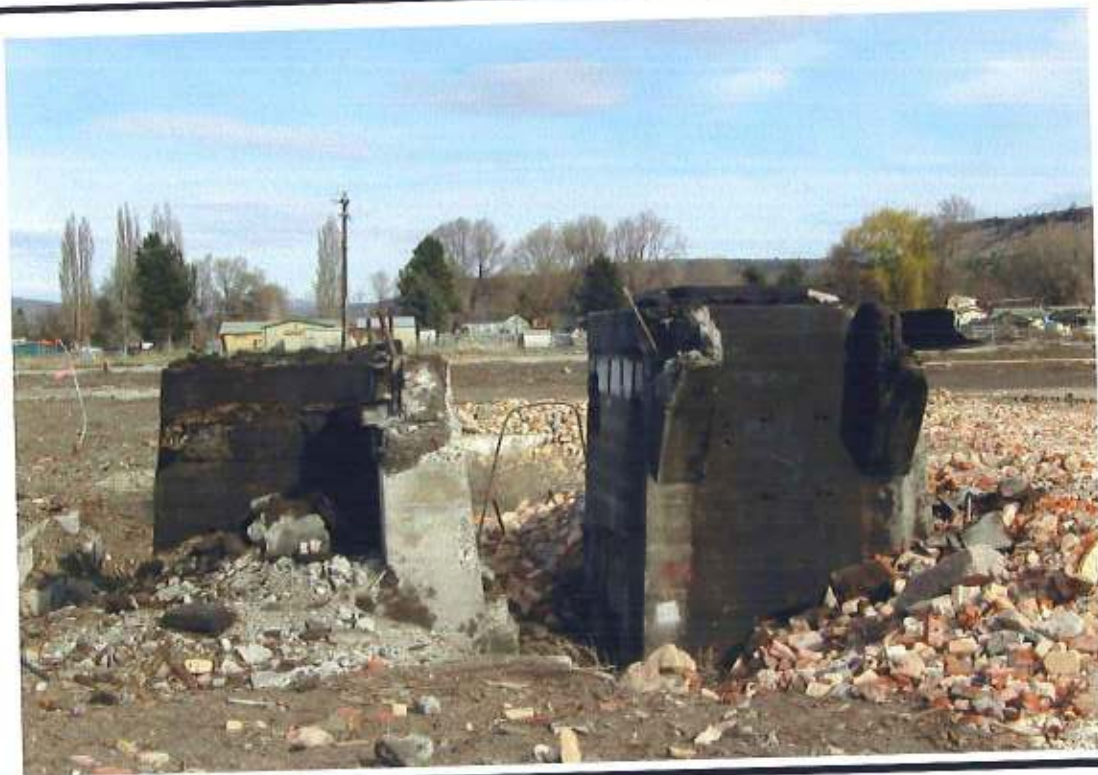
View of heavily stained foundations and soil at the former Powerhouse.

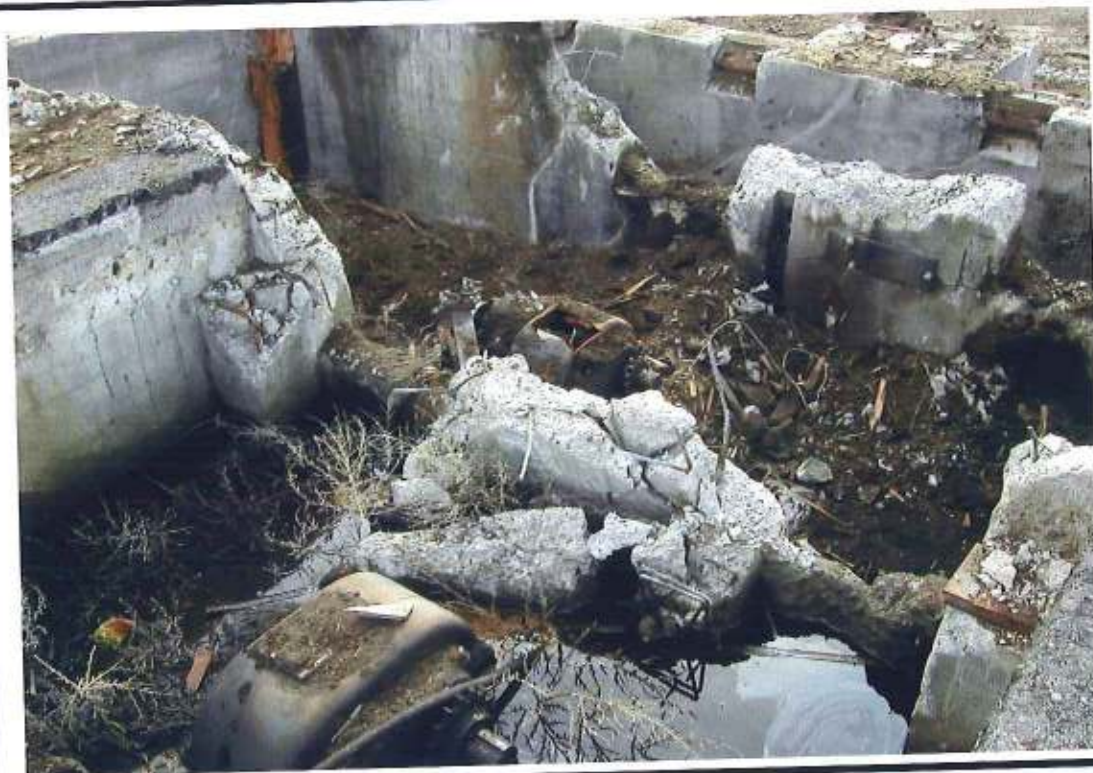
View of impacted soil and water present in the former Bull Chain Motor Shed.

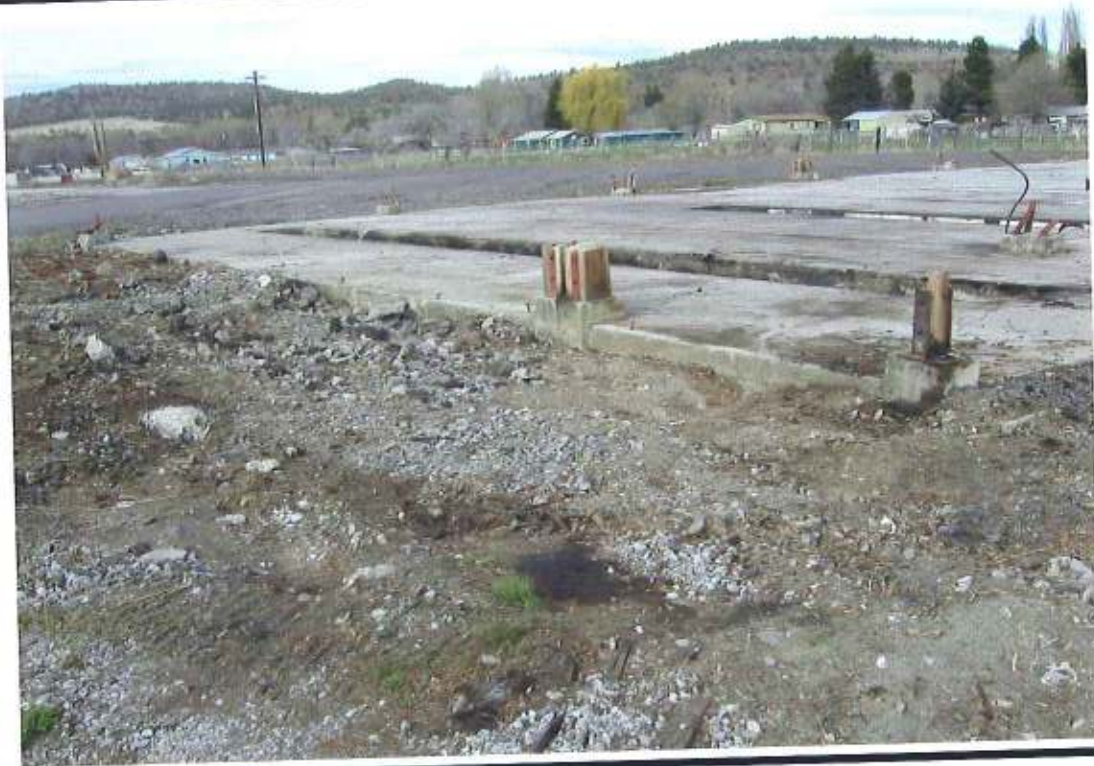
View of stained soil and mechanics trenches at former Truck Shop.

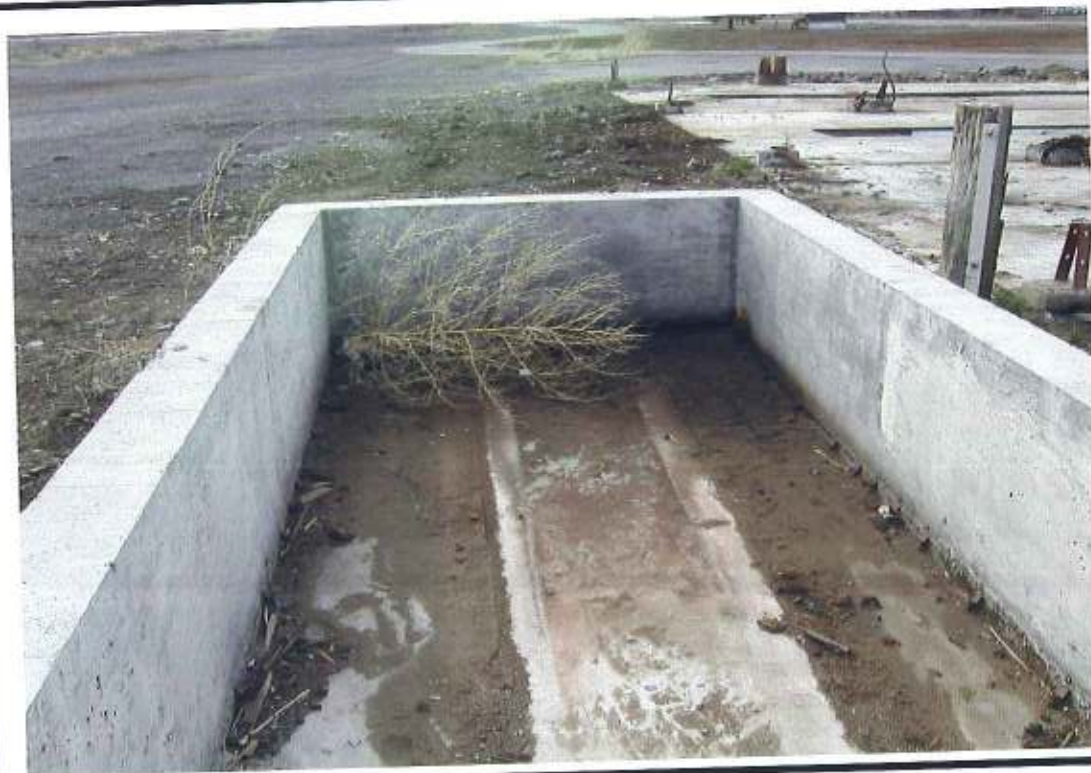
View of concrete containment basin at the former Truck Shop.

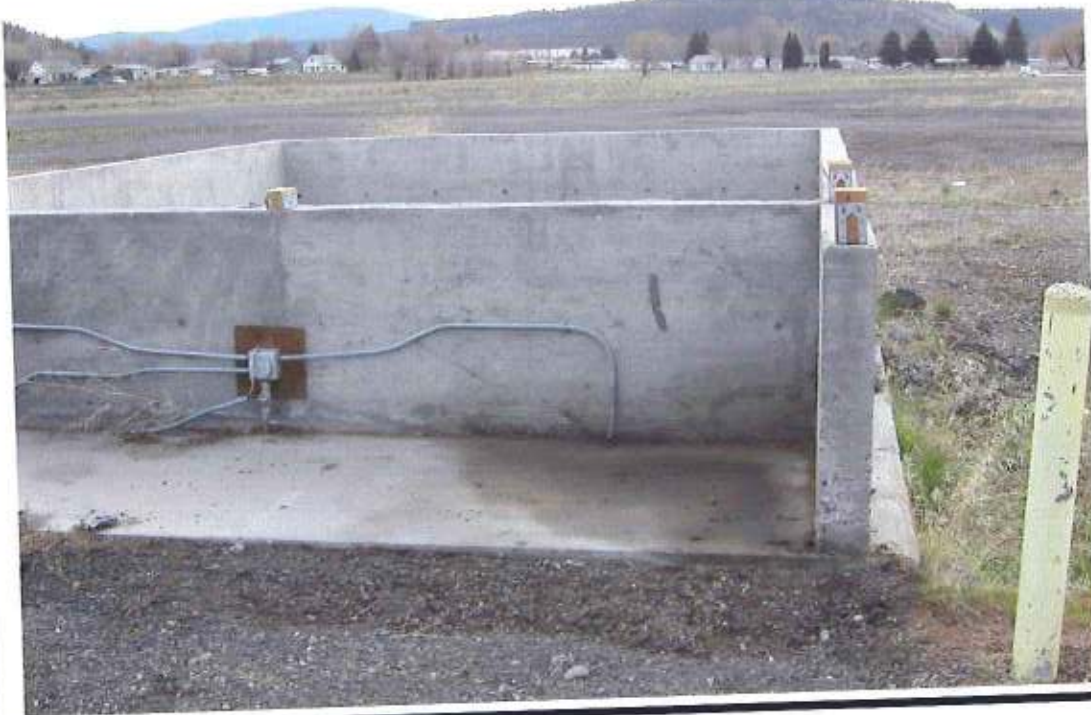
View of stained soil suspected to be associated with product overfilling at the AST concrete containment basin.

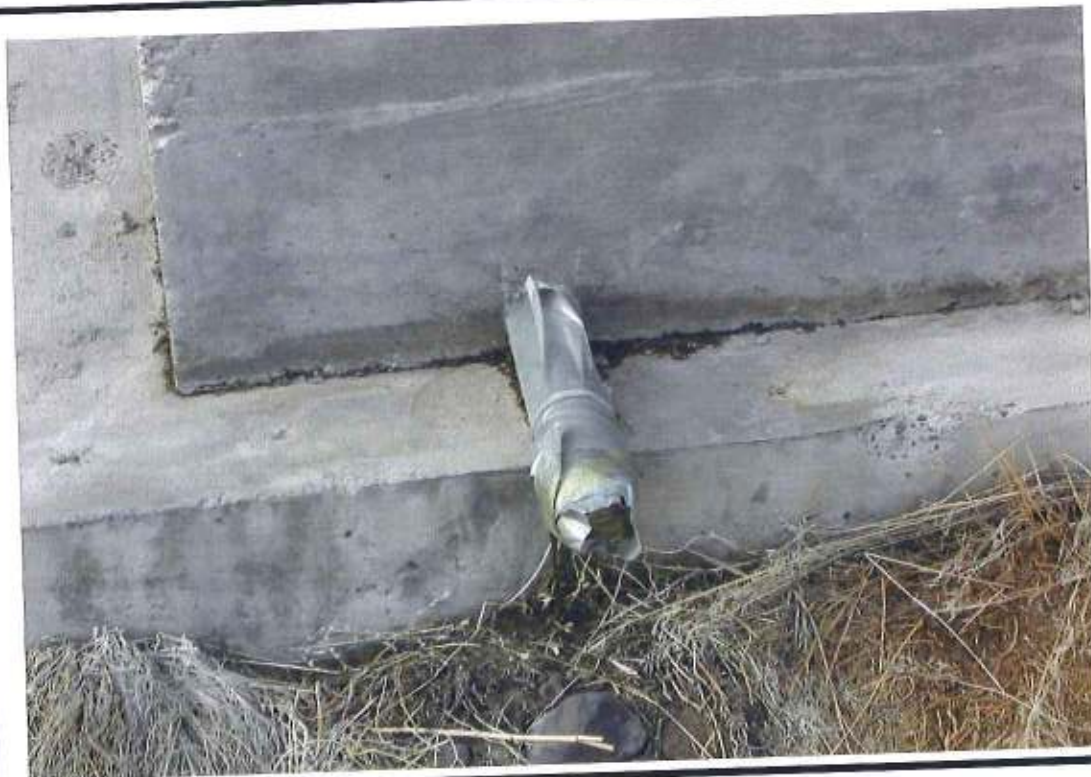
View of stormwater drain covered with duct tape at the AST containment basin.

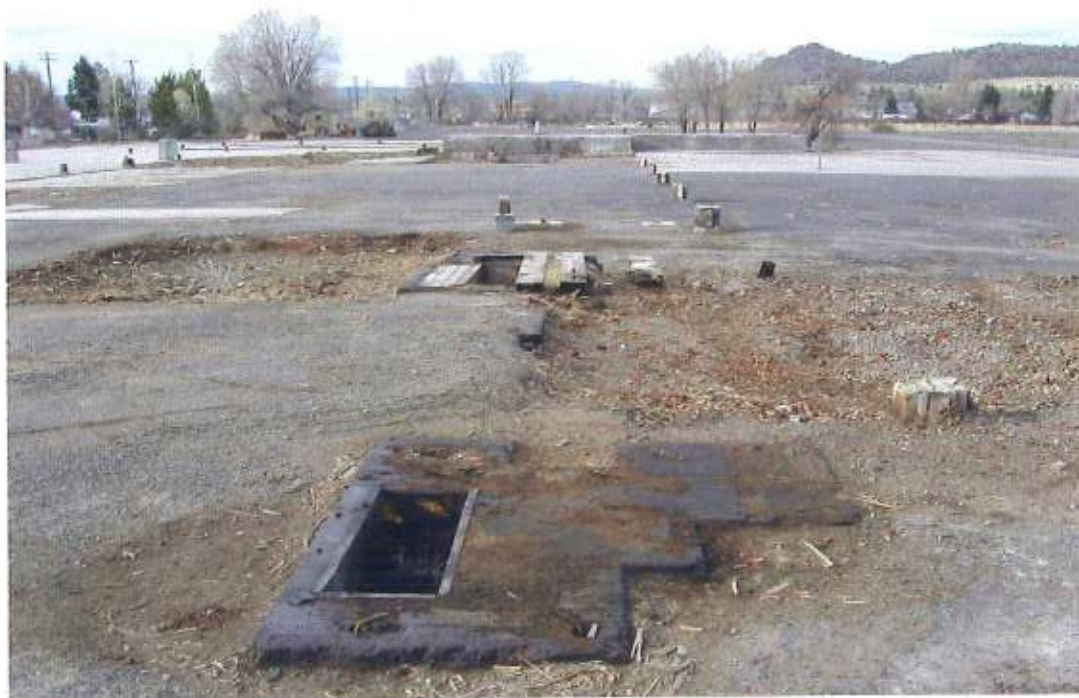
View of stained concrete and soil associated with the former Planner Building.

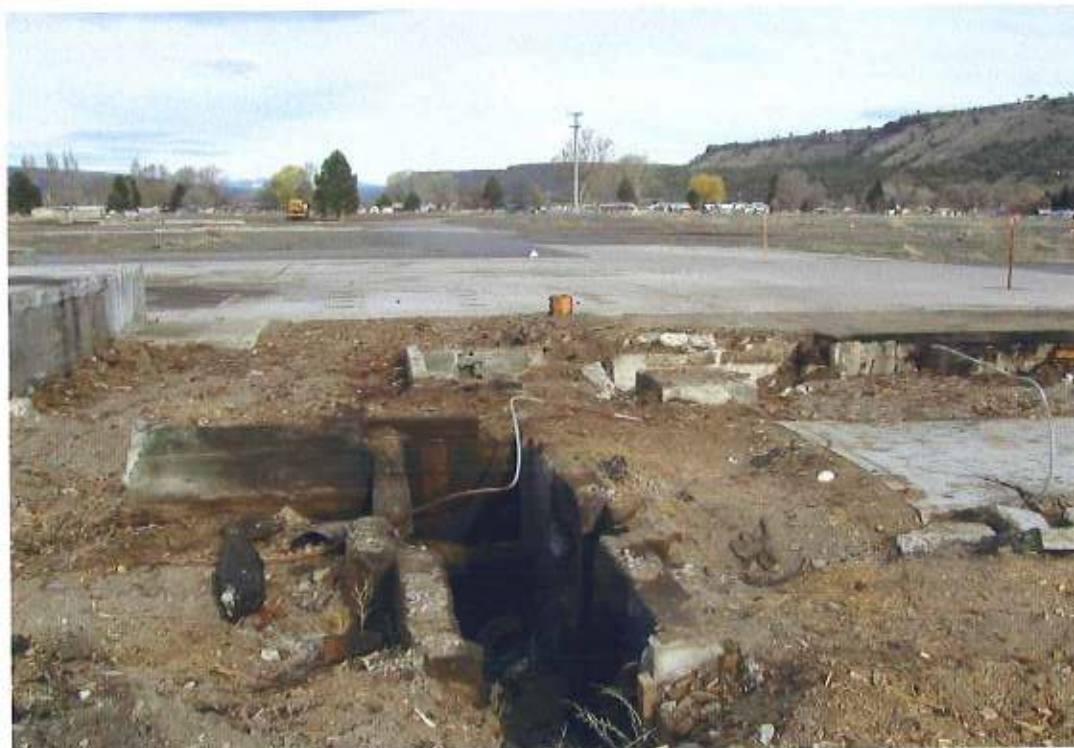
View of heavily stained foundations and soil associated with the main Planner Drive Gear in the former Planner Building.

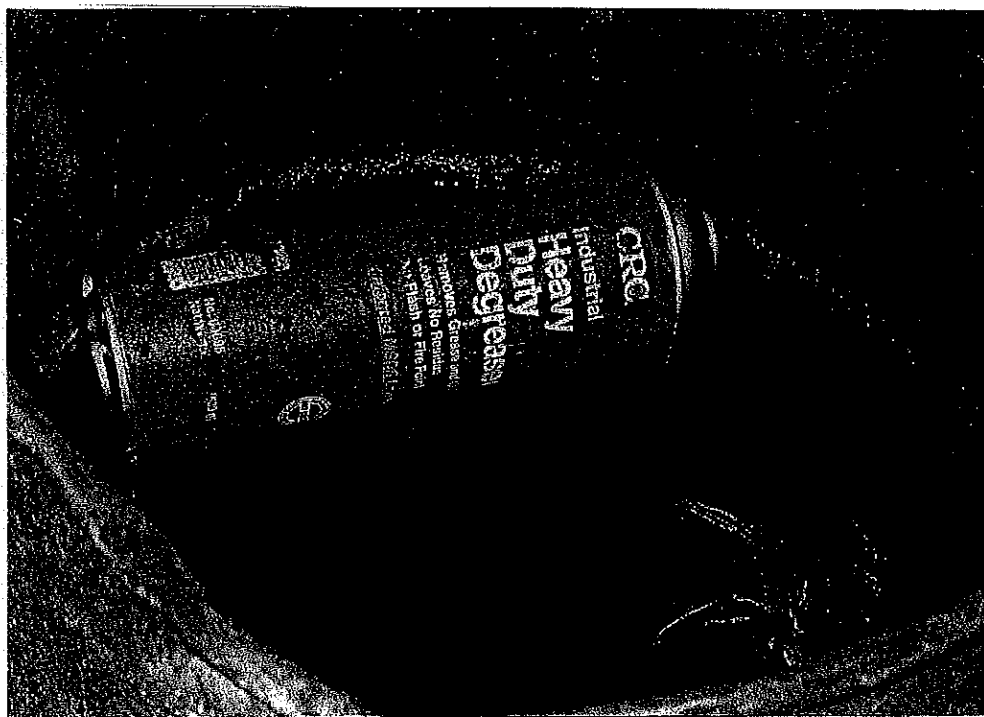
The Small Log Mill includes a second degreasing station.
