**RE: FIRST SEMIANNUAL 2024 TEMPORARY PROTECTIVE CAP INSPECTION
NAVIGATION CENTER CAP INSPECTIONS
1111 NORTHWEST NAITO PARKWAY
PORTLAND, OREGON 97209
FARALLON PN: 2395-017**

First Semiannual 2024 Temporary Protective Cap inspection
Navigation Center Cap Inspections
1111 Northwest Naito Parkway
Portland, Oregon

Farallon PN: 2395-017

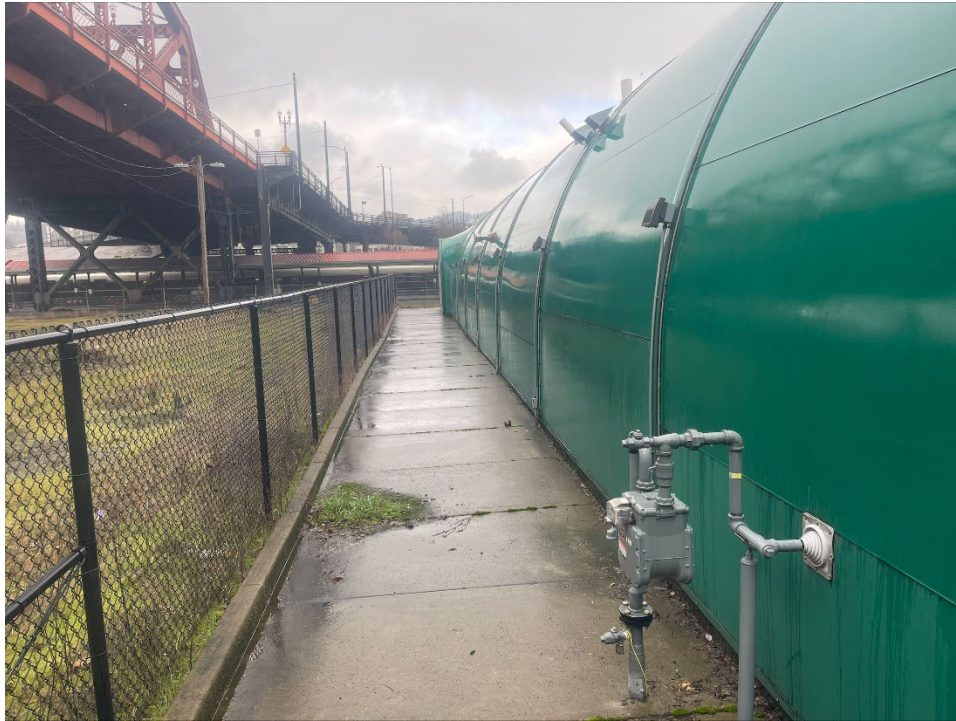
Photograph 1. Concrete and fencing on the Navigation Center property.

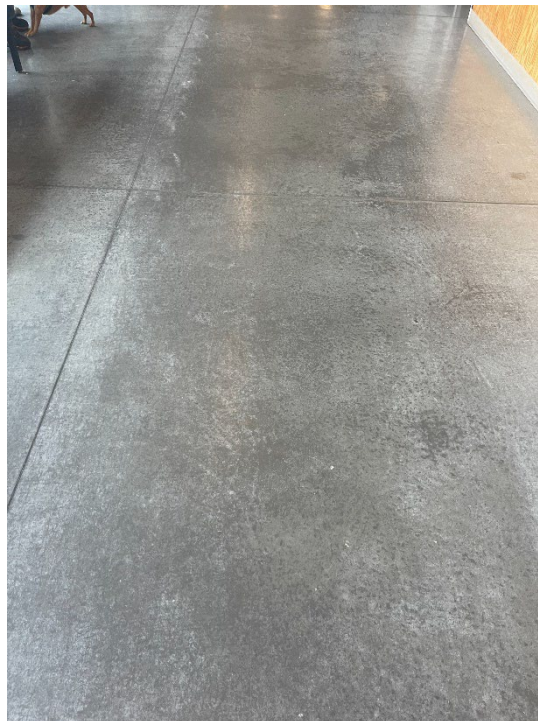
Photograph 2. Floor of the main hallway in the building.

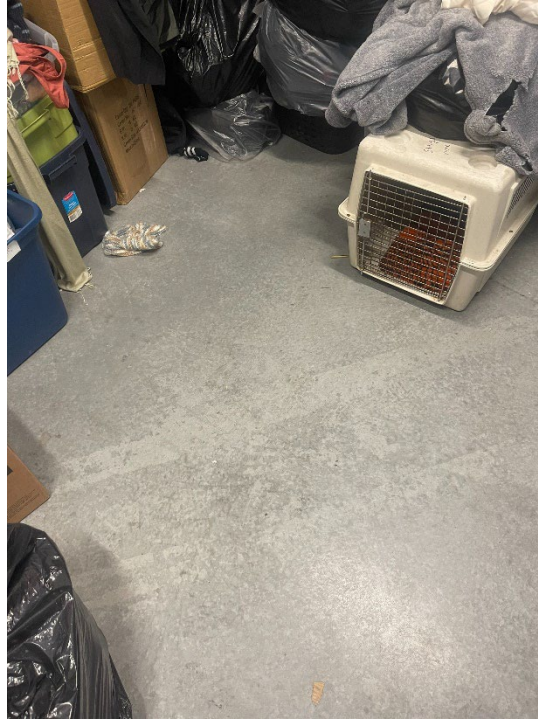
Photograph 3. Back closet concrete floor.

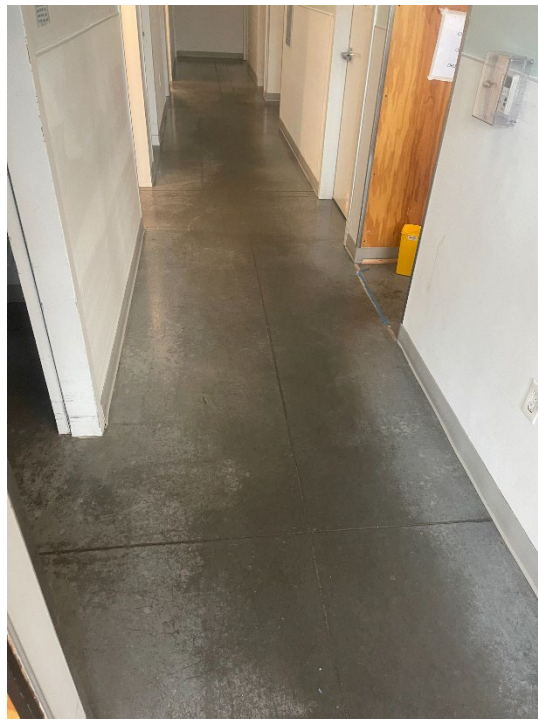
Photograph 4. Back hallway and restrooms.

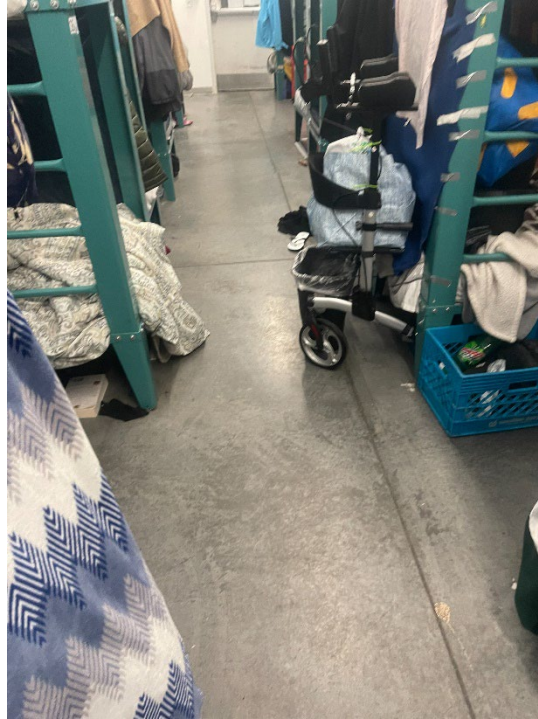
Photograph 5. Floor in dormitory.

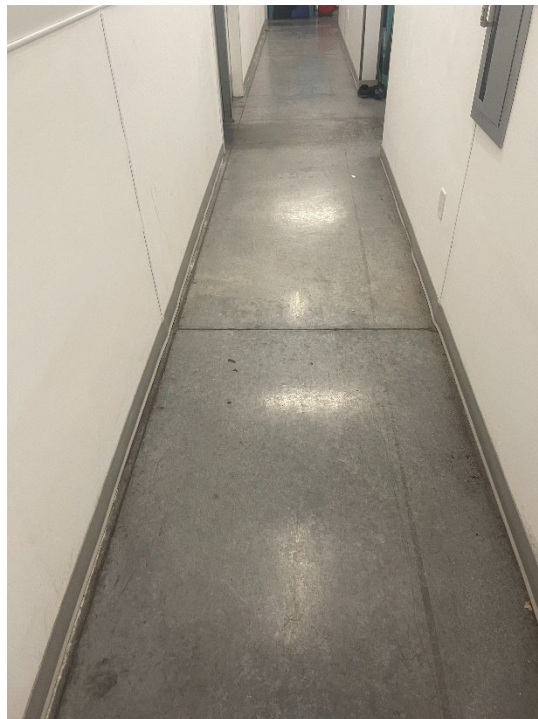
Photograph 6. Hallway leading to the back entrance.

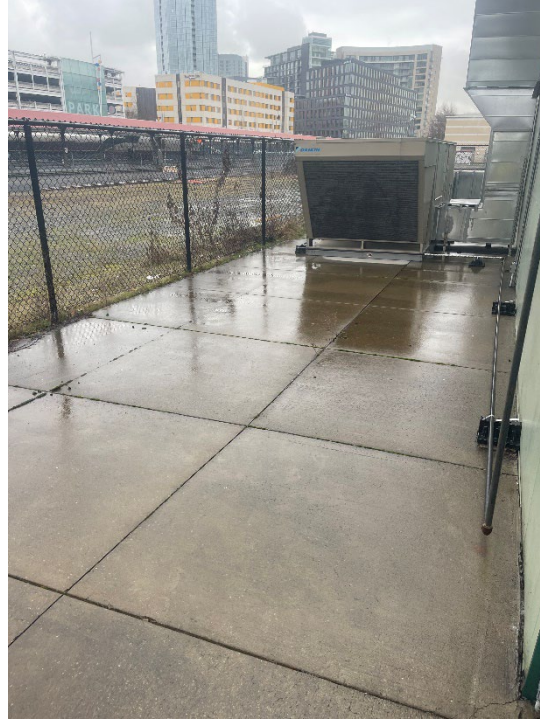
Photograph 7. Concrete pad in the back portion of the facility.

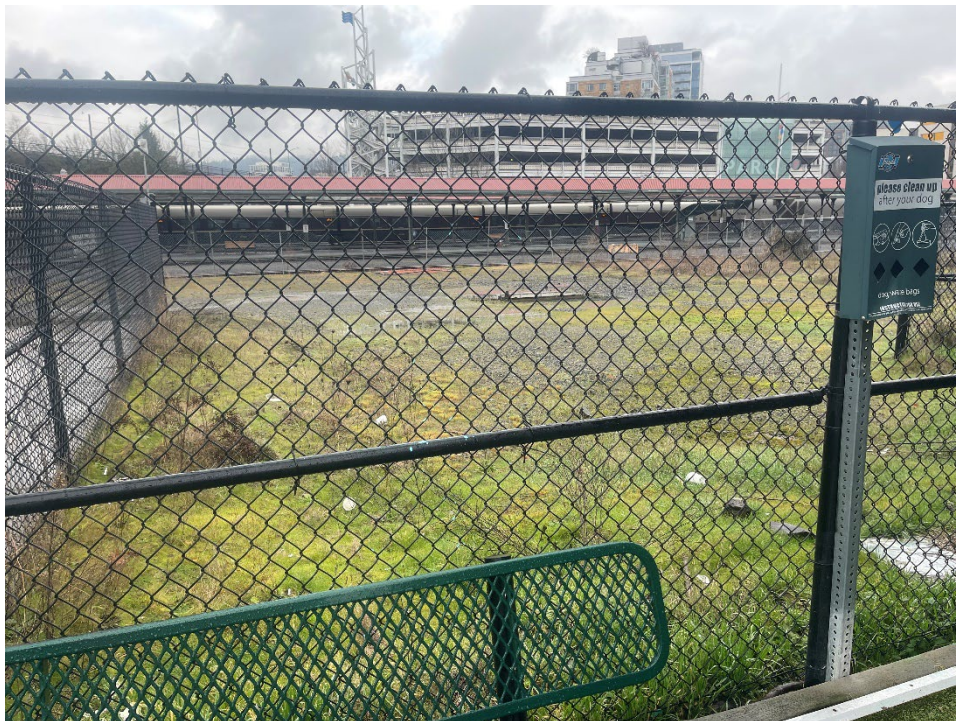
Photograph 8. Southeast-adjacent property.

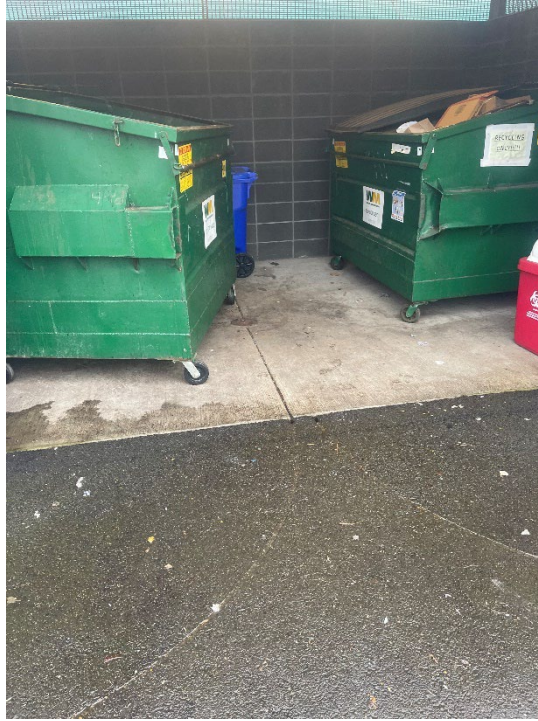
Photograph 9. Trash pickup area.

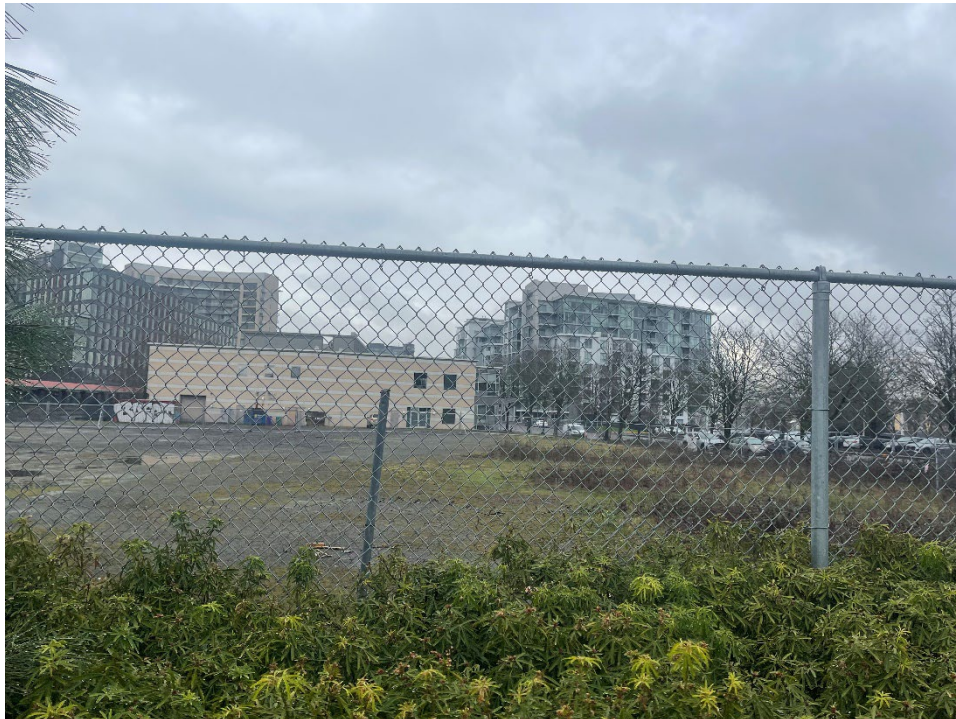
Photograph 10. Northeast-adjointing property.

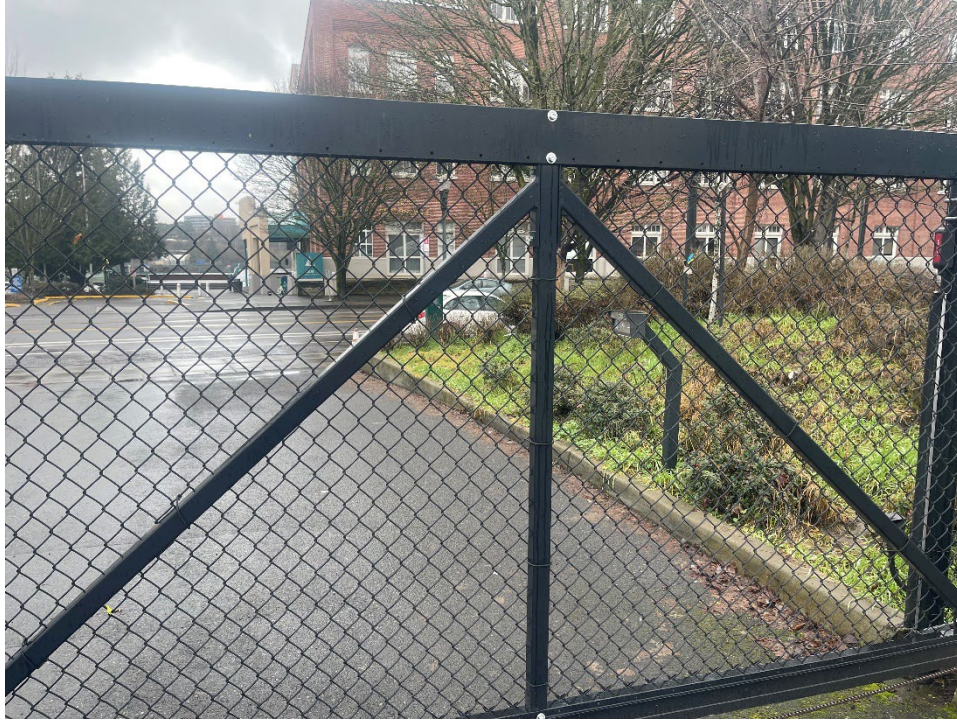
Photograph 11. North-adjointing property.
