**Reference: Surface Cap Inspection, DEQ ECSI #153, LUST Site No. 34-89-194 and 34-02-1000  
Former Rasmussen Paint – 12655 SW Beaverdam Road, Beaverton, Oregon**

**CAP INSPECTION REPORT**  
**FORMER RASMUSSEN PAINT/RASCO PROPERTY**  
**DEQ ECSI #153, LUST No. 34-89-194 AND 34-021000**  
**12655 SW BEAVERDAM ROAD, BEAVERTON, OREGON**

## Photographic Log

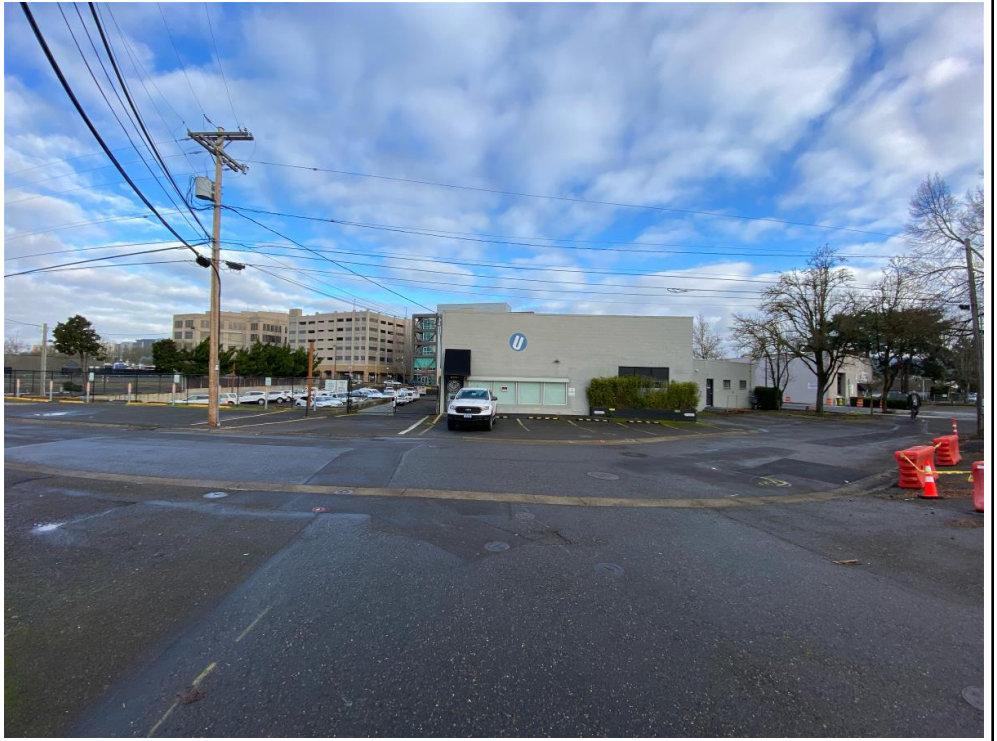
| <b>Photograph ID: 1</b> | | | |

| <b>Comments:</b><br>Front of property building. | | | |

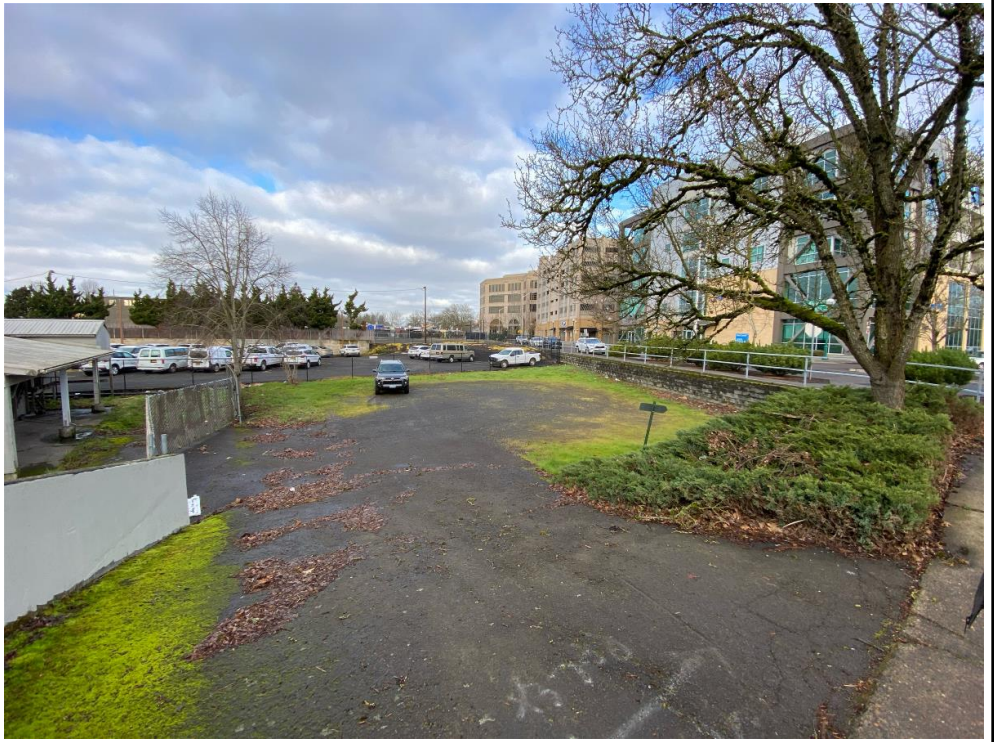
| <b>Photograph ID: 2</b> | | | |

*No damage or deterioration was observed in the northern third of the Property where compacted gravel serves as the protective cap. No erosion of the gravel was observed.*

| <b>Comments:</b><br>Former locations of tank pit #1 and drum storage area. Compacted gravel cap in good condition with no evidence of damage or failure. | | | |

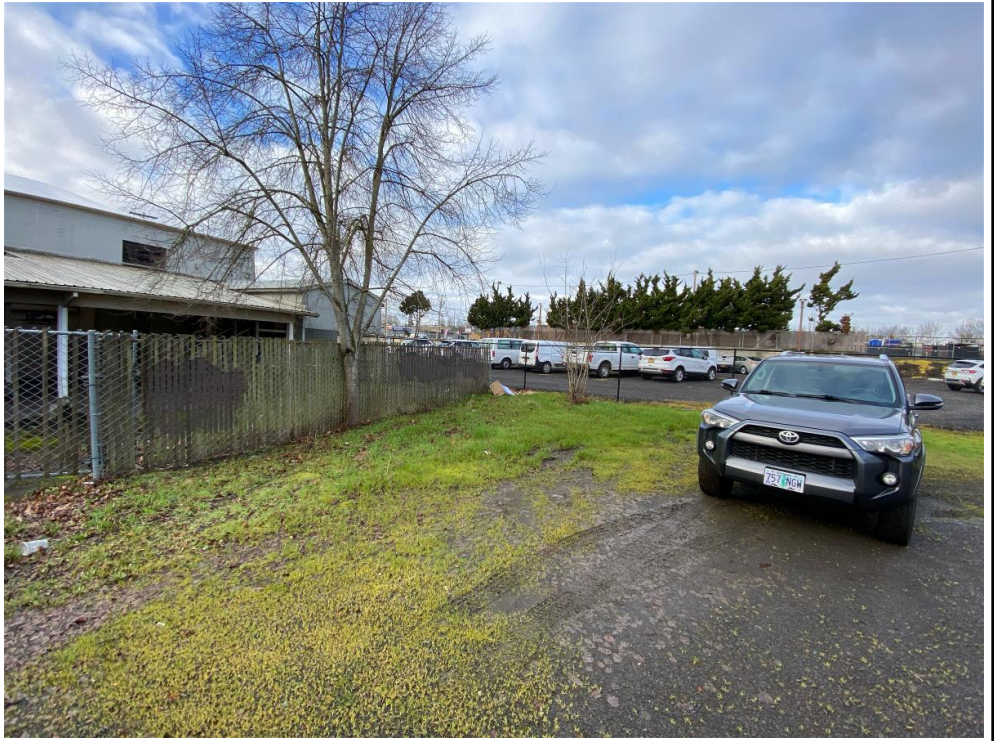
| <b>Photograph ID: 3</b> | | | |

| <b>Comments:</b><br>Additional view of compacted gravel cap in former tank pit #1 area. | | | |

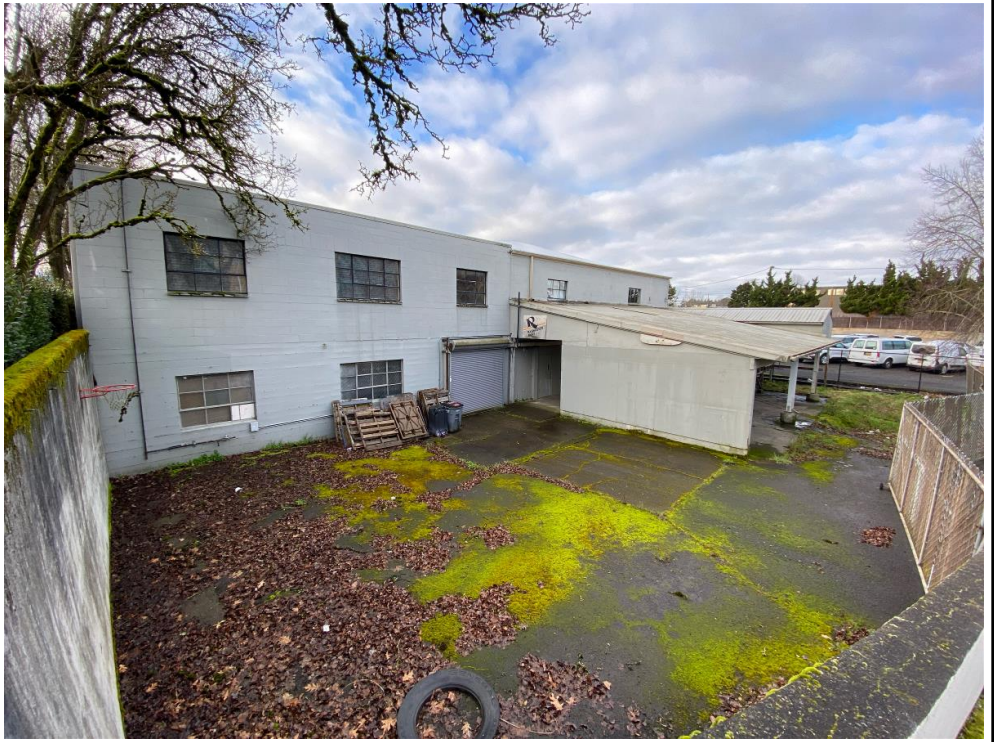
| <b>Photograph ID: 4</b> | | | |

*No problems observed in paved areas of the Property south (asphalt) and north (concrete) of the building. Surface cap of soil and/or mulch are in good condition.*

| <b>Comments:</b><br>Hardscaped surface behind Property building. | | | |

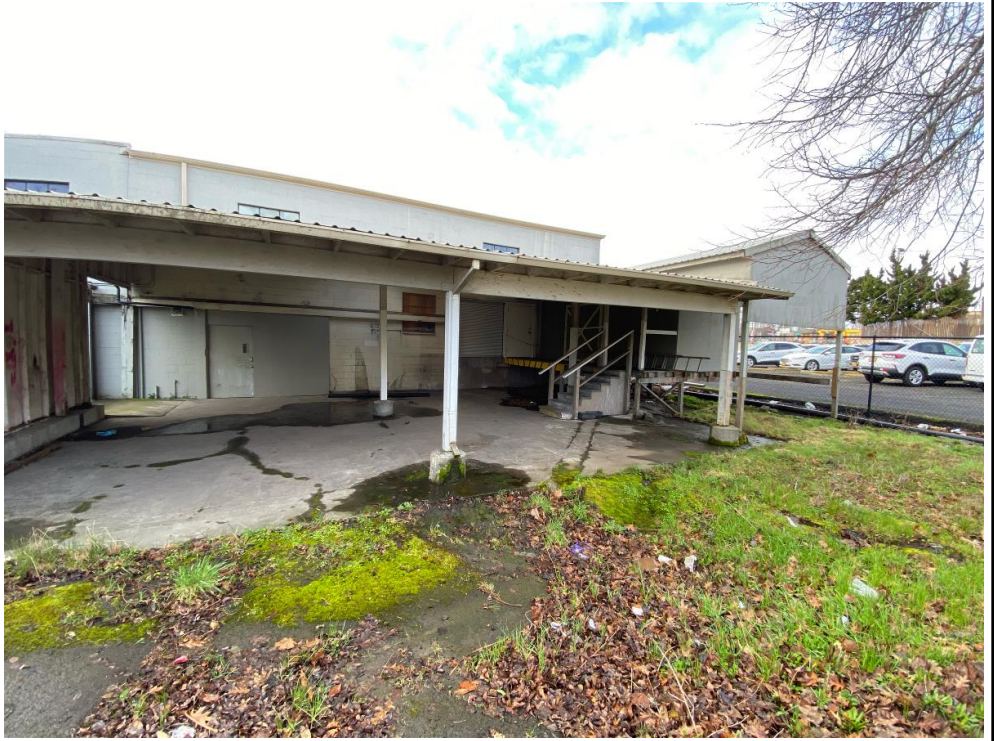
| <b>Photograph ID: 5</b> | | | |

| <b>Comments:</b><br>Additional view of hardscaped surface behind Property building. | | | |

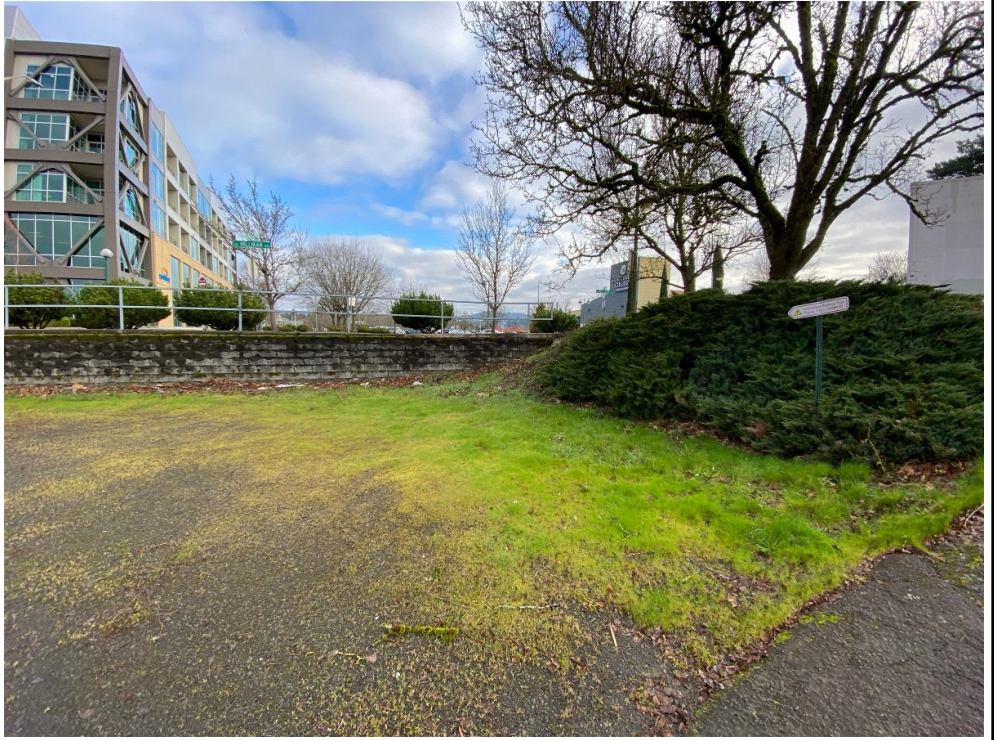
| <b>Photograph ID: 6</b> | | | |

*Some moss accumulation was observed on the gravel surface but does not compromise the effectiveness of the cap.*

| <b>Comments:</b><br>Former location of paint wash ditch. Compacted gravel cap in good condition with no evidence of damage or failure. Some moss accumulation. | | | |

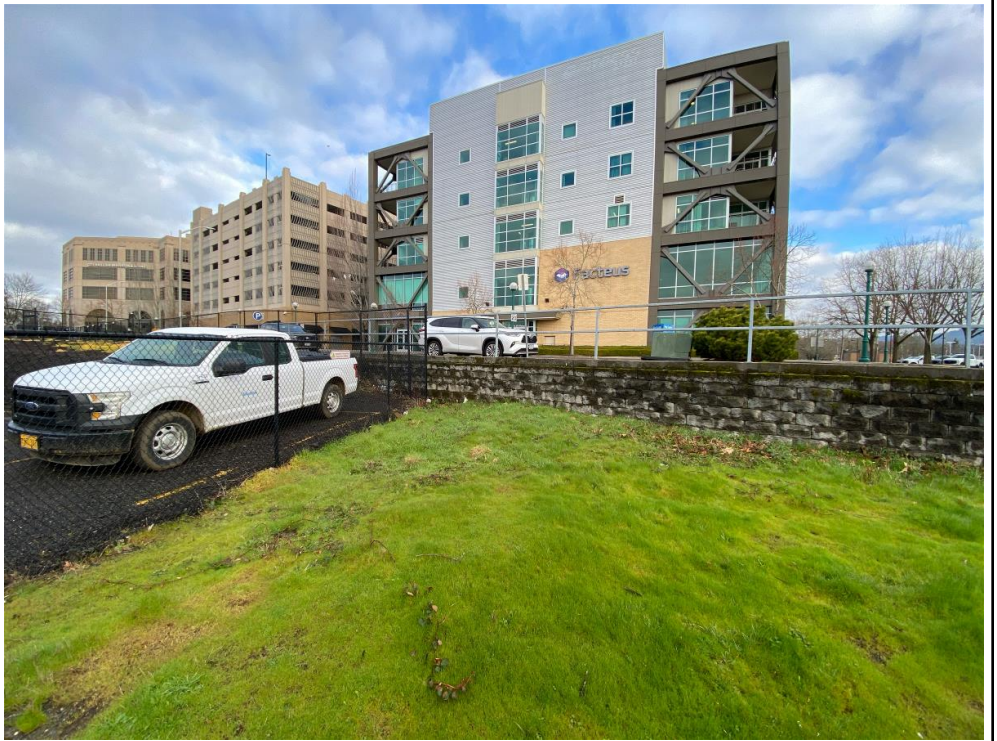
| <b>Photograph ID: 7</b> | | | |

| <b>Comments:</b><br>Former locations of drum storage area. Compacted gravel cap in good condition with no evidence of damage or failure. Some moss accumulation. | | | |

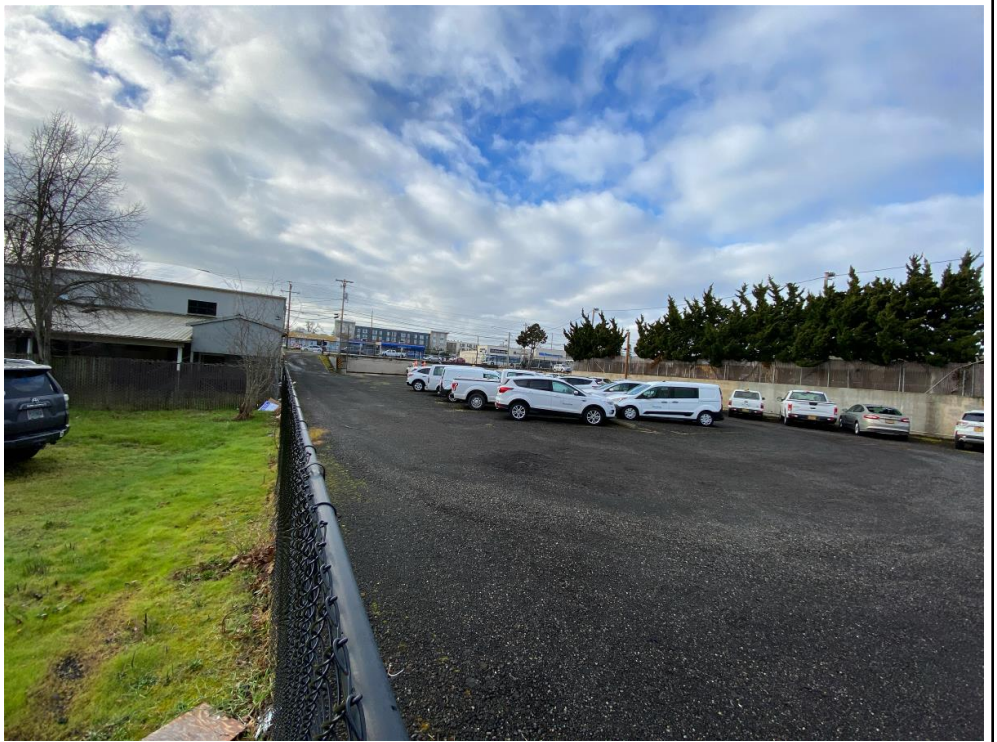
| <b>Photograph ID: 8</b> | | | |

| <b>Comments:</b><br>View along western Property boundary. | | | |
