**TECHNICAL MEMORANDUM**

To: Dan Hafley, Oregon DEQ NWR  
From: Samantha Biles, P.E. and Brad Berggren, P.E., R.G.  
Date: June 17, 2019  
Subject: Remedial Action Construction Completion  
Floragon Property, Former Dip Tank Area  
Molalla, Oregon  
ECSI File No. 0009

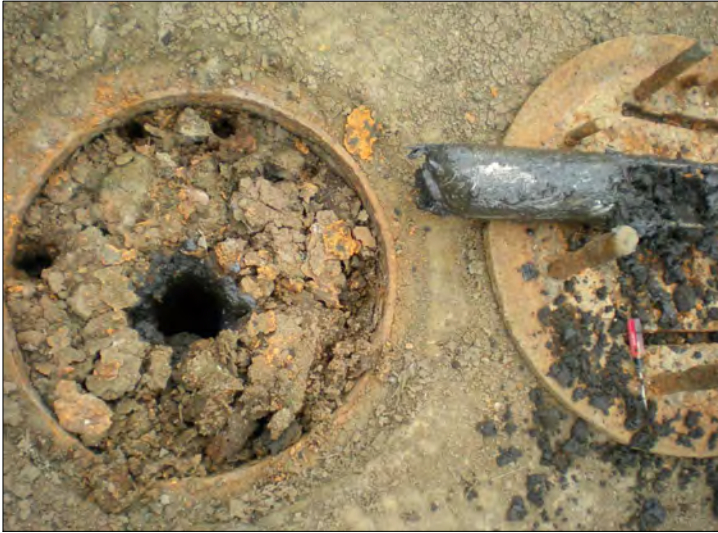
PHOTO 1  
Catch basin prior to cleaning.

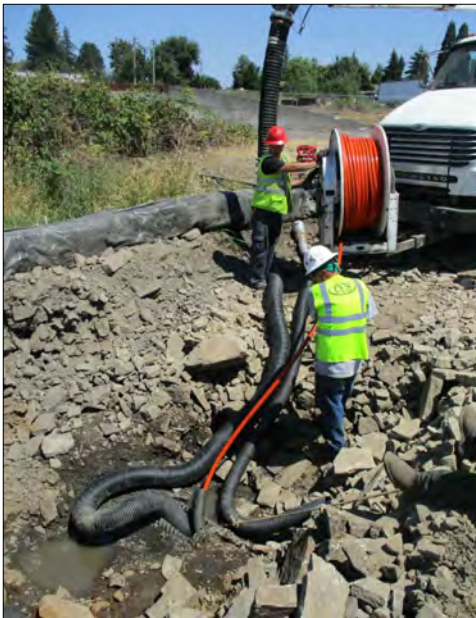
PHOTO 2  
After blocking storm sewer discharge at Bear Creek, jetted sediment from the catch basin line and collected the resulting slurry.

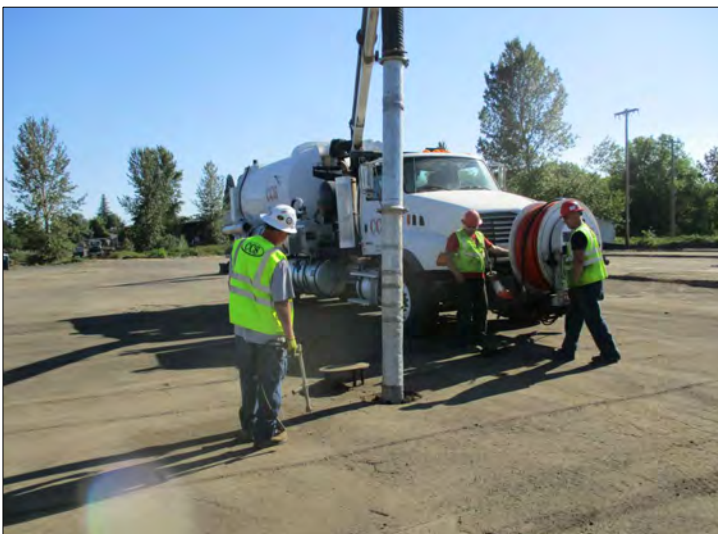
PHOTO 3  
Removal of sediment water slurry from catch basin with vacuum truck.

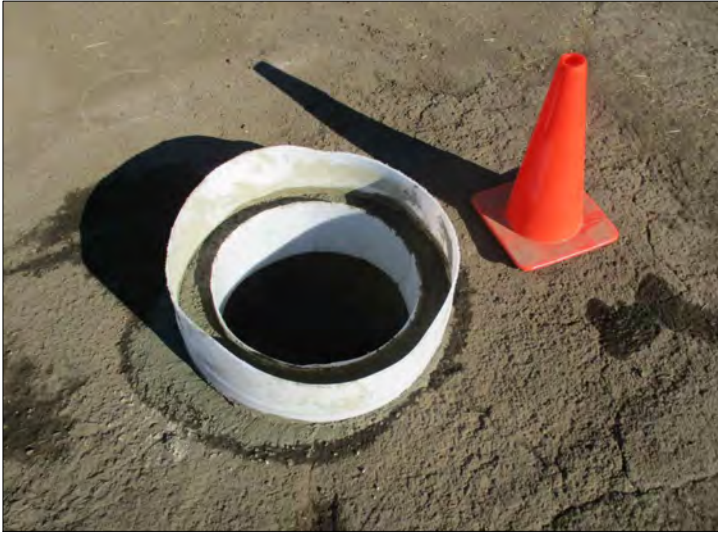
PHOTO 4  
Cleaned catch basin.

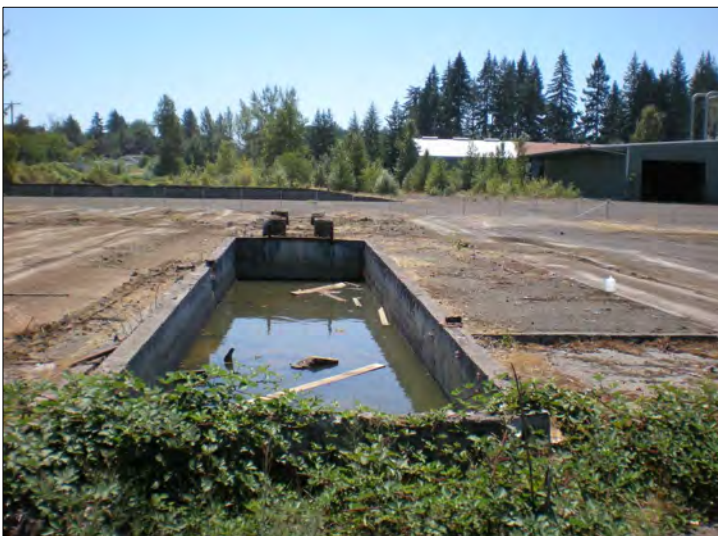
PHOTO 6  
Former Dip Tank #2 concrete containment vault  
prior to rainwater and debris removal.

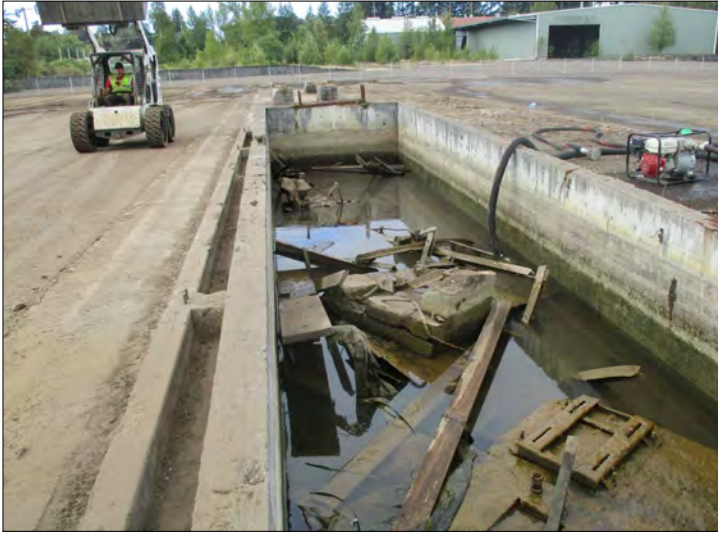
PHOTO 7  
Former Dip Tank #2 concrete containment vault debris.

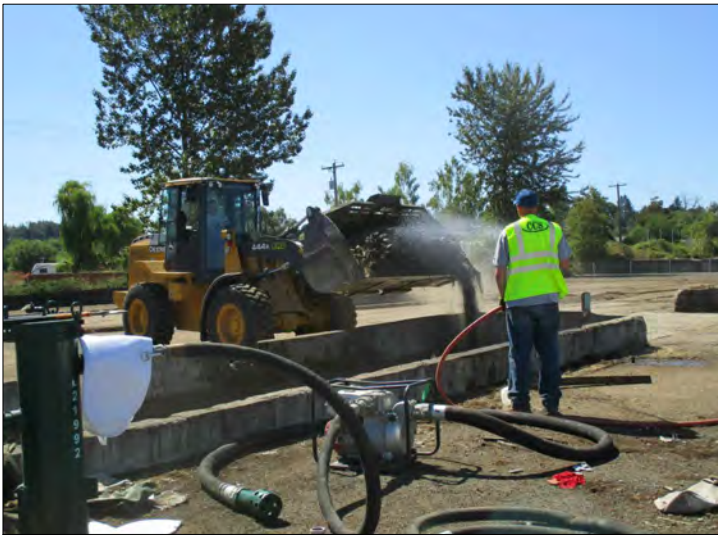
PHOTO 8  
Placement of soil fill in Former Dip Tank #2 concrete containment structure.

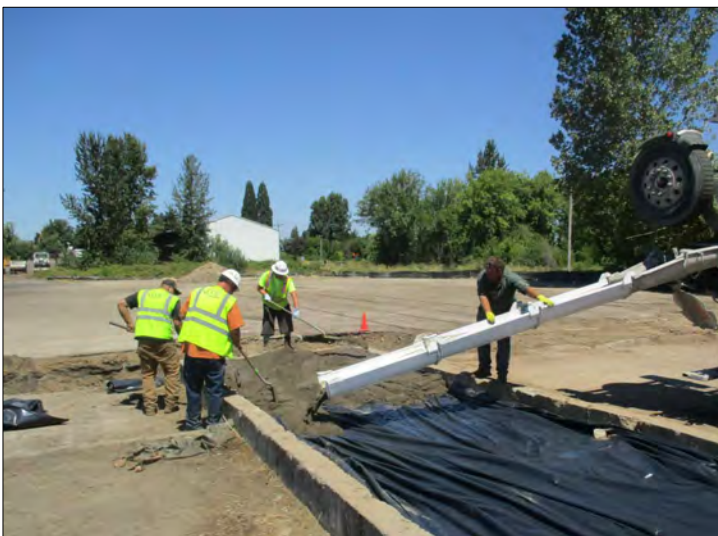
PHOTO 9  
Placement of concrete cap over fabric and soil fill in Former Dip Tank #2 concrete containment vault.

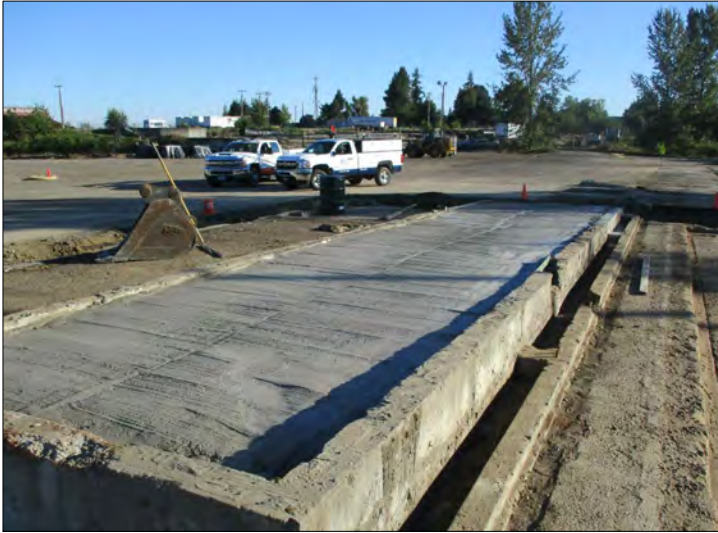
PHOTO 10  
Finished concrete cover on Former Dip Tank #2  
concrete containment vault.

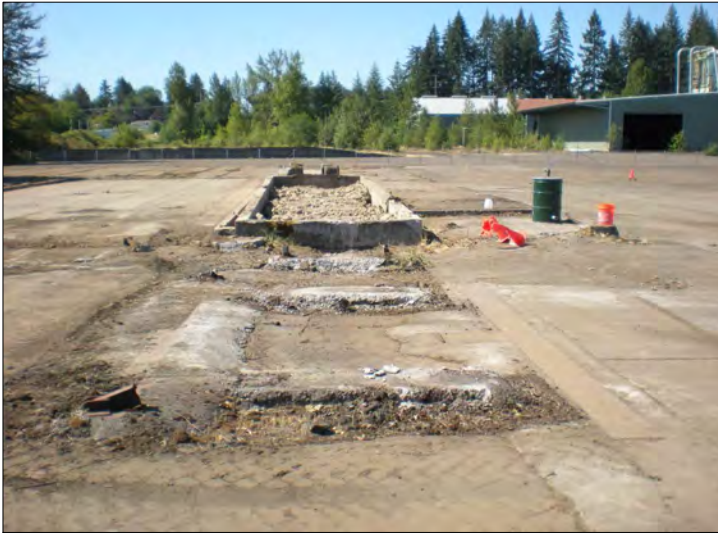
PHOTO 17  
Hot spot soil area prior to excavation. View from  
the north.

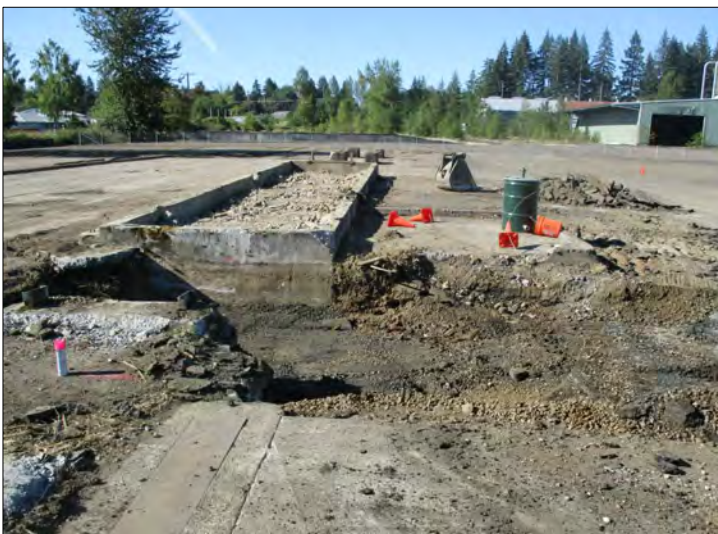
PHOTO 18  
Hot spot excavation. View from the north.

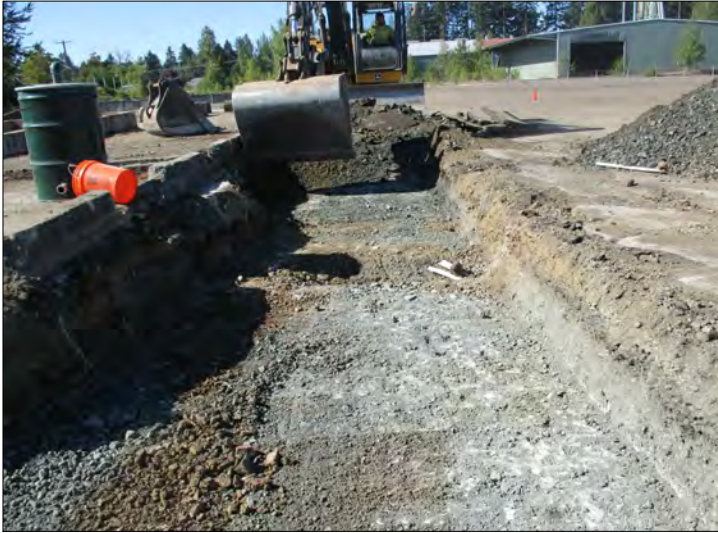
PHOTO 19  
Hot spot excavation. View from the north.

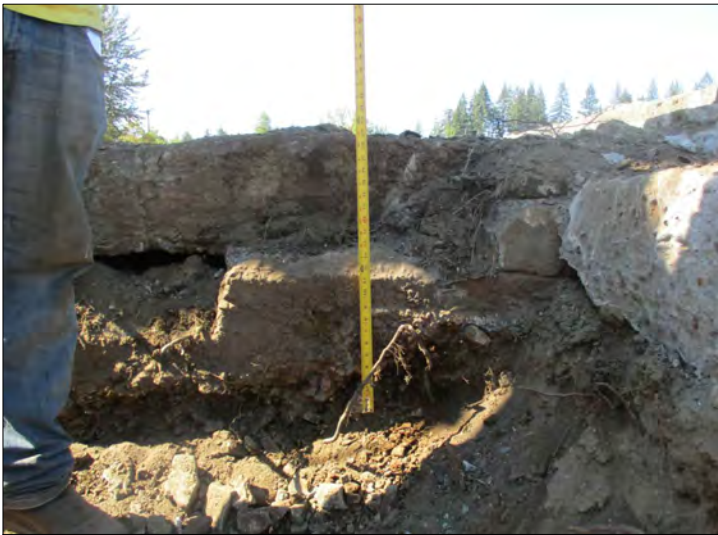
PHOTO 20  
Hot spot soil excavation final depth.

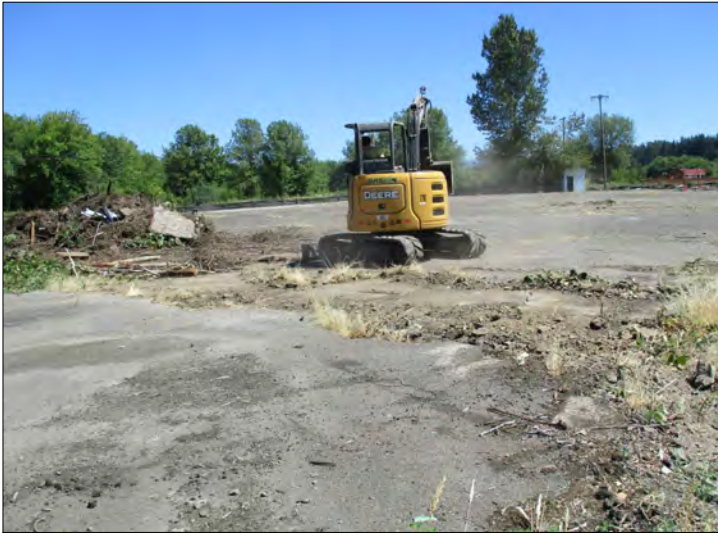
PHOTO 23  
Debris cleaning, existing concrete surface  
preparation for asphalt concrete overlay placement.

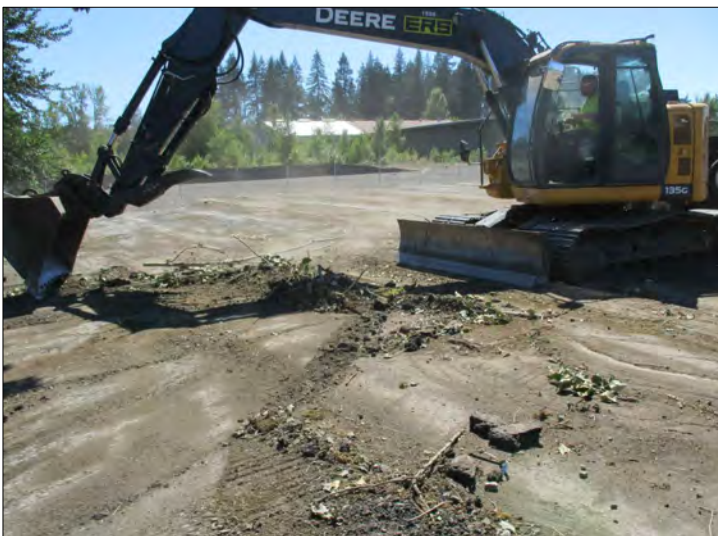
PHOTO 24  
Debris cleaning, existing concrete surface  
preparation for asphalt concrete overlay placement.

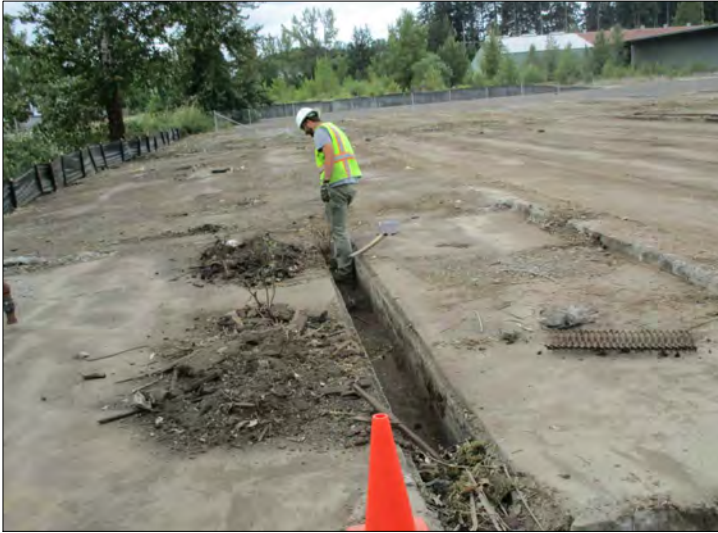
PHOTO 25  
Debris cleaning, existing concrete surface  
preparation for asphalt concrete overlay placement.
