October 2, 2012

Subject: Letter Response – Summary of Findings  
Portland Harbor Source Control Evaluation  
Site: Peninsula Iron Works, 6618 N Alta Street, Portland, OR  
CEC Project No. PIW - 2012.1 / 351-12023-01

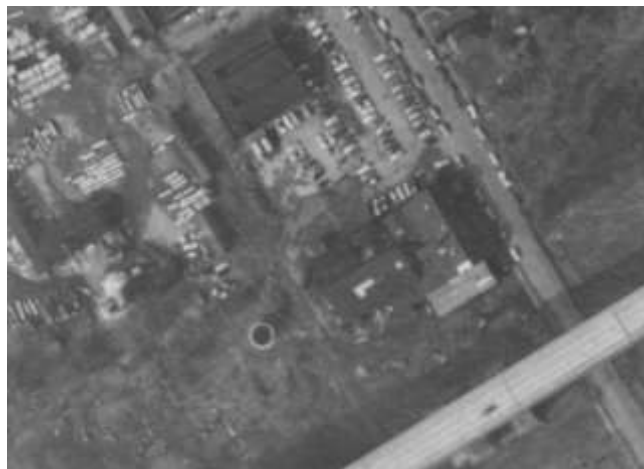
On January 19, 2012 the City of Portland sent an Industrial Source Control Memo to Peninsula Iron Works regarding ponding of water around the southwest portion of the site. This document clearly documents ponding of storm water between the subject site and the railroad easement/ballast located west of the subject site. It should be noted that ponding of storm water in this area of the site has occurred during heavy rain events since development of the property, as can be inferred in the 1956 aerial photograph, and based on conversation with Peninsula Iron Works owners<sup>8,12</sup>.

1956 Aerial photograph showing residual flood waters surrounding the south and north sided of the subject site (University of Oregon, Knight Library).

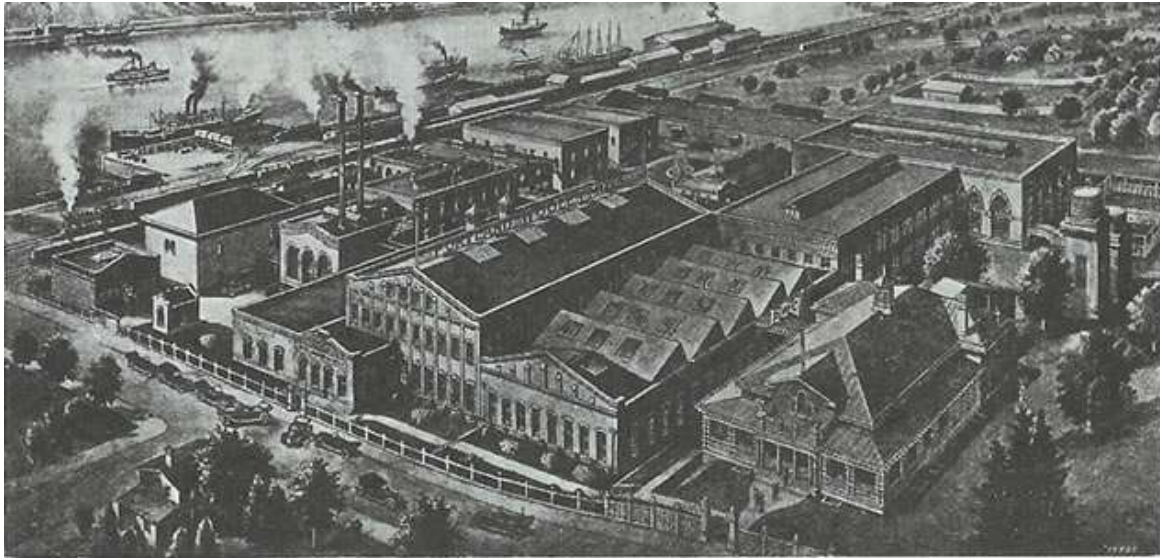
As the largest woolen mill in an area known for historic ship production, it seems that the mill could have been a source of PCBs from historic use.

Portland Woolen Mills – Largest Mills West of Cleveland. Drawing circa 1920<sup>14</sup>

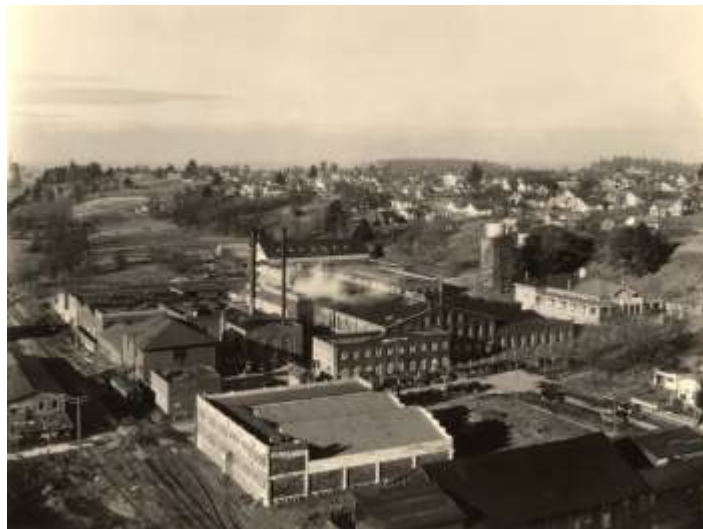
Portland Woolen Mills, Circa 1935

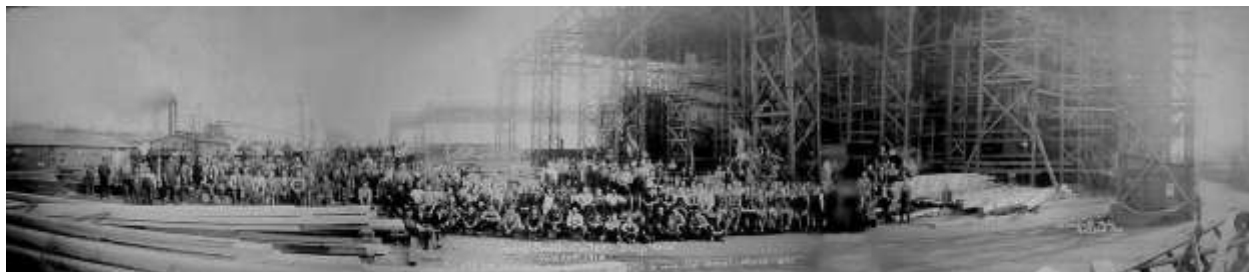
From about 1918 through the mid 1920s, the Grant Smith Porter Ship Co. was located on the opposite side of Alta Street north of the site as well as several blocks northwest of the site adjacent to the Willamette River. A large black smith shop with two furnaces occupied the south side of the block, and a crane and shipbuilding yard were located on the north side of the block. Grant Smith Porter's shipbuilding yard included piers/docks, cranes, and scaffolds.

Grant Smith Porter shipyards, Portland, Oregon, June 20, 1918<sup>15</sup>

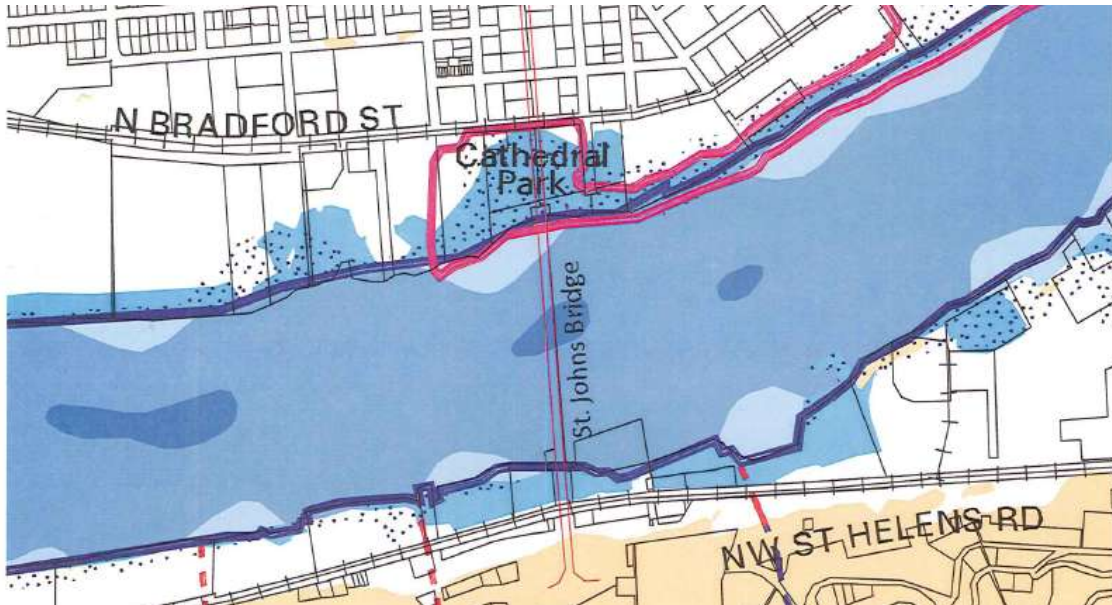
Diagram showing the extent of 1996 flood waters (Source, City of Portland<sup>17</sup>)

The contaminated sediments deposited along the western margins of the subject site are a potential PCB source.
