Date: July 2, 2020
To: Ben Leake, US EPA
Through: Paul Seidel, DEQ Cleanup Section Manager *PS*
From: Alex Liverman, Portland Harbor Stormwater Coordinator
Subject: Source Control Decision
PGE Rivergate North and South Substations
ECSI #6069

Figure 1
Sampling Locations
Rivergate Substations
Source Control Evaluation

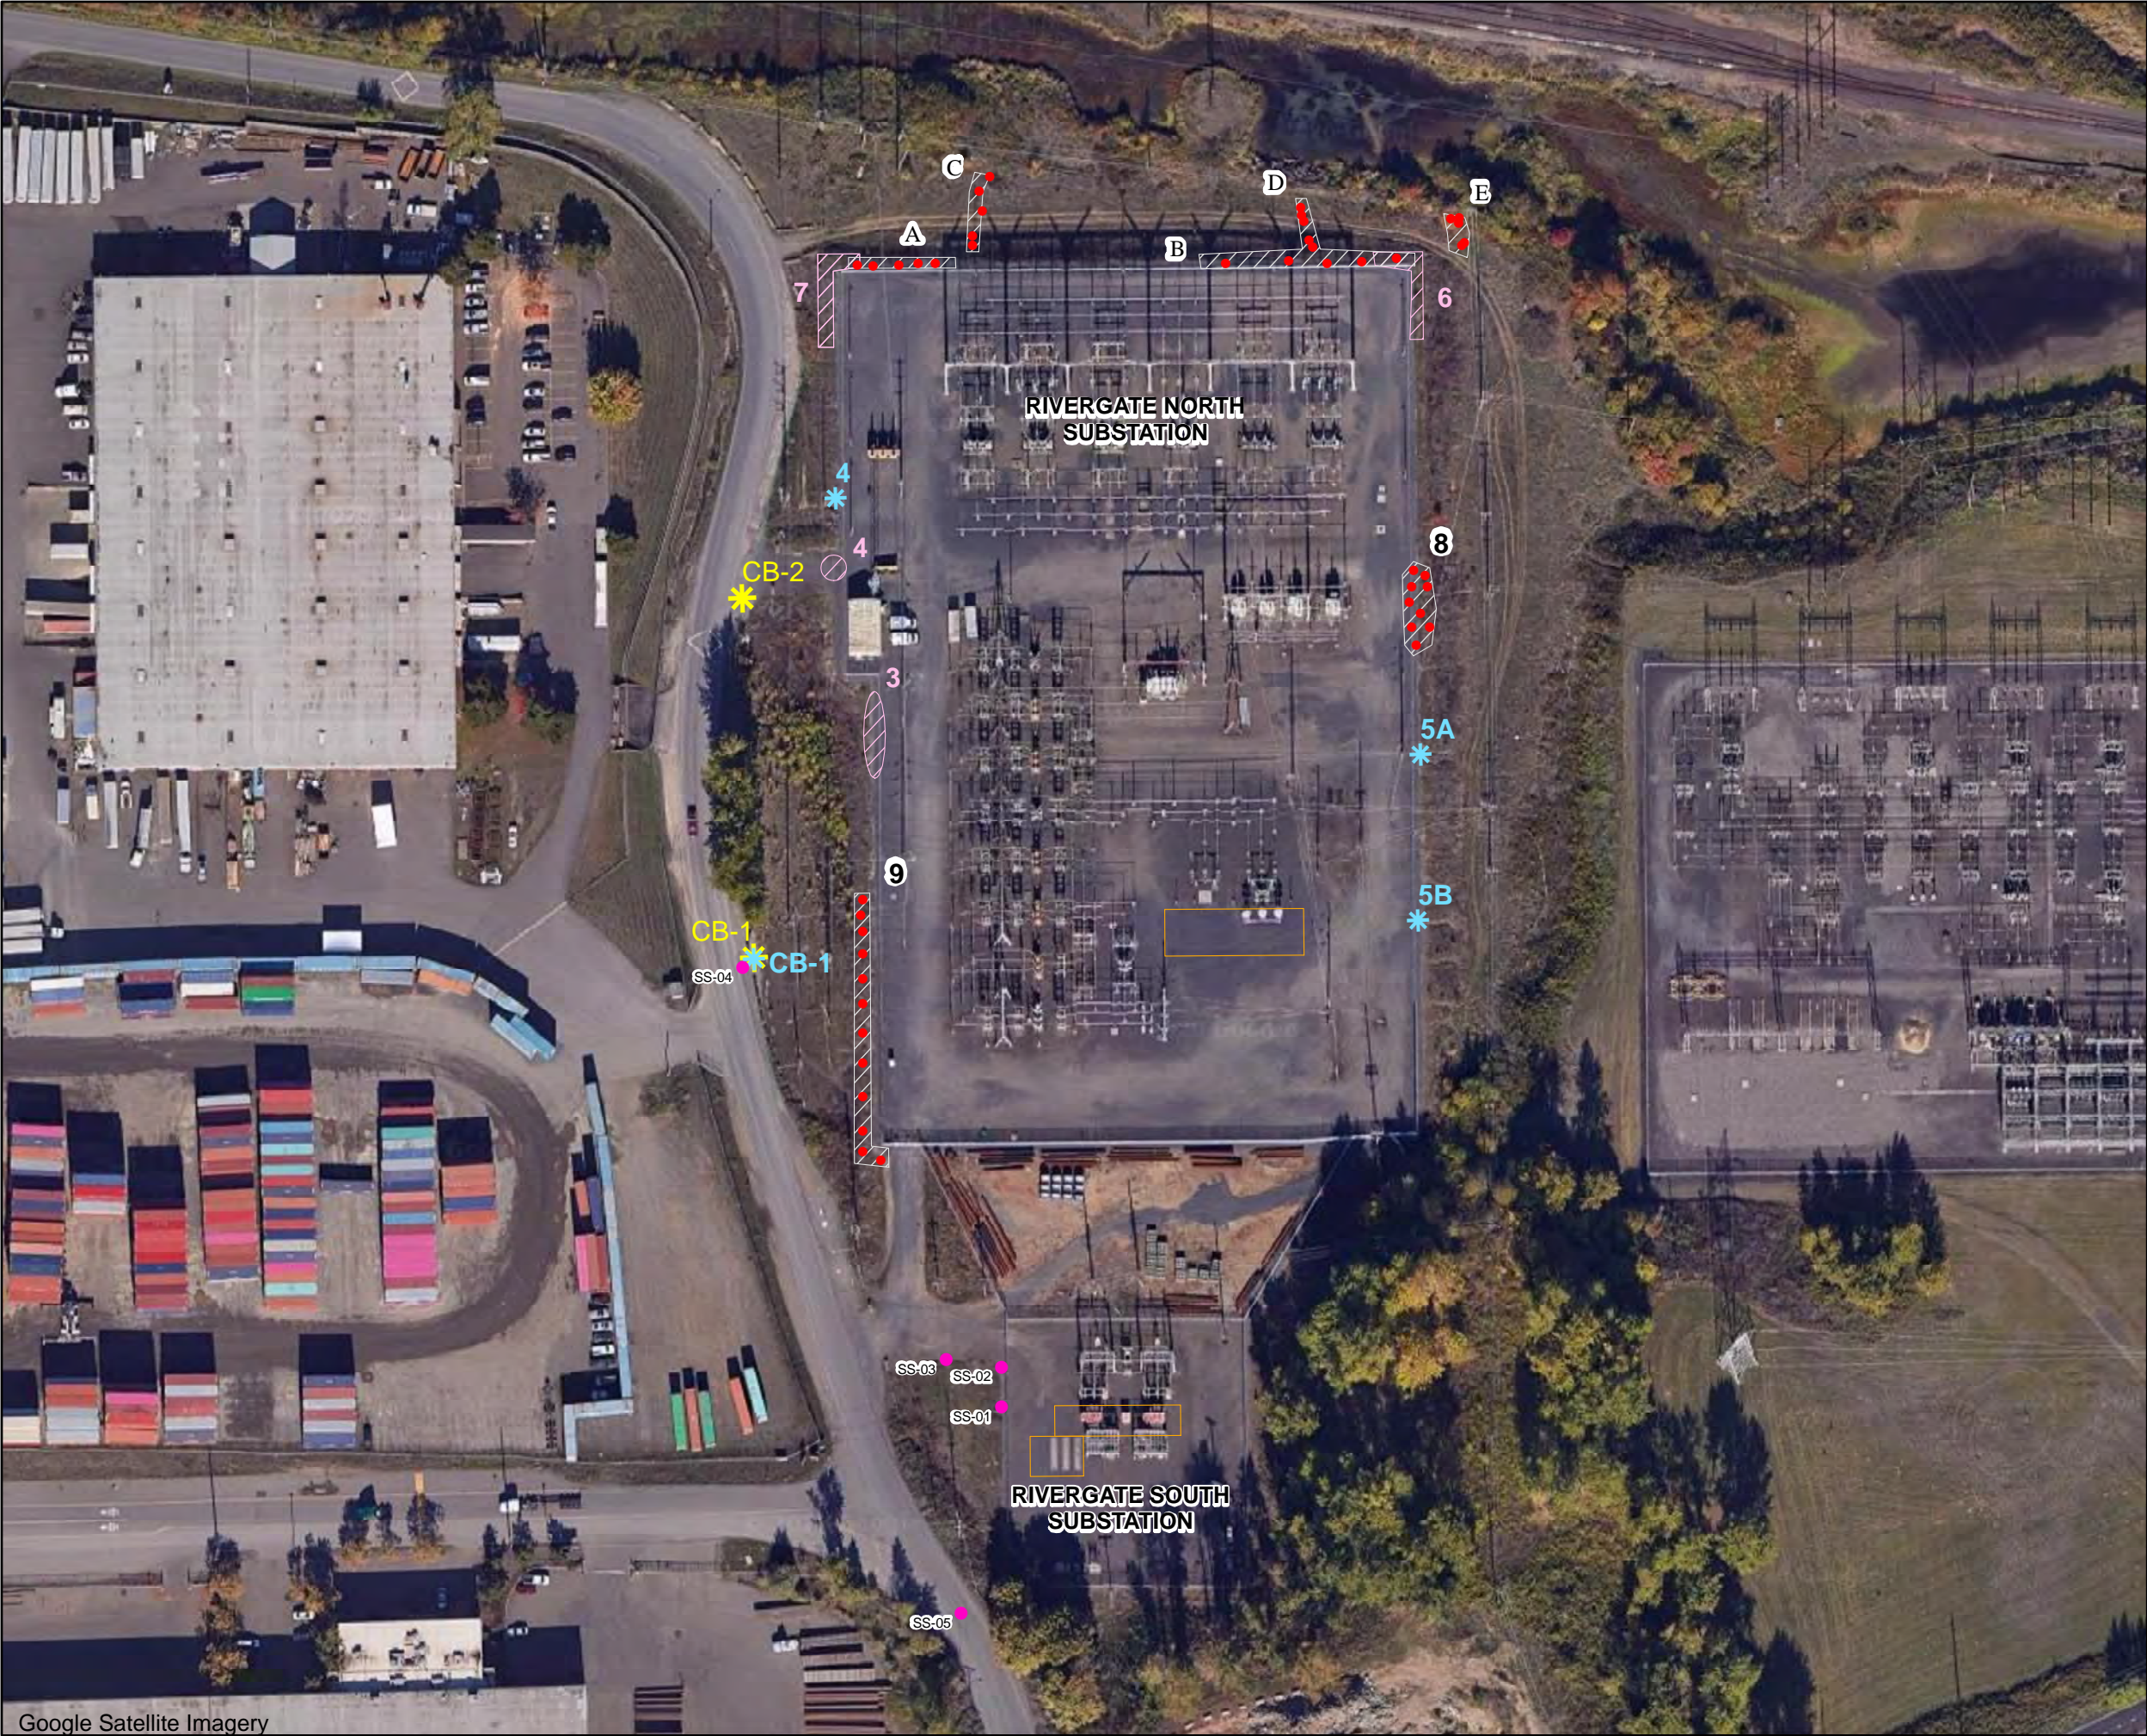
URS confirmed that the majority of stormwater falling on the sites infiltrates there. During intense rainfall, URS observed discharge of infiltrated stormwater through seeps at the fill/gravel interface at various locations around the edges of both substations. Seep discharges mostly infiltrated in the surrounding grassy areas, but in some cases collected in ponded areas along Time Oil Road. DEQ visited the site in 2015 and photographed rills observed along the three gravel and fill driveways (two at the north parcel and one at the south parcel) indicating stormwater flows toward Time Oil Road. URS also determined that a sump in the basement of the control house on the north substation could discharge to the fill slope and contribute to ponding along Time Oil Road. URS investigated the stormwater collection and conveyance infrastructure along Time Oil Road, which are shown in URS 2011 as two catch basins on each side of the road, with potentially interconnected piping, and a ditch along the opposite side of the road from the north substation. Subsequent PGE investigations discussed in Section 4.3 below, concluded the catch basins were not connected by piping. Large volumes of turbid stormwater were observed flowing down the sloped roadside from areas south of the south substation parcel, entering southernmost east side catch basin (CB-1), or ponding along the roadside adjacent to the north substation and at the inundated northeast catch basin (CB-2) (see Figure 1).

Because PCBs were detected in site soils, URS collected and analyzed solids samples along the flow paths of stormwater leaving the site toward the Time Oil Road active catch basin and from within the catch basin (see Figure 1). PCB aroclors 1254 and 1260 were detected in all samples, with 1248 in one sample, at concentrations that exceeded Portland Harbor soil screening level values then available for total PCBs (see Table 1).

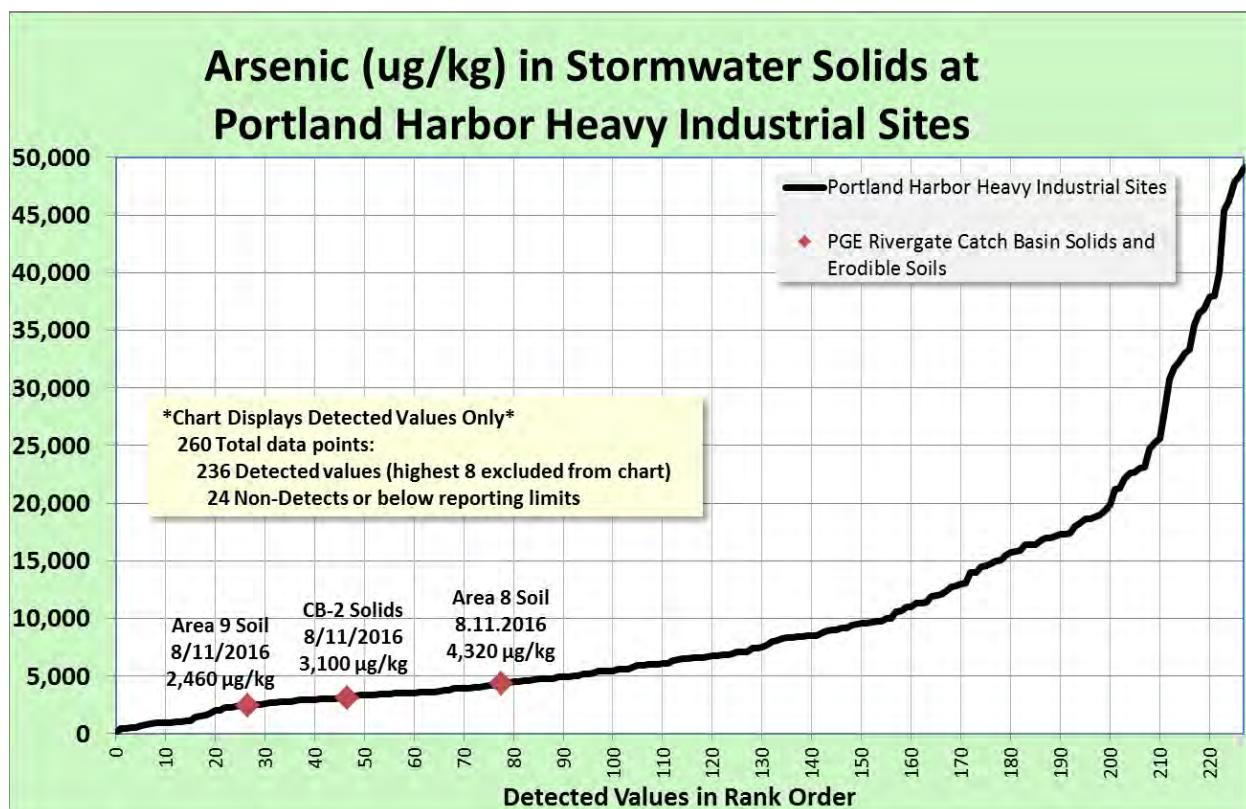
Figure 2: Arsenic in Stormwater Solids at Portland Harbor Heavy Industrial Sites with PGE Catch Basin Solids and Erodeable Soils Data.

Despite the fact that stormwater and any entrained solids no longer discharge from the site, sampling was screened against the relevant Portland Harbor Record of Decision Table 17 cleanup values and, for contaminants without CULs, the JSCS Table 3-1 screening level values. Tables 1 and 2 present the results of the sampling and screening for the recent data collected by PGE in 2016-17, as well as the earlier data collected by URS in 2011 and discussed in Section 3.2 of this report. For soil samples, the summary of CUL/SLV exceedances includes four individual PAHs exceeded individual SLVs in one of four samples, the PCBs CUL was exceeded in nine of 14 samples, three of four samples exceeded the arsenic CUL and one each of four samples exceeded the cadmium and zinc CULs. For stormwater samples, the summary of CUL/SLV exceedances included six to seven individual PAHs exceeded CULs in two of nine locations, total PCBs and cadmium exceeded the CULs in two of nine locations, arsenic exceeded the CUL in all nine locations, copper exceeded the CUL in eight of nine locations and zinc exceeded the CUL in five of nine locations. Although soil samples are not comparable to stormwater solids measurements that make up the DEQ rank-order curves, PGE also plotted the data on the available rank-order curves for both stormwater and stormwater solids (see Figures 2-13). With the exceptions of arsenic, one sample each of

3. Regional background soil concentrations of naturally occurring chemicals for evaluating stormwater solids – Although in three of four soil samples at the site arsenic was measured at concentrations above the CUL, arsenic concentrations were not measured above the regional background concentration of 8,800 ug/kg.

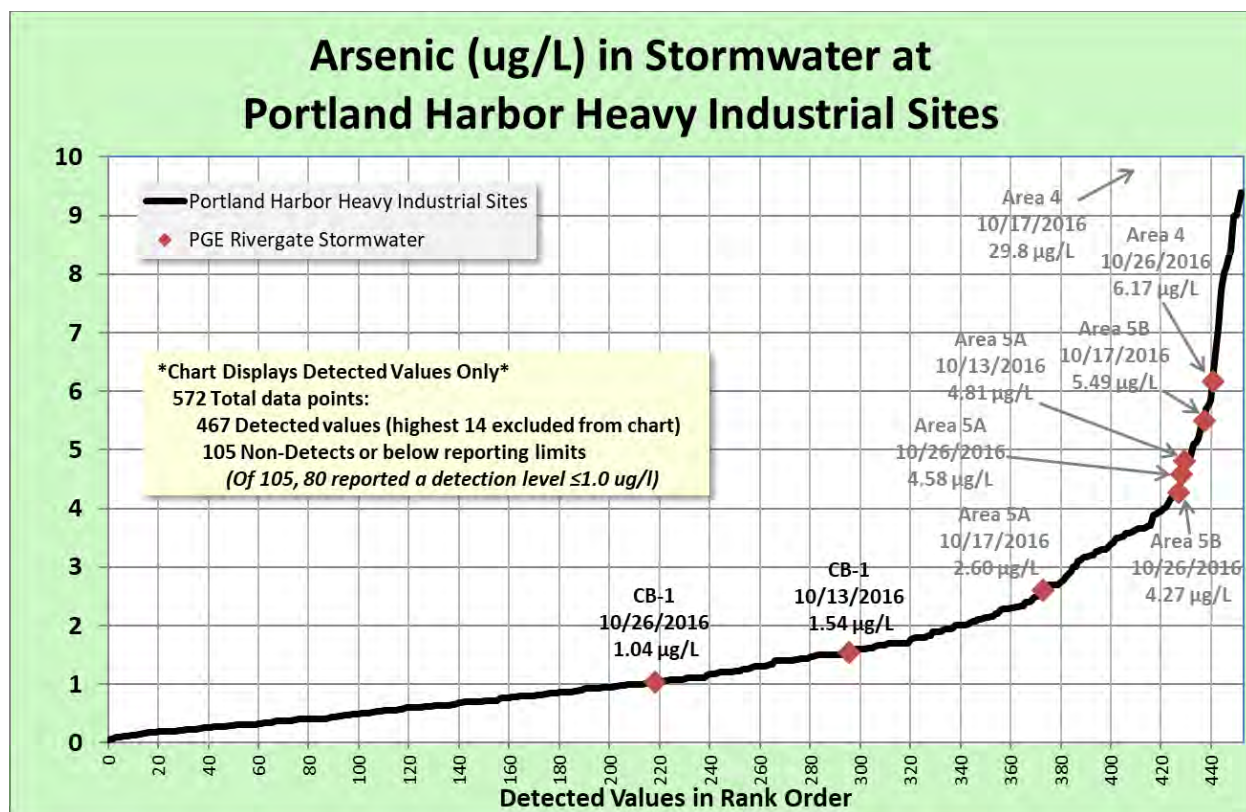
Figure 3: Arsenic in Stormwater at Portland Harbor Heavy Industrial Sites with PGE Stormwater Data. Data labeled in grey may not be reliable due to data quality concerns (see Section 5.1 of PGE 2020).

cadmium and copper, two samples of zinc in stormwater and two samples of PCBs in soil, the data fall below the flat portion of the curves. Thus, despite some contaminant CUL/SLV exceedances, contaminants in these media are not atypically elevated at the site and are not of concern for the Willamette River or Columbia Slough since neither soils nor stormwater discharge from the site.
