MEMORANDUM

Project No. AS210426-A-10

Re: Former L.D. McFarland Creosote Wood Treating Facility, Milwaukie, Oregon (ECSI #887) – Winter 2024 Vapor Intrusion Assessment Results

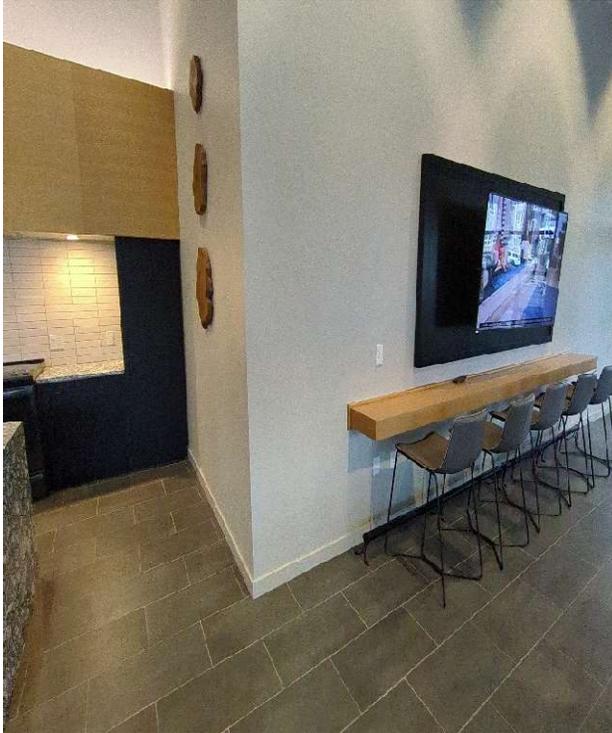
Photo 1. Clubhouse (north) Clubroom sample location general area during building site assessment (2/9/24).

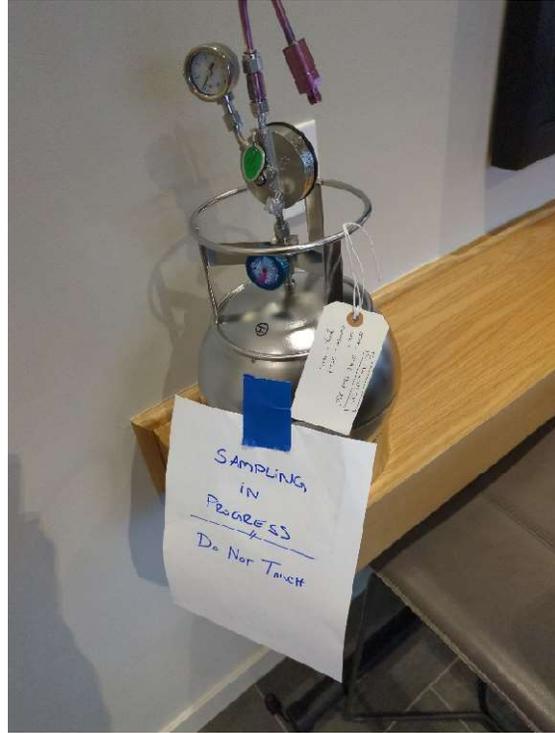
- Naphthalene was detected in both Clubhouse indoor samples at concentrations of 0.17 ug/m^3 and 0.20 ug/m^3 , which are below the urban residential and occupational RBCs (Table 1). The concentrations of naphthalene detected in indoor air are slightly elevated compared to the ambient (outdoor) air sample at the Clubhouse where naphthalene was reported at a concentration of 0.084 ug/m^3 .
- Naphthalene was detected in the Clubhouse effluent sample at a concentration above the urban residential but below the occupational RBC, at 0.32 ug/m^3 .

Photo 2. Sample CH-IA1-021924 collection in the Clubhouse (north) Clubroom (2/19/24).

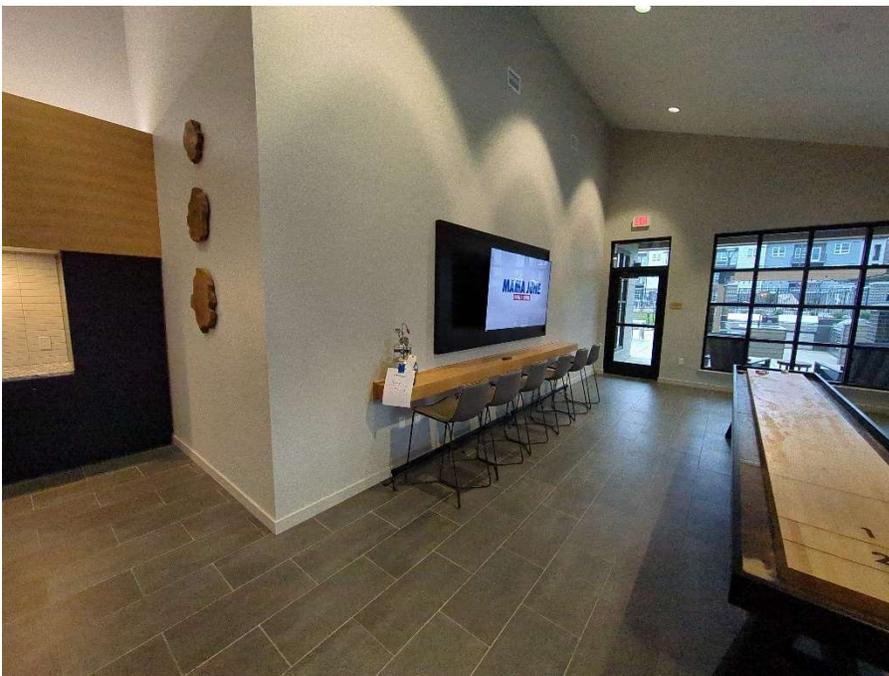
Photo 3. View of sample CH-IA1-021924 collection in the Clubhouse (north) Clubroom (2/19/24).

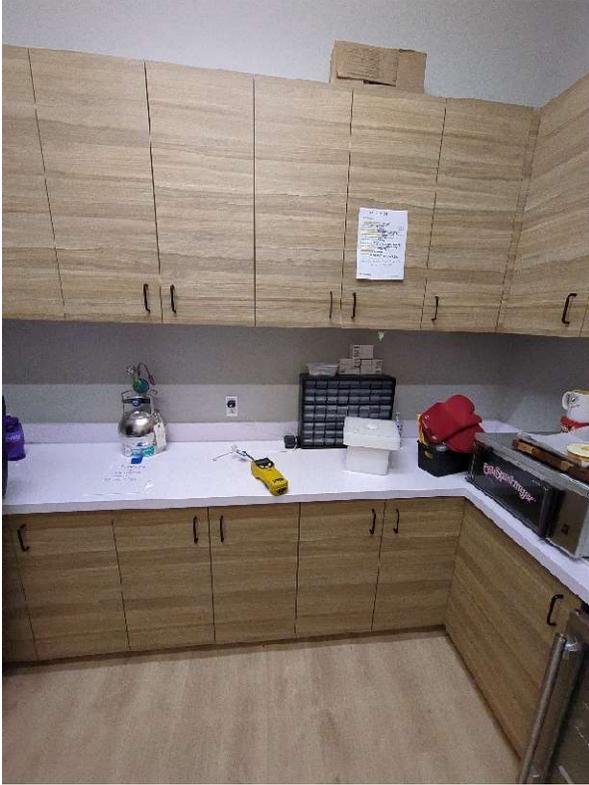
Photo 4. Sample CH-IA2-021924 collection in Clubhouse (south) Work Room (2/19/24)

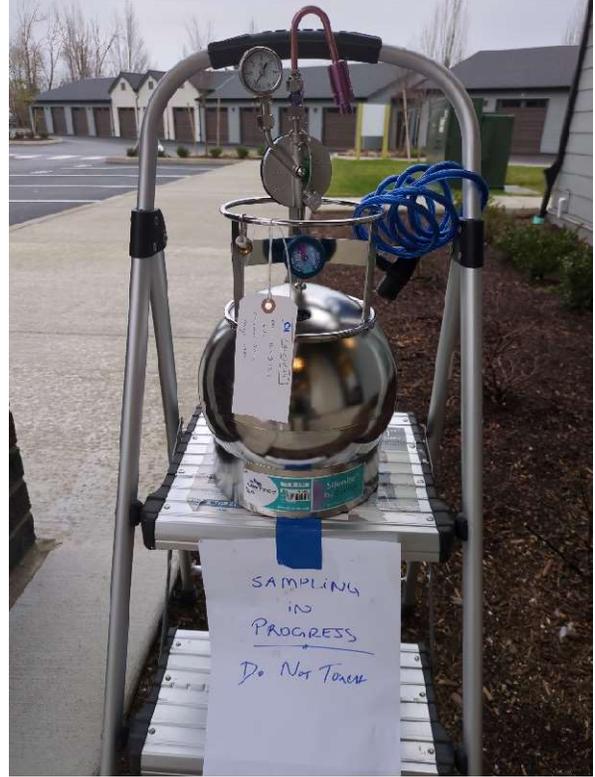
Photo 5. Ambient sample CH-AA-021924 collection outside of Clubhouse (east) (2/19/24).

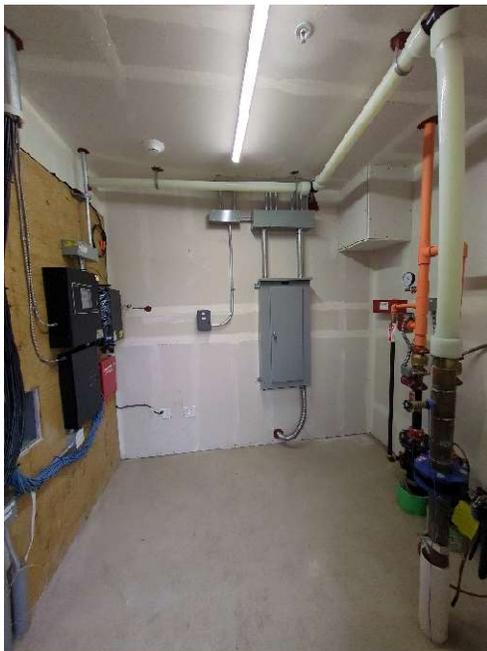
Photo 6. Building 4 (southeast) electrical riser room sampling area during building evaluation (2/9/24).

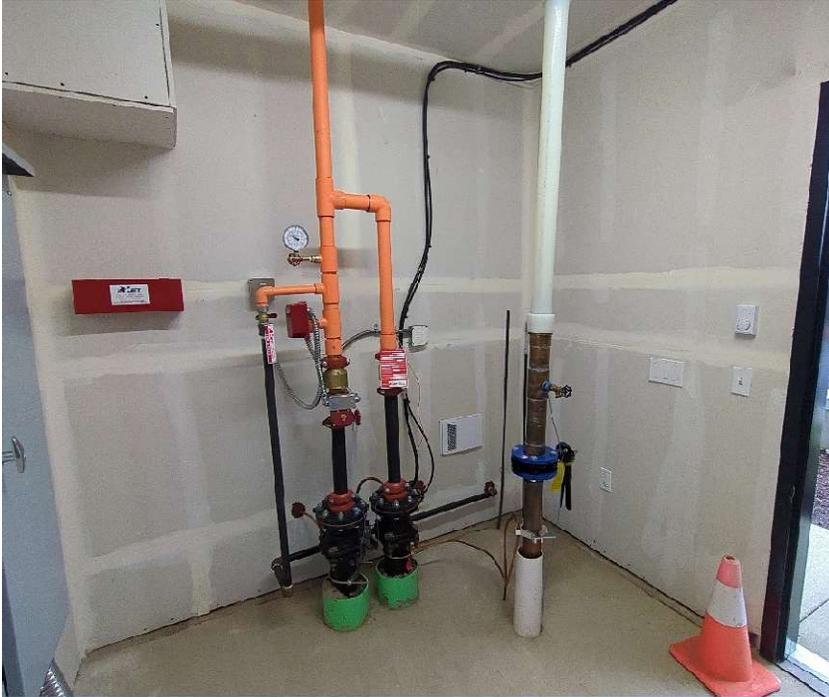
Photo 7. Building 4 (southeast) electrical riser room sampling area during building evaluation (2/9/24).

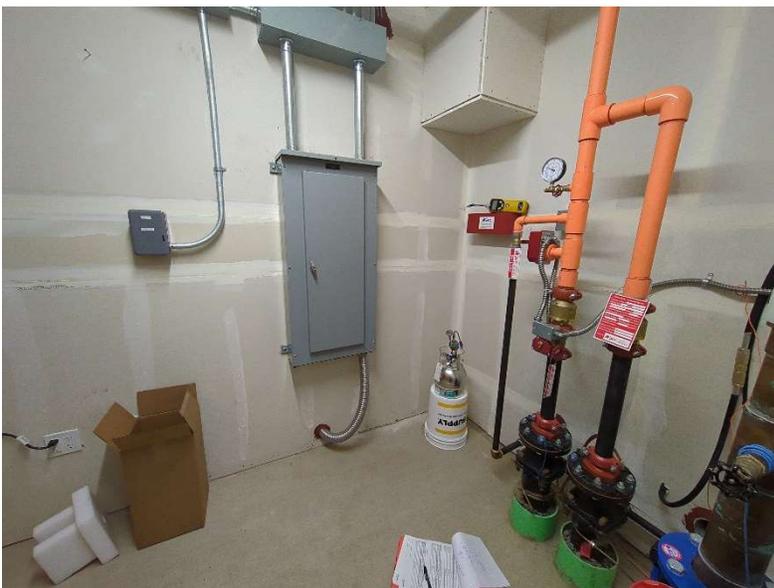
- Naphthalene was detected in the Building 4 indoor air sample at a concentration of 0.4 ug/m^3 , which is slightly above the urban residential and occupational RBCs of 0.2 and 0.36 ug/m^3 , respectively (Table 1). Naphthalene was detected below both the urban residential RBC and occupational RBC in the Building 4 ambient air sample at 0.1 ug/m^3 .

Based on the ambient air sample results, indoor air within the Clubhouse is representative of urban background conditions and is not impacted by naphthalene in soil on Parcel 2. Building 4 naphthalene detections are likely a result of new building materials and limited ventilation of the sampling location.

Photo 8. Sample B4-IA1-021924 collection in Building 4 (southeast) electrical riser room (2/19/24).

Concentrations of naphthalene detected in the Building 4 indoor air sample exceeds the urban residential RBC and occupational RBC. The Building 4 air samples were collected to provide additional monitoring data to evaluate potential interference from new building materials. The naphthalene detections in the Building 4 indoor air samples are likely a result of new building materials and limited ventilation. No additional indoor air sampling is planned for Building 4.

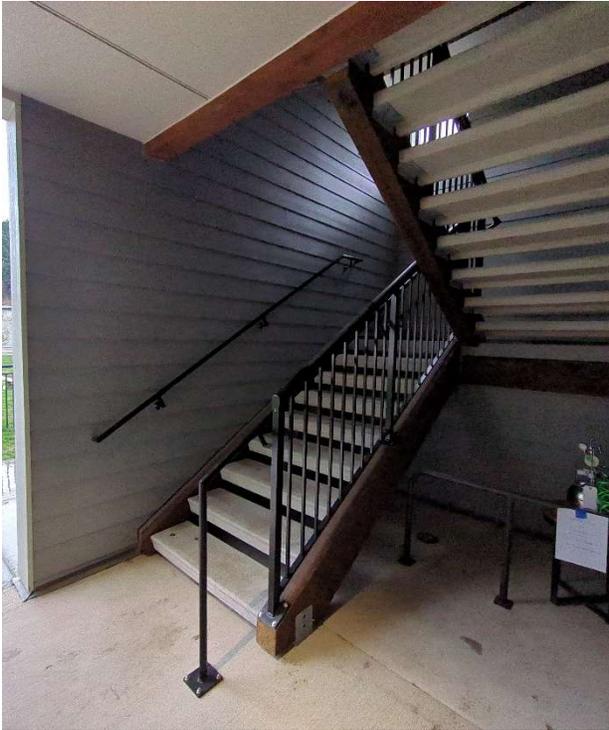
Photo 9. Ambient sample B4-AA-021924 collection at Building 4 (east) stairwell breezeway (2/19/24).

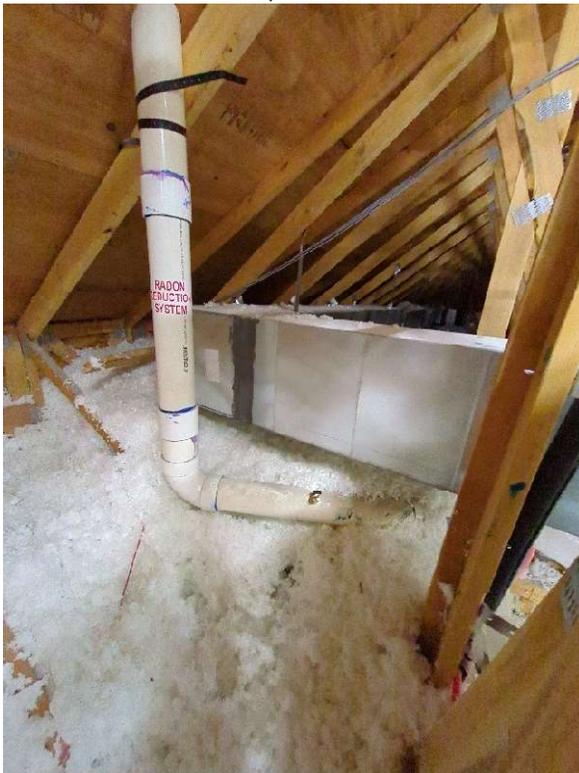
Results of the VI assessment indicate concentrations of naphthalene detected in Clubhouse indoor air are below DEQ risk-based concentrations. The air sample collected from the passive venting system effluent contains higher concentrations of naphthalene than were detected in indoor air. The elevated naphthalene concentration sampled from the effluent stack and the low concentrations observed in the Clubhouse indoor air samples suggest that the passive venting system is effectively venting naphthalene from beneath the Clubhouse.

Photo 10. View of passive venting system effluent stack in Clubhouse attic during site assessment (2/19/24).
