Department of Environmental Quality

September 25, 2012

RE: Project Status
Former Progress Dry Cleaners Site
8602 SW Hall Boulevard
Beaverton, Oregon
ECSI #4798

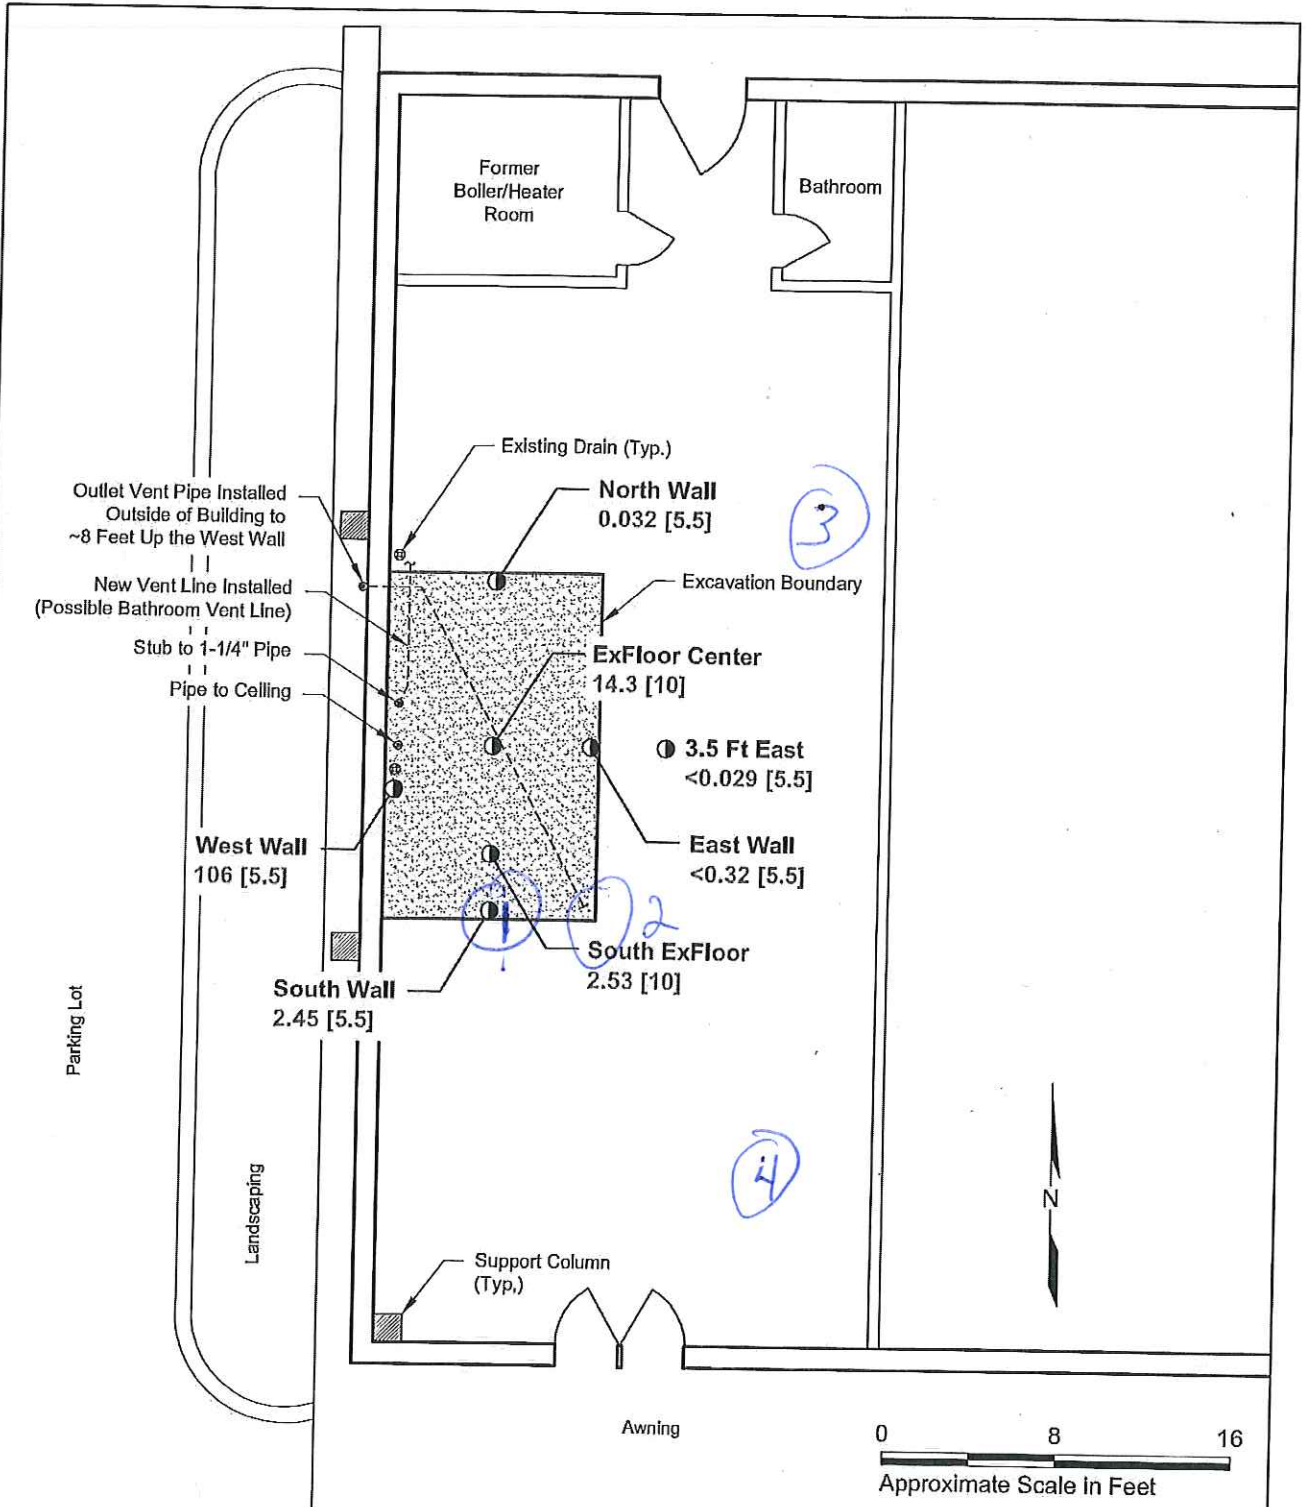
Former Progress Dry Cleaners 8602 SW Hall Boulevard, Beaverton, Oregon	
Site Plan	
15656-00/Task 5	11/07
 HARTCROWSER	Figure 2

At the time of sampling the concrete had a noticeable separation between the original floor and the patch installed by DEQ following the soil removal action (see attached photos). The locations of the photos are shown on the attached figure. Cracking was noted previously in 2009 and seemed to correlate with a moderate increase in indoor air concentrations with the vapor collection fan operating. Although levels increased after the initial cracking they were still below current RBCs for indoor air. After the cracks were repaired the first time the indoor air concentrations decreased.

The vapor collection system appears capable of mitigating vapor migration into indoor air even when cracking occurs in the floor. Thus the fan should be turned on, and will likely need to be run for the foreseeable future. DEQ plans on additional air testing (without sealing the cracks) with the vapor collection system operating to verify it is effective even when cracks are present in the floor. Following indoor air sampling DEQ would seal the cracks following discussion with you regarding a preferred sealant. DEQ has Dry Cleaner Program funds to complete this work.
