Re: Seismic Vulnerability Assessment, Seaport Midstream Partners, LLC, Portland Terminal

SEISMIC VULNERABILITY ASSESSMENT OF THE SEAPORT MIDSTREAM PARTNERS PORTLAND TERMINAL

SeaPort Midstream Partners, LLC
Portland Terminal
Portland, OR
May 2024

SGH Project 247052

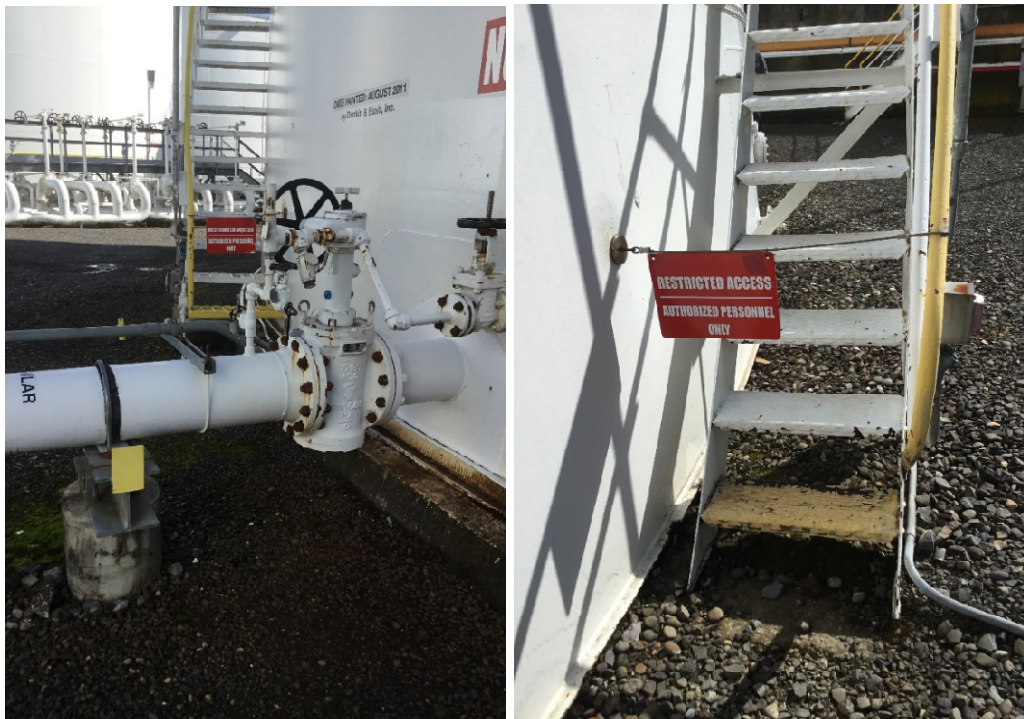
Figure E-1: Example Over-Constrained Conditions

Pipelines are rated Moderate throughout the terminal due to differential displacements from vertical settlement and the anticipated pipe stresses. At the dock, pipelines are rated High due to a higher consequence of damage and spill directly into the river. Additionally, the dock piping is likely to experience high stresses due to its supported condition on the wharf and the higher soil displacements estimated at the river front.

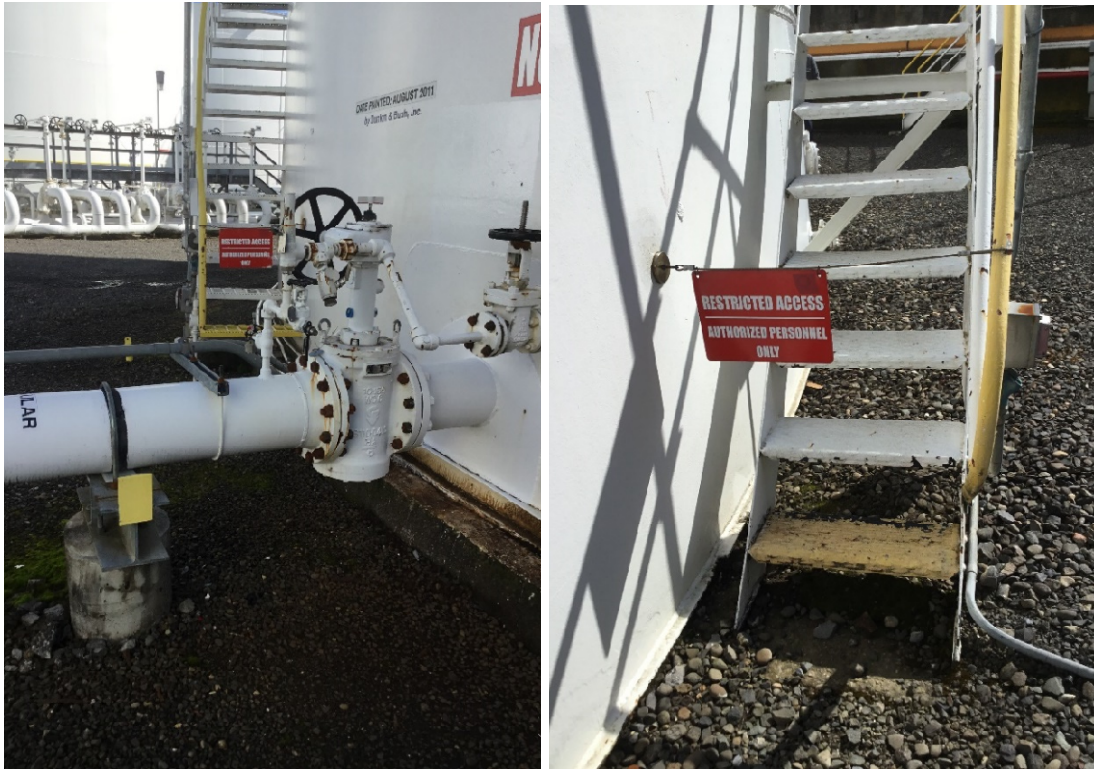
Figure 7-1: Example Over-Constrained Conditions

Pipelines are rated Moderate throughout the terminal due to differential displacements from vertical settlement and the anticipated pipe stresses. At the dock, pipelines are rated High due to a higher consequence of damage and spill directly into the river. Additionally, the dock piping is likely to experience high stresses due to its supported condition on the wharf and the higher soil displacements estimated at the river front.

Left: Short pipe run to u-bolt at Tank 5
