Re: Seismic Vulnerability Assessment of Shell Portland Terminal (Triton West LLC)

SEISMIC VULNERABILITY ASSESSMENT OF THE SHELL PORTLAND TERMINAL

Shell Trading & Supply
Portland, OR
May 2024

SGH Project 247040

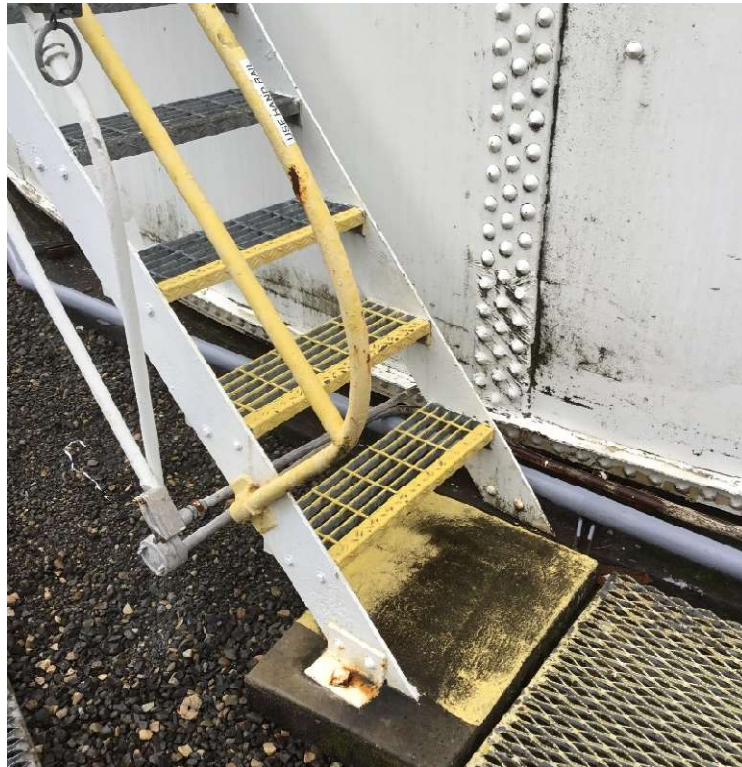
Figure E-1: Typical Stair Anchorage at South Tank Farm

Two of the tanks in the North Tank farm have a high Life-Safety severity due to over-constrained piping condition which increase Likelihood and a large volumes of gasoline which increases the Severity. This is also the case for the gasoline tank (T-55000) in the South Tank Farm. Other tanks in the South Tank Farm are rated Moderate primarily due to an over-constrained condition with the stairs anchored to the foundation. An example is shown in Figure E-1.

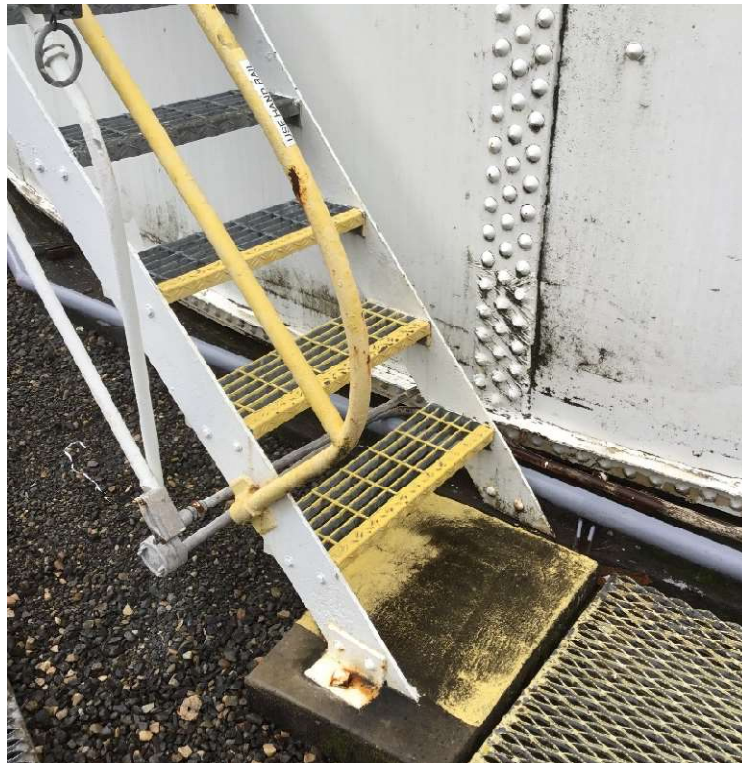
Figure 7-1: Typical Stair Anchorage at South Tank Farm

Two of the tanks in the North Tank farm have a high Life-Safety severity due to over-constrained piping condition which increase Likelihood and a large volumes of gasoline which increases the Severity. This is also the case for the gasoline tank (T-55000) in the South Tank Farm. Other tanks in the South Tank Farm are rated Moderate primarily due to an over-constrained condition with the stairs anchored to the foundation. An example is shown in Figure 7-1.
