ALPHA TECHNICAL GROUP INC.

**Pacterm- Portland Terminal
Seismic Vulnerability Assessment (SVA)
Phase 1**

Rev Date: May 30, 2024

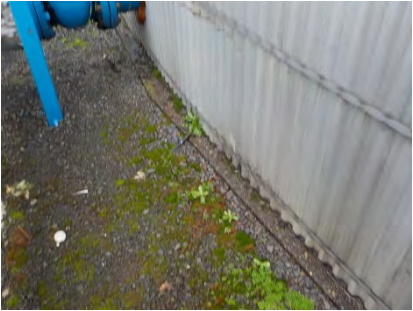
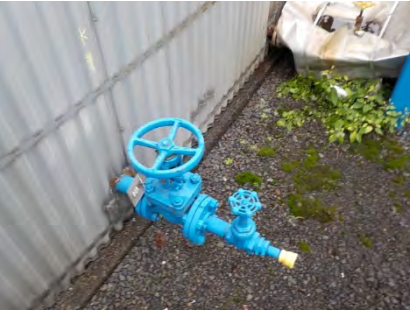
A fair amount of vegetation was found growing at the base of the tank.

INSPECTION RECOMMENDATIONS	
Recommendation ID	REC - 1
Component	Foundation
Recommendation Headline	Vegetation
Recommendation Description	<p>Findings: A fair amount of vegetation was found growing at the base of the tank.</p> <p>Recommendations: It is recommended that the vegetation be sprayed with an approved defoliant or the vegetation be removed manually.</p> <p>Post Actions:</p>
Recommendation Priority	Optional
Author Name	Byron Johnson API 653 Certification No. 33622 <i>Byron D. Johnson</i>
Status	This optional repair had not been addressed as of 1/22/2021

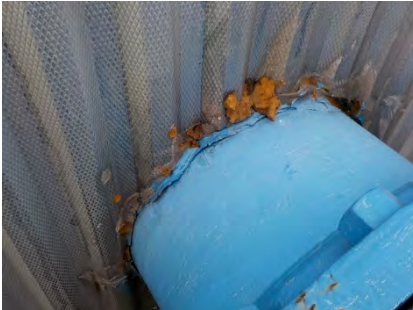
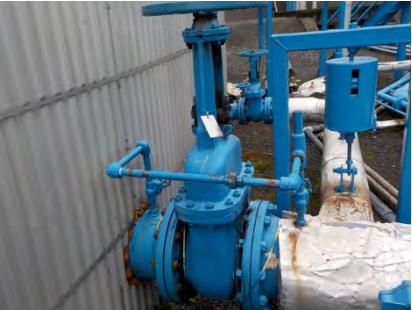
It would appear that the caulking which protects the insulation from the incursion of rain water was found to aged and cracking.

Recommendation ID	REC - 2
Component	Nozzles and appurtenances
Recommendation Headline	Insulation Jacket Seals
Recommendation Description	<p>Findings: It would appear that the caulking which protects the insulation from the incursion of rain water was found to aged and cracking.</p> <p>Recommendations: It is recommended that the nozzle the insulation interface be re-caulked.</p> <p>Post Actions:</p>
Recommendation Priority	Optional
Author Name	Byron Johnson API 653 Certification No. 33622 <i>Byron D. Johnson</i>
Status	This optional repair had not been addressed as of 1/22/2021

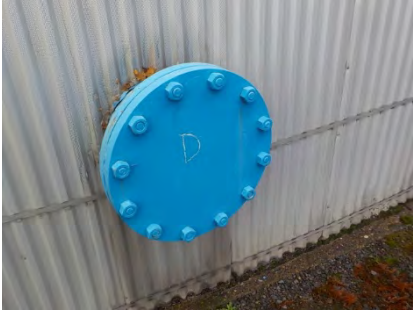
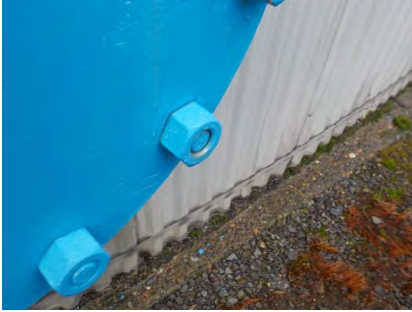
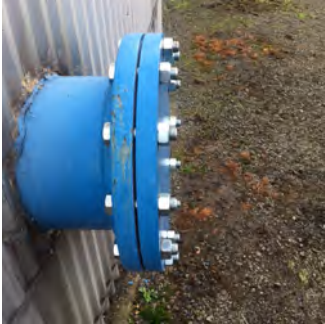
Nozzle D was found to have numerous bolts with short thread protrusion on nozzle flange bolts. Per API a minimum of two (2) threads should extend beyond the outer face of the nut.

Recommendation ID	REC - 3
Component	Nozzles and appurtenances
Recommendation Headline	Short thread protrusion on nozzle flange bolts.
Recommendation Description	<p>Findings: Nozzle D was found to have numerous bolts with short thread protrusion on nozzle flange bolts. Per API A minimum of two (2) threads should extend beyond the outer face of the nut.</p> <p>Recommendations: It is recommended that, one at a time the all-thread be replaced with a long enough piece so that proper thread protrusion can be achieved.</p> <p>Post Actions:</p>
Recommendation Priority	Mandatory
Author Name	Byron Johnson API 653 Certification No. 33622 <i>Byron D. Johnson</i>
Status	This mandatory repair has been addressed as of 1/22/2021 and is acceptable.

C.1.3.1c	Inspect for flange leaks around bolting and leaking threaded connections on shell couplings and nipples.	Mandatory	Nozzle D was found to have numerous bolts with short thread protrusion on nozzle flange bolts. Per API A minimum of two (2) threads should extend beyond the outer face of the nut.	It is recommended that, one at a time the all-thread be replaced with a long enough piece so that proper thread protrusion can be achieved.
C.1.3.1d	Inspect sealing of insulation around manways and nozzles.	Optional	It would appear that the caulking which protects the insulation from the incursion of rain water was found to aged and cracking.	It is recommended that the nozzle the insulation interface be re-caulked.
C.1.3.1e	Check for inadequate manway flange and cover thickness on mixer manways.	N/A	The tank is not equipped with a mixer.	
C.1.3.1f	Record all nozzle and appurtenance information on the "Shell Nozzle & Appurtenance Table". The station, heights, pipe size, repad size, repad type, weld spacing and distance from shell to flange face shall be recorded.	Satisfactory	See the nozzle and appurtenances table.

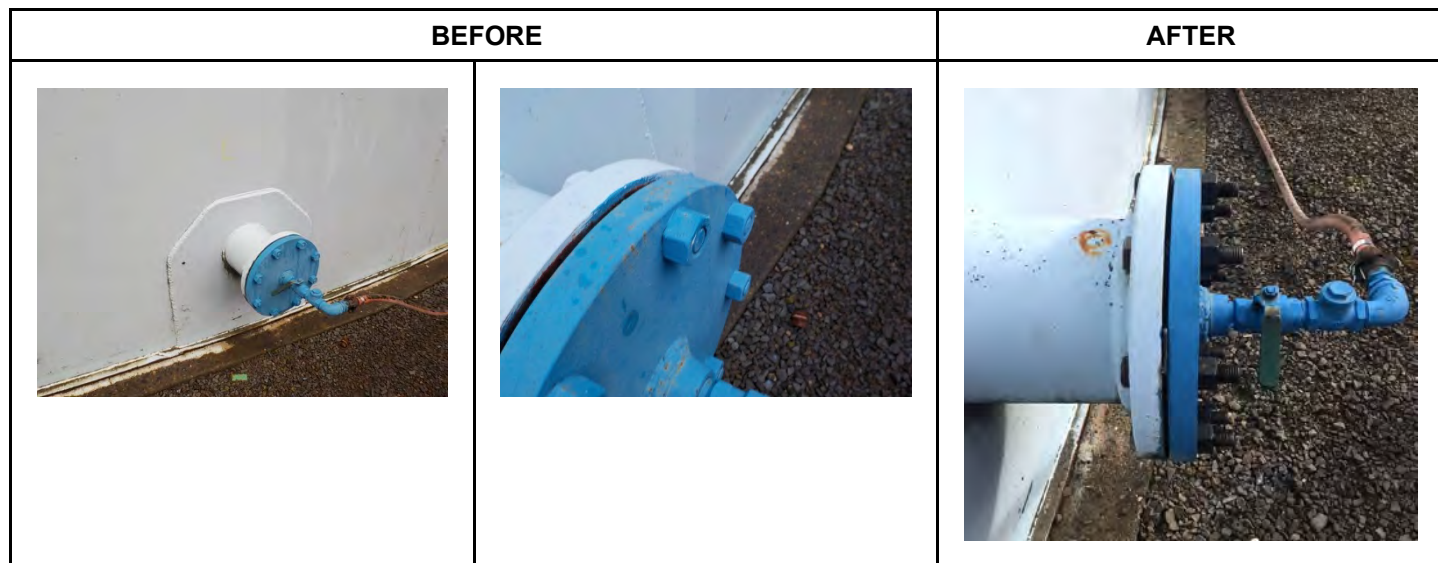
INSPECTION RECOMMENDATIONS	
Recommendation ID	REC - 1
Component	Nozzles and appurtenances
Recommendation Headline	Short thread protrusion on nozzle flange bolts.
Recommendation Description	<p>Findings: Nozzle L was found to have numerous bolts with short thread protrusion on nozzle flange bolts. Per API A minimum of two (2) threads should extend beyond the outer face of the nut.</p> <p>Recommendations: It is recommended that, one at a time the all-thread be replaced with a long enough piece so that proper thread protrusion can be achieved.</p> <p>Post Actions:</p>
Recommendation Priority	Mandatory
Author Name	Byron Johnson API 653 Certification No. 33622 <i>Byron D. Johnson</i>
Status	This mandatory repair has been addressed as of 1/22/2021 and is acceptable.

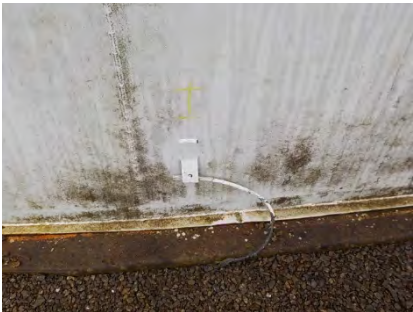
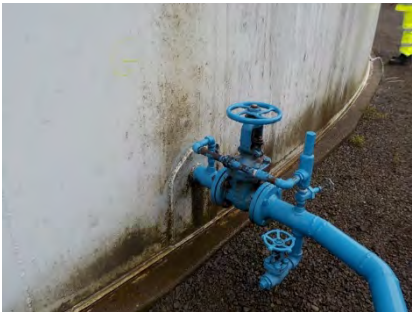
INSPECTION RECOMMENDATIONS	
Recommendation ID	REC - 2
Component	Shell
Recommendation Headline	Coating
Recommendation Description	<p>Findings: The shell was found to have large amounts of mildew present which if left un-checked could harm the coating.</p> <p>Recommendations: It is recommended that the roof and shell receive a light hydro wash to remove the mildew.</p> <p>Post Actions:</p>
Recommendation Priority	Optional
Author Name	Byron Johnson API 653 Certification No. 33622 <i>Byron D. Johnson</i>
Status	This optional repair had not been addressed as of 1/22/2021

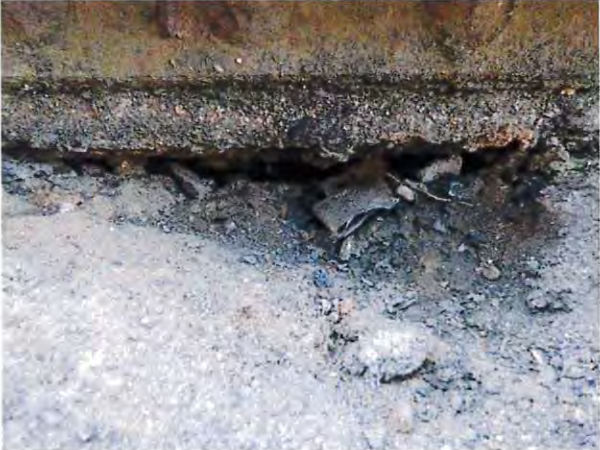
INSPECTION RECOMMENDATIONS	
Recommendation ID	REC - 1
Component	C.1.1 FOUNDATION
Recommendation Headline	C.1.1.1c Undermining
Recommendation Description	<p>Findings:</p> <p>There is a cavity present on the northeast side of the tank which extends underneath of the tank.</p> <p>Recommendations:</p> <p>The cavity should be backfilled as needed to prevent water from flowing underneath the tank.</p>
Recommendation Priority	Mandatory
Status	
Author Name	Alec Arpino API 653 Certification No. 77549
<div style="display: flex;"> <div style="flex: 1;">

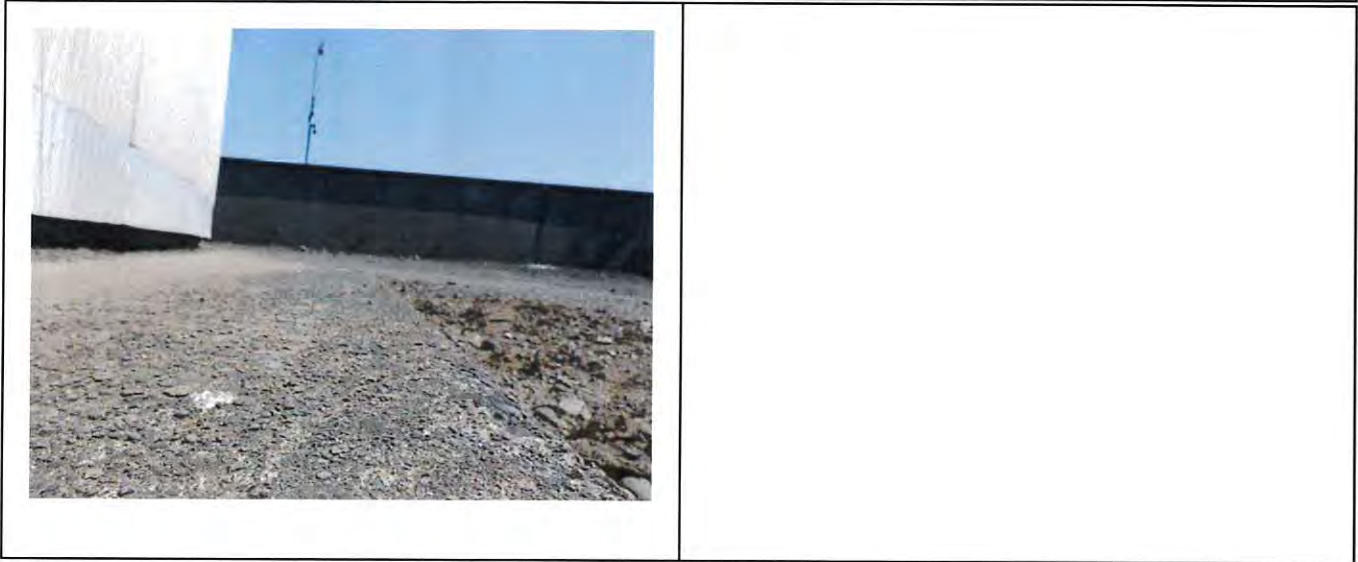
INSPECTION RECOMMENDATIONS	
Recommendation ID	REC - 2
Component	C.1.1 FOUNDATION
Recommendation Headline	C.1.1.2.a Asphalt Ring
Recommendation Description	<p>Findings:</p> <p>The asphalt ring surrounding the tank is sloped inward, preventing drainage away from the foundation.</p> <p>Recommendations:</p> <p>Modify or replace the asphalt to allow for proper drainage away from the tank.</p>
Recommendation Priority	Optional
Status	
Author Name	Alec Arpino API 653 Certification No. 77549

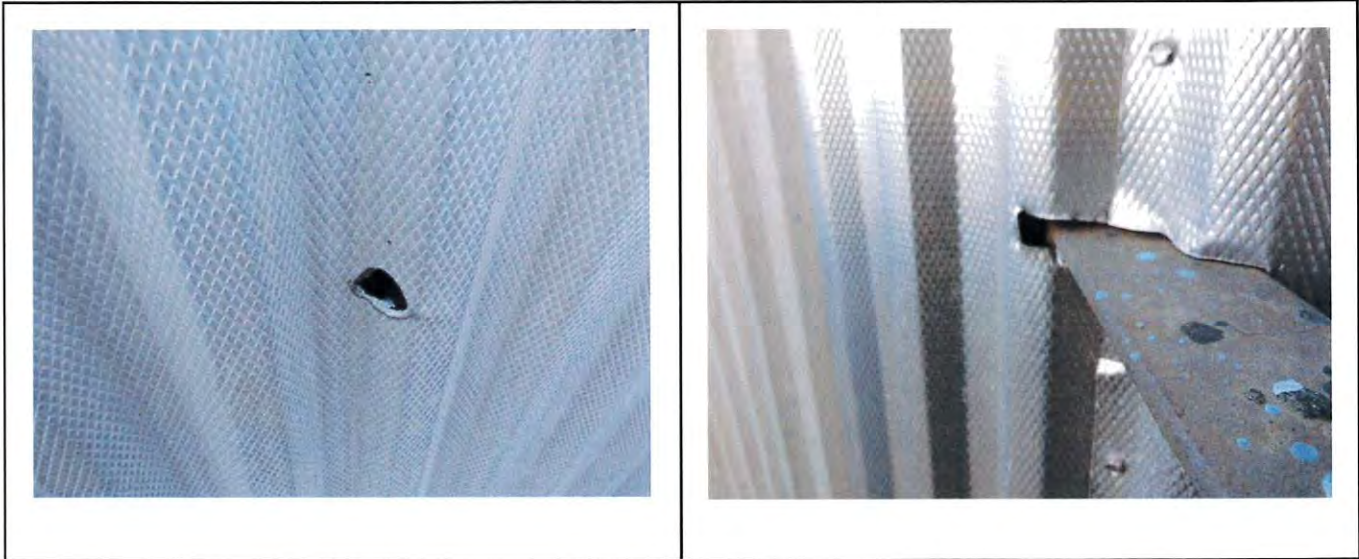
INSPECTION RECOMMENDATIONS	
Recommendation ID	REC - 3
Component	C.1.3 SHELL APPURTENANCES
Recommendation Headline	C.1.3.1d Insulation Sealant
Recommendation Description	<p>Findings:</p> <p>There are numerous holes evident through the insulation lagging. Additionally, there is no caulk/ sealant present on the shell attachments on the west side of the tank where the sight gauge system was removed.</p> <p>Recommendations</p> <p>Seal or repair the insulation as needed to mitigate water intrusion.</p>
Recommendation Priority	Optional
Status	
Author Name	Alec Arpino API 653 Certification No. 77549

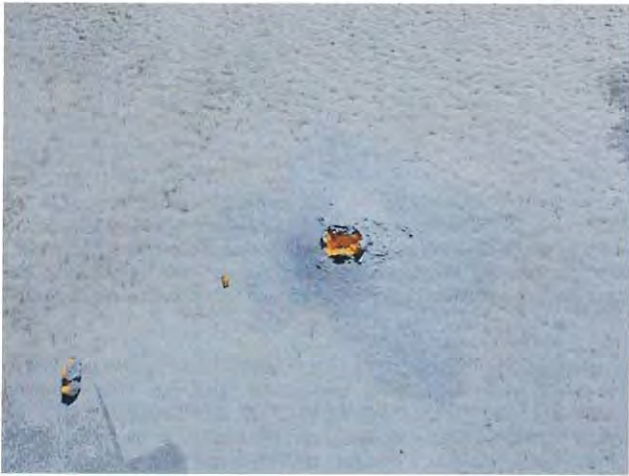
INSPECTION RECOMMENDATIONS	
Recommendation ID	REC - 6
Component	C.1.4 ROOFS
Recommendation Headline	C.1.4.6a Roof Insulation
Recommendation Description	<p>Findings: There are numerous holes through the foam insulation on the roof.</p> <p>Recommendations Seal the holes on the roof to mitigate water intrusion.</p>
Recommendation Priority	Optional
Status	
Author Name	Alec Arpino API 653 Certification No. 77549
<div style="display: flex;"> <div style="flex: 1;">

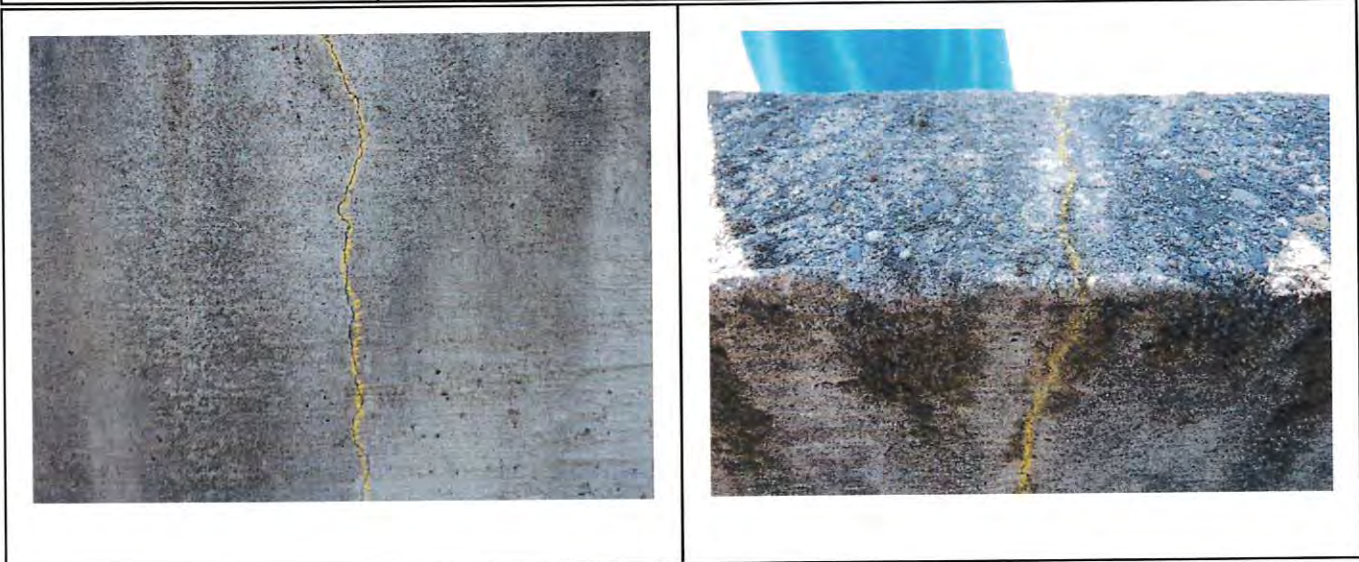
INSPECTION RECOMMENDATIONS	
Recommendation ID	REC - 1
Component	Shells
Recommendation Headline	Secondary Containment
Recommendation Description	<p>Findings:</p> <p>There is a crack in the southern containment wall which ranges from the top of the wall to the containment floor.</p> <p>Recommendations</p> <p>The crack should be prepped and repaired with an appropriate sealant in order to prevent further damage and to maintain an effective barrier in the event of a tank release.</p>
Recommendation Priority	Mandatory
Status	
Author Name	Alec Arpino API 653 Certification No. 77549

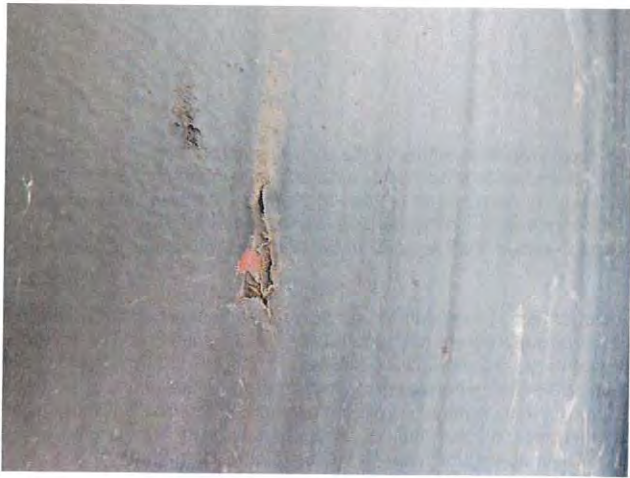
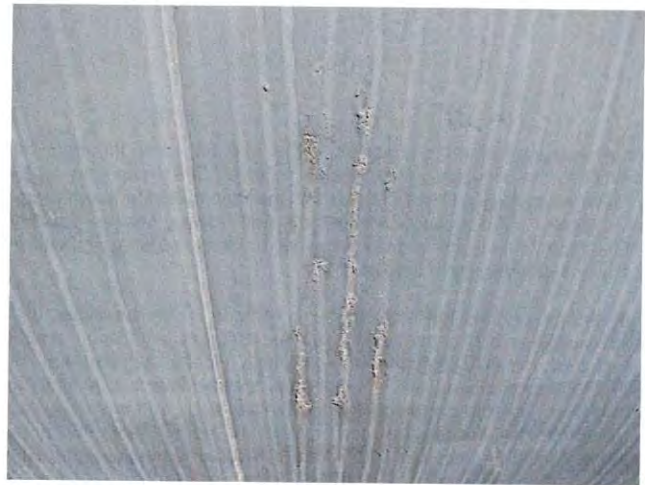
INSPECTION RECOMMENDATIONS	
Recommendation ID	REC - 2
Component	Shells
Recommendation Headline	Coating
Recommendation Description	<p>Findings: Some minor coating failure in the form of paint blistering with rust pitting was noted on the shell.</p> <p>Recommendations It is recommended that the shell coating be repaired as needed.</p>
Recommendation Priority	Optional
Status	
Author Name	Alec Arpino API 653 Certification No. 77549

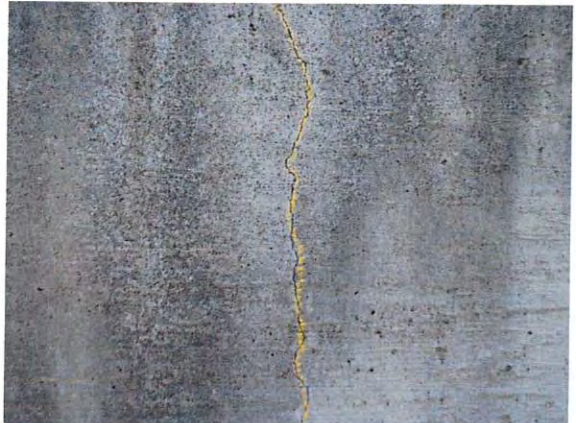
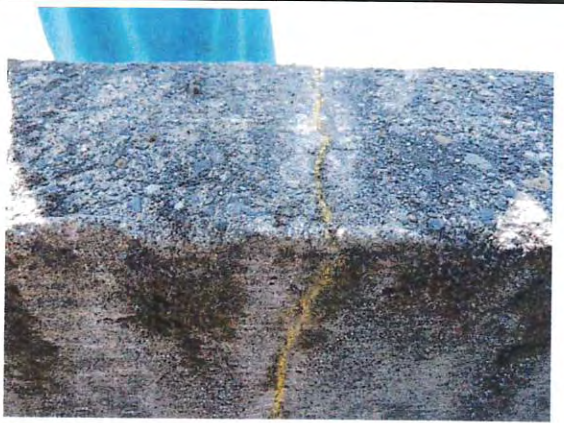
Containment Wall Crack	Containment Wall Crack (Top View)

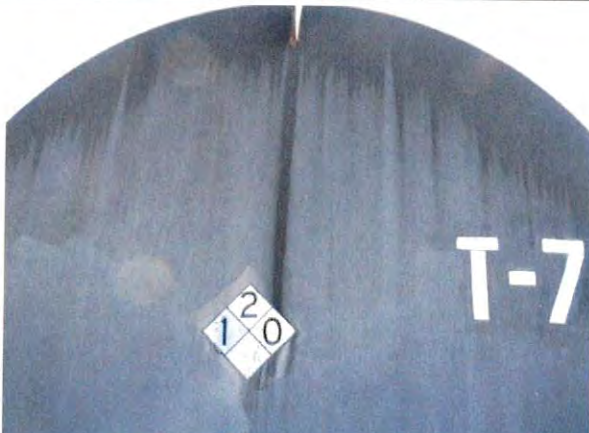
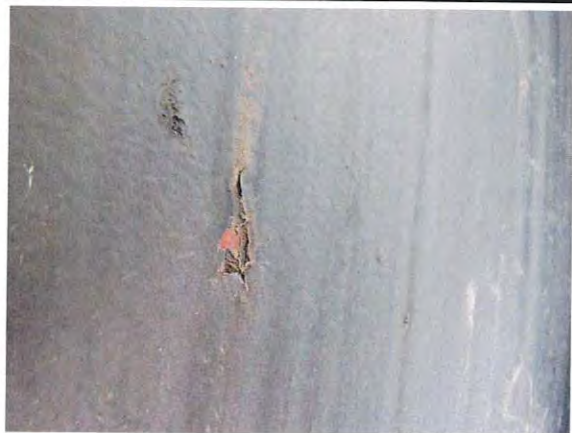
West Head	Coating Failure 1

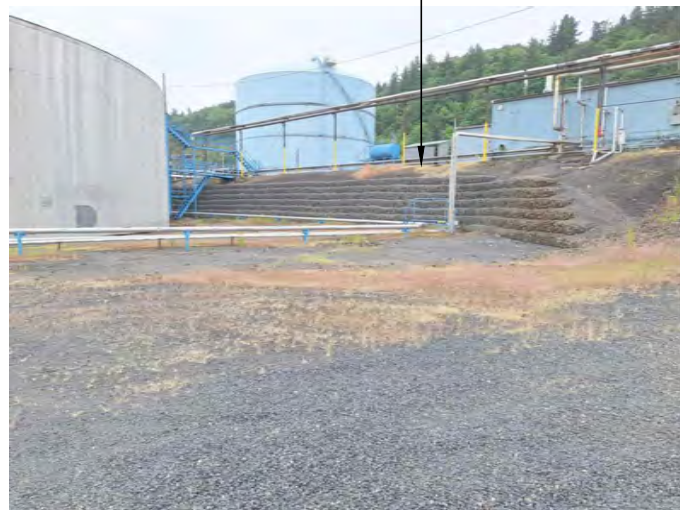
PHOTO #2 - OLD TANK FARM

EARTH BERM REINFORCED WITH ROCK GABION/WIRE BASKETS (NO ENGINEERING DATA FOUND AT TIME OF REPORT)

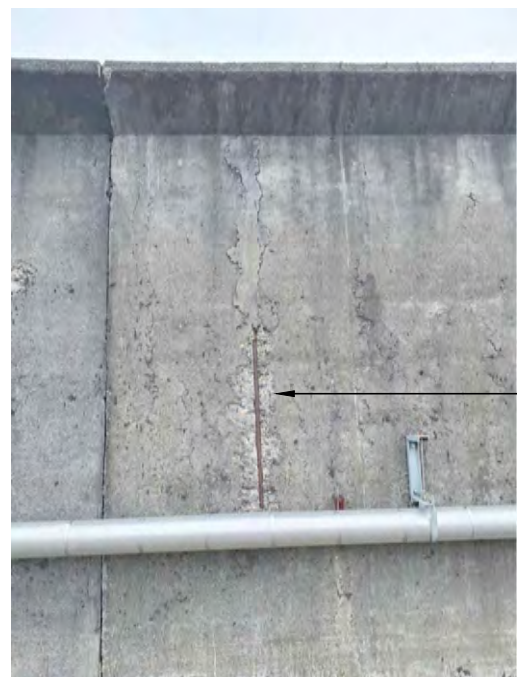
PHOTO #4 - OLD TANK FARM

CONCRETE SPALLING & EXPOSED REBAR
