RE: Submission of Seismic Vulnerability Assessment

SEISMIC VULNERABILITY ASSESSMENT OF THE CHEVRON WILLBRIDGE TERMINAL

Chevron Products Company
Willbridge Terminal
Portland, OR
May 2024

SGH Project 237372

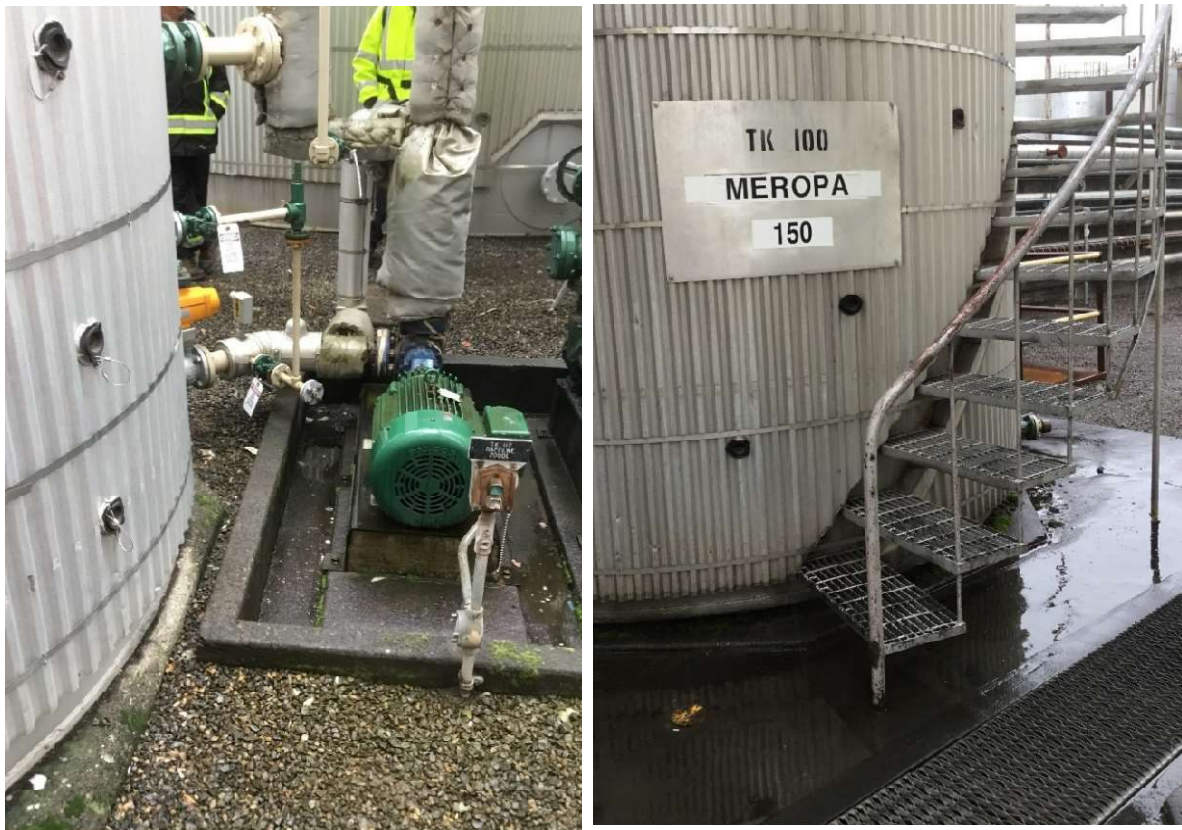
Many of the tanks in the Main Yard have a Moderate Risk due to their flammable contents and a higher Life Safety severity. Other tanks in the Main Yard are Moderate Risk due to a higher Likelihood of damage driven by an over-constrained condition with stairs or piping, as shown in the example photos of Figure E-1.

Figure E-1: Example Over-Constrained Conditions
Left: Short pipe run to anchored pump at Tank 117
Right: Anchored stair handrail at Tank 100

Items are categorized as Moderate or High Risk based on the full consideration of hazards, including earthquake induced ground deformations. For High Risk items, mitigations should be considered using an As Low As Reasonably Practicable (ALARP) risk reduction philosophy. For Moderate Risk items, further evaluation is recommended to determine if mitigation is necessary. For example, this may include detailed engineering calculations to quantify the seismic capacity of specific, existing components.

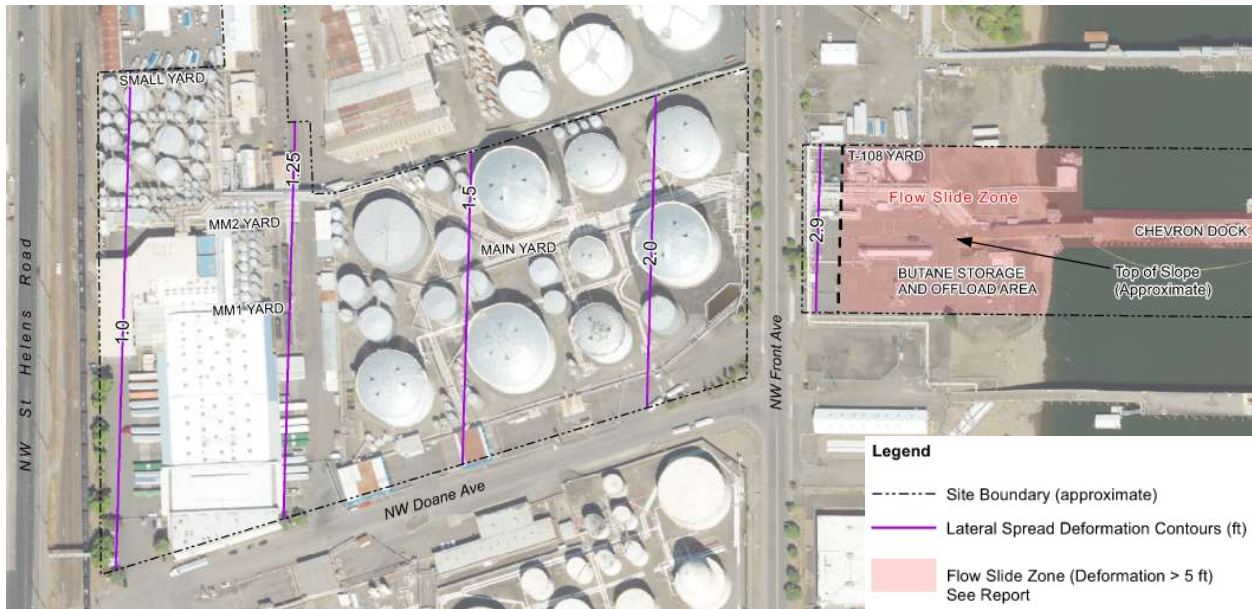
Figure 3-1: Estimated Lateral Spread Deformations

Lateral deformations due to lateral spreading are depicted as geographic contours in Figure 3-1. These estimates consider the proximity of the site to the free face slope of the waterfront along the Willamette River and a slope height of 70 feet. As shown in Figure 3-1, the estimated lateral spread deformations range from about 3 feet on the east side of NW Front Avenue (in the area of the dock, T-108 yard, and butane storage and offload area) to about 1 to 2 ½ feet on the west side of NW Front Avenue (in the area of the Main Yard, MM1 Yard, MM2 Yard, and Small Yard). It should be noted that the approach developed by Zhang, et al. (2004) and used to estimate deformations, could underestimate or overestimate lateral displacements by up to a factor of 2. Lateral spreading also results in ground settlement, which can be as much as about one-third to one-half of the magnitude of lateral displacement.

The primary mechanisms of liquefaction-induced settlement are reconsolidation (estimated as 2 to 6 inches), localized ejecta-induced settlements (up to 12 inches), and shear-induced foundation settlement (not estimated). Combined with the vertical component of lateral spreading, the total estimated settlement, with free-field conditions, ranges from 6 to over 30 inches.

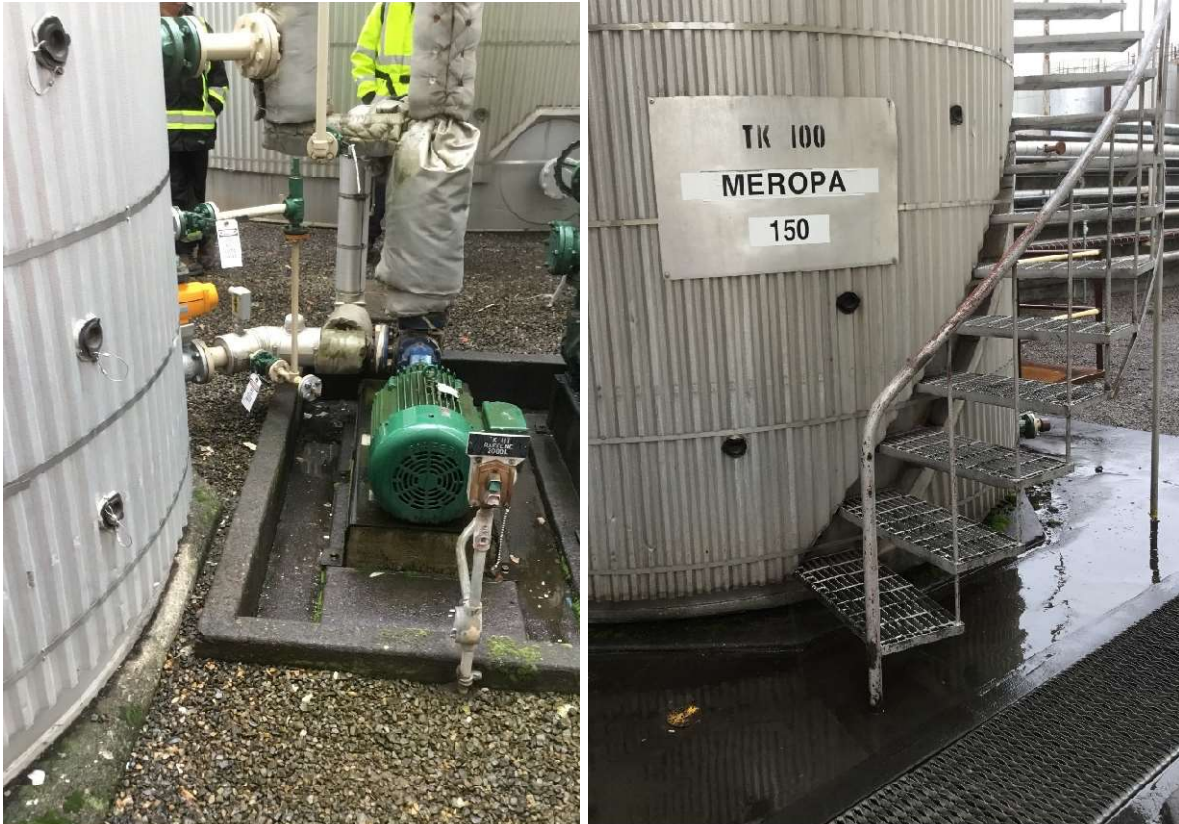
Figure 7-1: Example Over-Constrained Conditions
Left: Short pipe run to anchored pump at Tank 117
Right: Anchored stair handrail at Tank 100

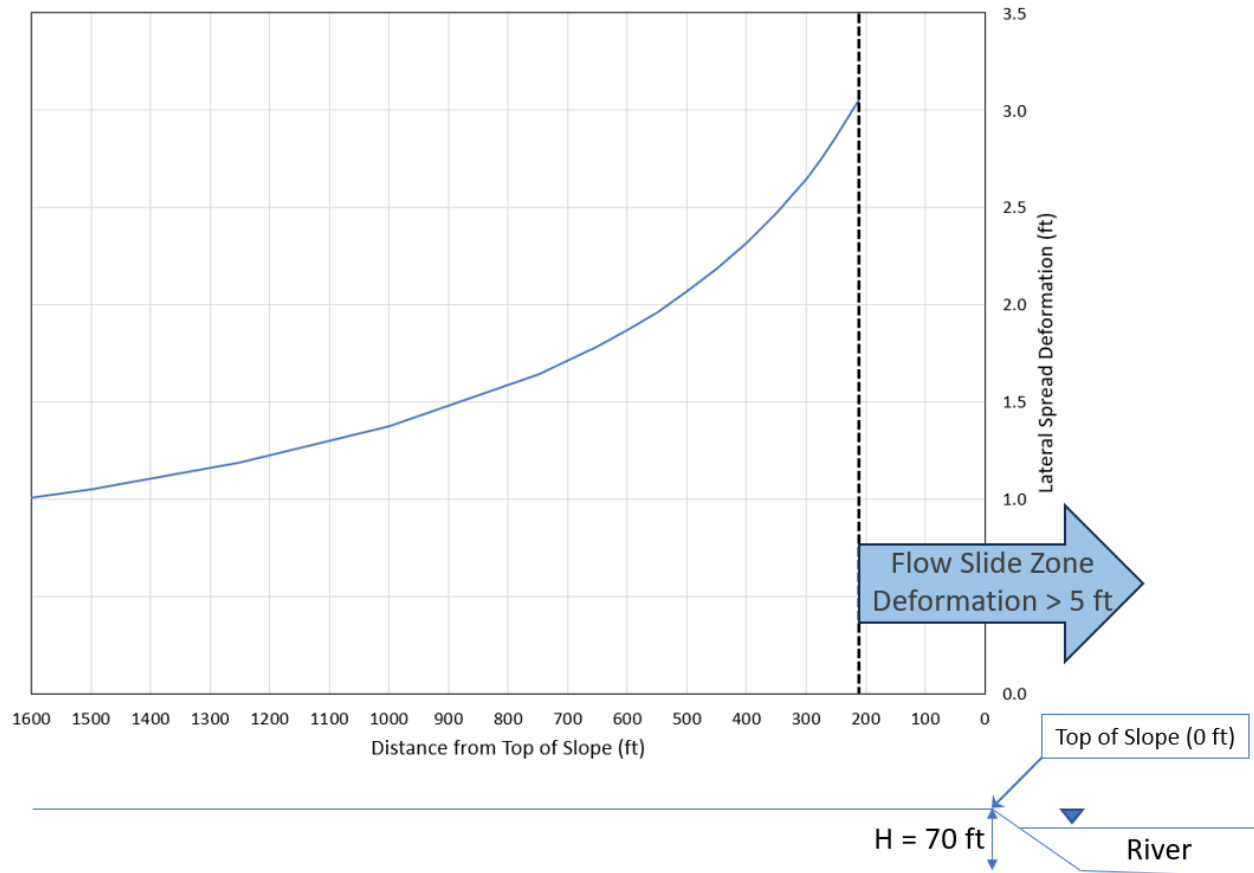
Exhibit 2: Seismically-Induced Lateral Ground Deformation

develop leading to a flow-type failure. In this case, large masses of ground may travel long distances (likely more than 5 feet) in the form of liquefied flows or blocks of ground riding on liquefied flows. The estimates of lateral spread deformation presented in Exhibit 2 are also shown on an aerial image of the terminal shown in the attached Figure 3. As shown in Figure 3, estimated lateral spread deformations range from about 3 feet on the east side of NW Front Avenue (in the area of the dock, T-108 yard, and butane storage and offload area) to about 1 to 2 ½ feet on the west side of NW Front Avenue (in the area of the Main Yard, MM1 Yard, MM2 Yard, and Small Yard).
