Seismic Vulnerability Assessment  
Phase 1

Phillips 66 Terminal  
Portland, Oregon

File No. 20545-035-02  
May 30, 2024

# WILLAMETTE RIVER TERMINAL: MARINE FACILITY STRUCTURAL CONDITION ASSESSMENT

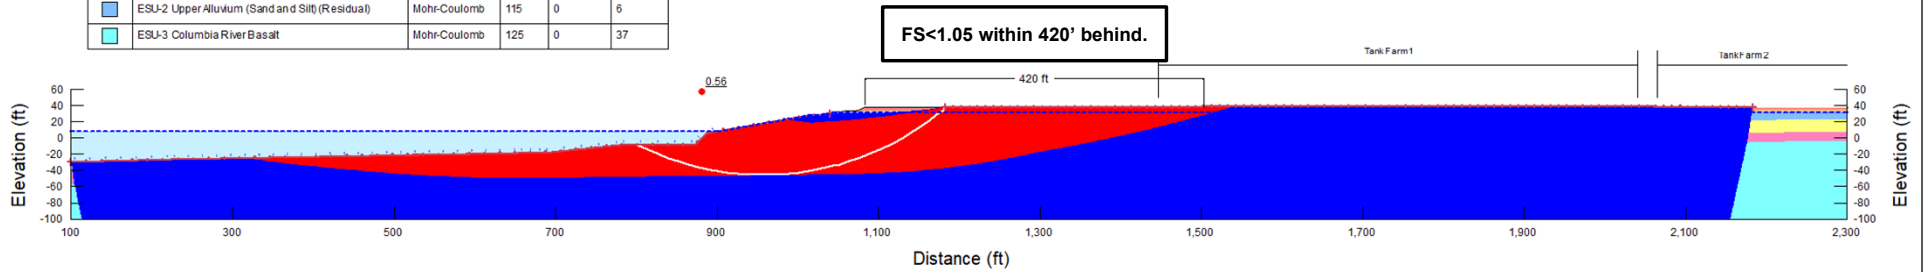
### Post-Earthquake Condition

- Liquefaction in ESU-2 and ESU-4.
- Flow failure within approximately 420' behind.

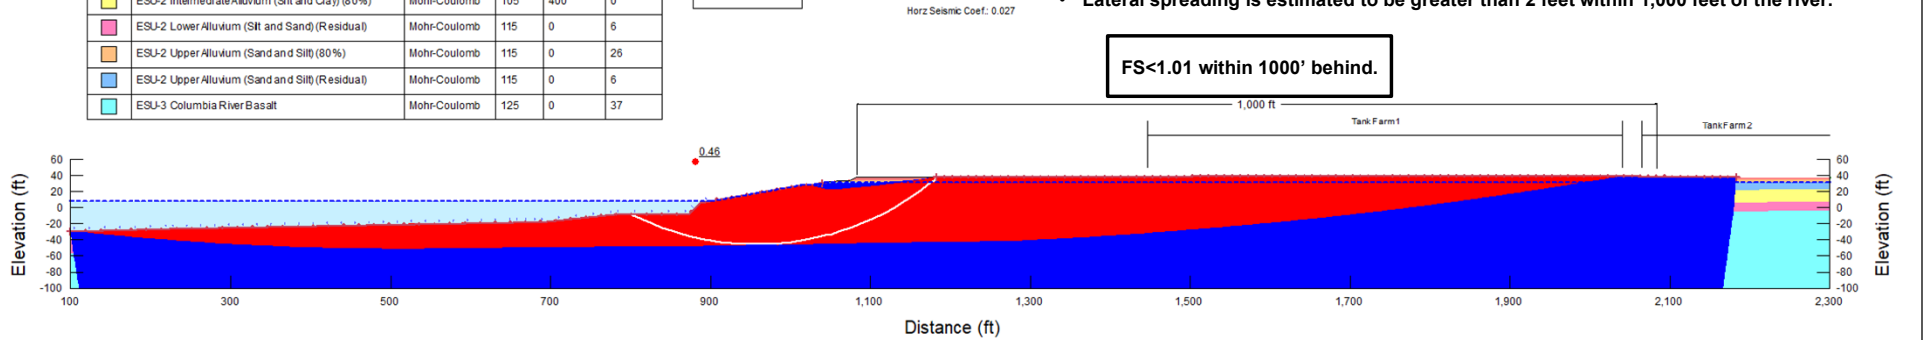
### Slope Stability Analysis Results

Figure 6 presents the slope stability analyses results for post-earthquake and during seismic conditions. In the post-seismic condition, the factor of safety (FOS) was estimated less than 1.05 for the slip surfaces going through the existing tank farm, which indicates a flow failure and an unstable condition. As shown in Figure 6, in the seismic condition, the yield acceleration was estimated as 0.027g within 1,000 feet from the free face. The yield acceleration is the horizontal seismic coefficient that results in a factor of safety of 1.0 computed from limit equilibrium slope stability analysis. The corresponding earthquake-induced lateral ground deformation was estimated to be greater than 2 feet using the simplified displacement approach developed by Bray and Travararou (2007) and Bray et al. (2018).

### Seismic Condition

- Liquefaction in ESU-2 and ESU-4.
- Lateral spreading is estimated to be greater than 2 feet within 1,000 feet of the river.

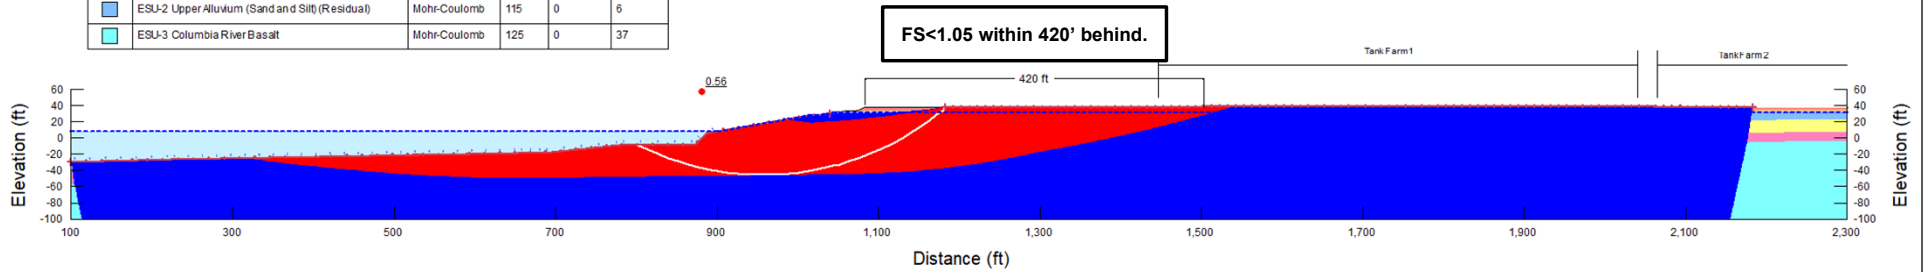
**Post-Earthquake Condition**

- Liquefaction in ESU-2 and ESU-4.
- Flow failure within approximately 420' behind.

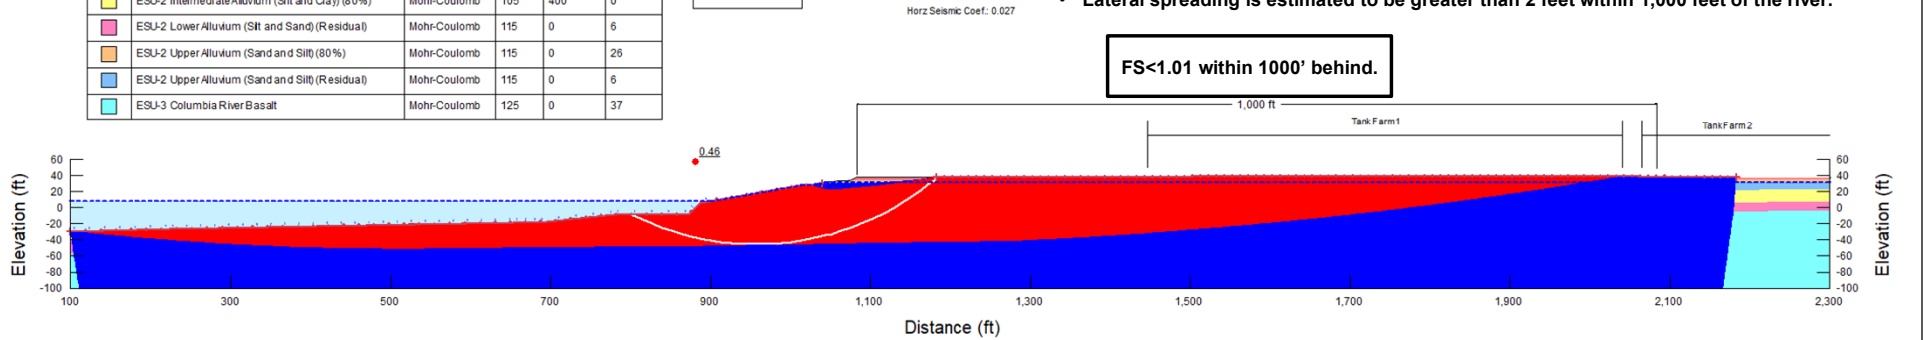
<b>Slope Stability Analysis Results</b>	
Philips 66 Portland Terminal Portland, Oregon	
	Figure A-3

**Seismic Condition**

- Liquefaction in ESU-2 and ESU-4.
- Lateral spreading is estimated to be greater than 2 feet within 1,000 feet of the river.

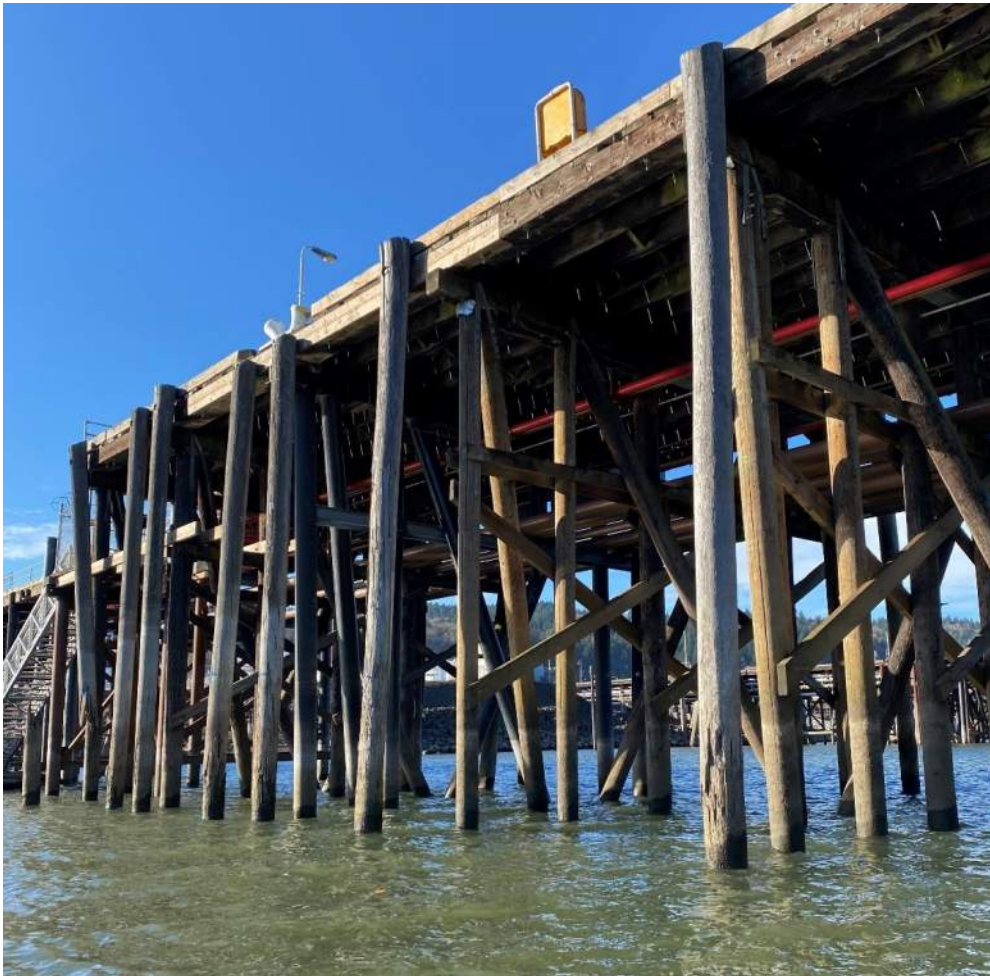
Picture 9. Upstream berth, shoreside. Note the fender piles broken at the water level., dead head.

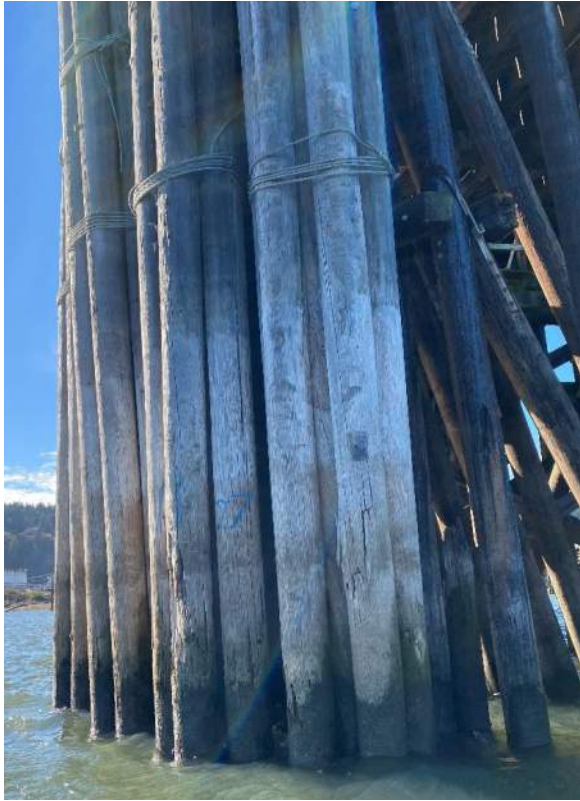
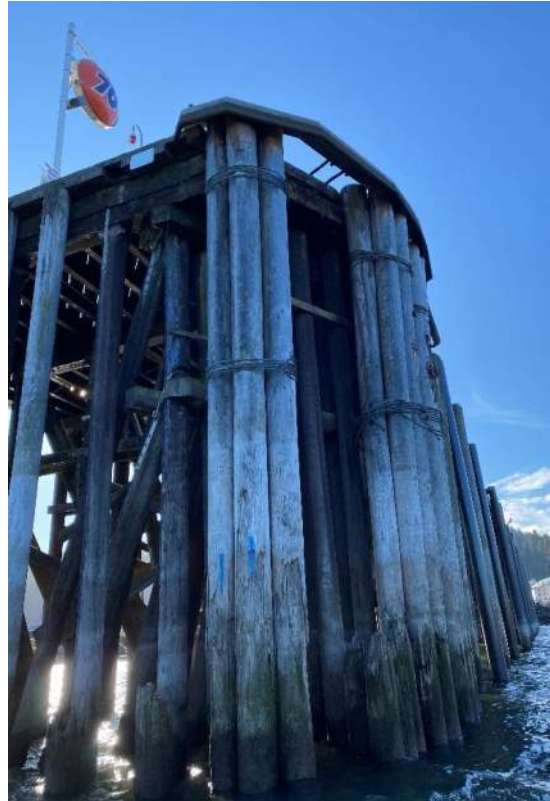
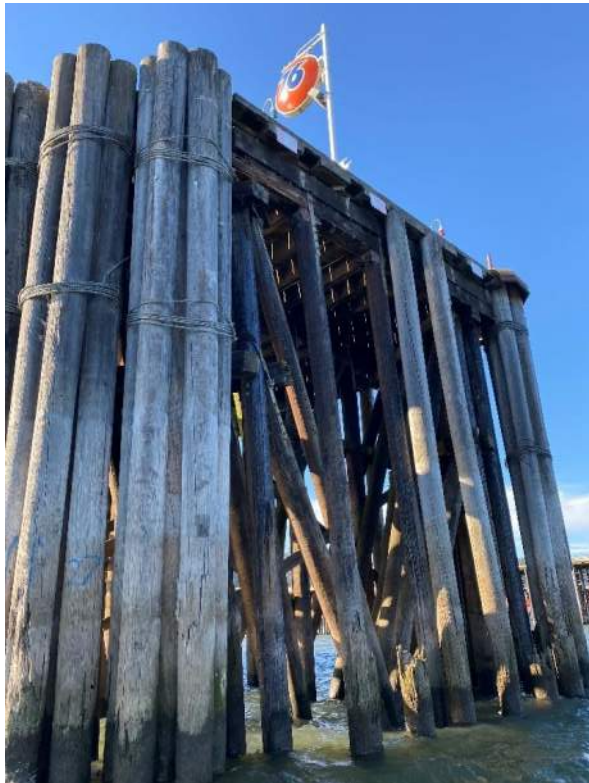
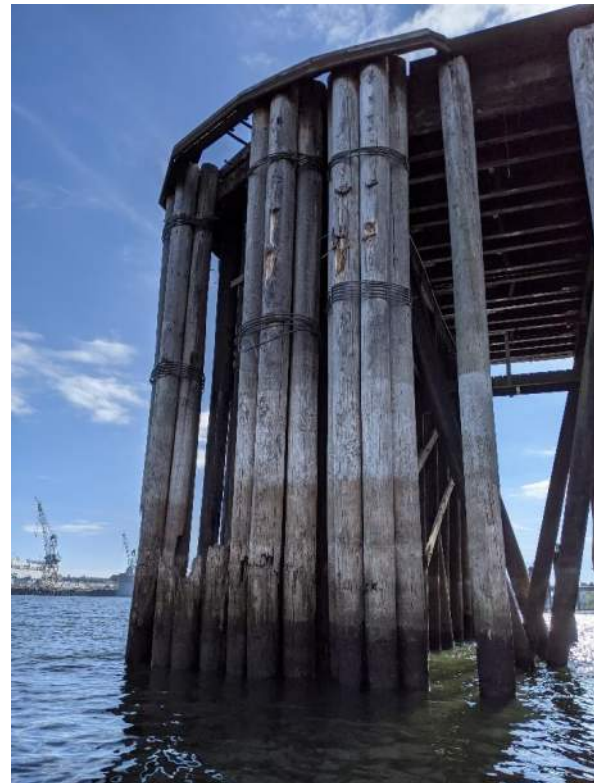
Pictures 11,12, 13, and 14. Pier head cluster piles. Note broken and missing piles, dead heads at either corner, broken and missing piles at head.

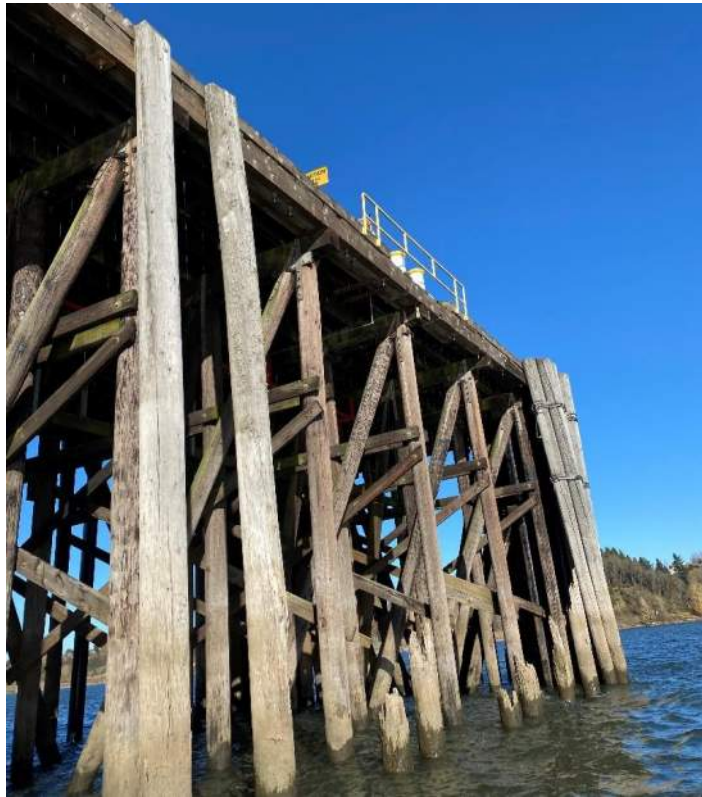
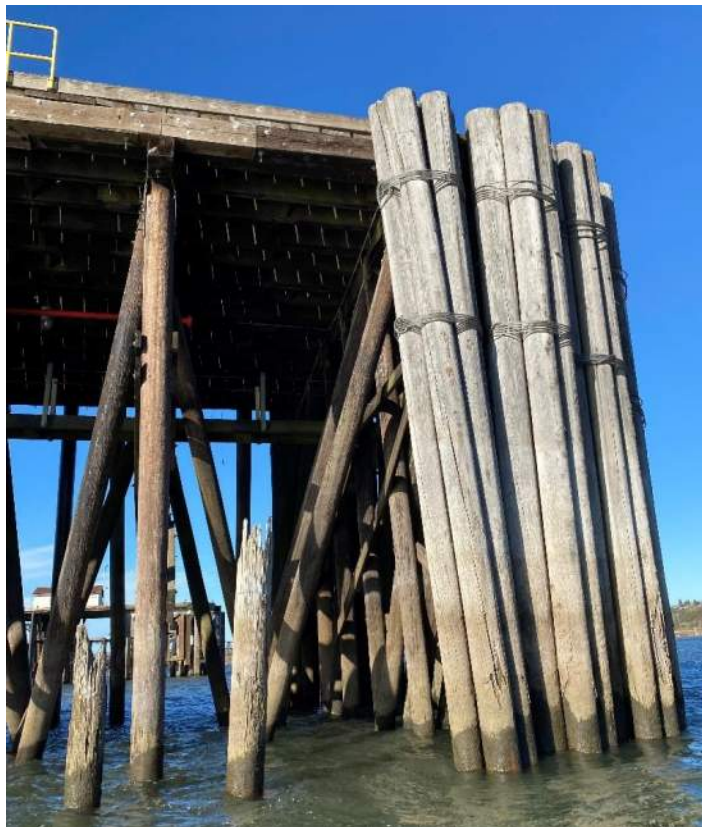
Pictures 15 and 16. Upstream berth, near head. Note broken/missing fender piles, exposed structure.

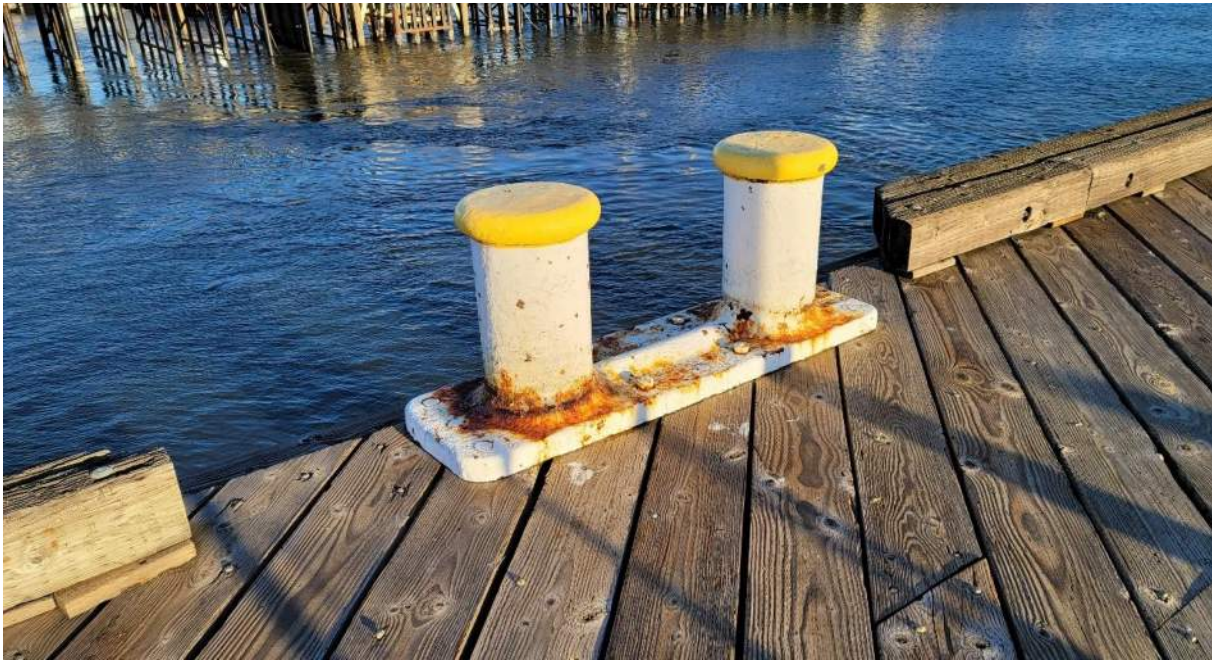
Picture 19. Bollard 'C'. Note wear to coating from line abrasion.

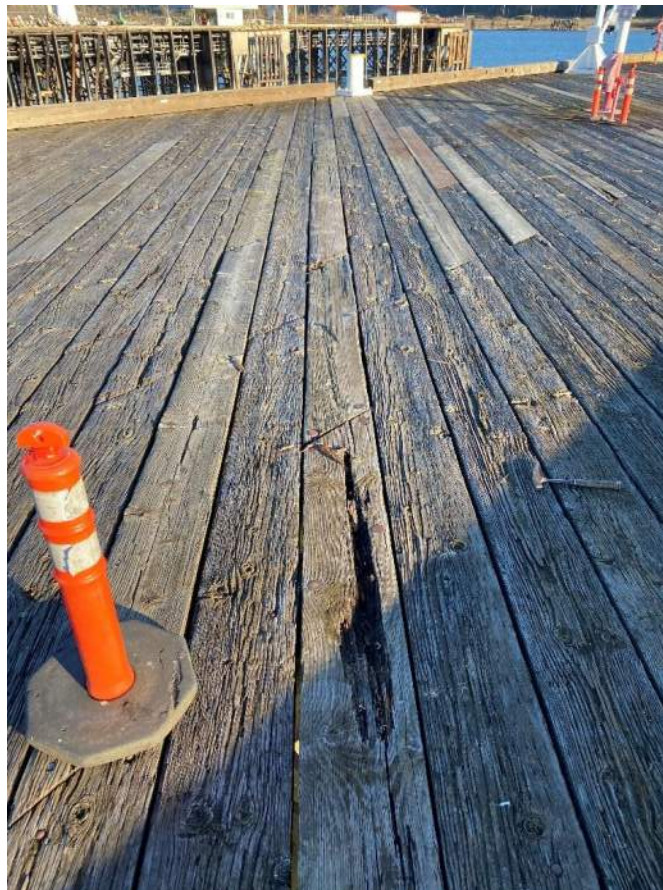
Picture 20. Evidence of significant decay to decking, shoreside of service area.

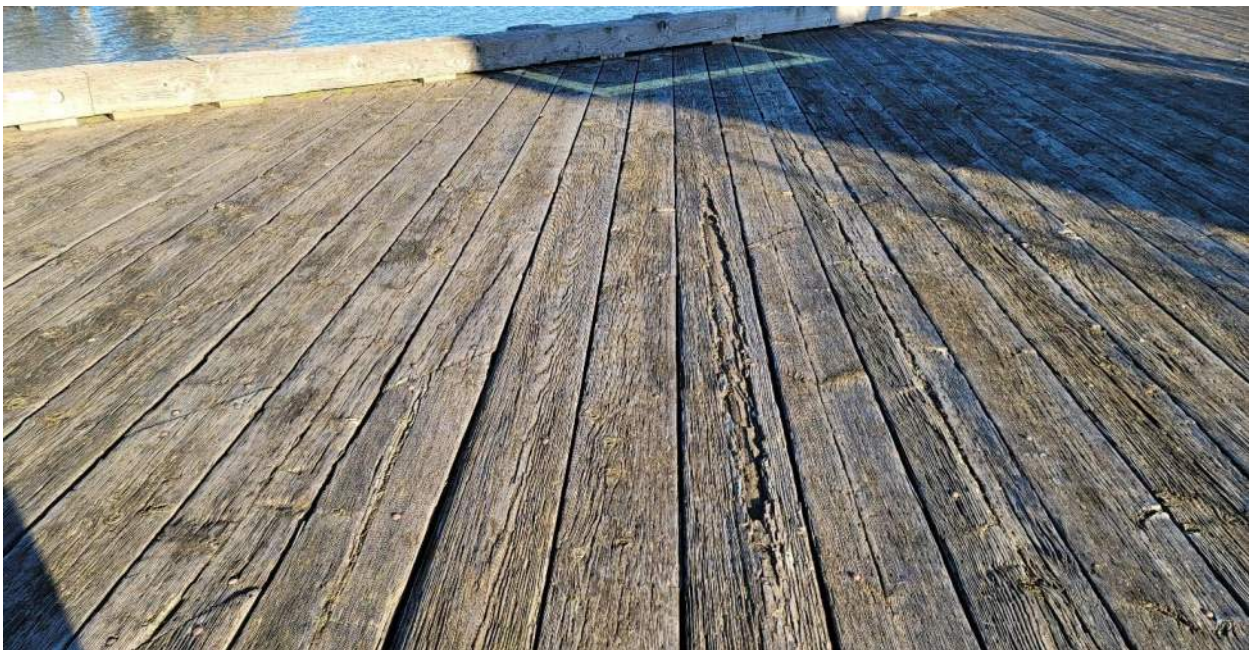
Picture 22. . Evidence of decay, riverside of service area.

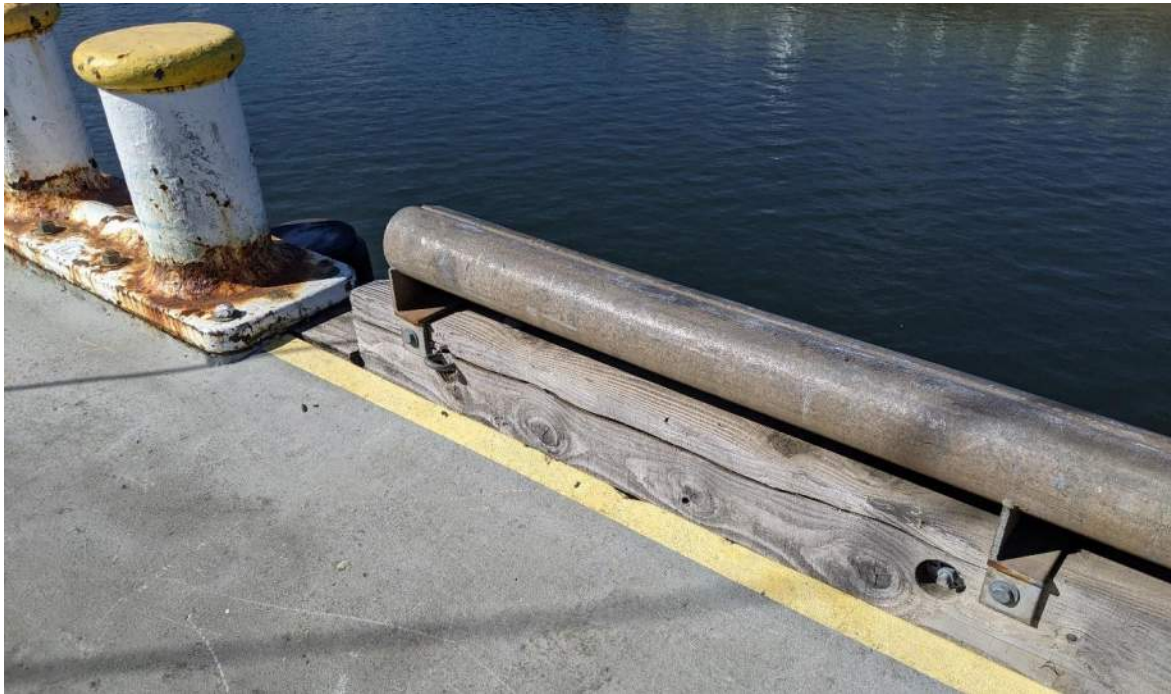
Picture 25. Split in bullrail, downstream berth.

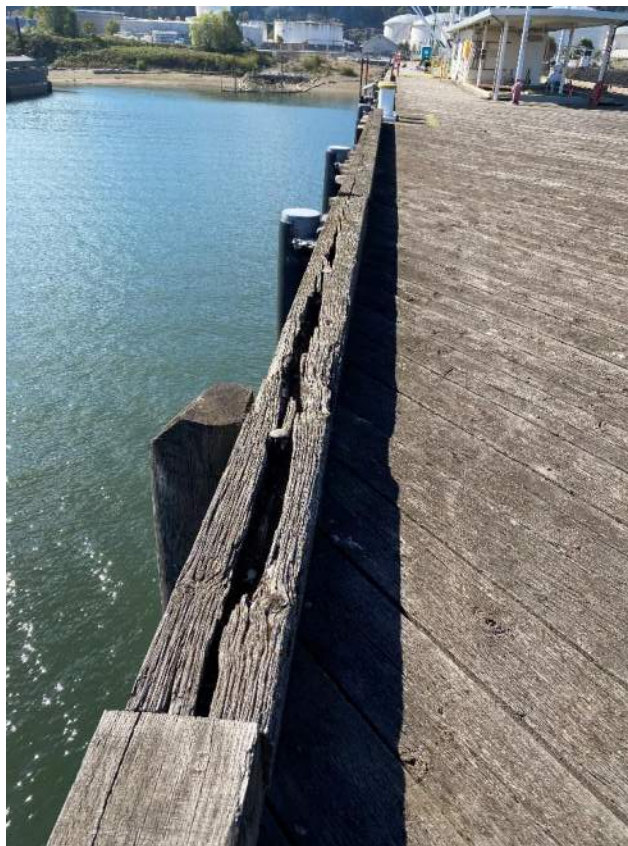
Picture 26. Severe fungal decay in bullrail, upstream berth.

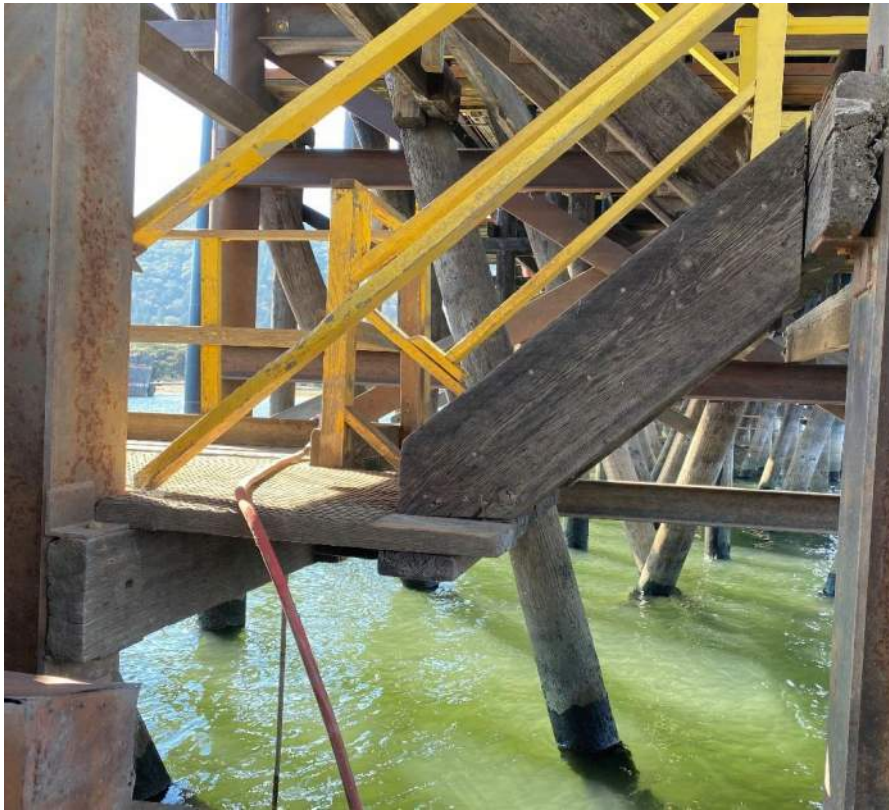
Picture 33. Grid 46, lower stair, taken from the floating deck. Note poor framing not catching base of stairs, evident decay in framing members, gaps forming in connections.

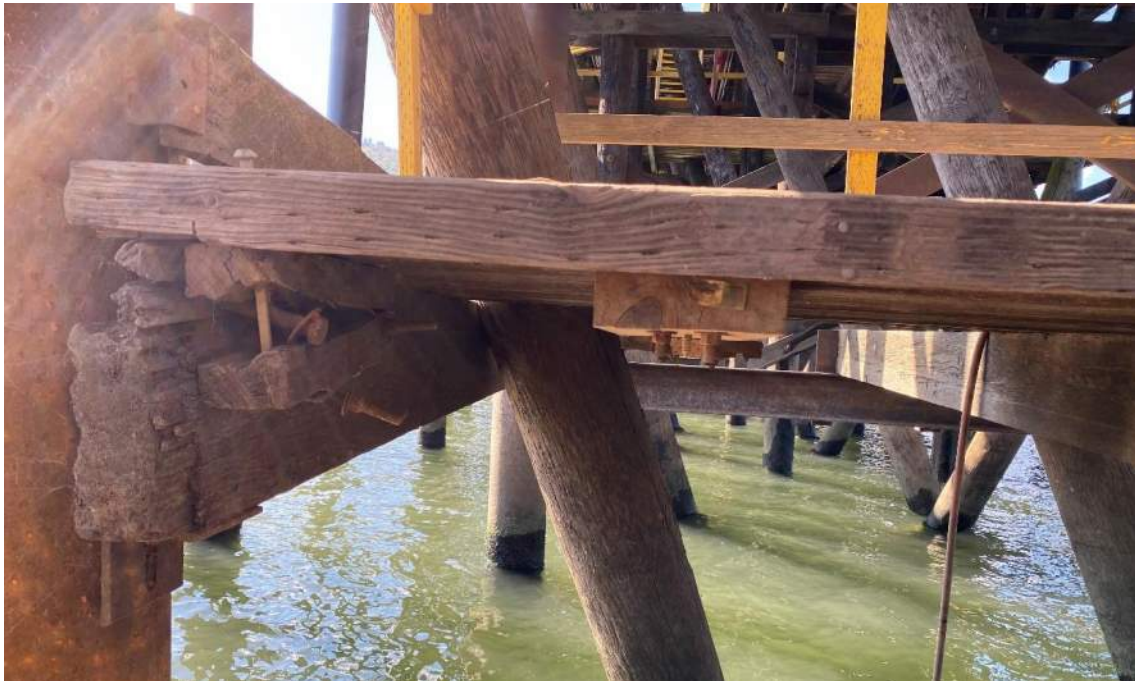
Picture 34. Grid 46, lower platform to floating deck, upstream side. Note significant framing decay and failing connection.

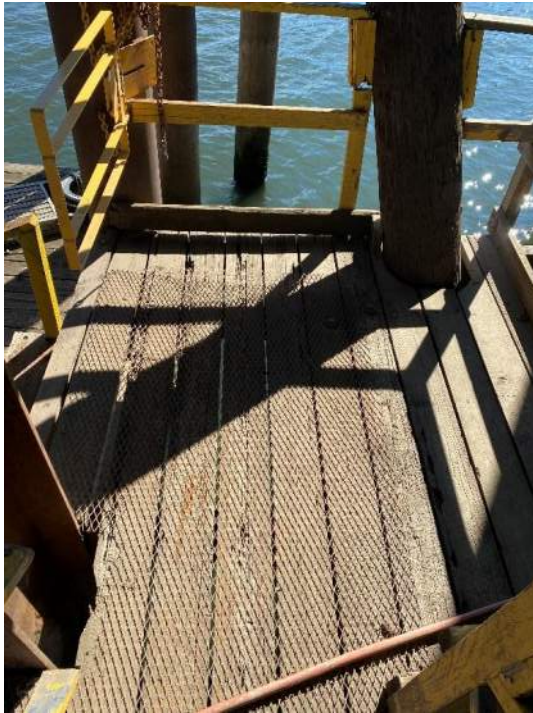
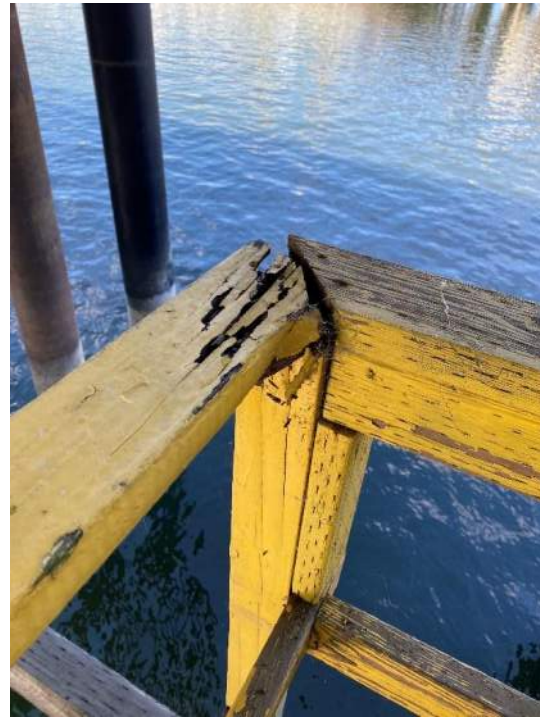
Pictures 35 and 36. Lower platform to floating deck in decay, Grid 46; handrail on third level broken at the corner connection.

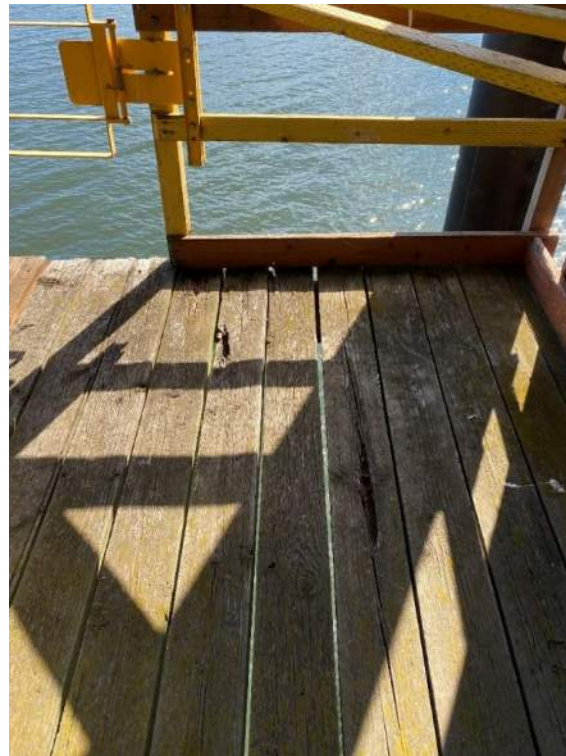
Picture 37. Platform near swing gate, upstream berth Grid 42. Note two deck boards in need of replacement, weathering and decay noted on ends of boards below gate in upper left corner.

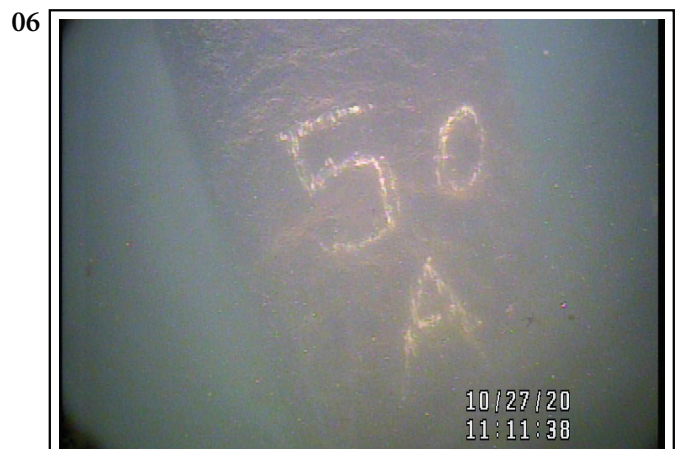
Pile 50 A - Loose at top.

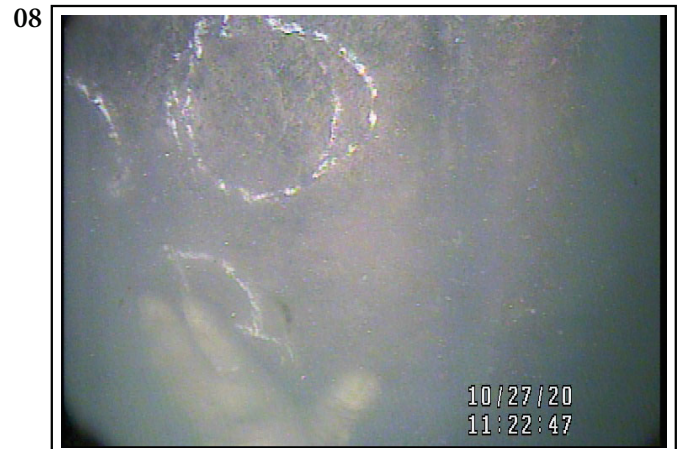
Pile 50 B - Splitting observed.

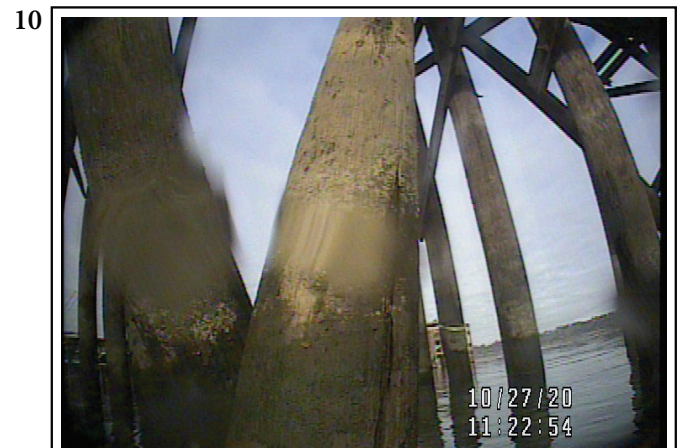
Pile 50 B - Splitting observed.

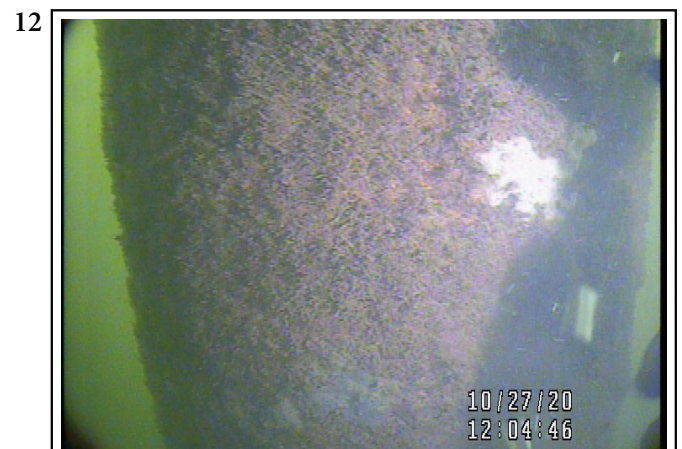
Pile 49 - Minor corrosion sighted.

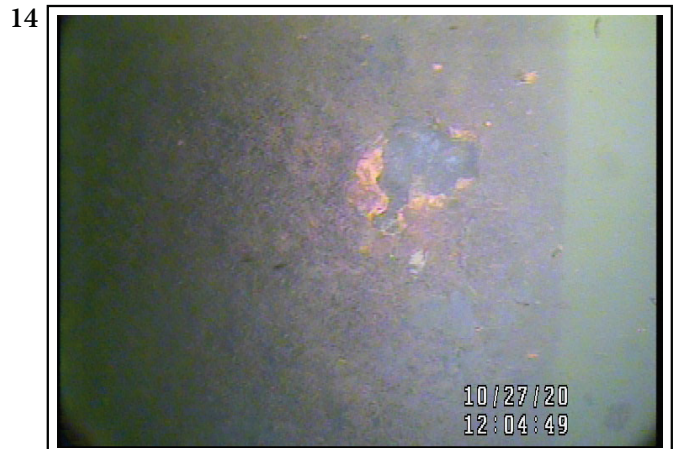
Fender Pile 48 - Minor corrosion sighted.

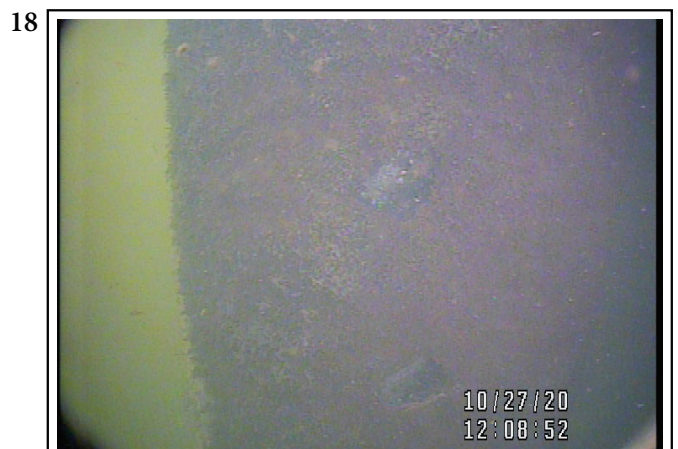
Pile 47 E - Minor corrosion sighted.

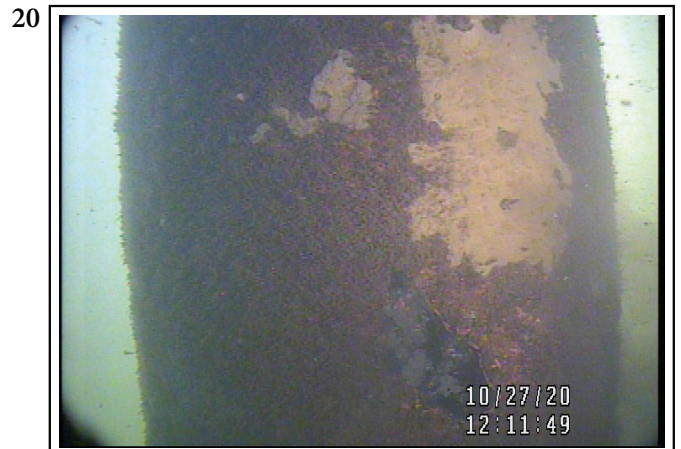
Pile 47 B - Minor corrosion sighted.

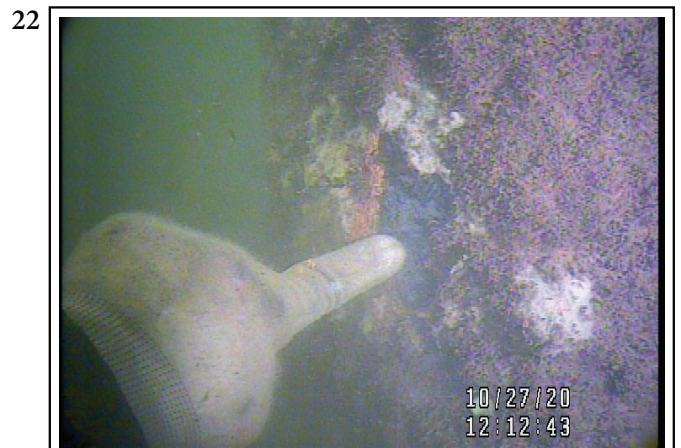
Pile 47 B - Minor corrosion sighted.

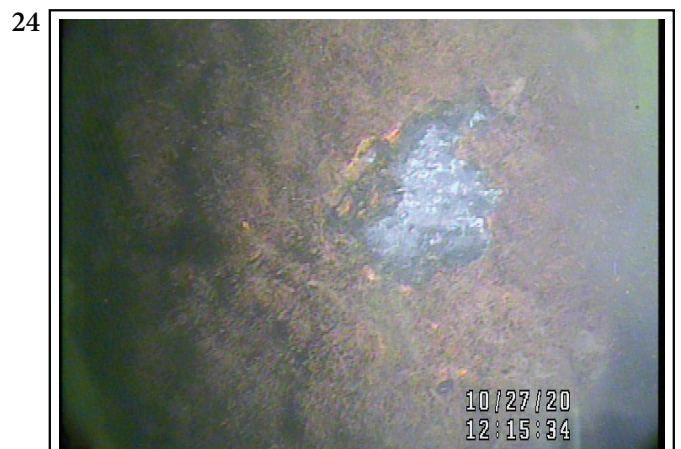
Pile 47 A - Minor corrosion sighted.

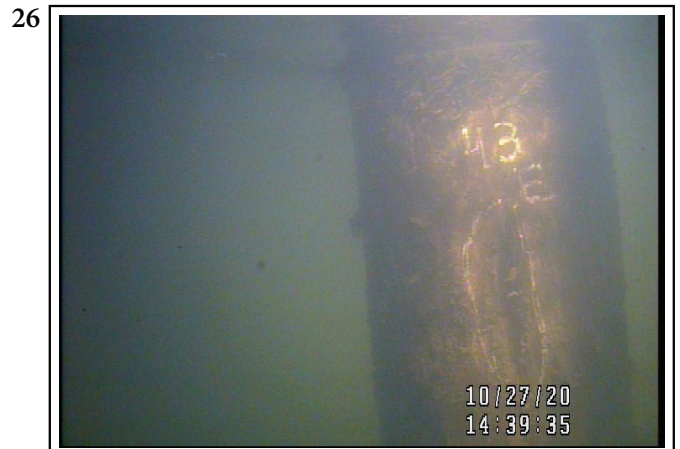
Pile 43 E - Timber compromise observed.

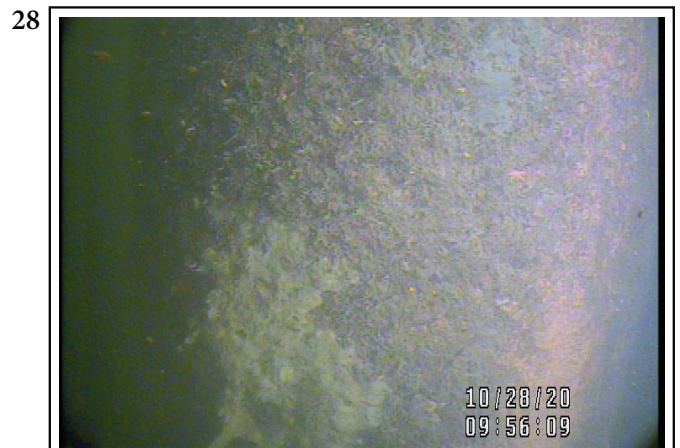
Fender Pile 41 - Minor corrosion sighted.

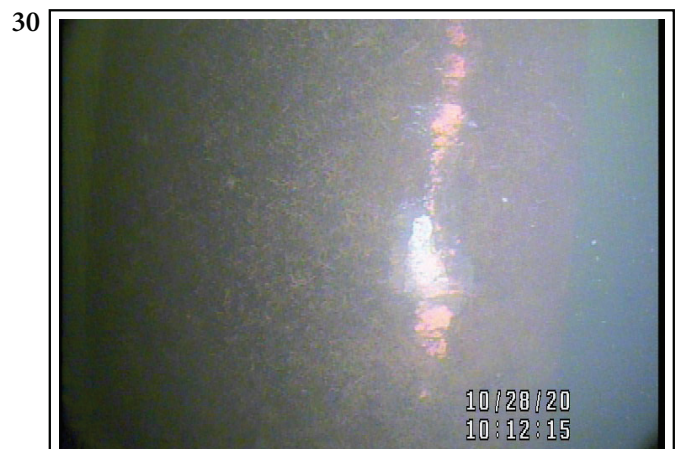
Fender Pile 41 Downstream side - Minor corrosion sighted.

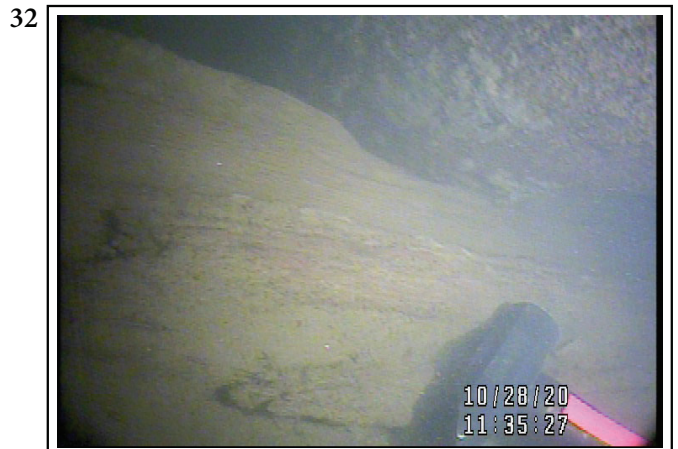
Pile 41 B - Loose at top. No splitting observed at mudline.
