Oregon Department of Environmental Quality

Operations and Maintenance Report January 2023 to December 2023

McCormick & Baxter Superfund Site Portland, Oregon ECSI No. 74

August 14, 2024

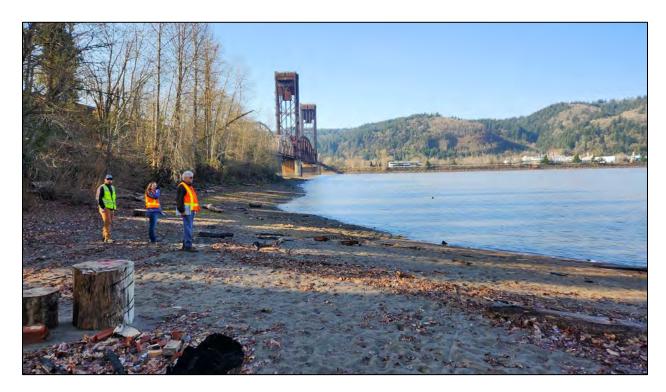
Photograph 1: Shoreline condition of the sediment cap in Willamette Cove. View facing west.

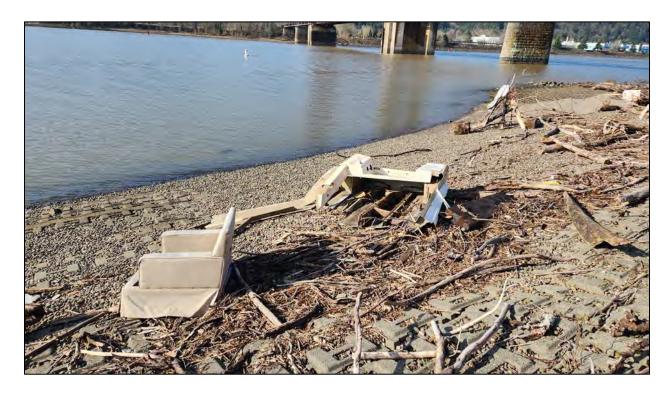
Photograph 2: Debris pieces from a small vessel on the Willamette River shoreline.

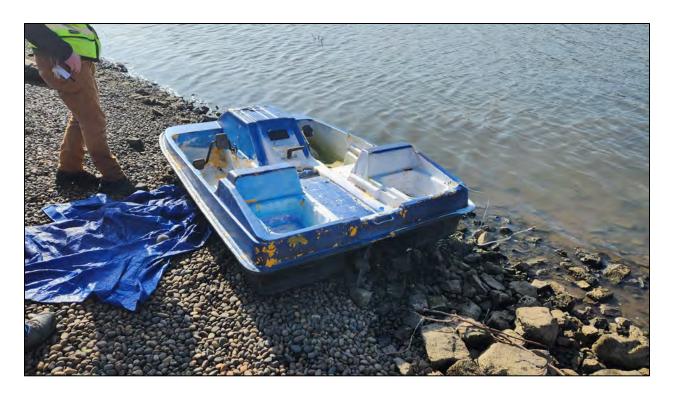
Photograph 3: A derelict paddleboat on the Willamette River shoreline.

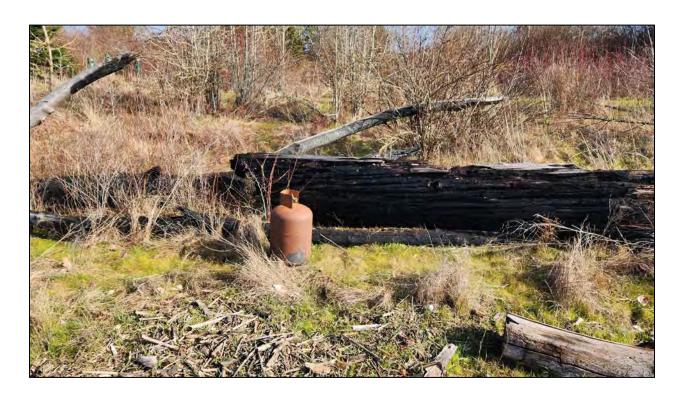
Photograph 4: An old propane tank that had hole punctures and partly filled with water.

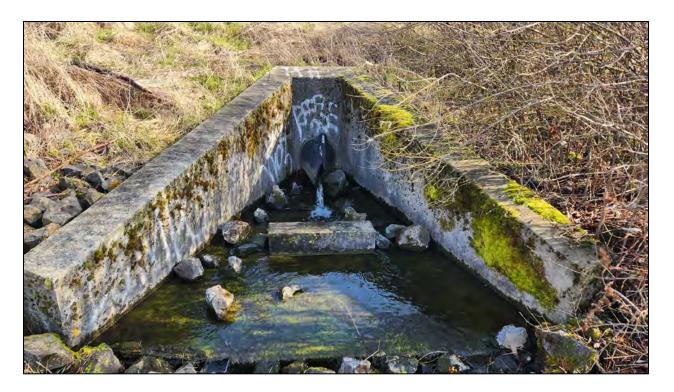
Photograph 5: Estimated 20 gpm flow from the stormwater outfall.

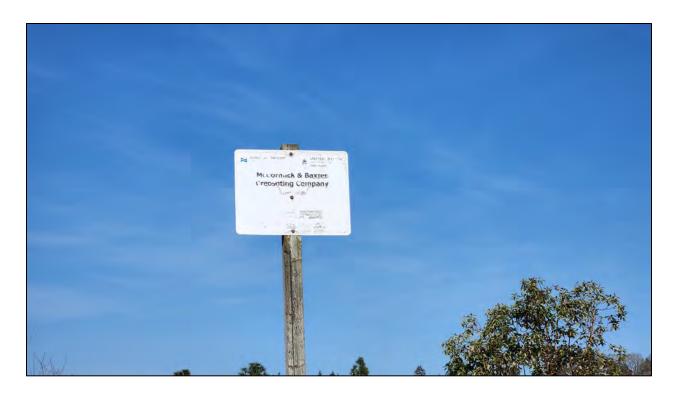
Photograph 7: Perimeter waring sign along fence on N. Van Houten that is faded and illegible and will require replacement.

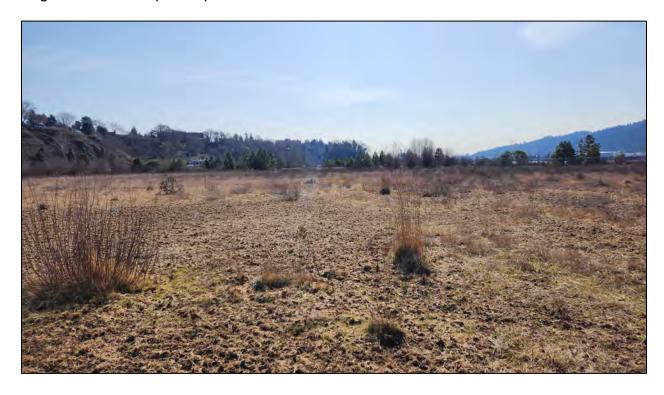
Photograph 8: Impermeable cap condition. View from center of cap facing south.

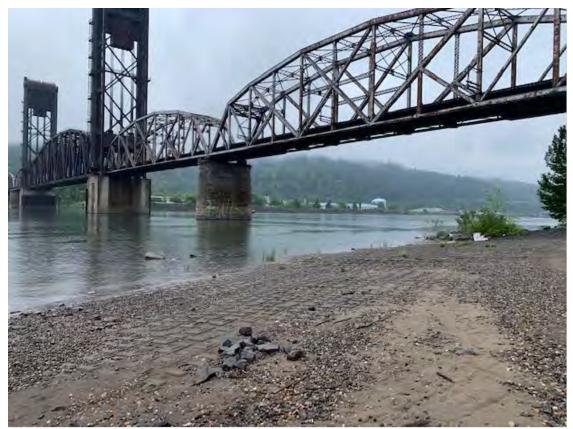
Photograph 1: Willamette River shoreline conditions south of the Burlington Northern Santa Fe Railroad lines. View facing north.

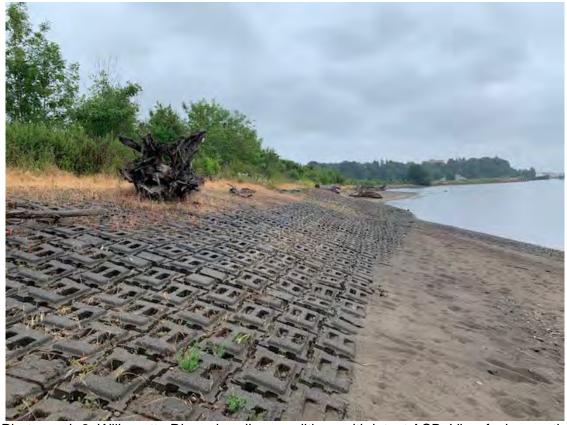
Photograph 2: Willamette River shoreline conditions with intact ACB. View facing south.

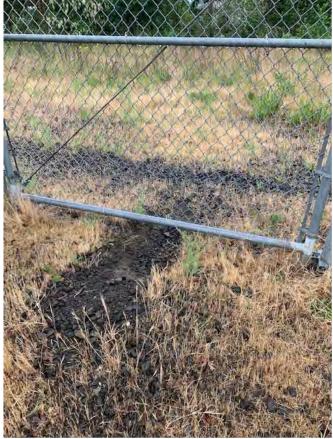
Photograph 3: Animal burrow at western fence. View facing west.

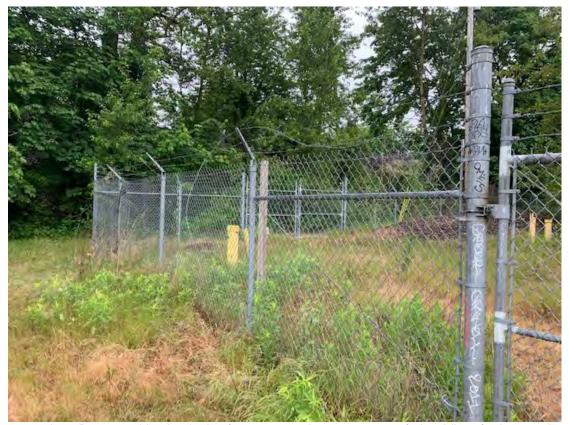
Photograph 4: Damaged barbed wire fence at northwest corner of site. View facing northeast.

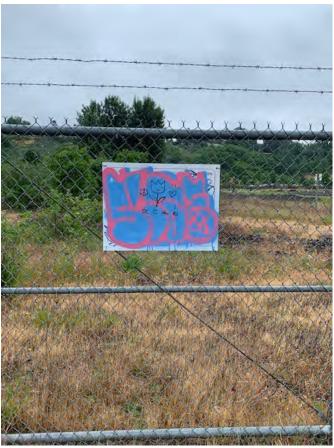
Photograph 5: Typical graffiti covering site sign at southwest corner of site. View facing east.

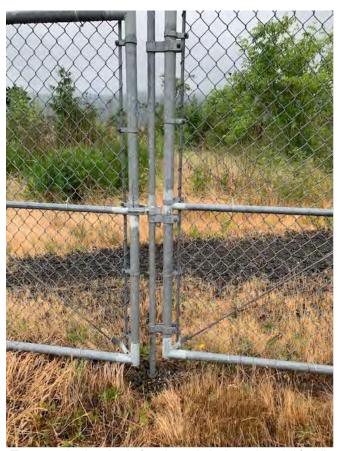
Photograph 6: Fence missing lock (replaced during site visit). View facing west.

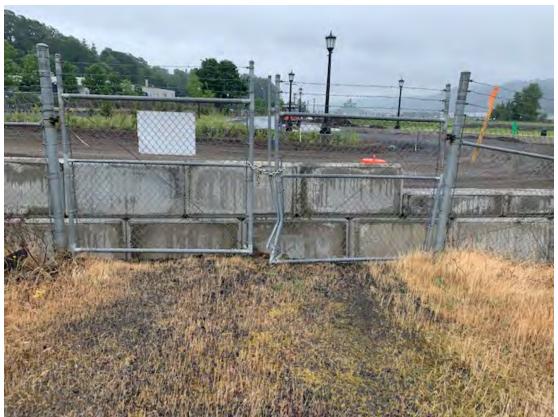
Photograph 7: Main site entry gate at southern side of site, blocked during road construction. View facing south.

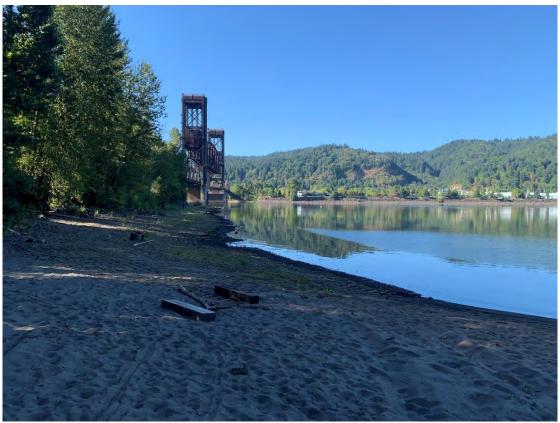
Photograph 1: Willamette Cove shoreline conditions. View facing west.

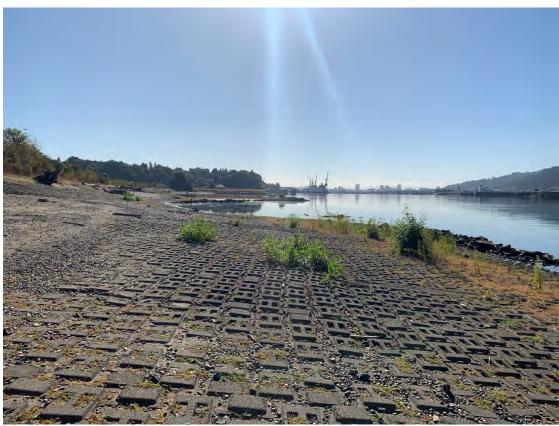
Photograph 2: Willamette River shoreline conditions with intact ACB. View facing south.

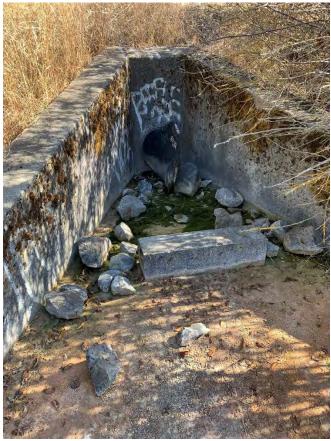
Photograph 3: Stormwater outfall was dry during inspection. View facing east.

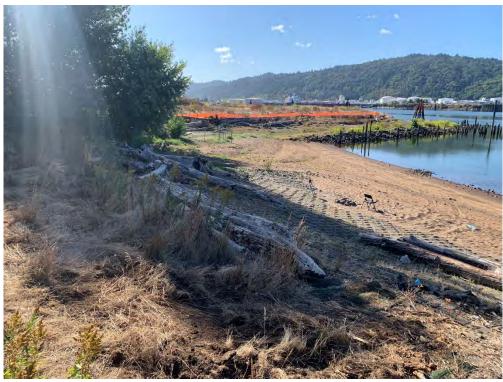
Photograph 4: Tire tracks were observed along the southern portion of the Site, originating from the southern adjoining University of Portland property. View facing south.

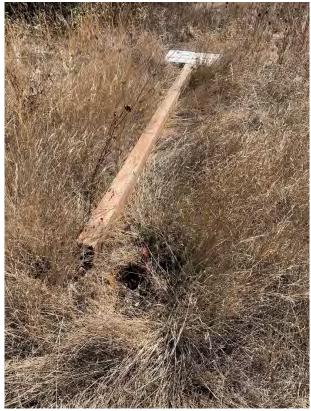
Photograph 5: Broken notification signpost. View facing east.

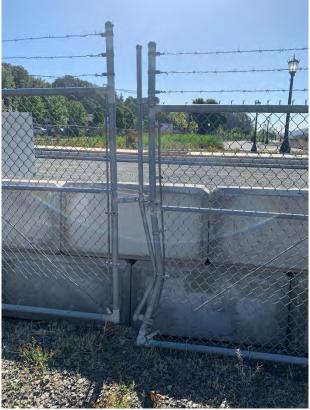
Photograph 6: Fence missing lock and chain. View facing south.

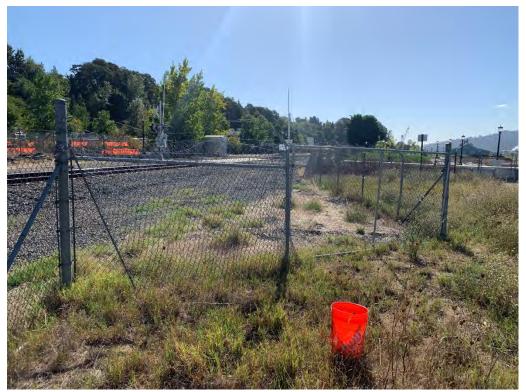
Photograph 7: Fence panel removed from southeast corner of Site. View facing south.

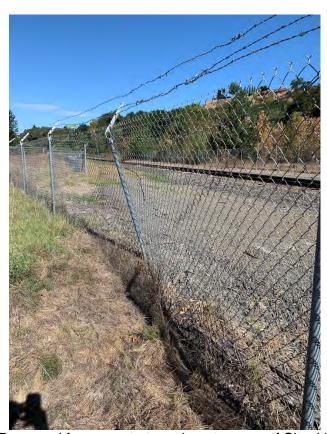
Photograph 8: Damaged fence post at southeast corner of Site. View facing east.

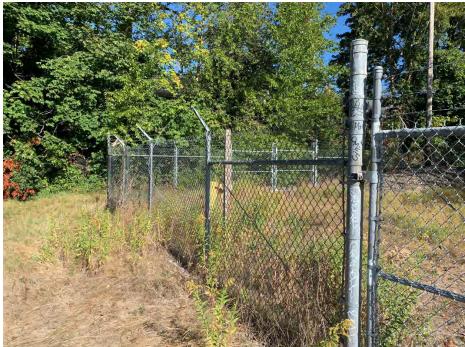
Photograph 9: Damaged barbed wire above fence at northwest corner of Site. View facing north.

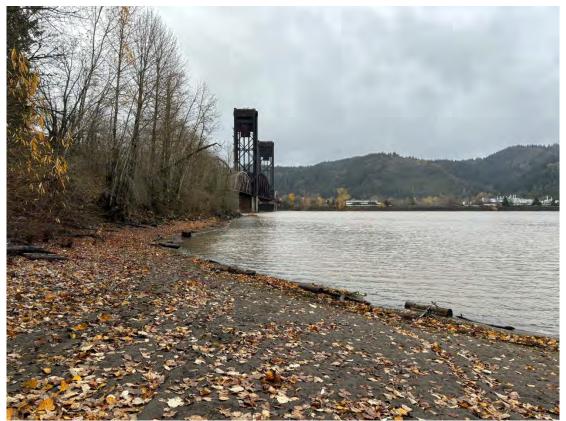
Photograph 1: Willamette Cove shoreline conditions. View facing west.

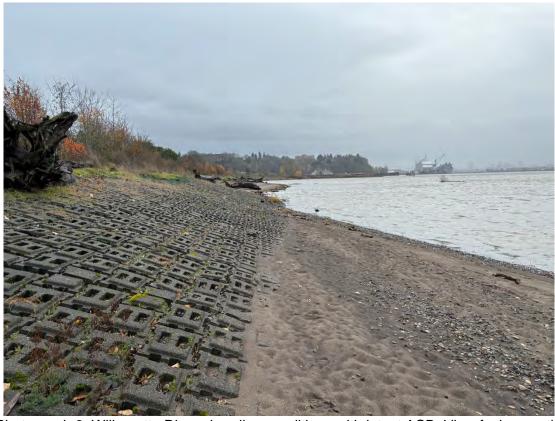
Photograph 2: Willamette River shoreline conditions with intact ACB. View facing south.

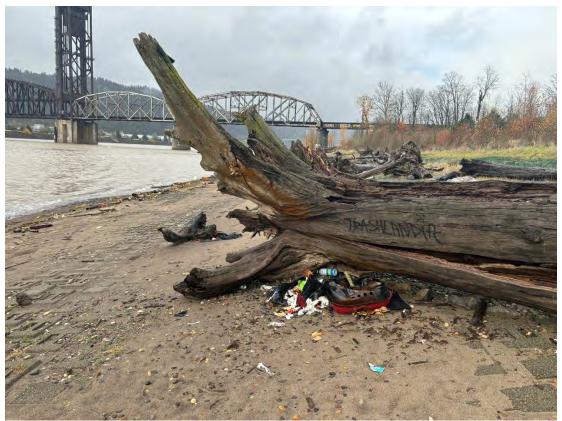
Photograph 3: Typical minor trash and debris observed along the Willamette River shoreline. View facing north.

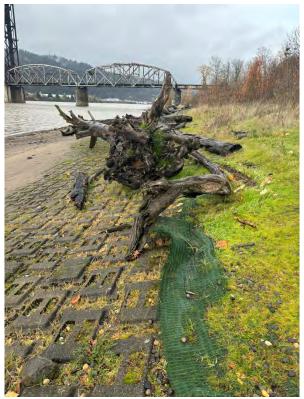
Photograph 4: Area with minor separation of vegetation mat due missing or damaged anchors as a result of mobile driftwood. View facing north.

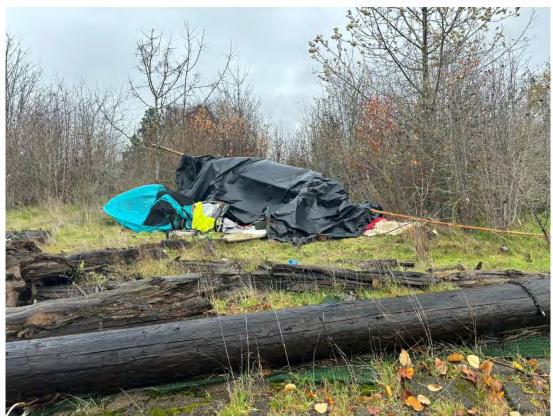
Photograph 5: Homeless encampment observed along the Willamette River shoreline between the on the Willamette River shoreline between the Former Waste Disposal Area and the Tank Farm Area. View facing east.

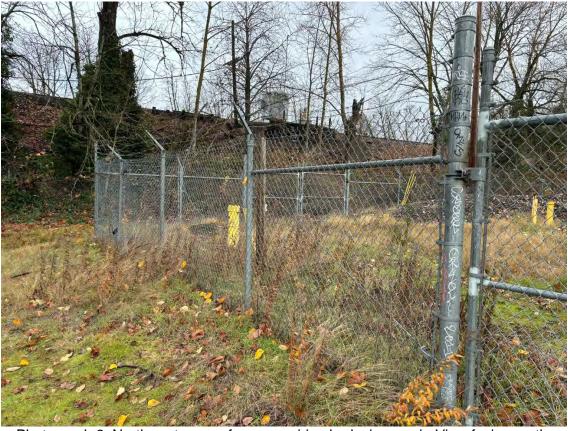
Photograph 8: Northwest corner fence requiring barbwire repair. View facing north.

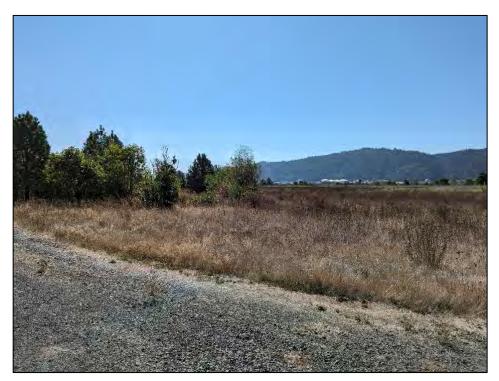
B1: Earthen cap and drainage swale in the foreground with impermeable cap in the background. Taken looking south form Photograph Station 1 comparing baseline and conditions in 2014. (Left – June 2011, Right – June – 2014)
