State of Oregon  
Department of Environmental Quality

Memorandum

**Subject:** Butler Ford, ECSI #6579; Staff Memorandum in support of a No Further Action determination

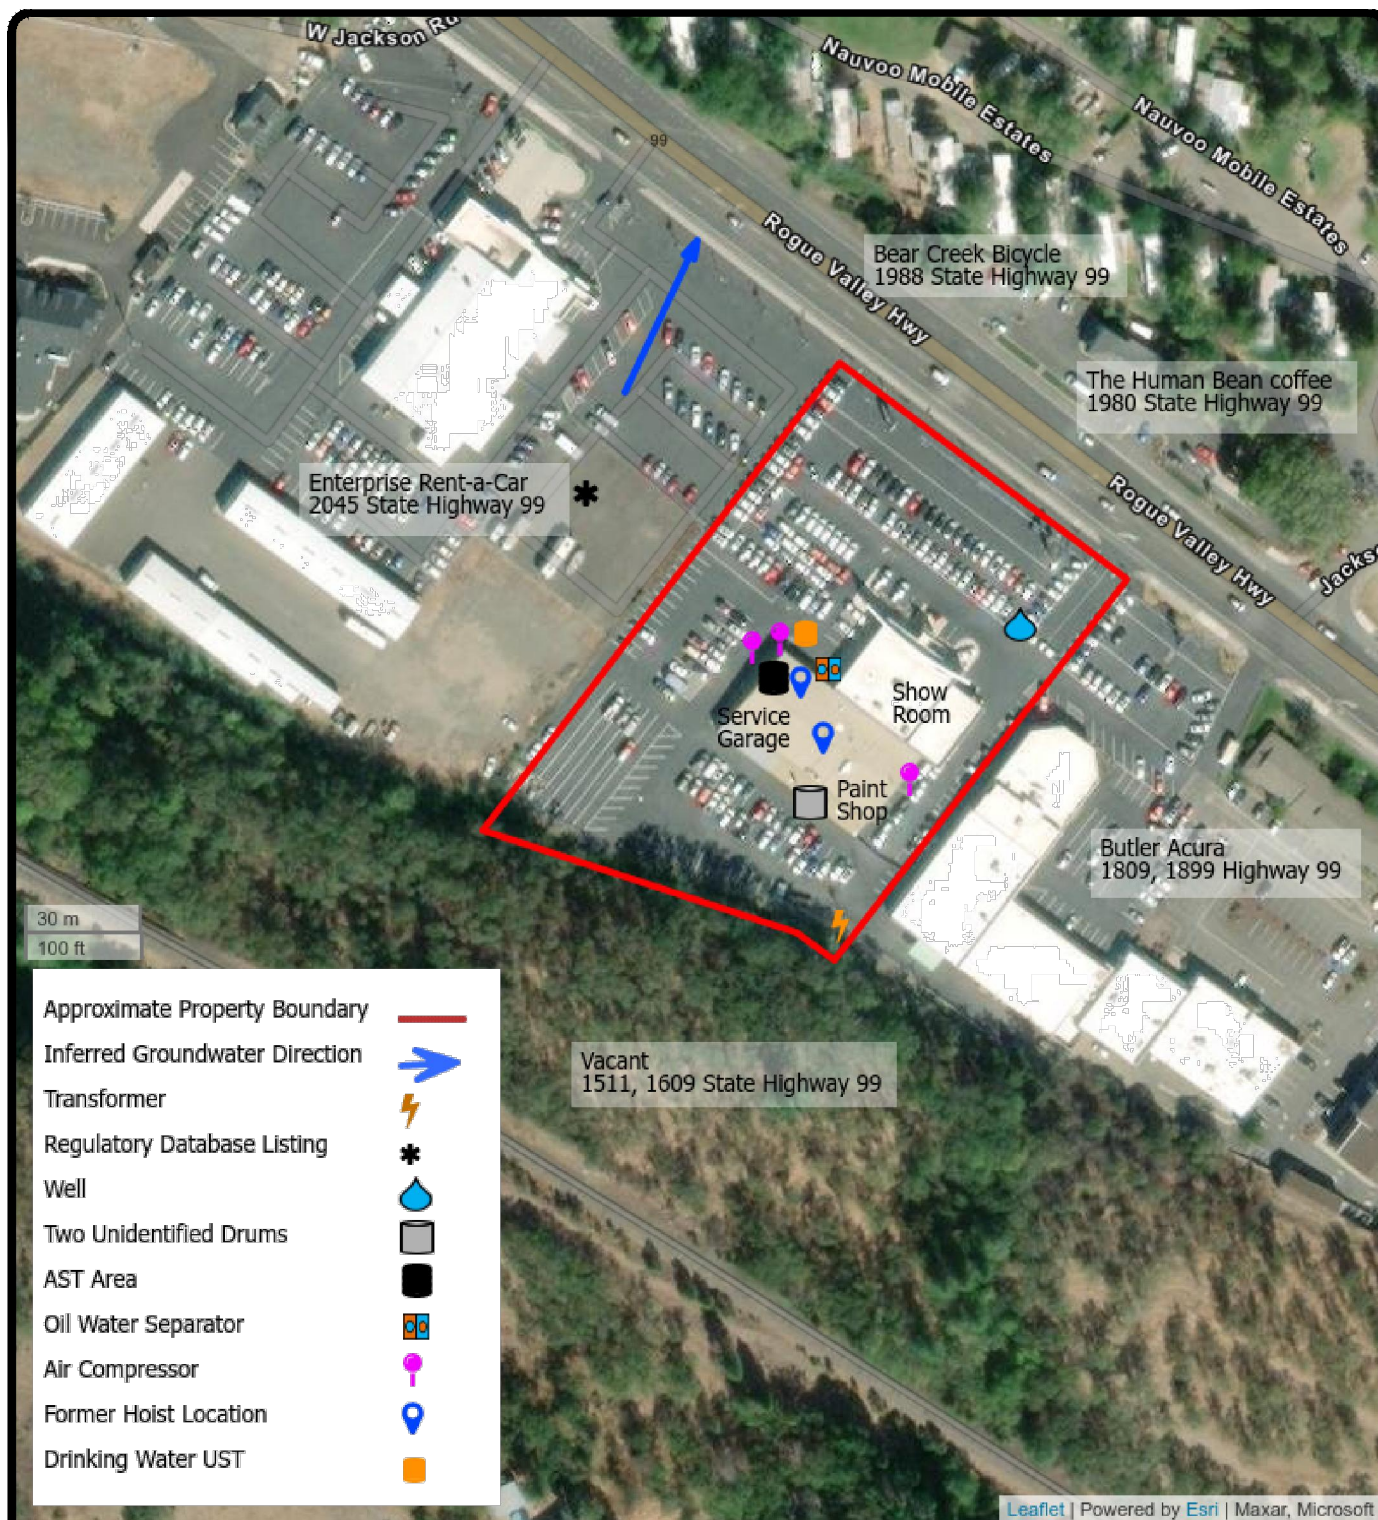
Figure 2  
Site Map  
Butler Ford  
1977 Highway 99 North  
Ashland, Jackson County, Oregon 97520

In 2021, a phase I site assessment identified the OWS as a potential environmental concern. The OWS is connected to a trench drain inside the maintenance area. The trench drain was filled with concrete in 2020 and is no longer in use. Additional investigations at the site were conducted between 2021 and 2023 to determine if there were environmental impacts related to the OWS. Investigations included two soil borings and temporary wells around the OWS and groundwater sampling of the onsite domestic well (Figure 2).

An excavation, approximately 20 feet by 5 feet, was dug next to the OWS to confirm the results from the soil borings. The excavation was terminated at groundwater, a depth of 12.5 feet. Two soil samples were collected. Approximately 21 tons of contaminated soil were excavated from around the OWS and disposed of at Dry Creek Landfill in Eagle Point, Oregon. A complete removal of the OWS and additional impacted soil was not completed due to physical barriers at the site.
